# McCosker Creek Restoration and Public Access Project:

## Alder Creek Daylighting Additional Monitoring Elements - Final Report

**San Francisco Estuary Institute**

December 2023

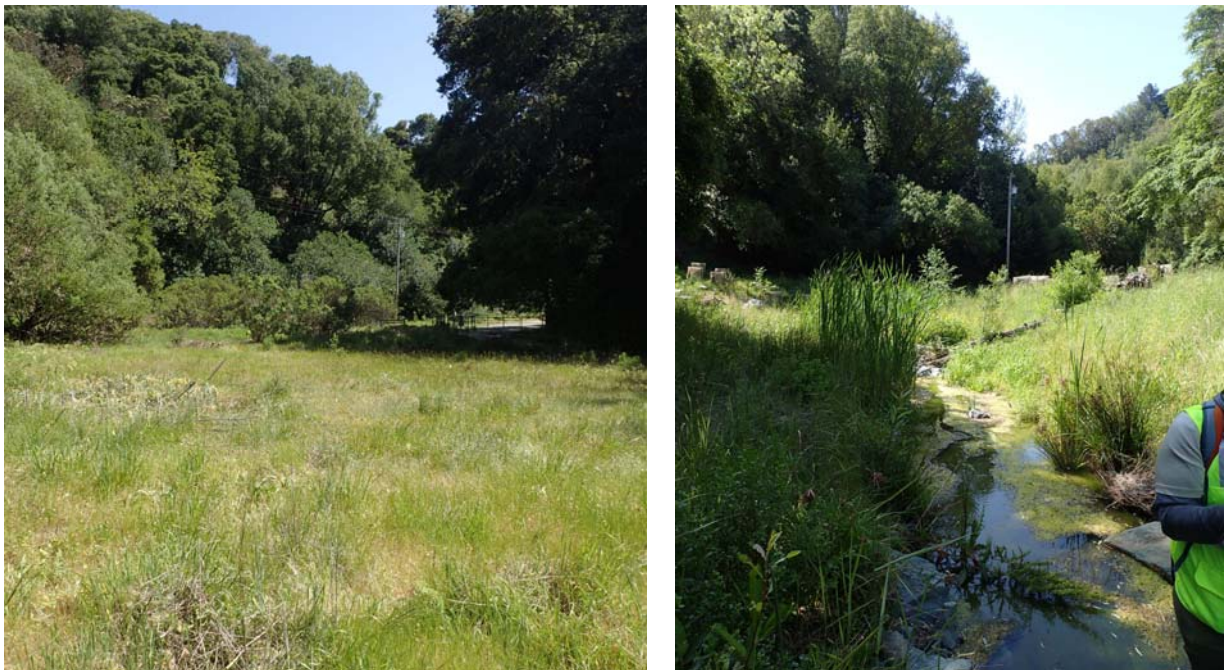
Daylighting and construction of the new channel caused significant changes to occur in the valley cross-section (Figure 3). The previously flat valley bottom was graded to contain an appropriately sized channel, gently sloping banks, and the access road. The resulting project is EBRPD's largest creek restoration project, and the largest creek daylighting project in the East Bay.

**Figure 3.** Photographs illustrating the 2019 pre-construction (left) and 2023 Year 1 post-construction (right) condition of Alder Creek in a representative lower-watershed location. Notice the power pole for reference in both photos.

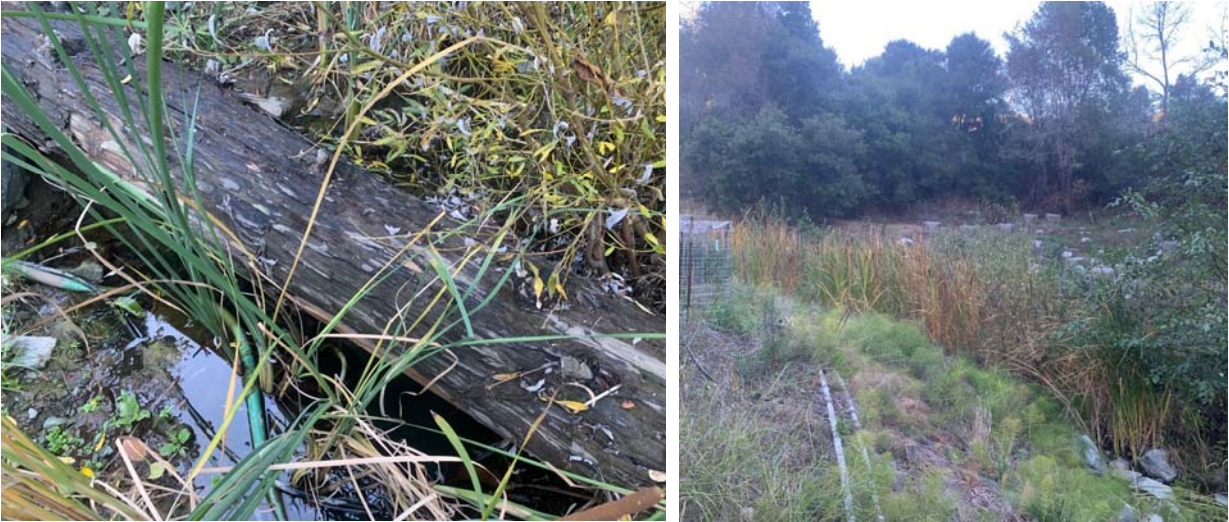
The 2022-2023 rainy season had a large total amount of precipitation, causing channel morphology change at both monitoring locations. In Alder Creek, the placed log caused the scour of a deeper pool on the downstream side, and the channel was more heavily vegetated in general. In 2023, the sensor was placed in this deeper pool, and benefitted from the additional shading provided by the vegetation (Figure 9). In Upper San Leandro Creek, the high flows caused the car body to shift downstream, causing the scour of a new pool approximately 5 m upstream of the previous deployment location. The 2023 sensor was deployed in this deeper pool (Figure 10).

**Figure 9.** Left: 2023 sensor location in Alder Creek, in the pool on the downstream side of the placed log. Right: Looking upstream towards the sensor and the vegetated channel. November 20, 2023.

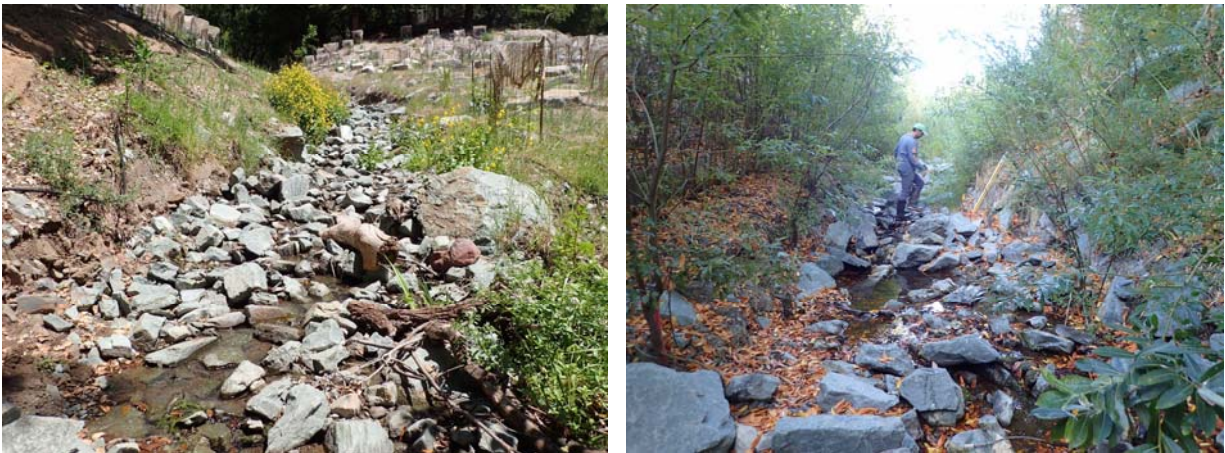
**Figure 26.** Illustration of the large grain size of the placed rock within the channel.

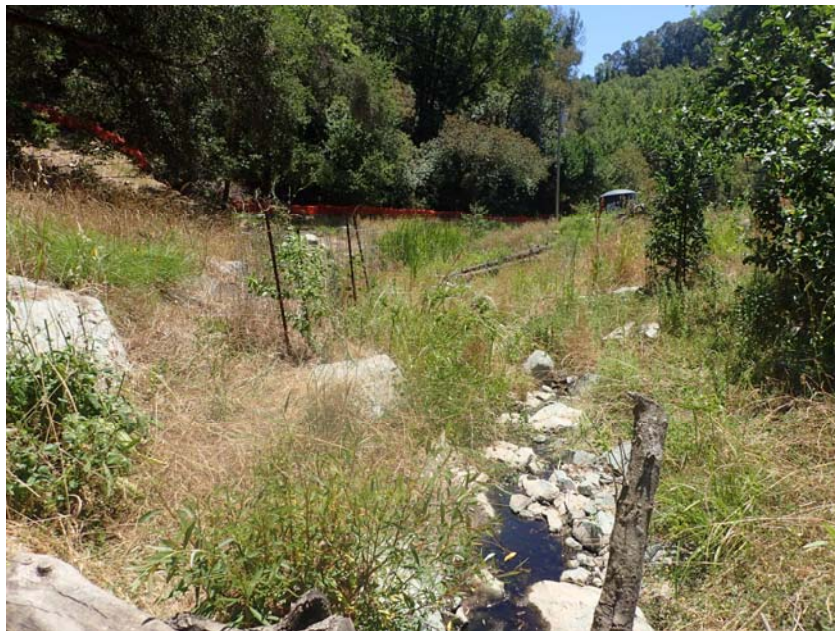
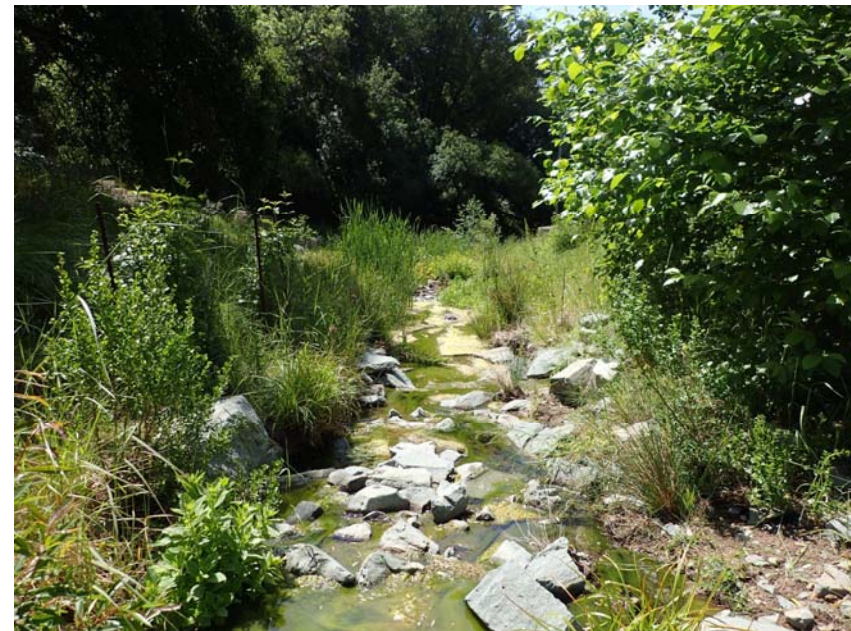
**Figure 27.** Example of the growth, and resulting increased canopy cover from the young planted alder trees in PHab1. See the same group of alders on the right side of each photo: Year 0 (2022) on the left, and Year 1 (2023) on the right.

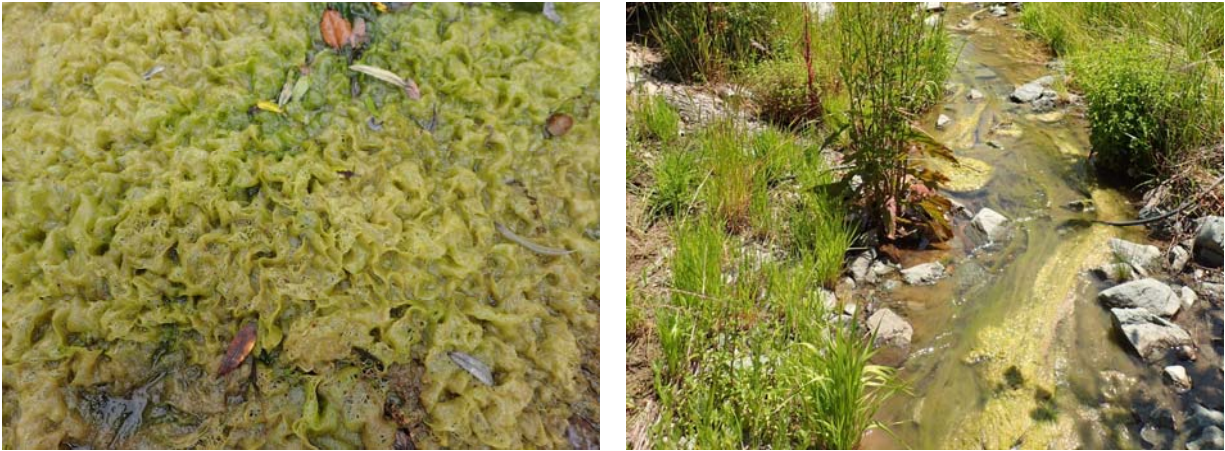
**Figure 28.** Filamentous algae observed in Alder Creek during Year 1 monitoring (2023).

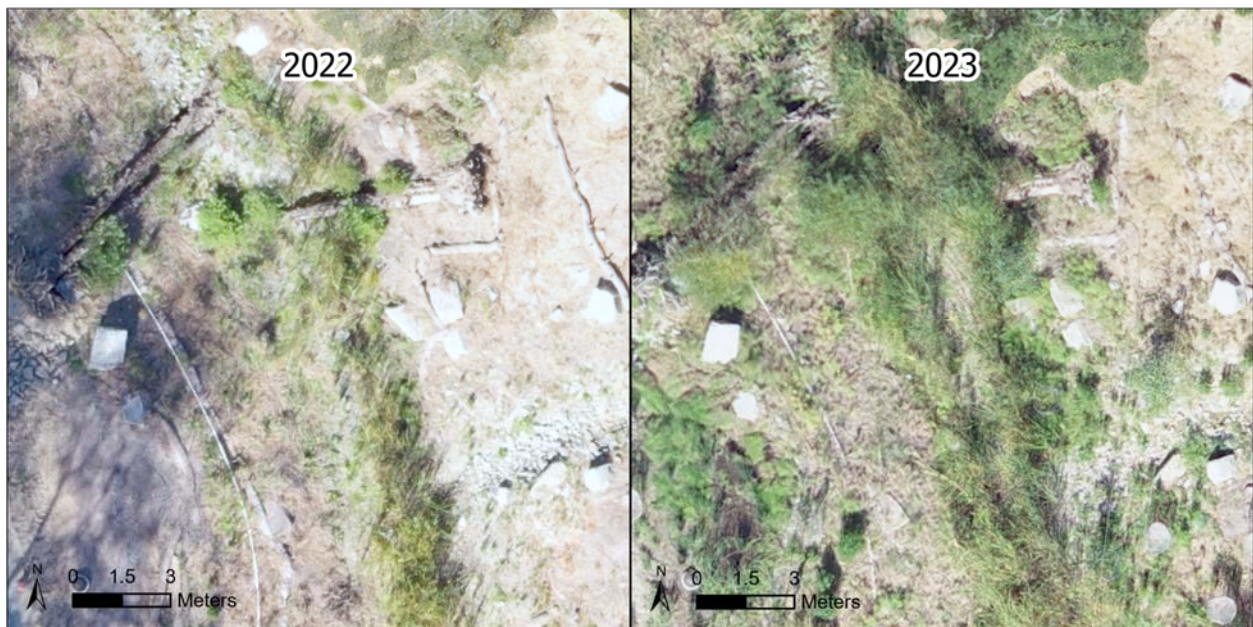
**Figure 31.** Comparison between 2022 and 2023 illustrating the increase in cattail growth at the temperature probe location.

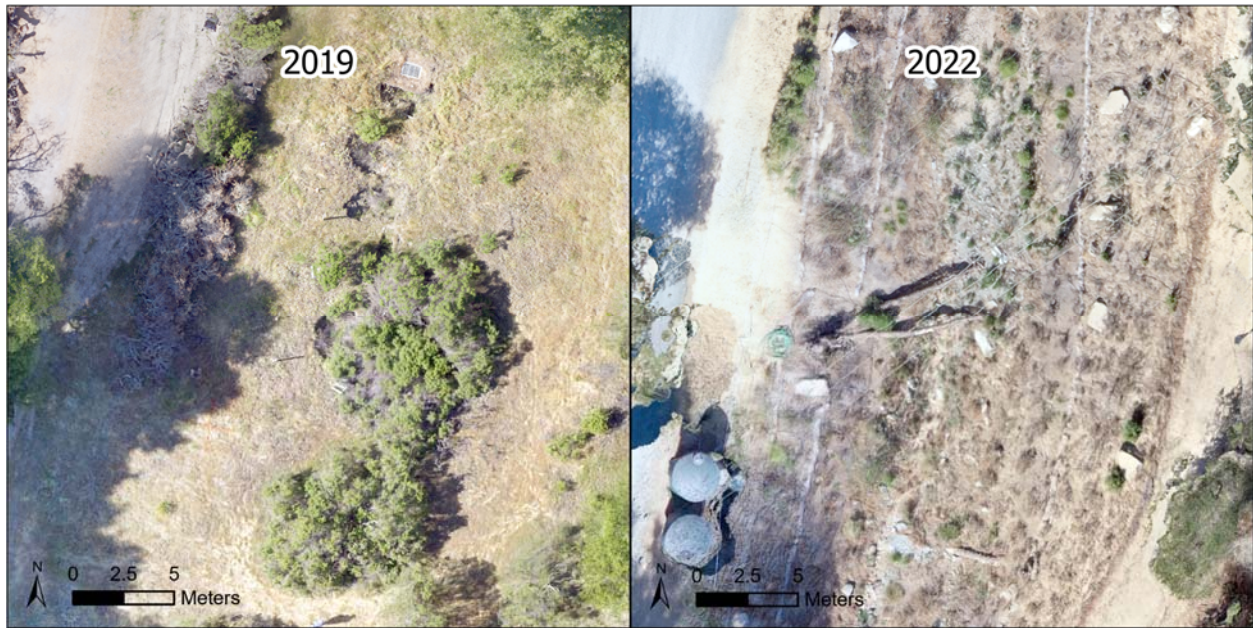
**Figure 32.** Comparison of the valley morphology in 2019 with visible sinkholes due to the failing culvert, with the 2022 valley morphology that features the newly created channel.

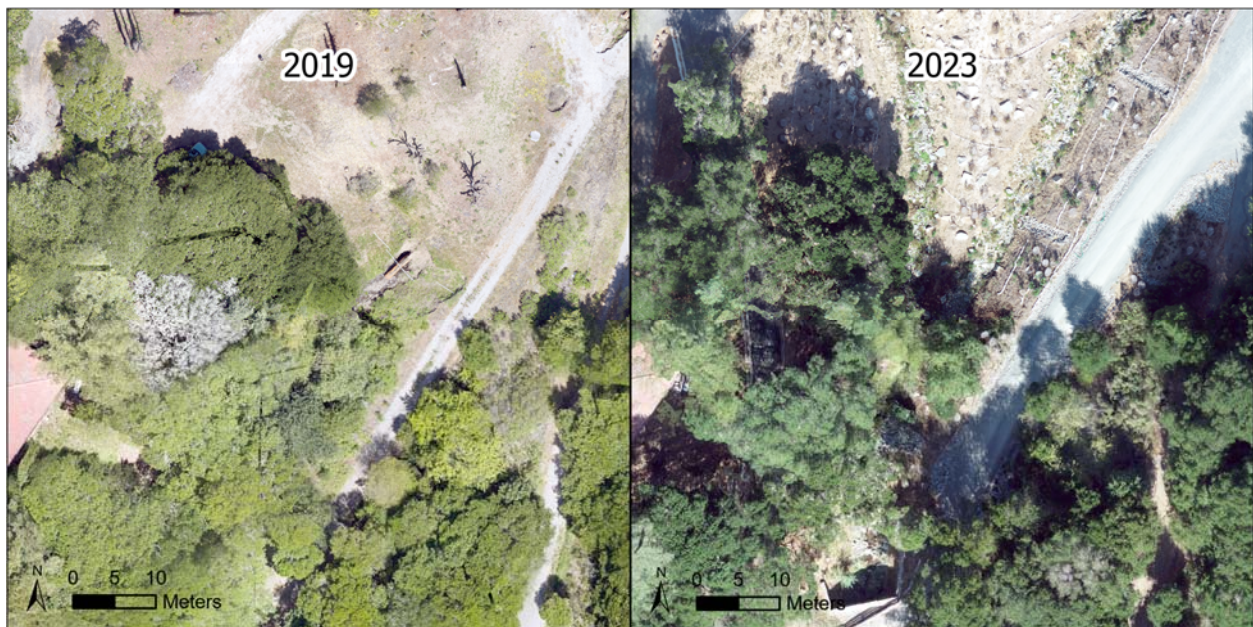
**Figure 33.** Comparison of the 2019 location of the hanging culvert and knickpoint with the 2023 newly created channel morphology.

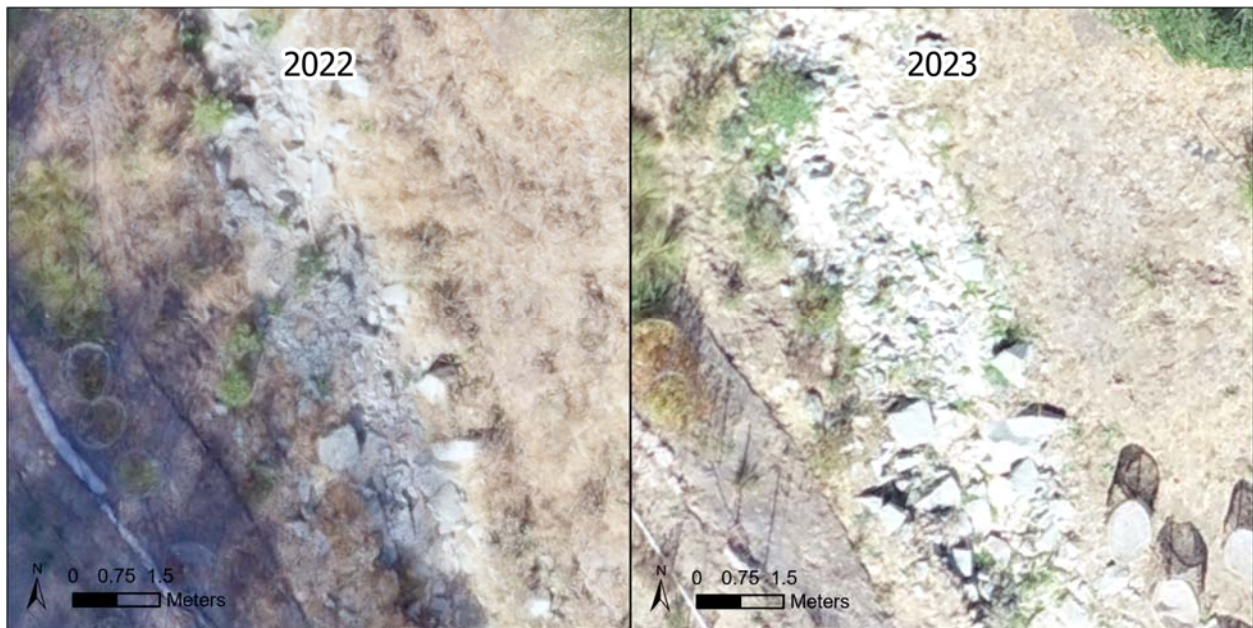
**Figure 34.** Illustration of the size of the placed rock in the channel bed, and its effect upon the grain size distribution of the channel and suitability for rainbow trout spawning.

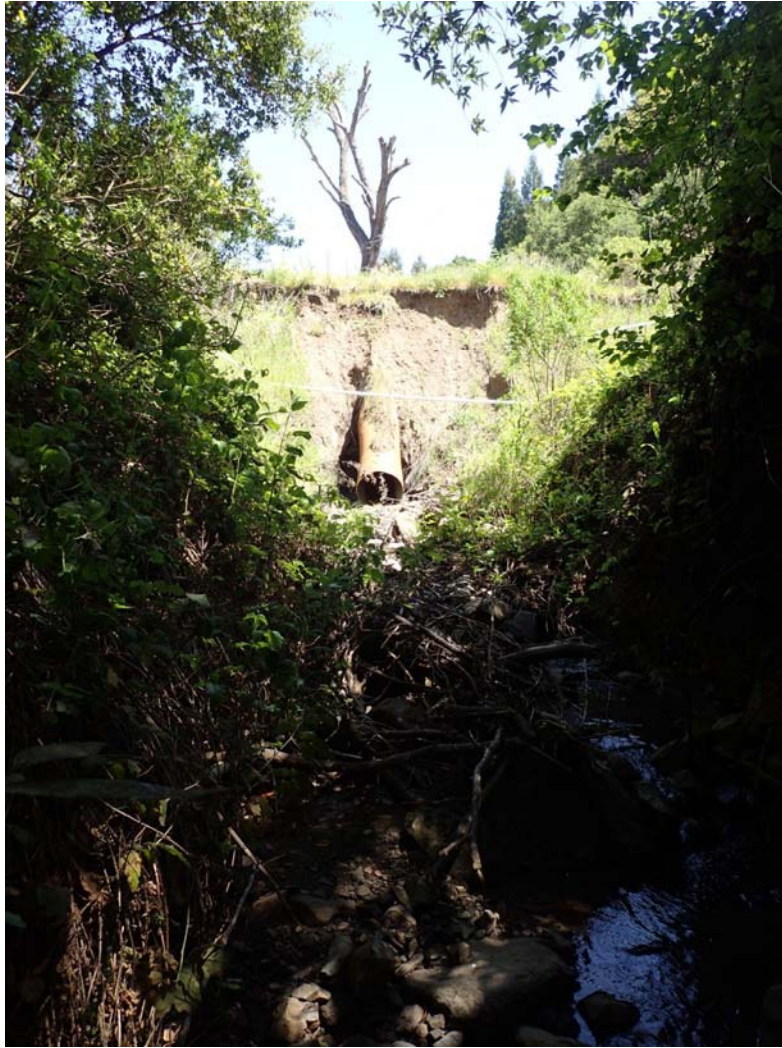
until the culvert began to deteriorate in the 1990s. As the culvert rusted, dangerous sinkholes formed in the valley floor, causing collapse of the overlying fill into the culvert, and subsequent transport of that sediment downstream to Upper San Leandro Creek. This degraded condition characterized the creek and the valley for almost two decades before the property was donated to EBRPD in 2010, and a restoration project was designed and implemented. The project aimed to daylight Alder Creek, and construct a stable step-pool channel that would provide appropriate aquatic habitat, encourage a healthy riparian corridor, reduce excess sediment erosion, and improve water quality. Construction initially began in late 2020, but experienced delays due to the Covid-19 pandemic. Phase 1 included construction of the daylighted channel in 2021, but planting of the lower channel was not completed until 2022. Phase 2 construction occurred in 2023 and included planting of the upper channel as well as many smaller elements across the project footprint.

**Figure 40.** Field photograph looking upstream at the knickpoint (labeled 4.95m high knickpoint in Figure 39) and collapsed culvert.

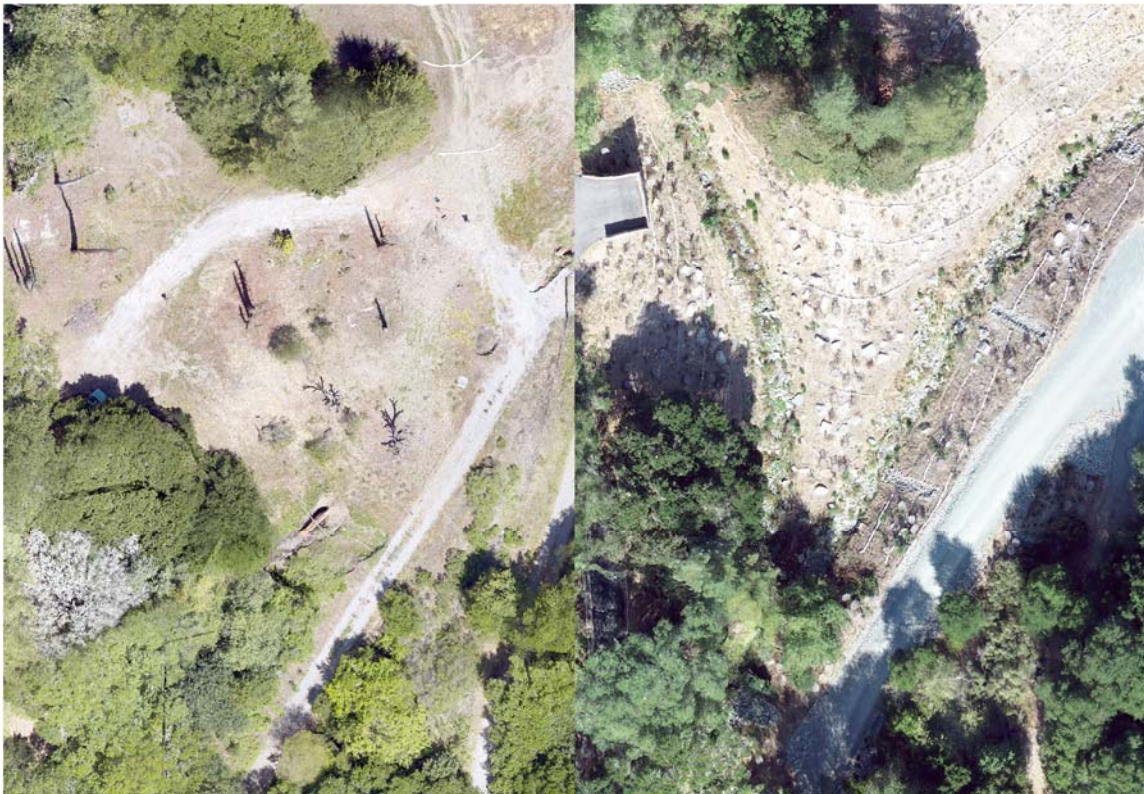
**Figure 44.** Comparison between the 2019 valley morphology (left) and the 2023 valley morphology (right) at the hanging culvert location. See inset black box on the longitudinal profile in Figure 43 for this location.
