APPENDIX
Dry Creek Reconnaissance Sediment Study
Technical Memo

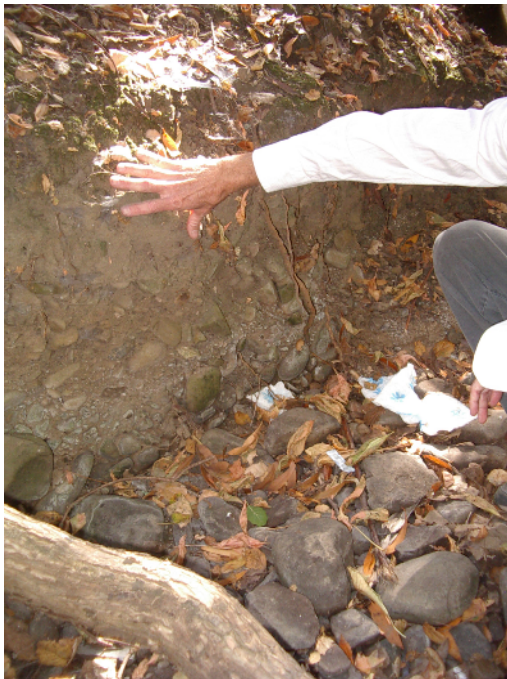
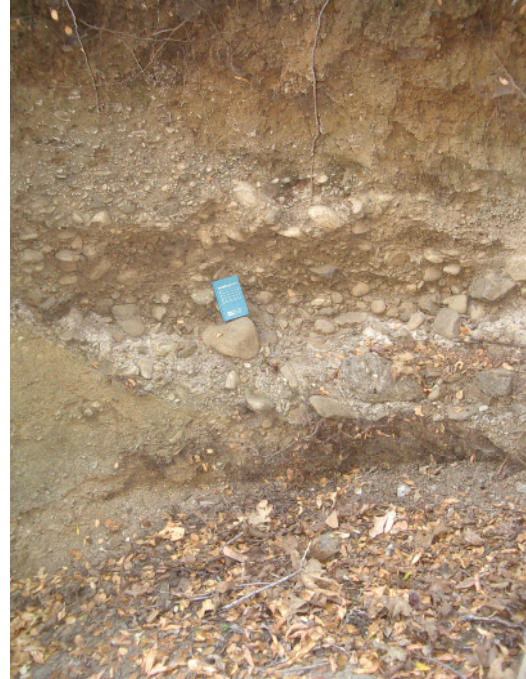
Appendix Figure 5. Photographs showing examples of channel incision (top), and erosion of coarse older valley alluvium (bottom).

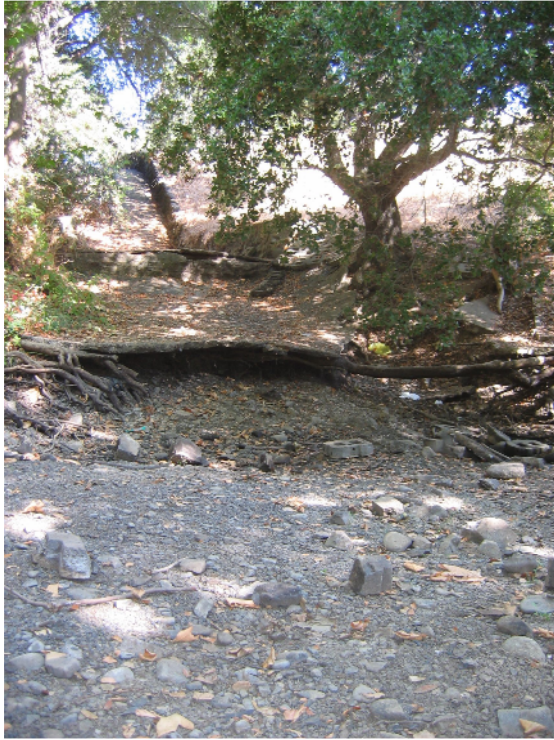
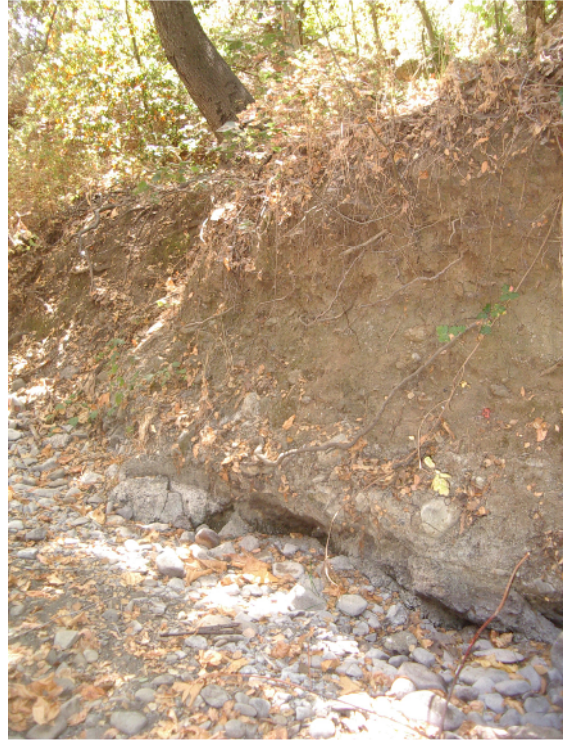
Appendix Figure 6. Left: looking up the channel at the spillway for Jordan Pond. Right: exposure of bedrock in the channel bed and base of the channel bank.

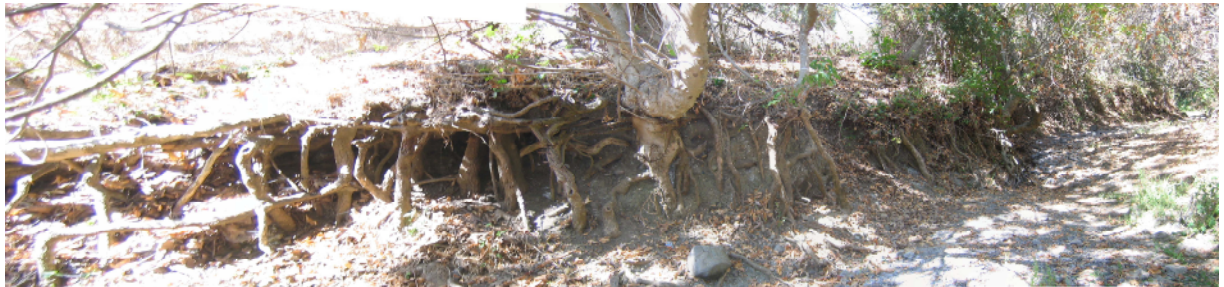
Appendix Figure 7. Example of bank erosion exposing tree roots along a stretch of the North Fork. Flow is from right to left.

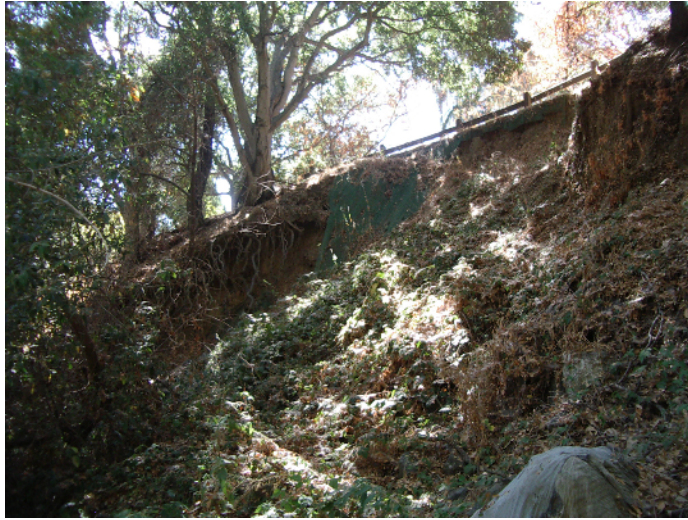
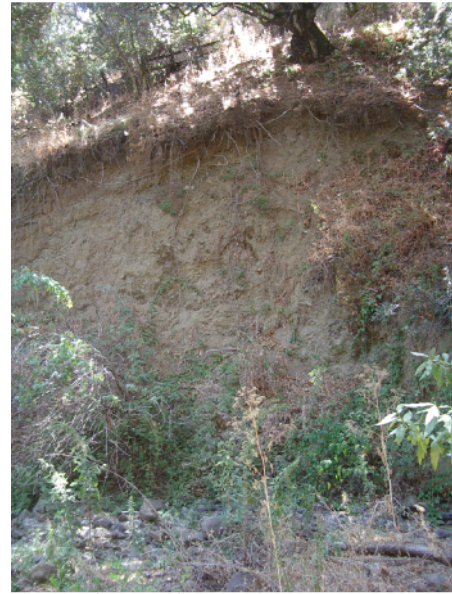
Appendix Figure 8. Two examples of streamside slides occurring on 3rd and 4th order channel segments. Right: slide occurring on a terrace. Left: slide occurring on a hillslope.

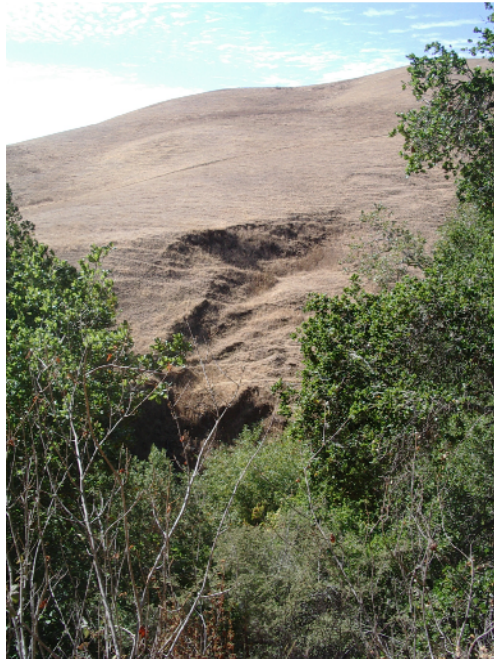
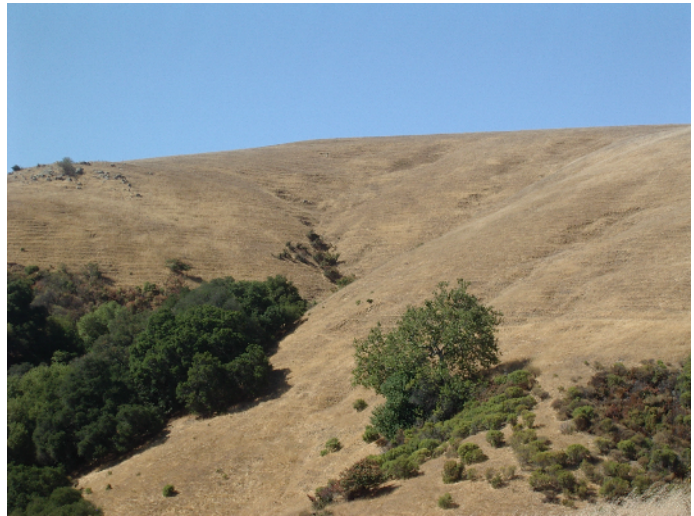
Appendix Figure 10. Examples of slope failures in the Dry Creek watershed. Left: deep-seated landslide. Right: numerous shallow soil slips and debris flows (now healed and covered in grasses).

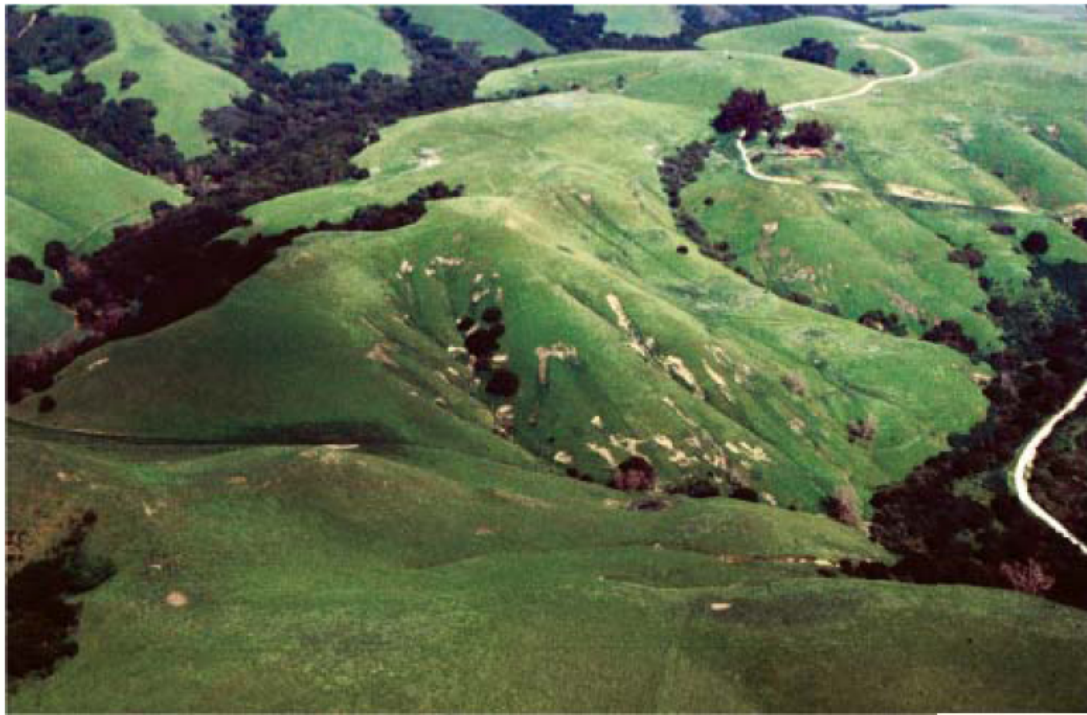
Appendix Figure 11. Photograph illustrating 1998 debris flows on Walpert Ridge (from Coe and Godt, 2002).

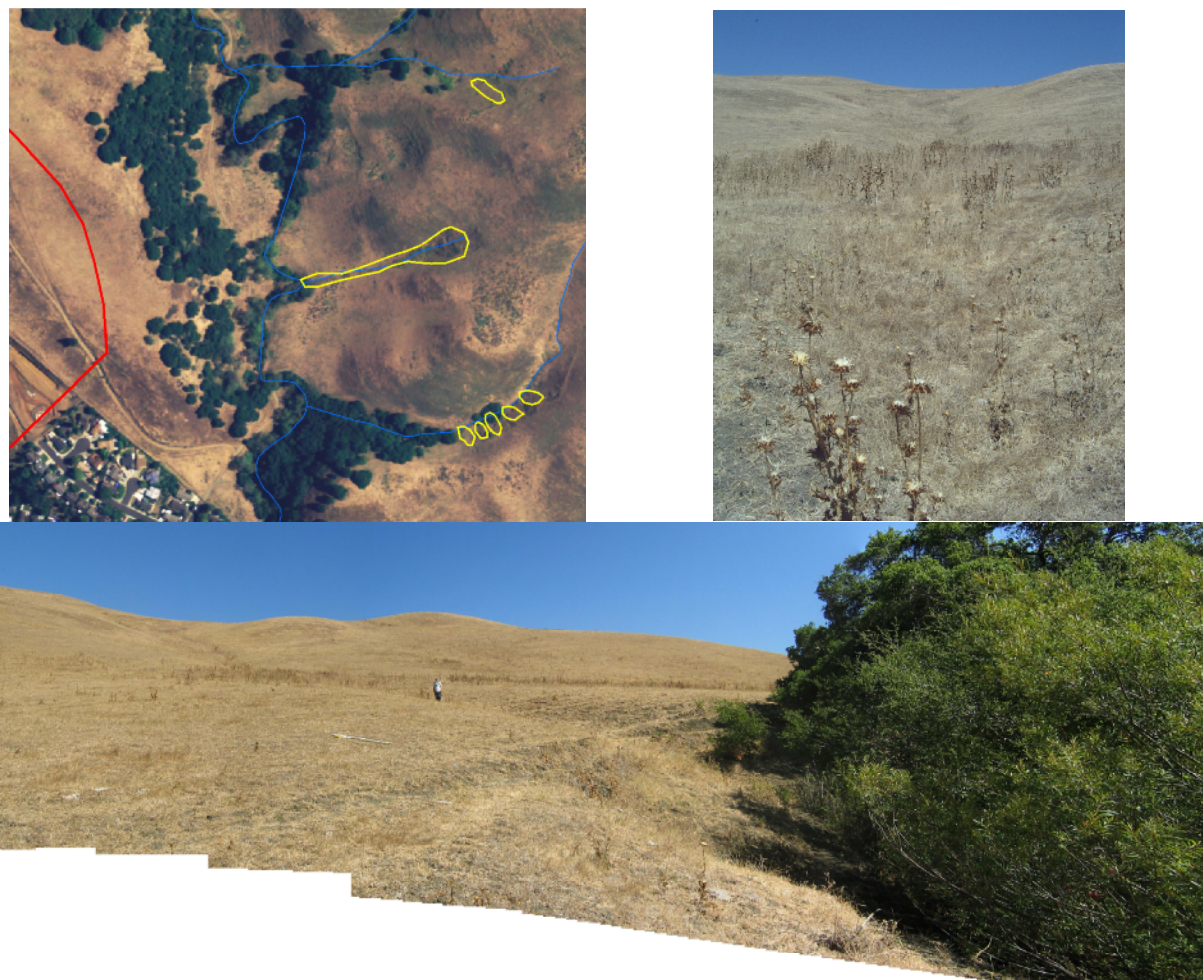
Appendix Figure 12. Example location of a landslide with direct connection to the channel. Upper left: USGS mapping of landslide location in 1998. Upper right: Field photograph standing in the landslide looking upslope. Lower: Panorama looking south at landslide connection to channel. Sarah is standing in the landslide location; the North Fork of Dry Creek is at the base of the slope in the willows.

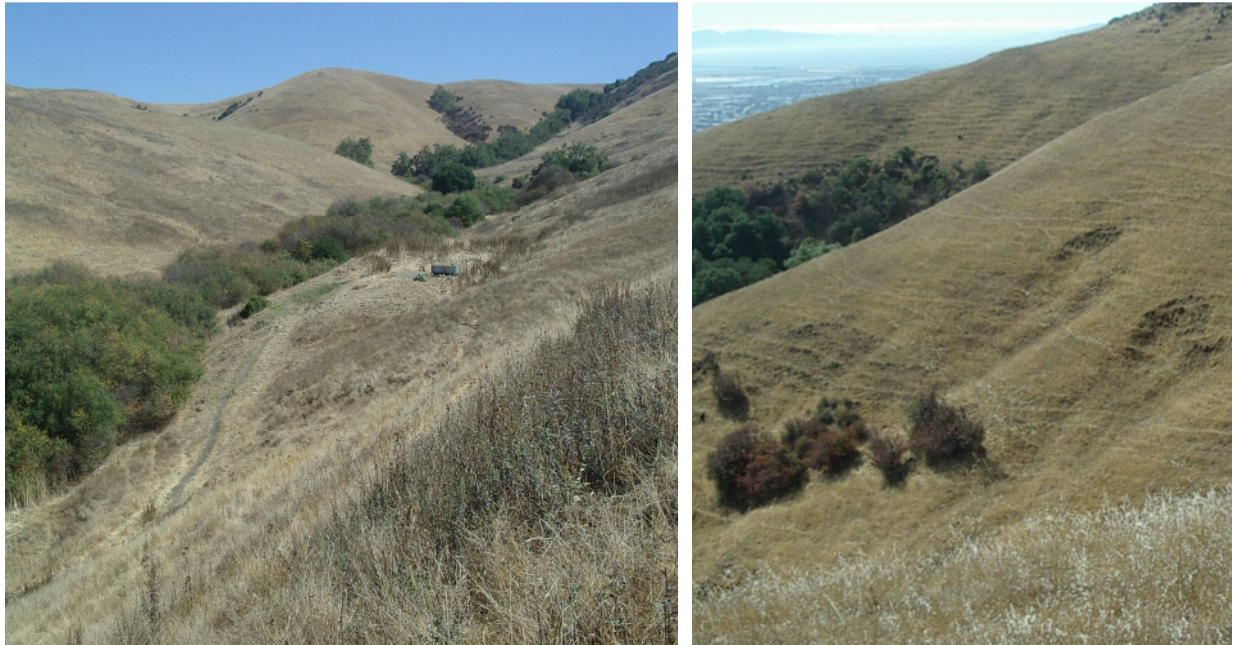
Appendix Figure 13. Left: example location of grazing pressure on a North Fork tributary. Right: example of terracettes.

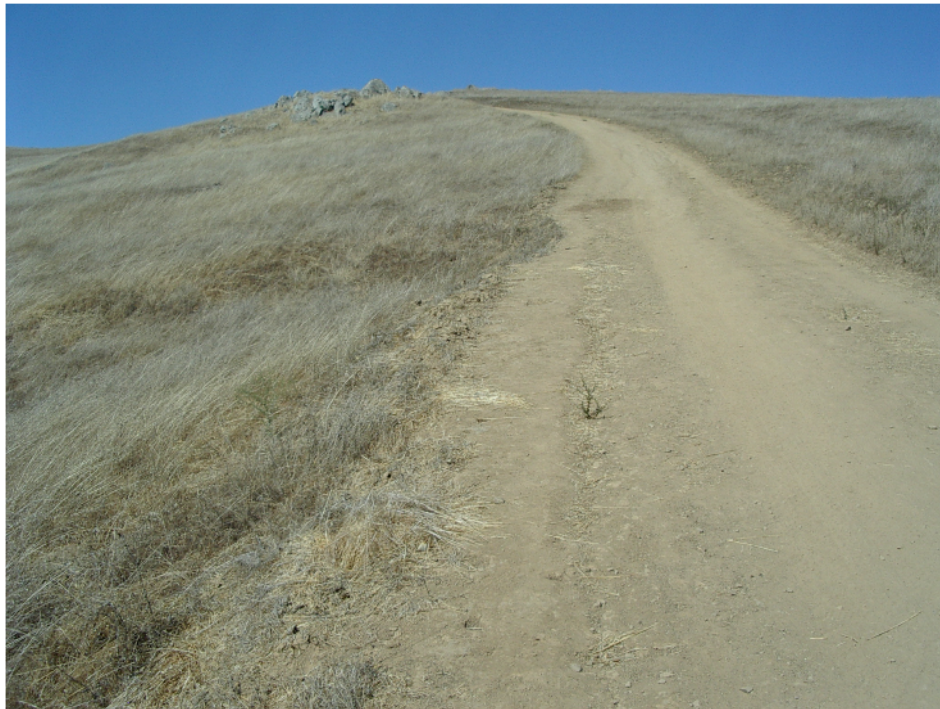
Appendix Figure 14. Photograph looking uphill at a road segment contributing to erosion; runoff exits the road to the left (middle of the photograph), and has contributed to the destabilization of the hillslope.

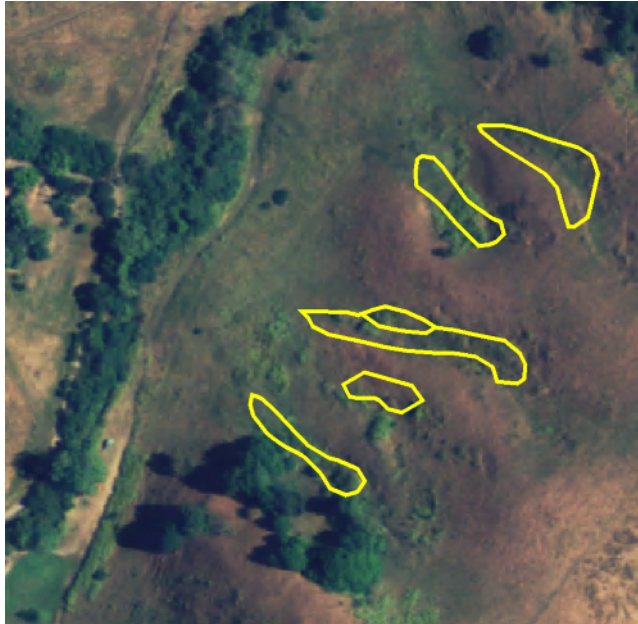
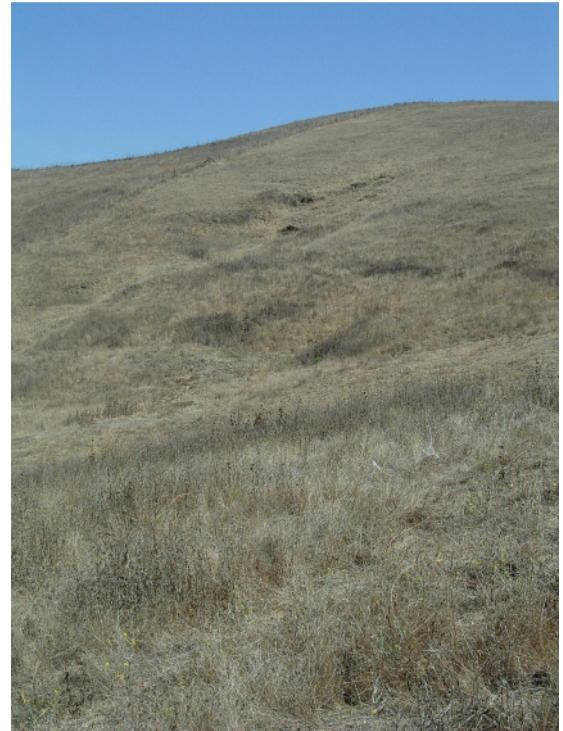
Appendix Figure 17. Left: Aerial photograph showing an example of mapped landslides that occur high upon the hillslope and do not have a connection with a channel. Right: Field photo illustrating hillslope storage of landslide deposits.

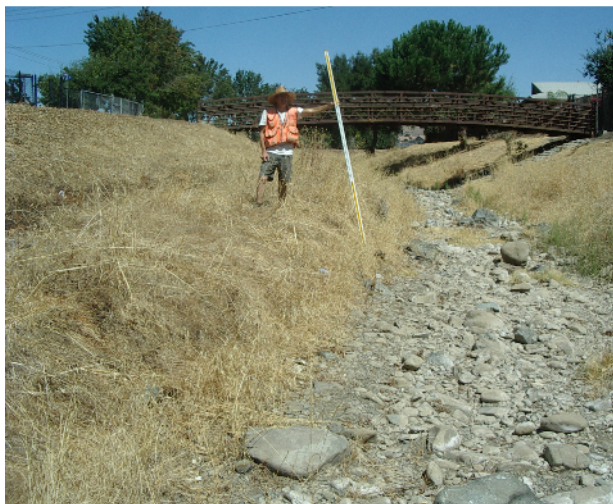
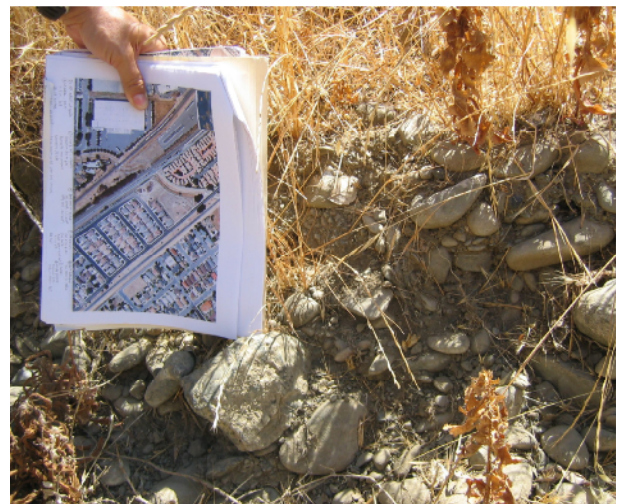
Appendix Figure 20. Left: Photograph showing a package of sediment deposited within the flood control channel. Right: a close-up of the heterogeneous nature of the deposit.

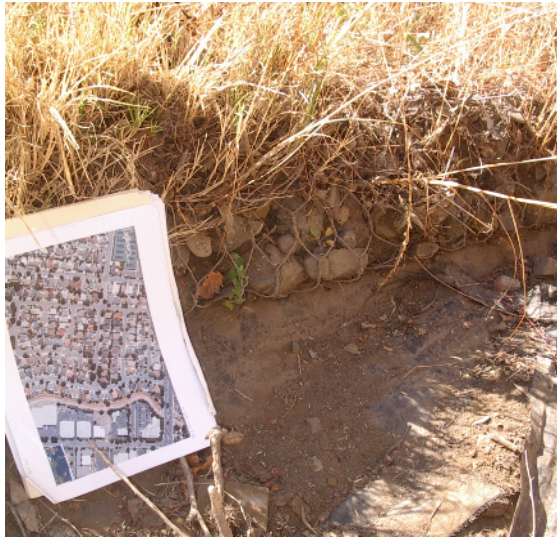
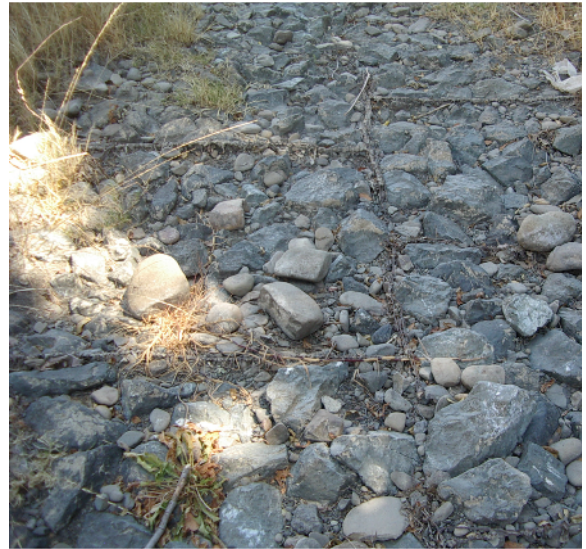
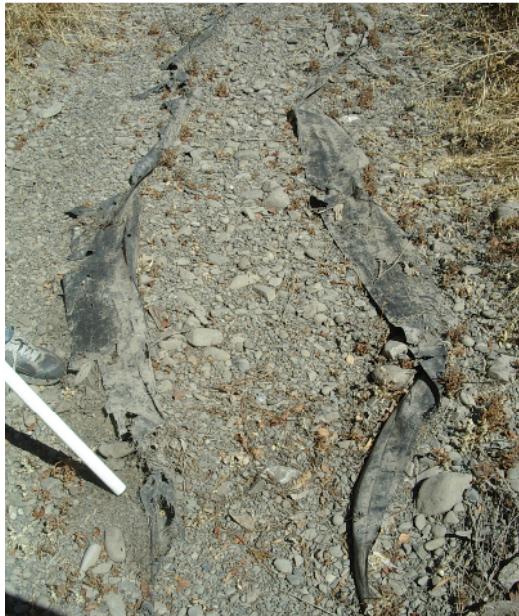
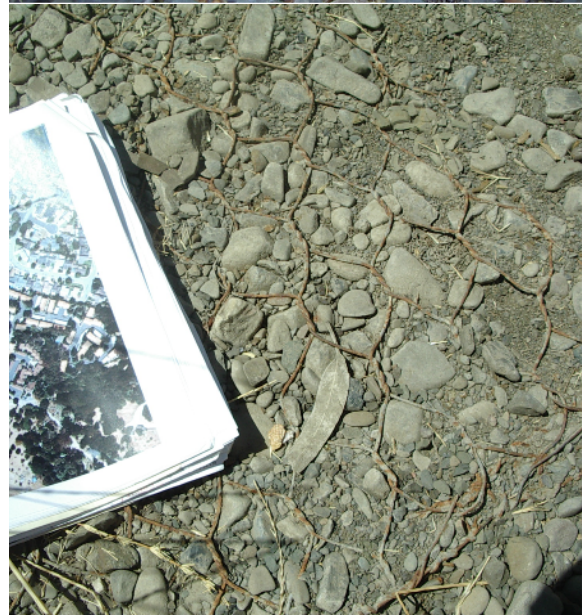
Appendix Figure 23. Photographs of gabions armoring the Dry Creek flood control channel. Upper left: photo showing exposed bank gabion. Upper right: photograph showing gabions on the bed surface. Lower left: exposed erosion control fabric. Lower right: exposed bed gabion.

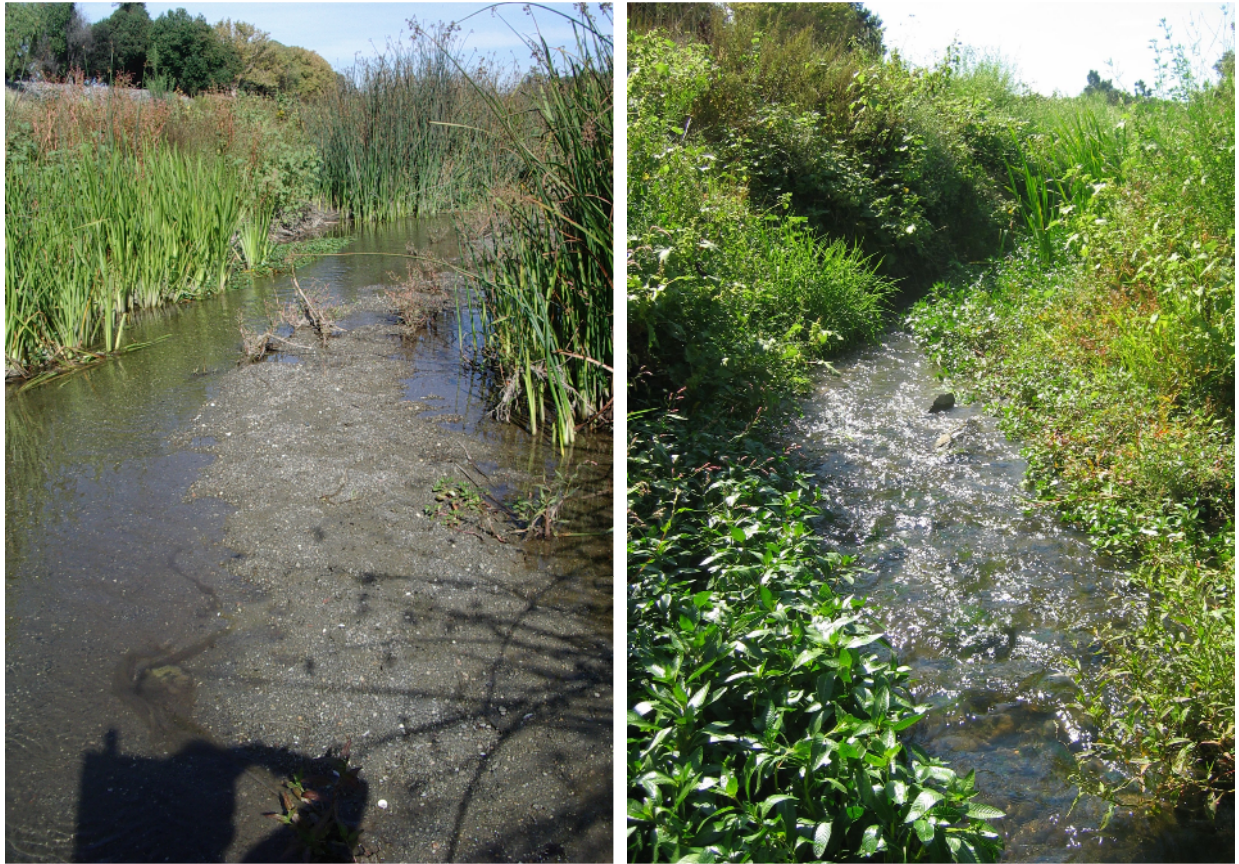
Appendix Figure 27. Comparison of riffles located upstream of the tributary fan (left) and adjacent to the fan (right). Notice the decreased channel width, increased grain size, and increased gradient of the riffle on the right.

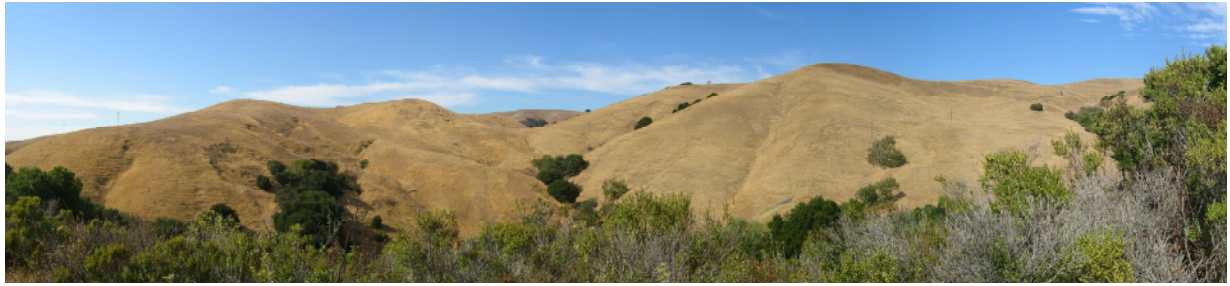
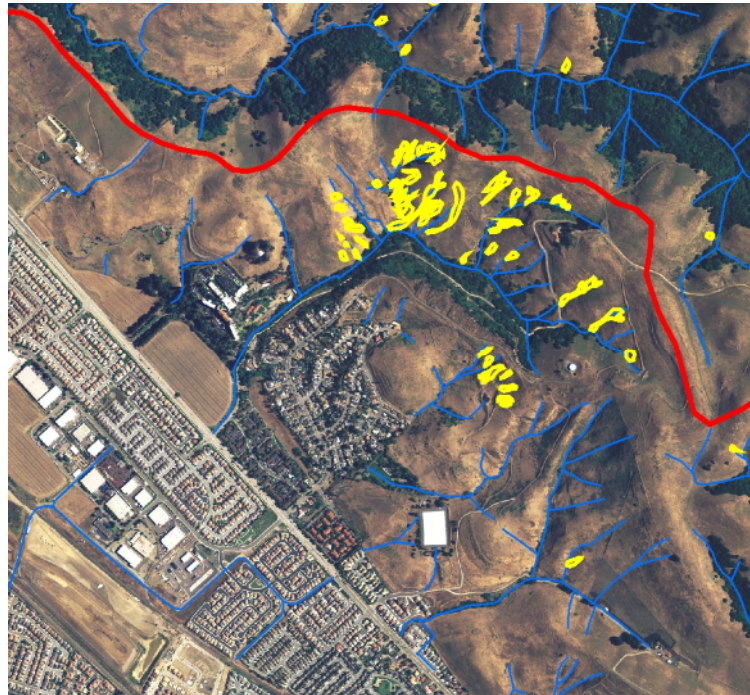
Appendix Figure 28. Upper: photograph of the hillslopes of the Masonic Home watershed showing the multiple debris flow scars. Lower: USGS mapping showing the density of debris flows occurring in the 1998 El Nino event. Note, the Dry Creek watershed is in the upper portion, and the Masonic Home watershed (not delineated) flows to the lower left of the figure.
