STREAM INVENTORY REPORT for LA HONDA CREEK

Midpeninsula Regional Open Space District

**SAN FRANCISCO ESTUARY INSTITUTE
Watershed Program**

June 2007

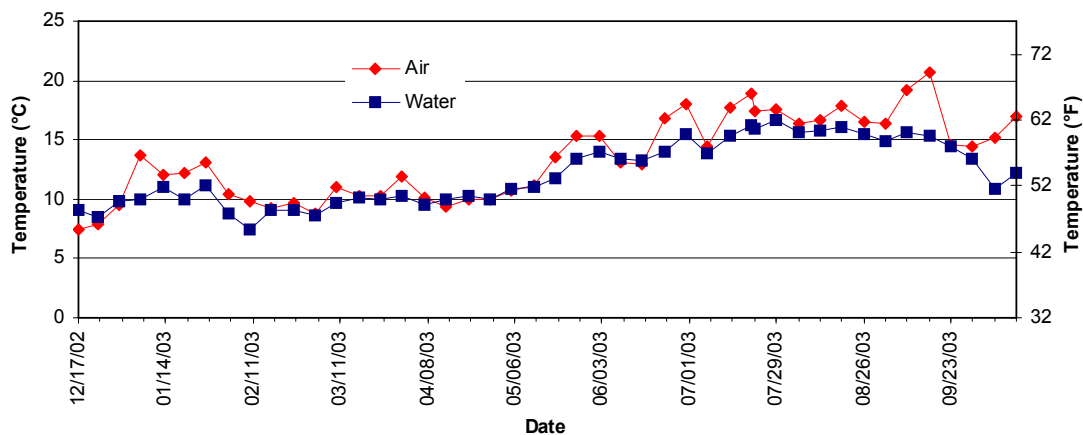
Figure 5. La Honda Creek water temperatures at Delay's bridge. Data is collected hourly from December 17, 2002 to October 24, 2003. Air temperatures for the same time period are from the California Department of Forestry La Honda (LAH) Station.

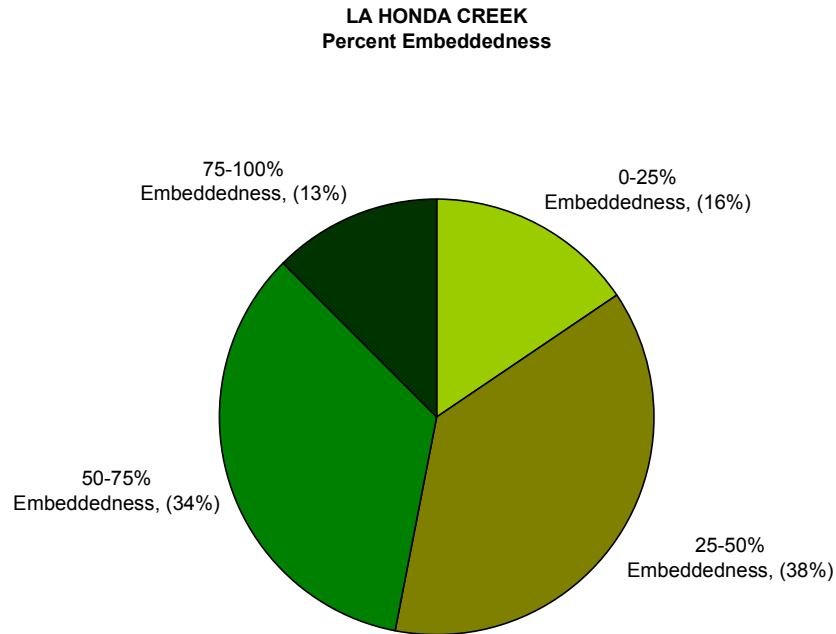
Although embeddedness was not directly measured in the previous Brady et al. (2004) study, field observations during bulk sediment sampling allowed qualitative assessment. In 2002/2003 the gravel and cobble substrate in most pool tail locations was found to be moderately to highly embedded. During bulk sediment sampling, many of the larger clasts in the bed had to be pried out using the blade of a rock hammer. In addition, the fine component of each sample often formed a dense cement-like slurry, which was extremely difficult to remove from sample containers. The bulk sediment sampling data is reproduced in Appendix E. Brady et al. (2004) concluded that embeddedness of the substrate in these pool tail out locations was a significant factor limiting salmonid success. They suggested that the high values of embeddedness were due to in-situ breakdown of mudstone clasts, due to the clay particles swelling and shrinking during wetting and drying. We have observed similar in-situ breakdown of clasts in several other

Figure 11. La Honda Creek percent embeddedness.

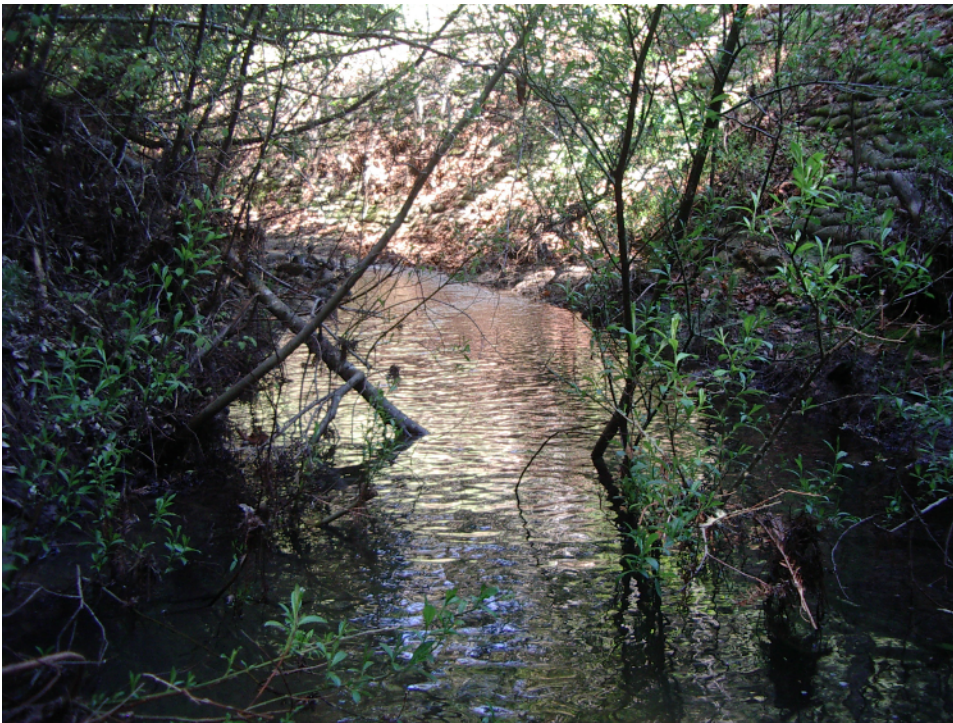
Figure 37. Channel bank revetment (sacrete) along the outside of a meander bend in reach 3A (S. Pearce, 2007).

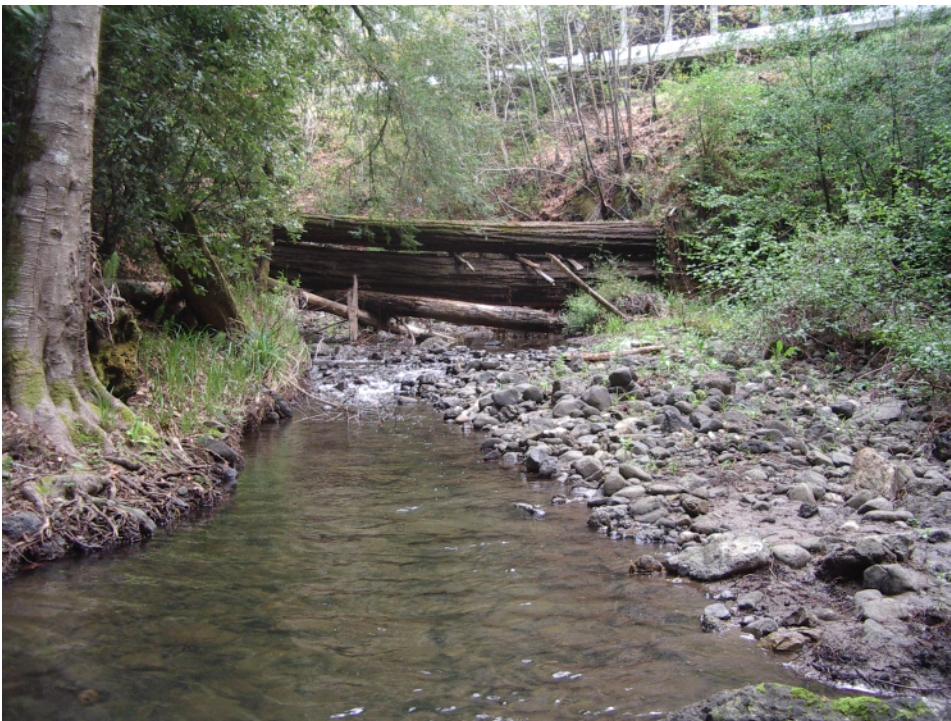
Figure 45. Photograph looking upstream at two fallen redwoods at Landslide Bend pressure point. The new Caltrans retaining wall for Highway 84 is visible in the upper right of the photograph (S. Pearce, 2007).

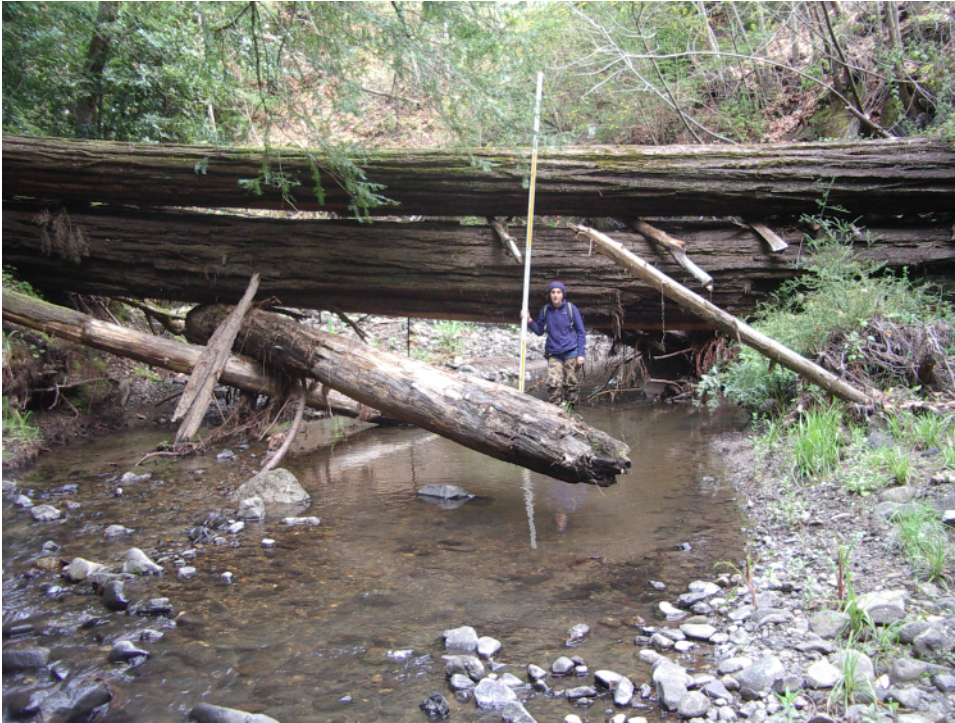
Figure 46. Close-up photograph looking upstream at Landslide Bend pressure point. This location is not currently a migration barrier for salmonids (S. Pearce, 2007).

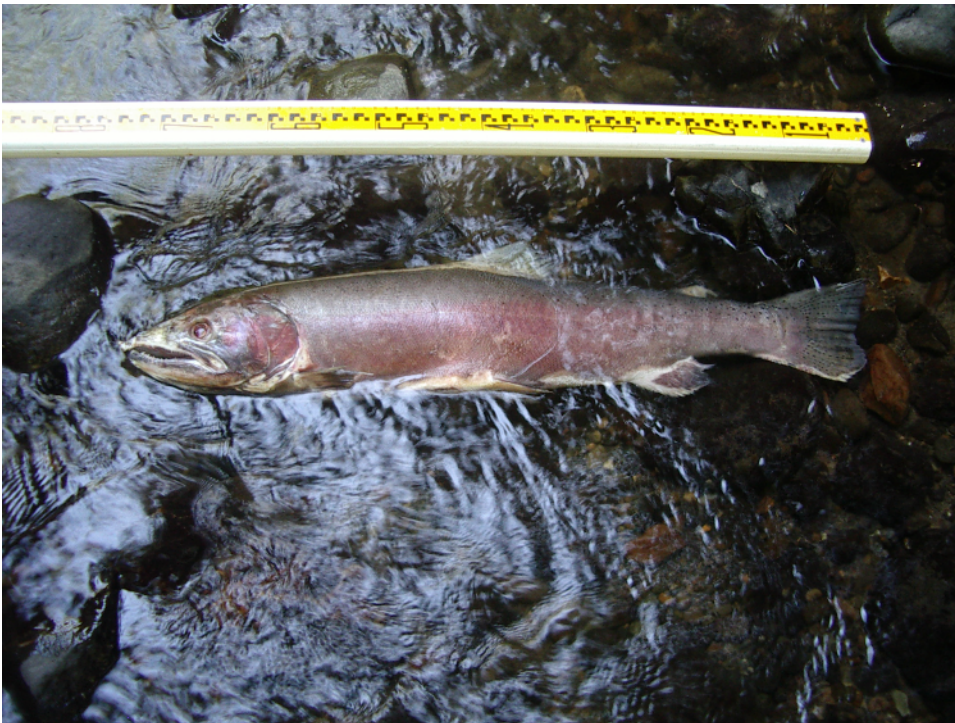
Figure 47. Steelhead carcass found on March 31, 2007 in reach 2B. Stadia rod in meters. (S. Pearce, 2007).

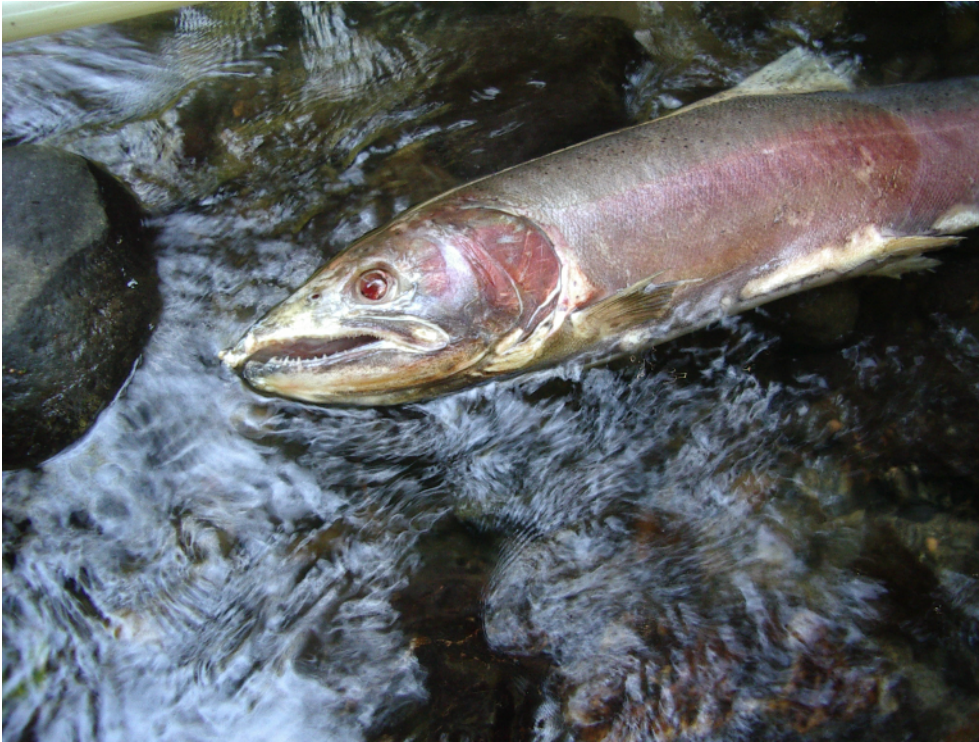
Figure 48. Close-up of steelhead carcass (S. Pearce, 2007).
