APPENDIX

Appendix A- Series of air photographs

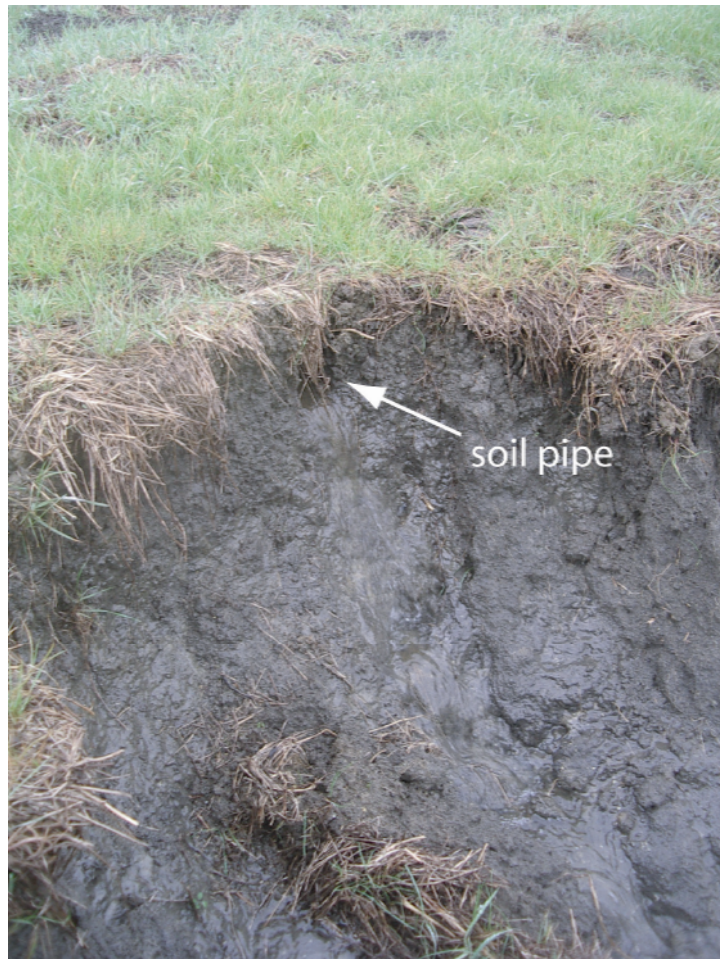
During one of the first major events of the season, the 12/17 and 12/18/05 storm, we observed active bank failure (small blocks were falling as we stood on the banks) along Gully A in the Mohring parcel. During the events in December and January, we observed significant soil piping, or input of water into the channels via small pipes that have formed in the soil profile, typically in the upper 0.5 m of the soil profile. This piping leads to localized saturation, erosion, and instability, ultimately causing bank failure in the immediate vicinity of the pipe. We also observed little surface overland flow in the pasture surface, indicating that the majoring of rainfall was able to infiltrate.

Figure A-4. Photograph of soil pipe discharging water into a gully channel.

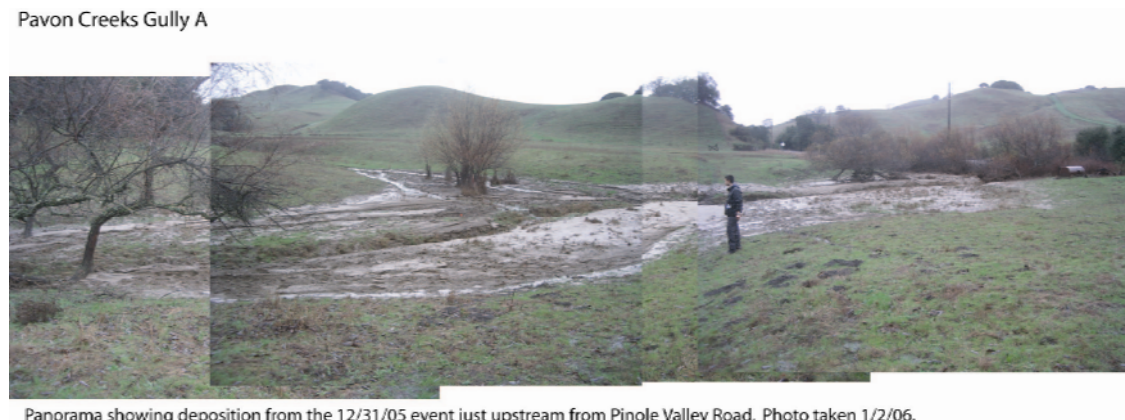
channel with low adjacent floodplain surfaces to an aggraded braided pattern extending from bank slope to slope. Deposition also occurred at the mouth of Gully A, extending up onto the adjacent floodplain surfaces. The package of deposition was in some places thicker than 0.6 m, and consisted of dominantly sand, with some silt and fine gravel. In Gully A, at cross-section AXS7, we observed continued incision, erosion, and soil piping. The largest change was the change in shape of the headcut, from a gradual slope between the pasture surface and the channel bed, to an abrupt, vertical headwall.

Figure A-5. Photograph of deposition at the mouth of Gully A. Photo taken looking downstream.

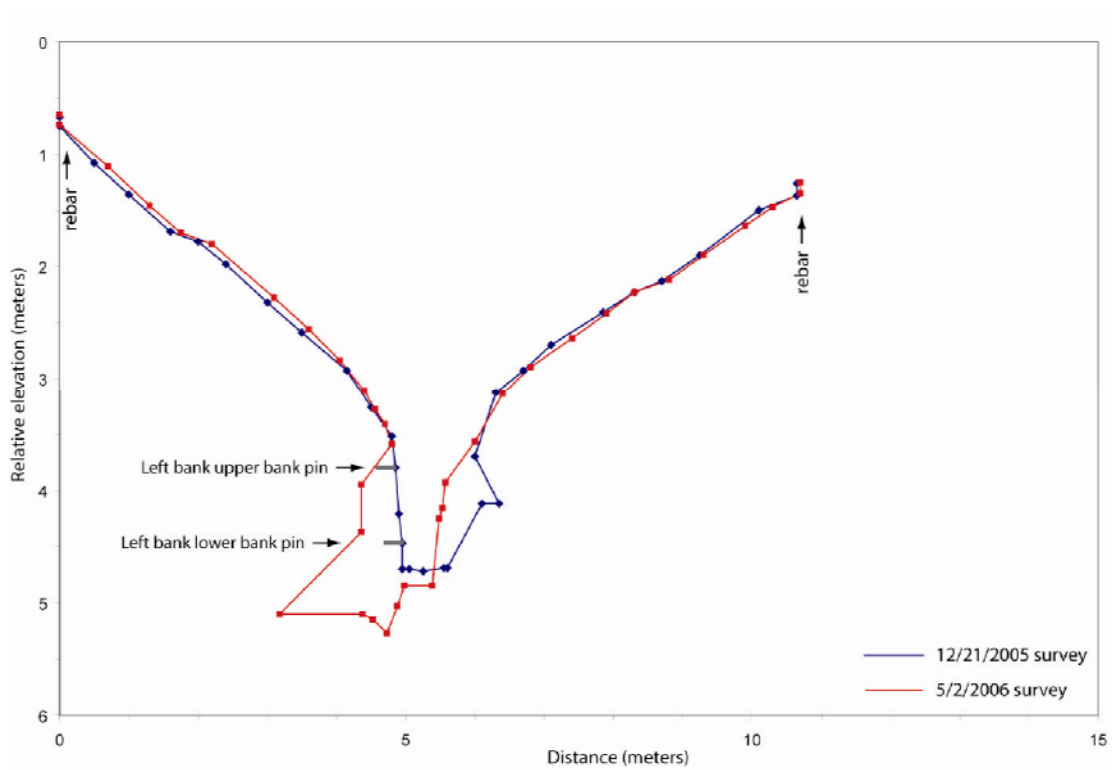
Figure A-30. Cross-section DXS3. Second survey left bank has a large undercut.

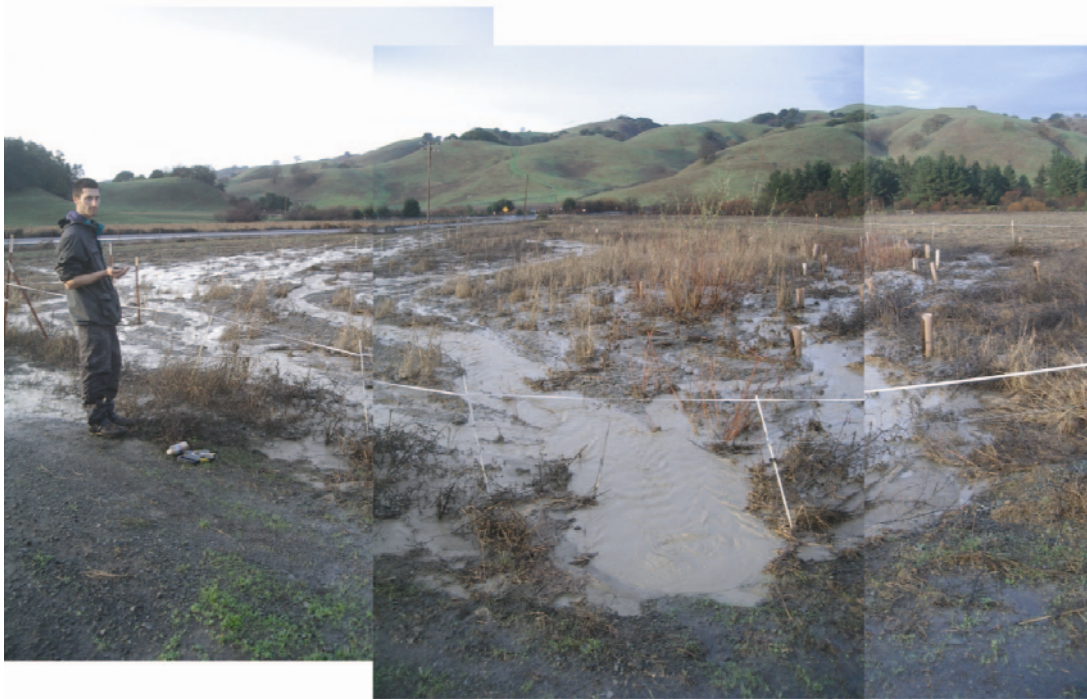
Pavon Creeks Gully C

Taken at the ranch road looking downstream towards the Y. Water is exiting the culvert under the road at the lower center of the photo. Note the wide area of deposition and braided channel pattern. Photos taken 1/2/06.

Figure A-32. Photograph of sediment deposition at Gully C and the ranch road. Photo taken from the ranch road, looking downstream.

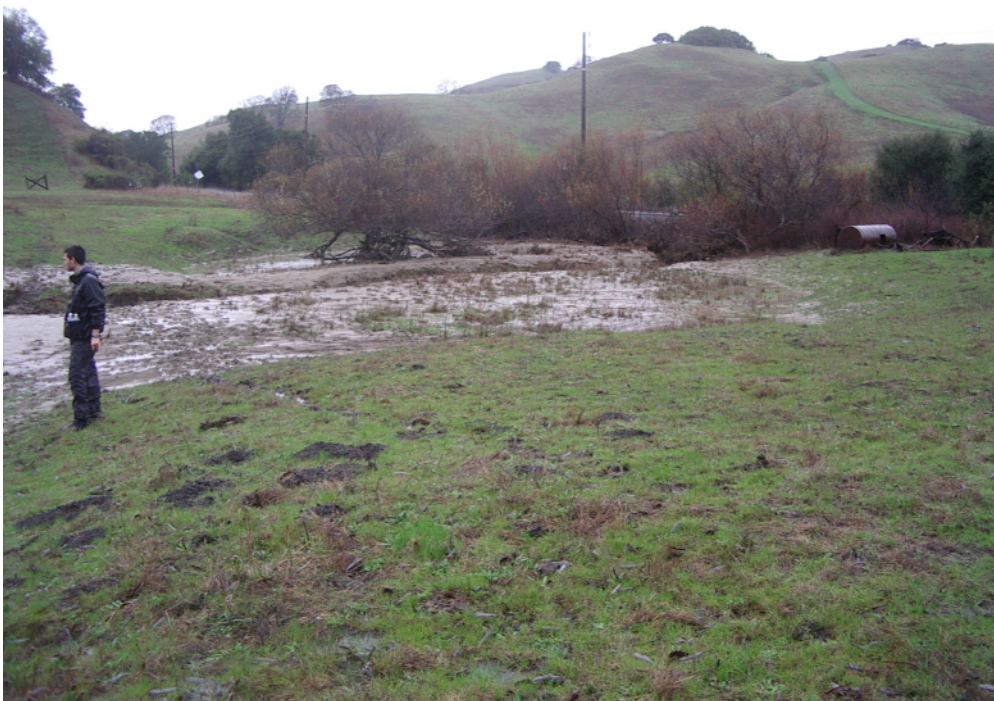
Figure A-33. Photograph of sediment deposition at Gully A at the mouth.

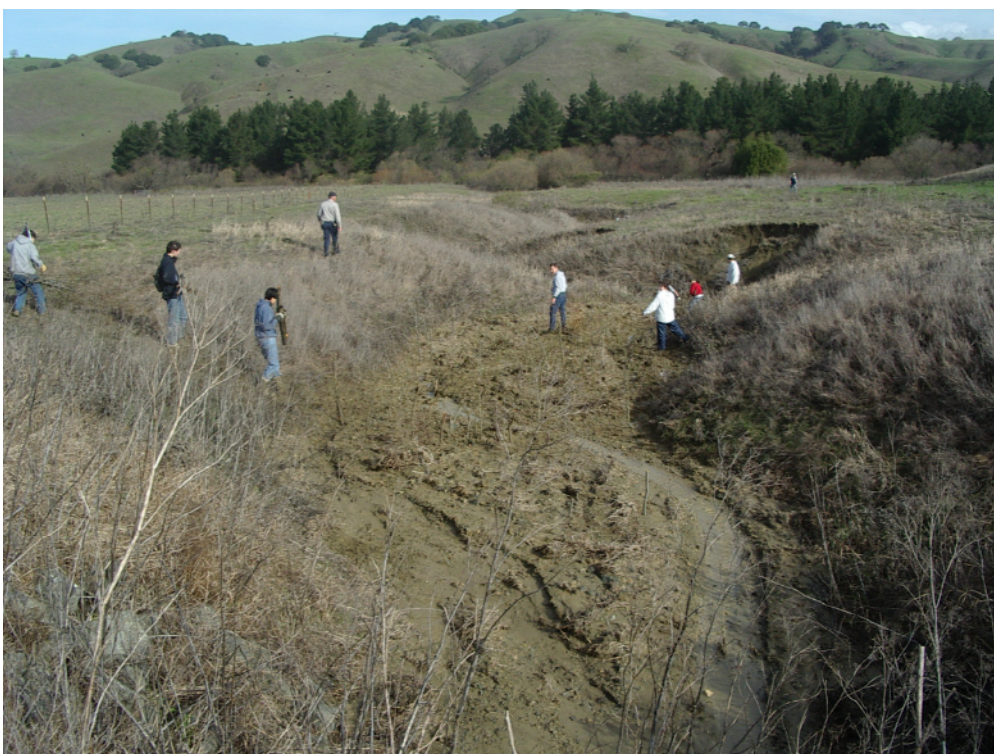
Figure A-34. Photograph of sediment deposition behind the check dam on Gully B. Photo taken looking downstream from the ranch road, during an EBMUD restoration day.

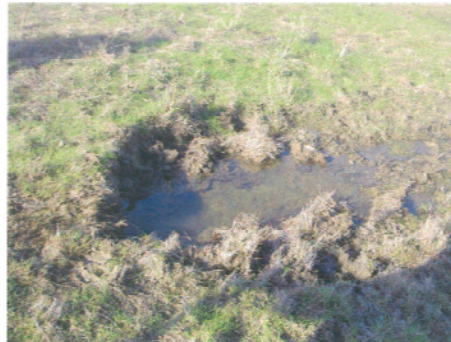
was separated by a vegetated strip. Each eroded spot is small, only about 3 to 4 feet across. There is a danger these head-cuts could advance during subsequent storms. Since they are small, it would be feasible to fill them to prevent further erosion.

One of three small, disconnected head-cuts.

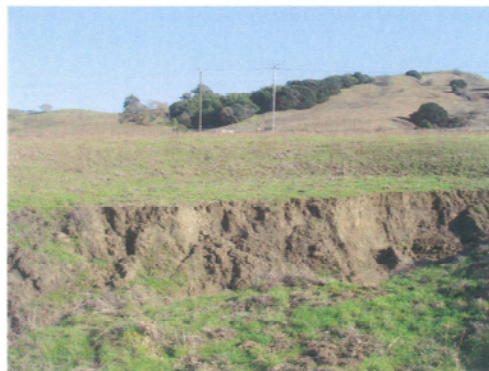
These gullies seem to have a long term history of cutting and filling. Sediment has apparently filled former, larger gullies and formed inset terraces. While the Cropley soil between the gullies is very dark gray and uniform, inset terraces are paler brown and stratified suggesting they washed into and filled a former larger gully. The color of the soil in the inset terraces matches that of the Altamont soil in the upper watershed. The Altamont soil may be the source of this fill. Ken reports finding a darker buried surface layer at a depth of 120 cm when augering through one of these inset terraces. The auger hole was about 170 cm from the outside edge of the inset terrace.

Inset terrace. From front to back: grassed tread, eroded riser, grassed tread, grassed slope of former bank of larger gully.

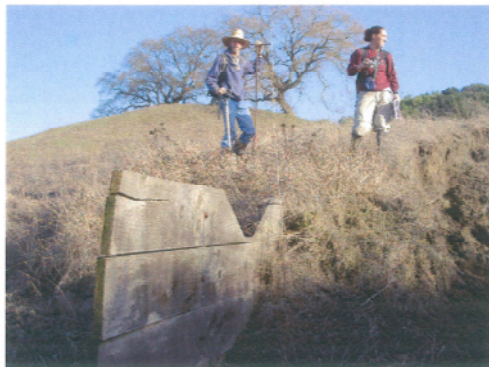
This check dam at Gully B was eroded around the side, causing further erosion impacts to the site.

- Stabilizing and maintaining the remaining grade control structure on Gully B downstream of the ranch road to prevent future failure (failure would release a large plug of sediment, and jeopardize the ranch road)

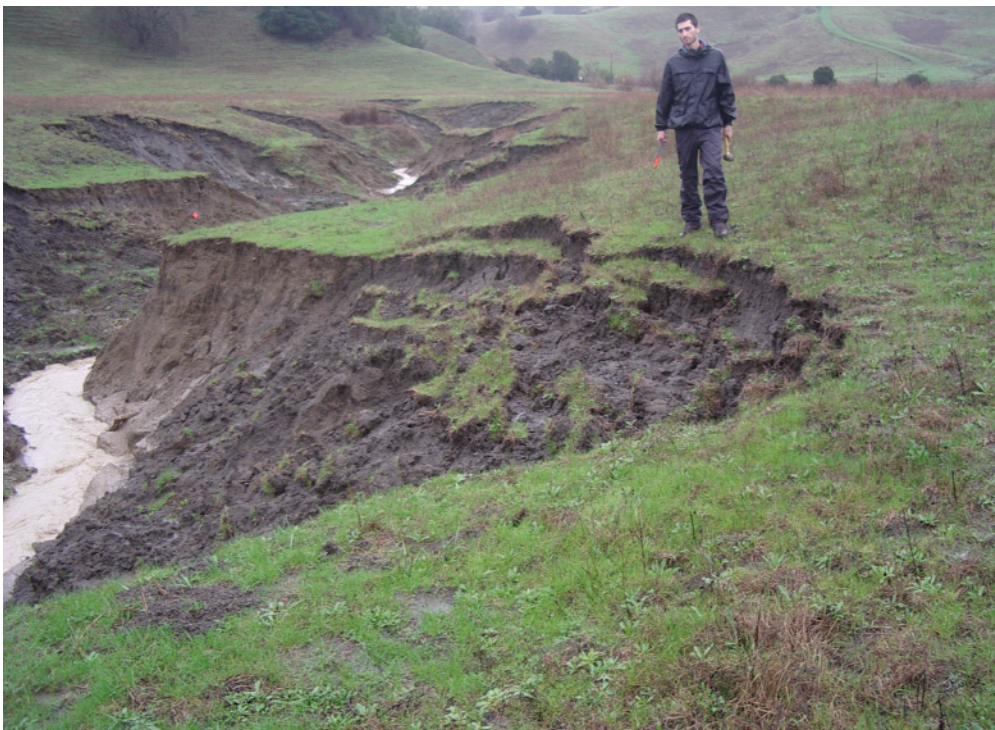
Figure A-44. Block failure along gully side slope, near AXS3.

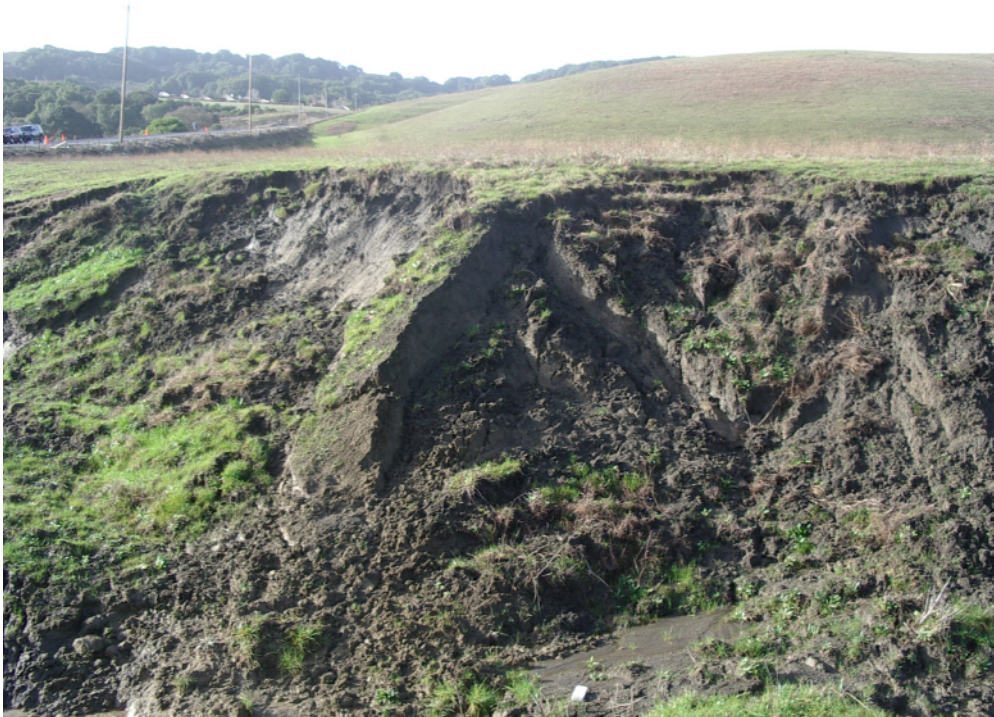
Figure A-45. Typical failure style of saturated banks in Gully A downstream of Castro Ranch Road.

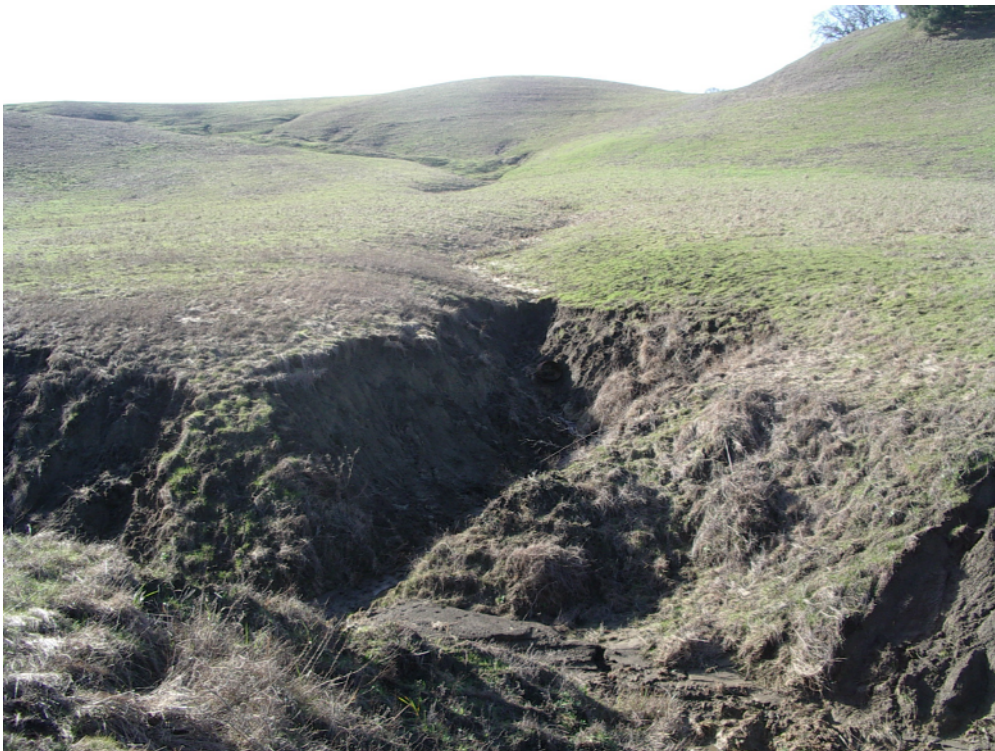
Figure A-48. Unmeasured other headcut on the AXS7 tributary, 1/9/2006.

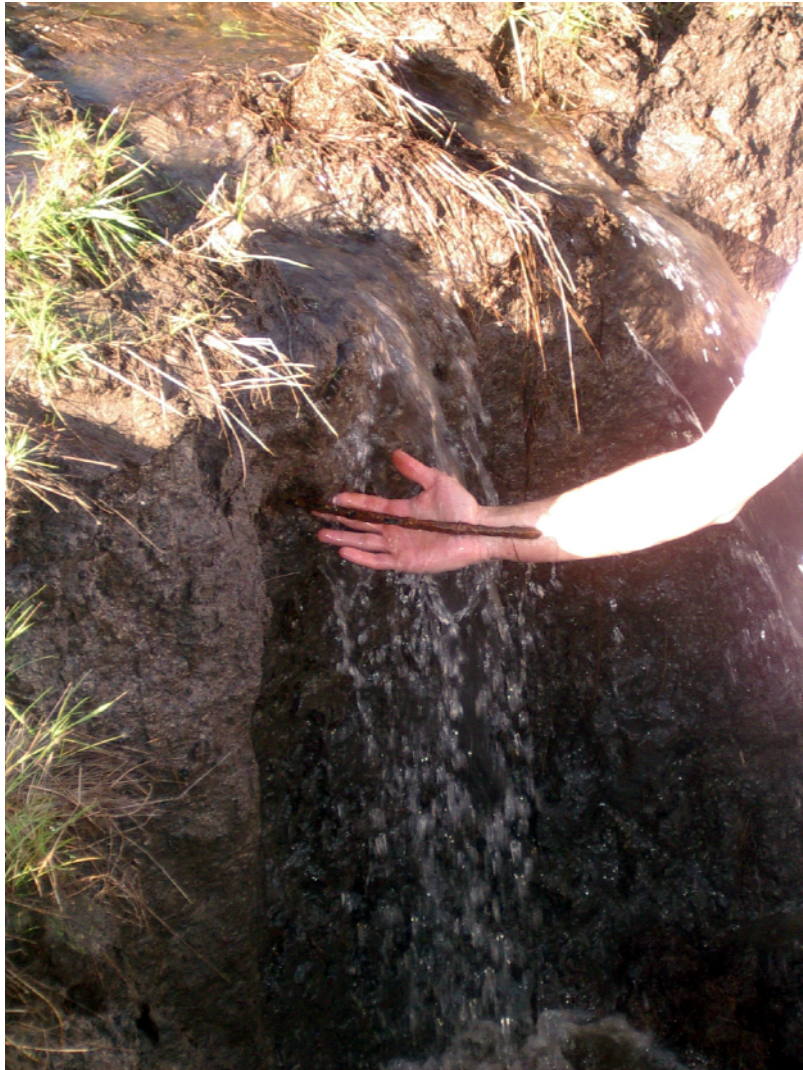
By the 3/2/06 event, the culvert under the ranch road at Gully C was completely plugged with sediment, diverting all flow across the pasture and the road. In Gully A, at the AXS7 headcut, the retreating headcut had exposed a long piece of rusty metal (object was unable to be identified, or removed from the bank) sticking out of the headcut wall 0.24 m below the current gully bed elevation. This suggests that at least the upper 0.24 m of

Figure A-49. A piece of rusty metal exposed in the AXS7 headcut wall, 3/2/2006.

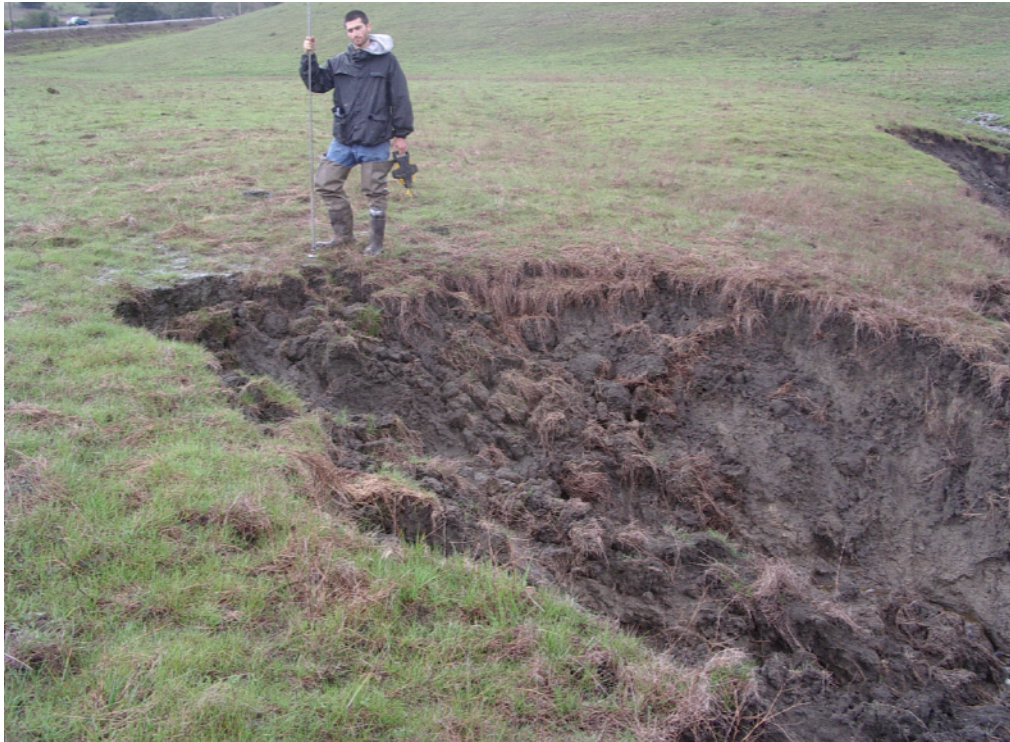
Figure A-50. An example of pasture surface runoff feeding bank slump erosion on Gully A, 2/27/2006.

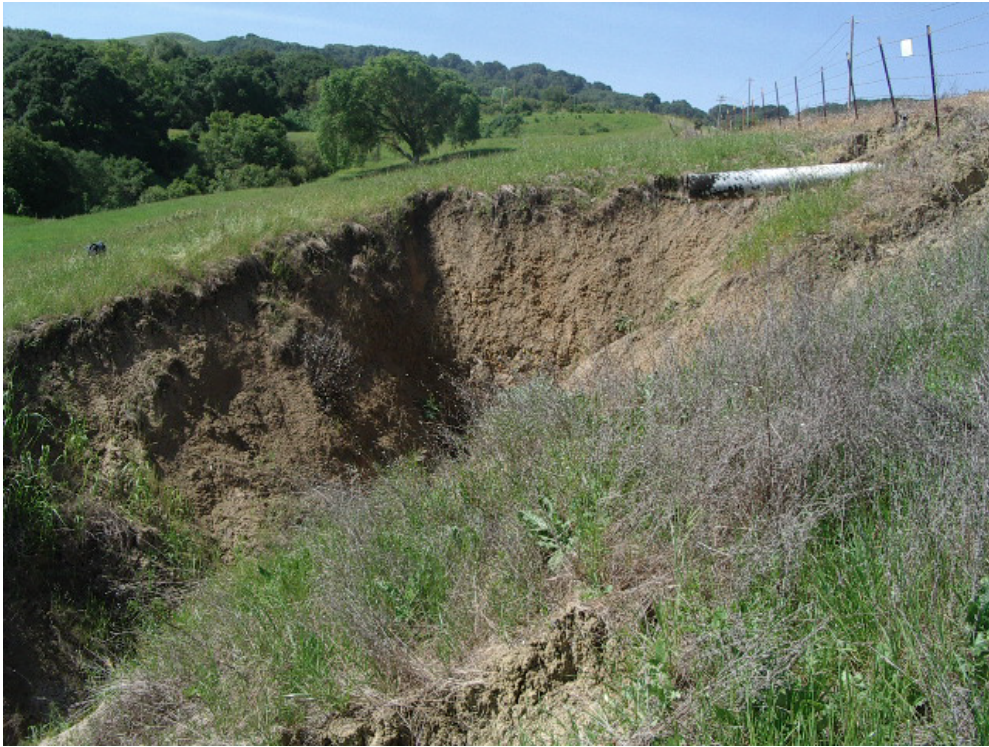
Figure A-57. The hanging culvert at AXS6, 5/12/2006.

- Fixing the hanging culvert to reduce erosive energy of stormwater flows. This solution should also address the bank erosion on this short tributary to prevent future Castro Ranch Road failure.

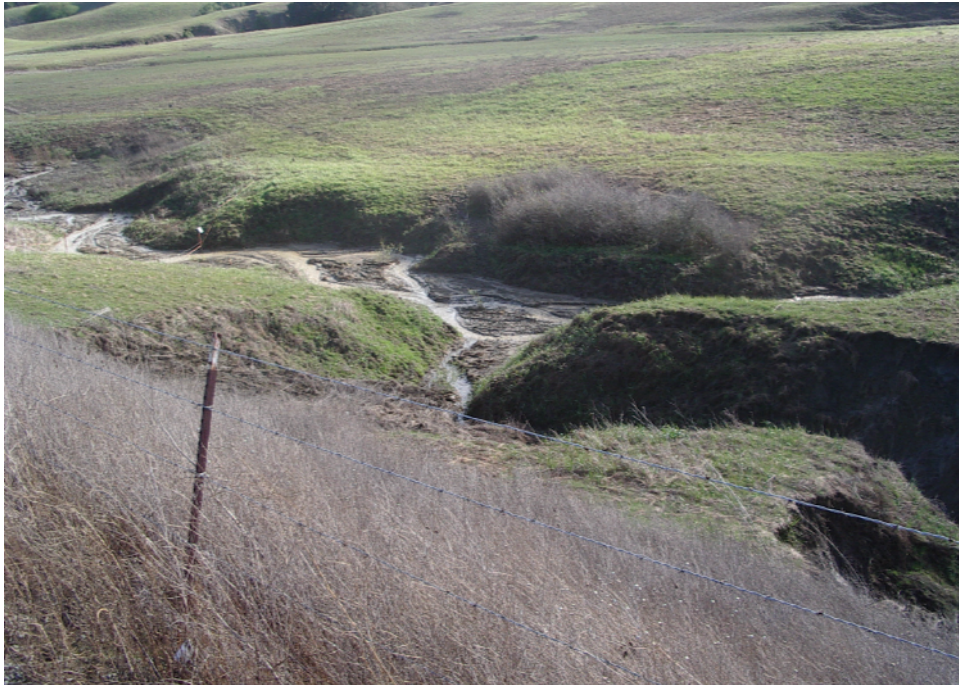
Figure A-58. Aggradation on Gully A, at the confluence with the AXS6 tributary.

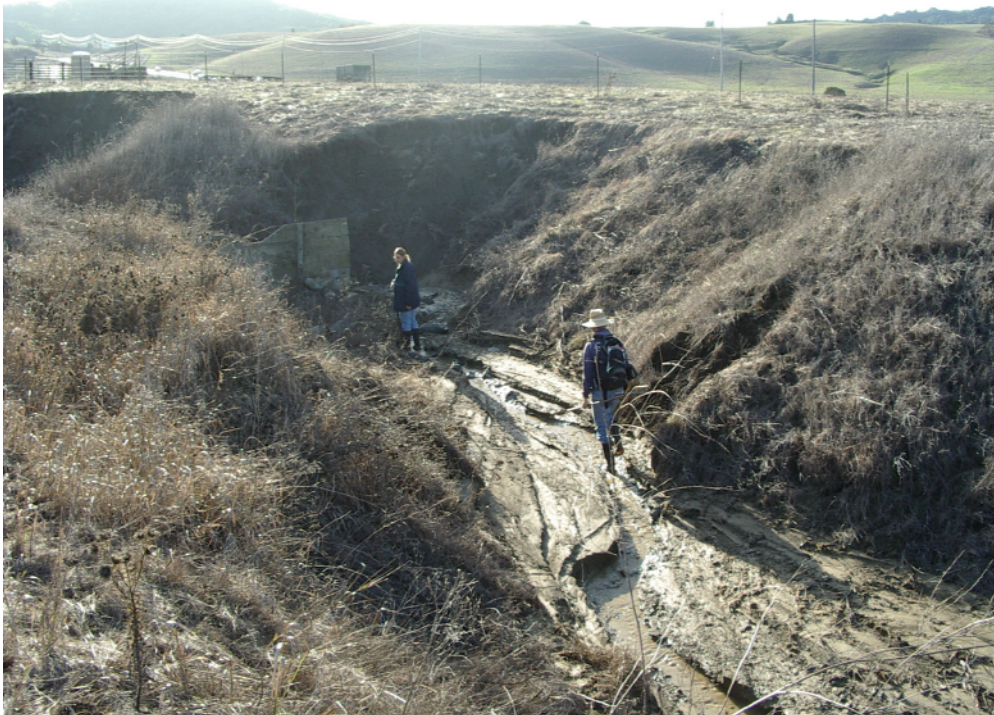
Figure A-60. Failed check dam on Gully B, looking upstream.

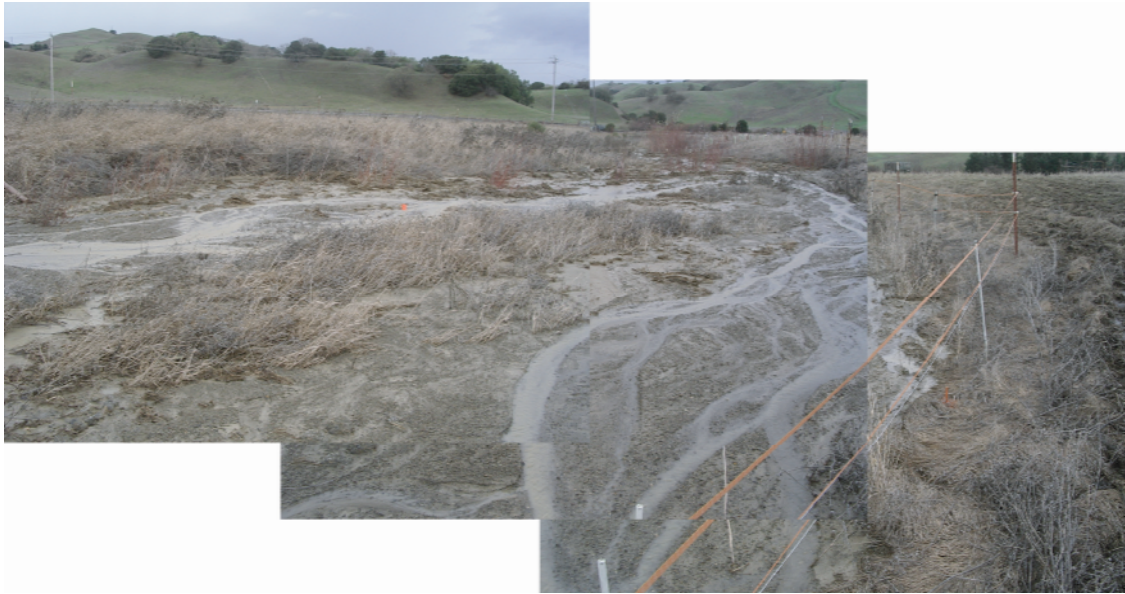
Figure A-74. Channel aggradation at CXS3, 1/1/2006.

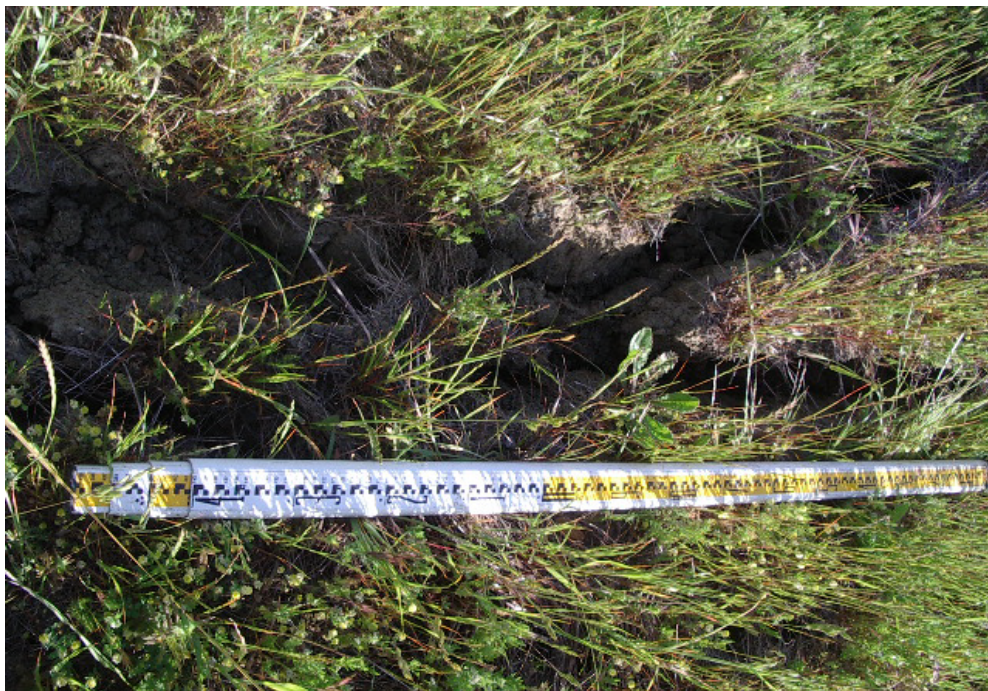
Figure A-79. Crack formed in shrink-swell soil.
