LOCAL LANDSCAPE DESCRIPTIONS

This chapter provides additional historical evidence for and discussion of specific locales in south Santa Clara Valley. We first describe the overall landscape patterns of the South Valley, then each subregion of the study area. Level of detail varies somewhat by subregion, depending upon available information. Historical landscape patterns are shown in the full region map (inside front cover) and, at greater scale, in the preceding map series (figs. 7.1-7.4).

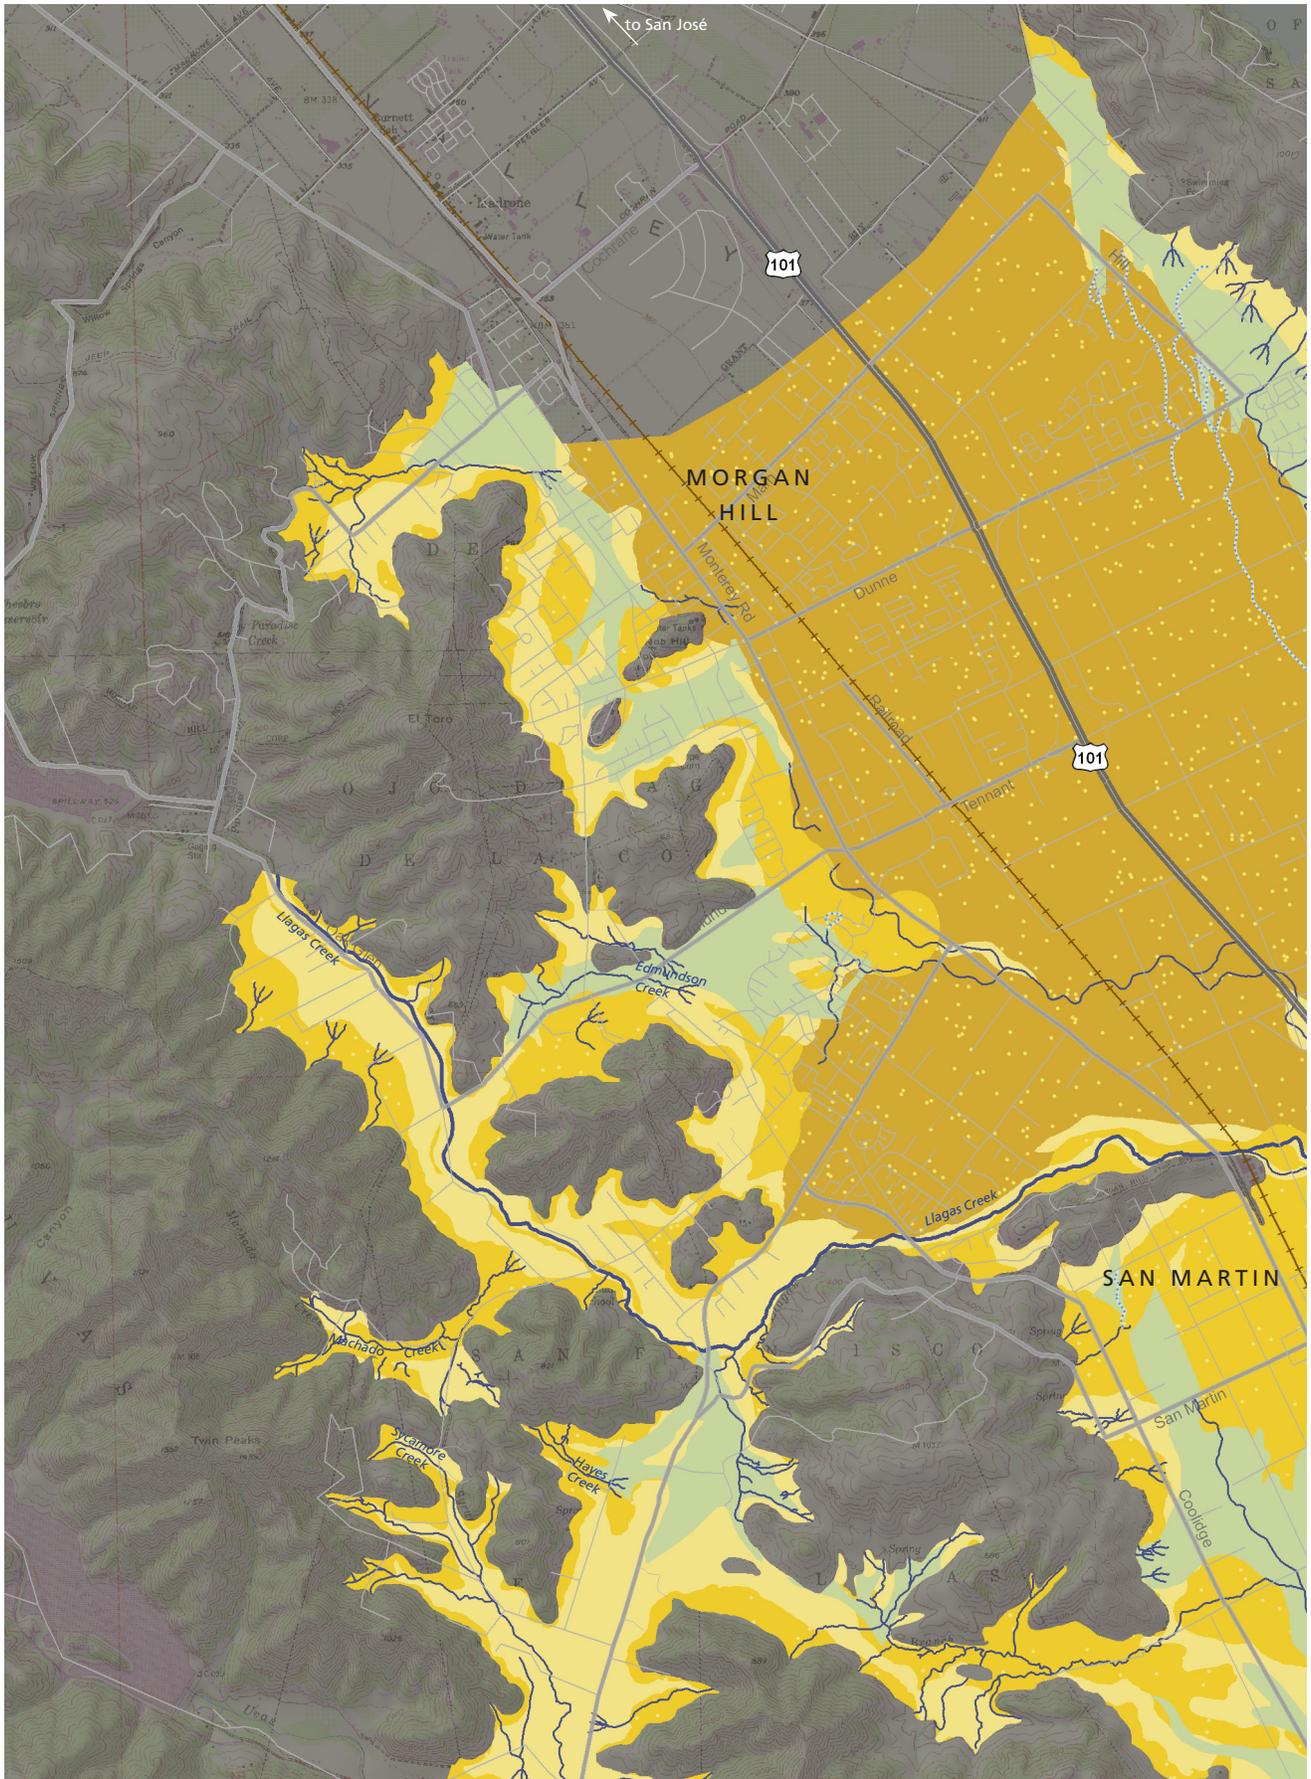
168 Figure 7.1. Reconstructed land cover map of south Santa Clara Valley prior to significant Euro-American modification (Morgan Hill area).

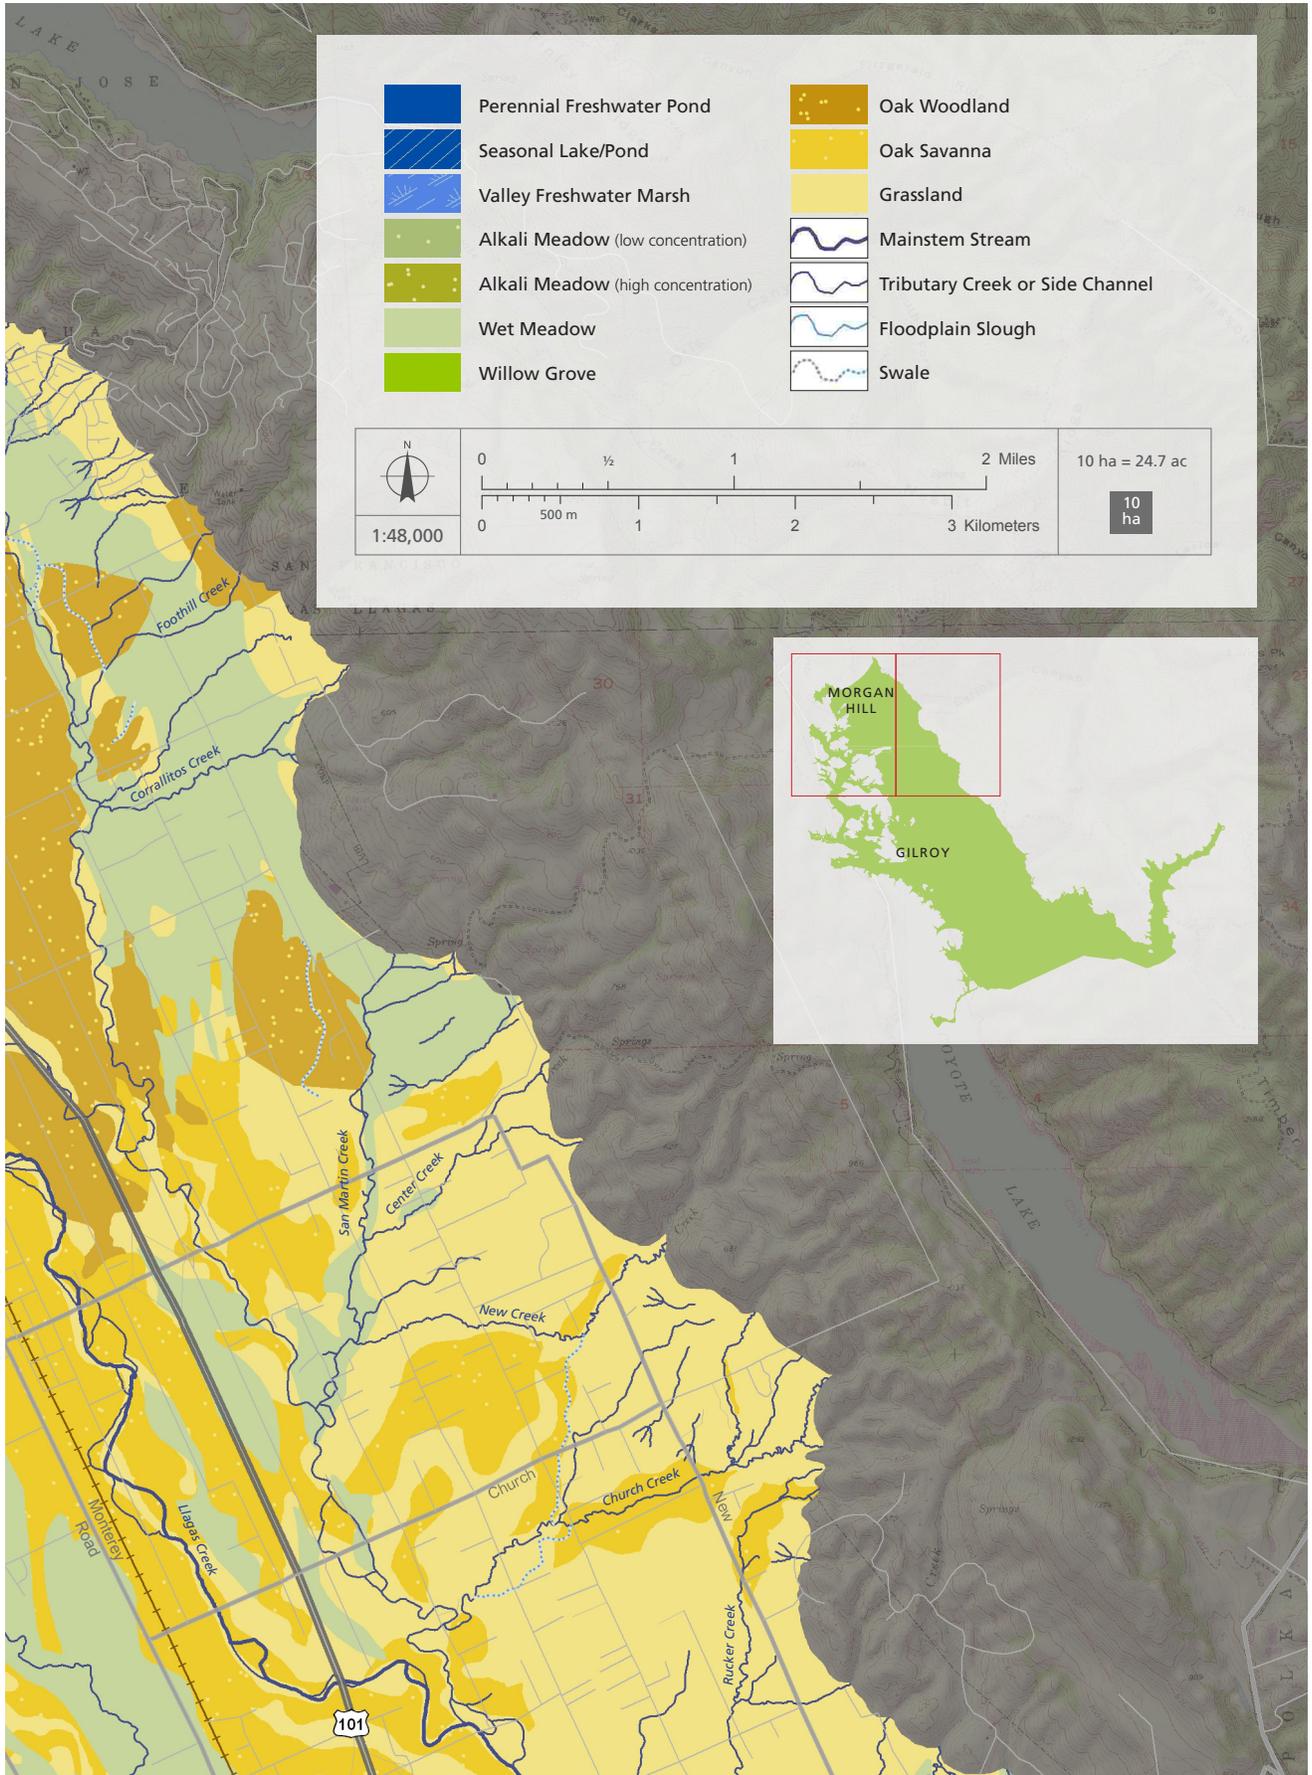
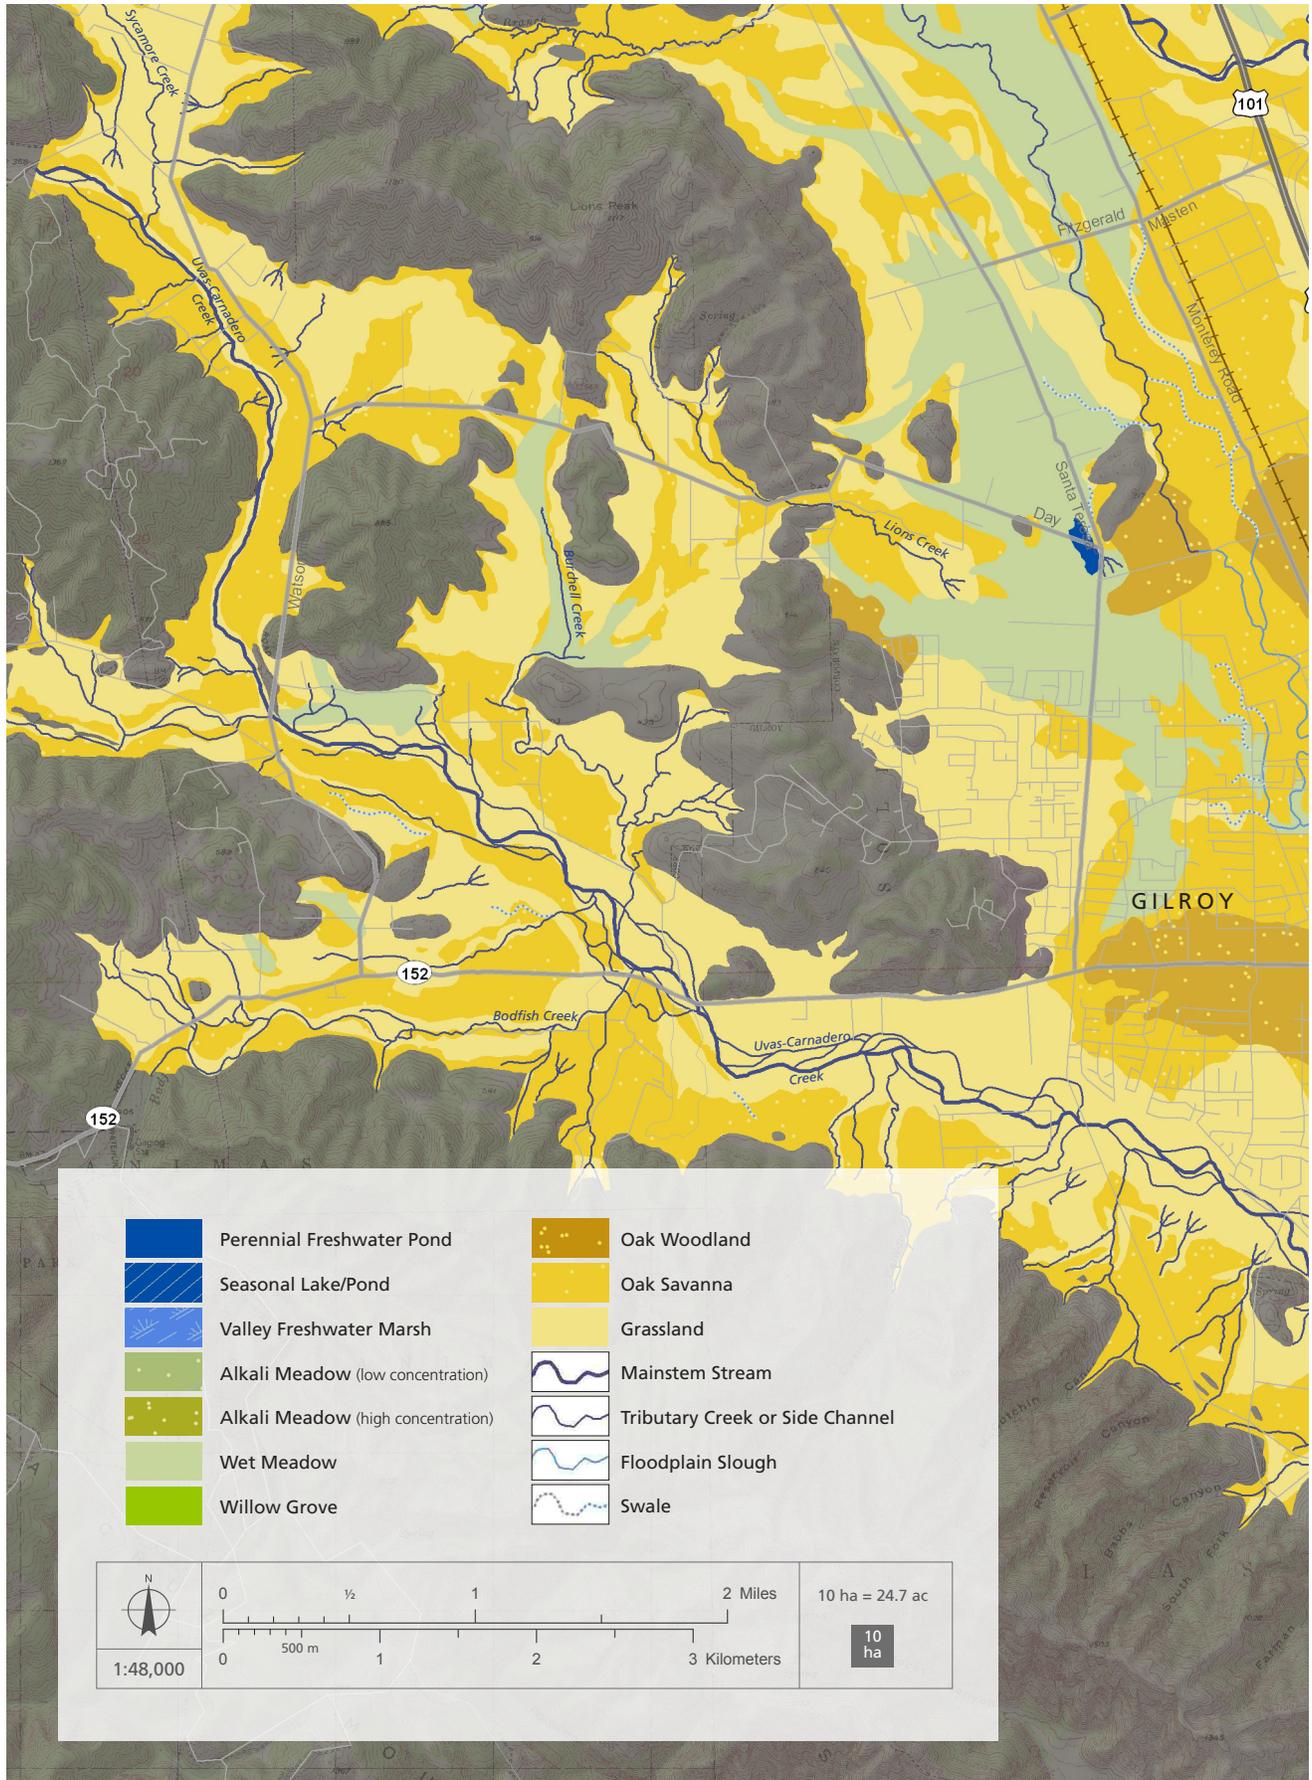
Figure 7.2. Reconstructed land cover map of south Santa Clara Valley prior to significant Euro-American modification (Gilroy area).

Though Pajaro Lake was by far the largest seasonal lake in the lower Llagas area, it was not the only one. Many small lagunitas dotted the area, occurring in larger pockets of freshwater marsh and willow groves (see fig. 7.2). One such lagunita recorded a corner of the boundary line between the San Ysidro (Gilroy) and Las Animas ranchos. It similarly was recorded as dry or of variable size, dependent on the season. Where winter surveyors (e.g., Hargenburgh 1872) noted a lagunita, a survey likely conducted in late summer or early fall noted a "small dry lagunita" (Upton 1867(?)). Hoffman (1864) called it a "small lagoon which spreads out to the marsh of the lands of the late Ignacio Ortega," conjuring a picture of a shallow lake only slightly lower than the marsh around it. By 1894, the spot was labeled only as "The Rock Corner" (after a boulder thrown into the lake to mark the corner in 1850; Herrmann 1894). It is likely that by this point, the extensive draining of the area had made the former lake a permanently dry feature.

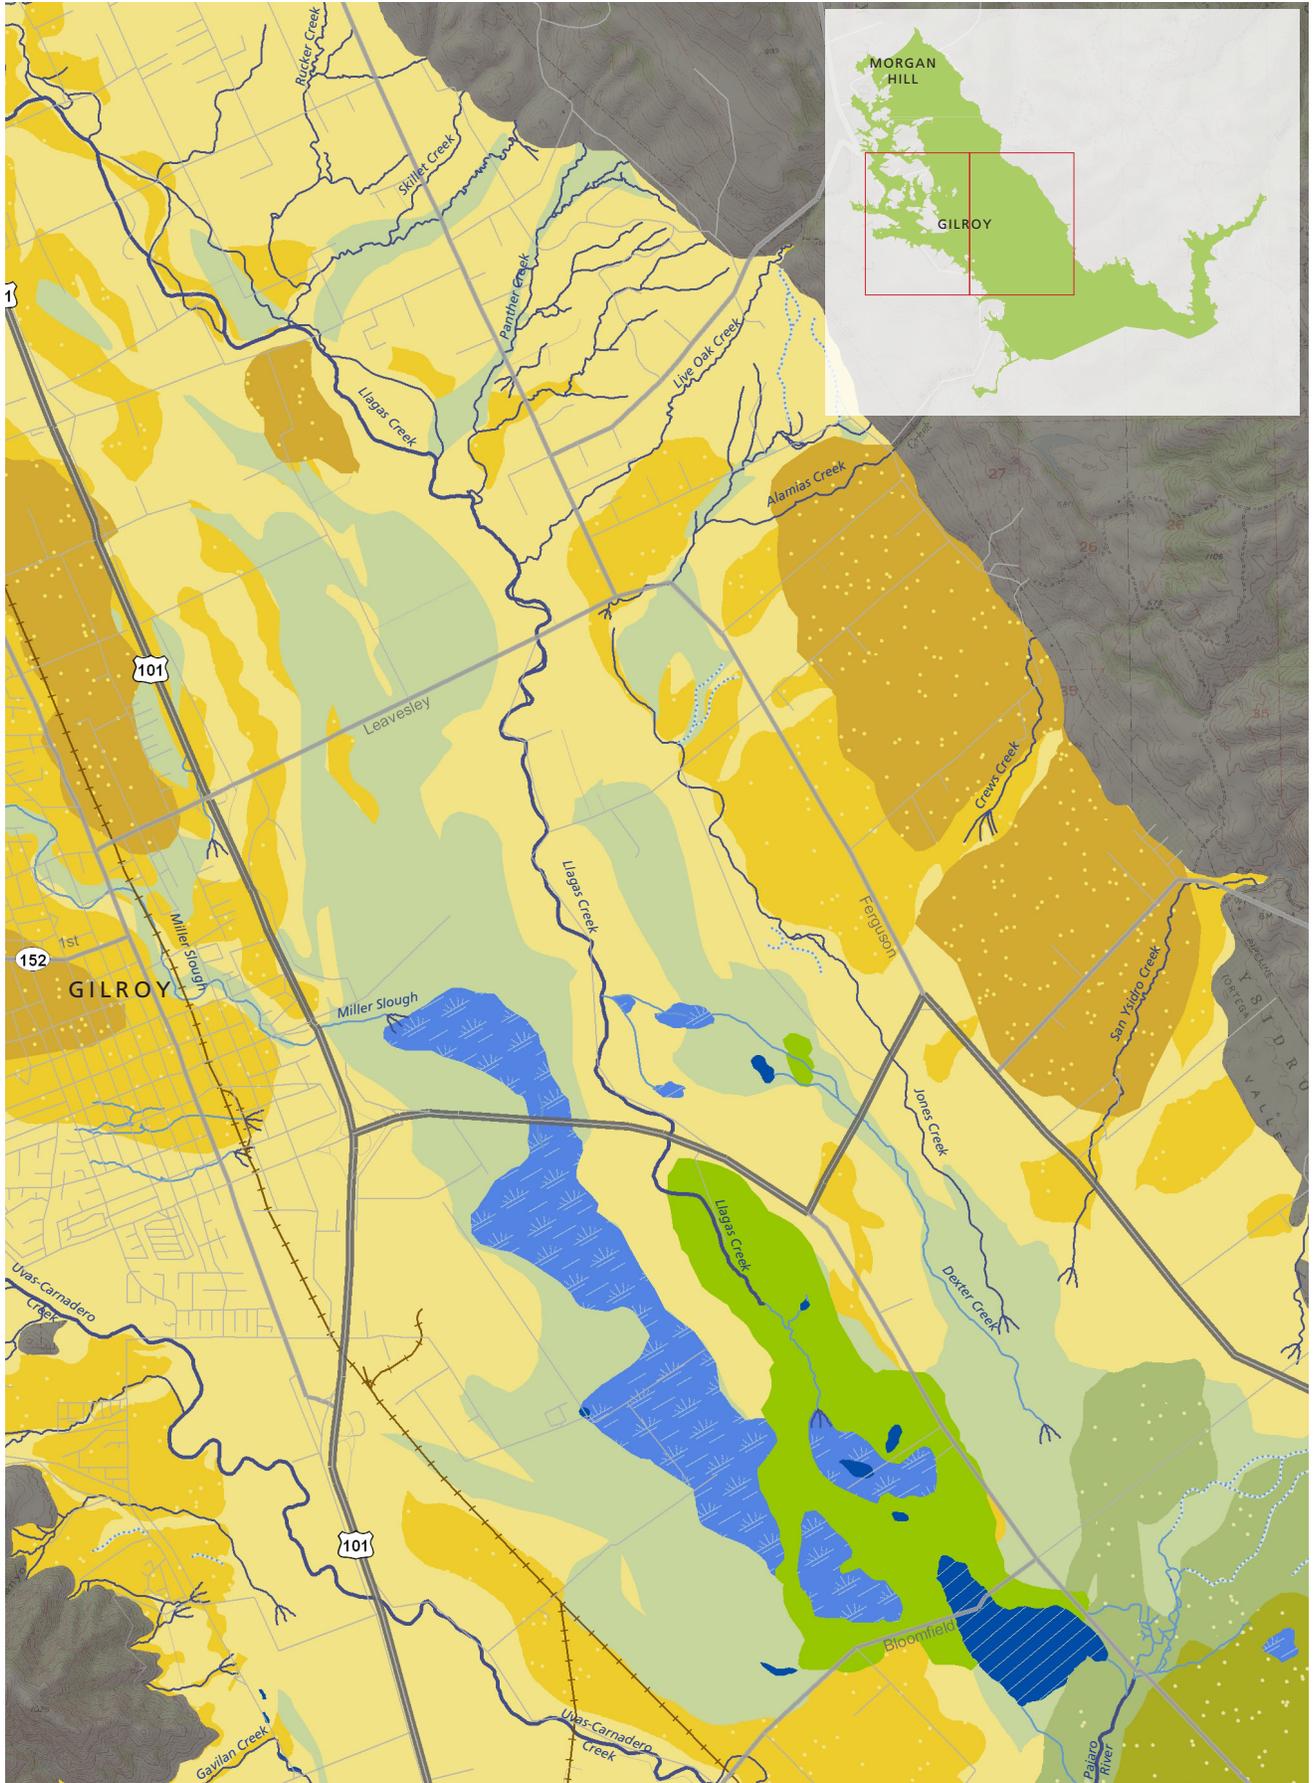
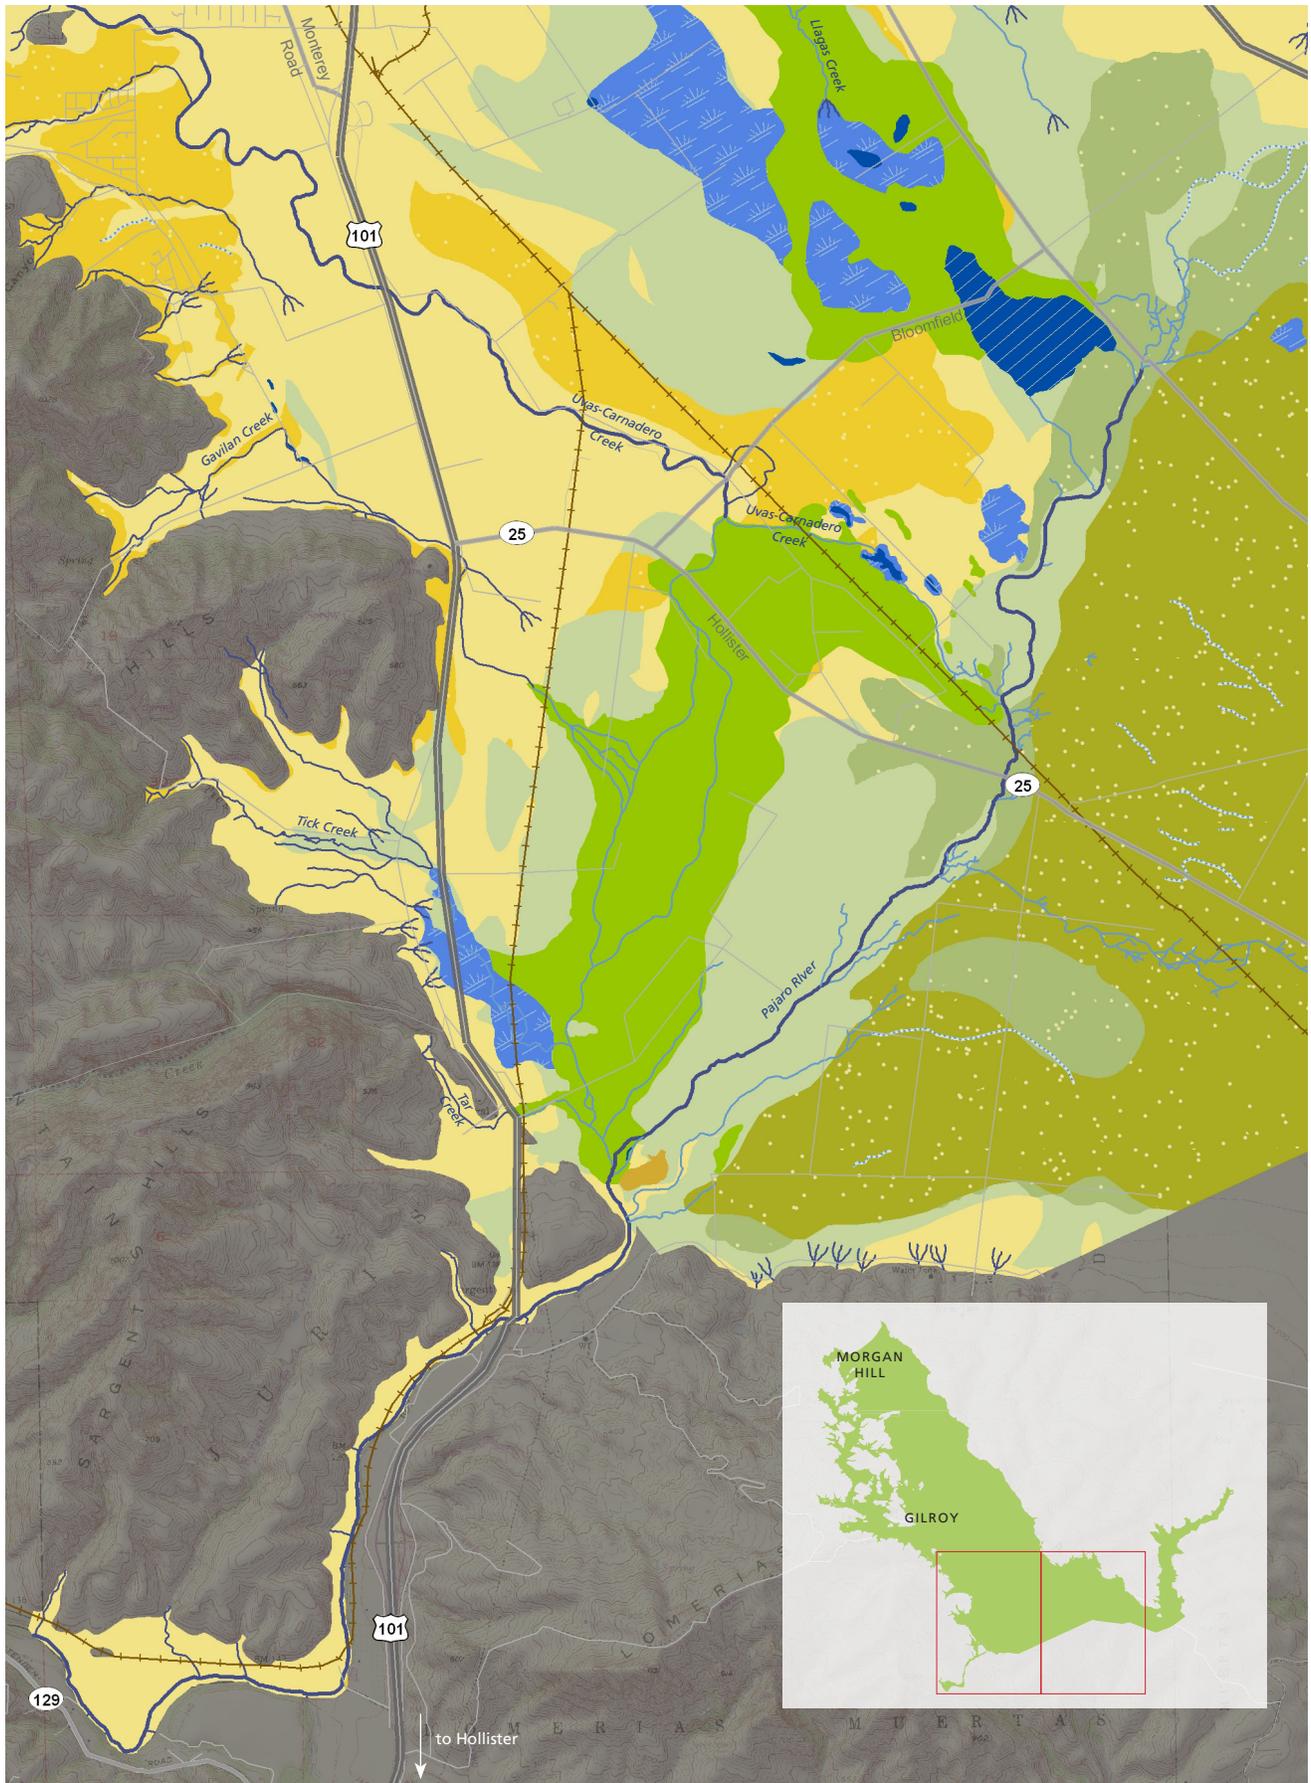
172 Figure 7.3. Reconstructed land cover map of south Santa Clara Valley prior to significant Euro-American modification (Soap Lake floodplain area).

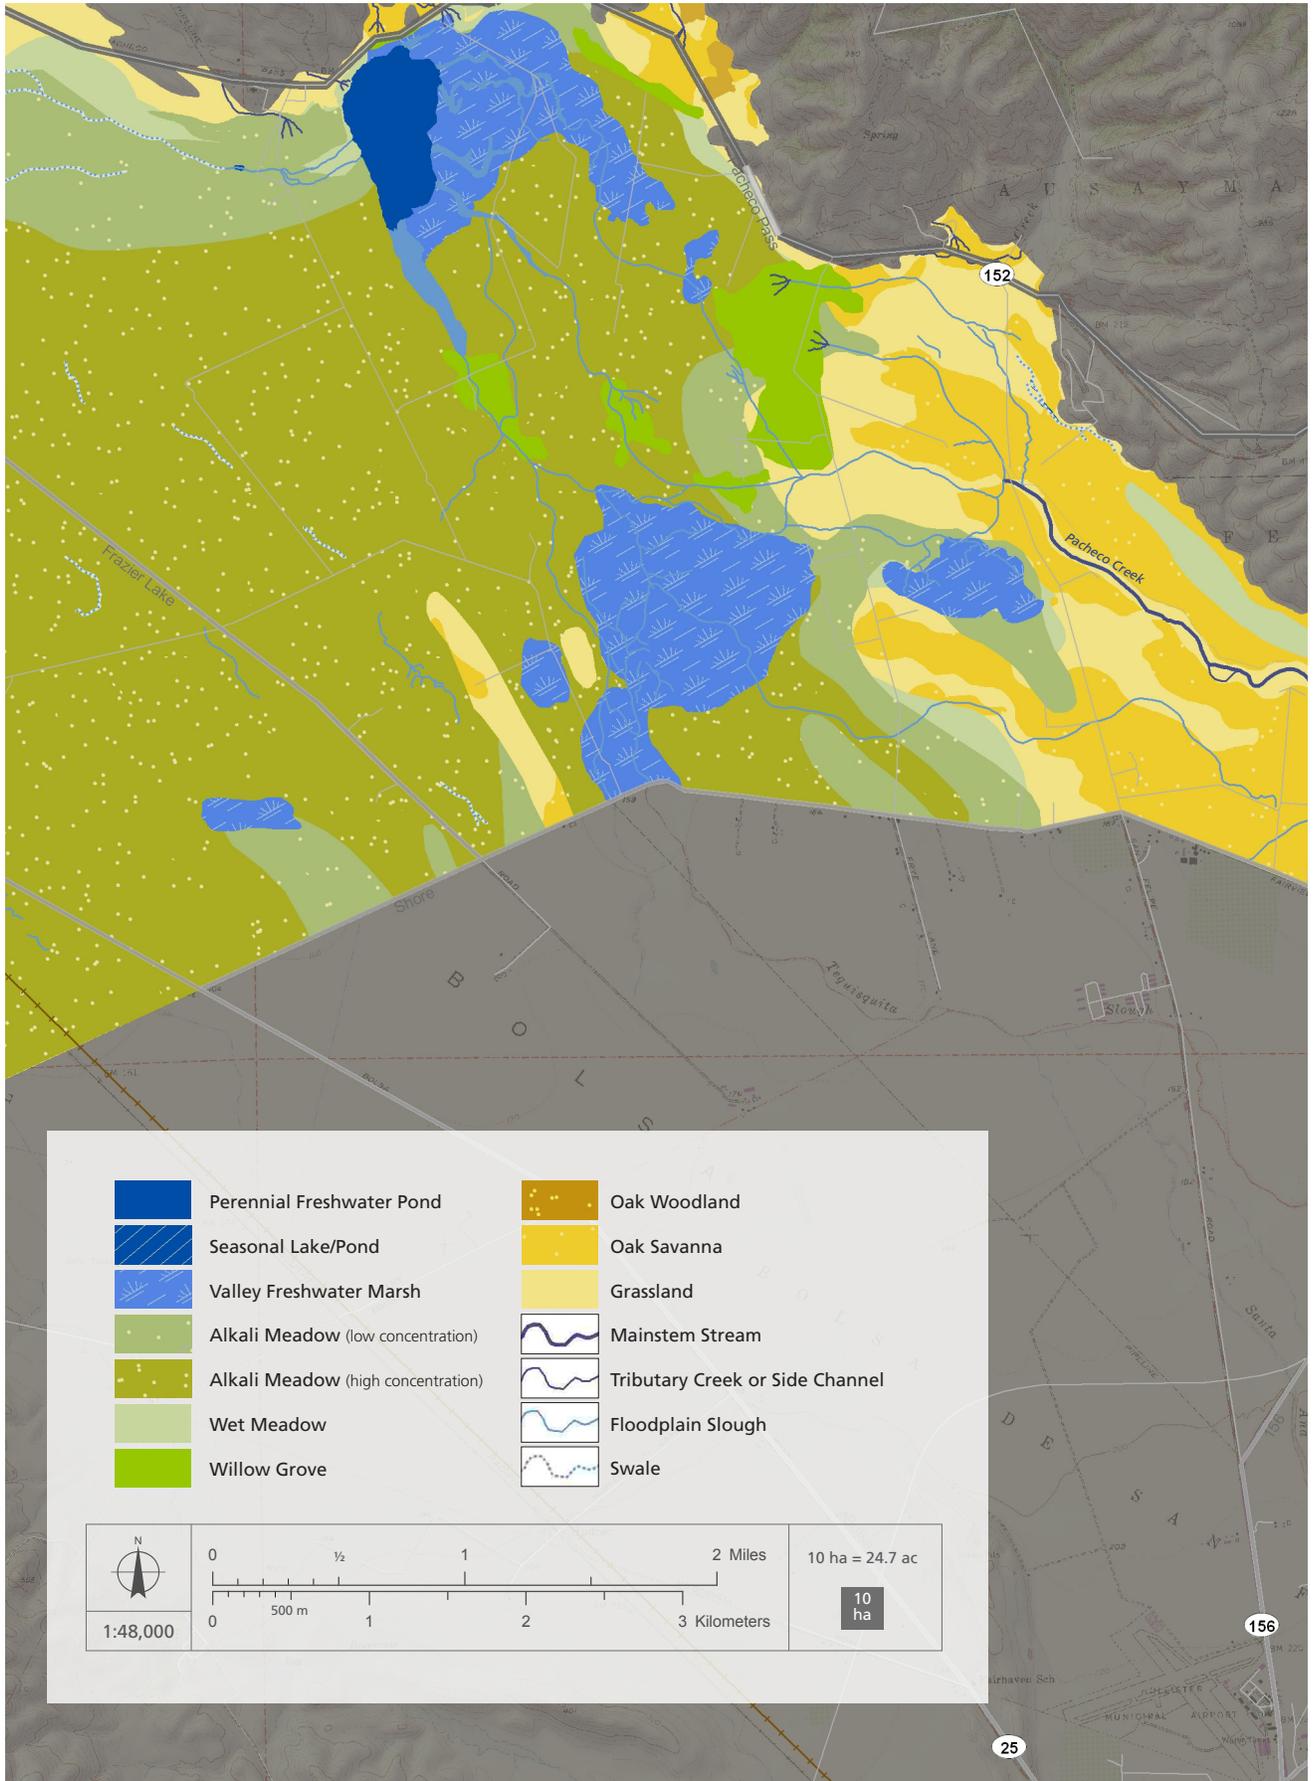
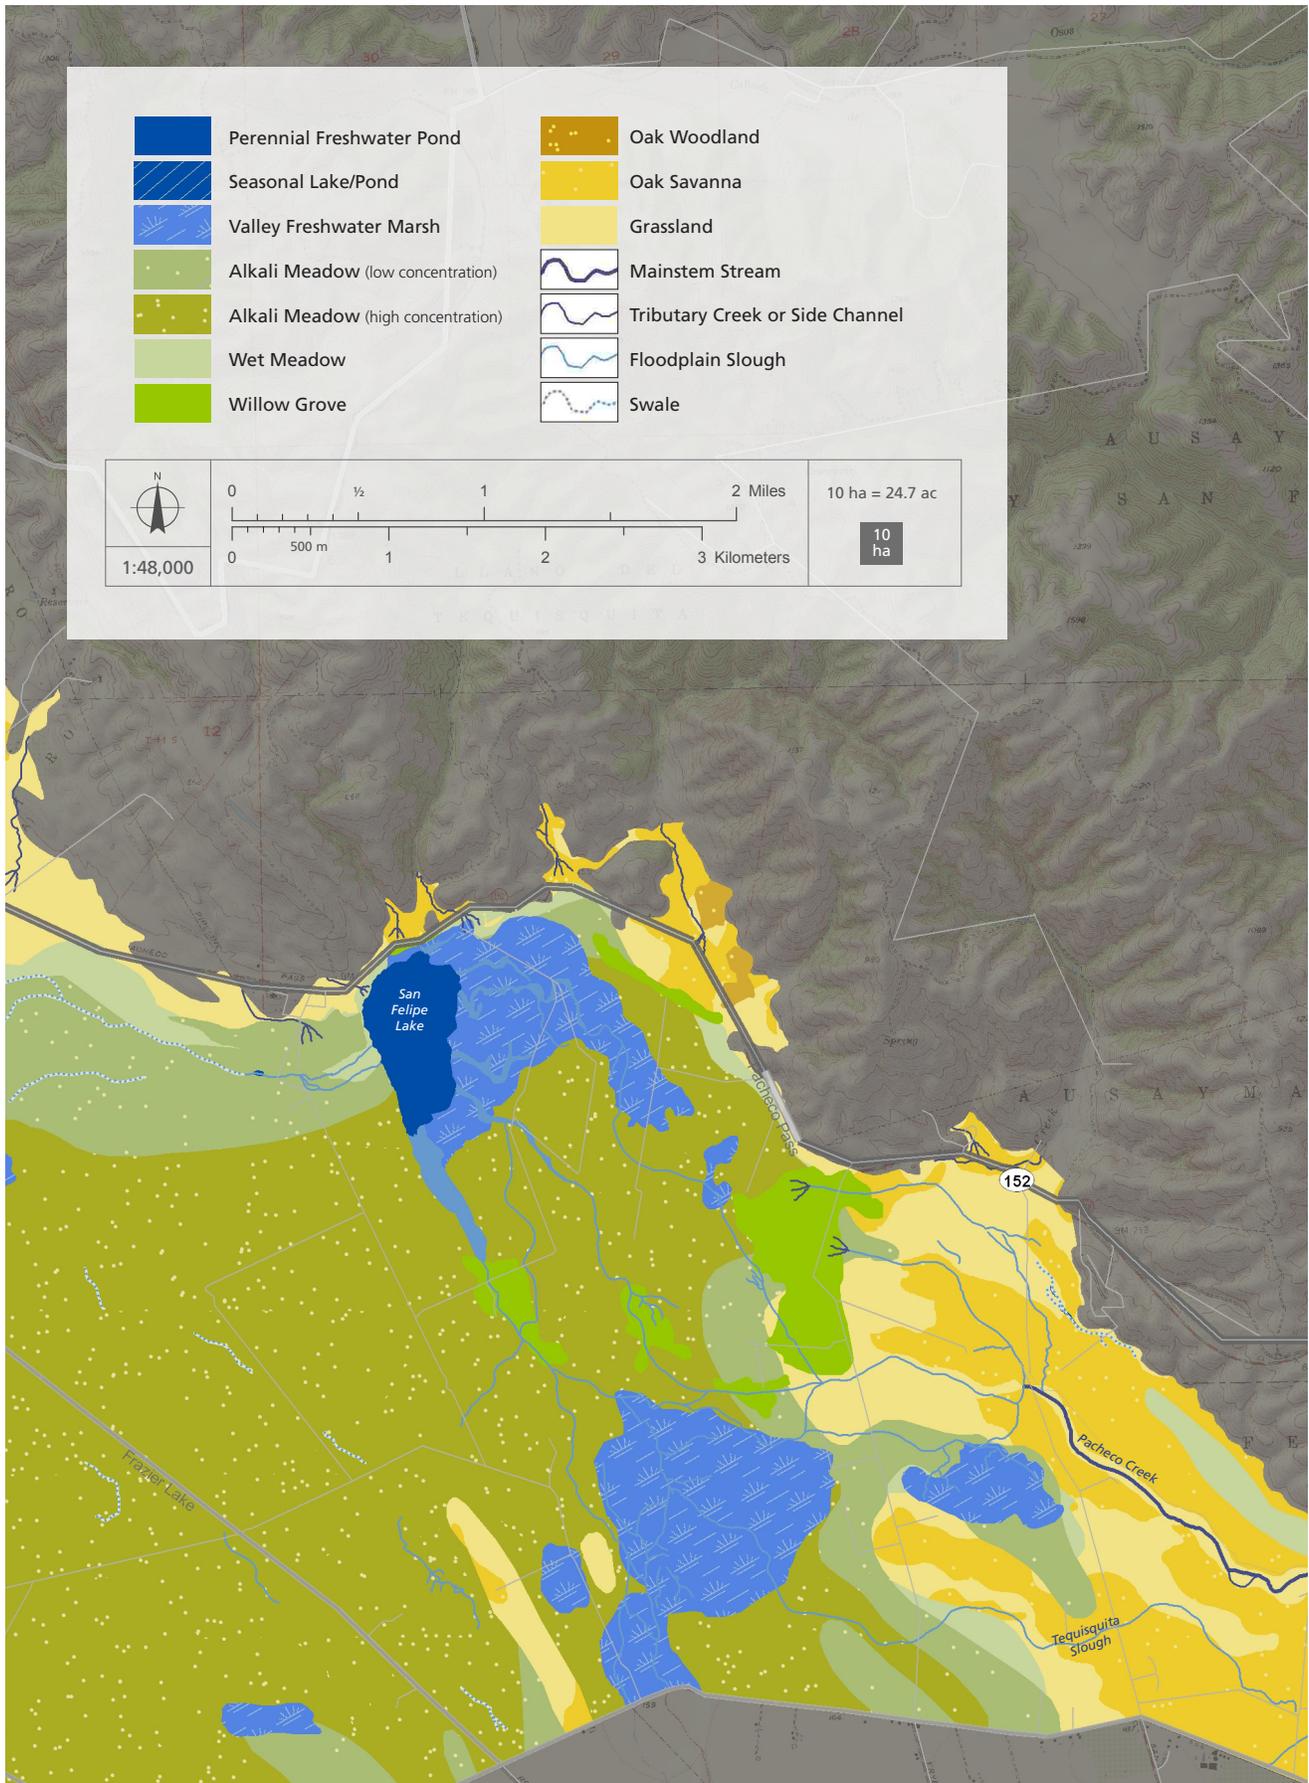
174 Figure 7.4. Reconstructed land cover map of south Santa Clara Valley prior to significant Euro-American modification (Pacheco Creek area).

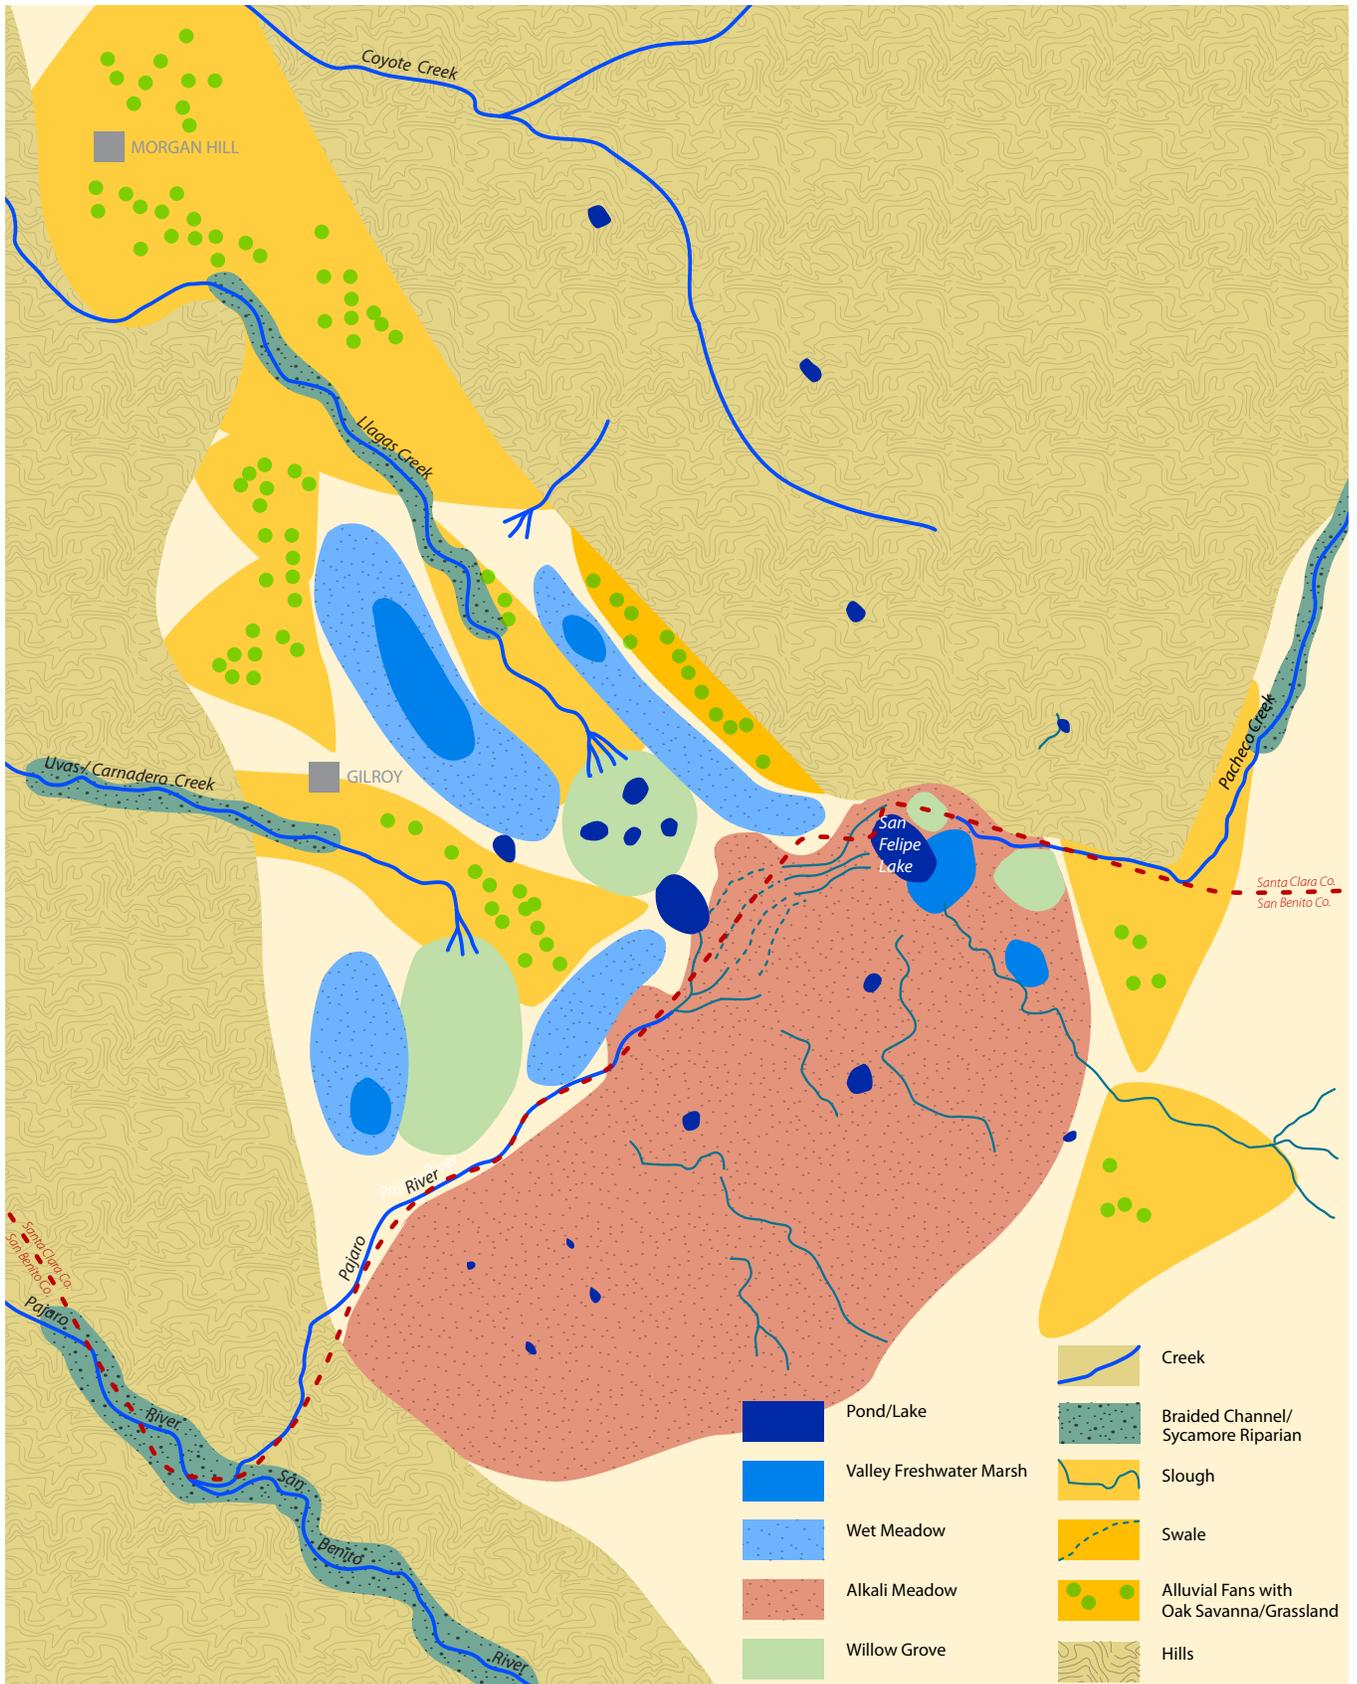
Figure 7.5. Conceptual model of landscape-level habitat patterns in south Santa Clara and north San Benito counties prior to significant Euro-American modification (simplified and not to scale).

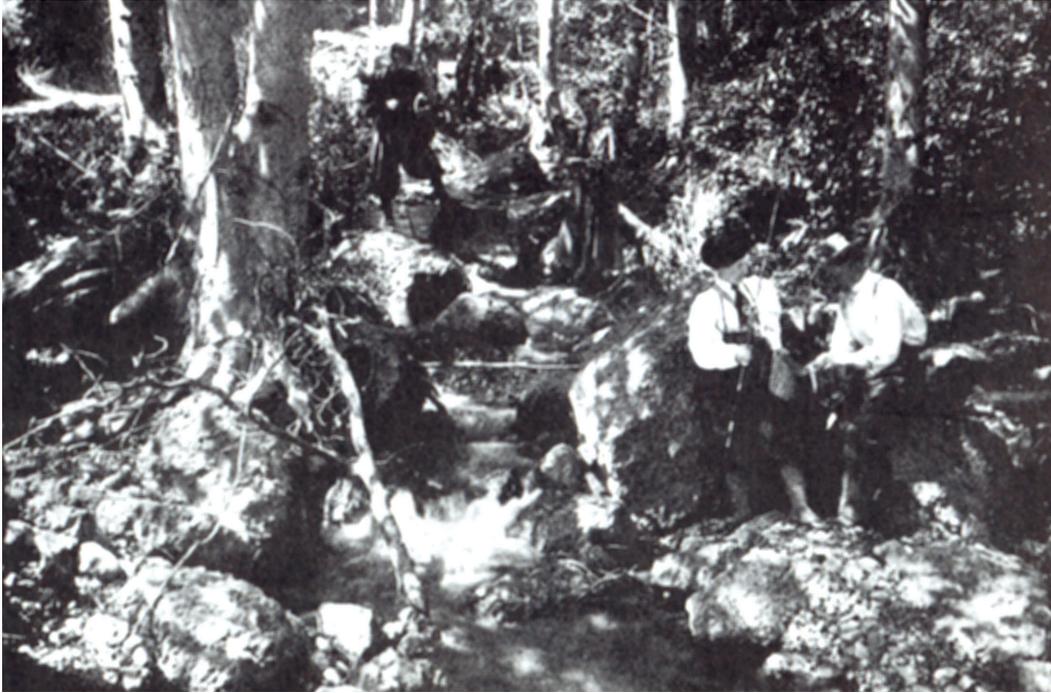
Figure 7.6. A photograph titled “Fishing on Llagas Creek,” illustrates a dense riparian canopy with alders in a rocky stream bed on upper Llagas Creek. (Unknown ca. 1896d, courtesy of History San José)

habitat varied along a corresponding gradient from canyon to canyon mouth to the open alluvial plain (fig. 7.6). On smaller streams, a narrow line of trees at the top of the alluvial fan rapidly gave way to occasional trees or no riparian trees. Larger streams rapidly shifted from forest to woodland to open, sycamore-dominated riparian savannas as they reached the valley floor. Subsurface flows supported these sycamore savannas. The extent of persistent summertime fish pools is not known, but it is clear that they were common in at least some areas and supported substantial native fish resources.

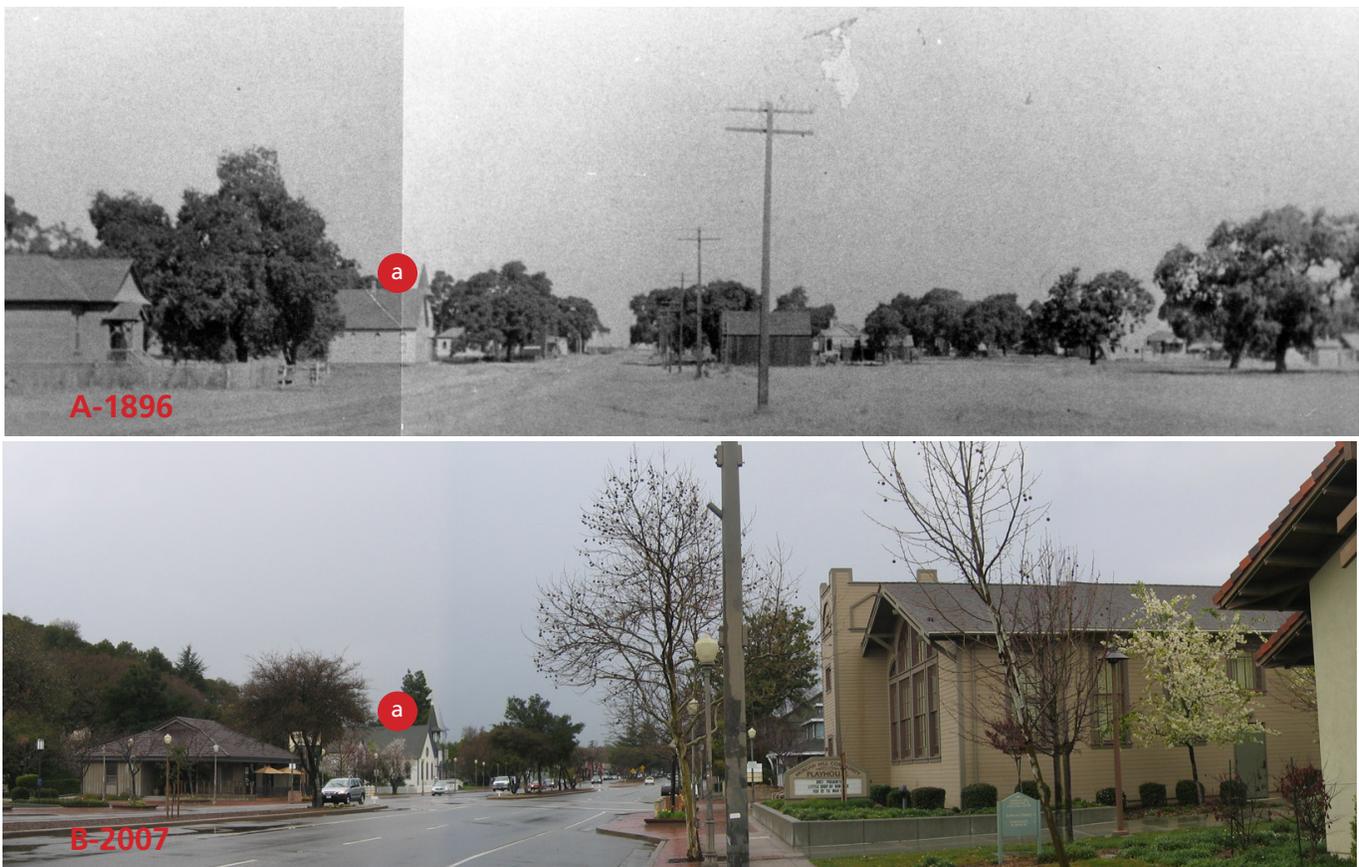
Figure 7.7. The 1896 view looking north along Monterey Road on July 25 shows some of the oaks remaining at that time (A). While few can be seen in the image from the same vantage point today (B), several large old trees are still found in Morgan Hill and younger live oaks can be seen in median strips along Monterey Road. Knob Hill, the vantage point for several of the Morgan Hill landscape photographs in Chapter 7, is on the left, behind the church which can be seen in both photos (a). (A: Unknown 1896, courtesy of the Morgan Hill Historical Society)

GLO surveyor Richard Howe (1851) described this area as a woodland, containing “low, mossy oak timber,” and landscape photography also shows closely spaced valley oaks (figs. 7.7 and 7.8; see Chapter 6). Progressing south toward the finer soils of the valley floor and higher
