LOCAL LANDSCAPE DESCRIPTIONS

This chapter provides additional historical evidence for and discussion of specific locales in south Santa Clara Valley. We first describe the overall landscape patterns of the South Valley, then each subregion of the study area. Level of detail varies somewhat by subregion, depending upon available information. Historical landscape patterns are shown in the full region map (inside front cover) and, at greater scale, in the preceding map series (figs. 7.1-7.4).

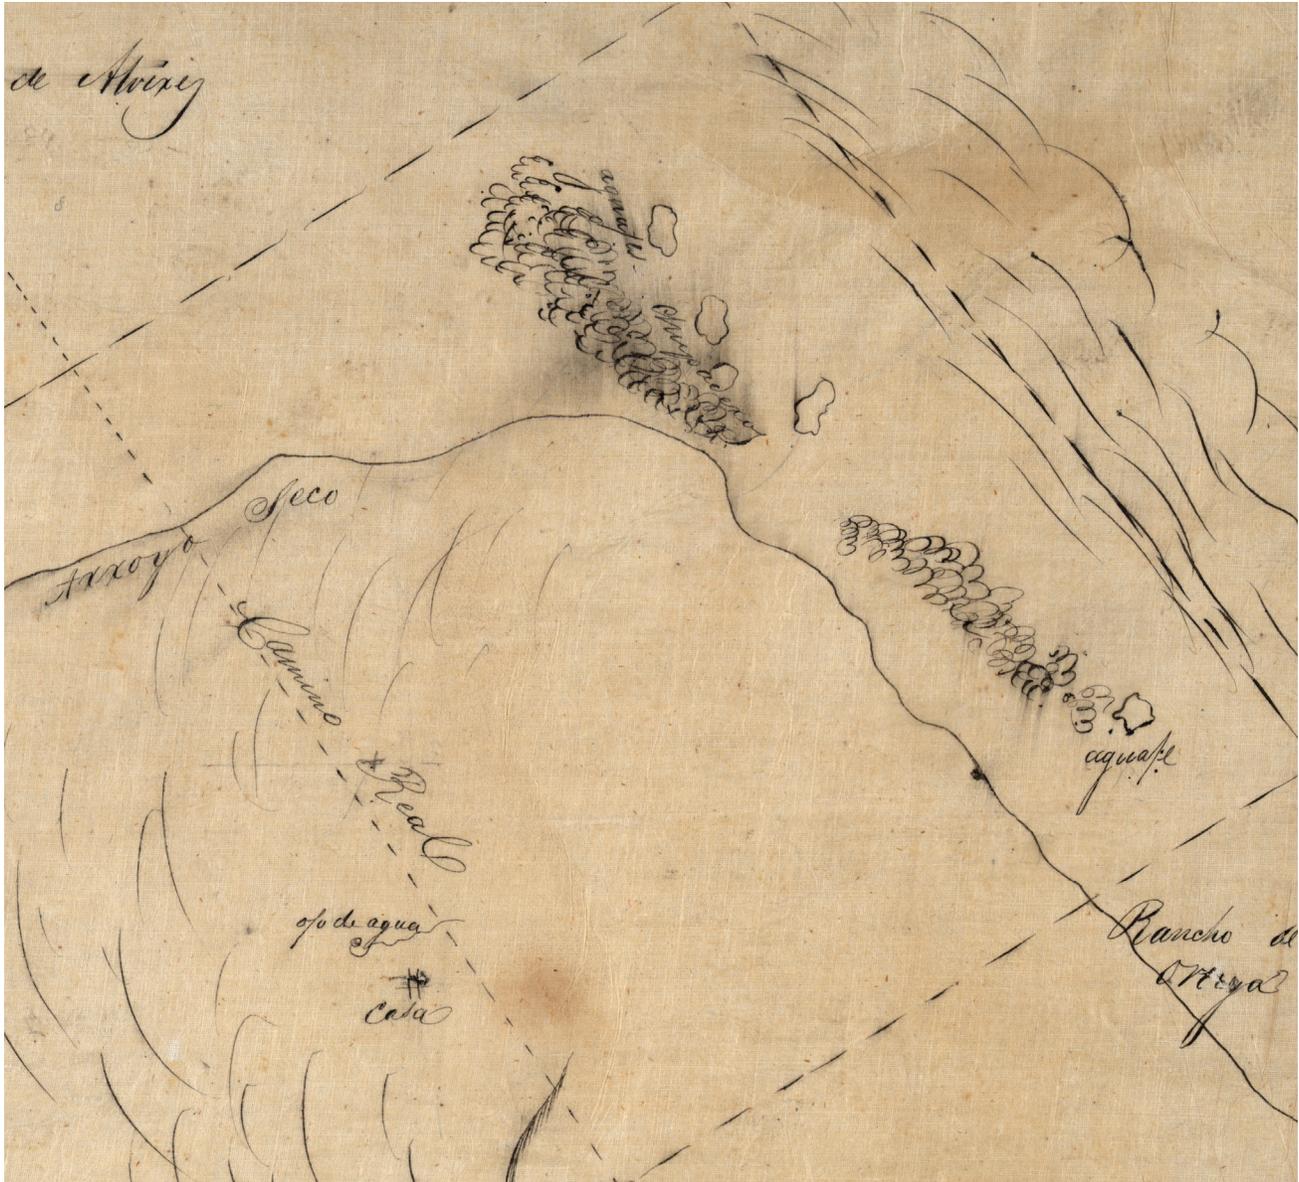
Figure 7.9. This 1840s *diseño* shows a series of aguajes (a potable water supply or spring) along Llagas Creek (here labeled “Arroyo Seco,” or dry creek) as it turns south along the valley floor. One is labeled “aguaje chupadero,” indicating saline conditions. Unlabeled vegetation is shown surrounding the aguajes. (U.S. District Court, Northern District [184-?]d, courtesy of The Bancroft Library, UC Berkeley)

early (1840s) map of the area, appear to have been part of a larger wetland complex (fig. 7.9). This map suggests that the aguajes were surrounded by (undefined) wetland vegetation and included multiple ponds. The top aguaje on this map is labeled “aguaje chupadero.” Gudde and Bright (1998) defines “chupadero” as “a brackish pool where animals come to drink,” implying that at least one of the aguajes shown was saline.

These aguajes appear to coincide with the wet meadow soils mapped by Cosby and Watson (1927a) alongside Llagas Creek.

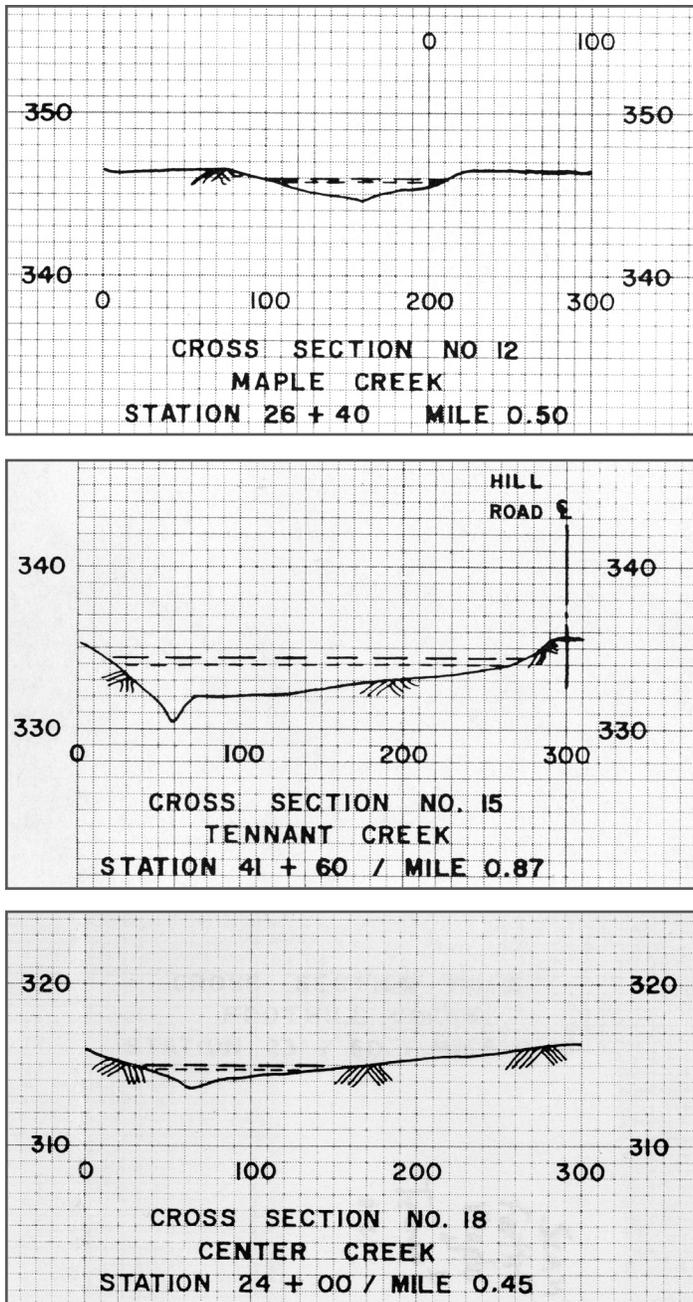
Figure 7.10. Creeks such as Maple, Tennant, and Center had broad and shallow cross-sections in the wet meadows east of Morgan Hill. In places, they could be considered sloughs or swales (cross sections have 10× vertical exaggeration). From USACE (1973).

surface of the soil” (Cosby and Watson 1927a). Many of these streams have remained extremely shallow, or have only been modified in the past few decades. Cross-sections and profiles of streams such as Center Creek, Maple Creek, and Tennant Creek made in 1975 show channels typically incised just 0.3-1 m (1-3 ft) below the adjacent valley surface (fig. 7.10; USACE 1975).

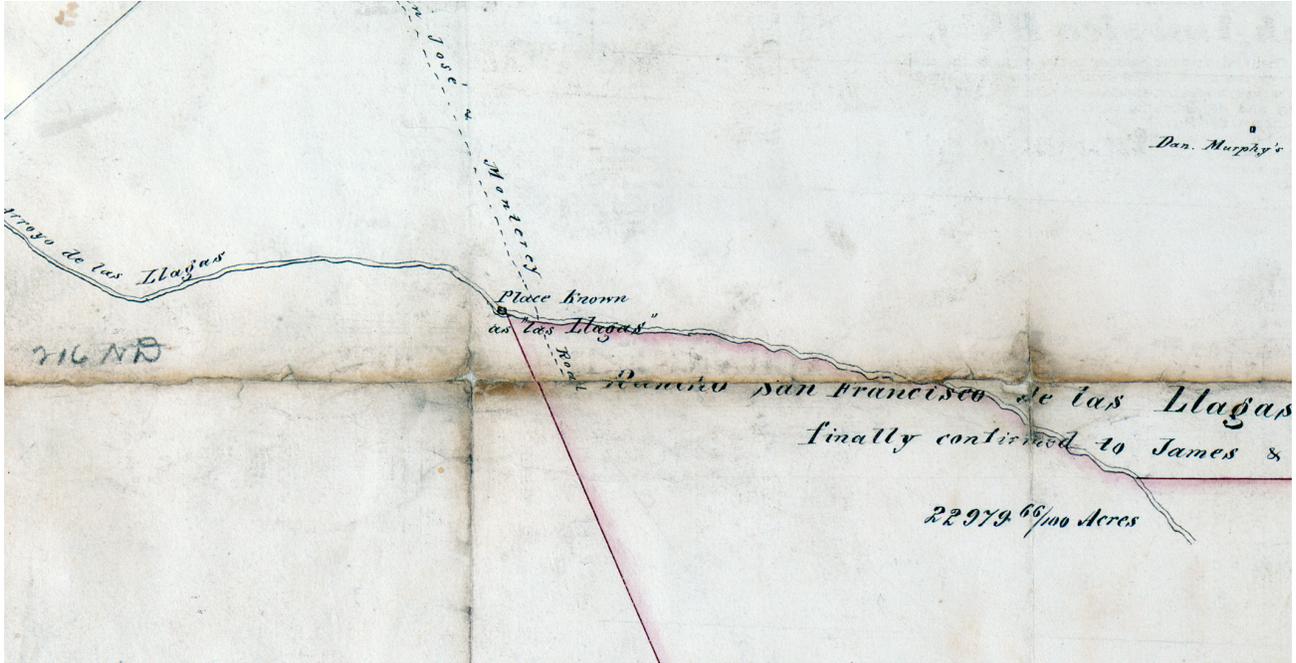
Figure 7.11. This early map shows the renowned pools (here labeled "Place known as 'las Llagas'") on Llagas Creek near the historical El Camino Real crossing. (U.S. District Court, Northern District 1860, courtesy of The Bancroft Library, UC Berkeley)

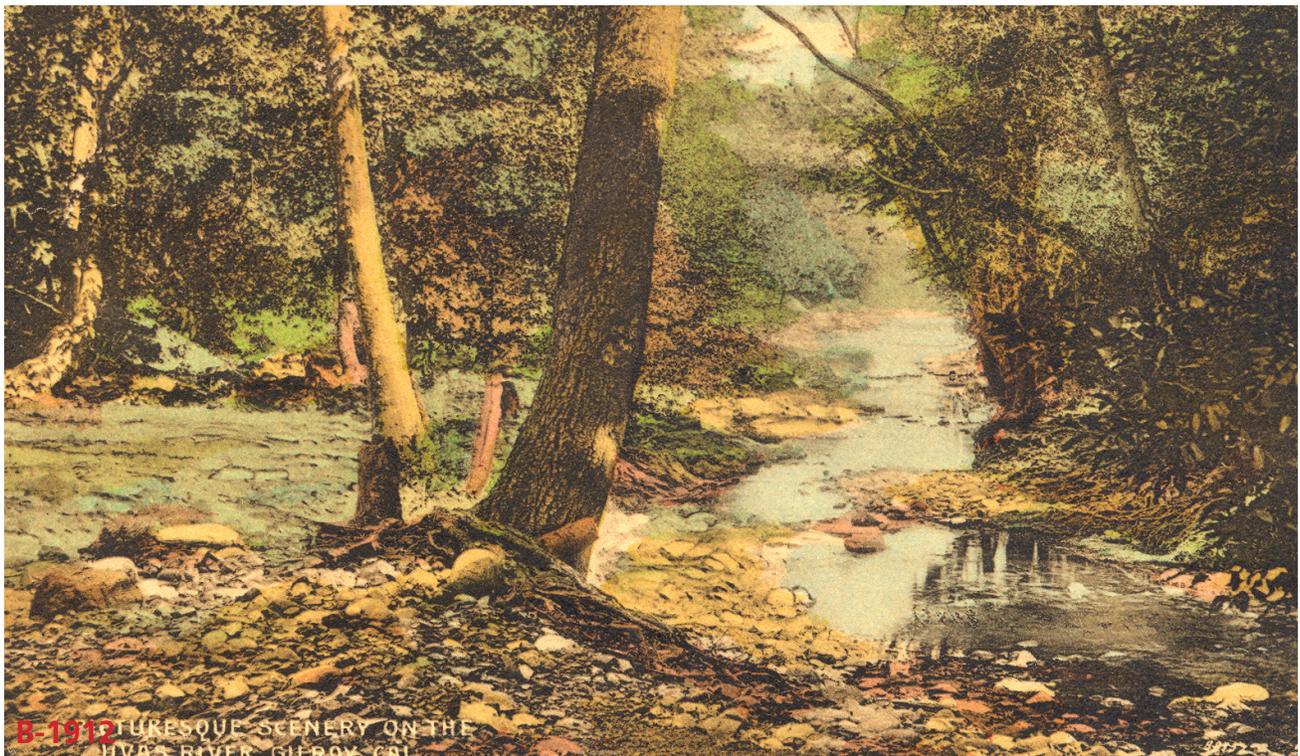
Figure 7.13. Uvas Creek, which historically referred to the reaches upstream of the Bodfish Creek confluence, is shown as a relatively densely vegetated, perennial stream in these two images. "Scene on Uvas Creek" (A), taken near Adams School in the vicinity of Adams-Chitactac County Park, shows large pools in the foreground and background, with a shallow riffle in between. An undercut alder can be seen on the bank at left. (A (Unknown ca. 1930) and B (Unknown ca. 1912b): courtesy of the Gilroy Museum)

Solorsano’s descriptions probably refer to the Uvas Creek reaches with denser riparian woodland and more base flow upstream of the Bodfish Creek confluence, where Solis Rancho was located. (This reach was consistently called Uvas Creek historically, while downstream was considered Carnadero Creek.) Historical fishing accounts also commonly referred to these upper reaches, e.g., “...the Uvas and its tributaries furnish excellent trout fishing...” (Harrison ca. 1888; fig. 7.13).

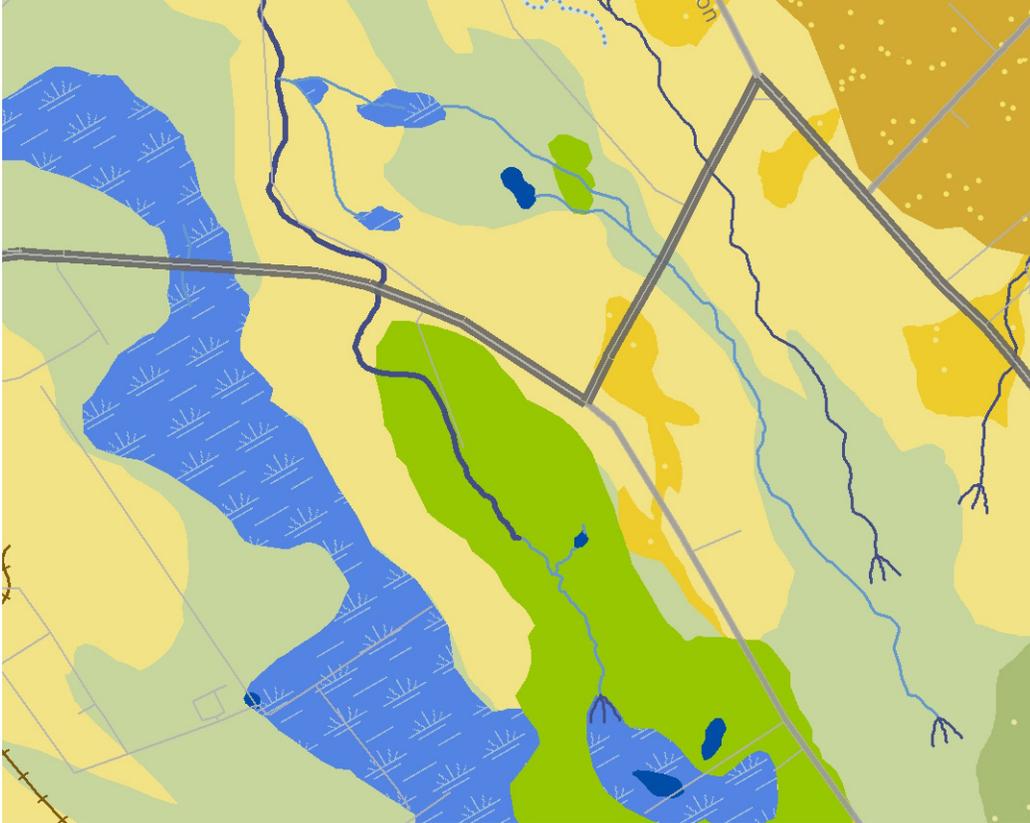
Figure 7.14. The GIS of historical habitats here shows the wetland mosaics surrounding Llagas Creek at Pacheco Pass Road. Immediately upstream of the road, the creek (flowing south in the center of the map) overflowed into the Jones Creek drainage. Downstream of the crossing, it spread into willow groves and freshwater marshes. (See inside front cover for map legend.)

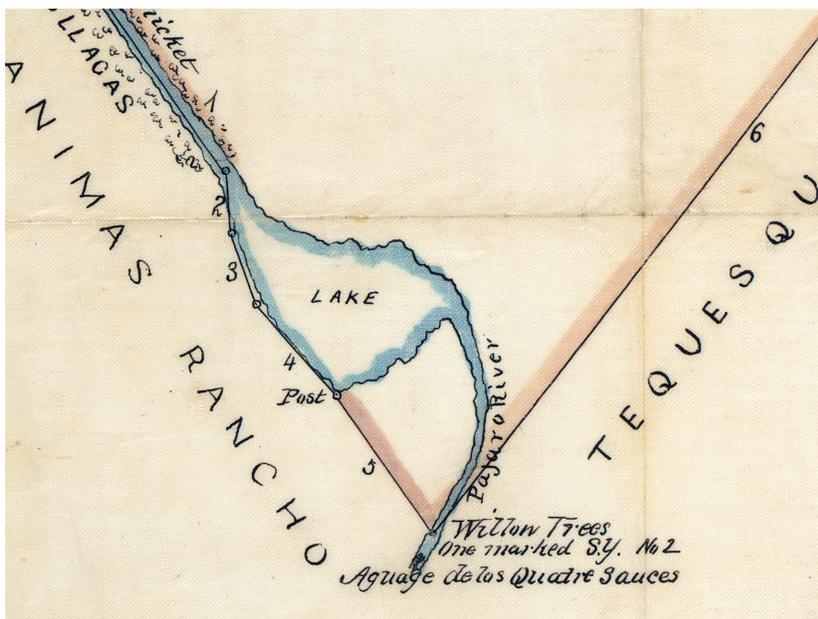
Figure 7.15. This map, from a March 1858 survey (Wallace 1858a), shows a schematic version of the connection between Pajaro Lake and the head of the Pajaro River. Here, the lake is shown as a connecting feature between the mouth of Llagas Creek and the origin of the Pajaro River. (Courtesy of The Bancroft Library, UC Berkeley)

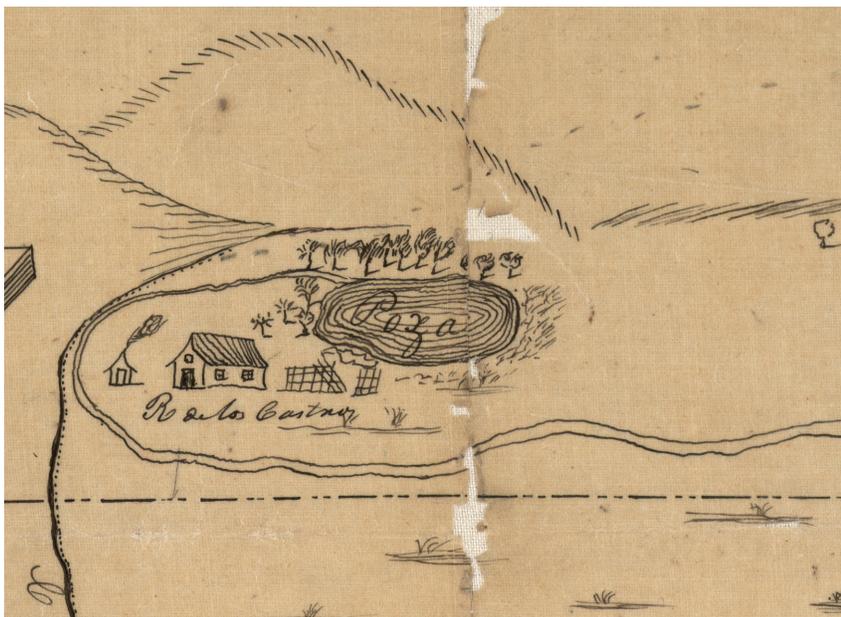
Figure 7.16. A detailed drawing of the "Poza de Carnadero" suggests surrounding wetlands and trees, as well as a direct connection to the creek. (U.S. District Court, Northern District [184-?]c, courtesy of The Bancroft Library, UC Berkeley)

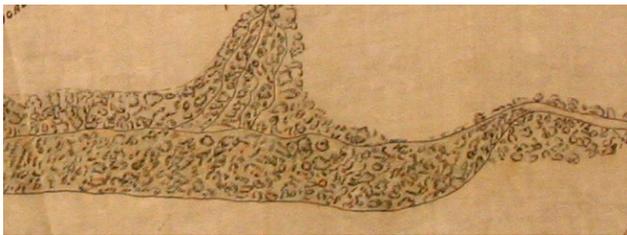
Figure 7.17. This close-up view of the Carnadero Creek willow grove shows multiple internal channels; such features were likely common in willow groves. (Herrmann ca. 1870, courtesy of the Office of the Santa Clara County Surveyor)

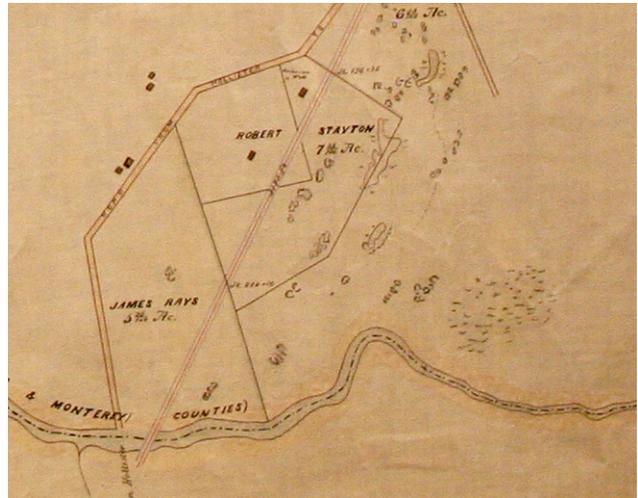
Figure 7.20. A detail from a ca. 1870 map of south Santa Clara County shows a series of willow groves, ponds, and wetlands northeast of the SPRR line (in red) and Bolsa Road (in yellow). These features likely marked a historical route of Carnadero Creek. A large wetland (indicated by a series of dashed lines) is shown at right. The Pajaro River runs at the bottom of the image. (Herrmann ca. 1870, courtesy of the Office of the Santa Clara County Surveyor)

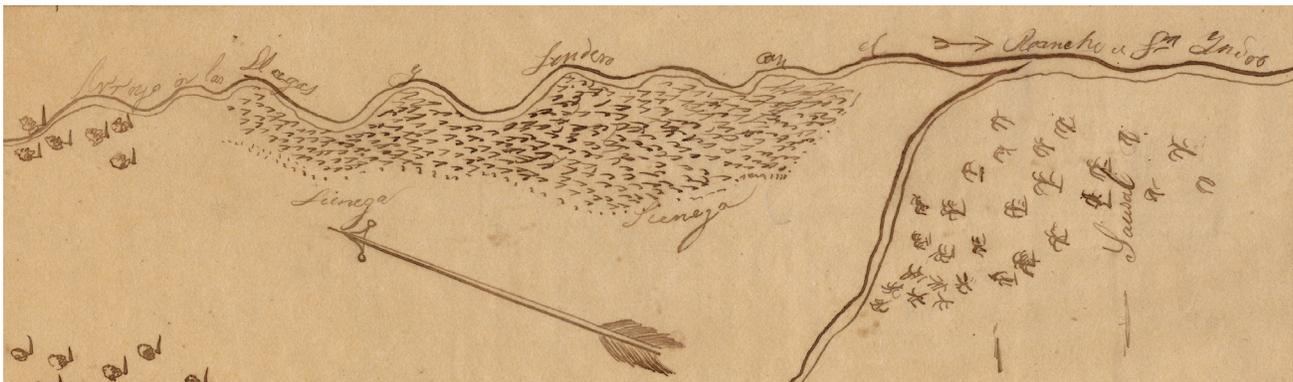
Figure 7.19. This early *diseño* shows Llagas Creek (horizontal, at top) and Carnadero Creek (vertical, at right). The large Carnadero Creek willow grove (labeled "sausal") is shown to the south of the old route of the creek. The large willow grove/wetland mosaic at the bottom of Llagas Creek (labeled "sienega [sic]") is shown with a different pattern than the Carnadero willow grove, indicating that the two features had distinct characteristics. Llagas Creek and Carnadero Creek are shown joining east of the Carnadero sausal, indicating that what is now called the Pajaro River – between the mouths of Llagas and Carnadero Creeks – was not associated with the Pajaro in the mid-1800s. (U.S. District Court, Northern District 1873b, courtesy of The Bancroft Library, UC Berkeley)

Carnadero Creek flowing to the north of the large willow grove rather than through it (fig 7.19). These maps show the Llagas and the Carnadero joining east of the sausal, indicating that what is now called the Pajaro River (between the mouths of Llagas and Carnadero creeks) was much less clearly associated with the Pajaro River in the mid-1800s.

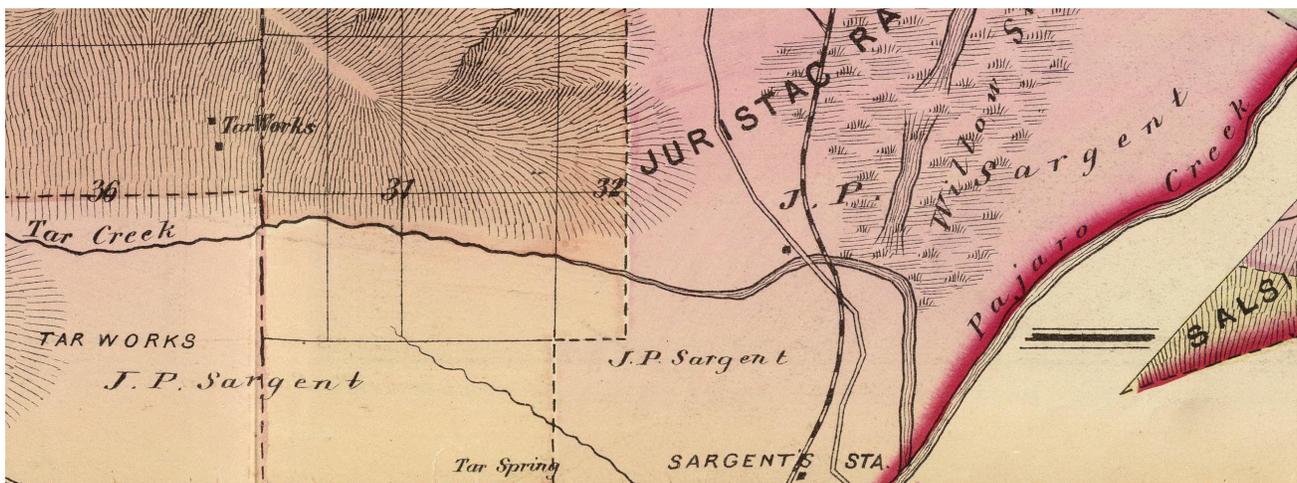
Figure 7.21. Historical evidence suggests that Tar Creek joined the Pajaro River near the present confluence of the Pajaro with Carnadero Creek. This Thompson and West (1876) map shows Tar Creek turning sharply south before joining the Pajaro. Carnadero Creek is shown to the north as broken, wide channels traversing the willow swamp. (Thompson and West 1876, courtesy of the David Rumsey Map Collection)

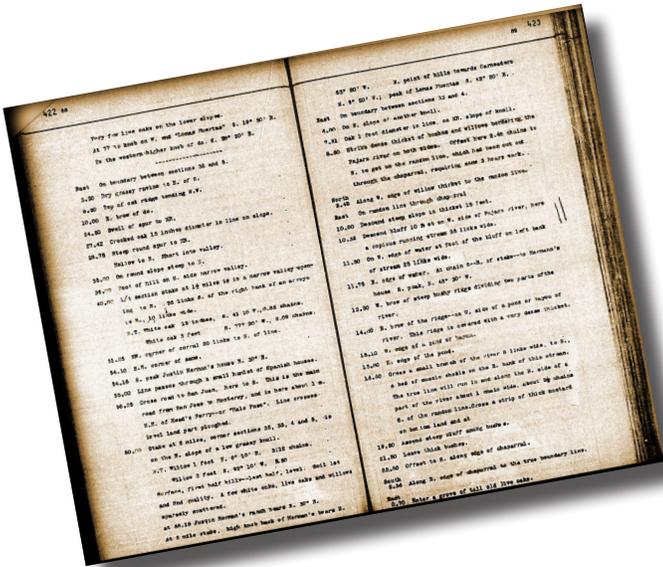
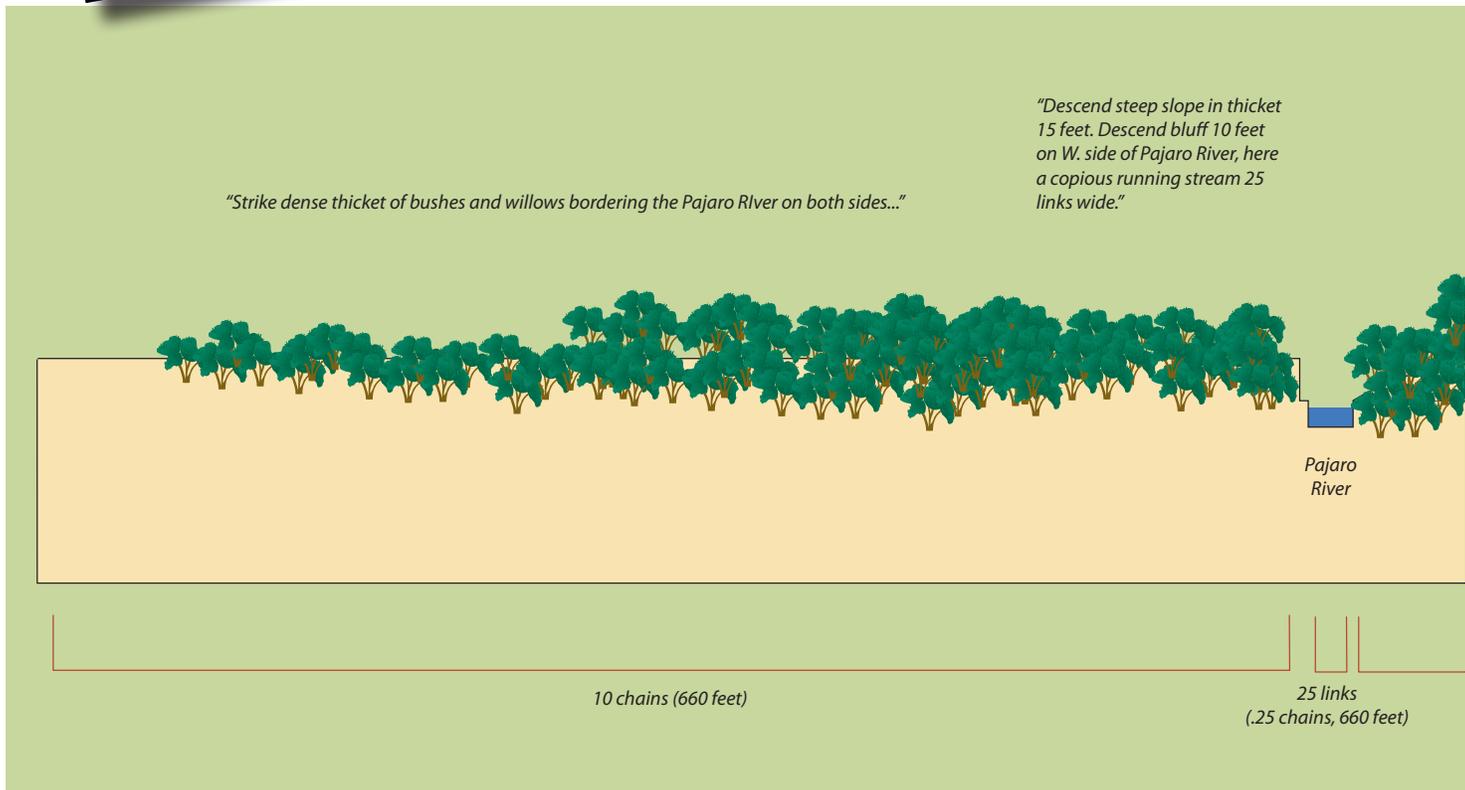
Figure 7.22. Riparian floodplain characteristics of the Pajaro River in 1854, as per Day’s 1854 survey notes (above left)

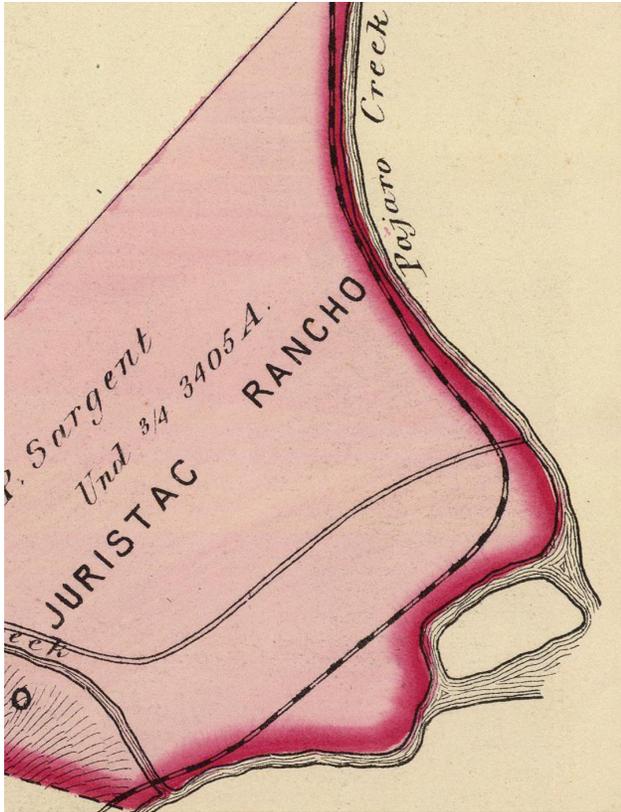
Figure 7.23. This 1876 map detail shows the island at the confluence of Pajaro “Creek” and the San Benito River. This island, and the associated pool, was the site of picnics, fishing expeditions, swimming trips, and baptisms. (Thompson and West 1876, courtesy of the David Rumsey Map Collection)

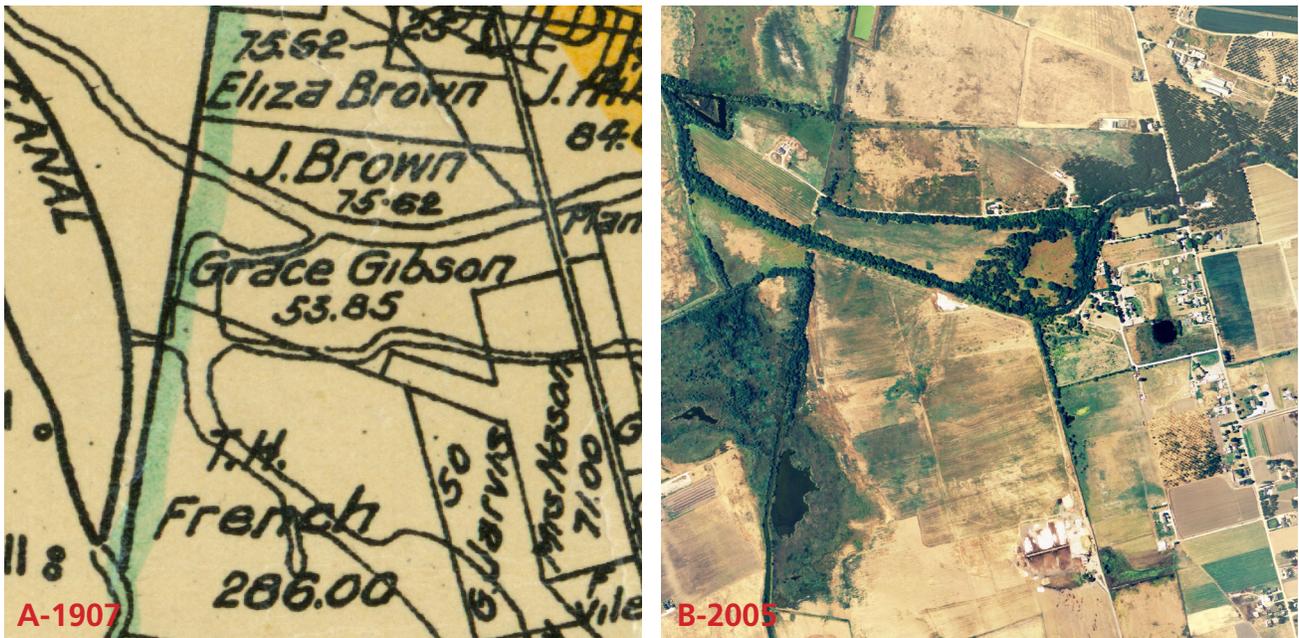
Figure 7.26. Remnants of complex slough patterns from 1907 (A) still function in 2005 (B). The boundary between Brown and Gibson appears to have been a slough; that boundary is still visible today. (A: McCray 1907, courtesy of the Earth Sciences and Map Library, UC Berkeley; B: USDA 2005, courtesy of NAIP)

Some evidence of historical sloughs is still visible in 1939 aerial imagery as well as in contemporary aerial photography. These residual features often correspond closely to the alignments indicated by historical maps, helping confirm the historical data. For example, sloughs entering the Tequisquita marshes from the east apparently served as the property boundary between two farms (McCray 1907) and now persist in the form of a narrow channel following the same alignment (fig. 7.26).

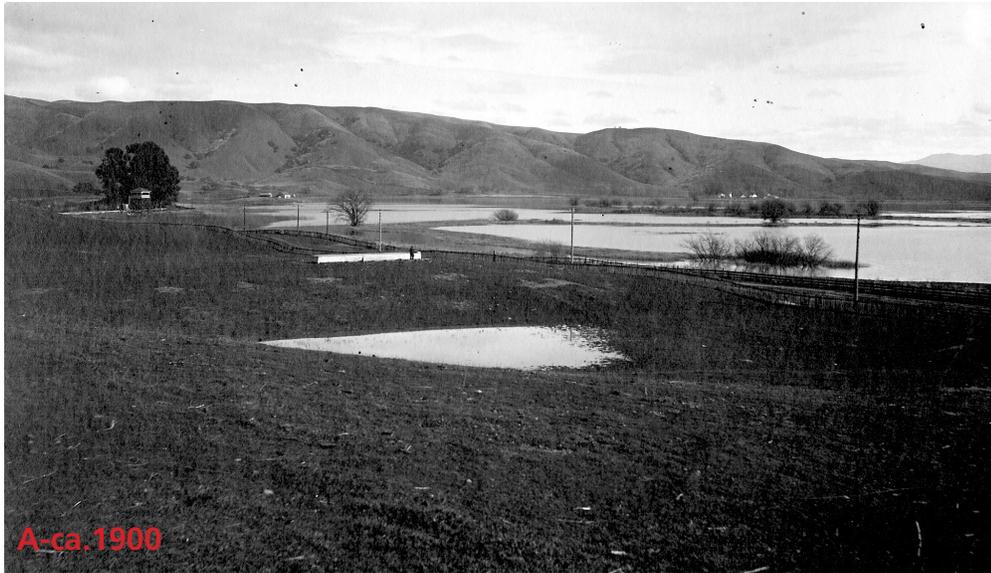
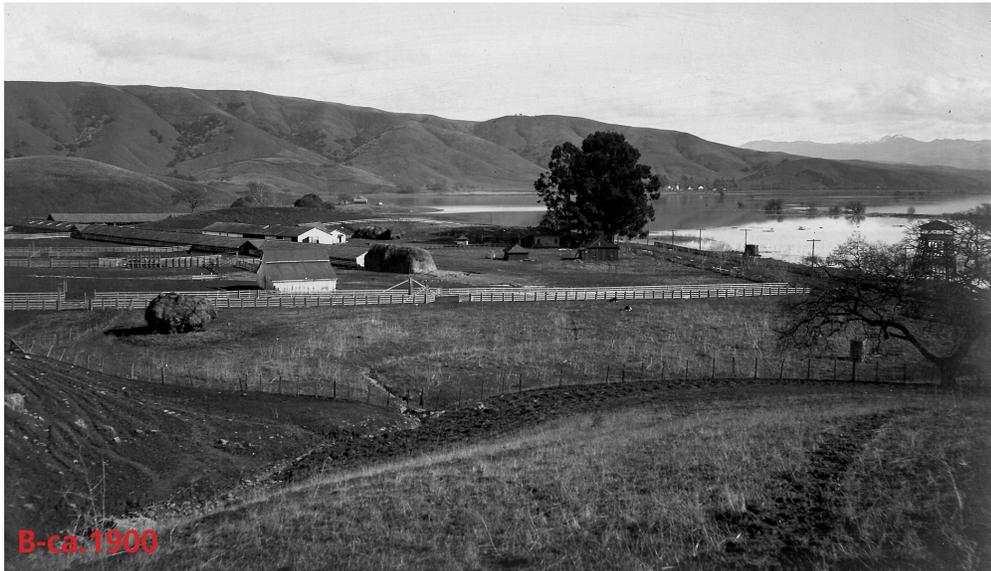
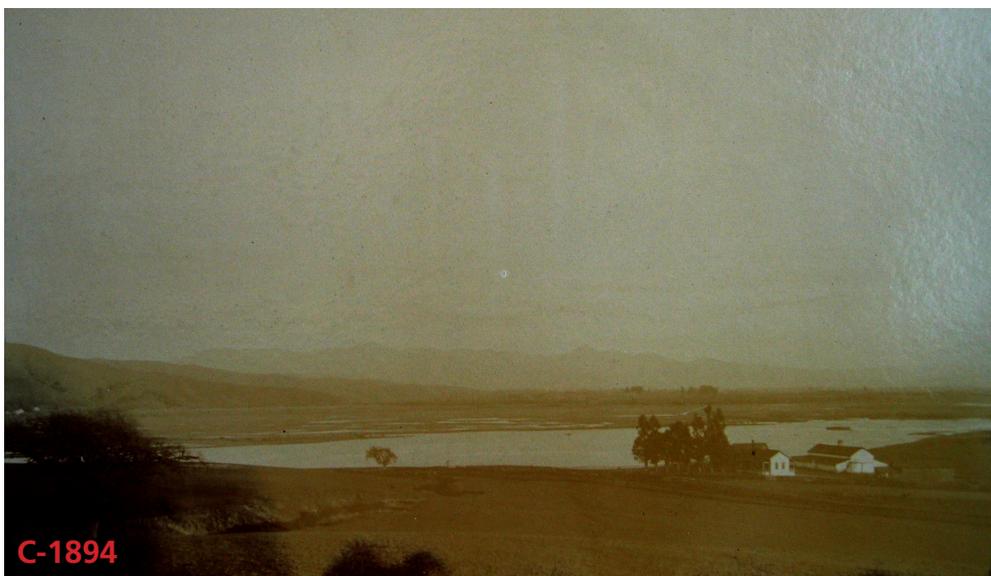
Figure 7.27. Three views of the Soap Lake floodplain from the northwest margin of San Felipe Lake. A and B were taken when the lake was in flood; submerged trees are evident. The lower image shows more average conditions, in 1894. While the image is somewhat indistinct, the white areas behind the far shore may be the sloughs and wetlands shown in 19th-century maps (see fig. 5.10). Parts of the lake's east (far) shore that are wooded today have no trees in the photograph, contributing to a picture of wetter conditions historically. (A (Unknown ca. 1900d) and B (Unknown ca. 1900e): courtesy of the San Benito County Historical Society; C: Unknown 1894b, courtesy of the Gilroy Museum)

large areas flooded north and east of the lake, extending nearly to the hills (fig. 7.27).

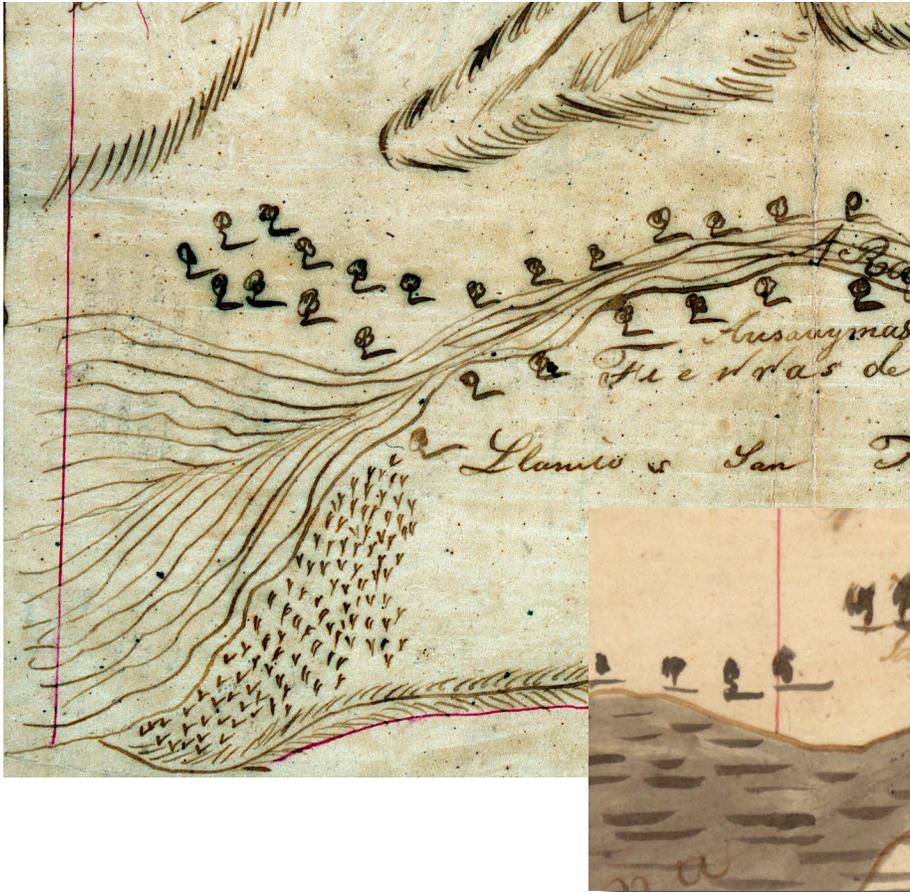
Figure 7.28. Riparian trees along Pacheco Creek give way to a willow grove (labeled “Sausal” in the inset), freshwater marsh, and open water, as the creek flows from right to left into the San Felipe Lake wetlands. Different versions of the same land grant map often show additional symbology or annotation that can help with interpretation. (U.S. District Court, Southern District [184-?]e and U.S. District Court, Southern District [184-?]d (inset), courtesy of The Bancroft Library, UC Berkeley)

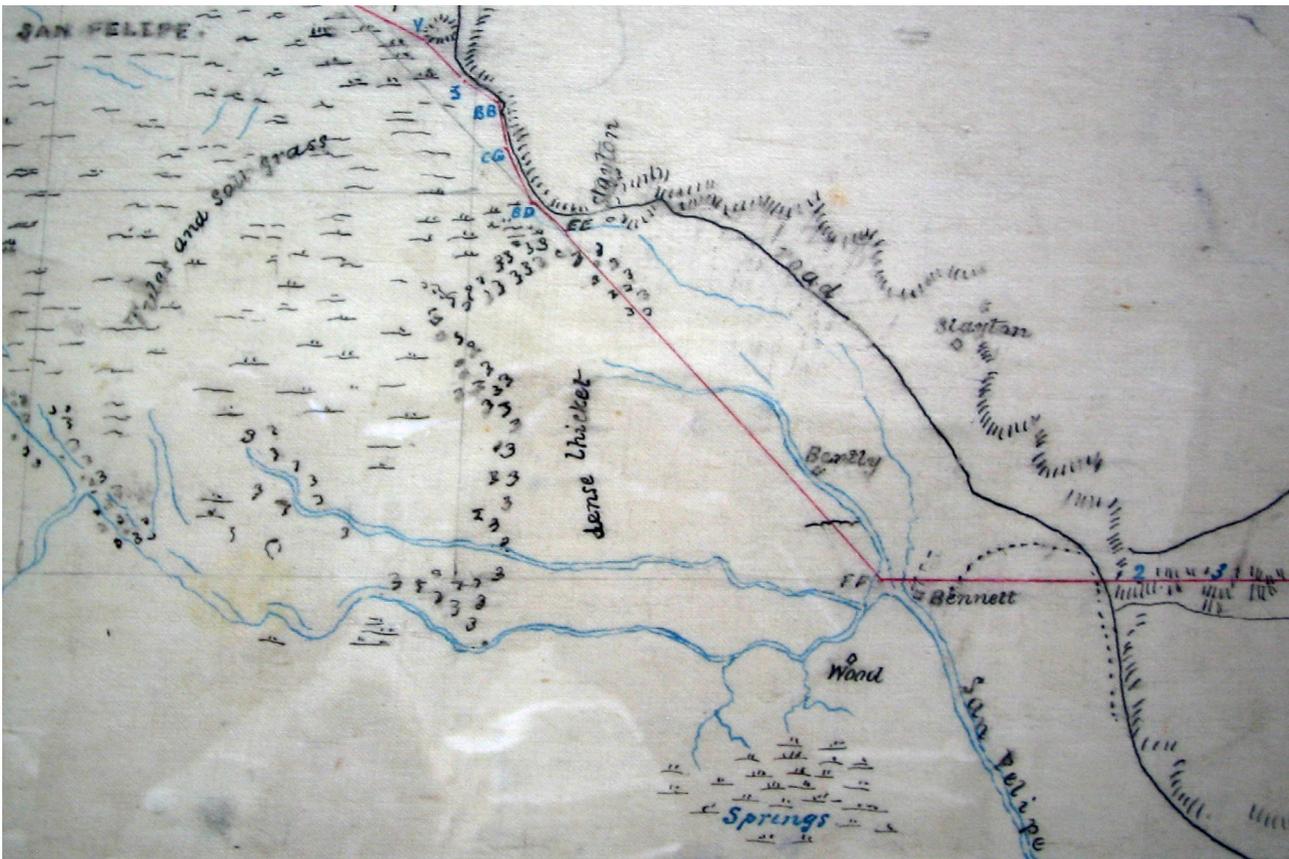
Figure 7.29. This portion of Healy’s 1858 map of the Santa Clara County line shows the spreading of San Felipe (Pacheco) Creek into the San Felipe Lake marshlands. (The edge of “Lake San Felipe” is shown at upper left.) Healy ran the boundary, drawn in red, around the edge of the “Tules and salt grass” and then made a straight line to the point at which the creek branched, before heading due east (on the right hand side of the map). The map also shows a spring-fed marsh (lower right) and willow groves, indicated by tree symbols and the phrase “dense thicket.” (Healy 1858b, courtesy of the San Benito County Recorder’s Office)

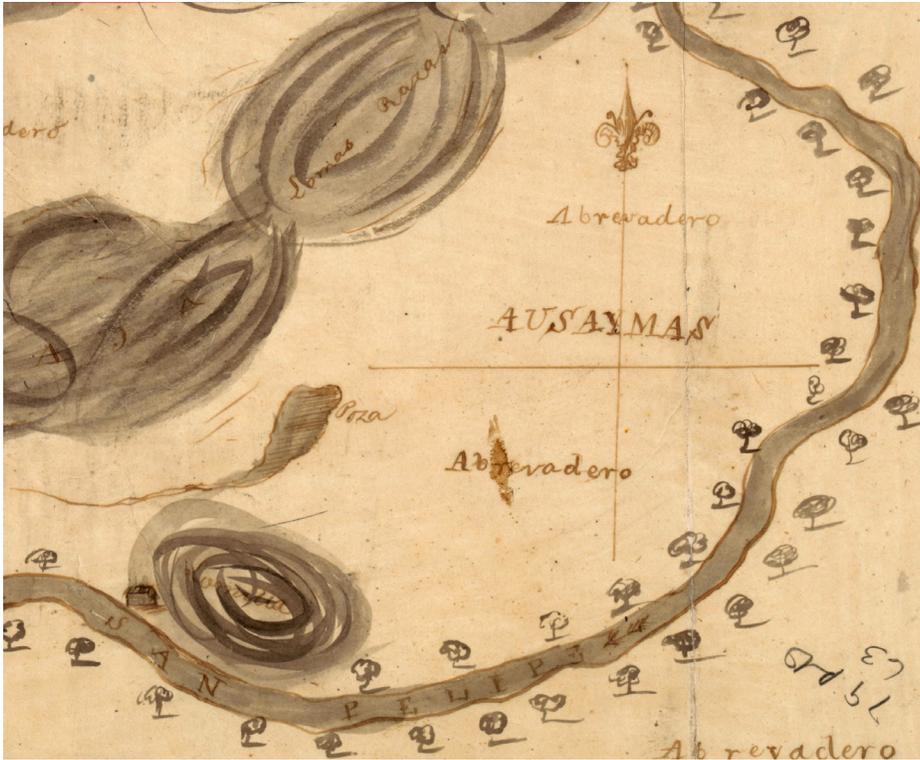
Figure 7.30. This circa late-1840s map shows a series of wetland-associated features between Pacheco Creek (“San Felipe”) and the hills as the creek turns up into Pacheco Valley. An elongate poza (pool or lake) is shown, as well as large areas suitable for watering cattle (labeled “abrevadero”). (U.S. District Court, Southern District [184-?]d, courtesy of The Bancroft Library, UC Berkeley)

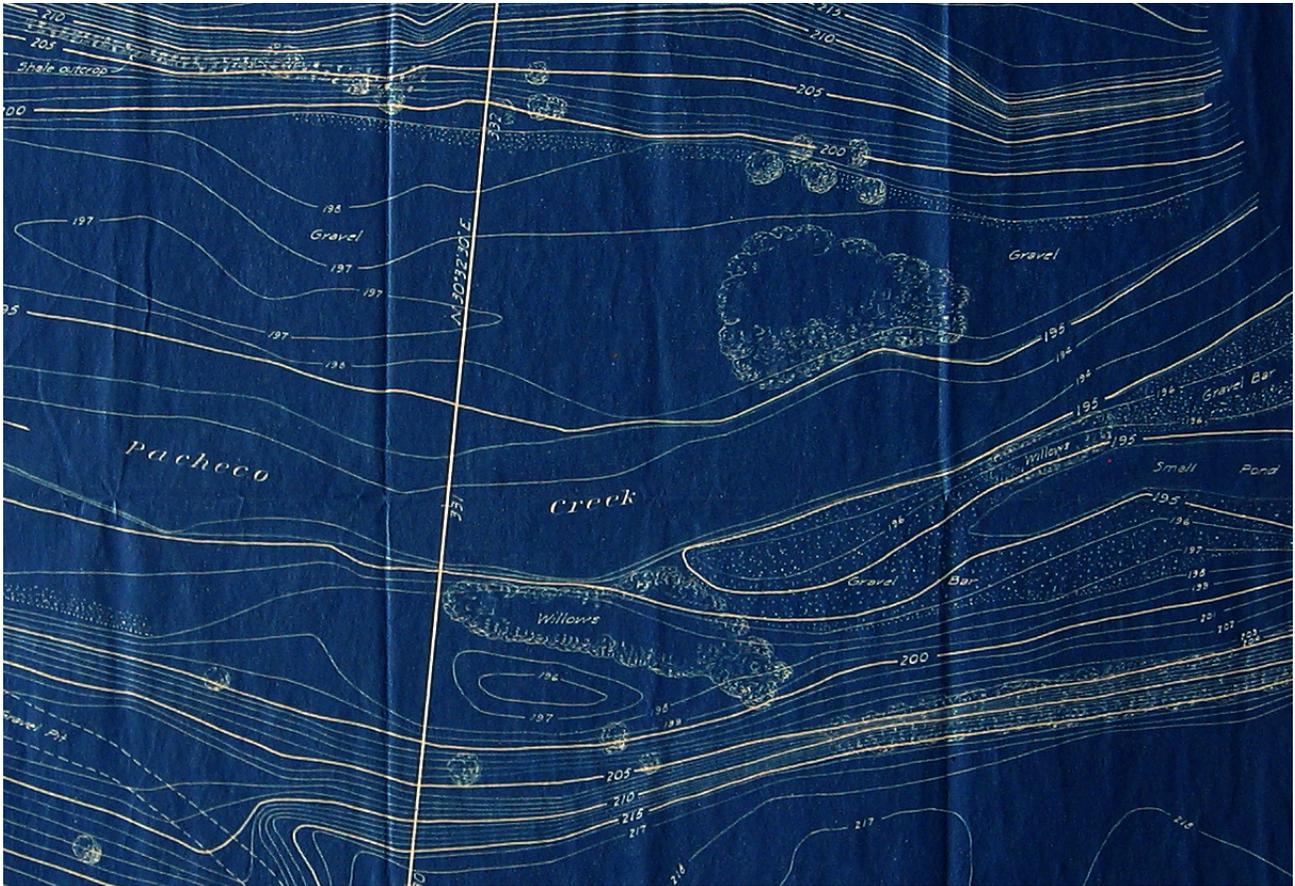
Figure 7.31. Map of bridge site at Pacheco Creek, ca. 1920. Willows populated wide, gravelly bars along Pacheco Creek, and a small pond is shown to the right. (California Highway Commission ca. 1924b, courtesy of San Benito County Public Works)

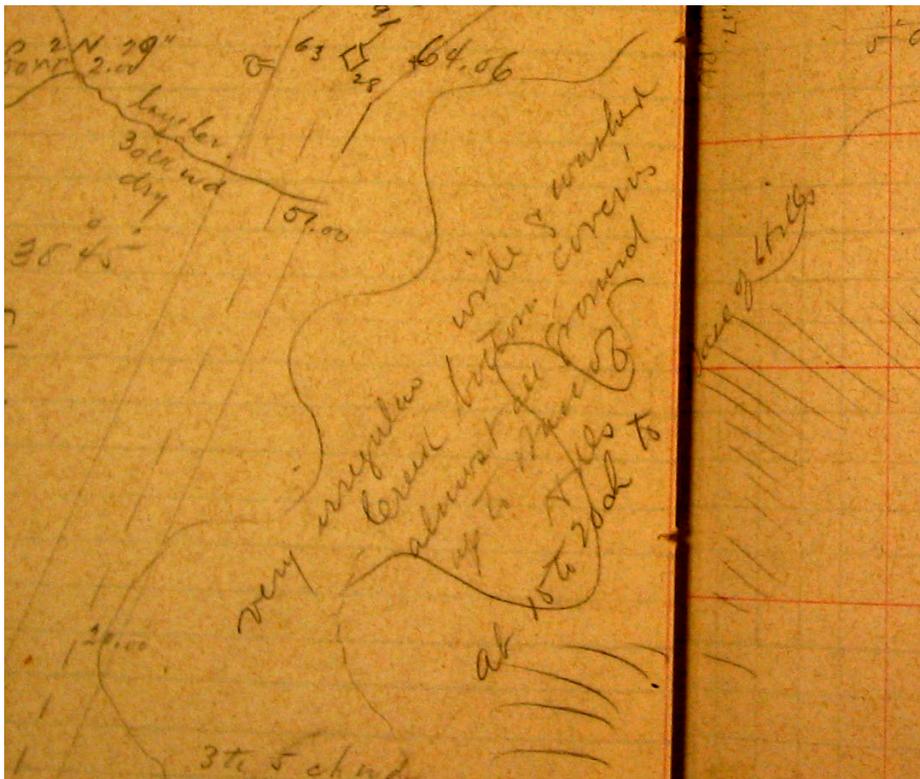
Figure 7.32. A.T. Herrmann, conducting a survey of Pacheco Pass Road in 1872, sketched upper Pacheco Creek (above Carmen Creek), and described it as: "very irregular wide and washed level bottom covers almost all ground up to base of hills." (Herrmann 1872, courtesy of the Office of the Santa Clara County Surveyor)

shallow channel: “Bank 2 feet high...Cross a bottom of rich soil through tall grass” (Day 1854). This early depiction of a series of shallow channels comprising a wide system matches Herrmann’s depiction of the creek at this spot.

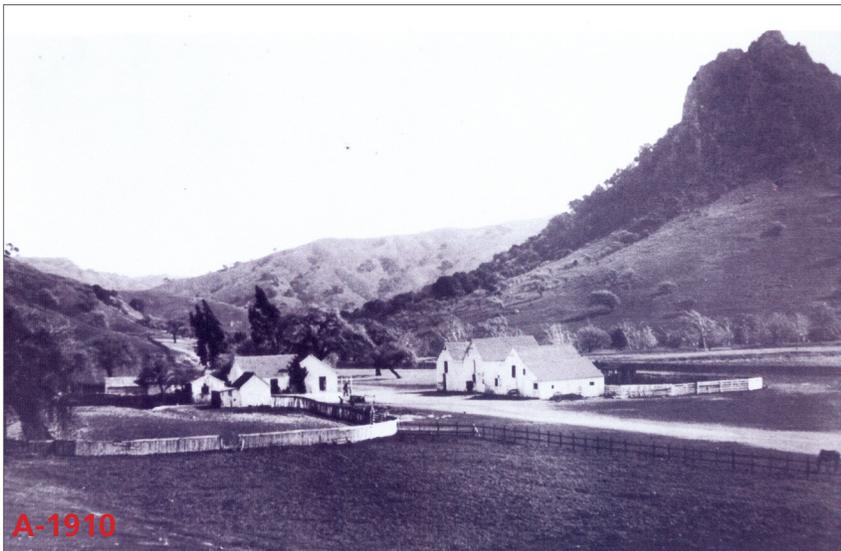
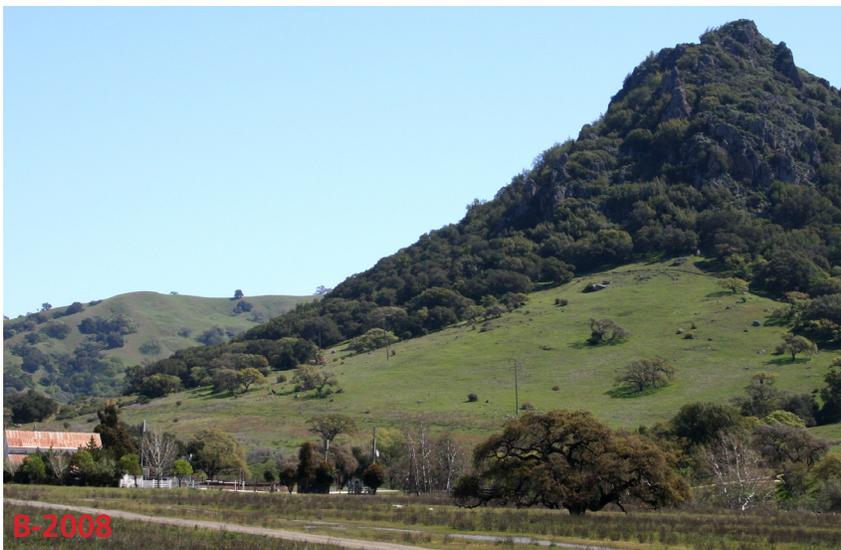
Figure 7.33. Pacheco Creek at Bell’s Station, ca. 1910 (A) and rephotograph, 2008 (B). Individual sycamore trees can be seen on the creek, which runs along the base of Lovers Leap (the prominent peak at upper right). (A: Unknown ca. 1910b, courtesy of the Gilroy Museum)

Above its confluence with Carmen Creek and below its split into north and south forks, Pacheco Creek was a broad, braided stream. The creek sometimes occupied nearly the entire valley floor with its multiple channels and broad, gravelly bars populated by sycamores and valley oaks (fig. 7.33).
