Historical Ecology and Landscape Change
IN THE CENTRAL
LAGUNA DE SANTA ROSA

Historical Ecology
and Landscape Change
in the Central
**LAGUNA
DE
SANTA ROSA**

MARCH 2017

SFEI-ASC PUBLICATION #820

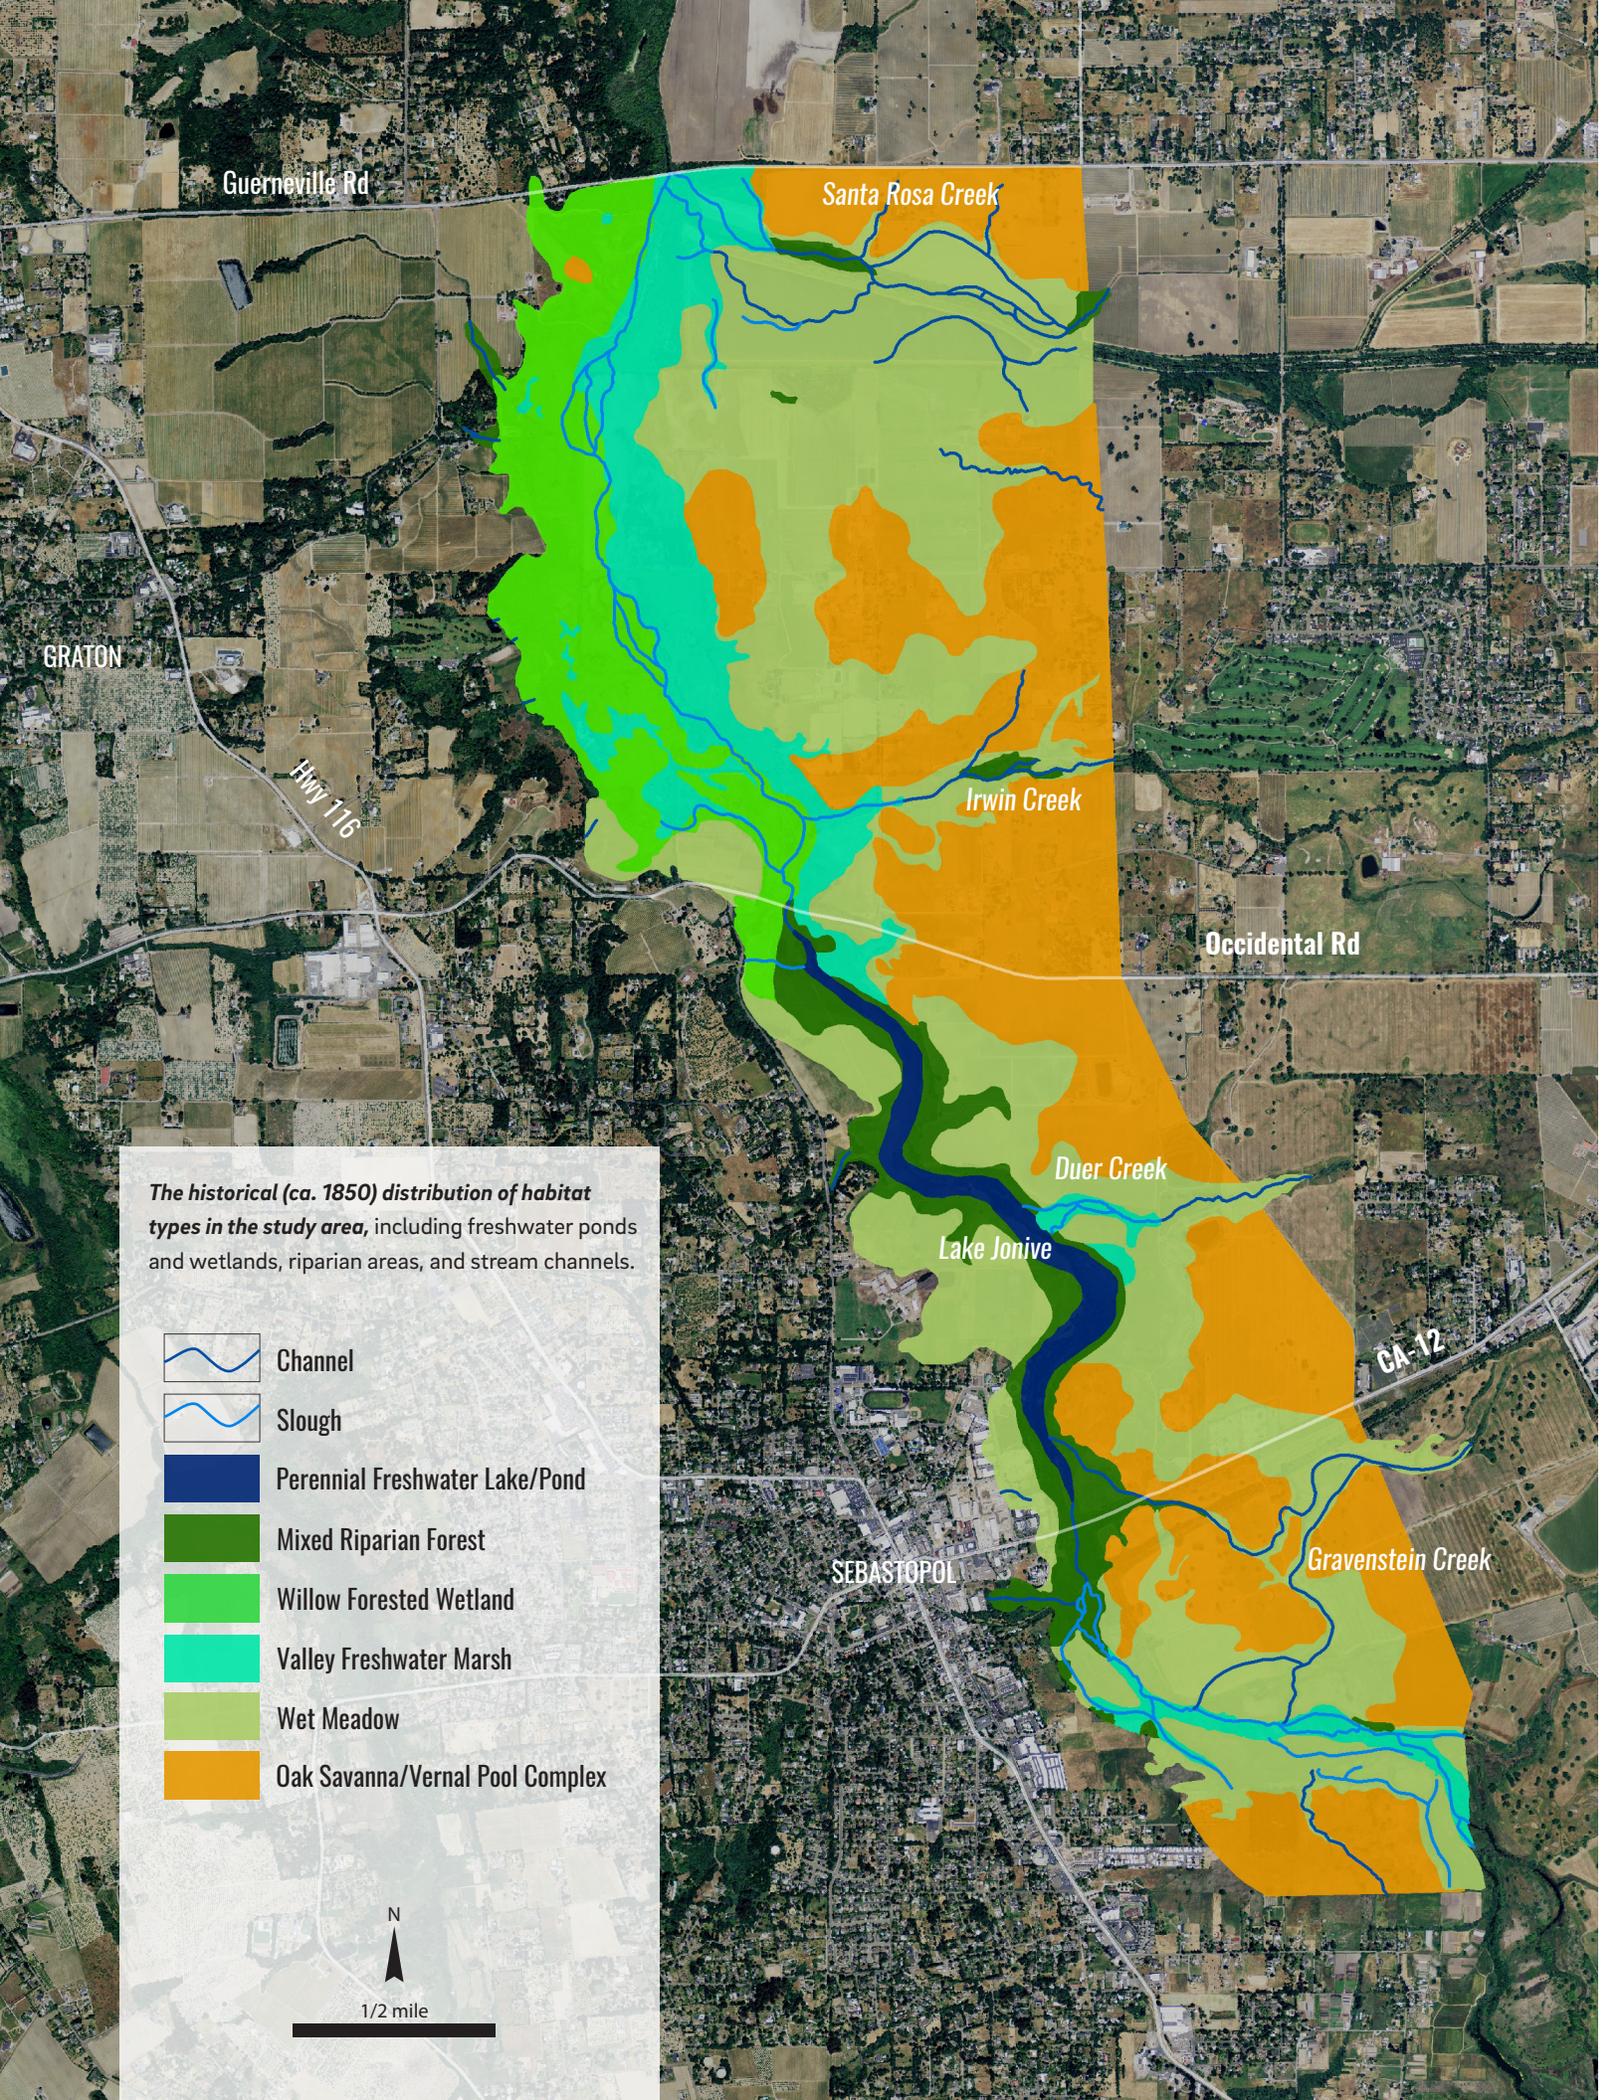
The historical (ca. 1850) distribution of habitat types in the study area, including freshwater ponds and wetlands, riparian areas, and stream channels.

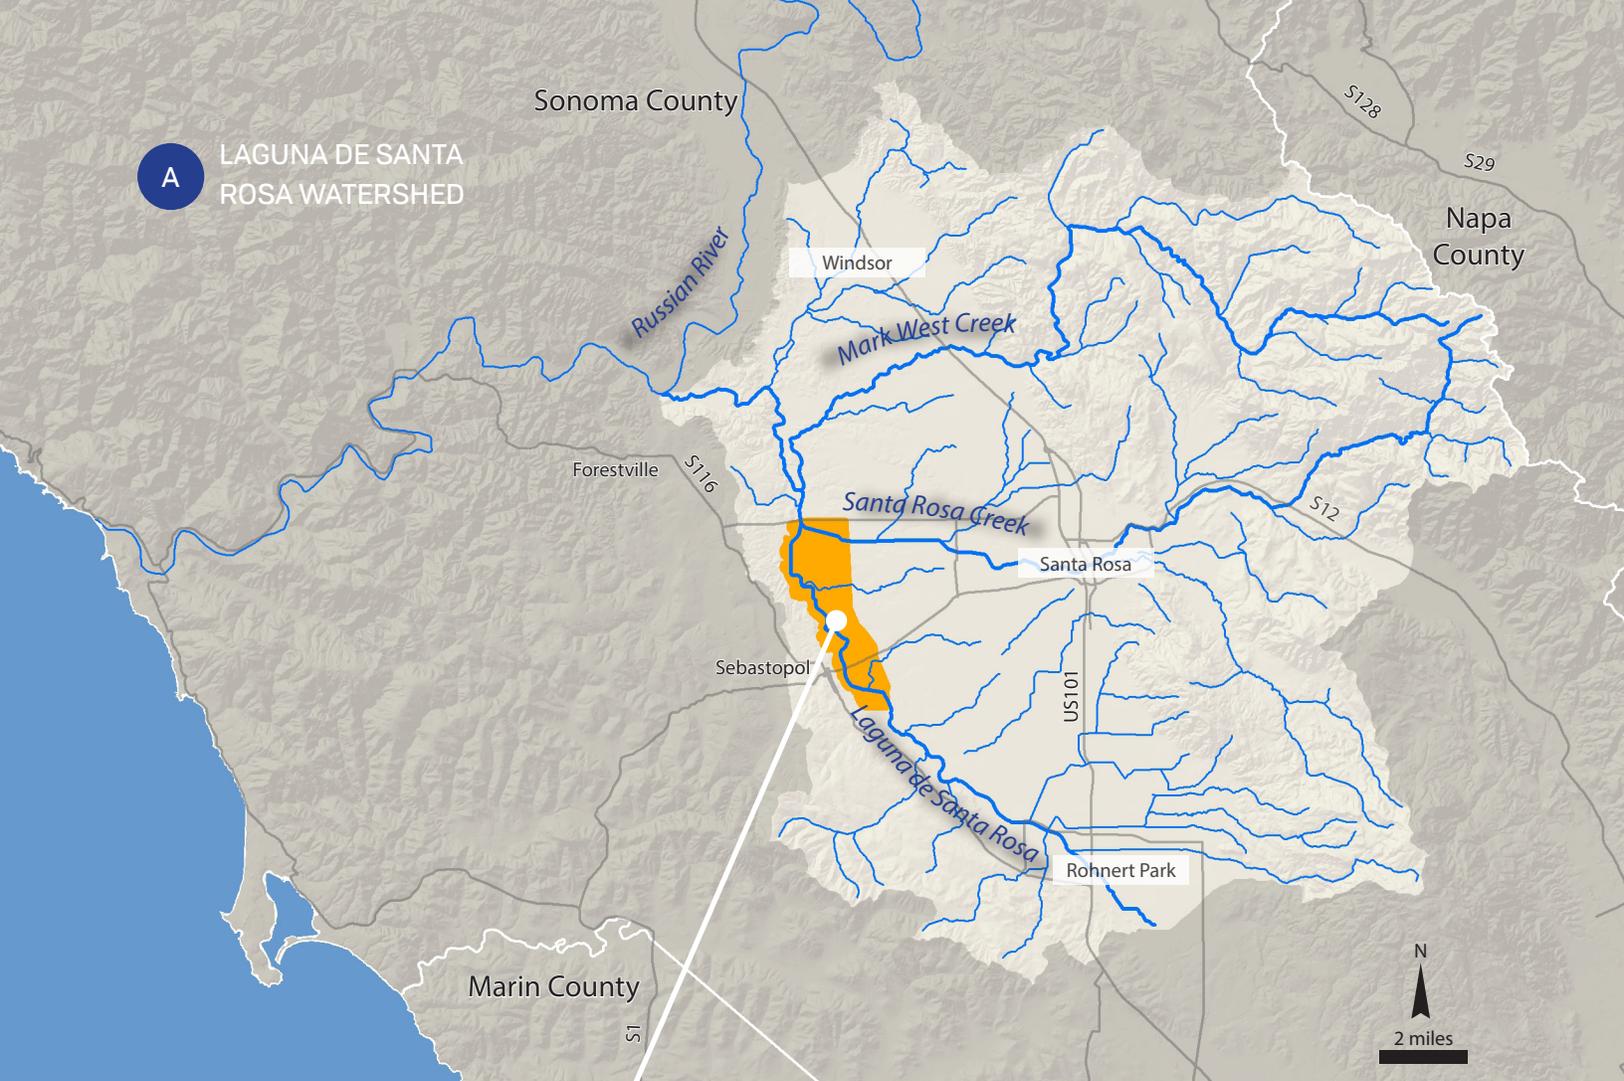
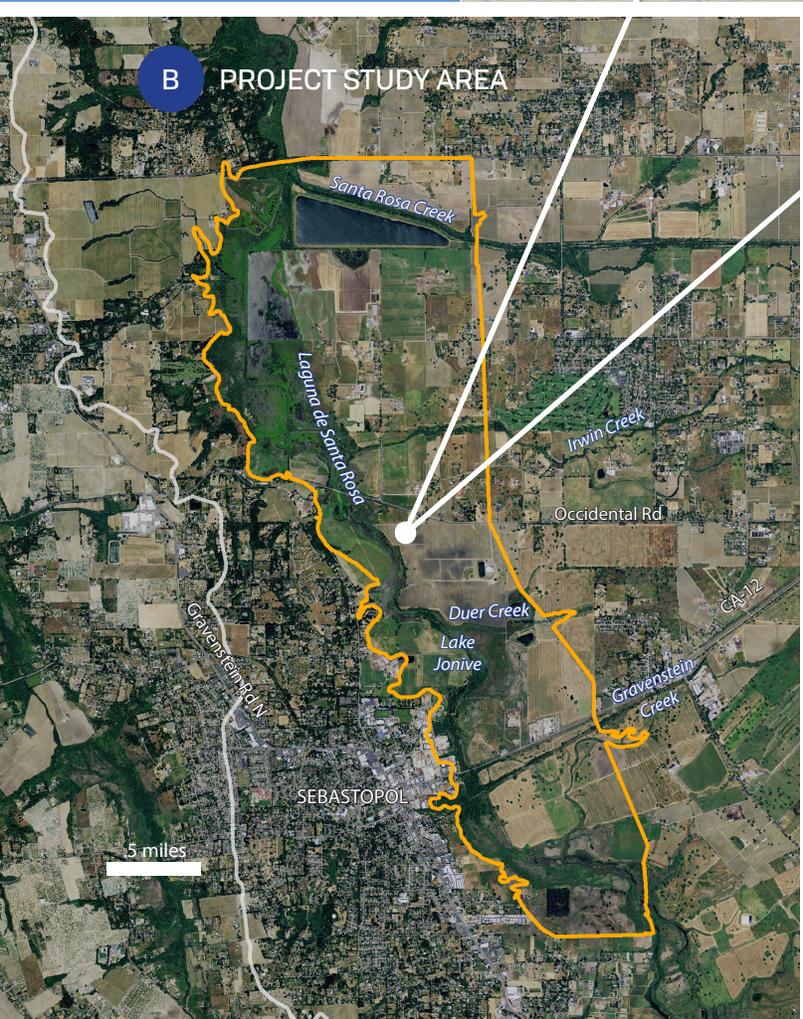
Fig. 1. The Laguna de Santa Rosa watershed (A) and project study area (B) are situated in Northern California. The study area, highlighted in orange, encompasses approximately 13 km² (5 mi²) of a central portion of the central Laguna de Santa Rosa and surrounding areas.

The study area encompasses approximately 13 km² (5 mi²) in the central portion of the Laguna de Santa Rosa to the east of Sebastopol (Fig. 1B). It extends from Guerneville Road on the north to approximately 7 km (4.5 mi) south. The western boundary of the study area is approximately defined by the geologic divide between the alluvium of the Santa Rosa Plain and the bedrock of the Wilson Grove Formation. The eastern boundary encompasses all of the wetland features contiguous to the Laguna, with the exception of oak savanna/vernal pool complex and wetlands extending upstream along the Laguna mainstem and Santa Rosa Creek.

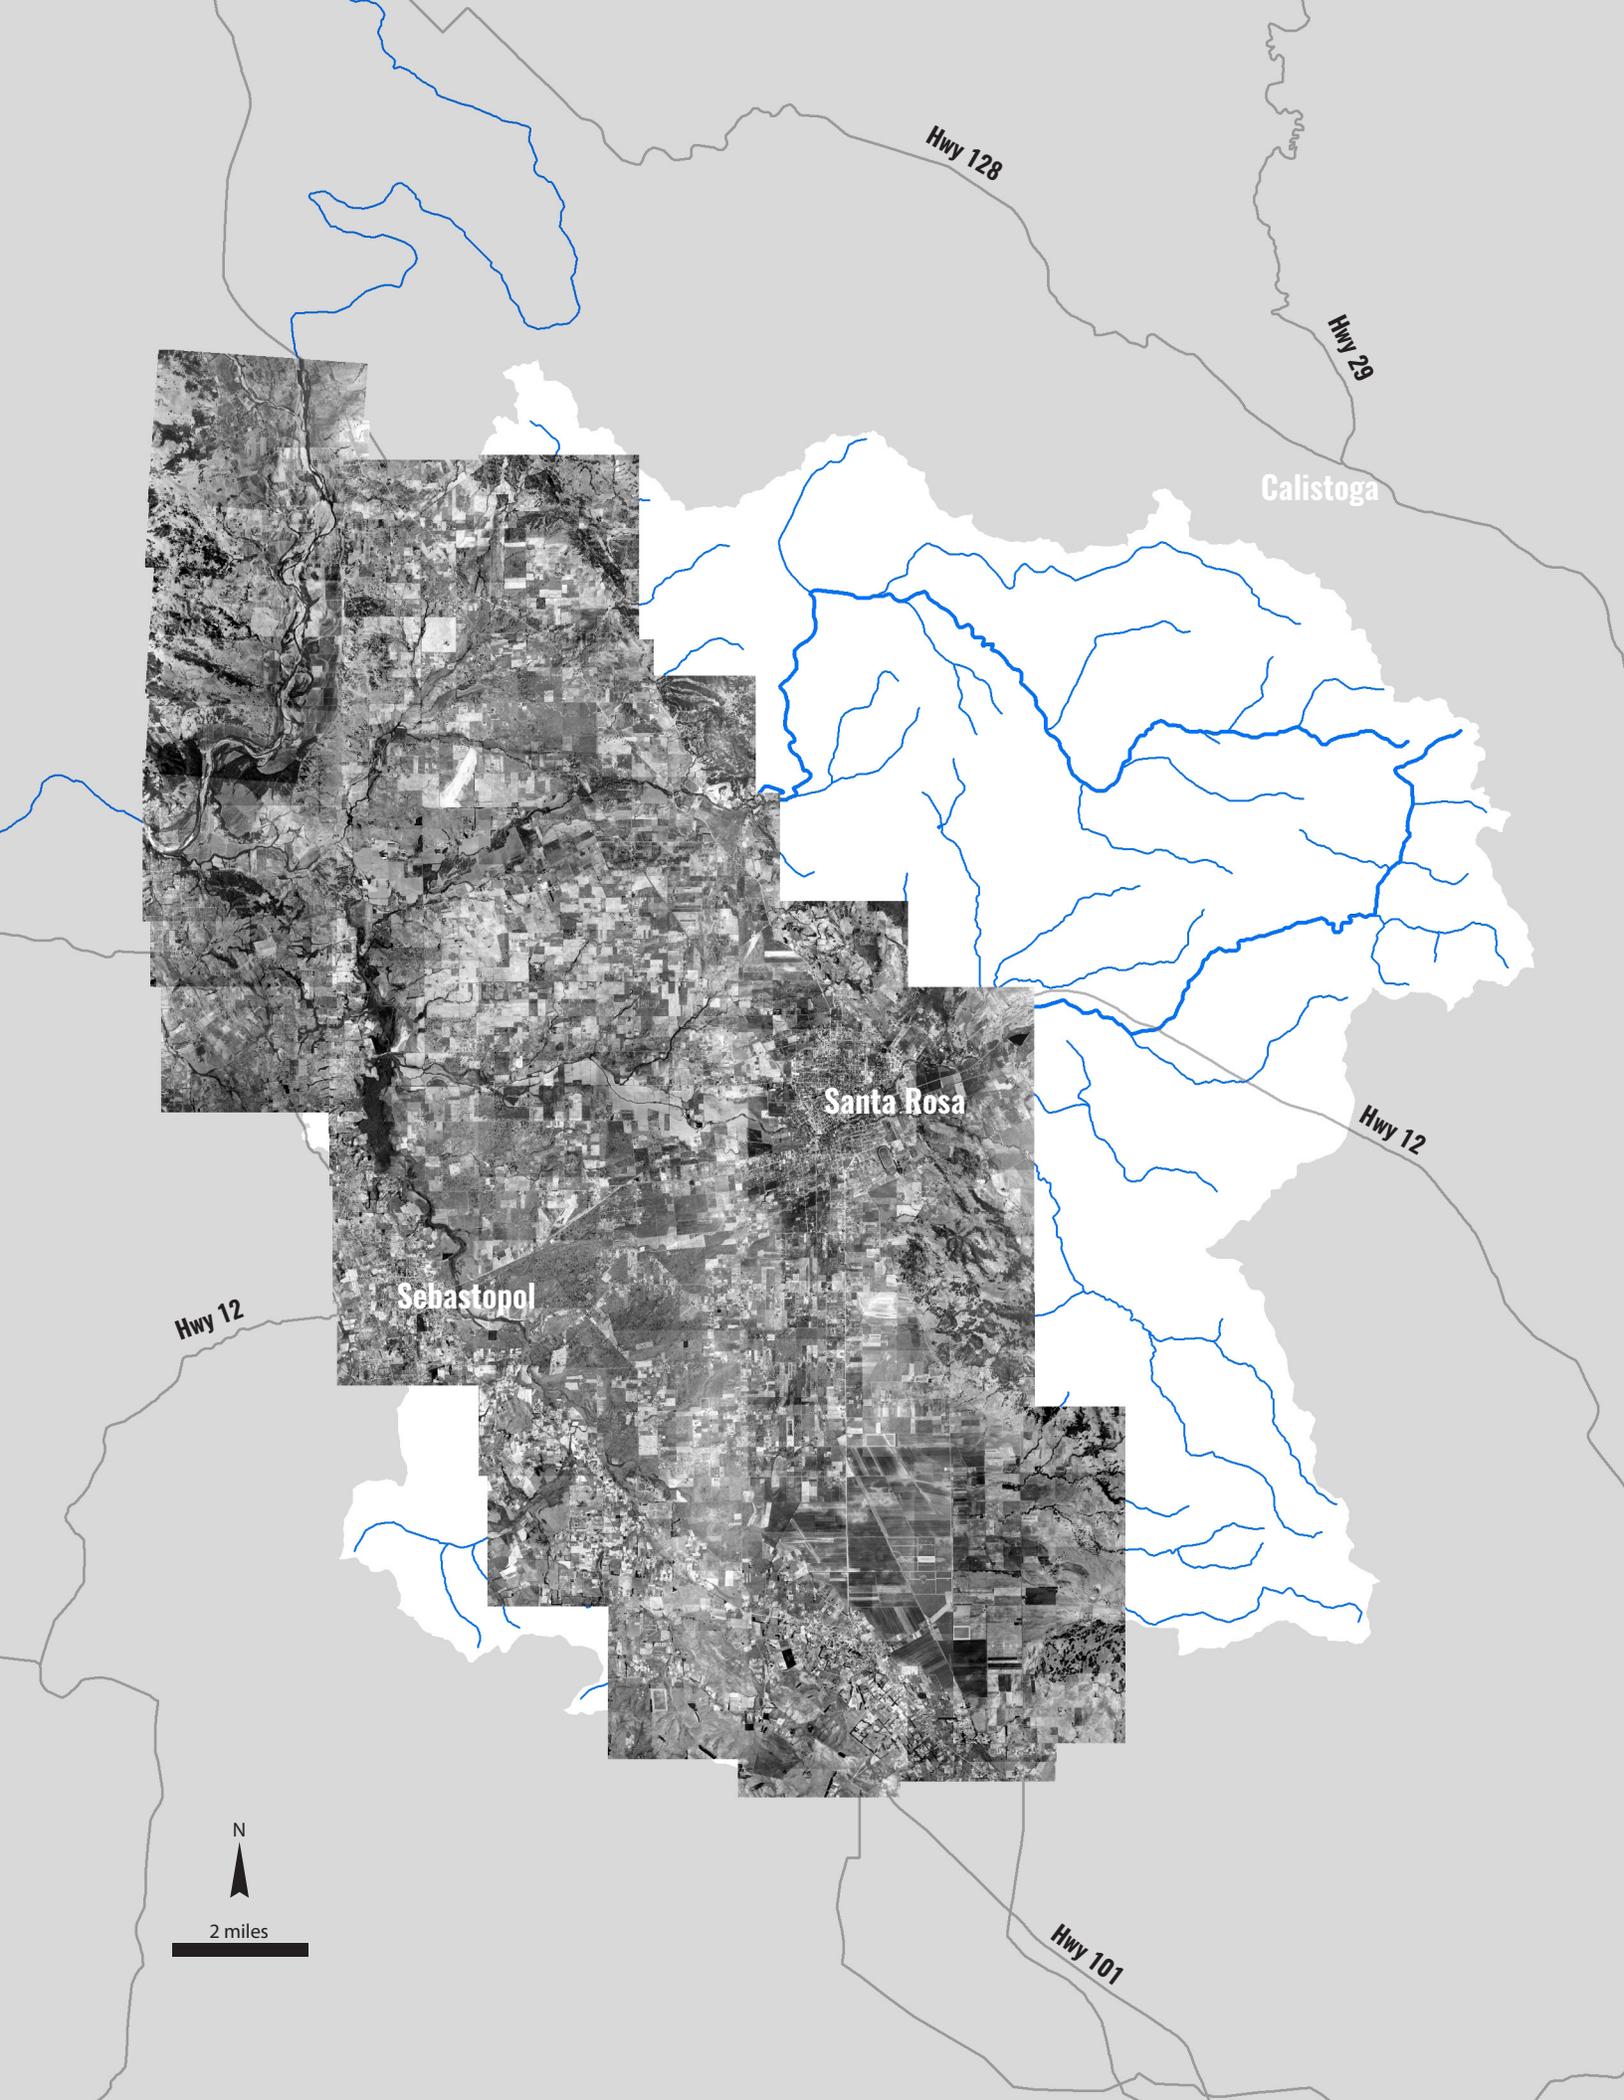
Fig. 3. (opposite) Photomosaic of historical aerial imagery, flown in 1942, of the Santa Rosa Plain. (USDA 1942)

One key data source for the study was a historical aerial photomosaic of the entire Santa Rosa Plain (Fig. 3) comprised of orthorectified and mosaicked aerial photos from 1942 (the earliest year for which coverage of the region is available). The photomosaic was created by SFEI in 2014 with funding from the Sonoma County Agricultural Preservation and Open Space District, and is viewable on the Sonoma Veg Map website (<http://www.sonomavegmap.org/1942/>).

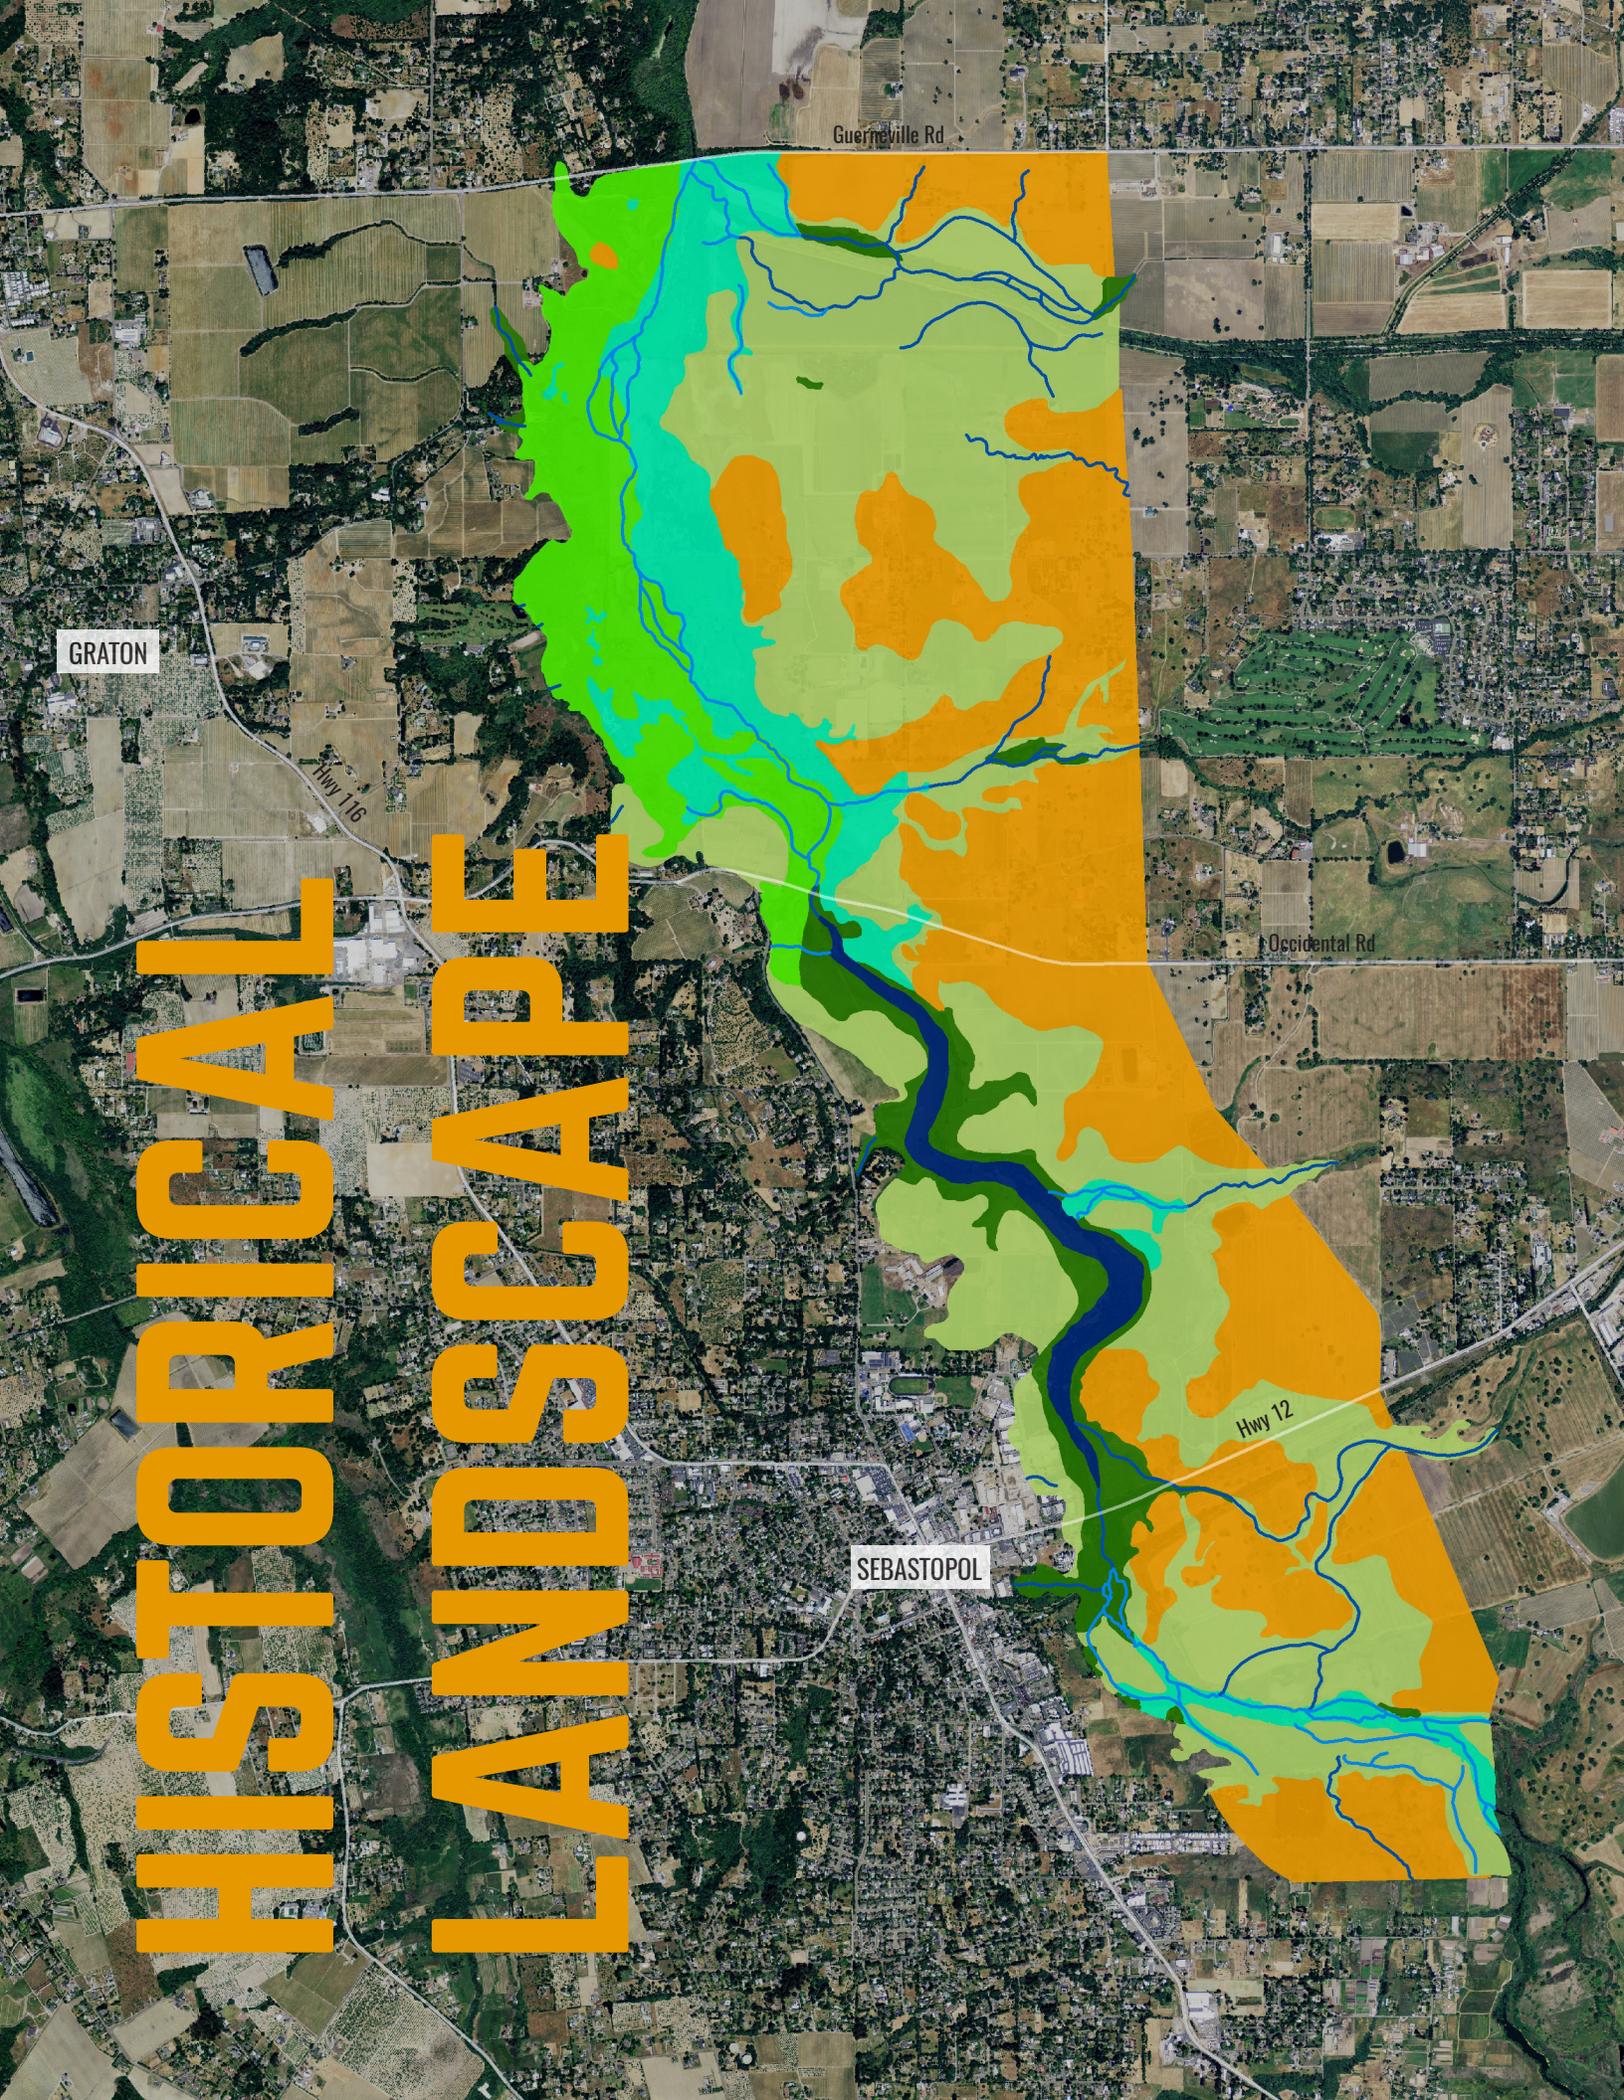
The historical (ca. 1850) distribution of habitat types in the study area, including freshwater ponds and wetlands, riparian areas, and stream channels.

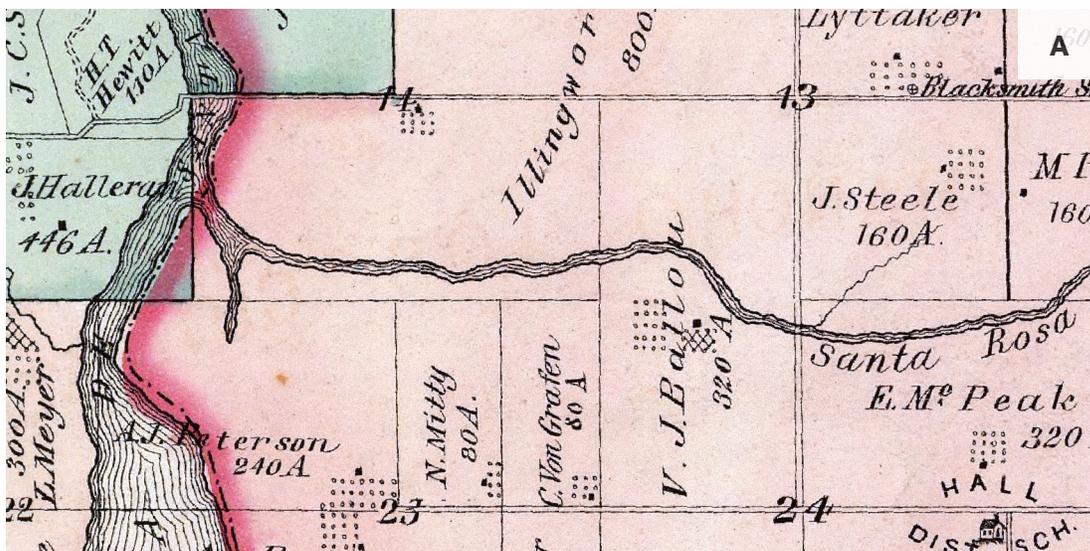
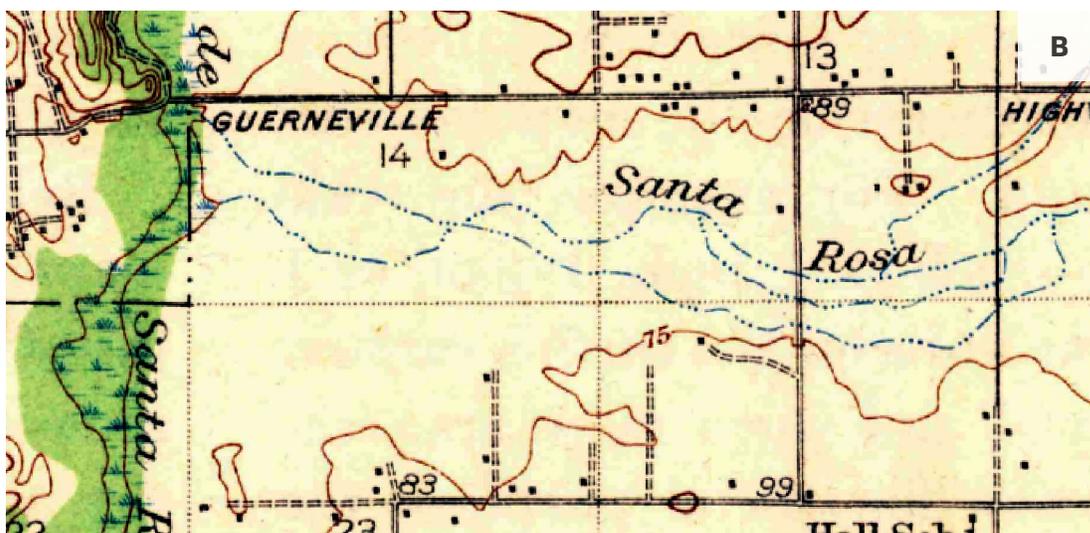
Fig. 8. While many 19th-century maps depict Santa Rosa Creek's confluence with the Laguna as a single channel (e.g., A), early-to mid-20th-century sources tend to show multiple channels approaching the Laguna (B). It is unknown whether these differing representations are reflective of changes in channel morphology or differences in cartography. (A: Thompson 1877b, courtesy of David Rumsey Map Collection; B: USGS [1933-5]1942)

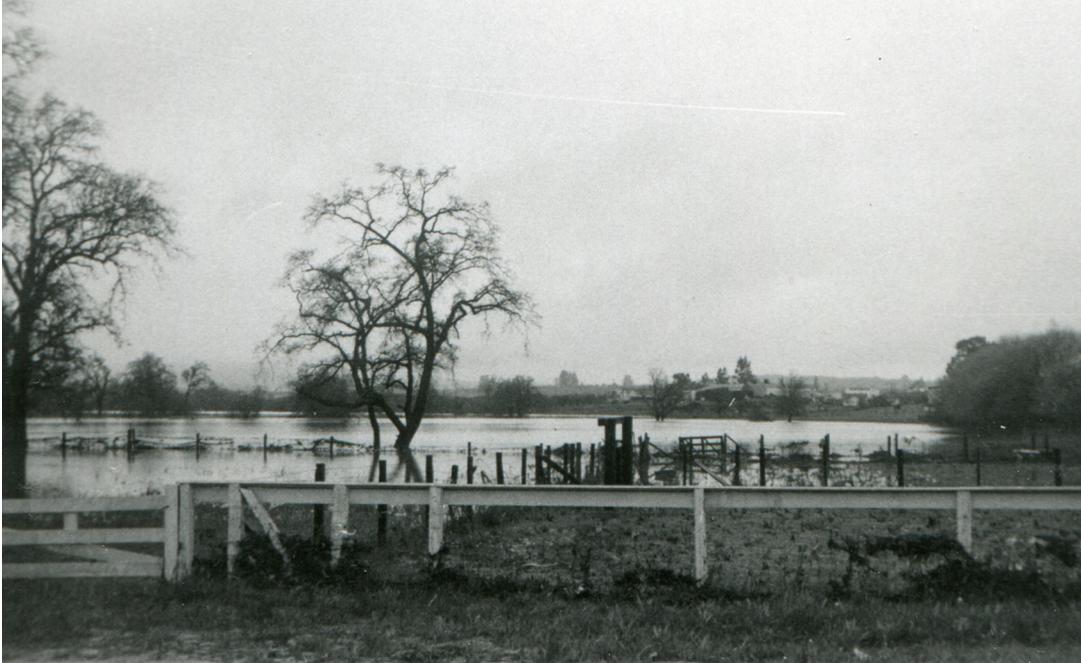
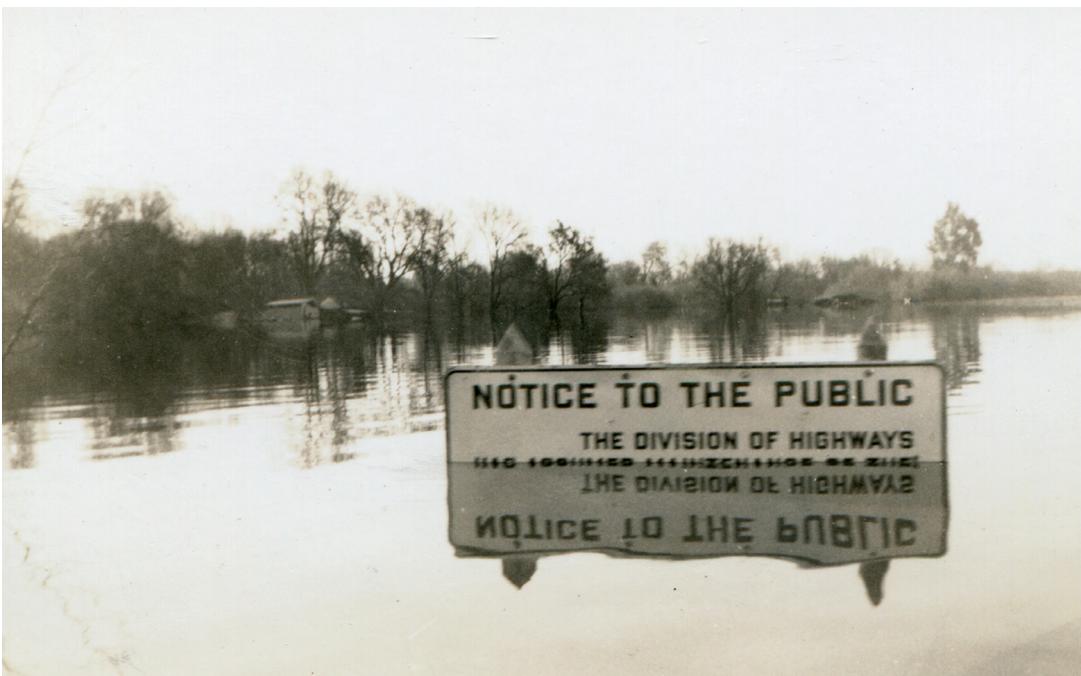
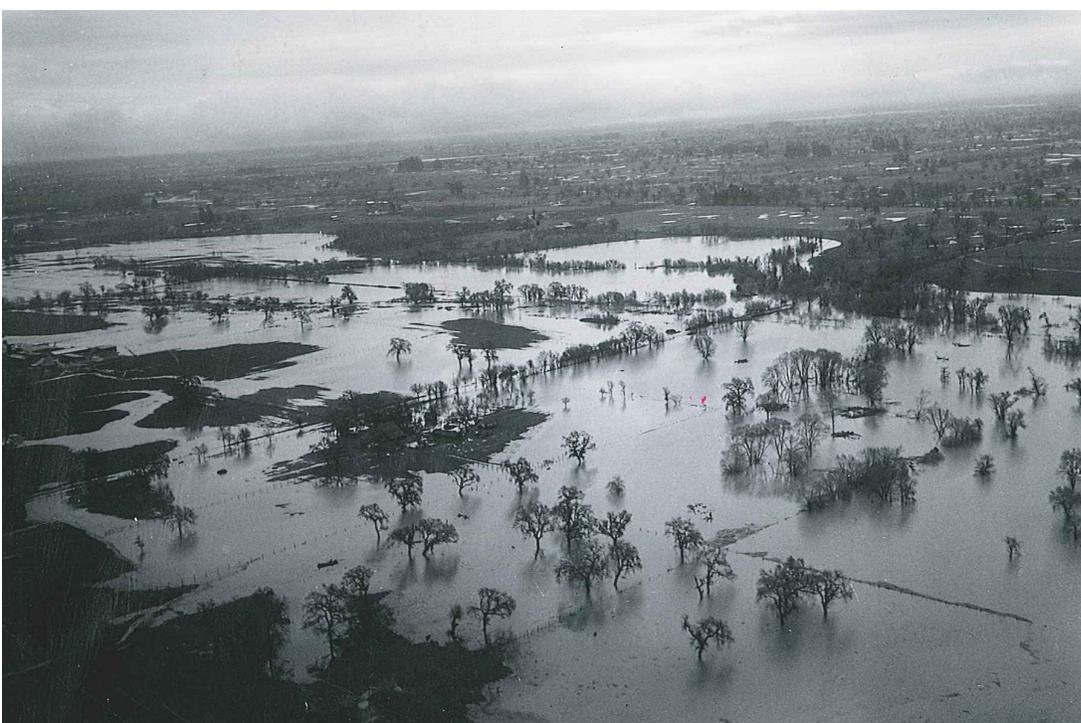
Fig. 9. The Laguna complex was frequently inundated by wet-season flood events, which often covered much of the study area with shallow open water. This series of images depicts a series of mid-20th-century floods. **Opposite: Flooded pastures near Sebastopol in 1951. **Top:** Floodwaters at Occidental and High School roads during the 1951 flood. **Center:** Flooding on Highway 12 near the Laguna, ca. 1940. **Bottom:** Flooding on Santa Rosa Creek just upstream of the Laguna confluence, December 19, 1955. (Opposite: Photo #13266, courtesy of Western Sonoma County Historical Society; Top: Photo #13219, courtesy of Western Sonoma County Historical Society; Center: Photo #2036, courtesy of Western Sonoma County Historical Society; Bottom: C-1967-6, courtesy of Sonoma County Water Agency)**

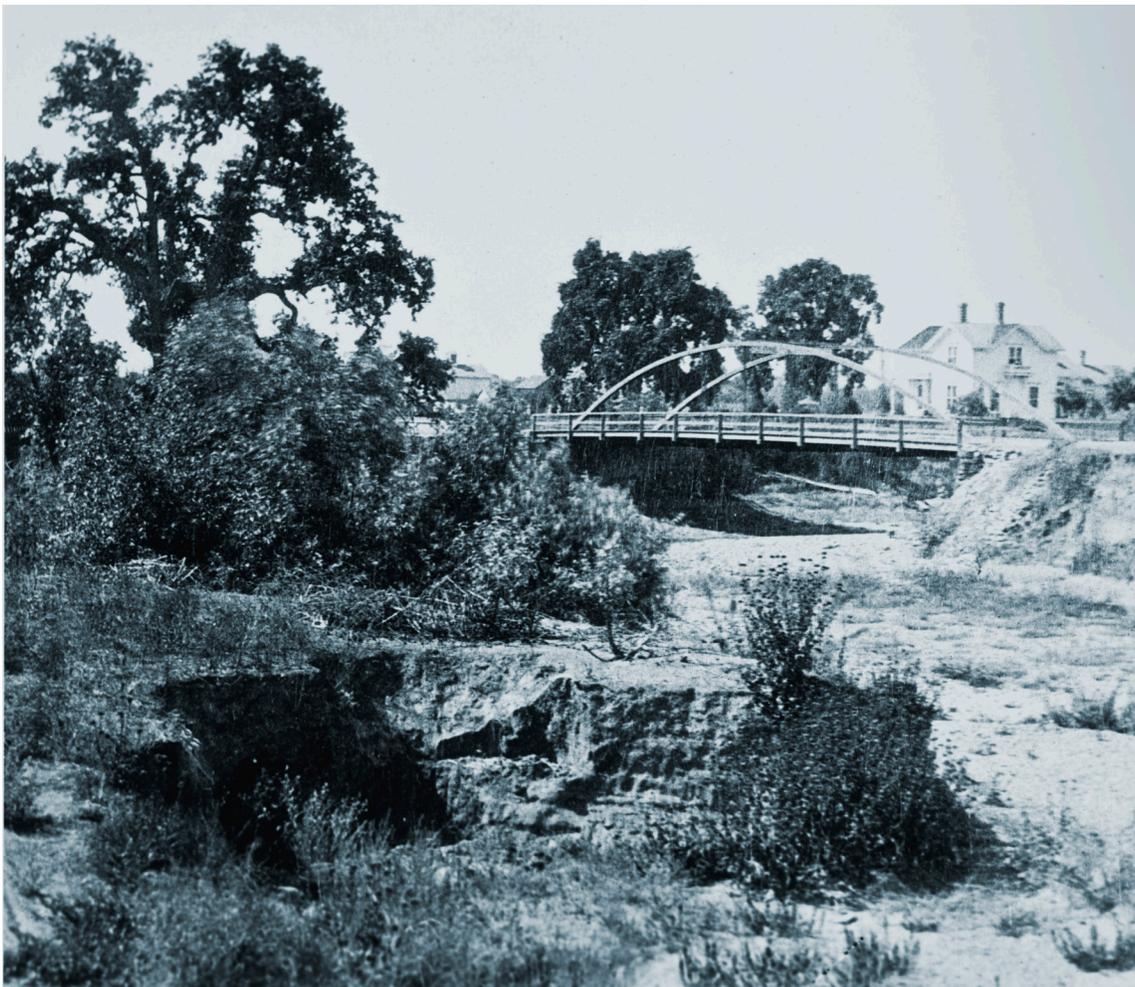
Fig. 11. Surface flows in Santa Rosa Creek, the largest tributary to the Laguna, did not extend to the Laguna confluence during the dry season. This 1879 photograph, looking towards Main Street Bridge in Santa Rosa (upstream of the study area), shows the dry bed of Santa Rosa Creek. (Annex Photo 546, courtesy of Sonoma County Library)

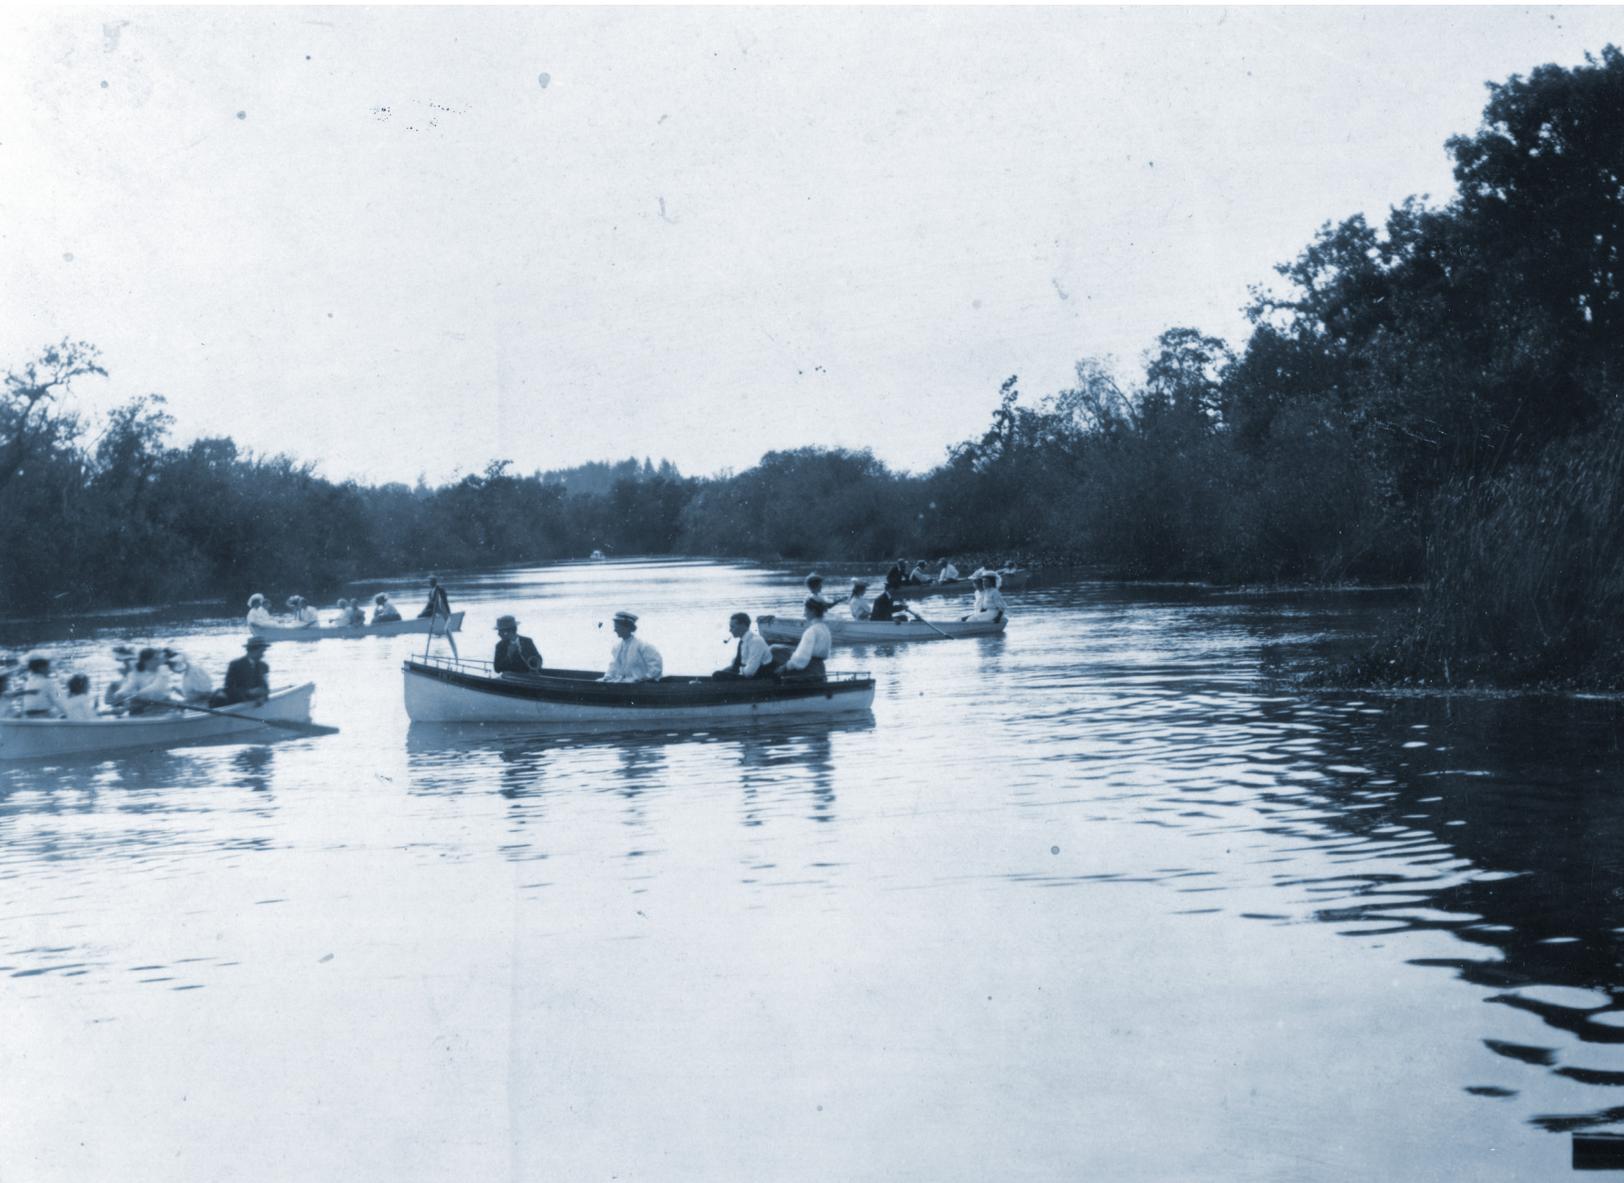
Fig. 18. Though relatively narrow, Lake Jonive extended along the valley for approximately 3 km (2 mi) and reached a maximum depth of just over 7 m (23 ft). As shown in these early 20th-century photographs, the lake was bordered by tules and a mixed riparian forest dominated by oaks and willows. (Above: Photo #2027, courtesy of Western Sonoma County Historical Society; Opposite, top: Photo #1376, courtesy of Laguna de Santa Rosa Foundation; Opposite, bottom: Photo #2028, courtesy of Western Sonoma County Historical Society)

Lake Jonive was bordered by a mixed riparian forest dominated by oaks and willows (see page 30). Landscape photographs from the late 19th and early 20th centuries also appear to show a narrow band of tules around the margins of the lake (not mapped separately; Fig. 18).

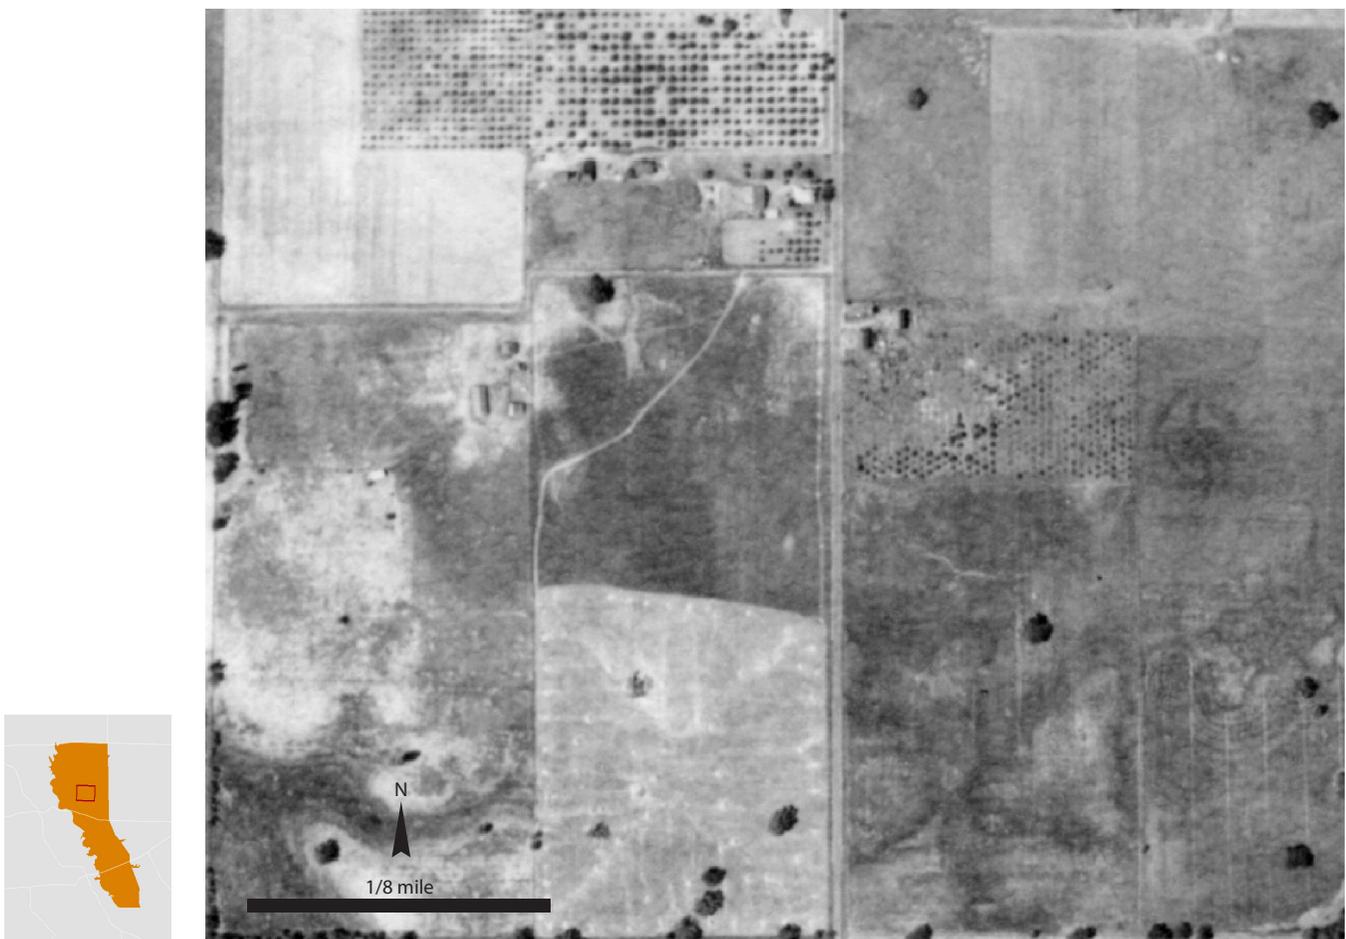
Fig. 23. Wet meadow, 1942. This detail from the historical aerial photomosaic east of the Laguna (just north of Irwin Creek) shows the dark patches often characteristic of wetter conditions and poor drainage. (USDA 1942)

Early maps and textual accounts often do not document or describe seasonal wetlands like wet meadow, likely as a result of their variable and somewhat ephemeral nature. As a result, the evidence for wet meadows within the Laguna wetland complex is much more limited than for other wetland types. Many of the areas mapped as wet meadow correspond approximately to areas mapped as Dublin Clay Adobe by the 1915 soil survey (Watson et al. 1915; see Fig. 12 on page 24). Dublin Clay Adobe is described as having "incomplete" drainage (Watson et al. 1917). There is also evidence for wet meadows from the 1942 aerials in the form of darker patches in areas with herbaceous cover, which are often a signature of wetter conditions and poor drainage (Fig. 23).
