Historical Ecology and Landscape Change
IN THE CENTRAL
LAGUNA DE SANTA ROSA

Historical Ecology
and Landscape Change
in the Central
**LAGUNA
DE
SANTA ROSA**

MARCH 2017

SFEI-ASC PUBLICATION #820

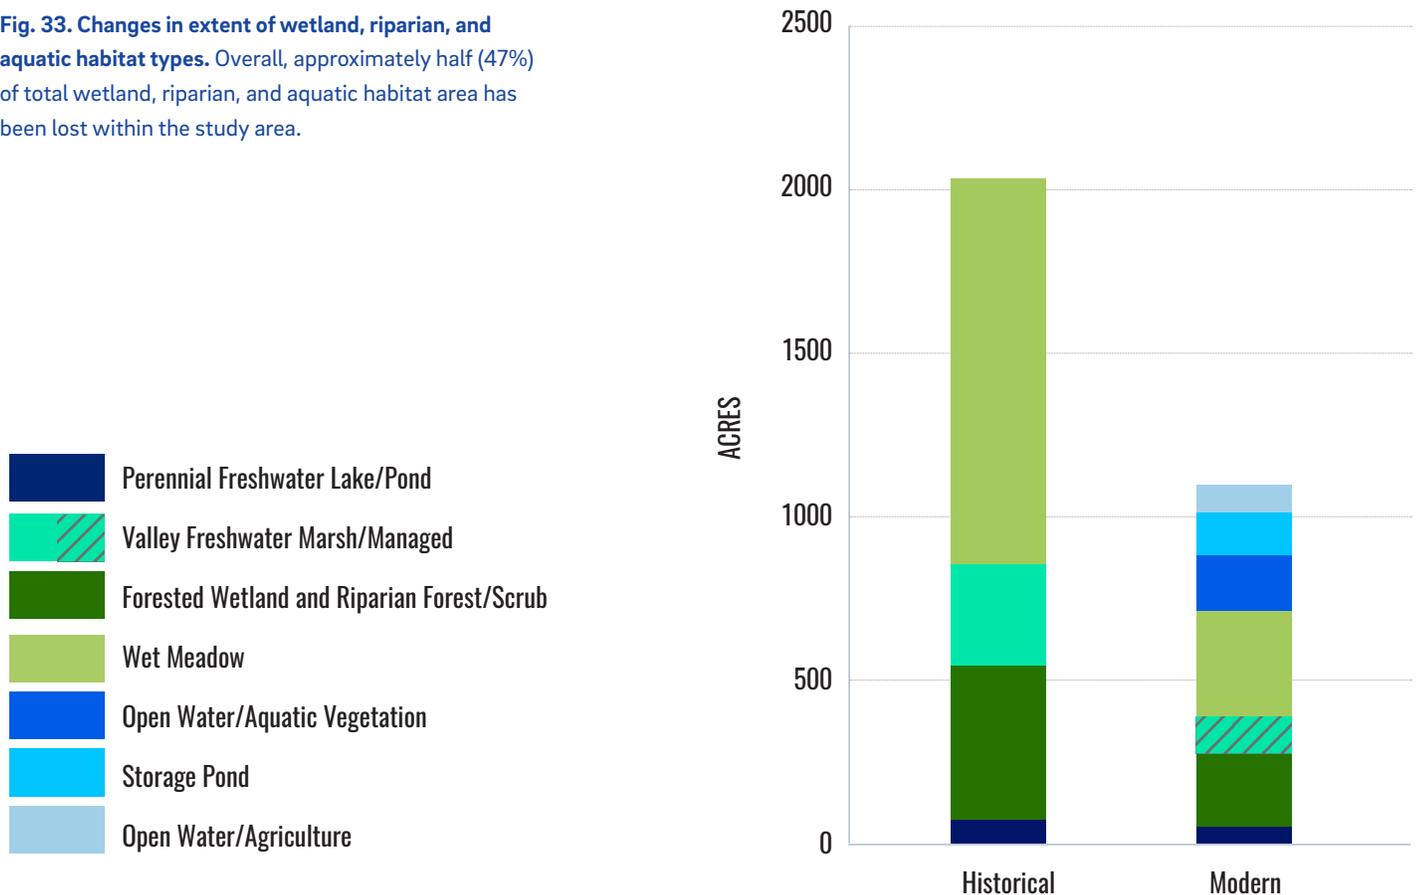
Fig. 33. Changes in extent of wetland, riparian, and aquatic habitat types. Overall, approximately half (47%) of total wetland, riparian, and aquatic habitat area has been lost within the study area.

One of the most notable changes is the loss of much of the broad riparian forest around Lake Jonive. Though a narrow riparian corridor still exists and provides valuable habitat and other ecological services, it is much narrower than the 10–350 m (30–1,150 ft) wide riparian buffer that historically surrounded the lake. The loss of riparian forest area would indicate that the remaining forest likely has a lower capacity to assimilate nutrients and other inputs from surrounding dairies and farms (see page 50). Lake Jonive itself has decreased in size by approximately 50% (from ~27 ha [66 ac] to ~14 ha [34 ac]), and is shallower today than it was during the mid-19th century (Butkus 2011a).

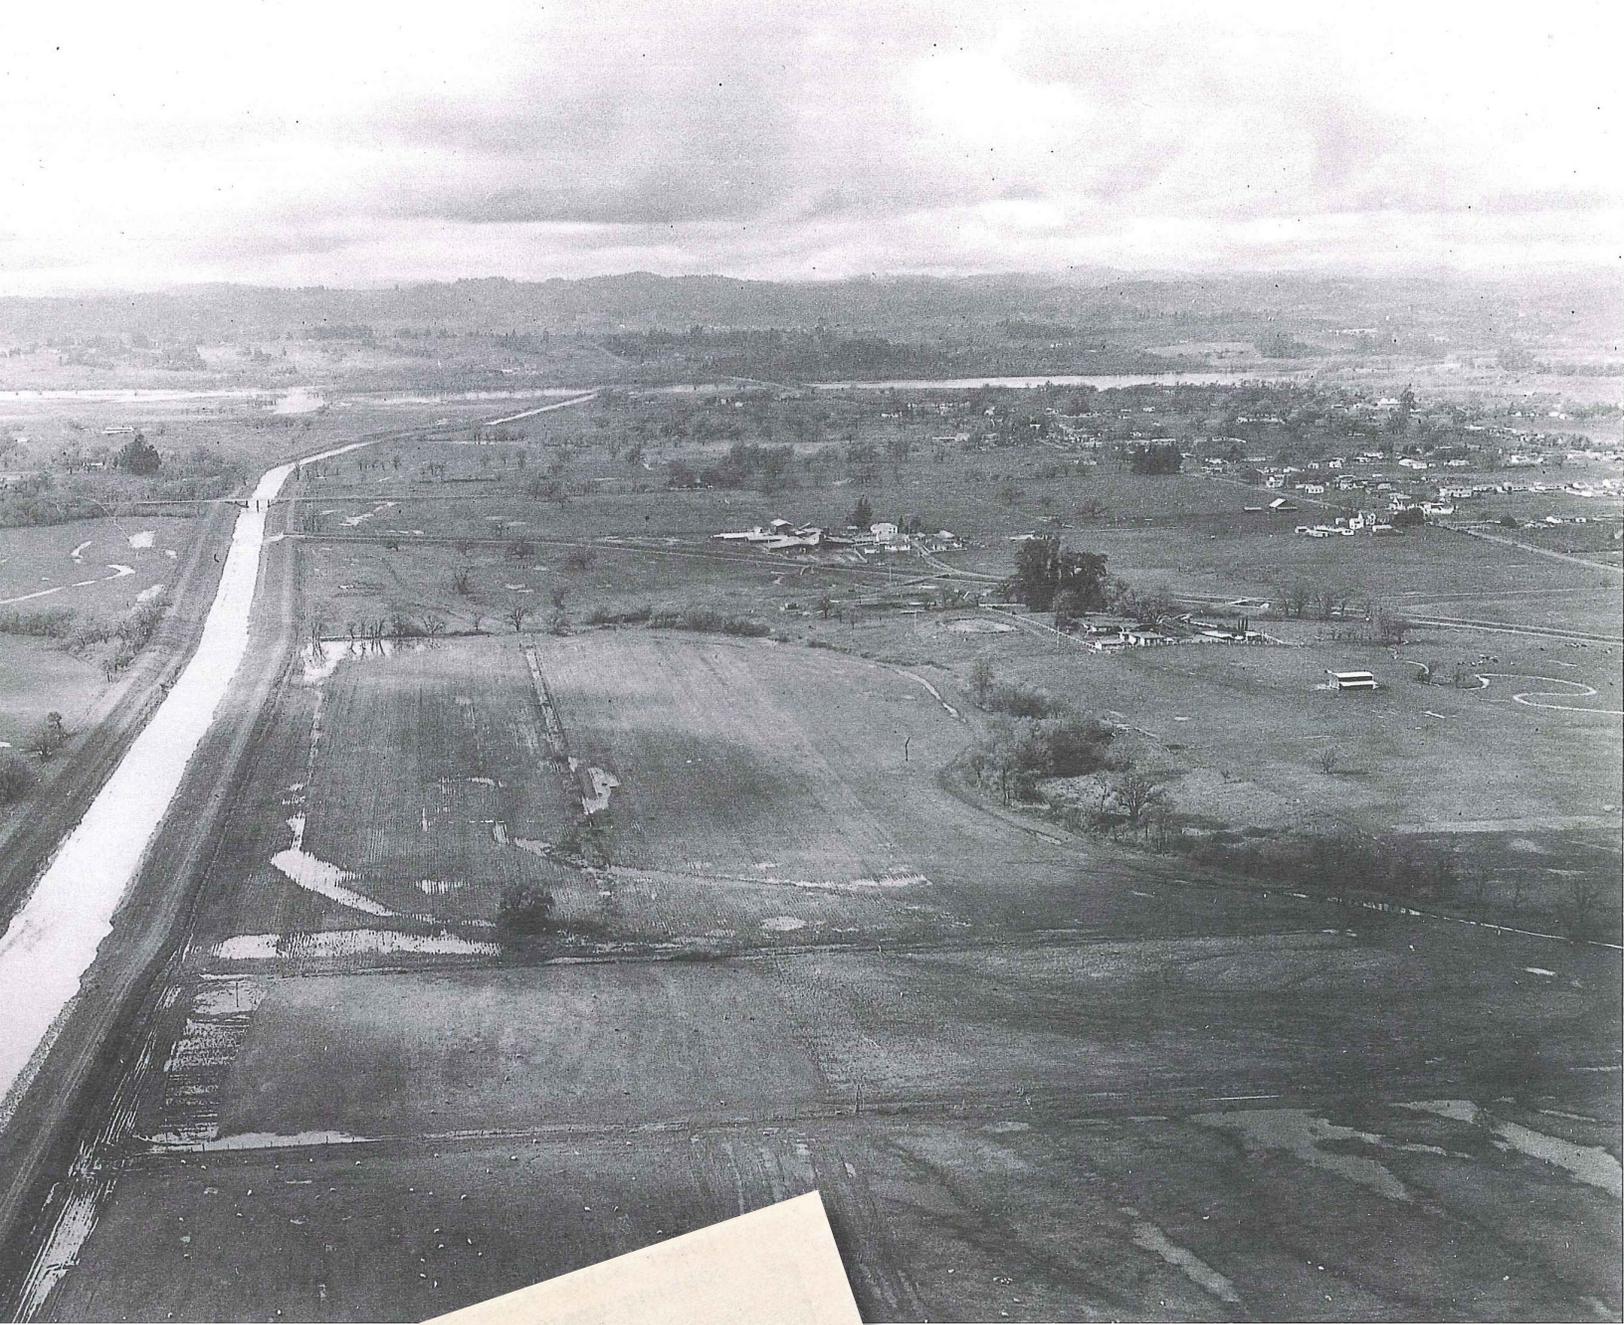
Fig. 35. Construction of the Santa Rosa Creek Flood Control Channel (bottom) in 1964, and completed channel (top) in 1967 looking west towards Laguna. (Top: Print no. 0-3, Location = "Wendell Prop"; Bottom: Photo #999, "Unit No. 2 Santa Rosa Creek Channel Lower Channel 3 construction"; both courtesy of Sonoma County Water Agency)

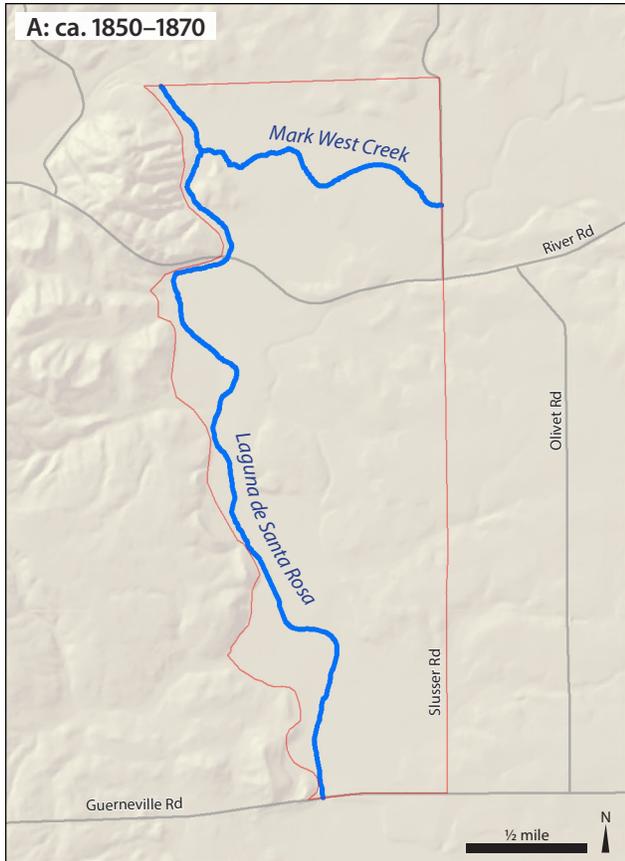
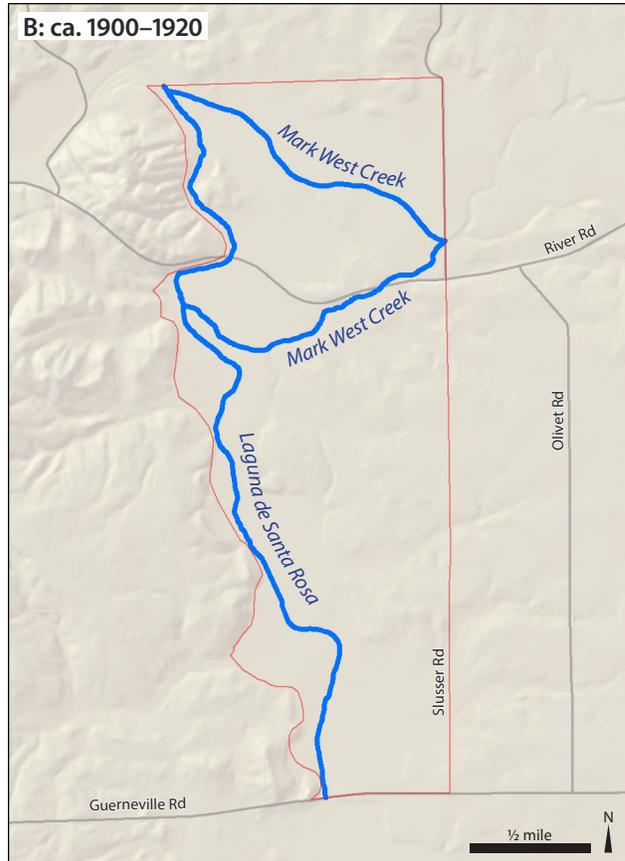
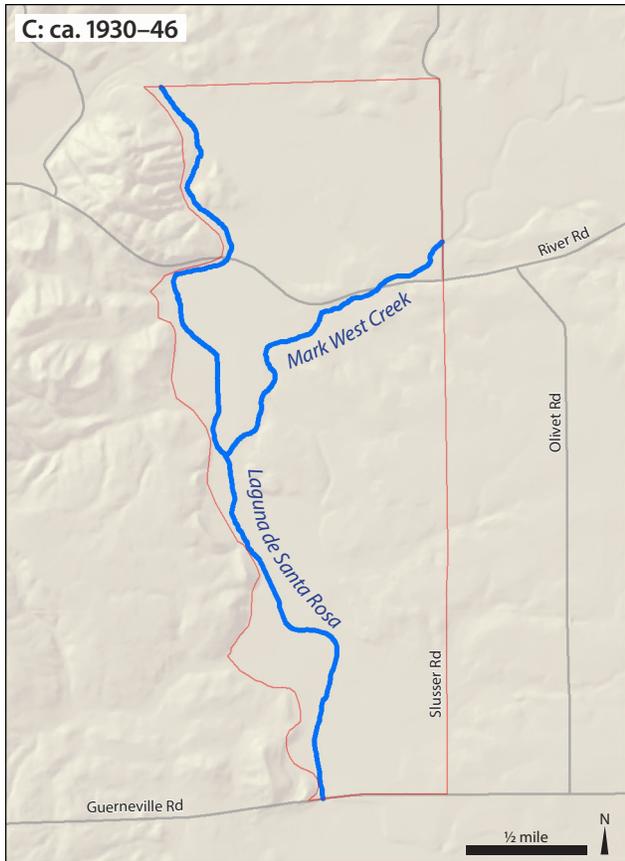
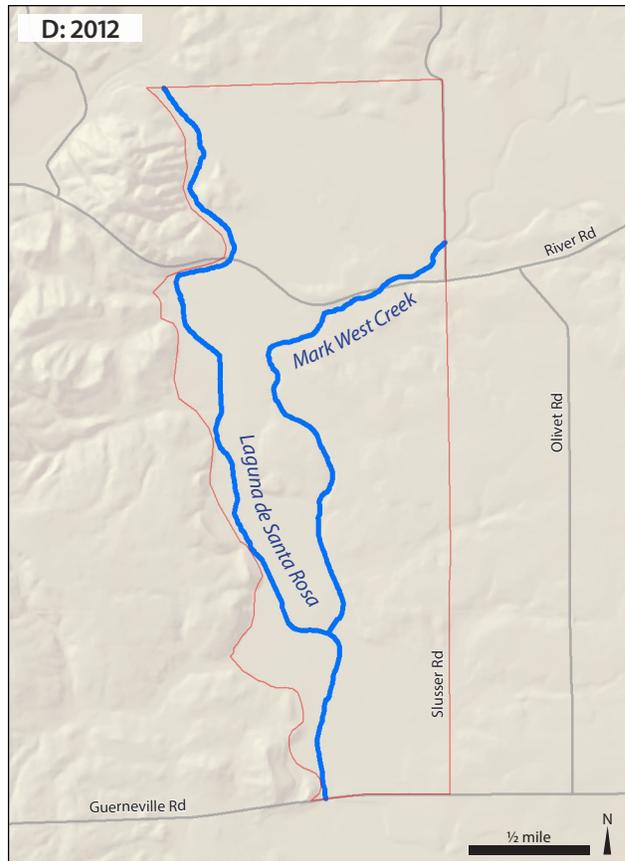
Fig. 36. (opposite) Change over time in the alignment of Mark West Creek, 1850-2012, north of the study area. A series of shifts intended to control flooding and sediment deposition have moved Mark West Creek's confluence with the Laguna approximately 3.2 km (2 mi) south of its historical location. (from Baumgarten et al. 2014a)

The decrease in flood storage (and hence the increase in flood risk) has been exacerbated by changes in the alignment of Mark West Creek, which connects with the Laguna mainstem approximately 1 km (0.7 mi) north of Guerneville Road (PWA 2004a, Winzler & Kelly-GHD 2012). Historically, lower Mark West Creek flowed northwest to connect with the Laguna approximately 0.75 km (0.5 mi) north of present-day River Road. Over the past 150 years, a series of channel modifications shifted the Laguna-Mark West Creek confluence approximately 3.2 km (2 mi) south. As a result, much of the sediment brought down by Mark West Creek during high flows is deposited in or near the Laguna just north of the study area, which contributes to flooding and other problems upstream (Fig. 36; Baumgarten et al. 2014a).

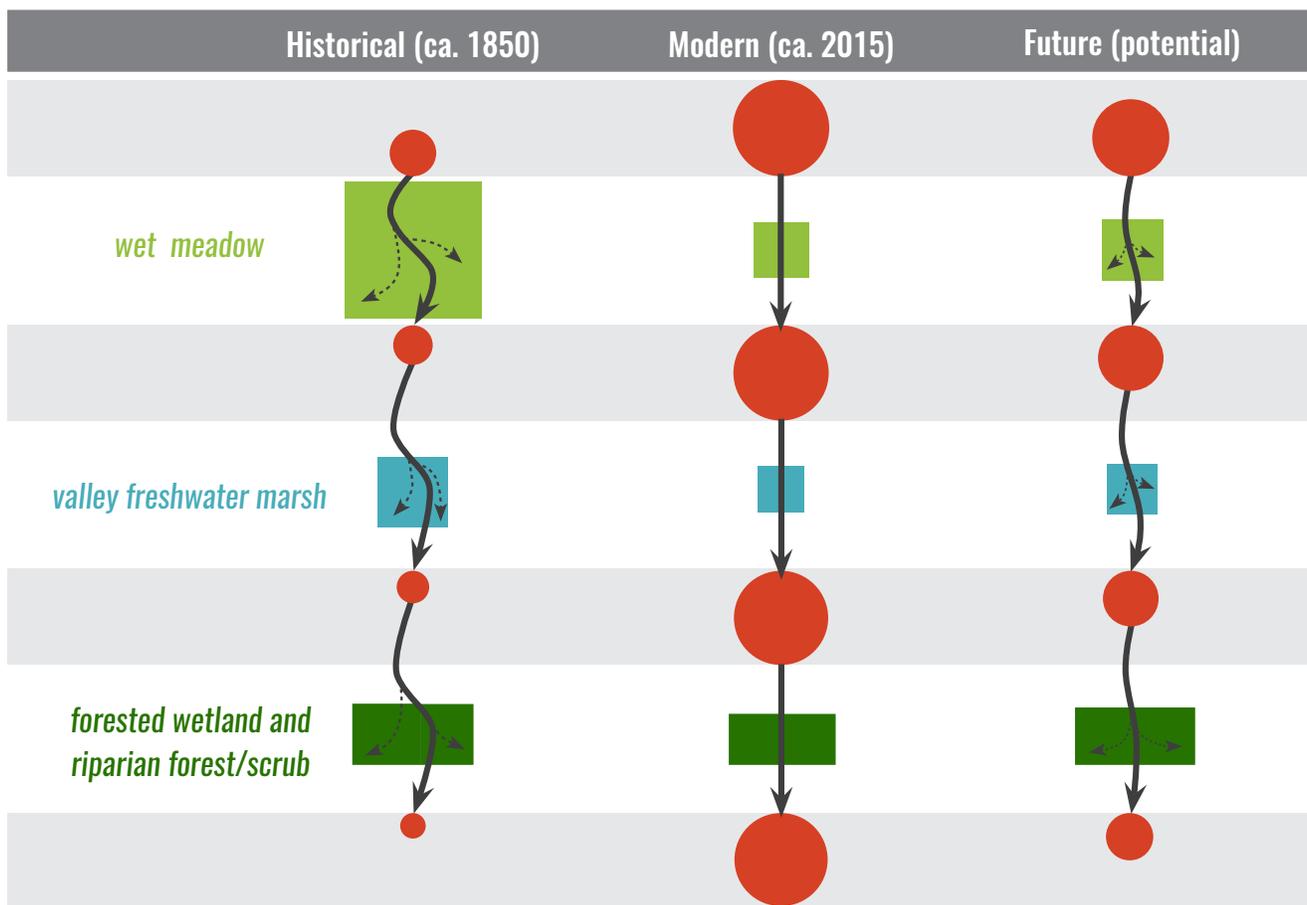
Fig. 38. Conceptual model representing past and potential future changes in nutrient assimilative capacity within the study area. Red circles represent external nitrogen and phosphorus loads as they move through the system. The colored boxes represent the wetland and riparian habitat types most likely to contribute significantly to nutrient assimilation. There is potential to mitigate external nutrient loading to the central Laguna in the future, both by reducing nutrient inputs from sources, and by restoring wetlands in strategic locations to increase the assimilative capacity of the system.
