## SOUTH SANTA CLARA VALLEY HISTORICAL ECOLOGY STUDY

INCLUDING SOAP LAKE, THE UPPER PAJARO RIVER, AND LLAGAS, UVAS-CARNADERO, AND PACHECO CREEKS

SAN FRANCISCO ESTUARY INSTITUTE

PREPARED FOR THE SANTA CLARA VALLEY WATER DISTRICT  
AND THE NATURE CONSERVANCY  
MAY 2008

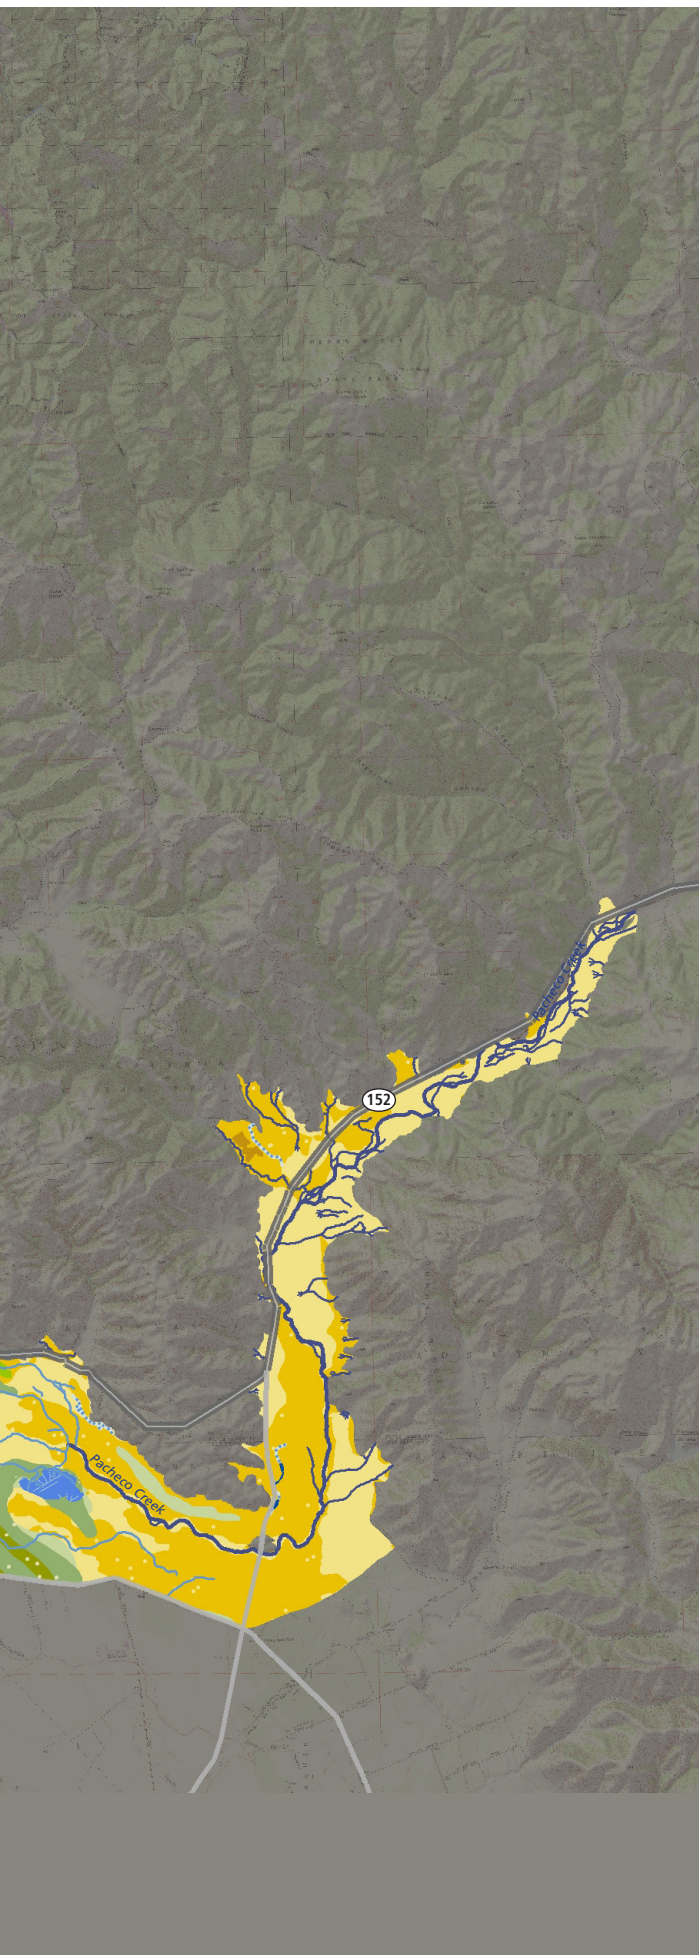
HISTORICAL CONDITIONS, CIRCA 1800

The map at left reconstructs the habitat characteristics of south Santa Clara Valley prior to significant Euro-American modification. More detailed views are provided on pages 168 through 175, in the map sections shown below.

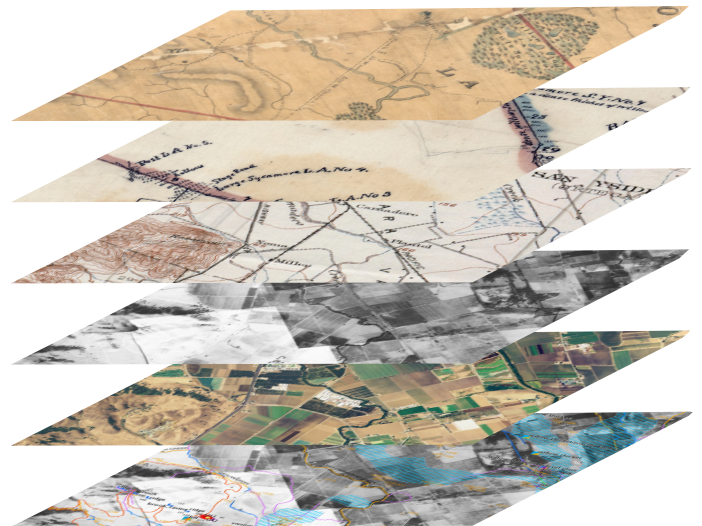
Figure 2.1. The geographic information system allowed us to assemble maps and information from different time periods.

A geographic information system (GIS) was used to collect, catalog, analyze, and display the spatial components of the study area. The relational database component of the GIS allows for storing many attributes about each feature, making a GIS ideal for these tasks. We were able to look through time by assembling maps and narrative information from different periods (fig. 2.1), which allowed us to both assess the different data sources and to better understand change.
