## 4

## STREAM AND RIPARIAN HABITATS

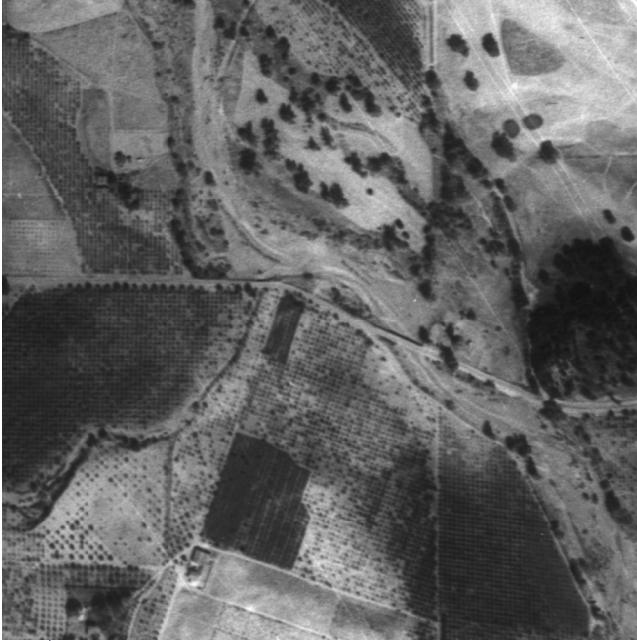
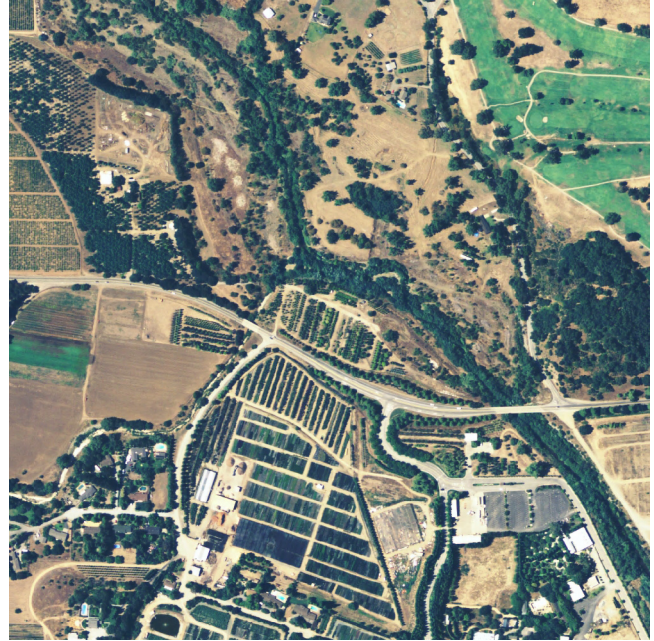
Above. Uvas-Carnadero Creek at the Hecker Pass Road crossing; images from 1939, 2005, 1884, and 1876 (clockwise from upper left).

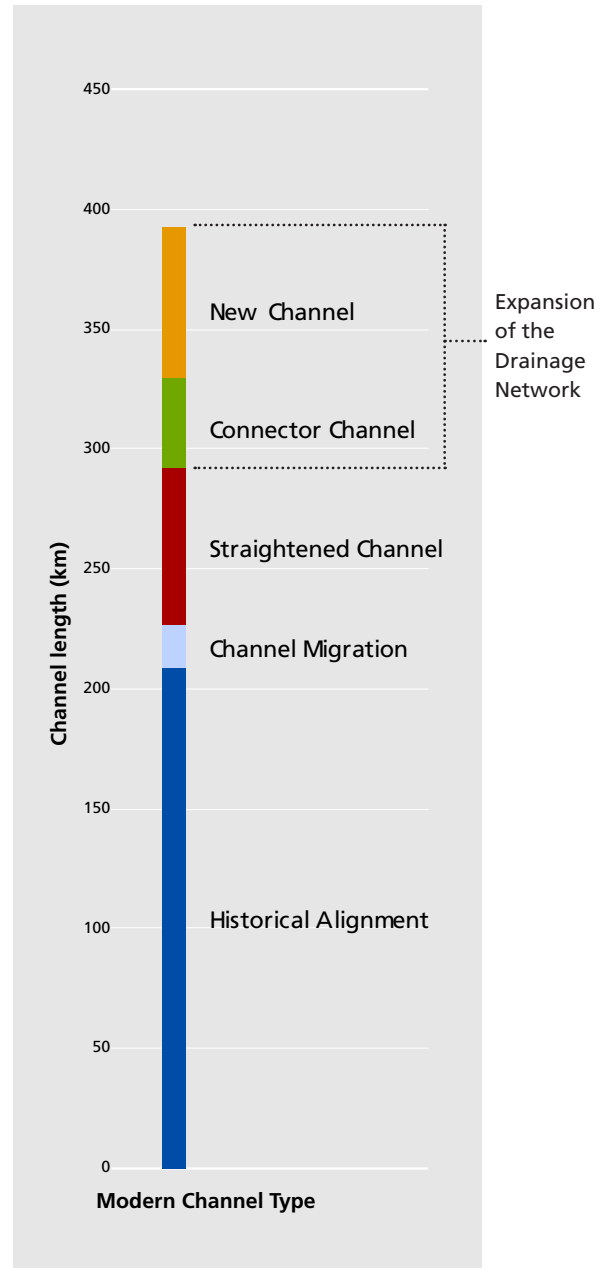
Figure 4.1. This figure describes the channels of the contemporary south Santa Clara Valley drainage network. It includes channels that follow their historical alignment and a small amount of channels that have naturally migrated. It also includes channels that have been straightened, channels dug to connect formerly discontinuous channels, and completely new channels. As a result, the drainage network has been substantially expanded. This same information is presented in map form in fig. 4.2.

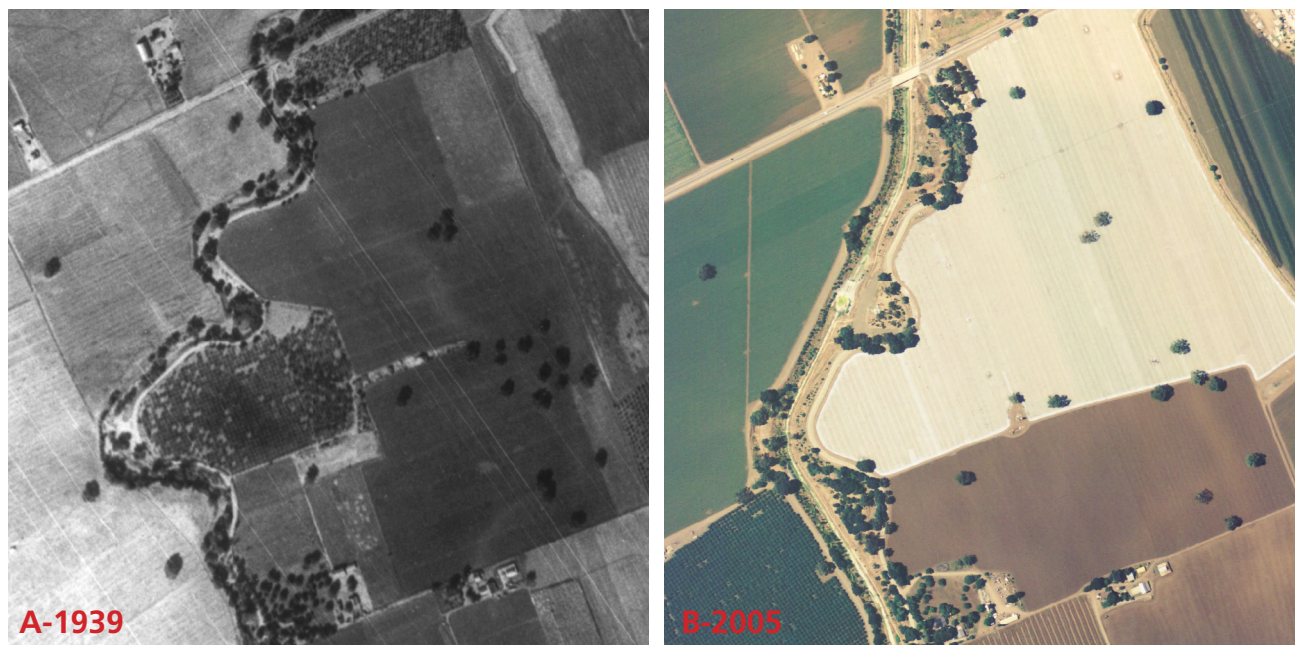
Figure 4.3. Former channel meanders of Llagas Creek. Over 60 km (40 mi) of historical streams (A) have been straightened or rerouted (B). Excavation of Llagas Creek in the early 1970s for gravel to construct Highway 101 and flood benefits produced these isolated oxbows along the current flood control channel (B; USDA 1982). (A: USDA 1939, courtesy of the Science & Engineering Library Map Room, UC Santa Cruz; B: USDA 2005, courtesy of NAIP)

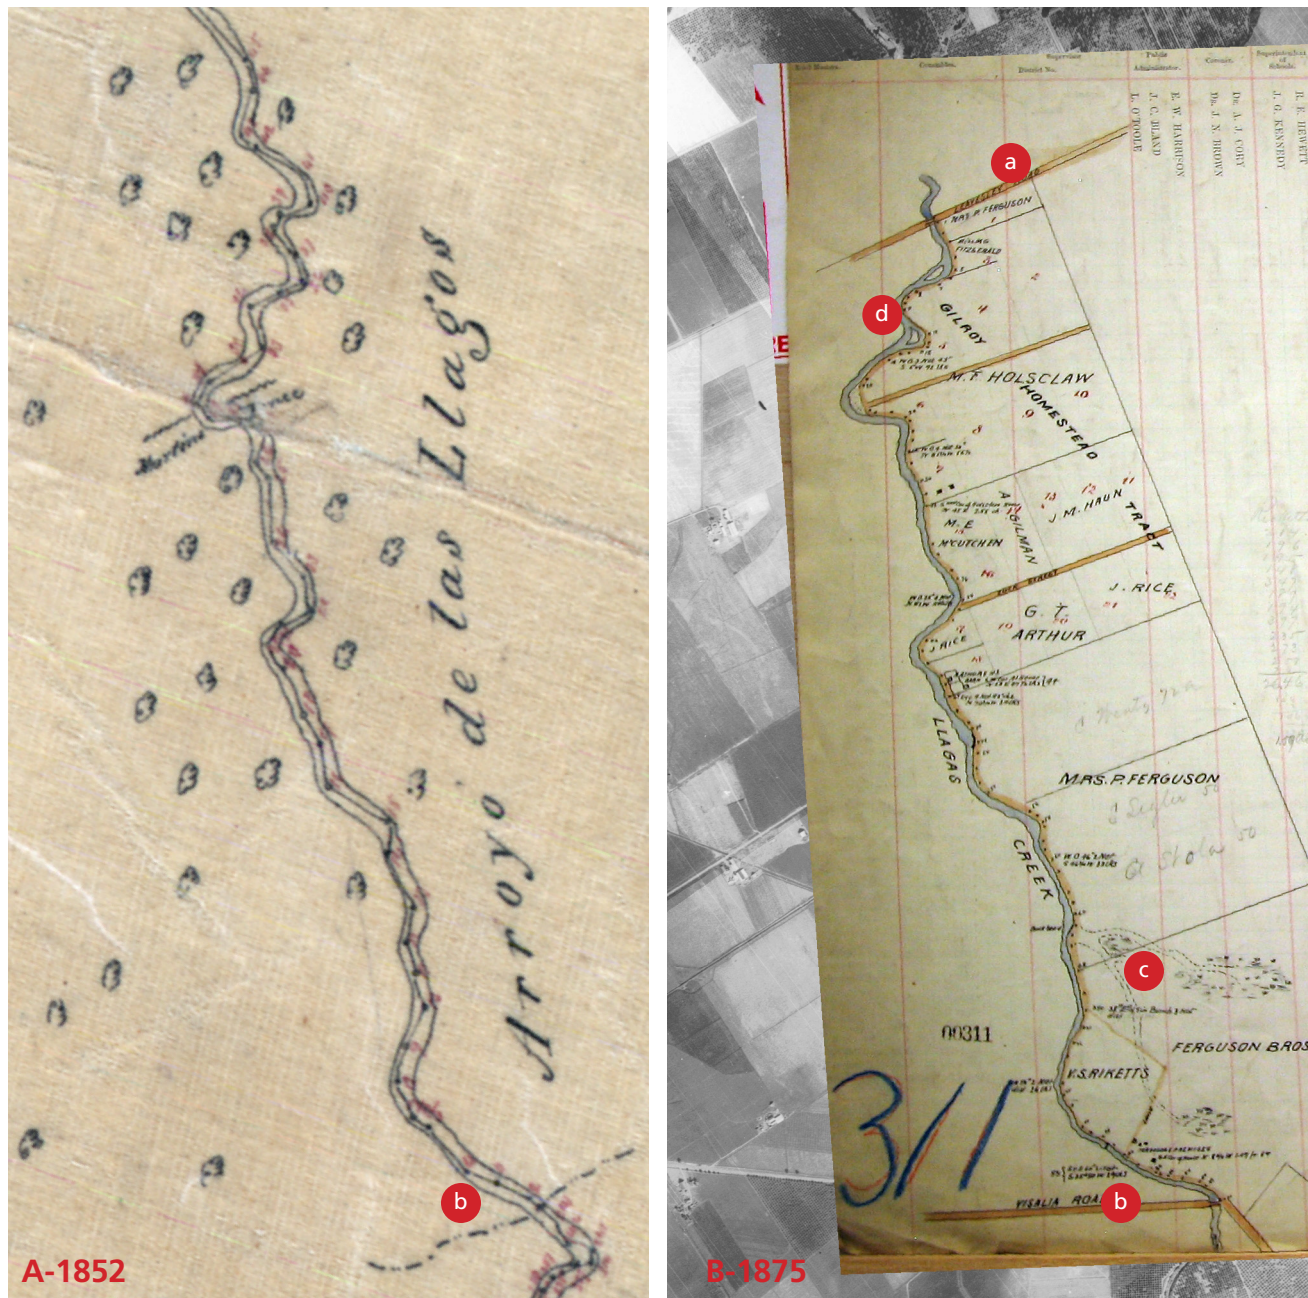
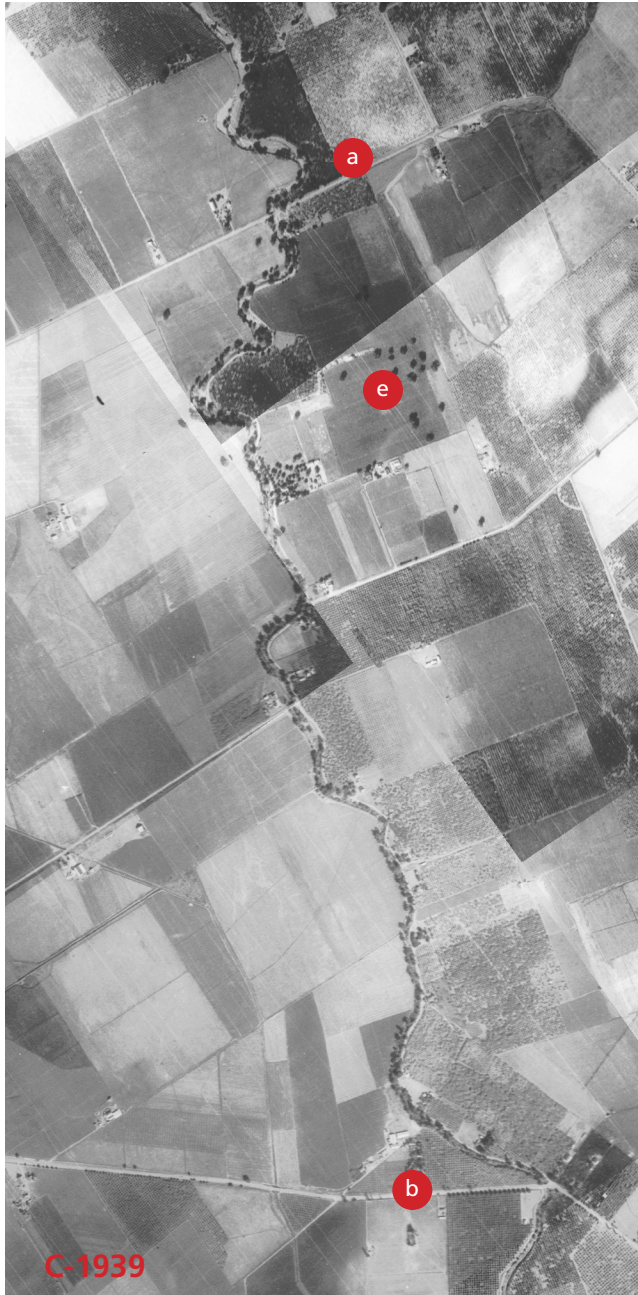
Figure 4.4. Llagas Creek between Leavesley Road (a) and Pacheco Pass Road (b). Maps of Llagas Creek by McDonald (A-1852) and Herrmann (B-1875) match later aerial photography meander for meander (C-1939 and D-2005). Former meanders on Llagas Creek can be seen upstream and downstream of Leavesley Road. The 1875 map also shows former distributaries of Llagas Creek spreading into wetlands (c) and several mid-channel bars (d). Oak savanna in the valley around the creek is suggested by the scattered trees in 1852 map; some remnant trees (e) are visible in 1939 (C)

and 2005 (D). The wetlands adjacent to the creek (c) suggest a relatively high water table in this area, as does the large willow grove just to the south of Pacheco Pass Road (b). (A: McDonald 1852(?)a, courtesy of The Bancroft Library, UC Berkeley; B: Herrmann 1875b, courtesy of the Office of the Santa Clara County Surveyor; C: USDA 1939, courtesy of the Science & Engineering Library Map Room, UC Santa Cruz; D: USDA 2005, courtesy of NAIP)

generally match closely (fig. 4.4). Within braided channels, however, the position of mainstem and side channels has been highly dynamic (e.g., figs. 4.20, 4.25, and 4.30).

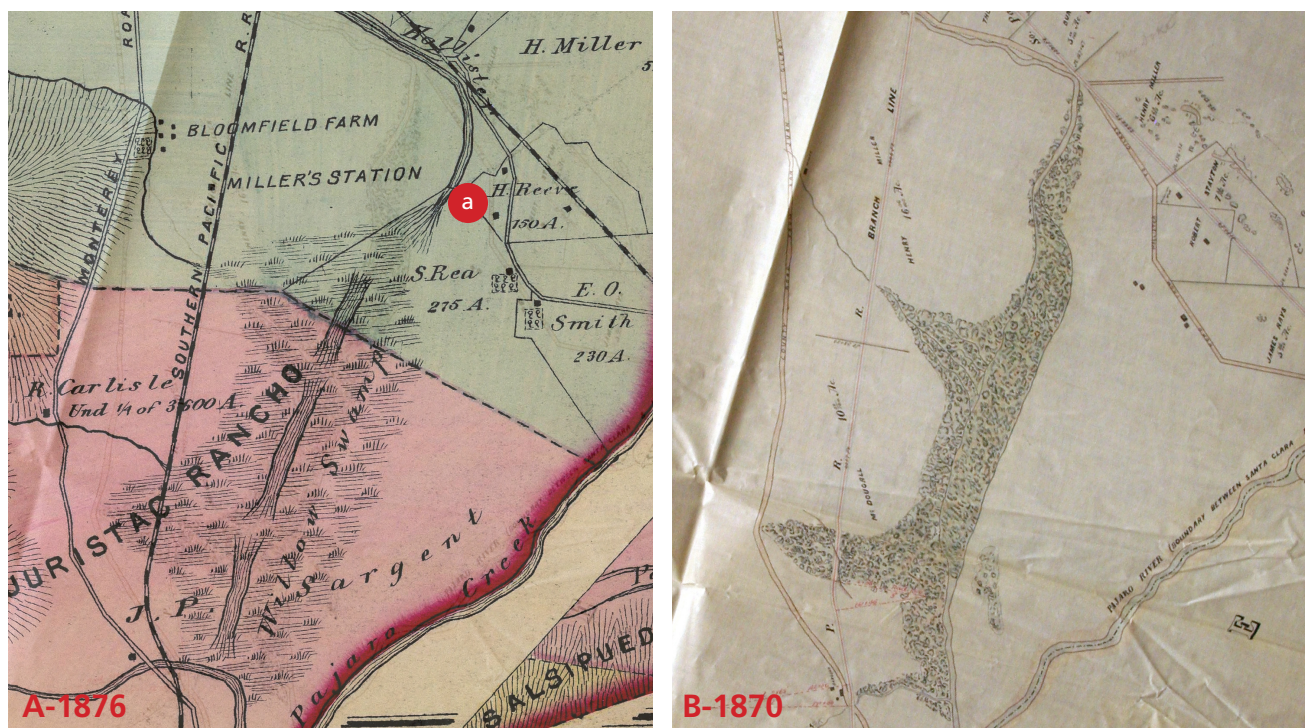
Figure 4.5. (A) The elegant Thompson and West atlases were commercial products produced by a traveling team. Created primarily by compiling existing information, they can show substantial detail but can also be inaccurate or imprecise in their depictions (Askevold 2005). The northern boundary of the Rea property (a) was defined by “the point where the ‘arroyo del Carneadero’ begins to branch into several channels” (Lewis 1851), leading to an unusual plat shape. (B) This county survey shows Carnadero Creek and Tar Creek spreading into multiple channels as they enter the Carnadero willow grove. (A: Thompson and West 1876, courtesy of the David Rumsey Map Collection; B: Herrmann ca. 1870, courtesy of the Office of the Santa Clara County Surveyor)

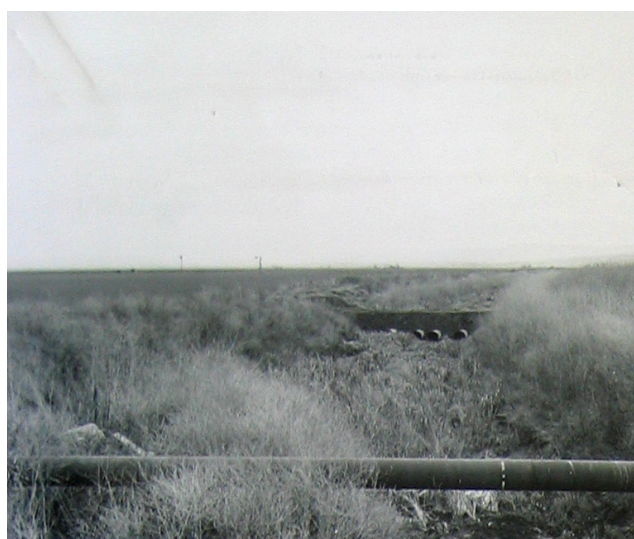
Figure 4.6. “Llagas Creek channel looking south from Bloomfield Road bridge,” January 1955. Despite decades of ditching by this time, the channel remains shallow and narrow. The present-day flood channel can be seen in figs. 4.16 and 5.16. (Soil Conservation Service 1955, courtesy of the Gilroy Museum)

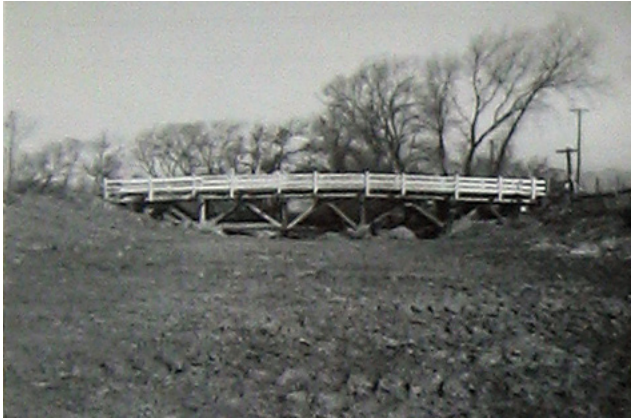
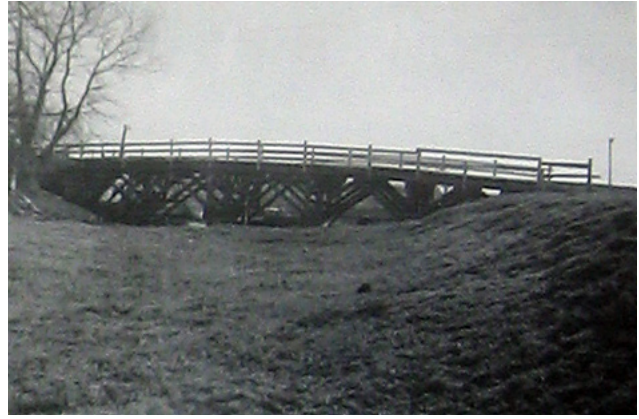
Figure 4.9. Rare photographs of a relatively unmodified, broad and shallow floodplain slough: Tequisquita Slough at Shore Road, February 1949. (Unknown 1949a, courtesy of San Benito County Public Works)

A set of 1949 cross-sections and photographs of Tequisquita Slough at Shore Road provide an unusually detailed illustration of the comparative geometry of a large floodplain slough and a neighboring, even more diffuse drainage. The cross-section (San Benito County Public Works 1949) shows the slough, here called “Tequisquita Creek”, and slightly to the west, a more poorly defined, irregular channel labeled “Tequisquita Overflow.”

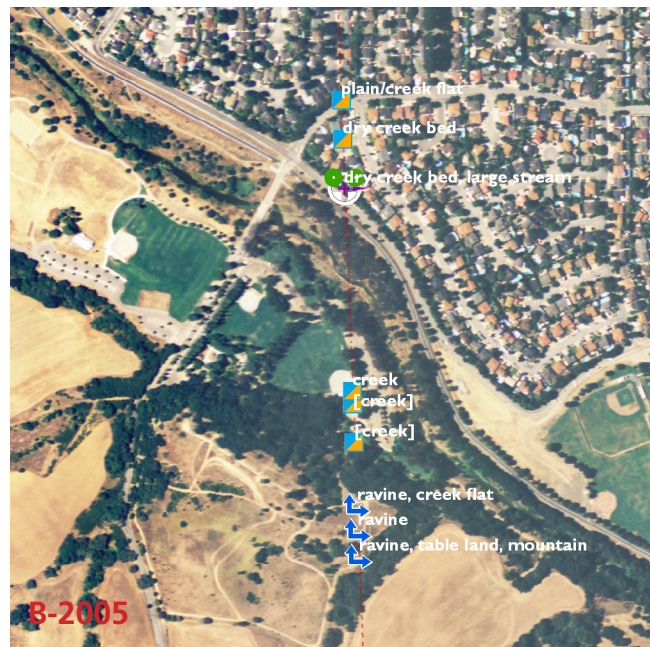
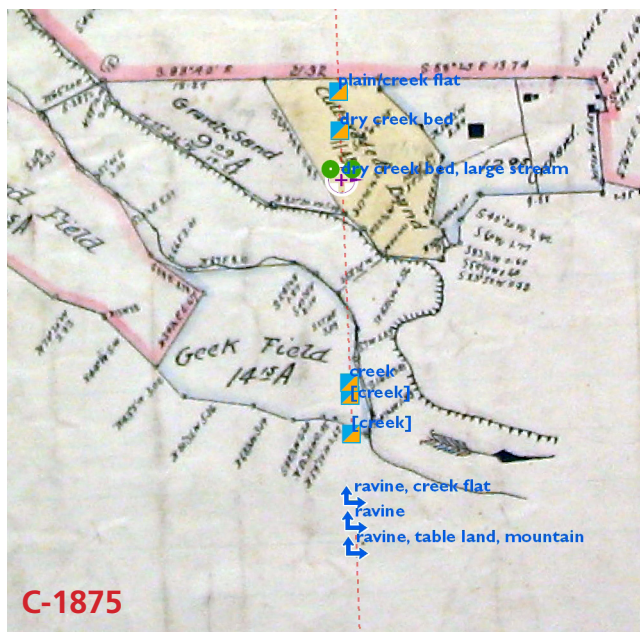
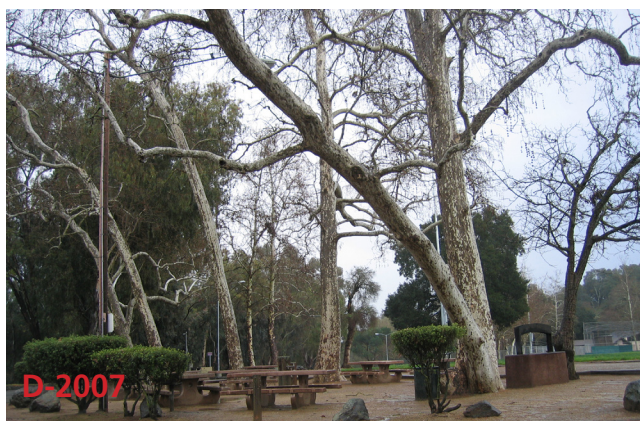
Figure 4.14. Historical reclamation of the Uvas-Carnadero Creek channel at Miller Avenue. This sequence of images compares information from four different eras. The base images are aerial photography from 1939 (A) and 2005 (B), and a county survey by Herrmann from 1875 (C). Overlaid on each of the images are survey notes from GLO surveyor Richard Howe in 1851. Howe documents a broad active channel area with side channels and adjacent stream benches ("creek flat") before development. By 1875 some of these areas are labeled "Cultivated Land" and "Creek Field." In 1939 aerial photographs, the area of former stream benches can still be distinguished within orchard patterns; a levee protects the orchards occupying the north portion of the former active channel. Presently, residential development occupies the points on the north side of the creek previously labeled "dry creek bed," and sycamore trees from the former riparian corridor (D) can be found in the Uvas Creek Preserve parking lot and picnic area. (A: USDA 1939, courtesy of the Science & Engineering Library Map Room, UC Santa Cruz; B: USDA 2005, courtesy of NAIP; C: Herrmann 1875(?), courtesy of the Office of the Santa Clara County Surveyor)

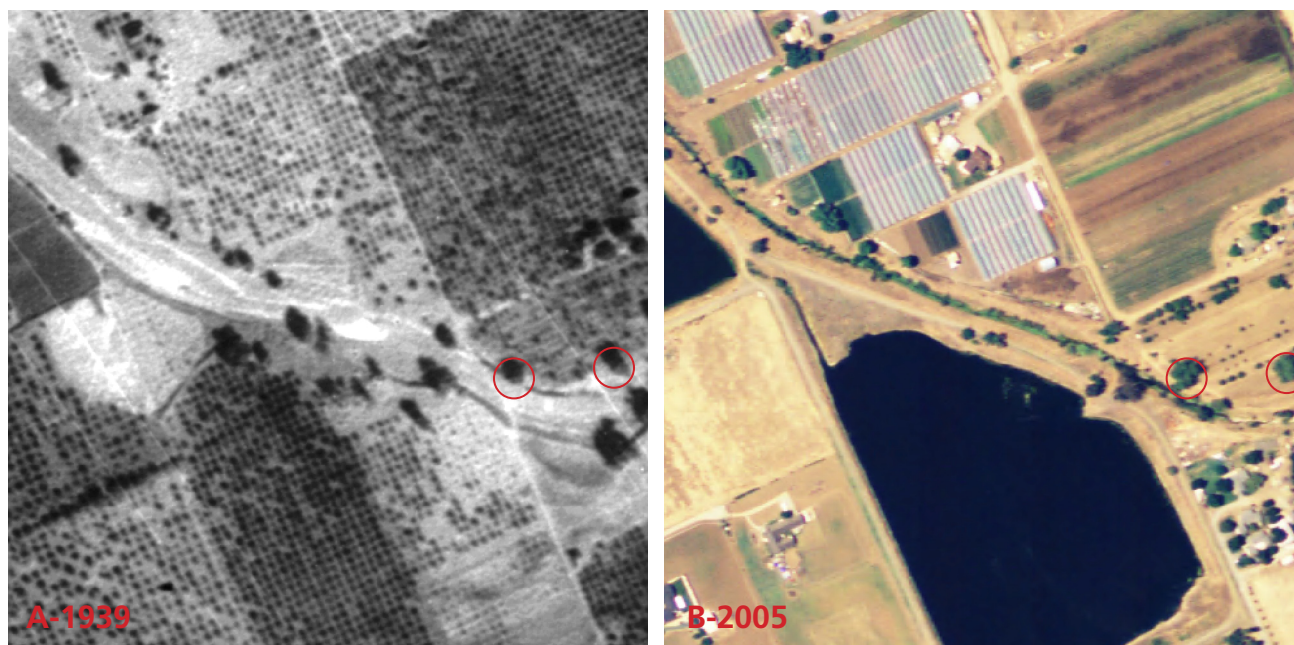
Figure 4.15. Llagas Creek at Church Street percolation ponds. To reduce flooding, the channel has been excavated and levees constructed on the former alluvial benches. Some of the riparian sycamore trees visible in 1939 (A) persist in 2005 (B), now isolated from the channel and floodplain. (A: USDA 1939, courtesy of the Science & Engineering Library Map Room, UC Santa Cruz; B: USDA 2005, courtesy of NAIP)

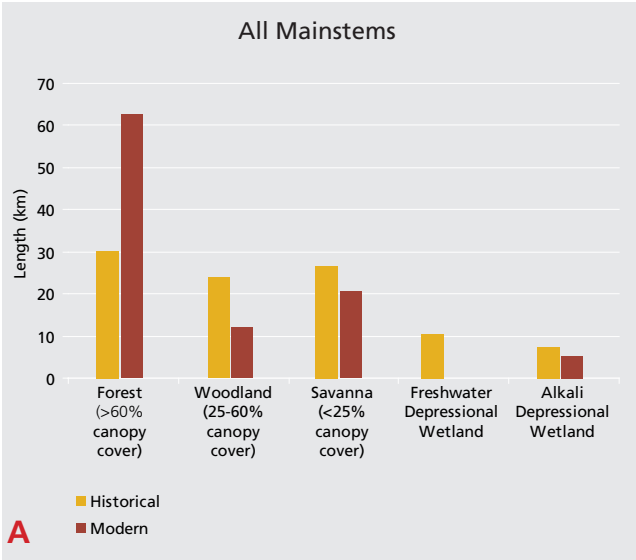
Figure 4.16. Total length of different riparian corridor types, past and present, on the Uvas-Carnadero, Llagas, Pacheco creeks and Pajaro River. Measurements are limited to the alluvial, valley floor mainstem reaches.

The expansion of riparian forest has occurred in two different landscape settings. Downstream of major dams, notably on Uvas-Carnadero and Llagas creeks, riparian woodland and savanna have converted to riparian forest (figs. 4.16B and 4.16C), presumably as a result of an increase in dry season flow and reduced winter scouring floods, which have allowed riparian vegetation to colonize formerly open channel surfaces. In these areas, the shift in hydrologic regime has caused a downstream extension of the extent of riparian forest.

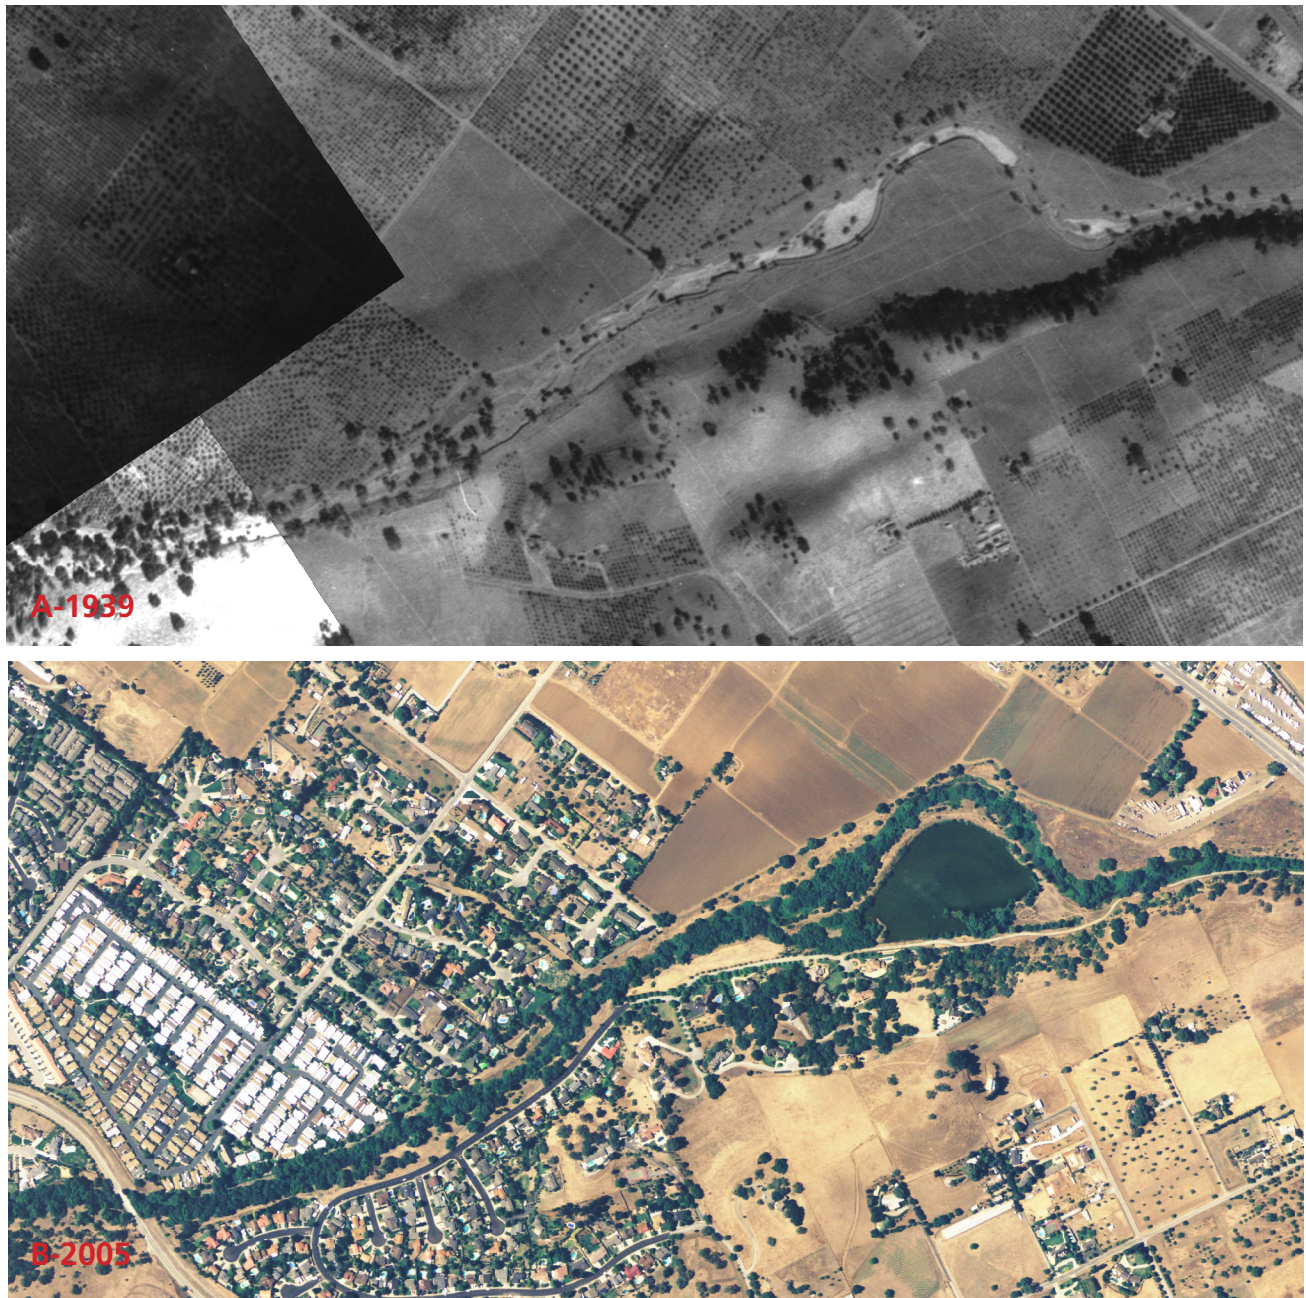
Figure 4.17. Llagas Creek between Santa Teresa Boulevard and Monterey Road. Historically, this reach was the transition point between a densely wooded riparian corridor and a more open or scattered riparian canopy. This transition corresponds to the shift from relatively narrow, meandering channel to a braided channel morphology as the stream outwashes onto the broad alluvial plain. Stream flow regulation has converted this reach to densely forested in the past few decades. (A: USDA 1939, courtesy of the Science & Engineering Library Map Room, UC Santa Cruz; B: USDA 2005, courtesy of NAIP)

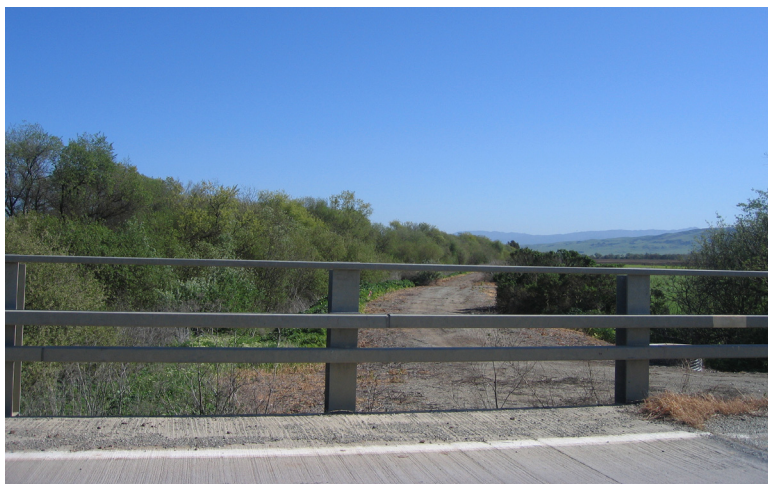
Figure 4.18. Dense riparian corridor of willow trees on the lower Llagas Creek flood control channel. The trees have established in the past few decades, within the historical extent of a much larger willow grove.

willow groves, have been confined to more well-defined channels. These channels tend to fill with riparian vegetation, especially willows, due to high groundwater levels and low stream gradient, establishing narrow, densely-forested channels (fig. 4.18).

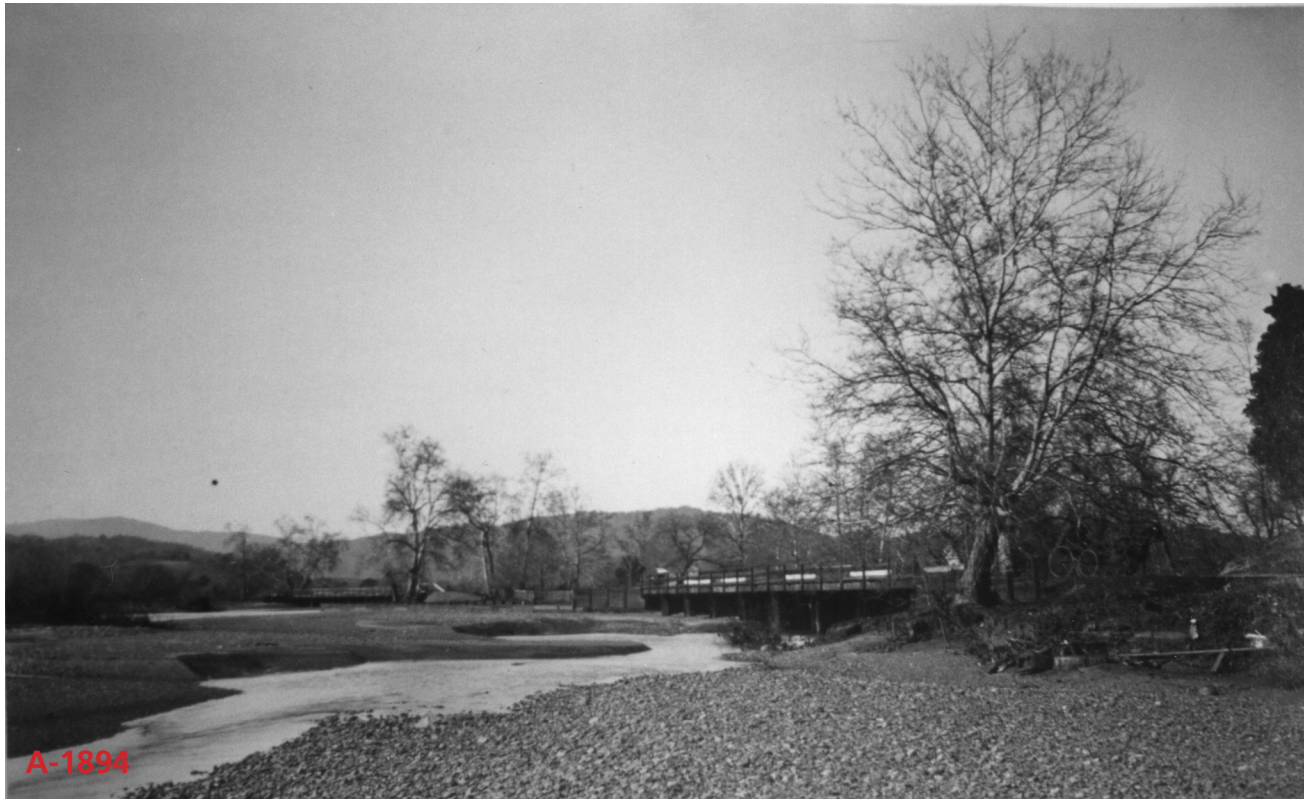
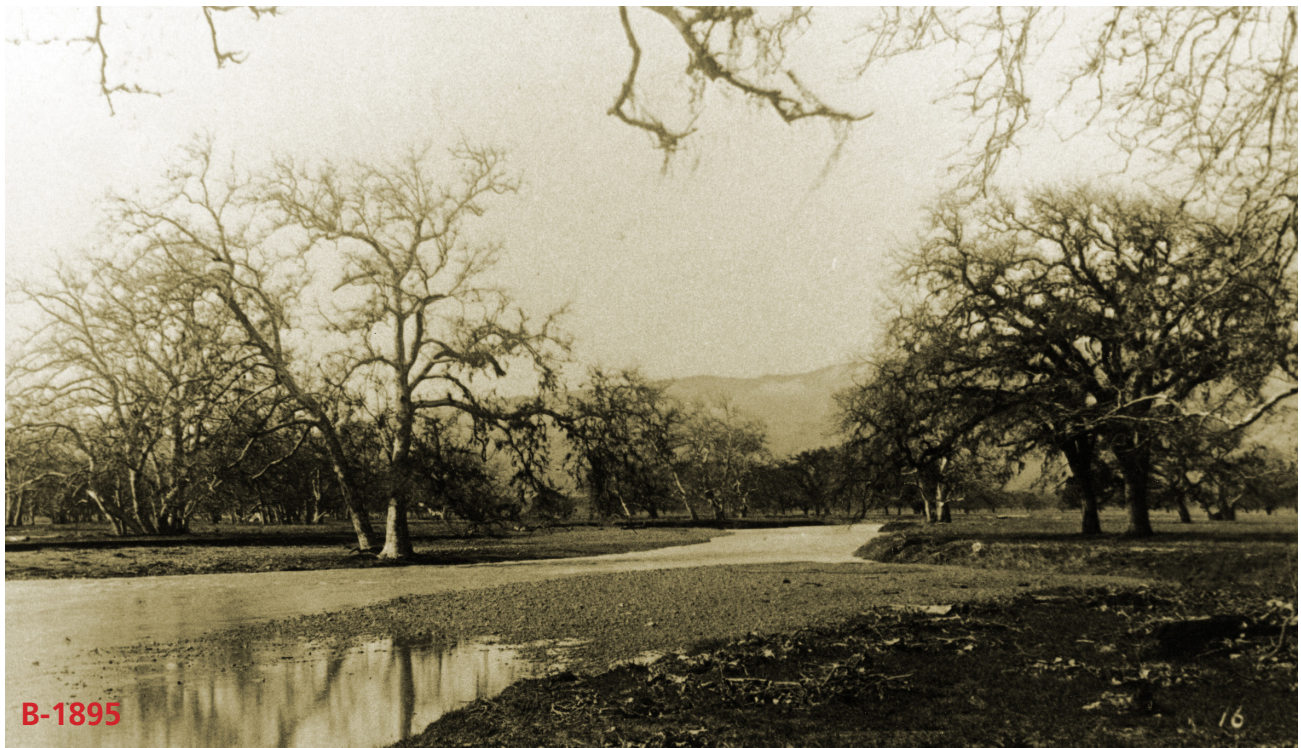
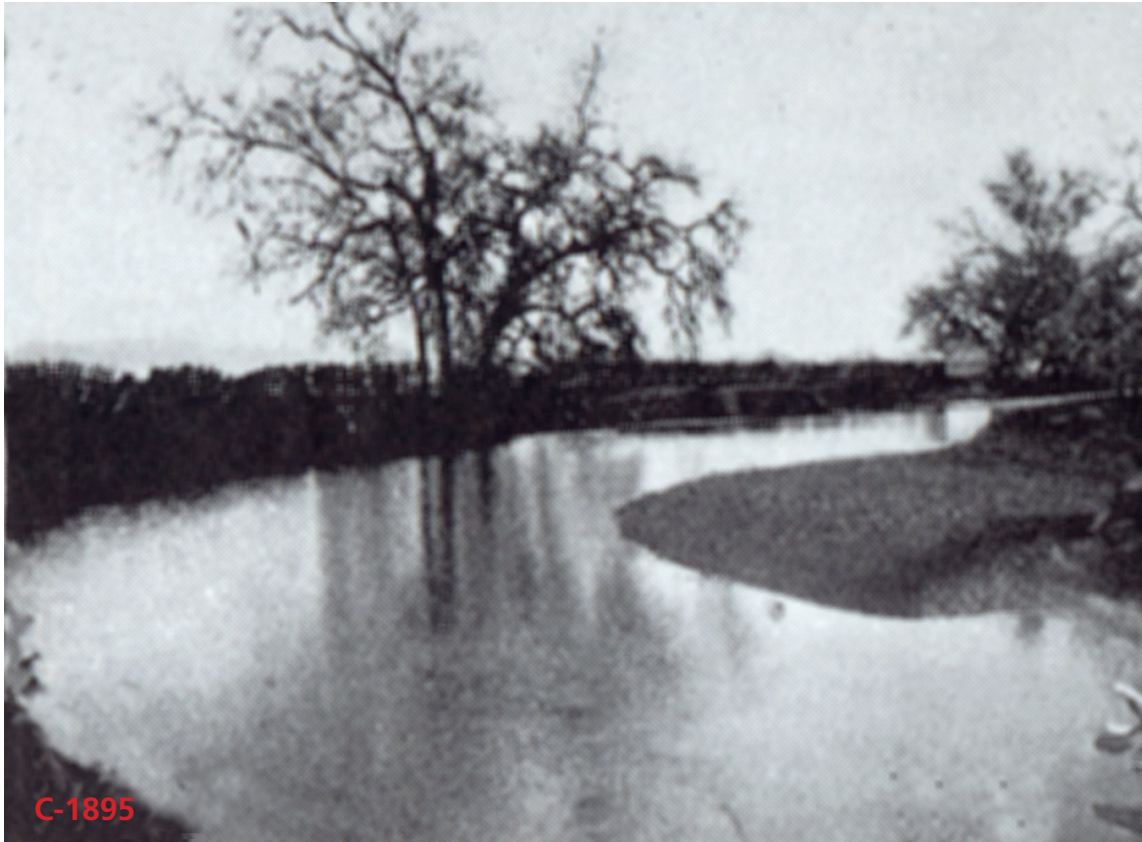
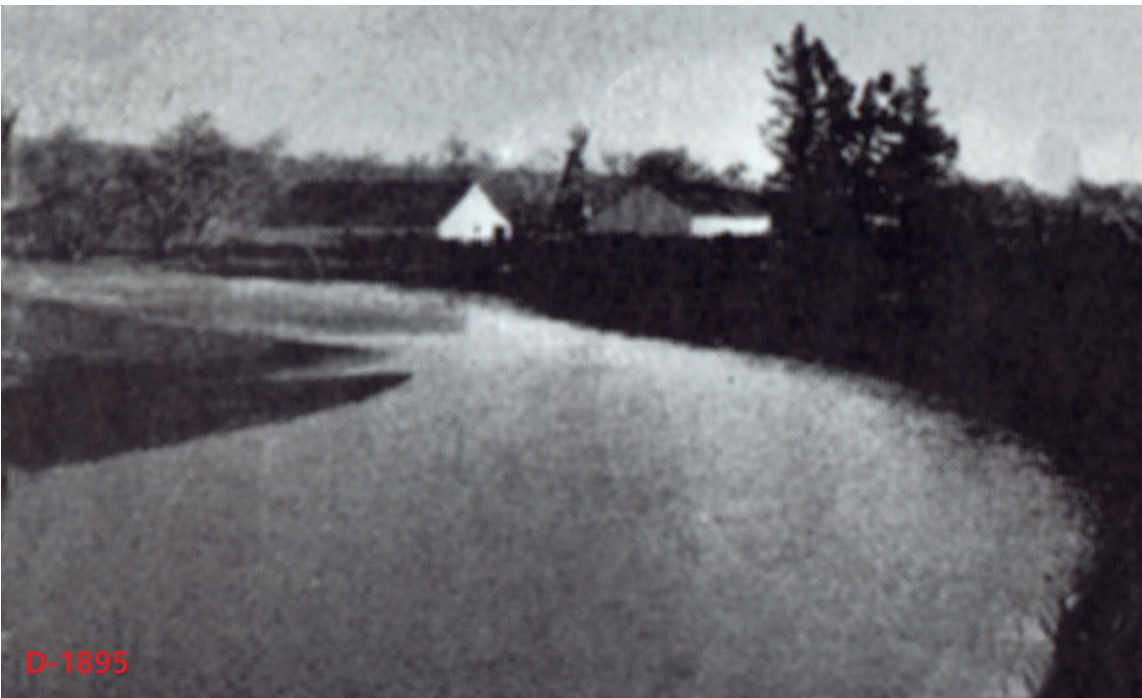
Figure 4.20. Historical landscape photographs of braided, gravelly, sycamore-dominated South Valley streams. Each shows wintertime flow in the mainstem channel, stand-alone sycamores without leaves, and limited other vegetation. These photos can be positioned as follows: (A) Uvas Creek looking towards the Hecker Pass Highway Bridge near the Bodfish Creek confluence, 1894; (B) Llagas Creek near the Monterey Road/Southern

Pacific Railroad crossing, 1895; (C) Llagas Creek north of Gilroy, 1895; and (D) Llagas Creek between Buena Vista and Rucker avenues, 1895. (A: Unknown 1894a, courtesy of Matt Kondolf and the Gilroy Museum; B: Hill & Yard ca. 1895, courtesy of the Morgan Hill Historical Society; C: Unknown ca. 1896a, courtesy of History San José; D: Unknown 1895, courtesy of the Gilroy Museum)

Historical landscape photographs (1890s) illustrating these stream reaches consistently show broad, mostly unvegetated low bars and terraces occupied by occasional large sycamore trees (fig. 4.20). These illustrations and 19th-century textual accounts are extremely consistent with the patterns observed in 1939 aerial photography, which shows the same reaches several decades later but prior to the construction of the dams and flood control projects. Despite increasing modification, general patterns remain similar in 1950 and 1963 aerial photography. The consistency across many decades suggests that these general vegetation patterns are not the result of short-term flood disturbance.

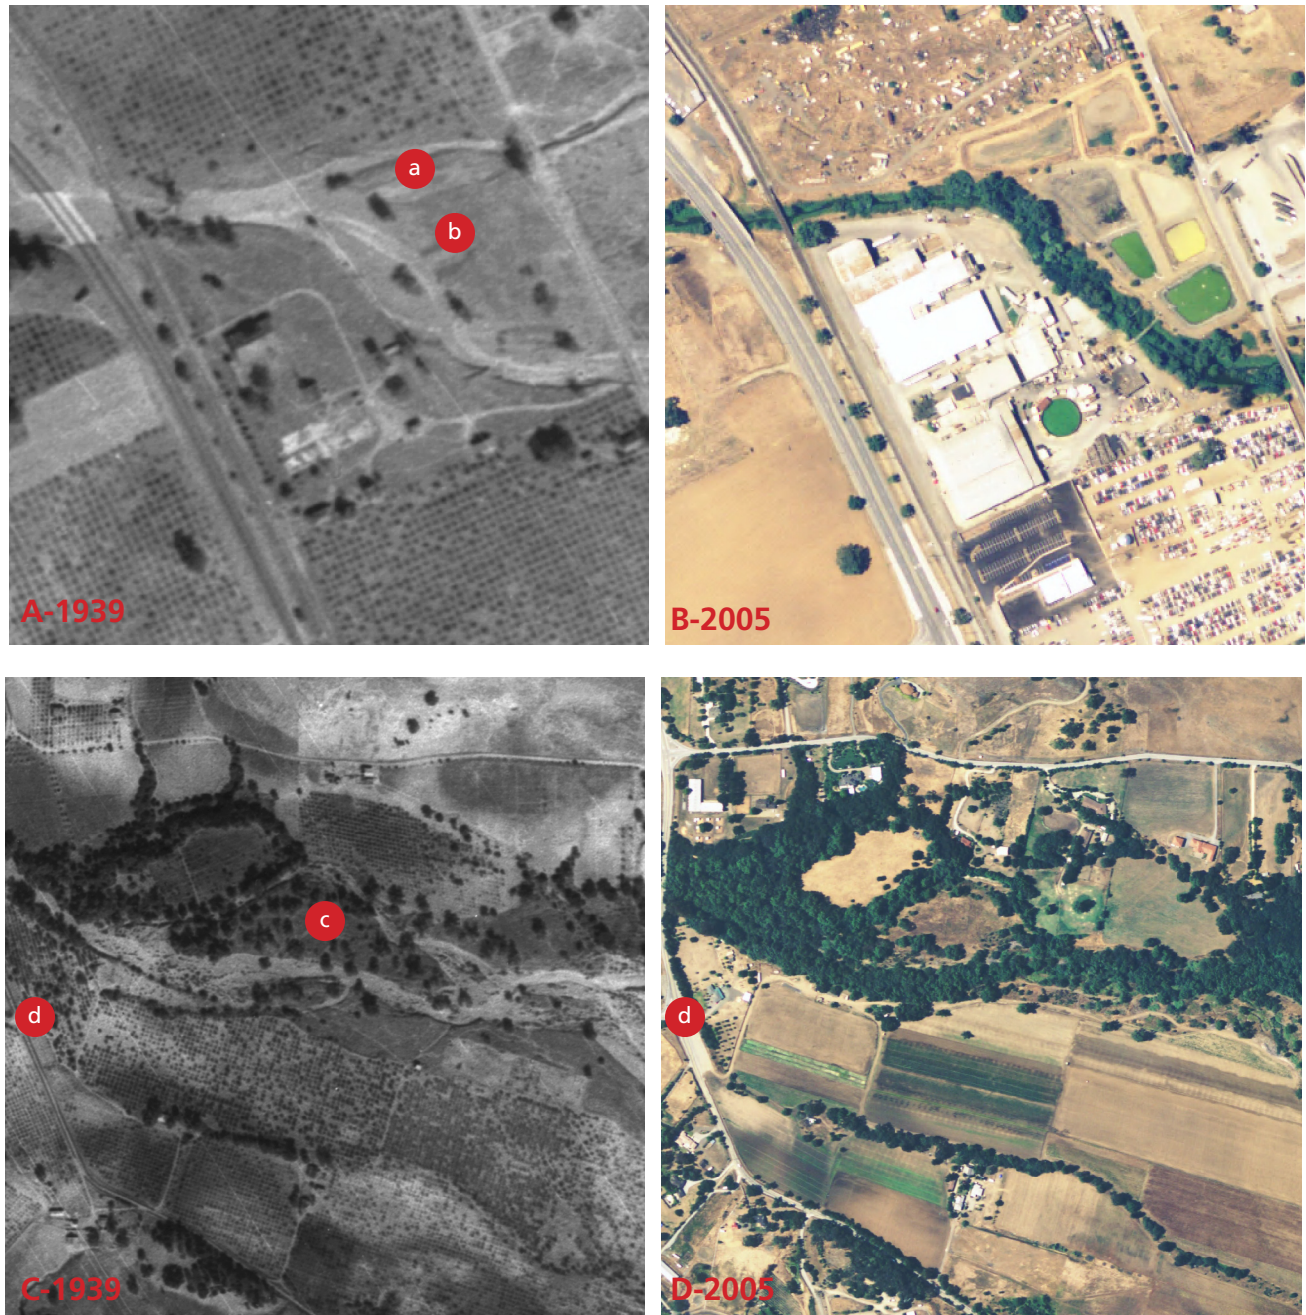
Figure 4.21. (A, B) Widely spaced sycamore trees (a, b) along the shallow, multithread Llagas Creek channel immediately downstream of the Monterey Road and railroad crossing. (C, D) A grove of sycamore alluvial woodland (c) on a mid-channel bar in Uvas Creek at Watsonville Road (d). In both cases, riparian forest has expanded within a narrower active channel during recent decades. (A and C: USDA 1939, courtesy of the Science & Engineering Library Map Room, UC Santa Cruz; B and D: USDA 2005, courtesy of NAIP)

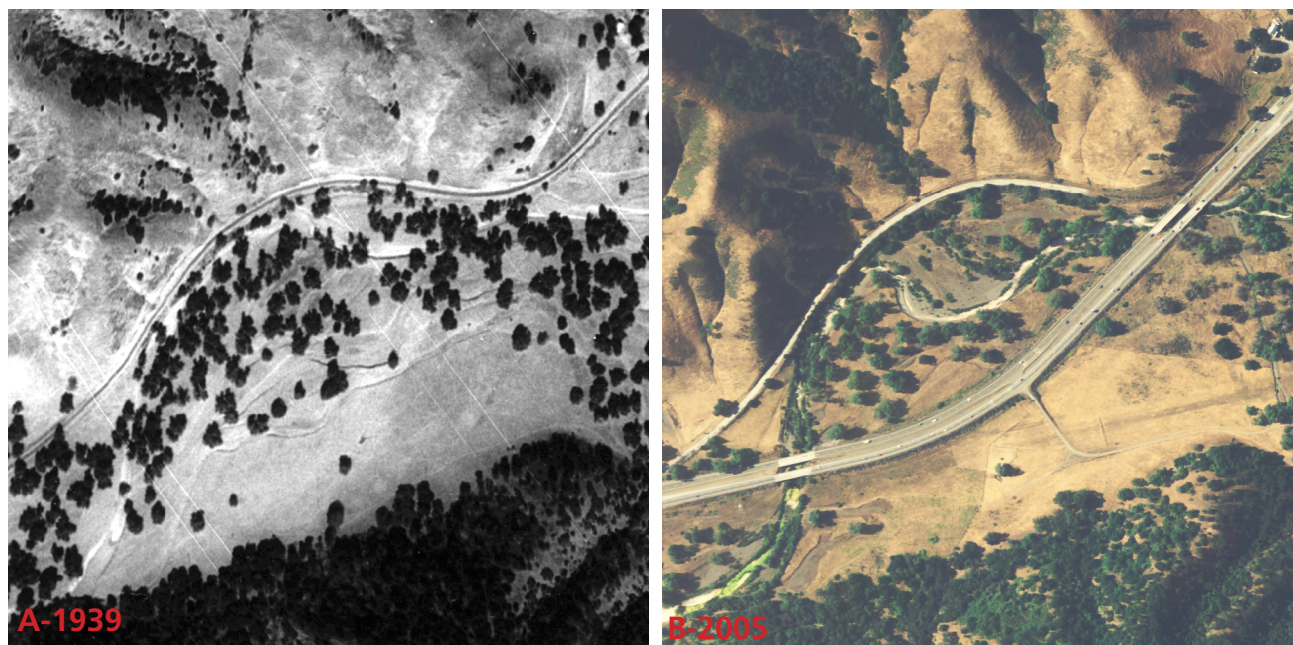
Figure 4.22. Sycamore alluvial woodland on the braided Pacheco Creek channel. Between 1939 (A) and 2005 (B) the main channel has migrated substantially. (A: USDA 1939, courtesy of the Science & Engineering Library Map Room, UC Santa Cruz; B: USDA 2005, courtesy of NAIP)

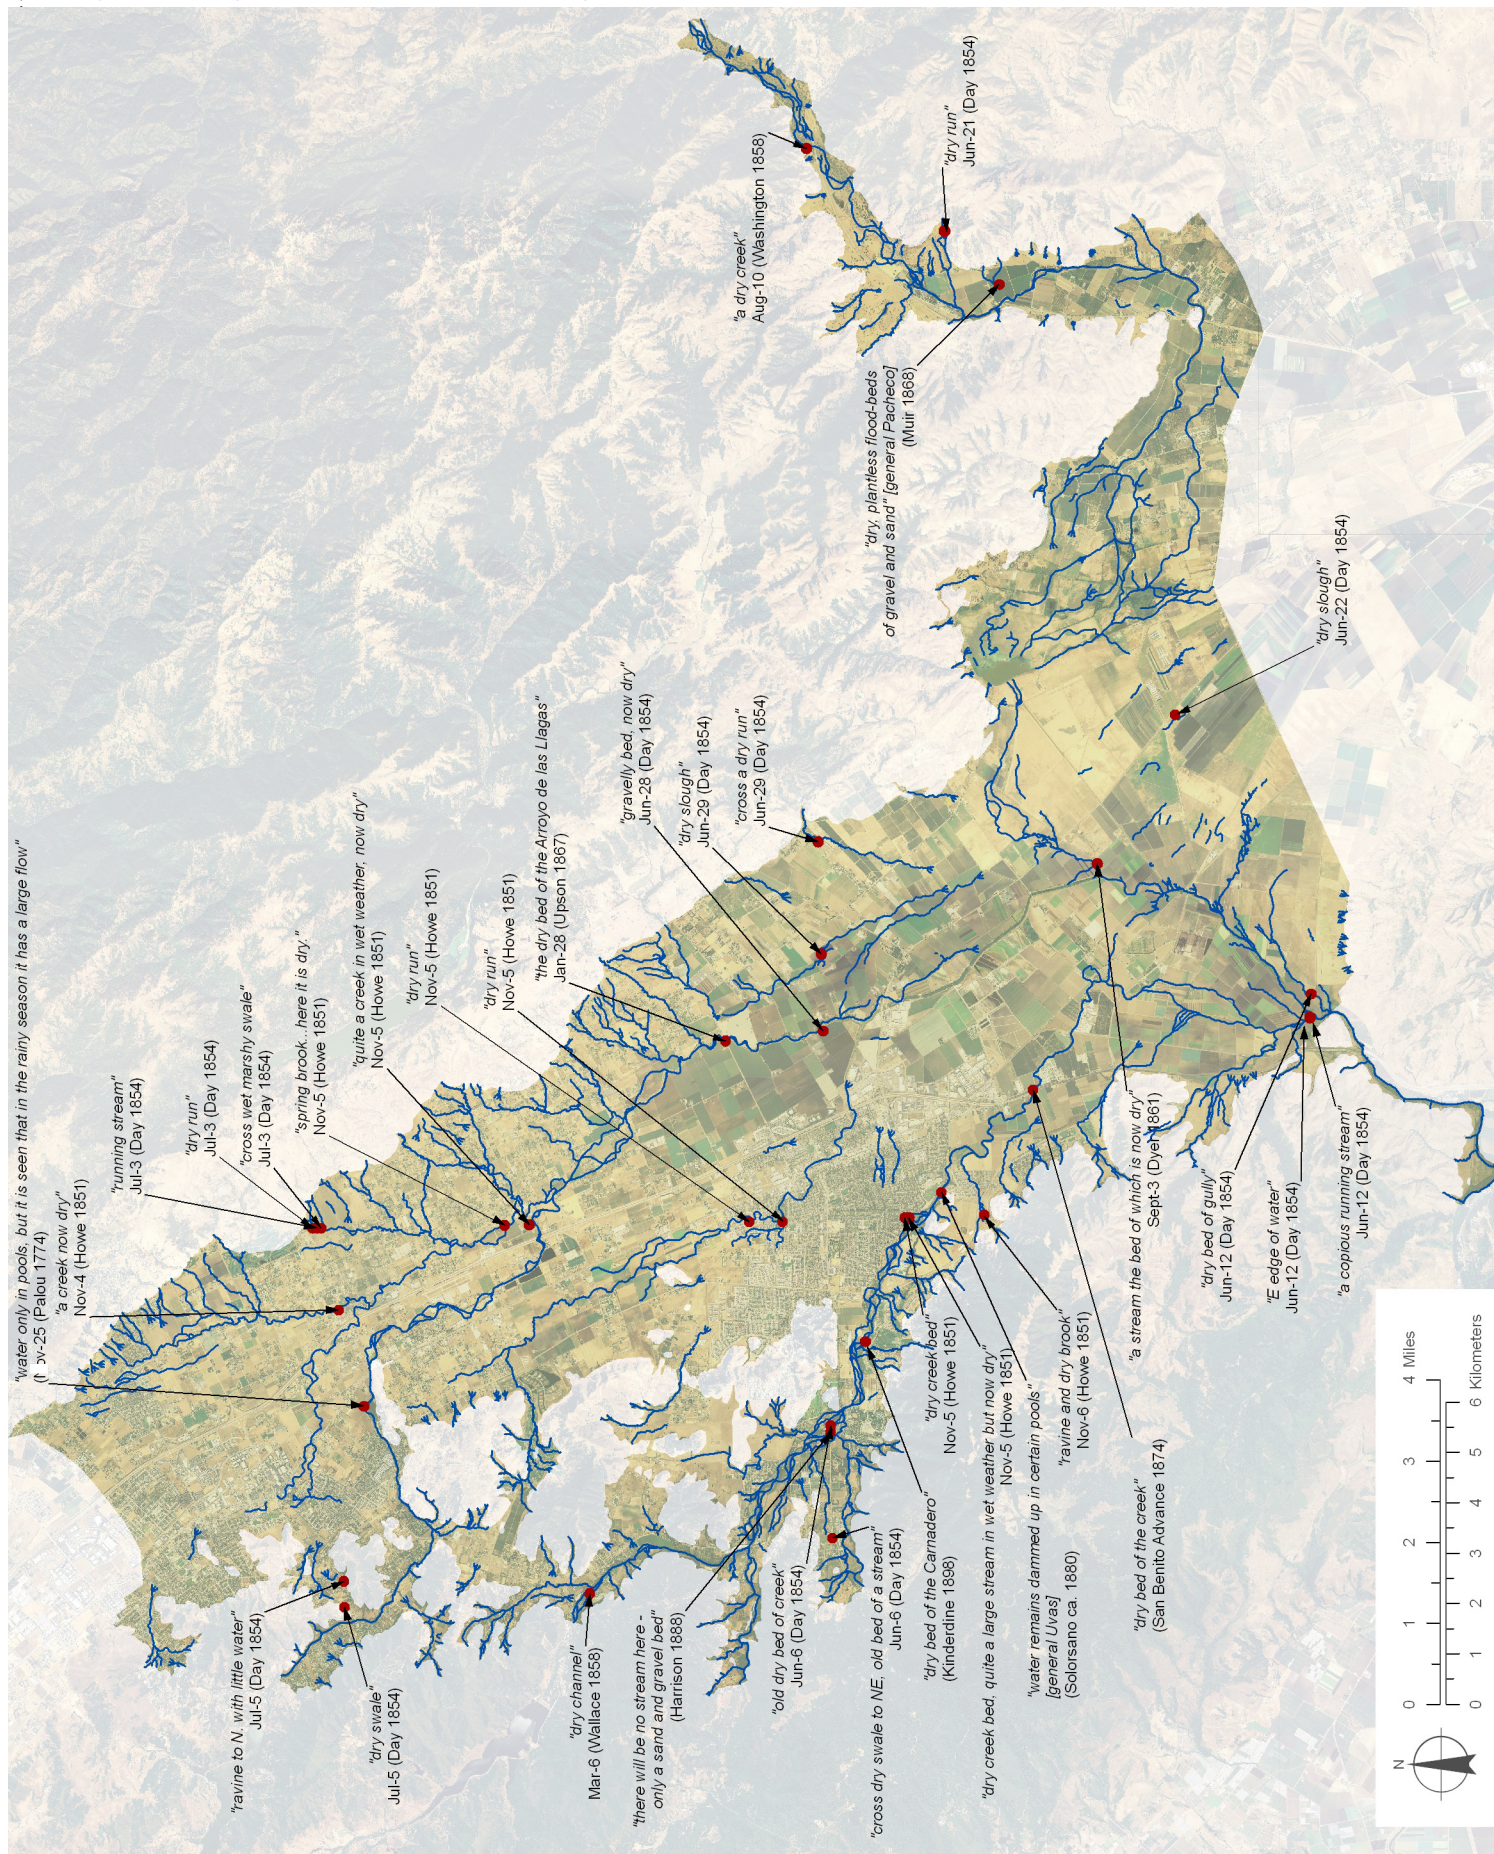
Figure 4.23. Historical evidence for dry season stream flow.

We found about 30 quotes describing dry season flow conditions between 1774 and 1923 (table 4.1, fig. 4.23). These quotes consistently characterize streams throughout the valley floor as intermittent, with the notable exception of the Pajaro River. While surface flow was highly restricted during the summer, there is evidence of scattered summer pools connected by strong subsurface flow. At least some of these were sufficiently persistent and reliable to serve as summer refuges for native fish, and fishing and swimming holes for local residents. Observers recognized that while flow would inevitably “sink in the gravel of the valley creek-beds,”
