## 4

## STREAM AND RIPARIAN HABITATS

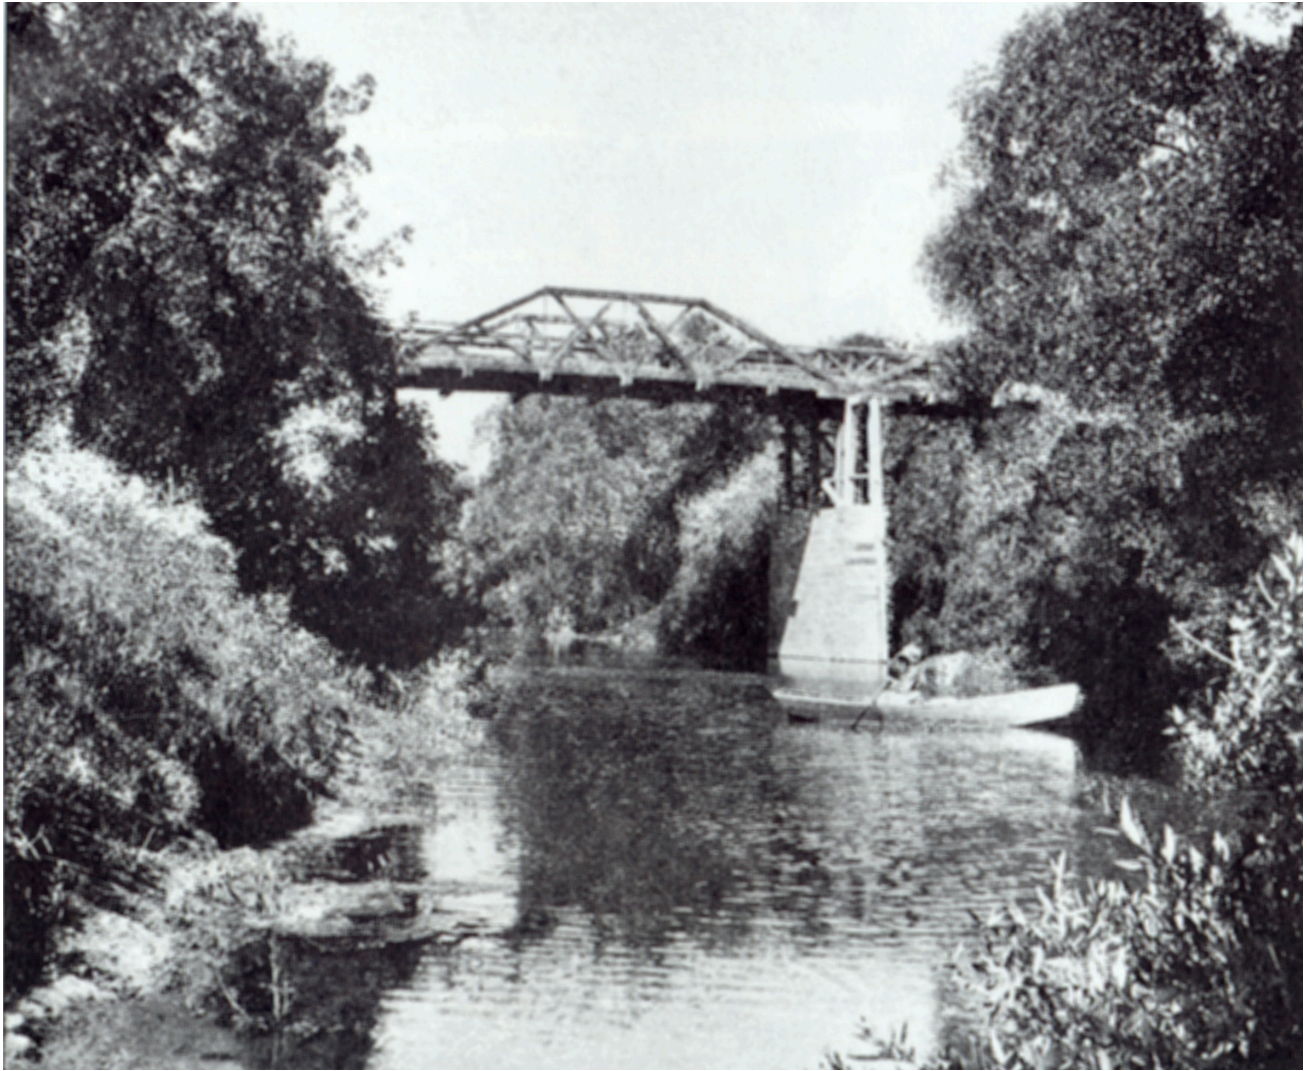
Figure 4.24. "Scene on Pajaro River, near Sargents." This photograph and the following (fig. 4.25) both show the Pajaro River between Sargent and Betabel Station. Substantial summer water is suggested by navigable conditions while deciduous trees are in leaf. (Unknown ca. 1896b, courtesy of History San José)

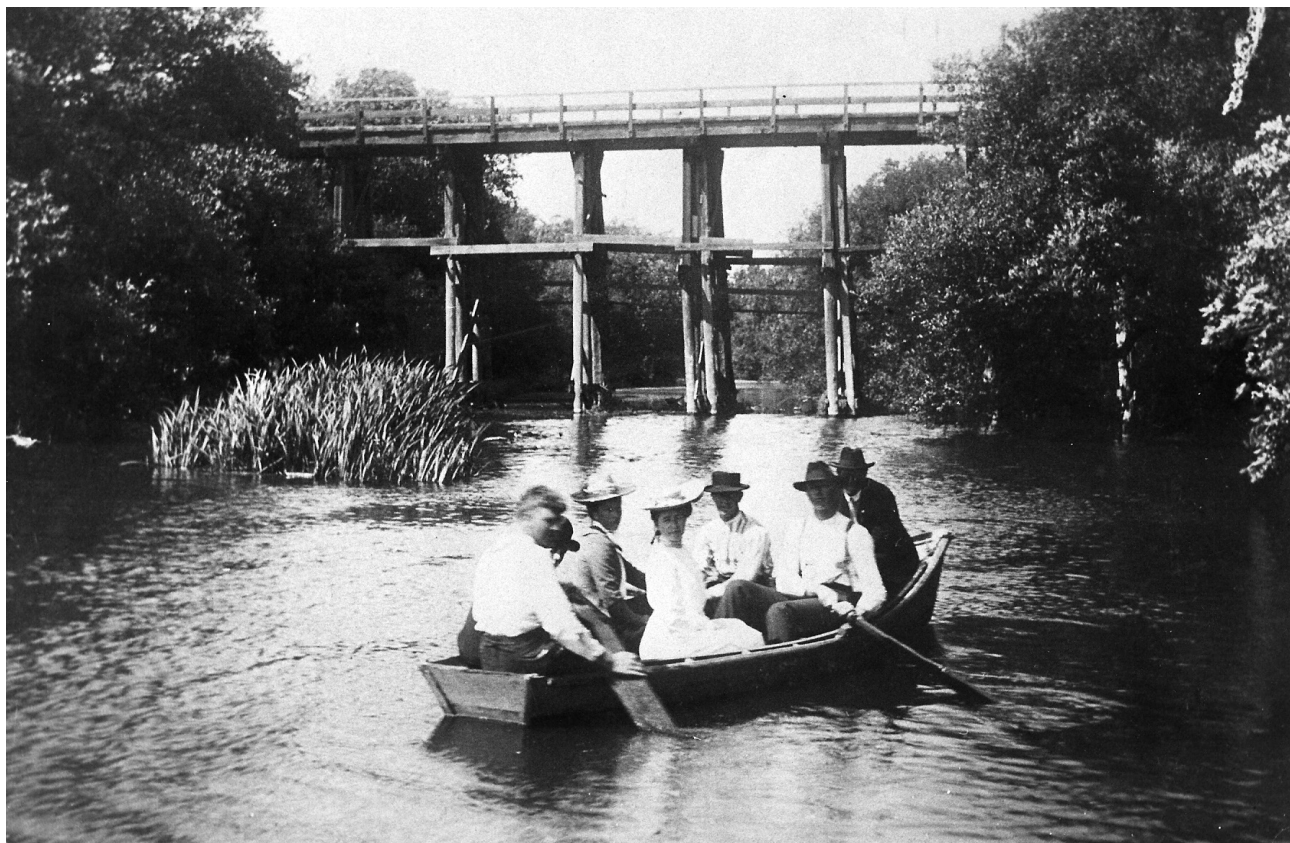
Figure 4.25. "Pajaro River near Sargent and Betabel station." (Unknown ca. 1890c, courtesy of the San Benito County Historical Society)

The Pajaro River appears to have been a rare regional instance of the more meandering, single thread, perennial river ideal (Kondolf 2006), in stark contrast to the dominant local stream types. This led to evocative descriptions characteristic of a low-gradient, densely-wooded perennial system: "The river at this point flows very gently, and the overhanging trees and windings of the river make the river scenery very beautiful"

(Shortridge [1896]1986). This distinctive reach, extending between the Llagas Creek and San Benito River confluences, had sharp boundaries. Downstream of the San Benito confluence, the Pajaro River's channel form was dominated by the San Benito, as both were described as "broad sandy streams" (Healy 1868).

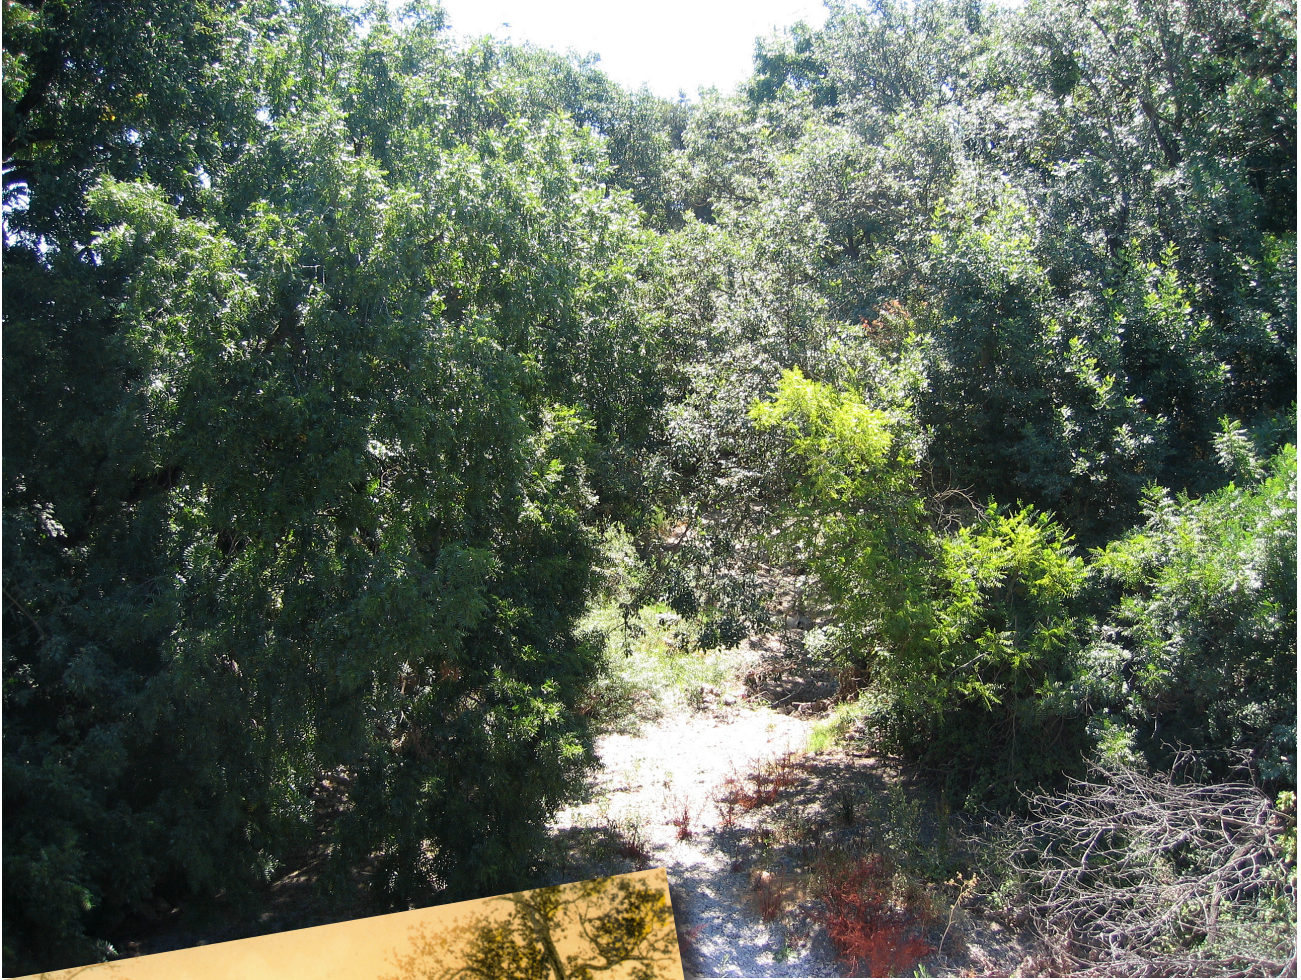
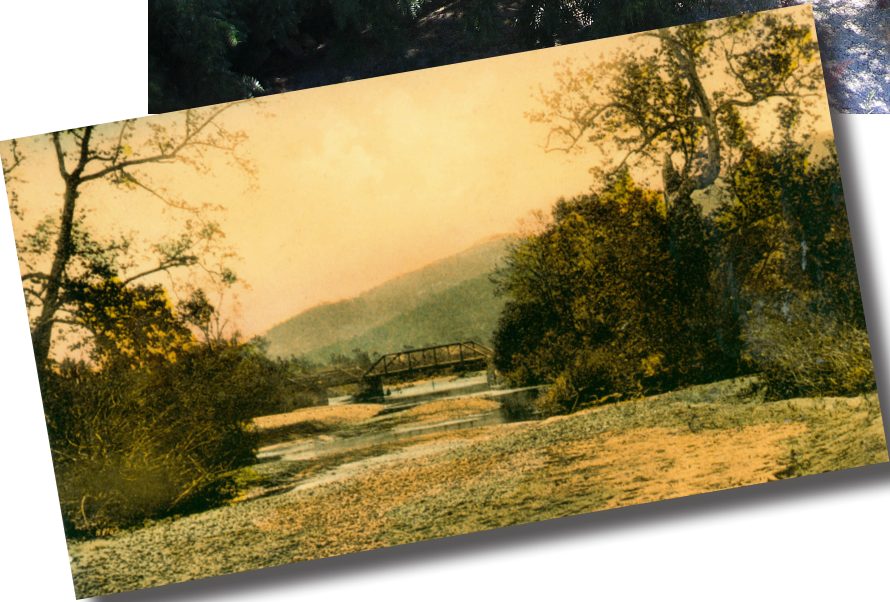
Figure 4.26. Two views of Uvas-Carnadero Creek near the Southern Pacific Railroad crossing. In-channel vegetation has increased between the postcard view, ca. 1912 (looking towards the railroad bridge) and the contemporary photograph, taken from the bridge. (Unknown ca. 1912a, courtesy of the California Historical Society)

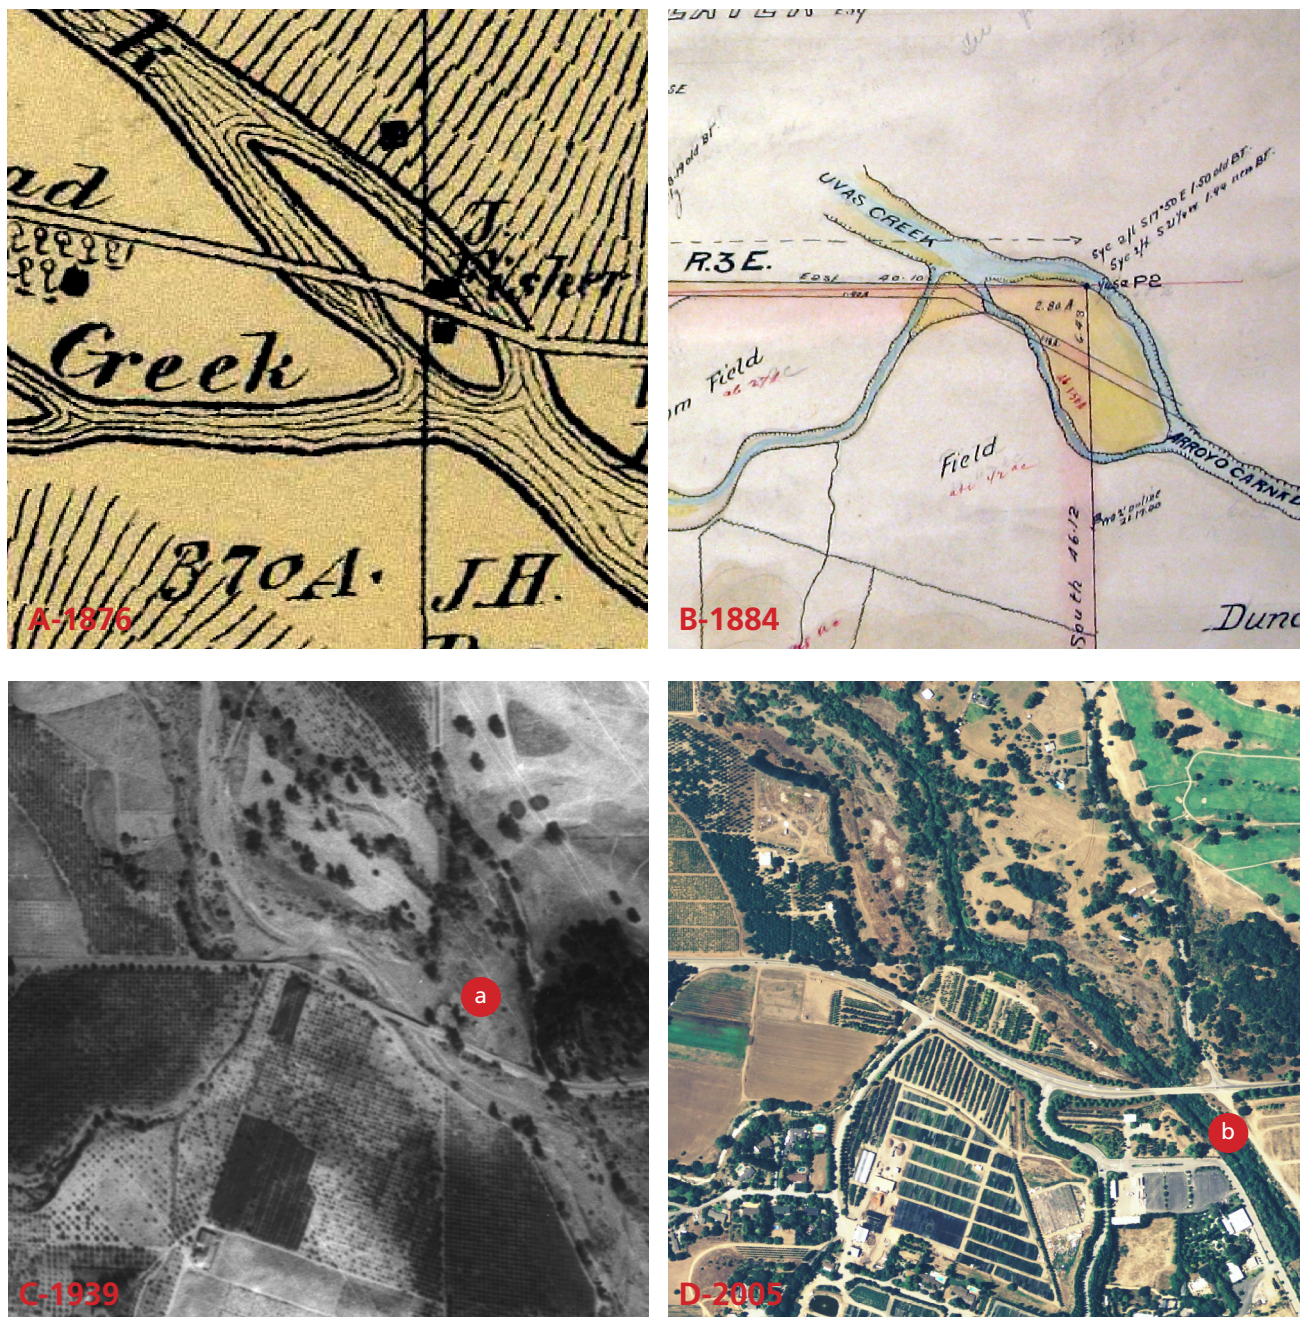
Figure 4.27. The well-documented Hecker Pass crossing gives a good overview of historical stream characteristics and change. Hecker Pass Road (Highway 152 West) crosses Uvas-Carnadero Creek at the Bodfish Creek confluence, near Gilroy (formerly Bonfante) Gardens. Views from 1876 (A), 1884 (B), and 1939 (C) show how the creek naturally split into two channels around a large bar, crossed by the “Twin Bridges.” In recent decades the braided channel has been narrowed, presumably by excavation and filling. This is particularly noticeable at the crossing, where the bridge now follows a more perpendicular route across a smaller channel (D). Trees at (a) can be seen in the 1894 landscape photograph in fig. 4.29. The viewpoints of this image and modern re-photographs are shown at (b). (A: Thompson and West 1876, courtesy of the David Rumsey Map Collection; B: Herrmann Bros. 1884, courtesy of the Office of the Santa Clara County Surveyor; C: USDA 1939, courtesy of the Science & Engineering Library Map Room, UC Santa Cruz; D: USDA 2005, courtesy of NAIP)

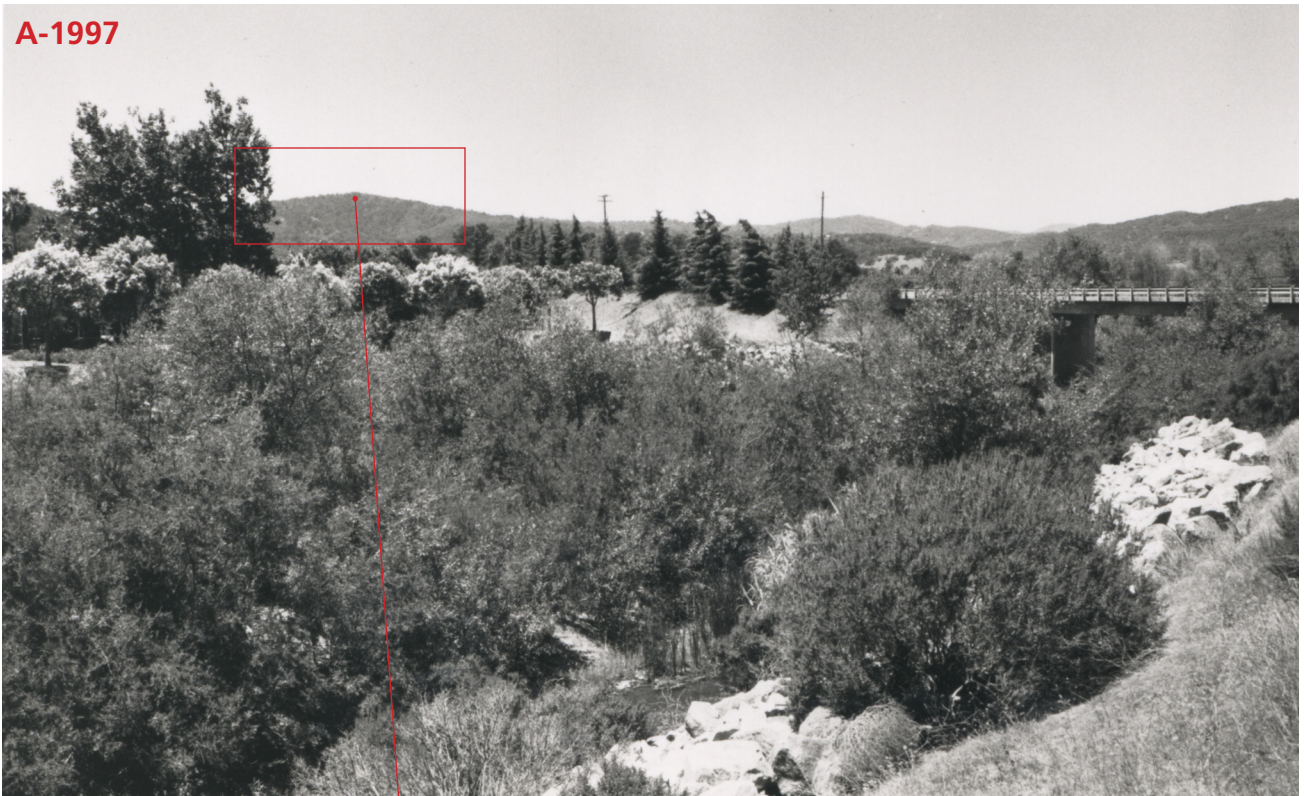
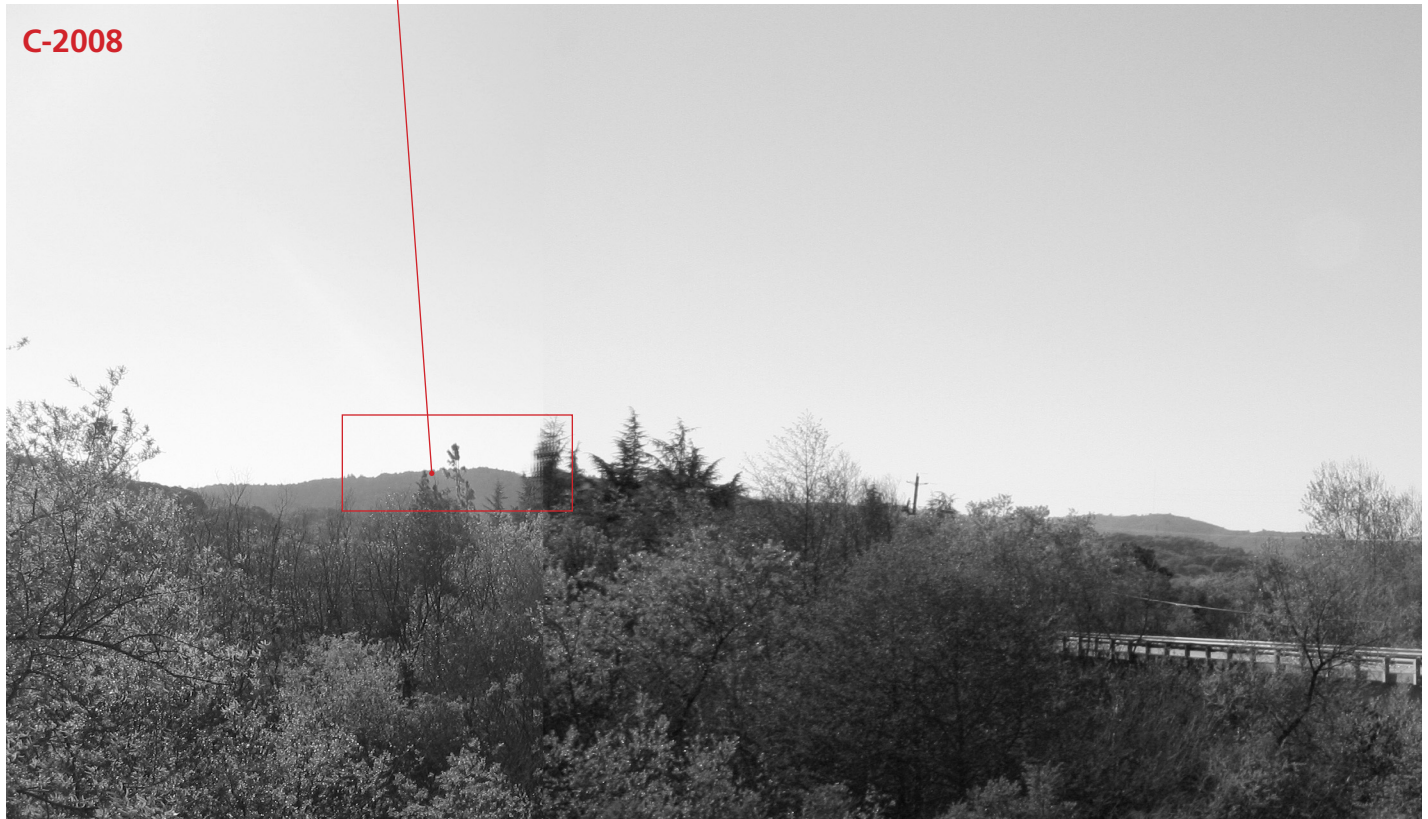
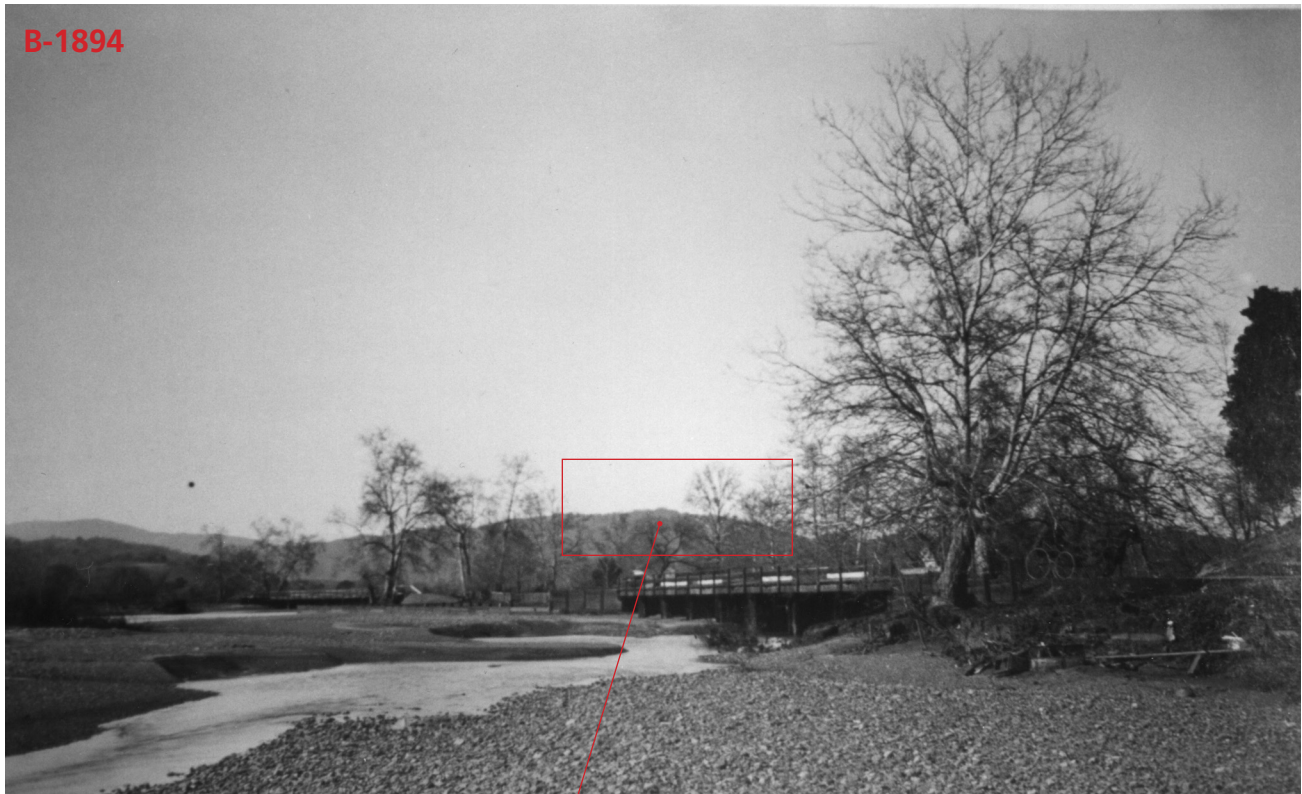
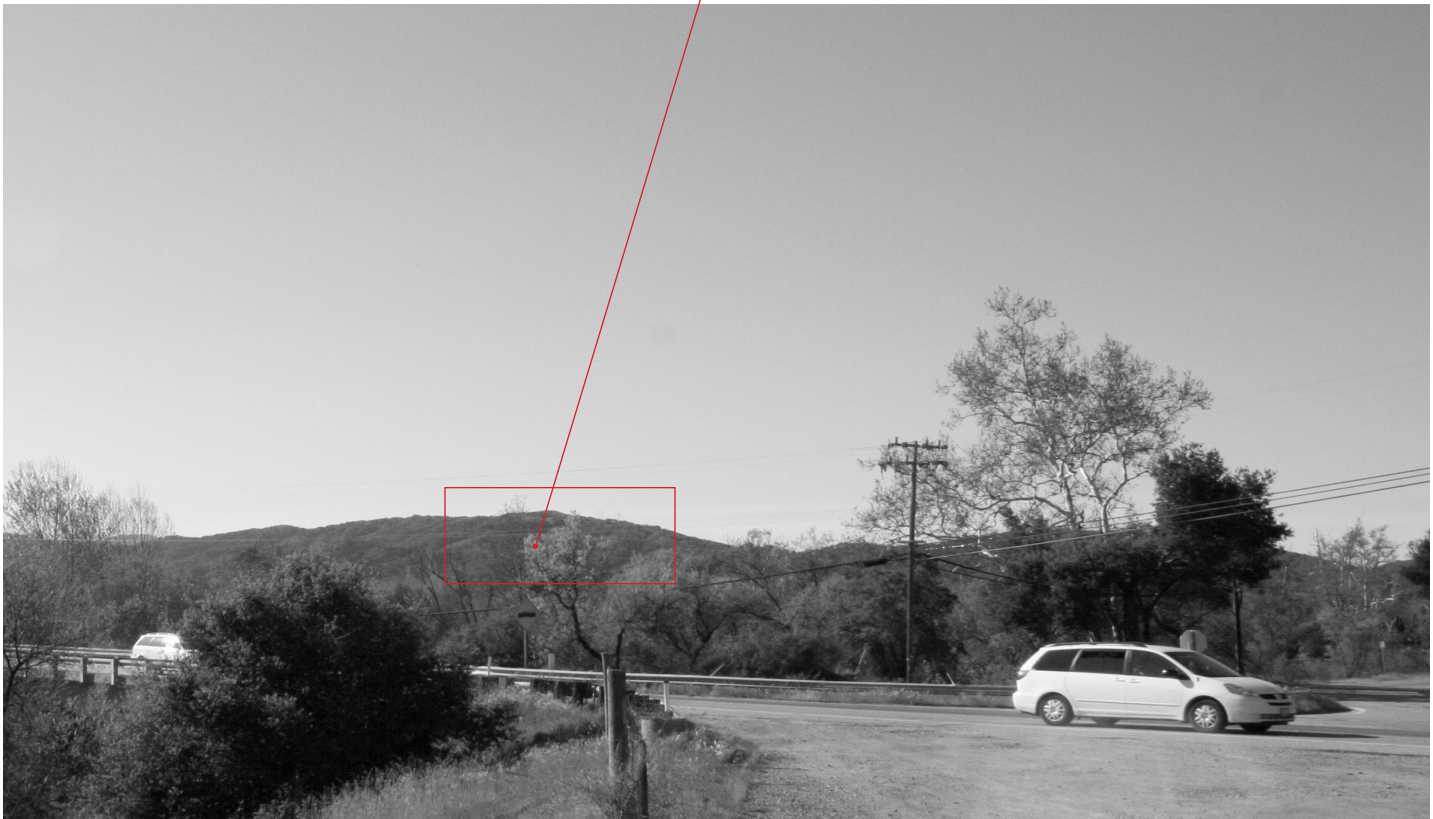
Figure 4.29. Renowned local painter/photographer Andrew P. Hill probably took the 1894 picture looking upstream from a gravel bar on Uvas Creek, titled "Twin Bridges from creek bed — 1894" (B). The image shows the large mid-channel sand and gravel bar, two main channels, and pair of bridges (illustrated in fig. 4.28). Several sycamores and other riparian trees, and large freshly scoured gravel surfaces, can be seen. (A horse and carriage heading west from the bridge are obscured by the tree on the right.) Precise re-occupation of the site is difficult because of the great expansion of vegetation in the channel

in the century since the photograph was taken (A), and also in the decade since (C). In addition, the right-hand margin of the channel has been filled (as part of modern bridge construction) so the original creek bed location of the photographer is now dry landfill. In concert with fig. 4.28, this unusually well-documented location illustrates the common trajectory of braided streams within the region, including channel narrowing, loss of fresh gravel surfaces, and riparian habitat conversion (A: courtesy of Matt Kondolf; B: Unknown 1894a, courtesy of Matt Kondolf and the Gilroy Museum).

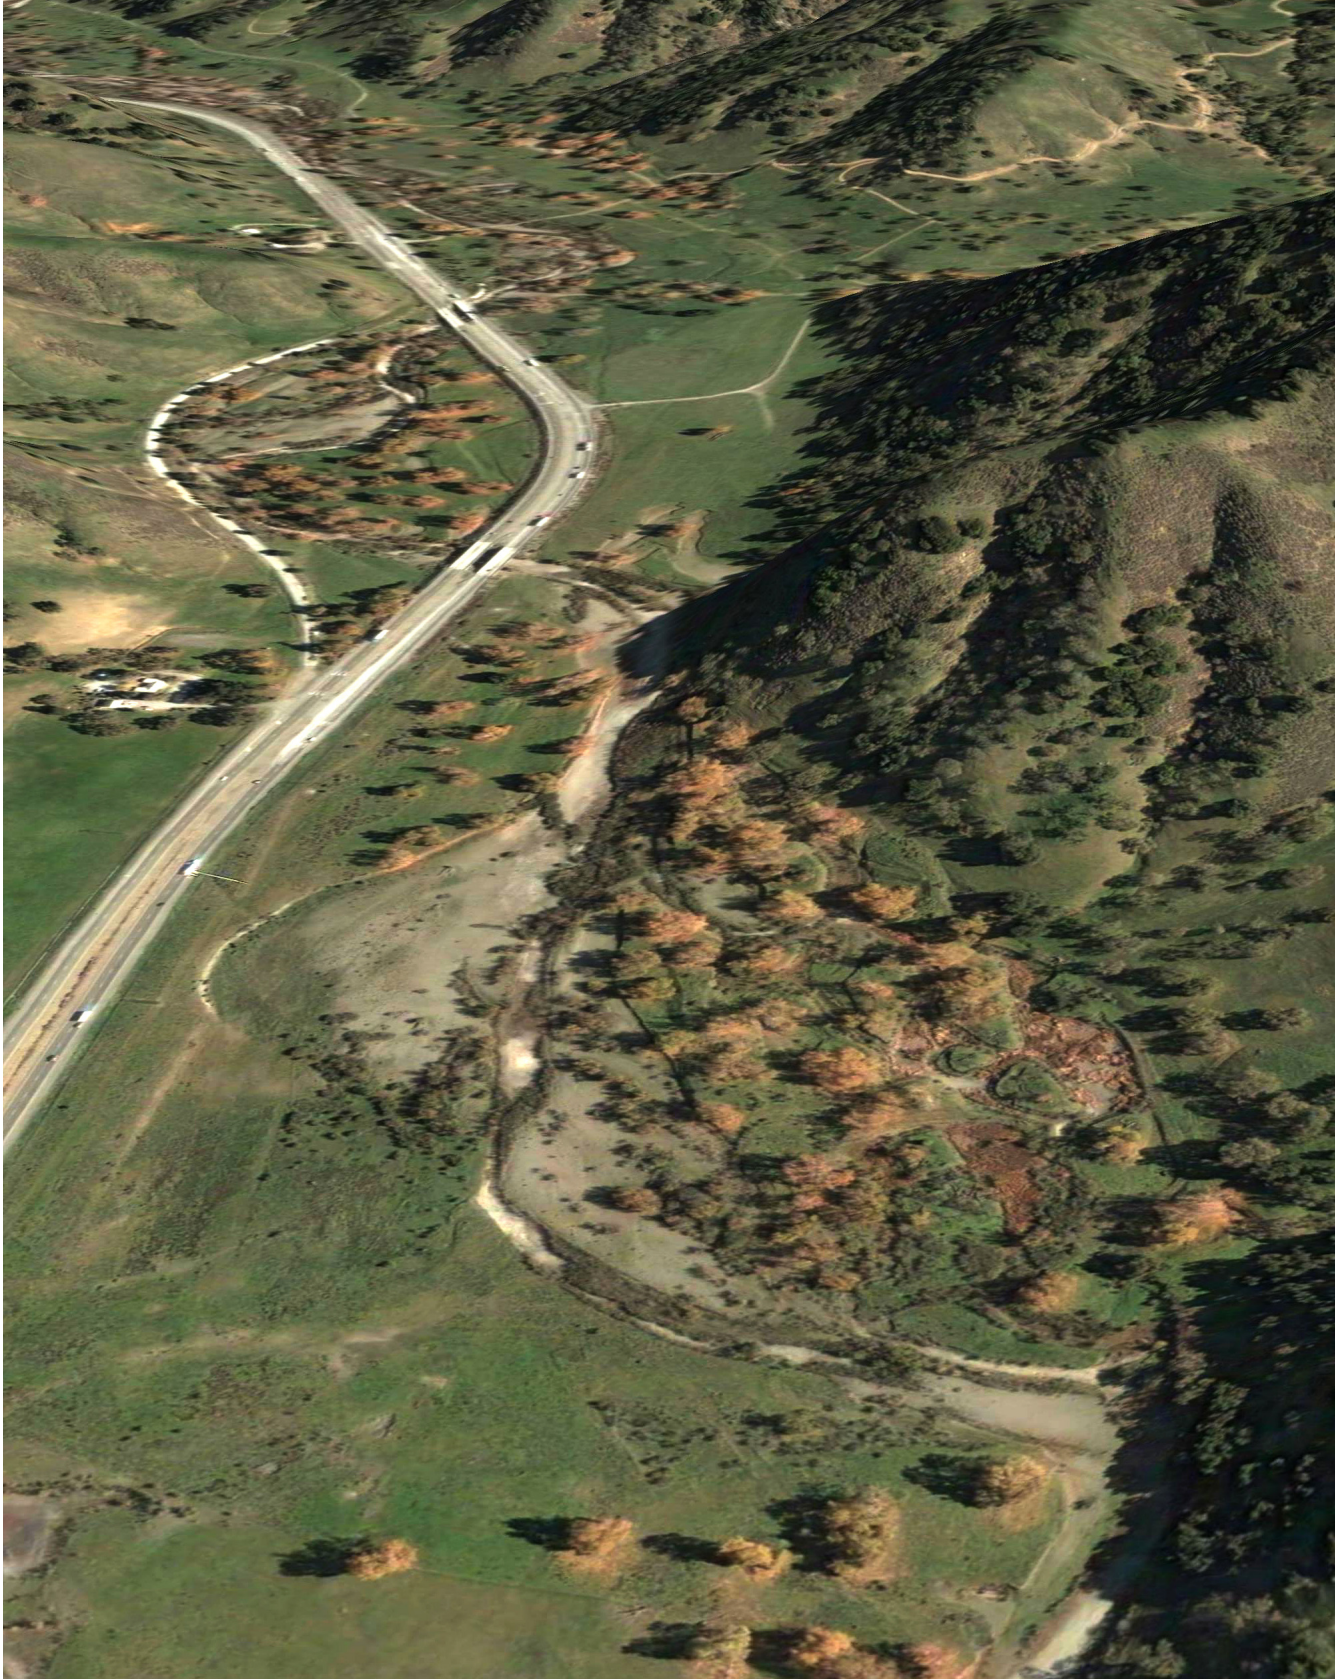
Figure 4.30. California sycamores along Pacheco Creek are particularly distinct in this Google Earth image. While the deciduous sycamores are in fall color, evergreen live oaks on the hillsides remain green. (Courtesy of Google)

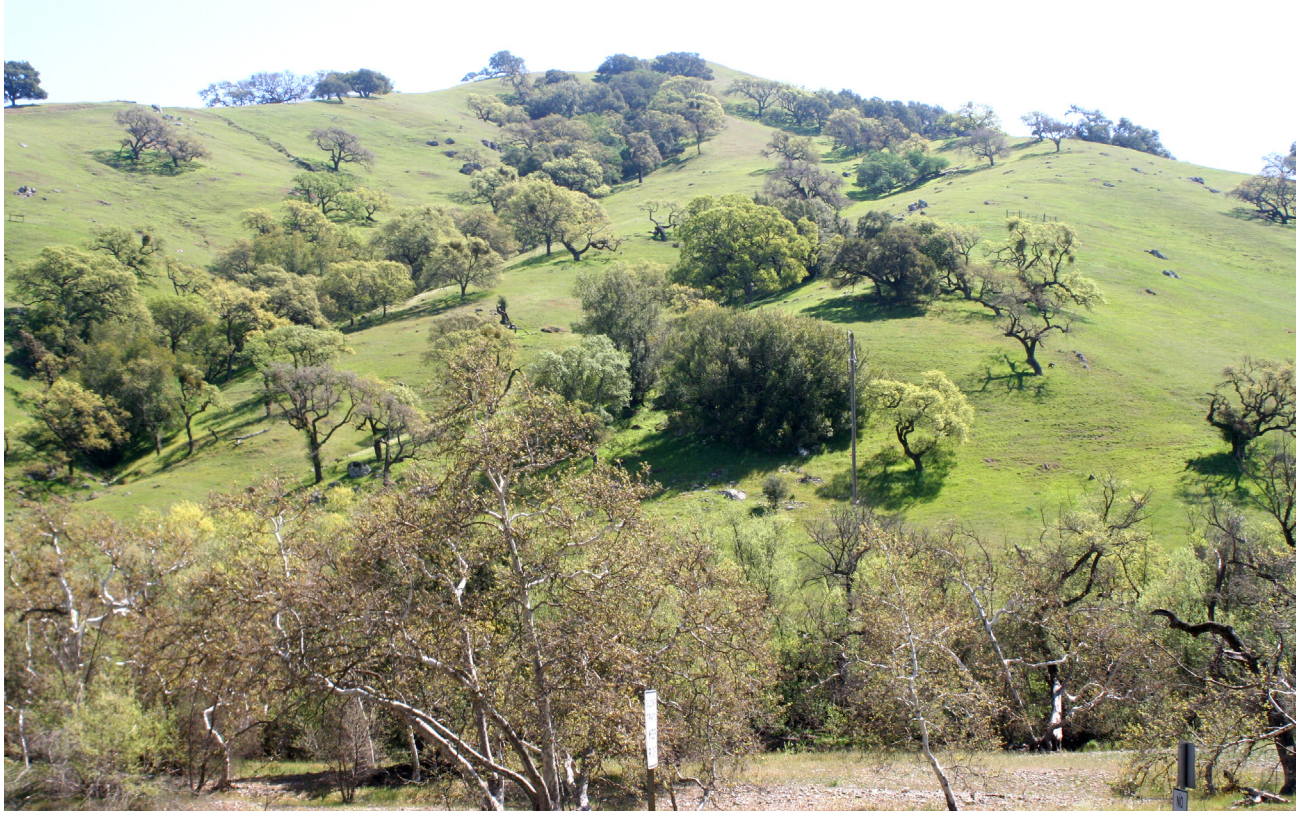
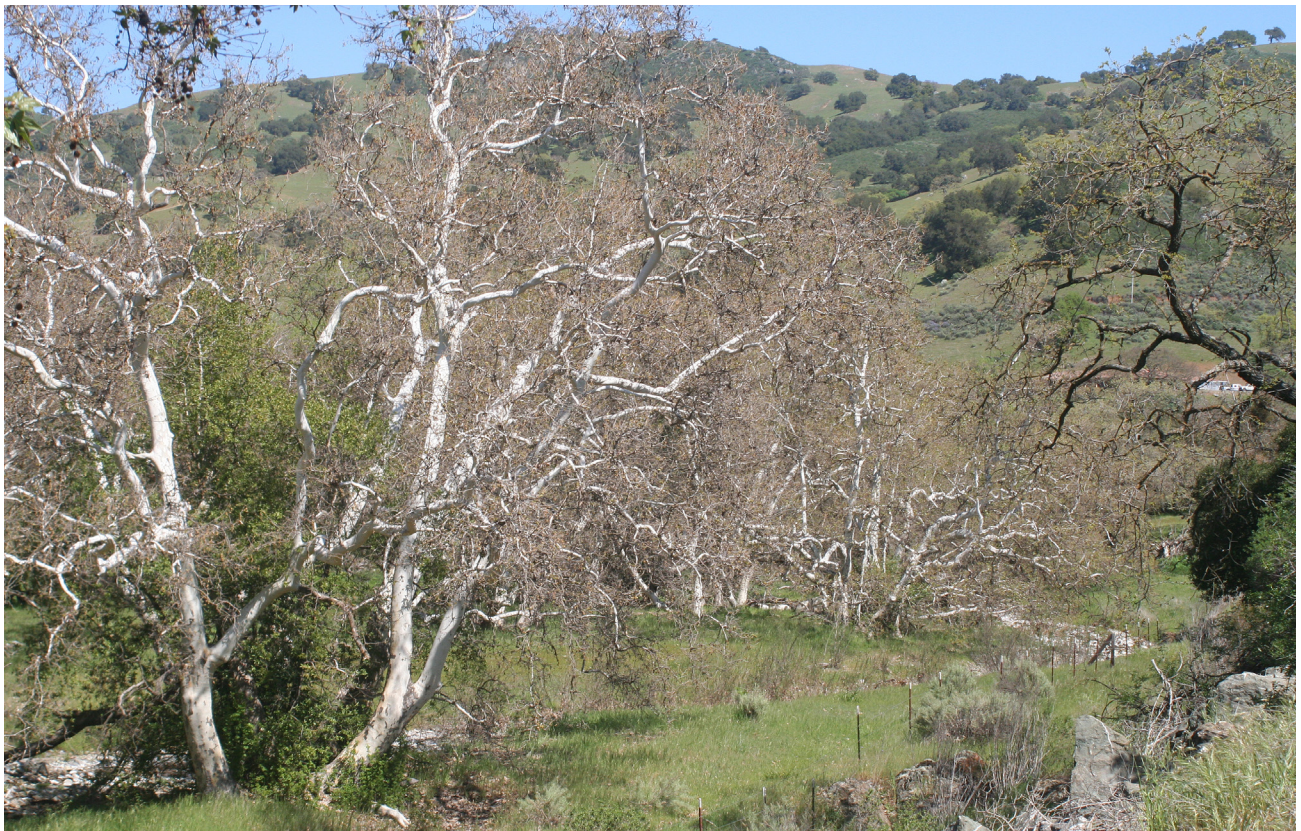
Figure 4.31. The relationship between sycamores and low-elevation, frequently scoured channel surfaces can be seen on Pacheco Creek just downstream from the North Fork Pacheco Reservoir.

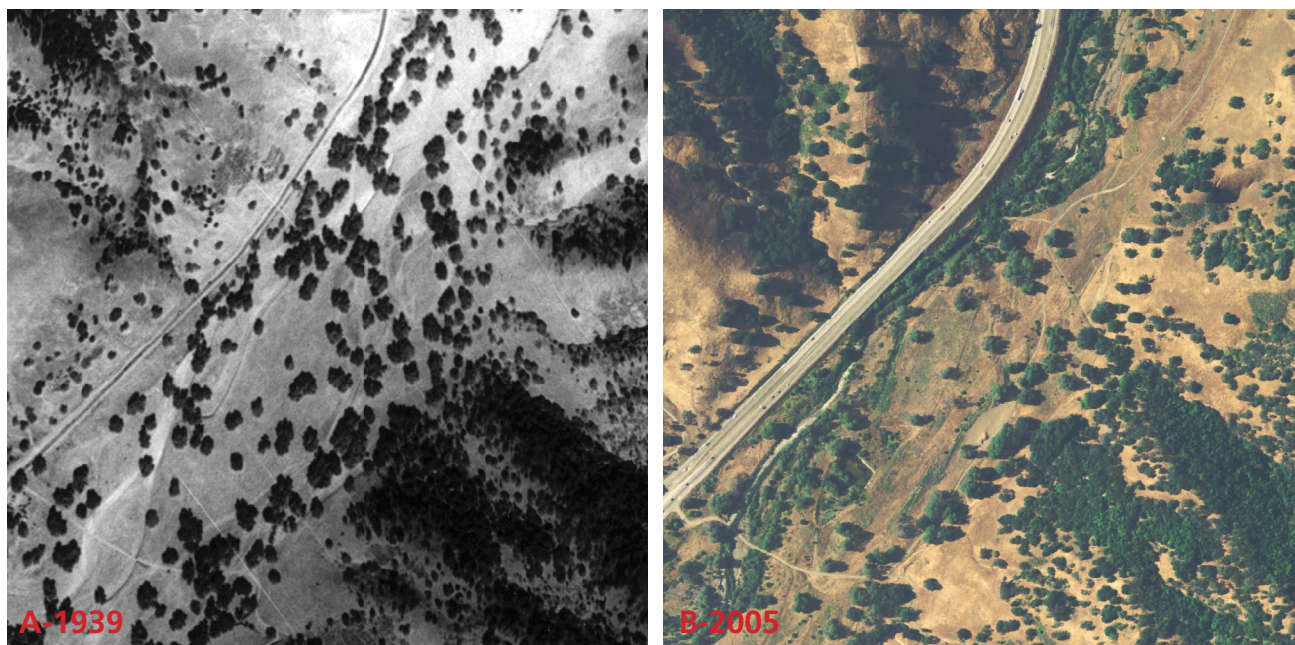
Figure 4.32. Several changes can be observed in these images of sycamore alluvial woodland on Pacheco Creek along Highway 152. In the contemporary image (B), there are fewer sycamores, less evidence for active side channels and floodplain scouring, and more riparian growth immediately along the low flow channel than in the historical image (A). (A: USDA 1939, courtesy of the Science & Engineering Library Map Room, UC Santa Cruz; B: USDA 2005, courtesy of NAIP)

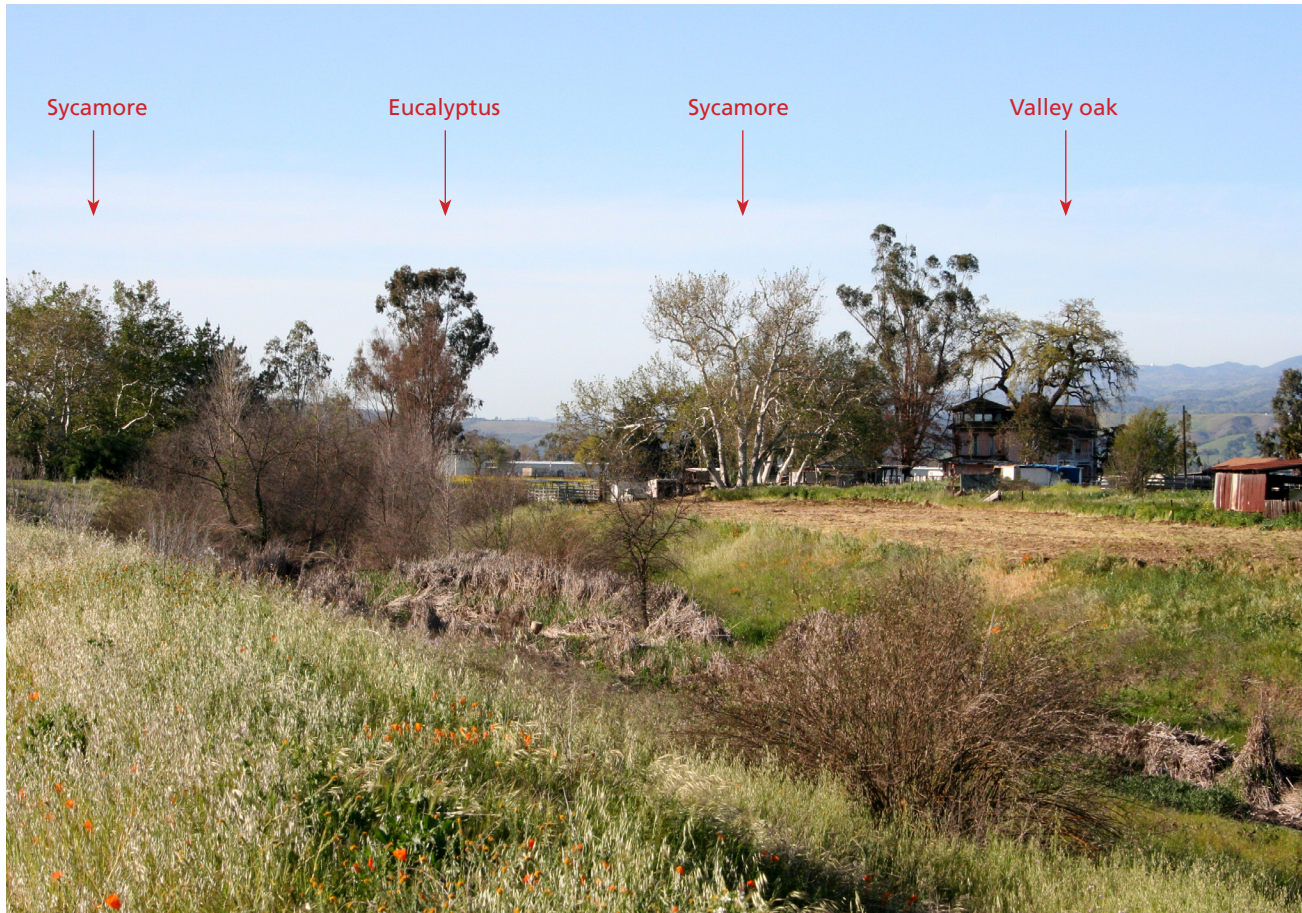
Figure 4.33. Llagas Creek between Highway 101 and Pacheco Pass Road is a narrow, excavated channel that nevertheless mostly follows its historical course. As a result, mature California sycamores and other riparian trees are frequently found alongside the channel on former bars, terraces, and banks of the historical channel. This pattern can be seen here near the Church Street percolation ponds. Eucalyptus trees are a common component of the new channel banks, dominant in places. A remnant tree of the adjacent valley oak savanna can be seen on the right.
