Coyote Creek Watershed Reassessment 2020:

10-Year Reassessment of the Ecological Condition of Streams
Applying the California Rapid Assessment Method

*Technical Report prepared for the Santa Clara Valley Water District (Valley Water)
Safe, Clean Water and Natural Flood Protection Program,
Priority D, Project D5: Ecological Data Collection and Analysis*

Valley Water Agreement #A4077F (CAS# 4802)
SFEI- ASC Project #8727.01
SFEI Contribution #1043
AUGUST 2021

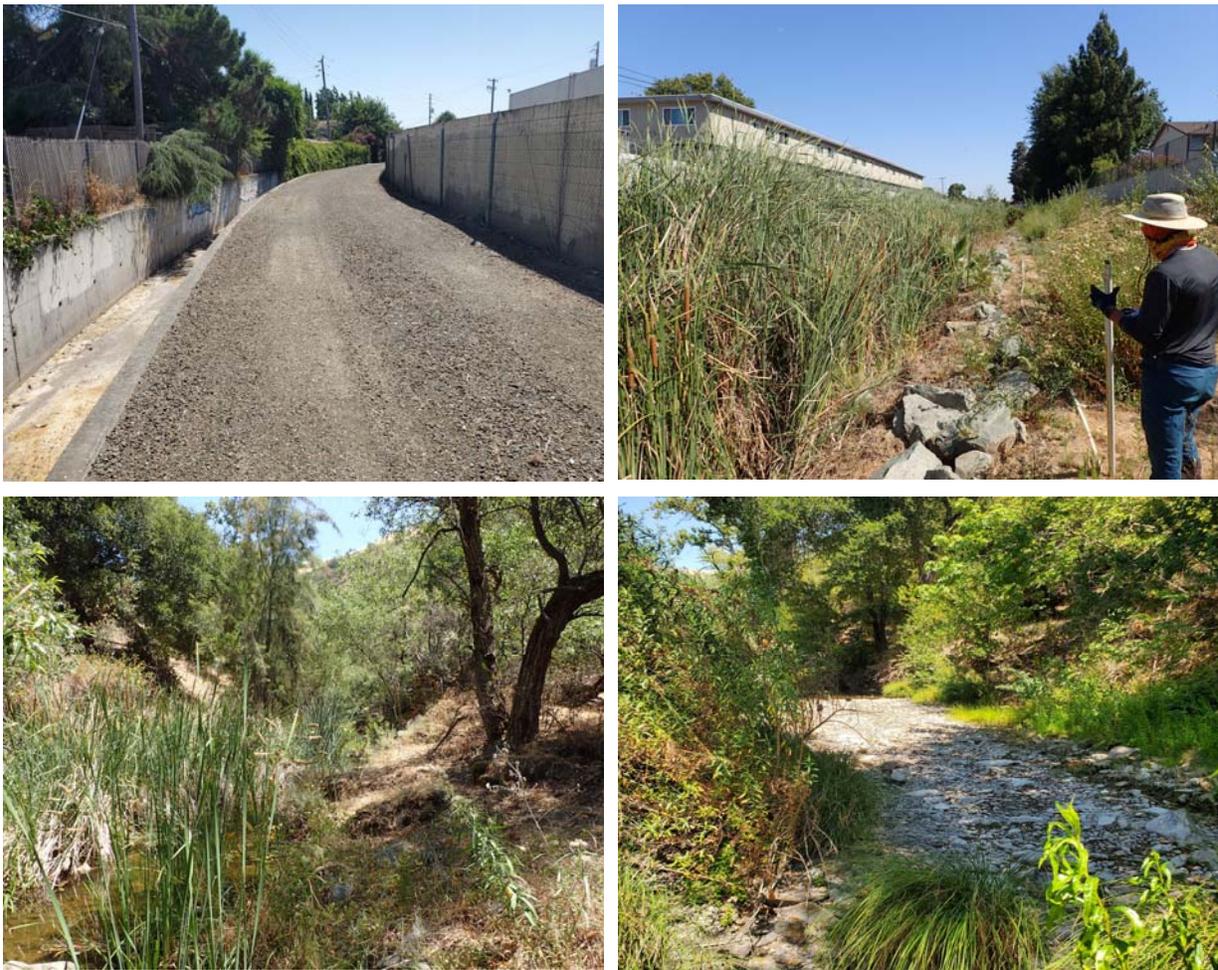
Figure 20. Examples of different stream reaches within the Valley PAI of the Coyote Creek watershed show a range of ecological conditions (from poor to very good) based on CRAM. Upper left: COY-085 (2020 Index Score = 31) Upper right: COY-090 (2020 Index Score = 55) Lower left: UP-186 (2020 Index Score = 73) Lower right: COY-026 (2020 Index Score = 94)

space, invasive vegetation species, stormwater impacts on the hydrograph, and unhoused populations living in the channel also affect channel form and function. The bar charts and CDF for this PAI shows only 22% of the stream miles in the Valley PAI are in good condition with 58% in fair condition and 20% in poor condition. Compared to the Hills CDF, the Valley CDF is shifted to the left and statistically separate, indicating worse overall condition (Figure 17.B). In addition, the Valley CDF curve is a straighter, relatively consistent slope upward, reflecting a wide range of ecological conditions across the PAI from poor to very good conditions (Index Scores ranged between 31 and 94). Figure 20 shows photographic examples of the full range of CRAM condition scores in the Valley PAI.
