FINAL REPORT

COYOTE CREEK WATERSHED HISTORICAL ECOLOGY STUDY

HISTORICAL CONDITION, LANDSCAPE CHANGE, AND RESTORATION POTENTIAL IN THE EASTERN SANTA CLARA VALLEY, CALIFORNIA

SAN FRANCISCO ESTUARY INSTITUTE

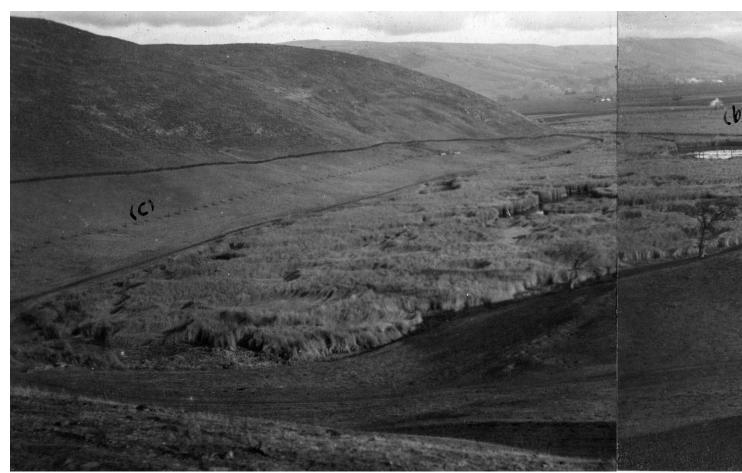
LAGUNA SECA, 1916. Looking southeast across the northern end of the *laguna*: tall tules, open water ponds, Tulare Hill at left (letters on photographs refer to photographer's notes; red circle at extreme left in Laguna Seca map series above shows photographer location).

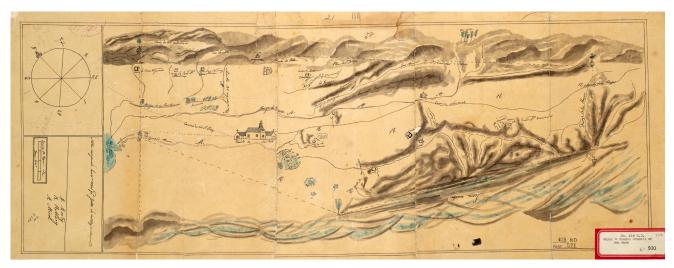
US District Court, Northern District [184-?]a. Land Case Map E-900. Courtesy The Bancroft Library, UC Berkeley.

As the Mission system disintegrated, influential Mexican citizens submitted claims to the government for land grants. The accompanying sketches of desired land, generally produced by anonymous, untrained men, show distinctive features of the land such as creeks, wetlands, and woods, often with watercolors, handwritten annotation, and varying systems of symbols and styles. Despite their substantial infomation content, they have been rarely used for environmental research.

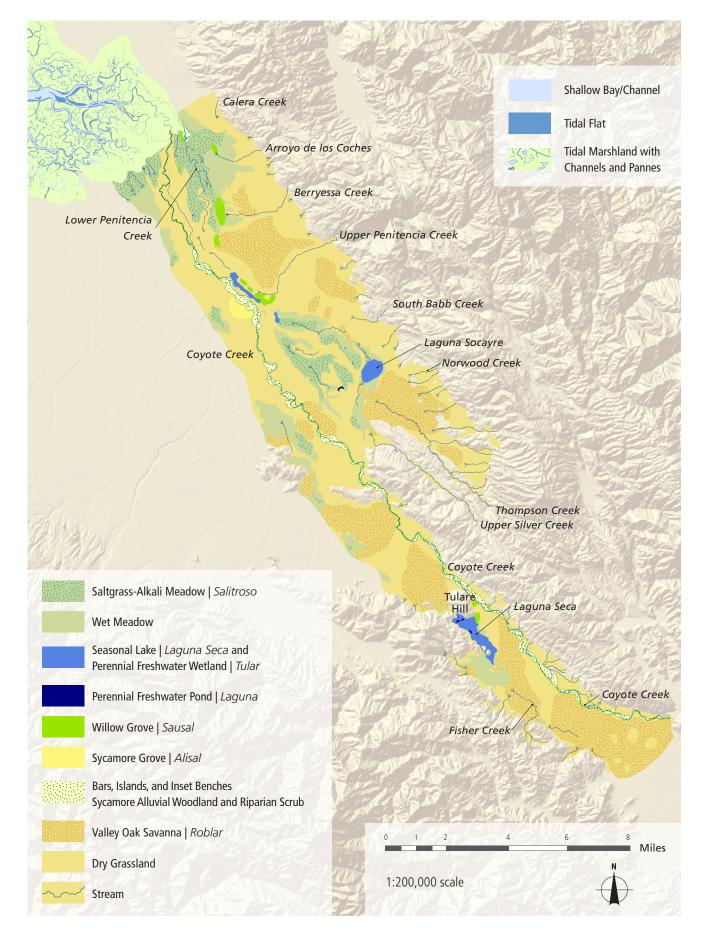
FIGURE II-2. HISTORICAL LANDSCAPE PATTERNS ALONG COYOTE CREEK. This composite map based on numerous historical data sources illustrates prevailing habitat conditions during initial Euro-American settlement, circa 1769-1850. The certainty level varies among features; valley oak savanna is a preliminary estimate. More information is available in the project GIS.

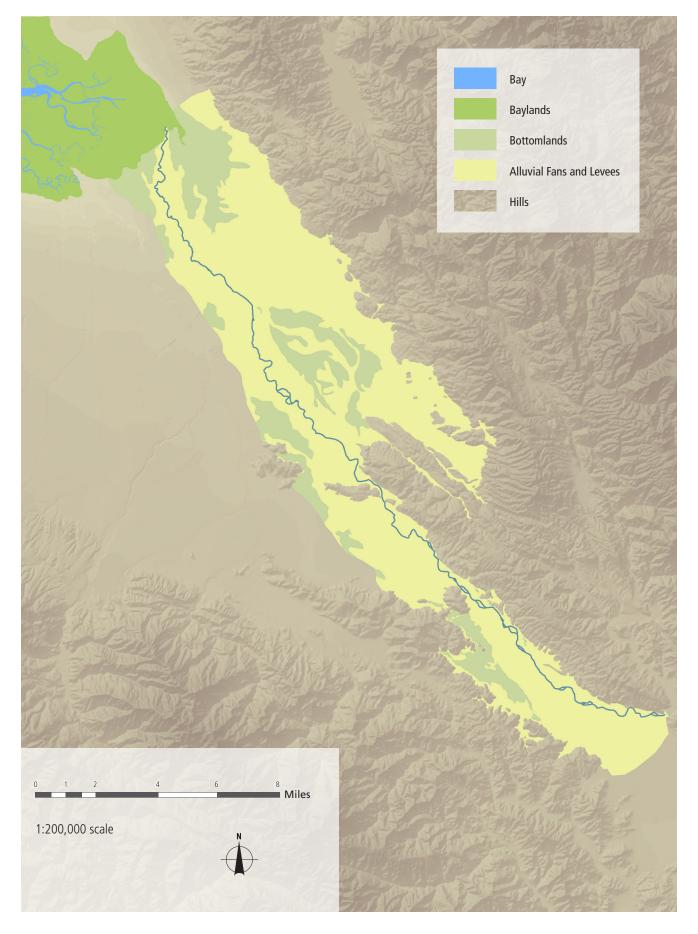
FIGURE II-5. LANDSCAPE TYPES characterizing the valley floor along Coyote Creek. Hills are bordered by alluvial fans (except where runoff is insignificant off small hills and no alluvial fan exists). The fans and levees form higher ground around the bottomlands. Bottomlands merge into the Baylands at the northernmost part of the Valley, while the Bay extends toward land through tidal sloughs.

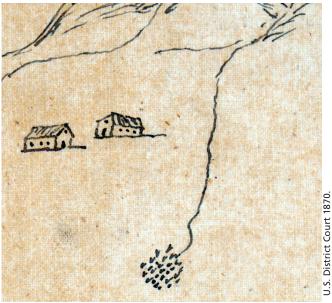
FIGURE II-12. DEPICTIONS OF WILLOW GROVES DOWNSTREAM OF UPPER PENITENCIA CREEK (top three images) and BERRYESSA CREEK (lower image) in early Spanish and American maps (courtesy Santa Clara County Surveyors Office (top two maps), and The Bancroft Library, UC Berkeley).

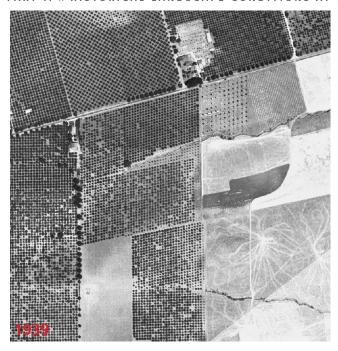
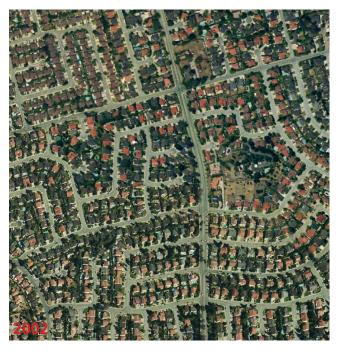
FIGURE II-13. THE LOWEST NATURAL REACHES OF NORWOOD CREEK, 1939 (LEFT) AND 2002 (RIGHT). The creeks flow right to left; Norwood Creek is above, an unnamed smaller creek is below. Spiderlike cow path patterns can be seen in the grazed area at lower right. Norwood and Ruby Avenues intersect at upper middle (AAA 1939; 2002 imagery copyright 2005 AirPhotoUSA, LLC, All Rights Reserved).

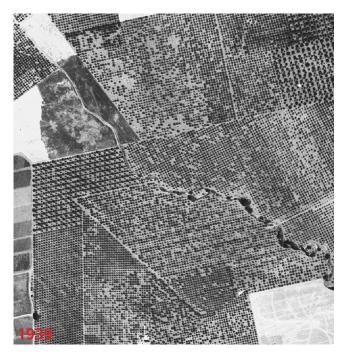
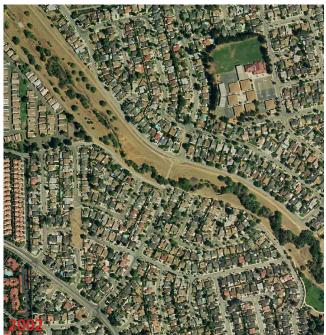
FIGURE II-14. THOMPSON CREEK IN 1939 (LEFT) AND 2002 (RIGHT). Thompson Creek flows to the northwest here, immediately downstream of Aborn Road. Note expansion of riparian vegetation (AAA 1939; 2002 imagery copyright 2005 AirPhotoUSA, LLC, All Rights Reserved).

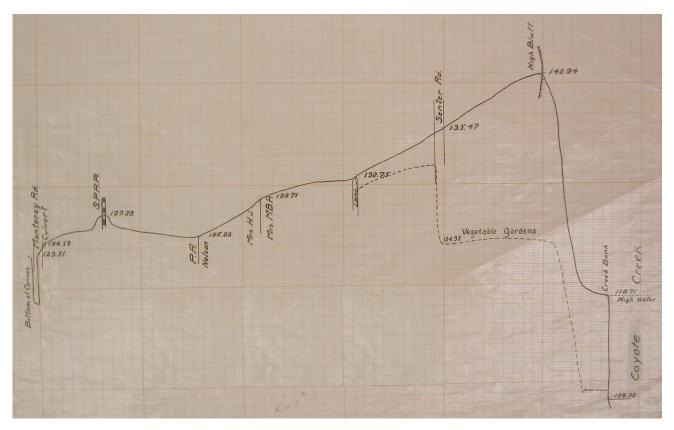
FIGURE II-17. "PROFILE [OF] PHELAN AVENUE FROM MONTEREY RD. TO COYOTE CREEK. MARCH 29, 1907." This county survey illustrates the natural levee along Coyote Creek ("High Bluff") and an inset bench with "Vegetable Gardens." The creek curves abruptly here, so the surveyor depicted two, adjacent sections of the stream bank (Hermann (?) 1907, courtesy Santa Clara County Surveyors Office).

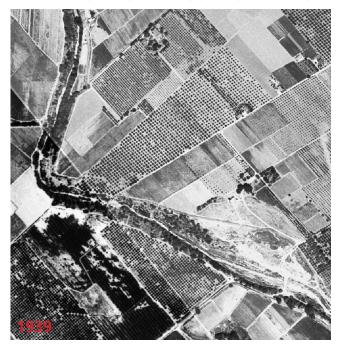
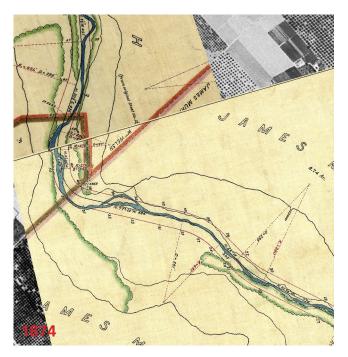
FIGURE II-19. COYOTE CREEK AT HIGHWAY 880: 1874 (LOWER LEFT), 1939 (UPPER LEFT), AND 2002 (RIGHT). Change in this reaches been extensive. In 1874, Hermann's Coyote River Survey documented a narrow main channel with some linear riparian habitat and broad adjacent benches partly occupied by willow thickets (his field notes indicate the tree species). By 1939, much of the former active channel area is occupied by agriculture, although the location of the willows and parts of the adjacent bars or benches can still be identified. The 1972 flood control project removed the channel's sharp turn; the banks have since been colonized by riparian vegetation (AAA 1939; 2002 imagery copyright 2005 AirPhotoUSA, LLC, All Rights Reserved; Herrmann 1874c).

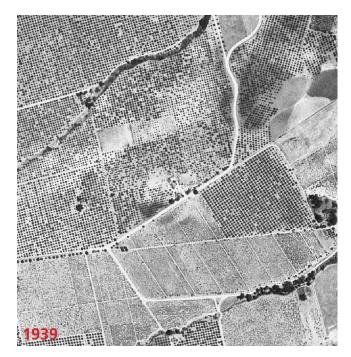
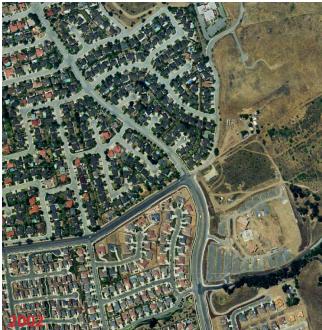
FIGURE II-20. QUIMBY CREEK AT THE BASE OF THE FOOTHILLS IN 1939 (LEFT) AND 2002 (RIGHT). Downstream extent of visible riparian vegetation in 1939 is similar on Quimby Creek (image lower right), the unnamed creek to the north, and other nearby systems. By 2002, the creek to the north is no longer aboveground and riparian vegetation has expanded on the remaining portion of Quimby Creek. Chaboya Road runs through the middle of both images (AAA 1939; 2002 imagery copyright 2005 AirPhotoUSA, LLC, All Rights Reserved).

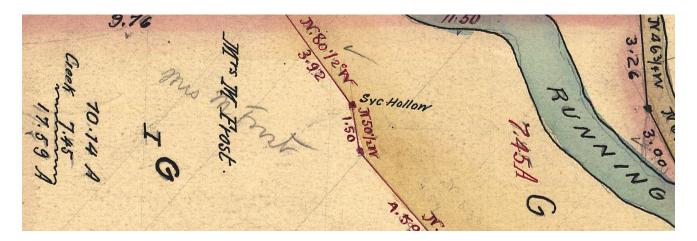
FIGURE II-22. SYCAMORE BEARING TREE ON A HERRMANN SURVEY ("Syc Hollow"; Herrmann 1874a, courtesy Santa Clara County Surveyors Office).

Following Coyote Creek — the western boundary of Rancho Yerba Buena — on consecutive GLO surveys, Wallace (1858: 429) and Tracy & Healy (1860-1863: 432) both recorded "[T]hree large sycamores in middle of creek," and Healy also notes a six-foot diameter sycamore bearing tree (a witness tree that was "notched" or "blazed" by the surveyor to facilitate relocation of the survey). These observations can be mapped precisely to the areas alongside present-day Cottonwood Lake, just downstream of the Highway 101 crossing, which show scattered trees in a wide, scoured, mostly unvegetated channel in 1939 (see FIG-URE III-20). Along the long Yerba Buena border, following the creek from Tully Road to Coyote Narrows, the only other trees recorded are another sycamore and two live oaks. Of the oaks, one is located at The

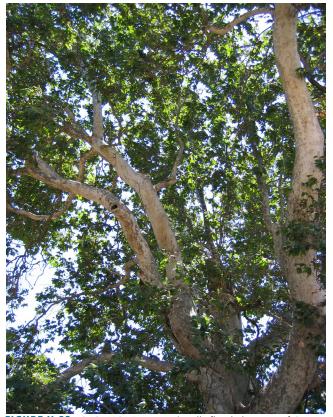
FIGURE II-23. SYCAMORE on occasionally flooded terrace of Coyote Creek, near Coyote Creek Golf Club.

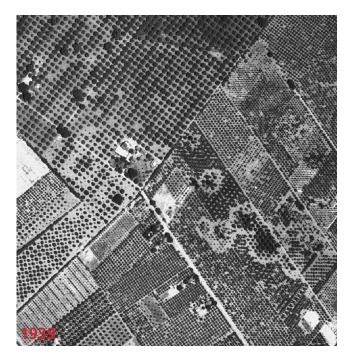
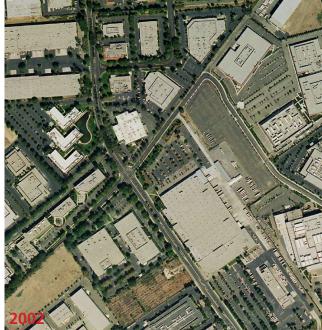
FIGURE II-24. EARLY AERIAL PHOTOGRAPHIC EVIDENCE FOR VALLEY OAK SAVANNA. Several large trees scattered within the orchard at upper left in the 1939 image (left image) are probably valley oaks. Additionally, the circular disease patterns visible at center right indicate the probable location of valley oaks recently removed for orchard planting, whose roots have caused oak root rot. There are no obvious residual trees in 2002 (right image) (AAA 1939; 2002 imagery copyright 2005 AirPhotoUSA, LLC, All Rights Reserved).

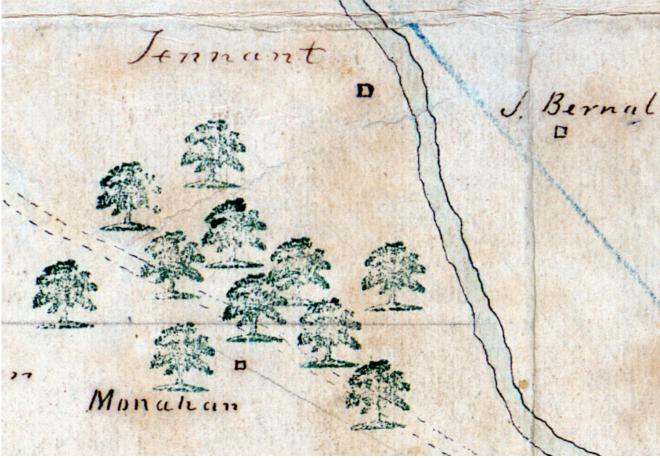
FIGURE II-25. DEPICTIONS OF VALLEY OAK SAVANNA using a tree stamp and text (lower right) (Healy, U.S. Dist. Court 1859, courtesy The Bancroft Library, UC Berkeley).

On Spanish maps, *roblar* is represented by various methods: numerous, individually drawn trees, the use of an oak tree "stamp," the word itself sometimes with additional spatial information (e.g. "*punto del roblar*", point of the oak grove), or, simply, the letter "R" (FIG-URE II-25).

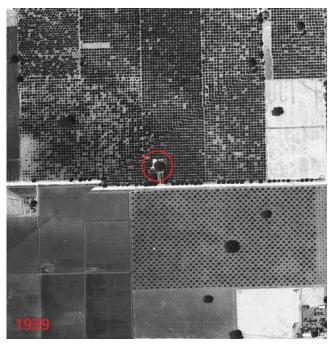
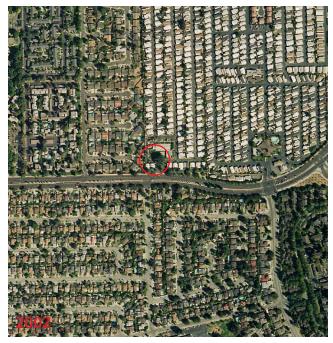
FIGURE II-27. BLOSSOM HILL ROAD IN 1939 (LEFT) AND 2002 (RIGHT). Aerial photographic overlay allows the identification of at least one persisting, heritage oak tree, shown in FIGURE II-28 (AAA 1939; 2002 imagery copyright 2005 AirPhotoUSA, LLC, All Rights Reserved).

cordingly, a surprising number of trees have persisted in yards and along roads, preserving portions of the *roblars* that intersected fortuitously with the rectilinear division and development of the alluvial fans (FIGURES II-27 and II-28).

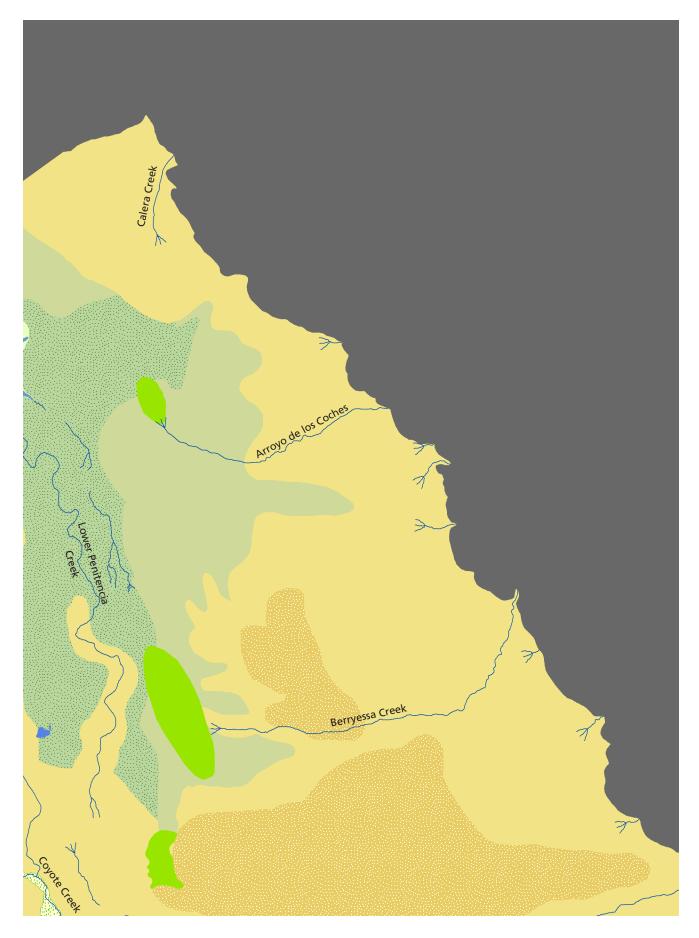
MAP 1B-CA.1800. LANDSCAPE FEATURES DURING INITIAL EURO-AMERICAN SETTLEMENT, CIRCA 1769-1850. Certainty level varies among features; valley oak savanna is a preliminary estimate. More information is available in the project GIS (scale 1:40,000; 1"~3300'; 1 square inch ~250 acres). See inside front cover for map legend.

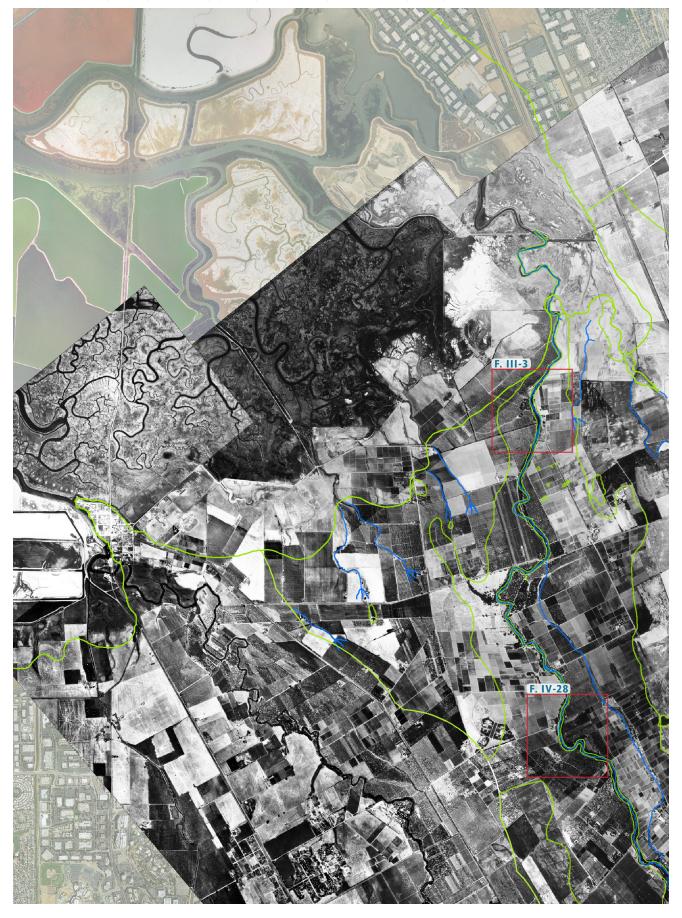
MAP 1A-1939. PHOTOMOSAIC OF EARLY AERIAL IMAGERY, WITH HISTORICAL LANDSCAPE FEATURES OVERLAY. Historical fluvial features in blue; other features, green; project boundary, white (scale 1:40,000; 1"~3300'; 1 square inch ~250 acres; original photographs courtesy SCVWD, USGS Menlo Park, and UC Santa Cruz, UC Santa Barbara, and UC Berkeley).

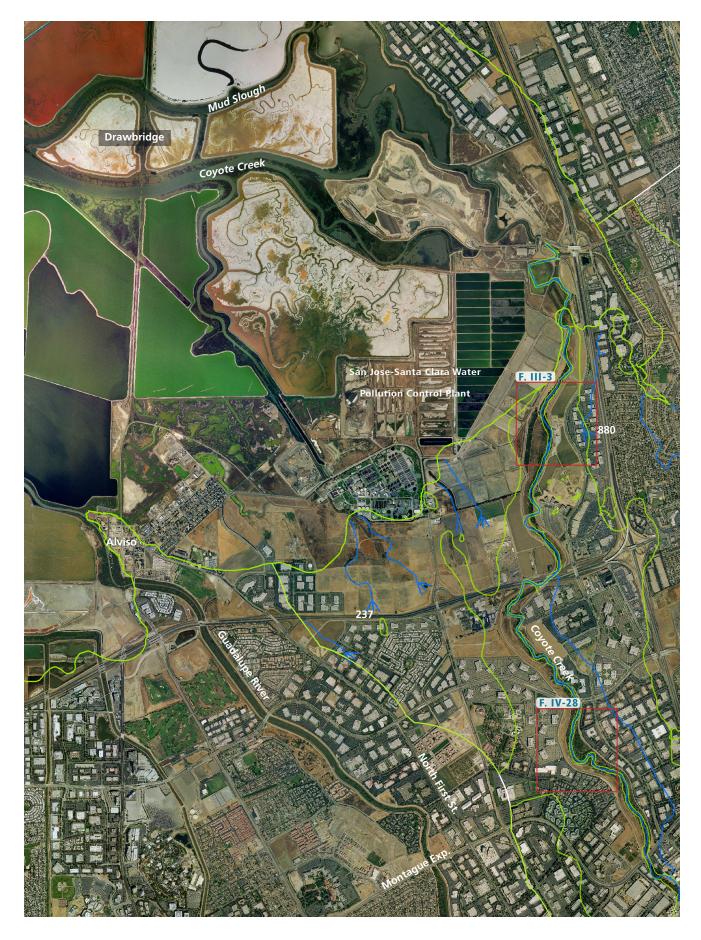
MAP 1A-2002. MODERN AERIAL IMAGERY, WITH HISTORICAL LANDSCAPE FEATURES OVERLAY. Historical fluvial features in blue; other features, green; project boundary, white (scale 1:40,000; 1"~3300'; Imagery Copyright 2005 AirPhotoUSA, LLC, All Rights Reserved).

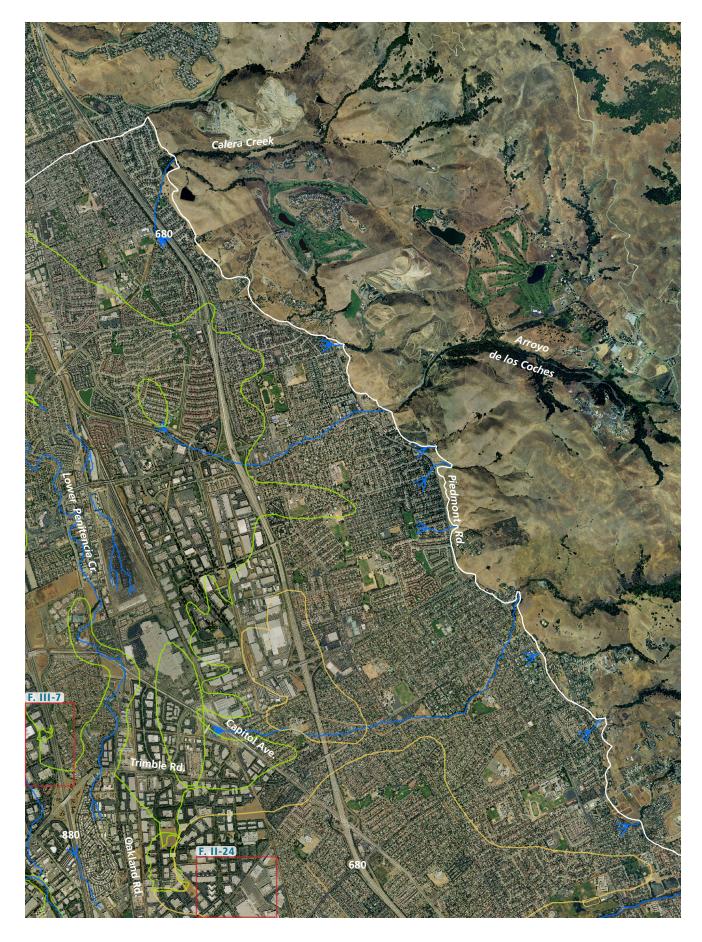
MAP 1B-2002. MODERN AERIAL IMAGERY, WITH HISTORICAL LANDSCAPE FEATURES OVERLAY. Historical fluvial features in blue; other features, green; project boundary, white (scale 1:40,000; 1"~3300'; Imagery Copyright 2005 AirPhotoUSA, LLC, All Rights Reserved).

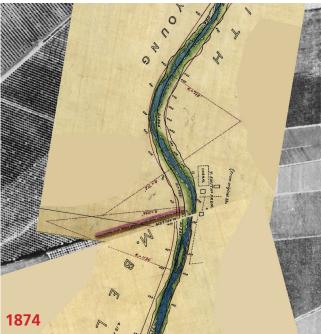
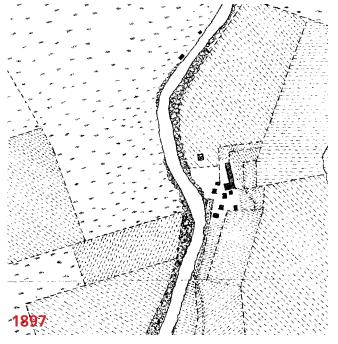
FIGURE III-3. SEQUENTIAL IMAGES OF LOWER COYOTE CREEK ADJACENT TO THE PRESENT-DAY SAN JOSE-SANTA CLARA WATER POLLUTION CONTROL PLANT. These data illustrate conditions in 1874 (lower left, Herrmann 1874, courtesy Santa Clara County Surveyors Office), 1897 (lower right, Westdahl & Morse 1896-97, courtesy National Ocean Service), 1939 (upper left; AAA 1939), and 2002 (upper right; Imagery Copyright 2005 AirPhotoUSA, LLC, All Rights Reserved). These views indicate a nearly continuous, narrow riparian corridor that has persisted through time, with some expansion in recent decades. This reach is also the likely location for the following landscape photographs by Hare circa 1905 (FIGURE III-4).

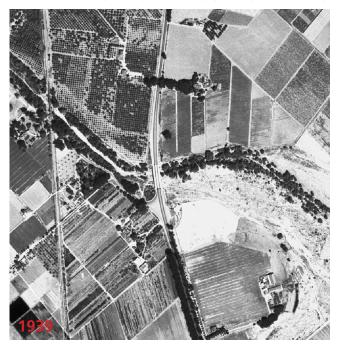
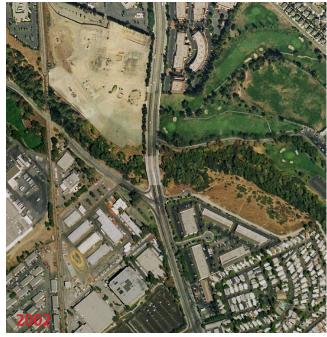
FIGURE III-10. COYOTE CREEK AT OAKLAND ROAD IN 1939 (LEFT) AND 2002 (RIGHT). Long-standing crossings such as Oakland Road (center, running north-south in each image) and the Southern Pacific Railroad (left side) were established at this short, naturally narrow reach. On the right side of the 1939 image (AAA 1939), a broad active channel area can be seen in the form of scour patterns and unvegetated areas excluding agriculture. These stream benches are now occupied primarily by the South Bay Mobile Home Park, which has been subject to flooding, the San Jose Golf Course, and the North Coyote Park (brown area at middle right, 2002 Imagery Copyright 2005 AirPhotoUSA, LLC, All Rights Reserved), which provides some undeveloped floodplain capacity.

In the Mid-Coyote reach, Coyote Creek shifted to a mostly wide, entrenched system with broad flood-prone benches. Wide reaches were interspersed with narrow reaches (FIGURE III-10). This pattern of constriction and expansion significantly shaped transportation patterns on the east side of San Jose, with important crossings associated with the narrow reaches between the S. Pacific Railroad and Oakland

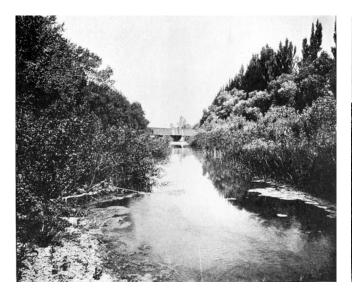
FIGURE III-11. PHOTOGRAPHS OF COYOTE CREEK BETWEEN THE OAKLAND ROAD AND SOUTHERN PACIFIC RAILROAD CROSSINGS, 1896. This pair of photographs shows the dense and tall riparian forest canopy along this relatively narrow channel reach. Even the narrow reaches had significant unvegetated gravel bars and pools. Such a clear view is no longer possible as vegetation has now encroached substantially into the former channel, with some apparent incision (see inset) (Shortridge 1896: 20,174, courtesy History San José).

Road (FIGURE III-11). and between Julian Street and San Antonio Street. Agriculture and garbage dumps encroached upon the stream benches, then commercial development and other uses – but little housing. Many former dumps are now city parks (FIGURE III-12).

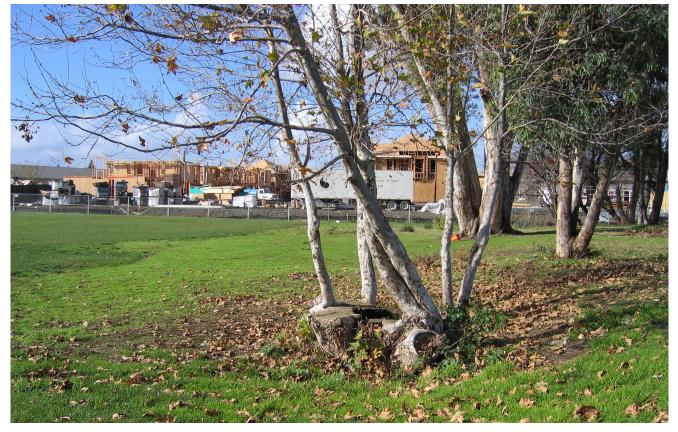
FIGURE III-13. RESIDUAL ELEMENTS OF THE FORMER LOWER PENITENCIA CREEK CHANNEL. Low area through center of photograph indicates historical channel location. A large, historic sycamore has resprouted.

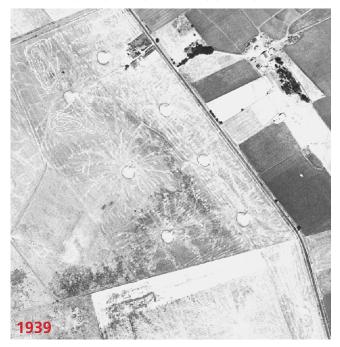
FIGURE III-15. LOCATION OF LAGUNA SOCAYRE AND LAKE CUNNINGHAM IN 1939 (LEFT) AND 2002 (RIGHT). Cow paths mark the unfarmed area of the historical Laguna Socayre in 1939 (AAA 1939). Part of the area has now been excavated to create Lake Cunningham, a stormwater detention basin. Some elements of alkali meadow persist in the fields along the north edge of the lake. A blue circle indicates the location of FIGURE III-16 and red circles locate the images in FIGURE III-17 (2002 Imagery Copyright 2005 AirPhotoUSA, LLC, All Rights Reserved).

These conditions limited agricultural development such that grazing, not orchards, was dominant in the 1930s (FIGURE III-15). As a result, a number of large, institutional land uses currently predominate here, including Reid Hillview Airport, Lake Cunningham, and Pleasant Hills Golf Course — and some wetland features are still apparent. Low areas of the golf course, coinciding with the historical Laguna boundary, form ponds in the winter (FIGURE III-16). Saltgrass meadows with seasonal ponds coexist with grassy fields on the north edge of Lake Cunningham at the exact site of Day's alkaline description 150 years earlier (FIGURE III-17).

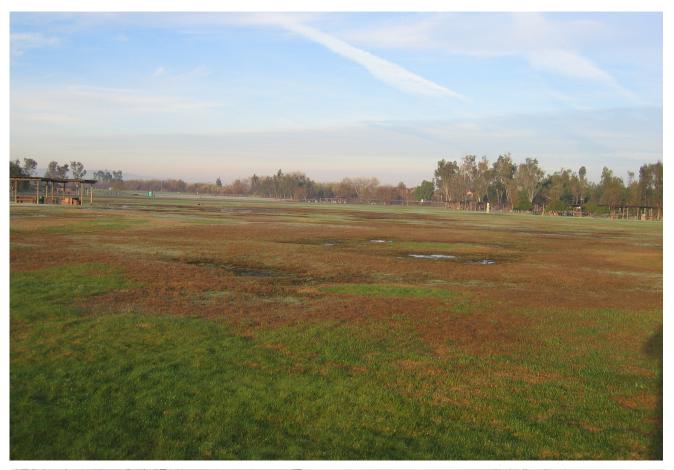
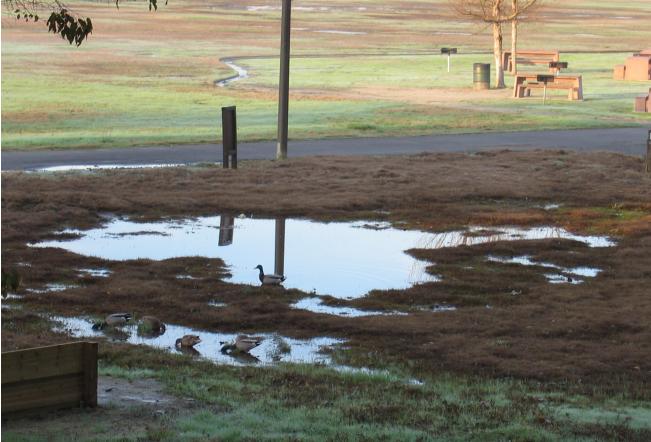
FIGURE III-17. SALTGRASS-ALKALI MEADOW AT LAKE CUNNINGHAM REGIONAL PARK. Reddish-brown areas are predominantly *Distichlis* patches. Scattered ponds form during rainfall events. The lower image shows a well-defined panne with mud bottom and forage for dabbling ducks; other ponds are more temporary.

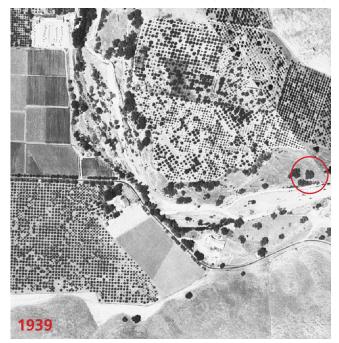
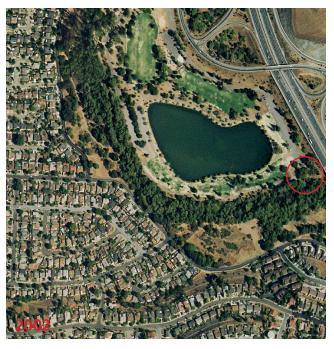
FIGURE III-20. COYOTE CREEK AT COTTONWOOD LAKE IN 1939 (LEFT) AND 2002 (RIGHT). In the earlier image, we can see a wide main channel with little vegetation except for patches of riparian scrub. Larger trees are located on the adjacent stream benches and, in places, there are linear strands of riparian forest along the outer banks of the channel area. The contemporary image shows a more dense and continuous riparian forest. The sycamore shown in FIGURE III-21 is indicated by a red circle in both images (AAA 1939; 2002 Imagery Copyright 2005 AirPhotoUSA, LLC, All Rights Reserved).

Coyote Creek displayed a braided channel pattern throughout this reach. Scattered sycamore trees occupied islands, bars, and benches in the broad channel reaches. Linear strands of riparian forest were occasional on the outer banks of the channel area. FIGURE III-20 shows this riparian pattern along present-day Cottonwood Lake, where surveyors Wallace and Healy reiterated the wide spacing of sycamore trees in the mid-19th century (see PART II, Riparian Habitat), and a few remnant trees can be found presently (FIGURE III-21). Riparian habitat has shifted to a dense forest dominated by cottonwoods.

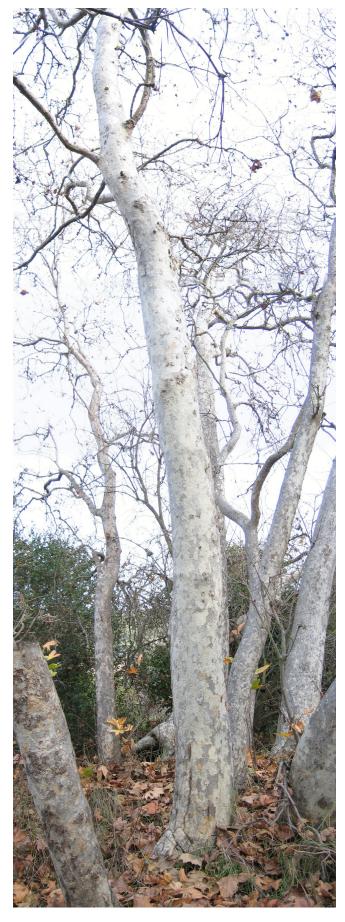
FIGURE III-21. SYCAMORE CIRCLE AT COTTONWOOD LAKE. These trees are sprouts from a giant stump in the center, potentially one of the "large sycamores" reported by Wallace and Healy in 1858-1863 (see page II-42).

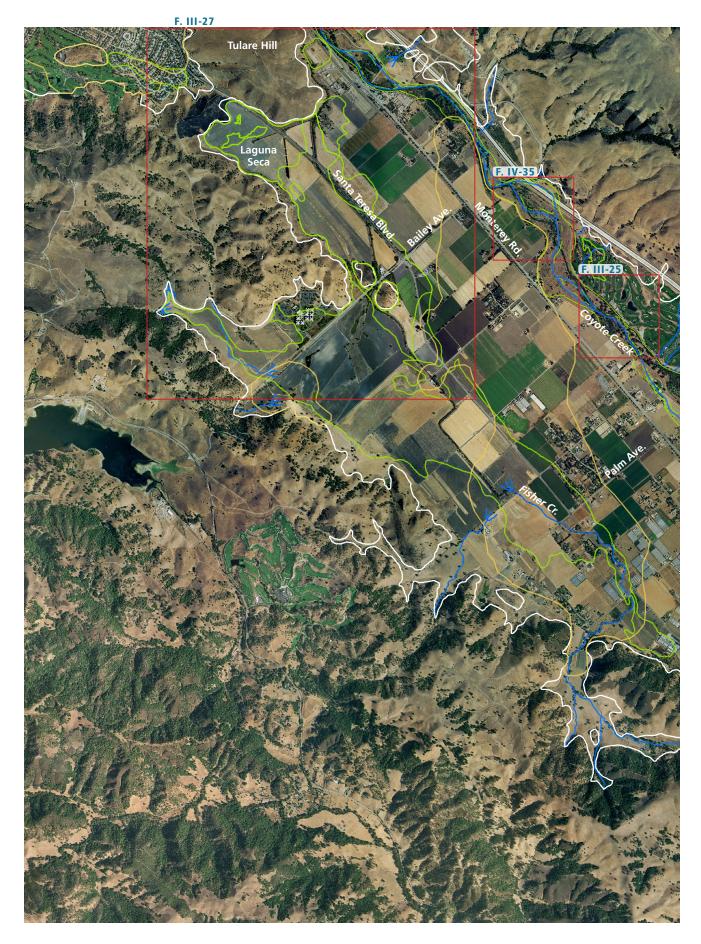
MAP 4A-2002. MODERN AERIAL IMAGERY, WITH HISTORICAL LANDSCAPE FEATURES OVERLAY. Historical fluvial features in blue; other features, green; project boundary, white (scale 1:40,000; 1"~3300'; 1 square inch ~250 acres; Imagery Copyright 2005 AirPhotoUSA, LLC, All Rights Reserved).

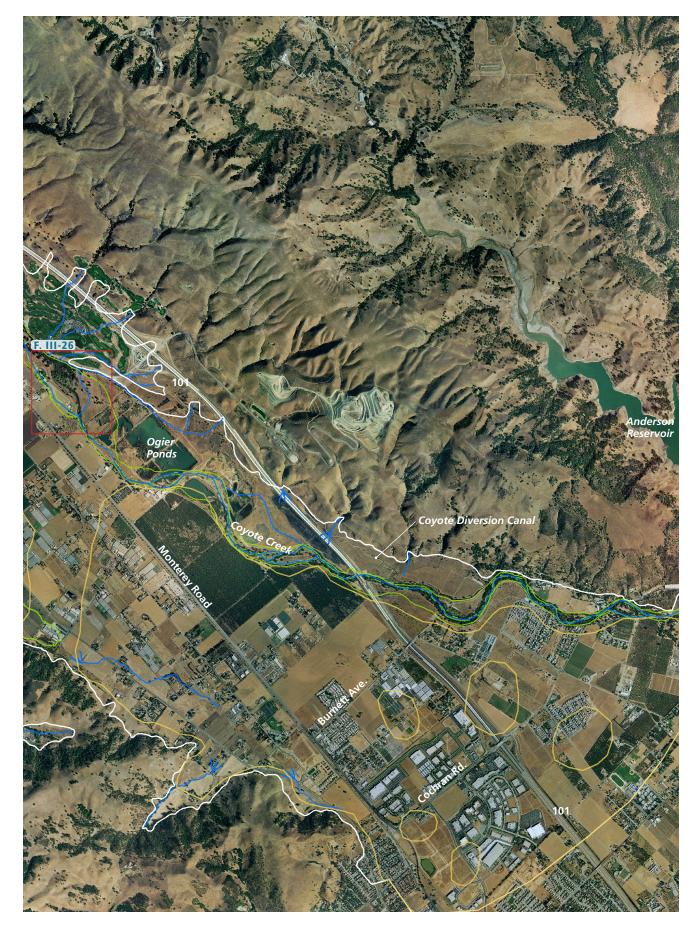
MAP 4B-2002. MODERN AERIAL IMAGERY, WITH HISTORICAL LANDSCAPE FEATURES OVERLAY. Historical fluvial features in blue; other features, green; project boundary, white (scale 1:40,000; 1"~3300'; 1 square inch ~250 acres; Imagery Copyright 2005 AirPhotoUSA, LLC, All Rights Reserved).

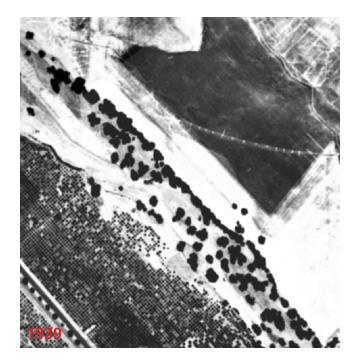
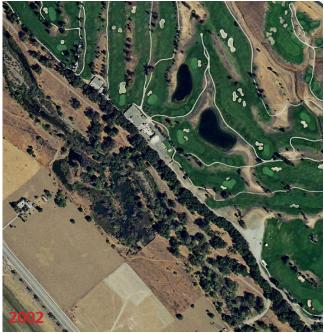
FIGURE III-25. COYOTE CREEK AT THE COYOTE CREEK GOLF CLUB IN 1939 (LEFT) AND 2002 (RIGHT). The 1939 (AAA 1939) image shows several of the common characteristics of the braided Coyote Creek channel historically found from approximately Tully Road to Ogier Ponds/Highway 101 crossing. These include riparian woodland composed of large widely spaced trees; substantial unvegetated, scoured areas; and strands of mixed riparian forest following one of the outer banks. These elements are relatively intact presently, as can be seen in the contemporary image (2002 Imagery Copyright 2005 AirPhotoUSA, LLC, All Rights Reserved).

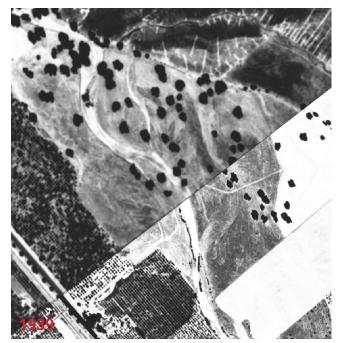
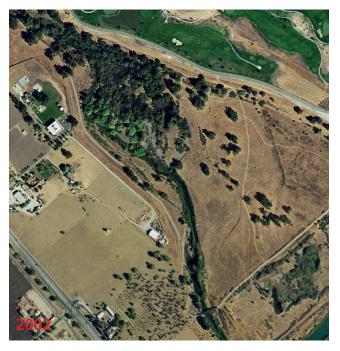
FIGURE III-26. COYOTE CREEK IMMEDIATELY DOWNSTREAM OF OGIER PONDS IN 1939 (LEFT) AND 2002 (RIGHT). The open riparian and channel pattern visible in 1939 (AAA 1939), which closely matched that described by Howe in 1851, has filled in substantially, probably as a result of decreased winter flows and increased summer flows (2002 Imagery Copyright 2005 AirPhotoUSA, LLC, All Rights Reserved).

In this reach, Coyote Creek presently exhibits some of its most un-modified morphology and riparian habitat. Examples of sycamore alluvial woodland and open riparian scrub can be found upstream and downstream of Ogier Ponds, representing significant residual habitats (FIGURES III-25 and III-26, see also FIGURE IV-35).

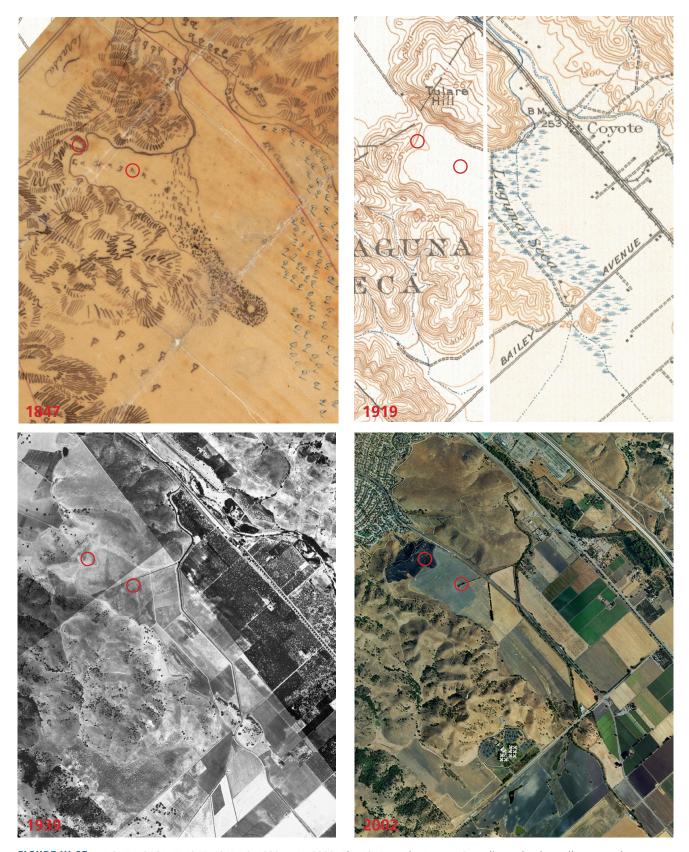
FIGURE III-27. LAGUNA SECA IN 1847, 1915-16, 1939, AND 2002. The 1847 Rancho Laguna Seca diseño, by the well-respected surveyor Chester Smith Lyman (e.g. Arbuckle 1986:56), shows perennial wetlands and an open water area, with valley oaks located some distance to the east and south. The outlet channel, probably an extension of Alvirez's canal, has not changed shape much over time, but has received an increasingly greater drainage network. Mottled soil patterns (1939, lower left; AAA 1939) and less agricultural diversification (2002, lower right; Imagery Copyright 2005 AirPhotoUSA, LLC, All Rights Reserved) mark the Laguna site after the 1916-17 reclamation. Approximate locations of the following panoramas are indicated with red circles. Lyman 1847, courtesy The Bancroft Library, UC Berkeley; USGS 1919 and 1940 courtesy Santa Clara Valley Water District.

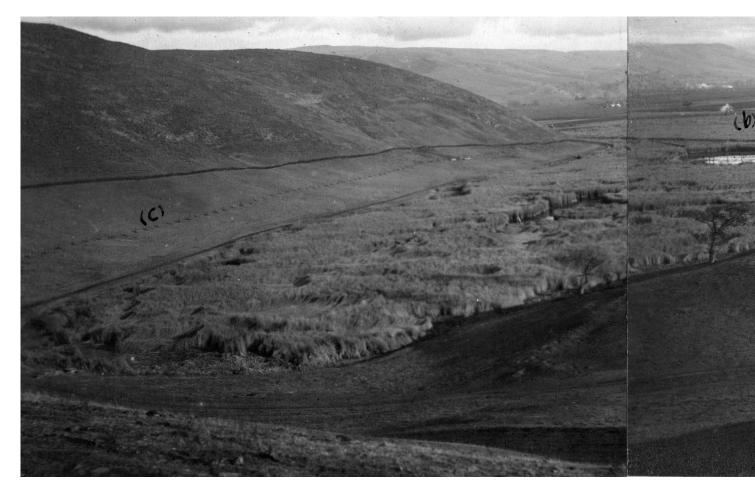
FIGURE III-28. LAGUNA SECA PANORAMA, DECEMBER 28, 1916. This view from the north end of the Laguna shows wetland vegetation and perennial ponds immediately before draining for agriculture. See **FIGURE III-27** for location. SCVWD Vault 1916: 64-65, courtesy the Santa Clara Valley Water District.

FIGURE III-28 is a panorama taken from the north end of the Laguna, showing a tule marsh with ponds of open water, one of them called "Mallard Pond." Another photograph looks across one pond to the hill on the left, appropriately named Tulare Hill (FIGURE III-29). These pictures and the associated captions (see also FIGURES II-10 and II-11) confirm tule vegetation greater than 10 feet tall and water depths of 4-5 feet.

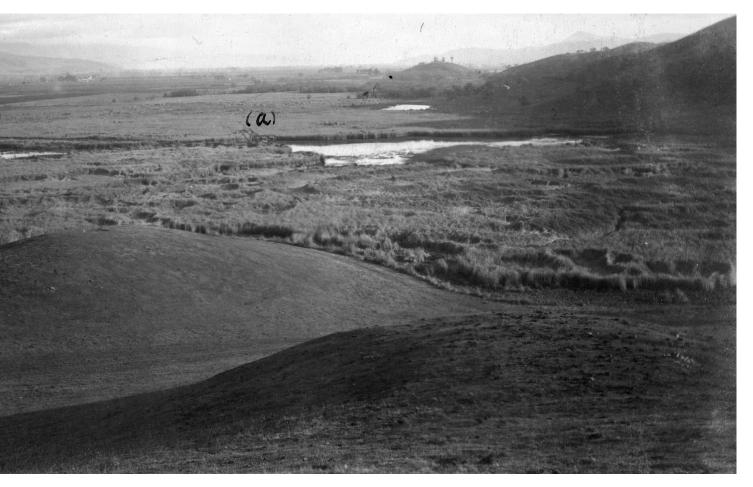
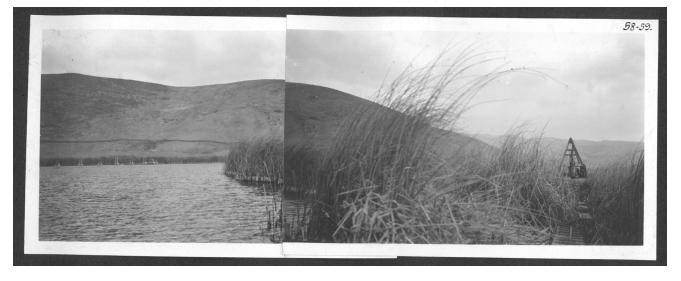
FIGURE III-29. LAGUNA SECA PANORAMA ACROSS A TULE POND, DECEMBER 20, 1916. "View looking westward from Lagoon showing open water (about 4 1/2 ft. deep) with clam-shell working on Ditch advancing through tulles (Sta. D' 22+50) to drain lands." [Original caption text]. See FIGURE III-27 for location. SCVWD Vault 1916: 58-59, courtesy the Santa Clara Valley Water District.

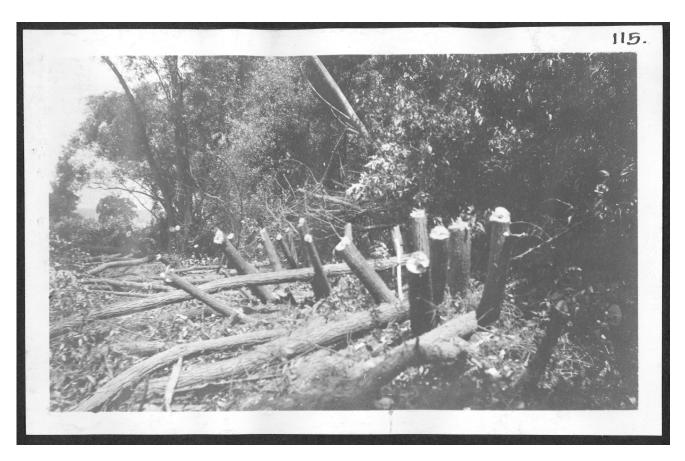
FIGURE III-32. LAGUNA SECA WILLOW GROVE, 1917. This image provides a rare photograph of a Santa Clara Valley *sausal*, or willow grove. SCVWD Vault 1917: 115, courtesy the Santa Clara Valley Water District.

grove" at the Coyote Narrows. This feature may have been part of the *sausal* at the Laguna Seca wetland complex, whose clearing is recorded in the Laguna Seca Reclamation photographs (FIGURE III-32; SCVWD Vault 1916-17: 116, 130, 132, 137). The Laguna Seca *sausal* can be generally located based upon the photographs and USGS Morgan Hill Quadrangle (1917).

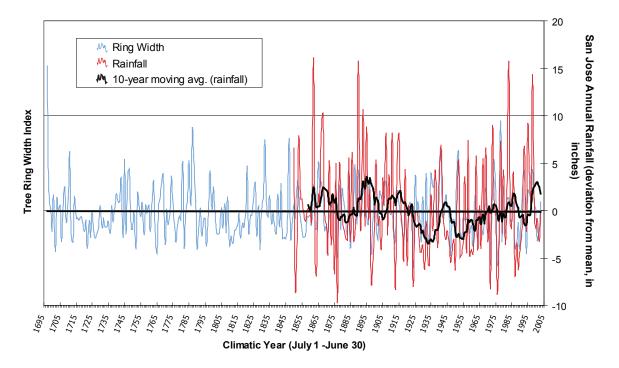
FIGURE IV-1. CLIMATE TIMELINE FOR SANTA CLARA VALLEY. Rainfall data for San Jose, 1874-2004, with 1850-1873 extrapolated based upon San Francisco data, courtesy of Jan Null. Tree ring data from a blue oak near Alum Rock Park (unpublished data provided by David Stahle, University of Arkansas).

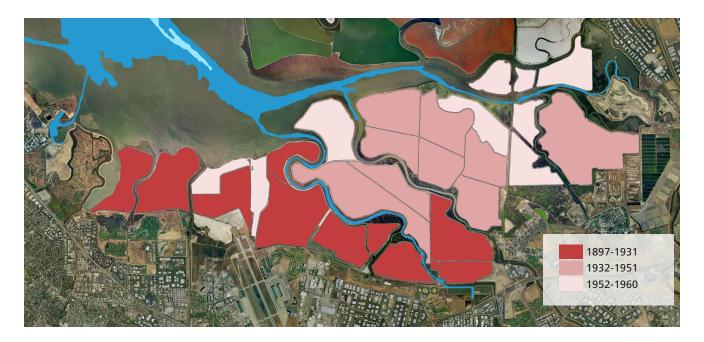
FIGURE IV-6. TIMING OF SALT POND DEVELOPMENT AT THE NORTHERN END OF SANTA CLARA VALLEY. The area at the mouth of Coyote Creek (right side) was one of the last Bayland areas in the region to be diked (2002 Imagery Copyright 2005 AirPhotoUSA, LLC, All Rights Reserved).

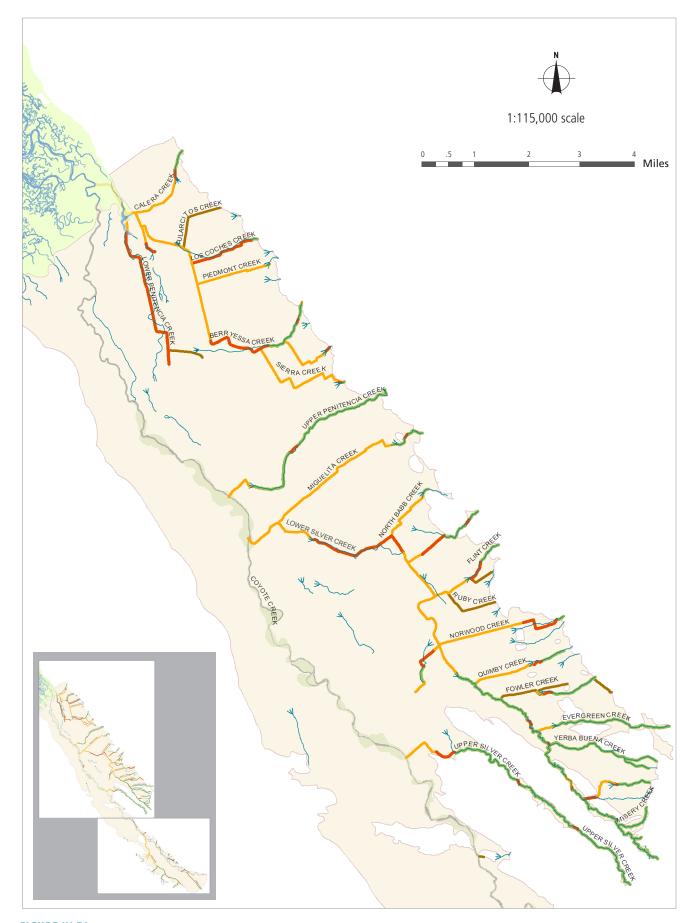
FIGURE IV-7A. EXPANSION OF THE COYOTE CREEK WATERSHED DRAINAGE NETWORK WITH CONSTRUCTED CHANNELS. These maps show both the historical and present-day valley floor creek network. The historical data was developed by SFEI as part of this project. To assess the origin of modern creeks, we compared the historical data to the recently-developed SCVWD GIS. Some very small constructed channel segments may be excluded. See legend on facing page.

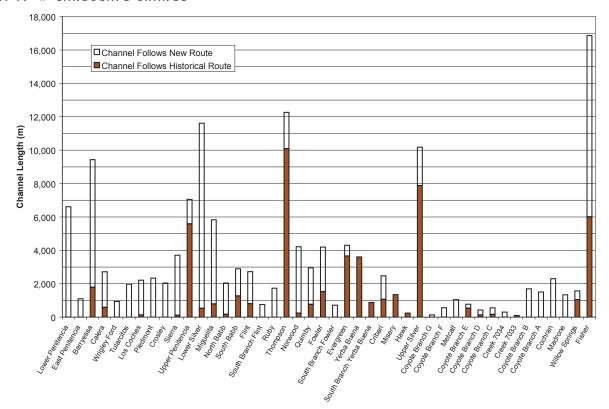
FIGURE IV-8. RELATIVE PROPORTION OF NATURAL VERSUS ARTIFICIAL CHANNEL BY CREEK. This chart considers the valley floor portion of each tributary creek in the Coyote watershed. Some occupy their historical channel across most of the valley floor, while others were mostly created by engineering.

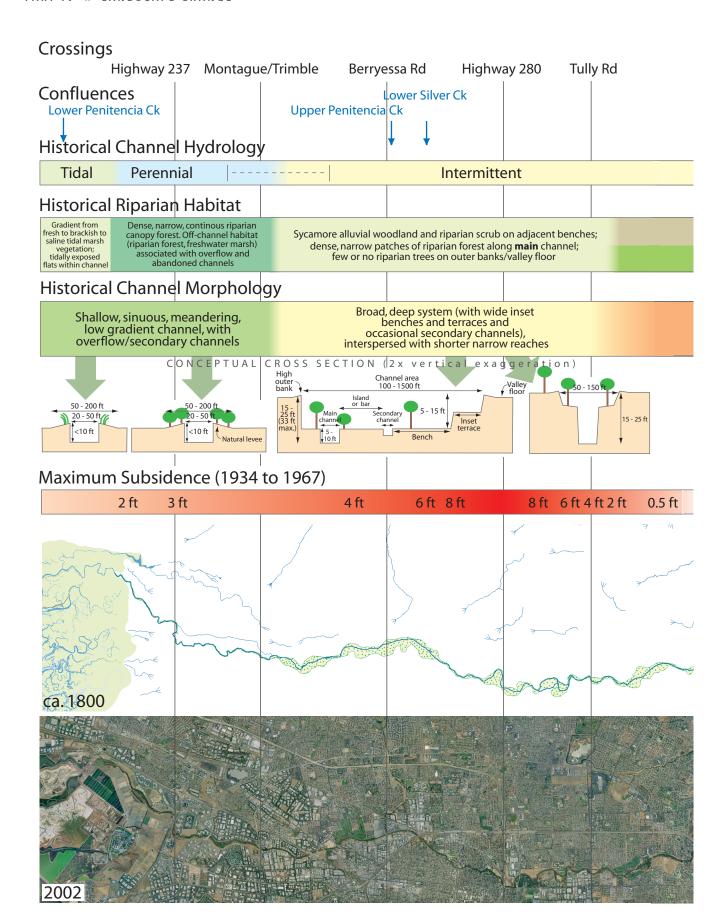
FIGURE IV-12. HISTORICAL MORPHOLOGY, HYDROLOGY, AND HABITAT OF COYOTE CREEK. This diagram shows how key attributes of the creek varied naturally by reach. The close relationships between morphology, habitat, and hydrology indicate how physical and ecological processes are interrelated. Transitions between reaches were gradual and varied through time. Cross-sections are generalized to illustrate reaches based upon historical data (2002 Imagery Copyright 2005 AirPhotoUSA, LLC, All Rights Reserved).

Upstream from tidal influence, Coyote Creek was a relatively shallow, narrow, single thread channel with many of the classic characteristics of a meandering, low-gradient stream. Perennial flow supported dense riparian forest. Channel banks were frequently overtopped during flood events, sending flow broadly across the lower valley floor and through overflow channels. This also deposited fine sediment, contributing to the building and maintenance of natural levees.

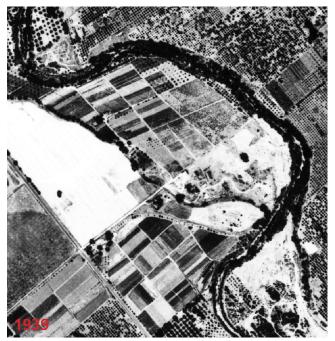
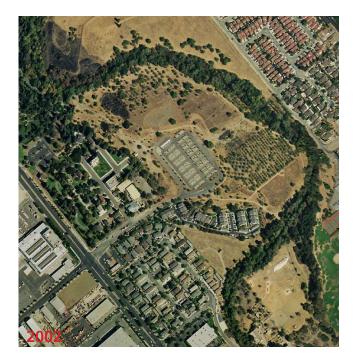
FIGURE IV-14. COYOTE CREEK AT KELLEY PARK, 1939 (LEFT) AND 2002 (RIGHT). Coyote Creek follows a highly sinuous course in this reach. Historical maps (Hermann 1905, Thompson and West 1876) also show secondary channels, which appear to correspond with lines of riparian vegetation distinct from the main channel in 1939 (AAA 1939). By 1939, farms occupy most of the floodplain bench area along the creek; presently, orchard remnants, a parking lot, and several large sycamore trees can be found. A housing development was recently built on the odd peninsula jutting into the creek area at lower middle (2002 Imagery Copyright 2005 AirPhotoUSA, LLC, All Rights Reserved).

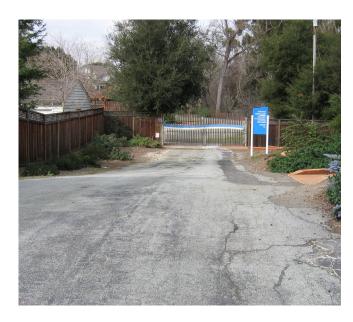
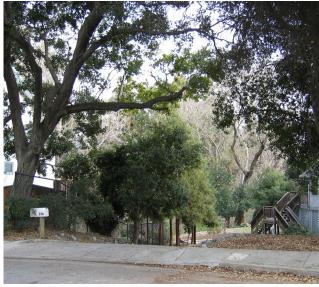
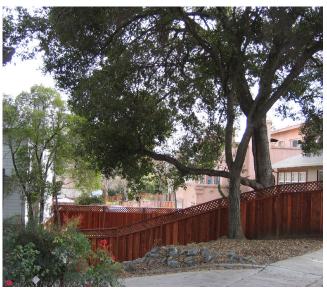
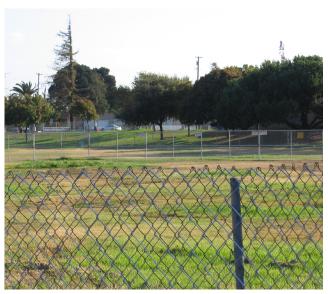
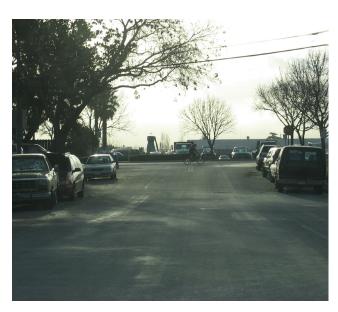
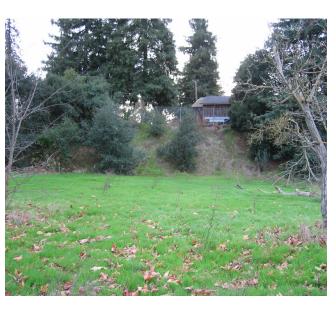
FIGURE IV-15. STREAM BENCHES ALONG MID-COYOTE CREEK. Despite filling and grading, these features are still evident along many parts of the creek as distinct "drops" below the adjacent valley floor terrace. Locations are, clockwise from upper left: the Santa Clara Valley Water District's Coyote Creek Outdoor Classroom; private residences on Arroyo Way near William Street Park; Watson Park; Kelley Park; Nordale Ave. near Kelley Park; and private residences on Arroyo Way.

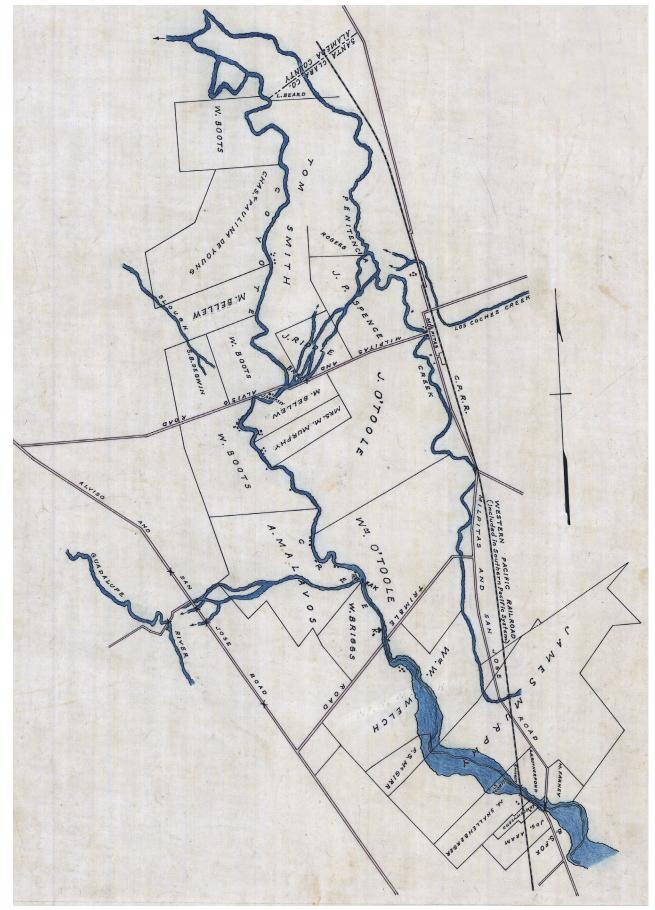
FIGURE IV-17. LOWER COYOTE CREEK HISTORICAL OVERFLOW PATTERNS. This map shows the series of "breakouts" along Coyote Creek. Overflow channels extended all the way to Guadalupe River and Lower Penitencia Creek. It also shows the pattern of wide and narrow stream reaches (Herrmann 1874d, courtesy Santa Clara County Surveyors Office).

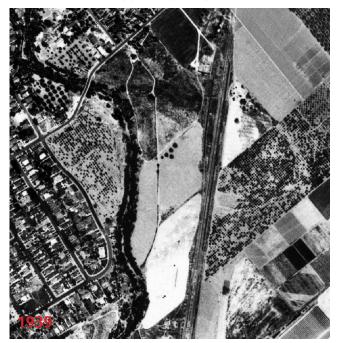
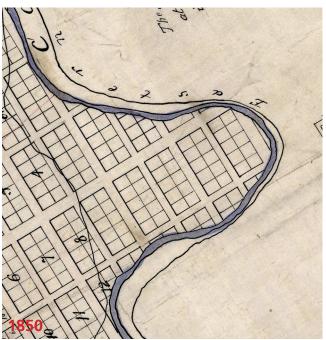
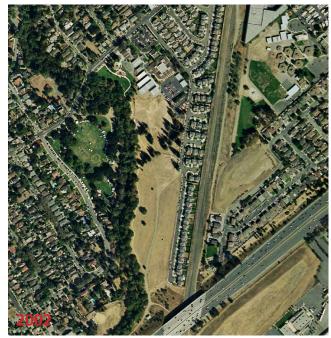
FIGURE IV-18. COYOTE CREEK AT WILLIAM AND OLINDER PARKS IN 1850 (LOWER LEFT), 1939 (UPPER LEFT), AND 2002 (RIGHT). Some evidence of the former main channel course shown by White (1850; courtesy Santa Clara County Surveyors Office) is visible in 1939 (AAA 1939) as less vigorous orchard growth. Martin Park (the triangular green field in the upper right corner of the modern photo) corresponds with the former main channel (2002 Imagery Copyright 2005 AirPhotoUSA, LLC, All Rights Reserved).
