FINAL REPORT

COYOTE CREEK WATERSHED HISTORICAL ECOLOGY STUDY

HISTORICAL CONDITION, LANDSCAPE CHANGE, AND RESTORATION POTENTIAL IN THE EASTERN SANTA CLARA VALLEY, CALIFORNIA

SAN FRANCISCO ESTUARY INSTITUTE

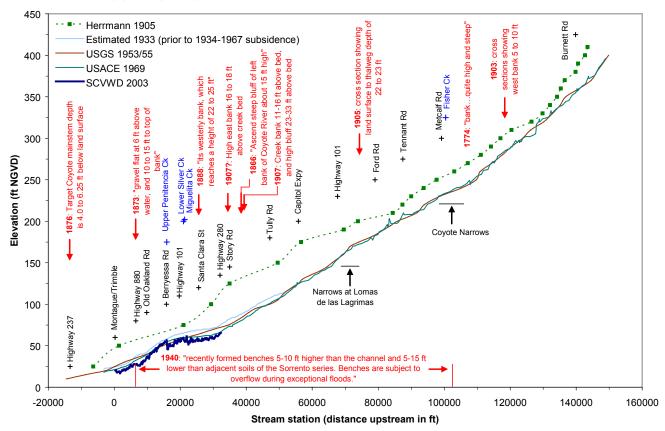
FIGURE IV-19. HISTORICAL AND MODERN LONGITUDINAL PROFILE DATA FOR COYOTE CREEK. See text for details. Comparison to the other data sets indicates that the profile based on Herrmann (1905) is not of comparable accuracy. The Mid-Coyote reach is shown in more detail in FIGURE II-20.

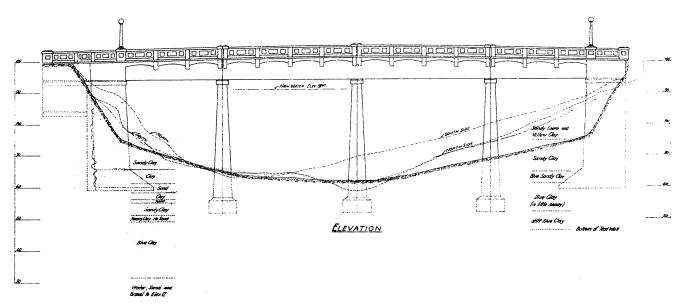
FIGURE IV-21. CONSTRUCTION DIAGRAM FOR THE "SANTA CLARA ST. BRIDGE OVER THE COYOTE RIVER." Courtesy City of San Jose, Department of Public Works (1918).

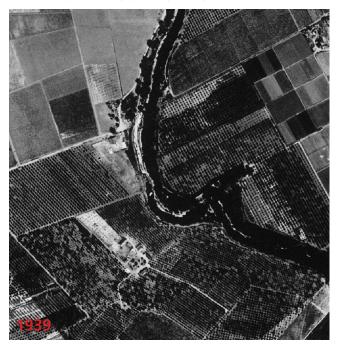
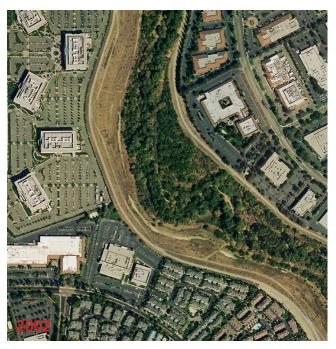
FIGURE IV-28. RIPARIAN RECOVERY ON LOWER COYOTE CREEK BETWEEN 1939 (LEFT) AND 2002 (RIGHT). Location immediately upstream of Tasman Drive (AAA 1939; 2002 Imagery Copyright 2005 AirPhotoUSA, LLC, All Rights Reserved).

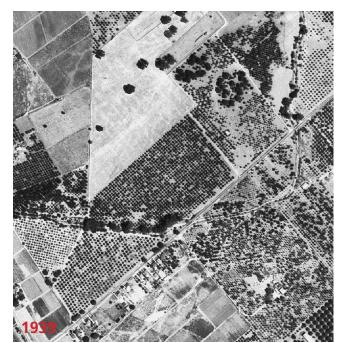
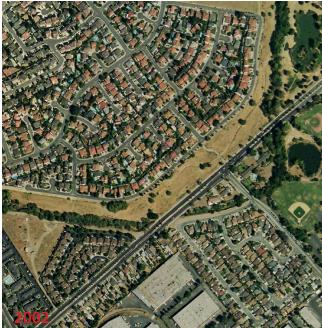
FIGURE IV-31. RIPARIAN RECOVERY ON UPPER PENITENCIA CREEK BETWEEN 1939 (LEFT) AND 2002 (RIGHT). The gaps in riparian forest visible in 1939 (AAA 1939), presumably the result of adjacent agricultural practice, have substantially filled in the subsequent years (2002 Imagery Copyright 2005 AirPhotoUSA, LLC, All Rights Reserved).

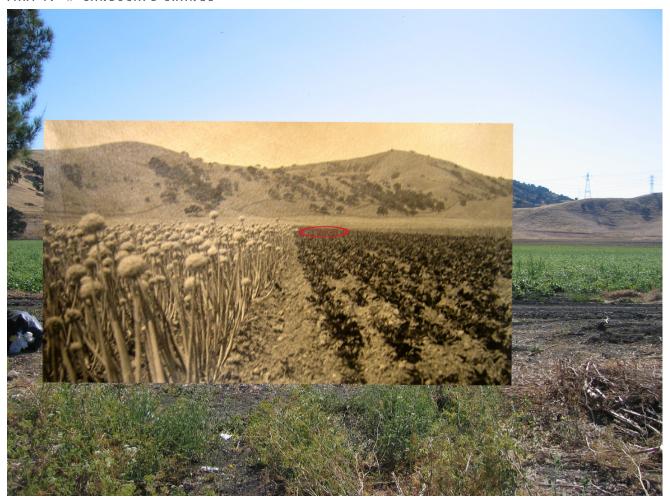
FIGURE IV-34. LAGUNA SECA 1919/2005. The area has changed relatively little since the reclamation for agriculture in the early part of the 20th century. Red circle shows location of **FIGURE III-30**. SCVWD Vault 1919: 169, courtesy Santa Clara Valley Water District.

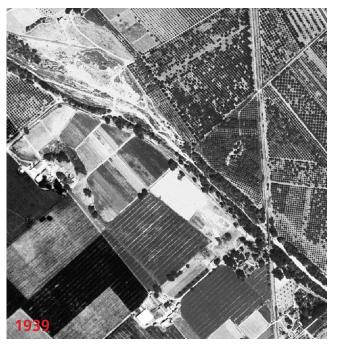
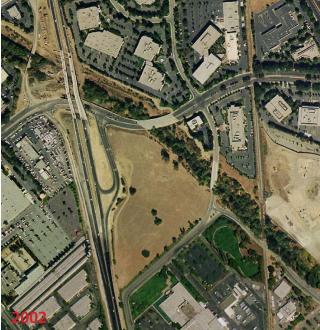
FIGURE IV-36. COYOTE CREEK CHANNEL AT HIGHWAY 880 CROSSING, CIRCA 1800 (LOWER LEFT), 1939 (UPPER LEFT), AND 2002 (RIGHT). The 1800 view identifies naturally broad and narrow channel reaches, which are not easily distinguished in the more recent aerial photography. Naturally wide reaches may have potential for floodplain restoration. For example, the undeveloped area in the center of the 2002 image is a former stream bench that remains flood-prone. Highway 880 runs north-south on the left side of the 2002 image. The San Jose Mercury News building can be seen at image bottom, immediately right of the highway. (AAA 1939; 2002 Imagery Copyright 2005 AirPhotoUSA, LLC, All Rights Reserved).
