## AN INTRODUCTION TO THE *HISTORICAL ECOLOGY* OF THE FITZGERALD MARINE RESERVE CCA

*A tool for developing an action plan for the Critical Coastal Areas program*

# FITZGERALD MARINE RESERVE CCA

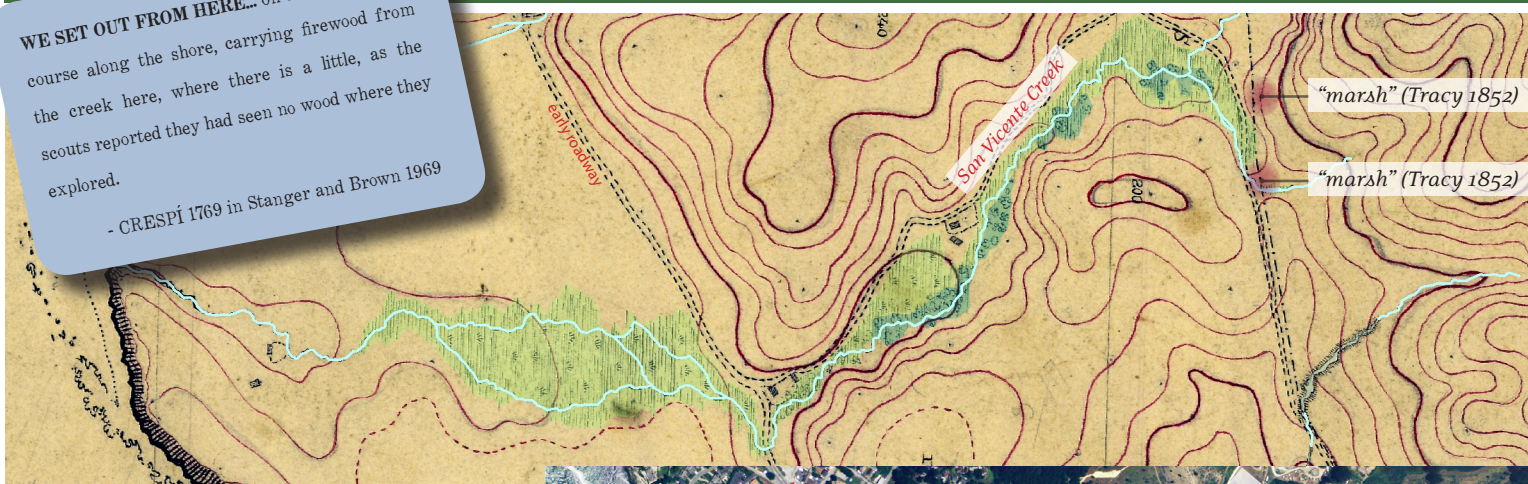
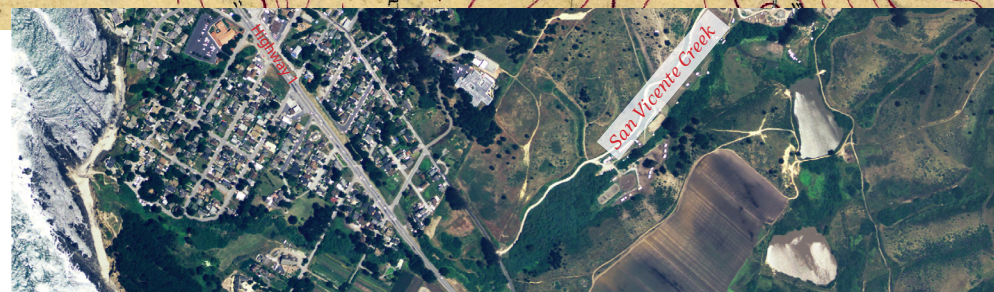
Above, US Coast Survey map courtesy NOAA; imagery below courtesy USDA NAIP 2005

The image from the 1866 USCS T-sheet shown above depicts **freshwater marsh (light green) merging into a willow riparian forest (dark green)** along San Vicente Creek's braided reaches on the flat alluvial fan at the base of the Montara hills. The map suggests both a broader and more open (covered with herbaceous vegetation) wetland environment than the riparian reaches found along San Vicente Creek today. GLO surveyor C. C. Tracy (1852) also noted marshes (see above) along his survey line that crossed the creek and passed close to where reservoirs sit today. A similar progression of marsh to willow riparian forest is suggested along Montara Creek upstream of Harte St. (not shown). Considering the water quality and flood control benefits of wetland and marsh complexes, areas where open space still exists next to stream channels may be important sites to consider for recovering elements of the historical systems. Areas along the San Vicente and Montara creeks may contain restoration and conservation opportunities for freshwater marshes and wet meadows.

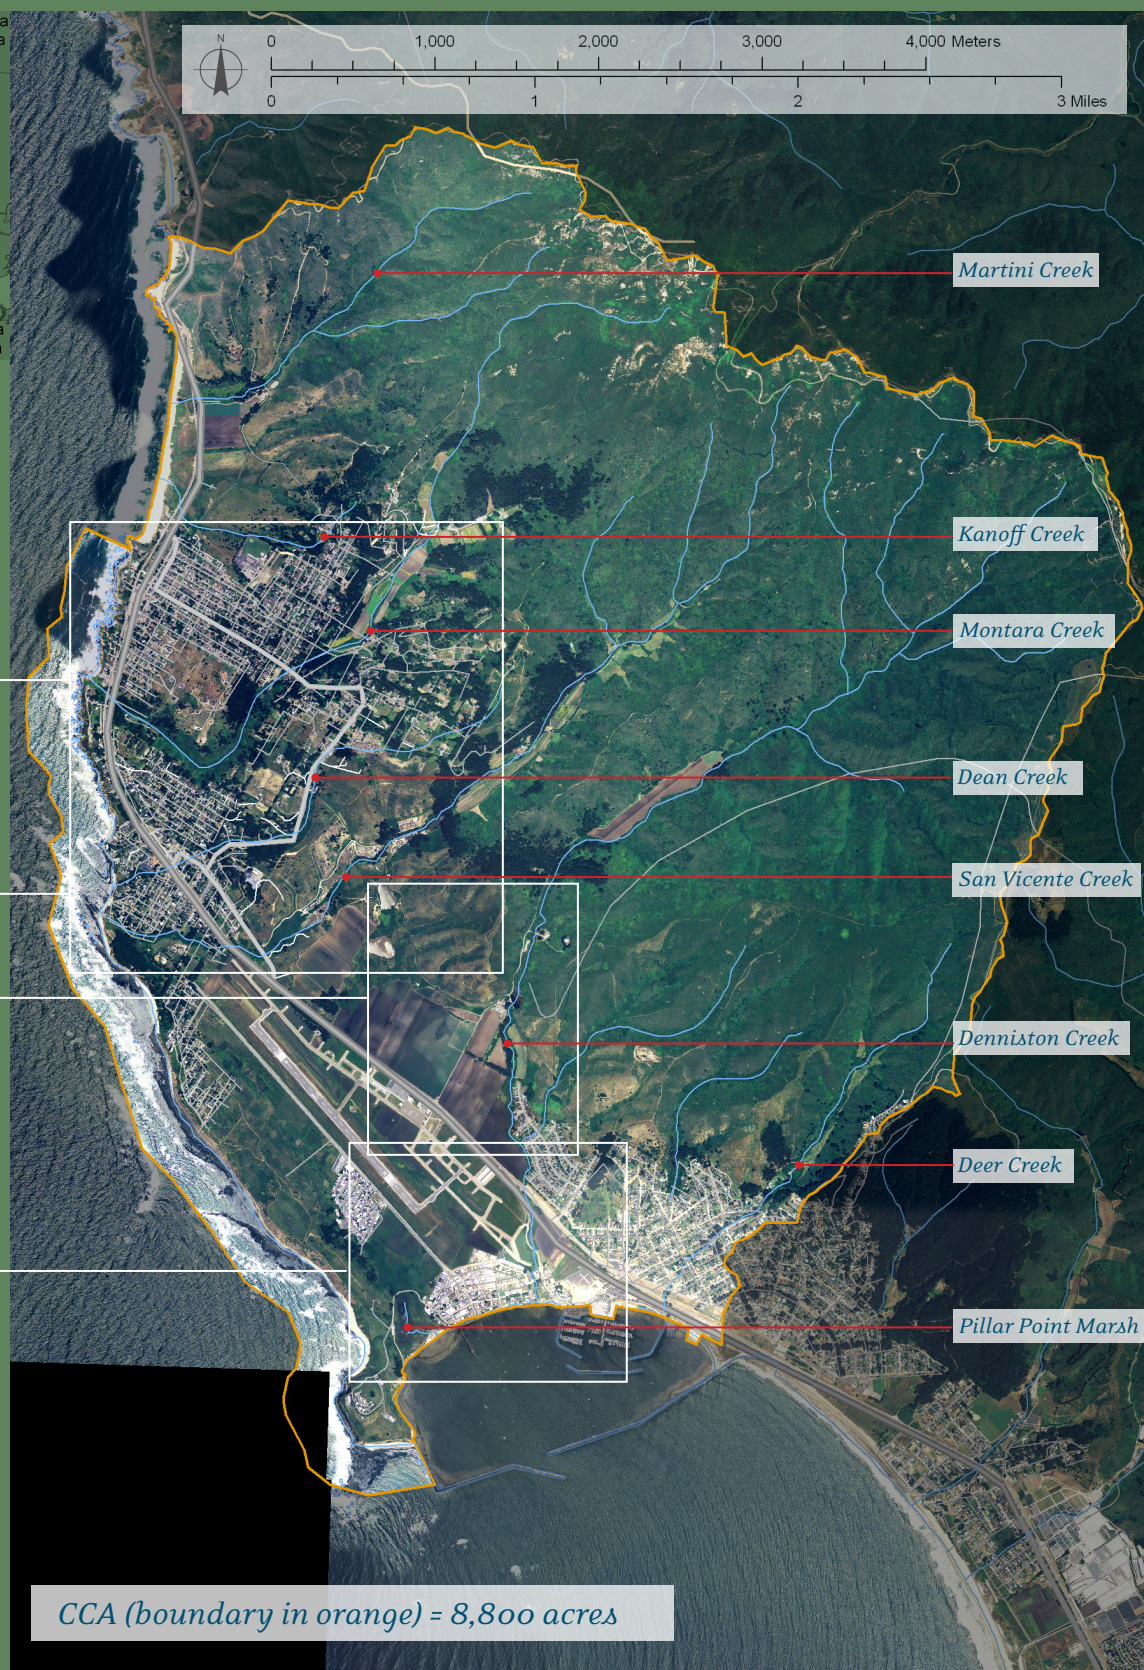
The 1896 USGS map suggests a more **discontinuous drainage network** on some of the smaller local streams prior to hydrologic modifications, which is a commonly recognized pattern among California's historic streams. Small intermittent creeks (in red boxes above) emerging from the steep Montara Mountains lacked the energy to form well defined tributary channels as they encountered the relatively flat alluvial fans of the larger creeks. Instead, the channels dissipated like those shown in this 1896 USGS map. These networks were often associated with downstream wetlands. Although not depicted on the maps examined here, GLO surveyor C.C. Tracy reported entering and leaving a "marsh" along his line close to where Highway 1 is now.

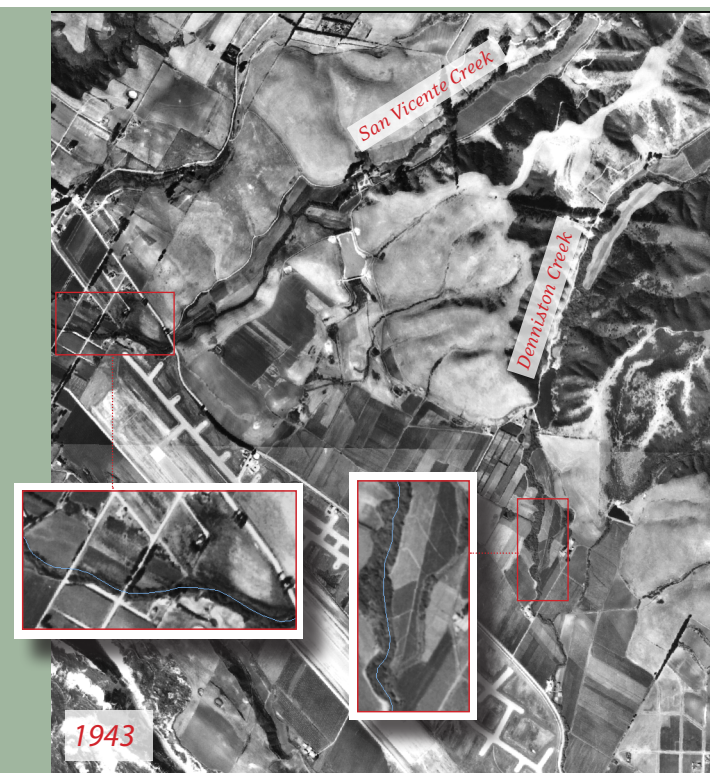
Aerial imagery courtesy USDA

The 1943 aerial photography (overlain by contemporary stream mapping) shows a **highly modified drainage network**. While remnants of Denniston Creek's multiple channels persist, San Vicente is a clear single-channel system. The airport's construction resulted in significant hydromodification of the Denniston Creek and Pillar Point drainage networks. Where water historically drained toward Pillar Point marsh, it now appears directed more toward Denniston Creek through ditches. Such modification can also have the effect of connecting the small discontinuous creeks, like those shown in the 1896 map, to larger stream channels.

The images above and to the right illustrate hydrologic change over time: wetland complexes and multi-thread channels (1866), and discontinuous drainage networks (1896) shift to a highly modified system in 1943.

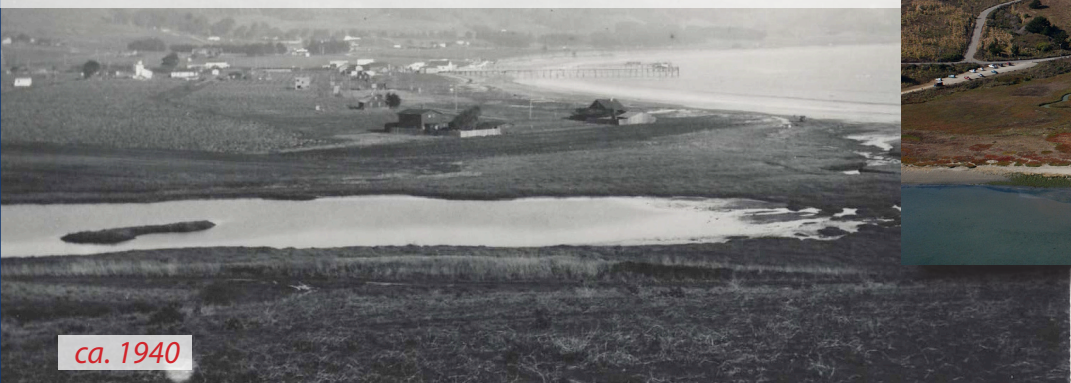
Pillar Point Marsh (shown below ca. 1940 and at right in 2005), persists today as a unique system within the Fitzgerald Marine Reserve CCA.

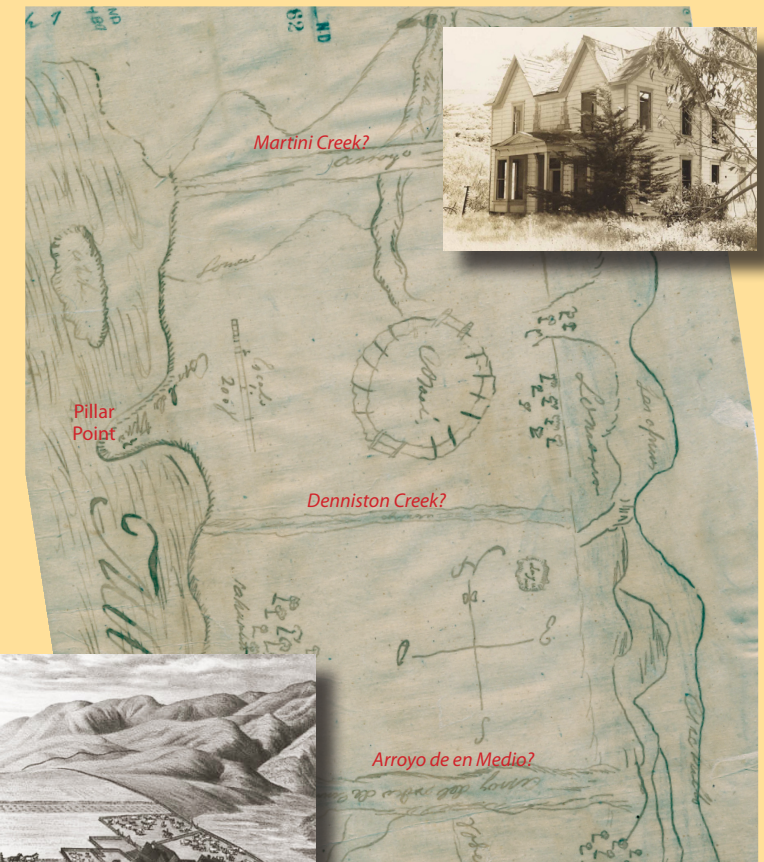
Map courtesy The Bancroft Library, UC Berkeley; photograph Courtesy San Mateo County History Museum; oblique drawing courtesy HalfMoonBayMemories.com

The 1837 diseño map above of the **Rancho Corral de Tierra** land grant uses natural features to locate the boundaries of the rancho. The "arroyos" (creeks) and "lomarias" (hills) formed the "earthen corral" (a constructed corral is also shown) after which the grant was named. The map likely shows Martini Creek to the north, and Denniston Creek in the middle, close to Pillar Point. Francisco Guerrero received this grant from the Mexican government in 1839. The lithograph and photograph above shows his son Victor's homestead, which became the home of James Denniston in the mid-1800s.

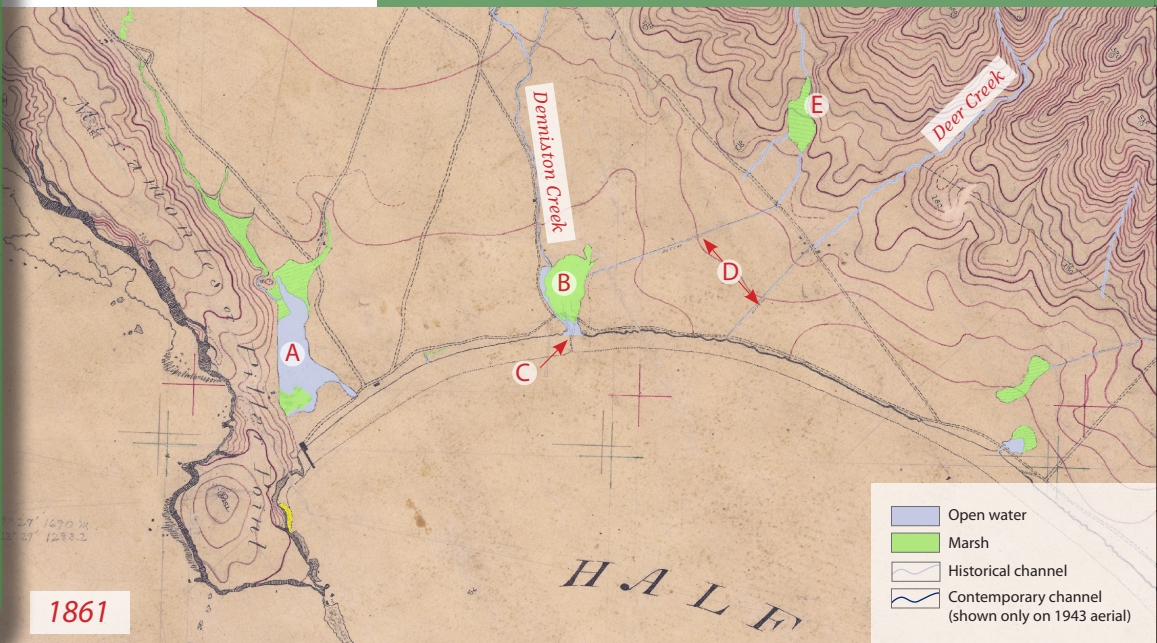
In the comparison below, the 1861 **Pillar Point Marsh** complex (A) contains more open water (approximately 10 acres) and a longer adjacent marsh than that shown in 1943 aerial photography (with approximately 4 acres of open water). In 1861, only the southernmost portion shows any emergent vegetation, suggesting a perennial water body. The open water transitions to emergent marsh (horizontal lines) approximately at the historic dam where West Point Ave. is today. US General Land Office (GLO) survey data adds another layer of information to help confirm the general character and location of the marshes and creek mouths. Surveyor C. C. Tracy (June, 1862) noted entering and leaving the "marsh" north of West Point Ave and commented on "wet, good grass," indicating a more continuous marsh complex than today.

The 1861 T-sheet also shows a wetland system at the **mouth of Denniston Creek (B)** (interpretation aided by 1863 USCS hydrographic map shown on p.1), the presence of which is supported by the "level marsh" noted by Tracy. The subtidal channel

Interestingly, the T-sheet already shows hydrologic modifications to the Denniston Creek watershed. A ditch (D) originates from a freshwater marsh (E) and connects to the Denniston Creek marsh; another connects to Deer Creek. This perhaps explains the drained appearance of the freshwater marsh in the 1943 aerial photography, which has since been replaced by dense vegetation. These ditches are early representations of the common trend toward increasing drainage density by connecting creeks that would have otherwise spread into marshes or alluvial fans (see pgs. 6-7).

The 1861 USCS T-sheet (at right), which covers the Pillar Point area, depicts marsh complexes and channel networks along the coastline (Johnston 1861). Initiated in 1807 by the U.S. government, the Coast Survey maps provide an early and detailed cartographic depiction of the coastal landscape. The unprecedented use of geodetic surveying techniques - employing a common reference, or datum, to which all points are tied - produced remarkably accurate maps for the time period. Despite the absence of a standardized legend, T-sheets show hydrologic patterns and the distribution of coastal ecosystem types, which can be interpreted through a standard methodology (Grossinger and Askevold 2005).

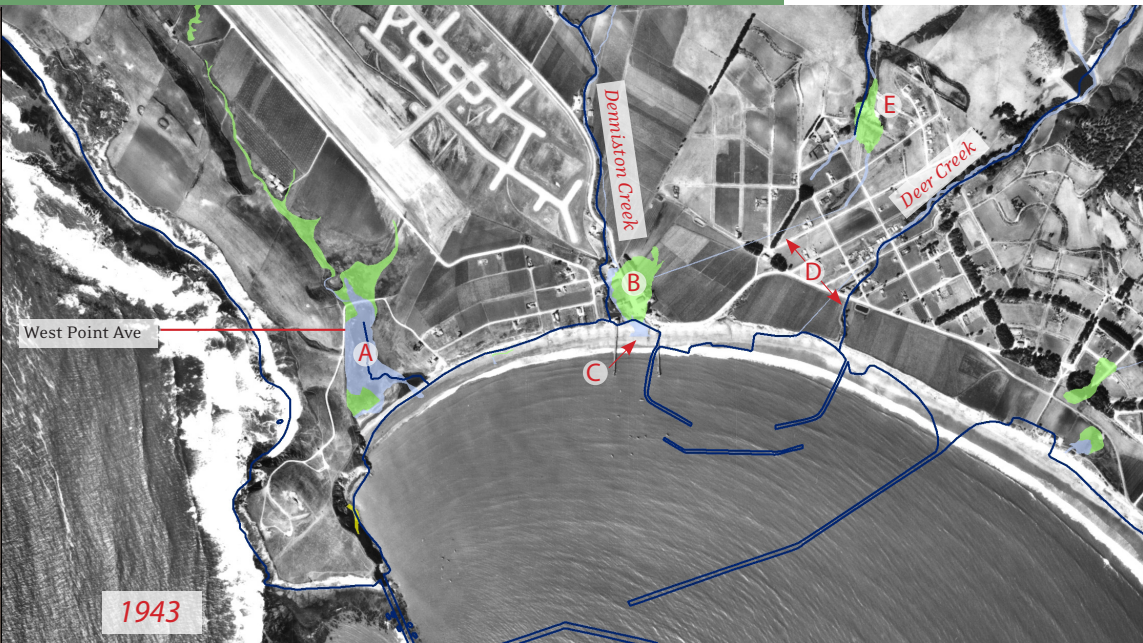
(C) drawn suggests that the marsh system may have been more consistently open to the ocean than Pillar Point Marsh. The 1943 aerials show the creek in roughly the same location as the T-sheet channel, but the marsh complex at the mouth of Denniston Creek appears to be largely absent. The inset oblique photographs show the mouth of Denniston Creek at the approximate time of the 1943 aerials in comparison to today.

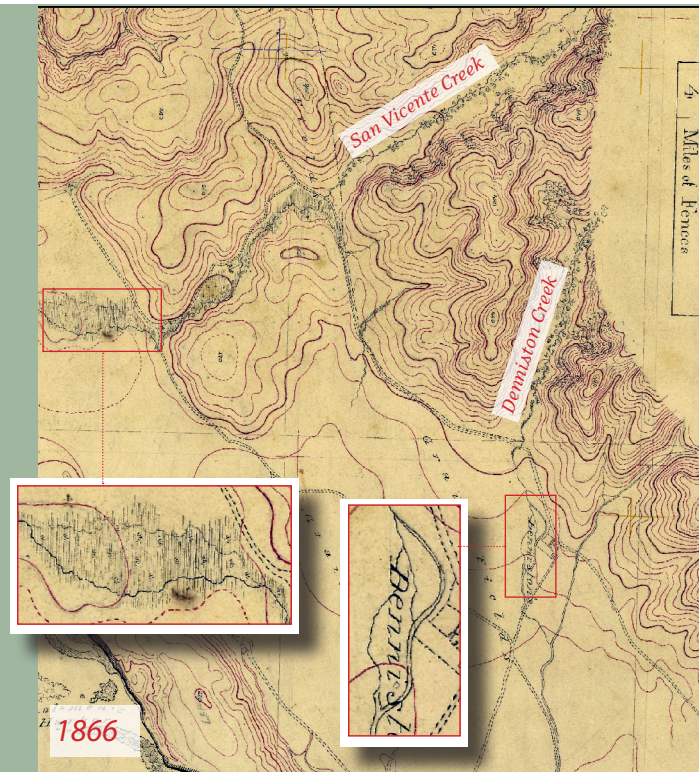
US Coast Survey map courtesy NOAA

For streams like San Vicente Creek and Denniston Creek, which appear to have had sufficient flow to form distinct channels to the ocean (see quote below left), **complex, multi-thread reaches** are indicated in the 1861 T-sheet, in the locations highlighted above. This area (in white box above) on Denniston Creek was once known as “Three Bridges,” supporting the evidence of multiple channels (Cloud 1928). The San Vicente Creek reach is slightly different in that it is associated with a freshwater marsh complex (see p. 8).

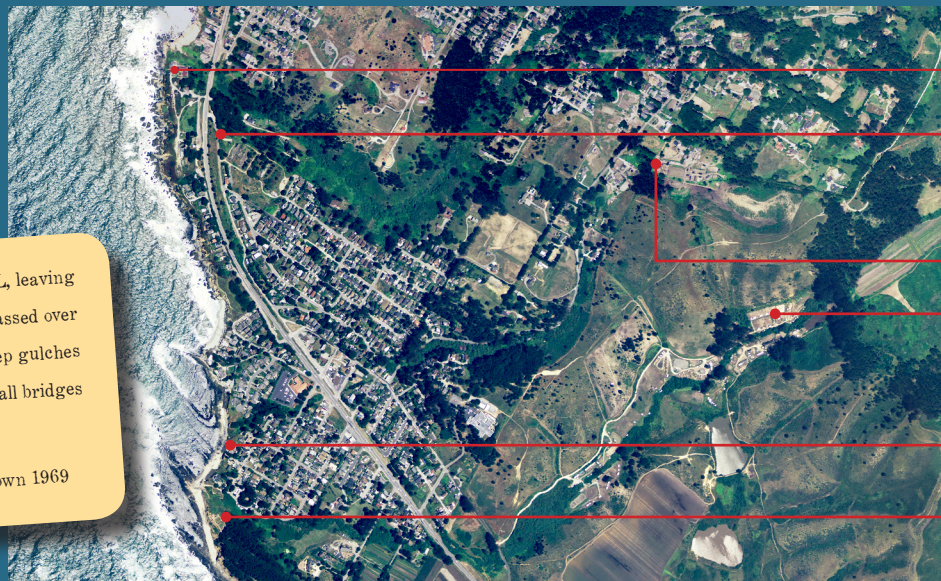
The example here shows information that can be used in comparison to contemporary stream channel widths. The red lines imposed on the modern imagery to the right point to locations of known creek width, as recorded by an 1859 survey.

The figure at left shows stream widths at various locations on San Vicente, Dean, and Montara Creeks, recorded by General Land Office (GLO) surveyor William J. Lewis. The GLO Public Land Survey established the 6-mile square townships we are familiar with today across the western U.S. and confirmed land grant boundaries. The GLO reached Half Moon Bay in the 1850s. The surveys contain valuable ecological information: surveyors noted up to four "bearing" trees (marked trees with azimuth and distance to identify the location of survey lines) at every mile and half-mile point (notably no trees were found in the Fitzgerald CCA), described distinctive features along their survey lines, such as creeks (including width information which is shown here), lakes, marshes, or areas of thick brush, and commented on general soils and land characteristics.
