**SECTION THREE:**

**GEOLOGY AND  
GEOMORPHOLOGY**

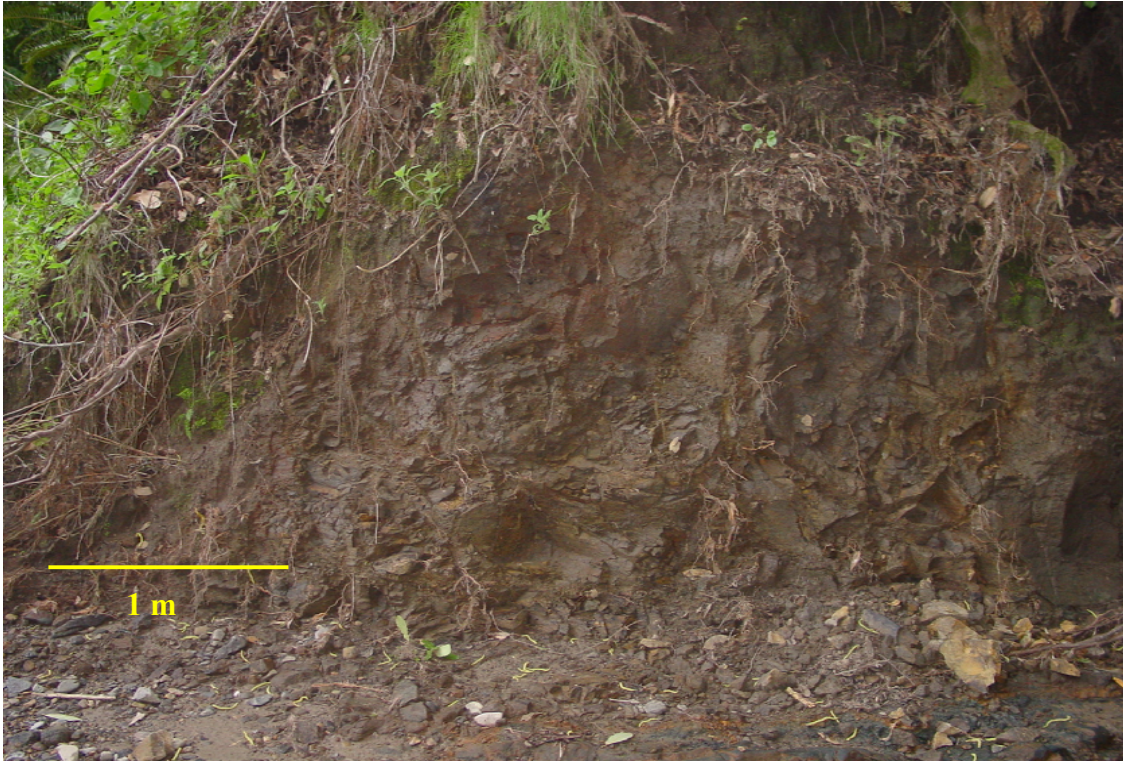
**Figure 3-2.** Tertiary Sedimentary Rock map unit in bank of La Honda Creek (Plate 1A).

Tertiary sedimentary rocks exposed within the La Honda Creek channel include pale gray to brown, fine-grained sandstone, siltstone, and mudstone (Figure 3-2). With the exception of some sandstones that are moderately indurated, these rocks are poorly cemented and poorly indurated. Based on crater quality (CQ) response to the Schmidt rebound hammer test, the unconfined compressive strength is fairly uniform at 7-21 MegaPascals (MPa) (1000 to 3000 psi) throughout the study reach.

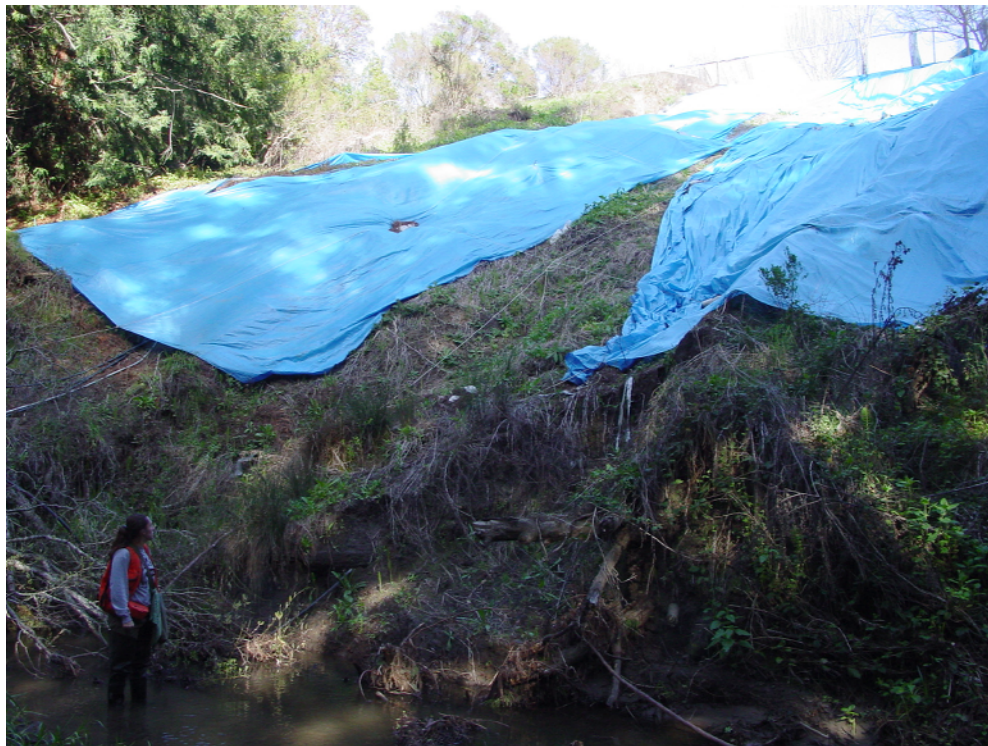
**Figure 3-5.** Desperate measures used in an attempt to reduce infiltration into the "Blue tarp landslide" (Plate 1A).

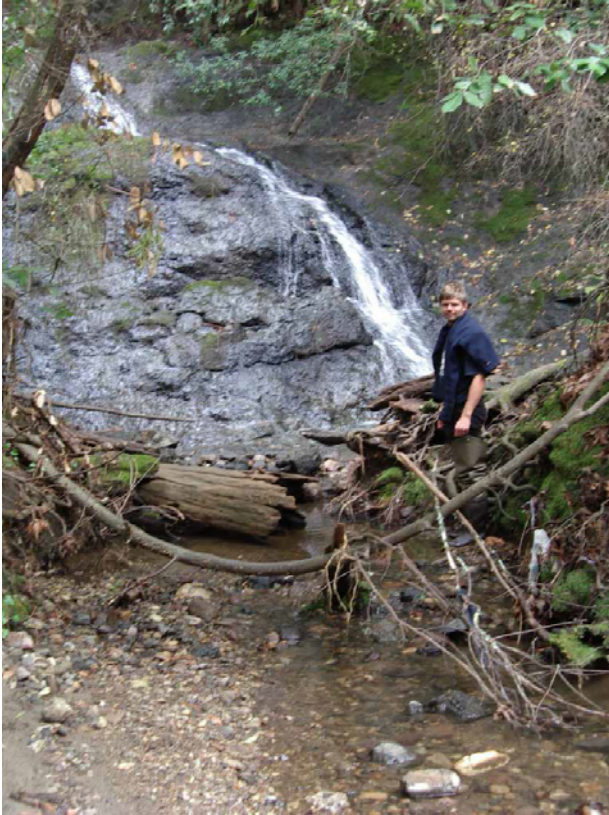
**Figure 3-6.** Hanging tributary at Woodhams Creek (Plate 1A).

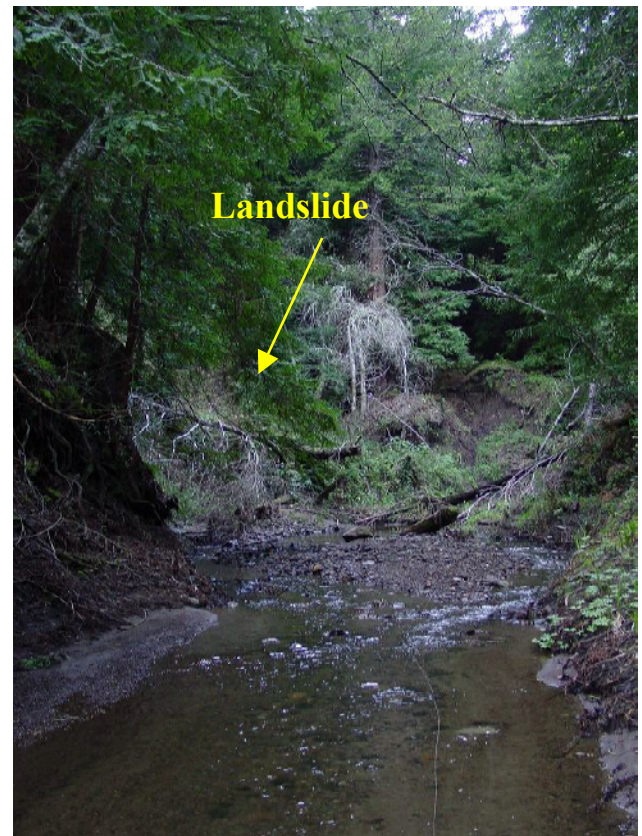
**Figure 3-7.** View upstream of sediment body winnowed from debris flow entering channel temporarily producing braided pattern. Landslide scar seen at upper end of photo. In time, the creek breeches the dam, returning to its original gradient. Reach 2B (Figure 6-3) appears to be affected by this process: the bankfull channel width is much wider compared to up and downstream, and remnants of landslide material are visible in many locations.

Localized landslides also have a significant influence on the bed elevation. Initially, the stream forms a temporary, braided pattern. As fines are winnowed, the freed granular sediment moves in pulses downstream, progressively filling pools and forming bars. This process occurs over several years: a pool can fill with sediment in a single year, and remain filled for a couple of years until a flow event scours the pool, moving the sediment downstream where it may deposit in another pool.

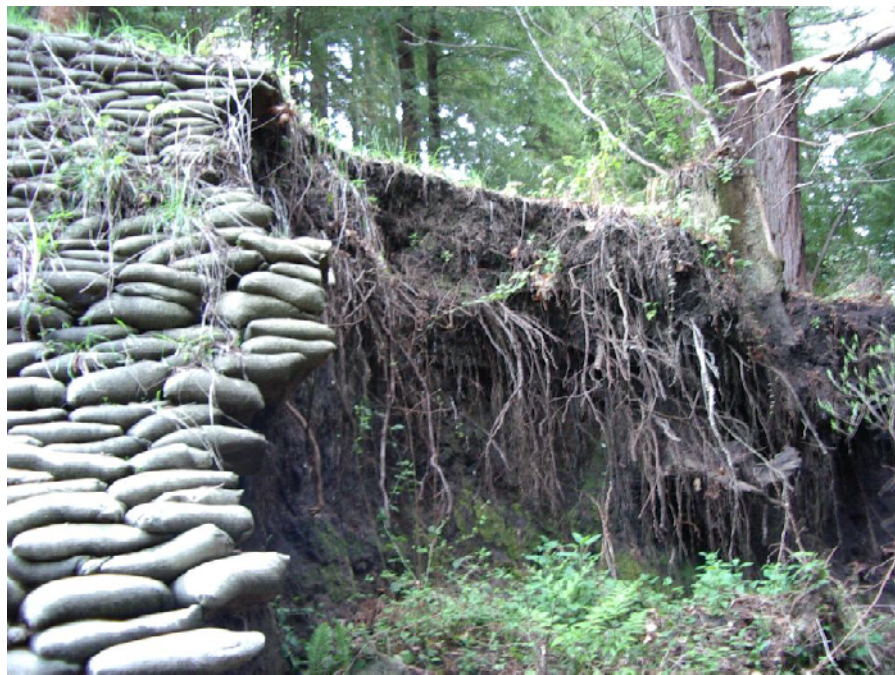
**Figure 3-8.** Failing portion on the downstream end of sackrete bank revetment, 790 m (864 yd) downstream of Weeks Creek (Plate 1B). Flow from left to right.

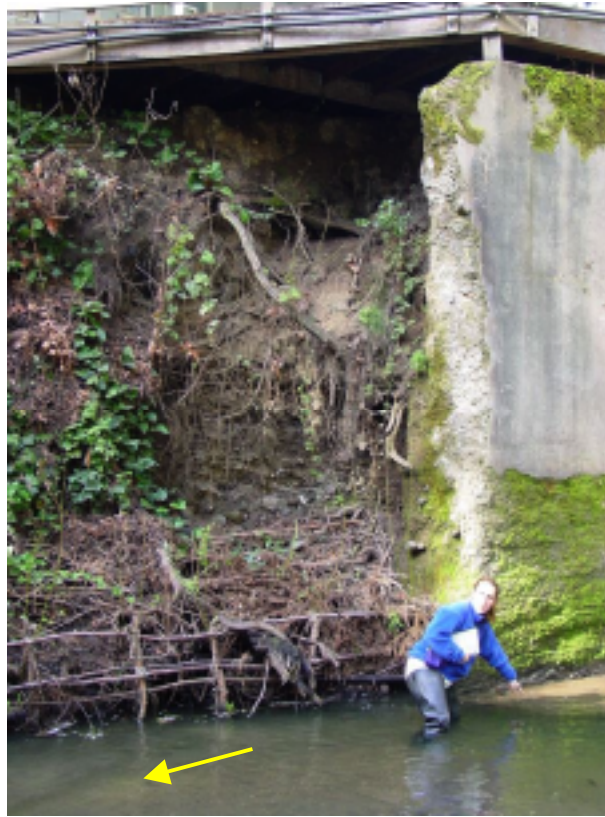
**Figure 3-14.** Downstream end of concrete wall in the town of La Honda (Plate 1C). Arrow indicates flow direction. Sarah points to the former grade level at the time the wall was constructed. The footing is now undermined 0.75-1 m (2.5 – 3.3 ft) by down cutting. Accelerated bank erosion is also evident at the end of the wall. Attempt at bioengineered repair at stream level.

- 1) Most of the engineered structures in the channel, such as the concrete footer at the Trailer Park bridge, the gabion wall downstream from Apple Jack's, or the concrete wall on the south side of the town of La Honda are being undermined or otherwise damaged by erosion (Plate 1C, Figure 3-14). The gabion wall shows two generations of repair, each more extensive (Figure 3-15). The latest was emplaced because of down cutting at its base. Damages are probably due to flows later than the 1997 event because the wire shows little wear, denting, or distress as it would have had if it been there during the 1997 event.

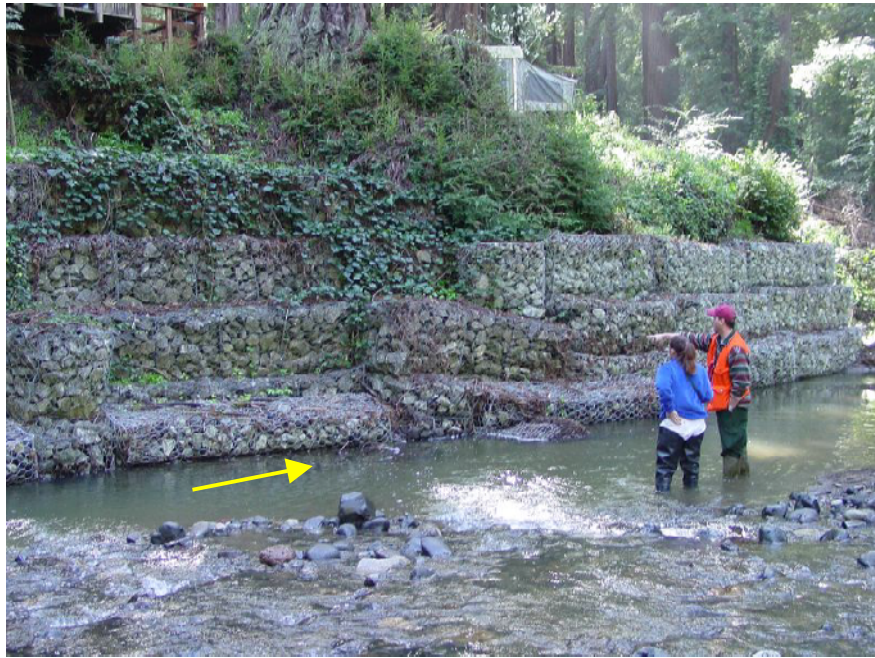
**Figure 3-15.** Gabion wall undermined by erosion. Arrow indicates flow direction. Downstream (right) end and base have been extensively repaired (Plate 1C).

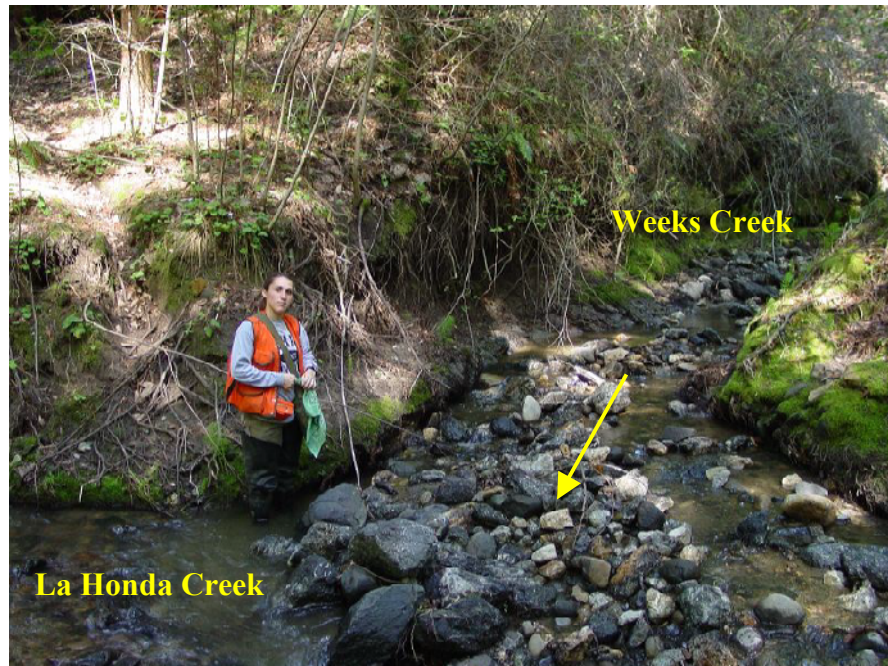
**Figure 3-16.** Oversized clasts in gravel bar at the confluence of Weeks Creek (Plate 1A). Arrow indicates flow direction. Note steepened lower banks due to downcutting.
