LANDSCAPE SCALE MANAGEMENT STRATEGIES

for Arroyo Mocho and Arroyo Las Positas

PROCESS-BASED APPROACHES FOR DYNAMIC, MULTI-BENEFIT URBAN CHANNELS

Prepared for
ZONE 7 WATER AGENCY

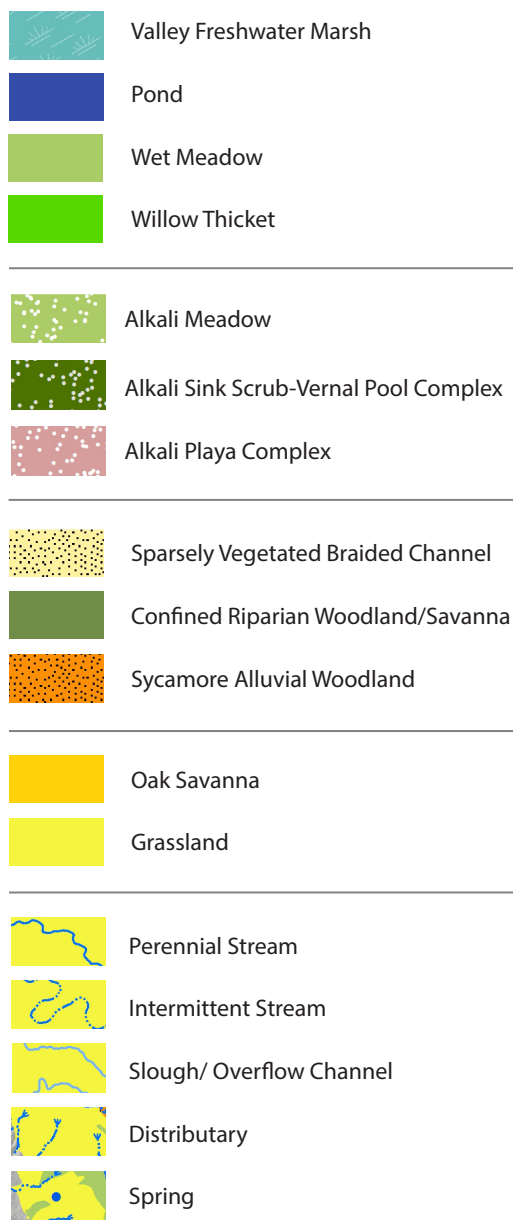
Figure 2.1. Livermore-Amador Valley ca. 1800.

Patterns across Livermore-Amador Valley varied from north to south and from east to west. The two wetland complexes—Pleasanton marsh complex in the west and Springtown alkali sink in the east—were prominent historical features. (Stanford et al. 2013)

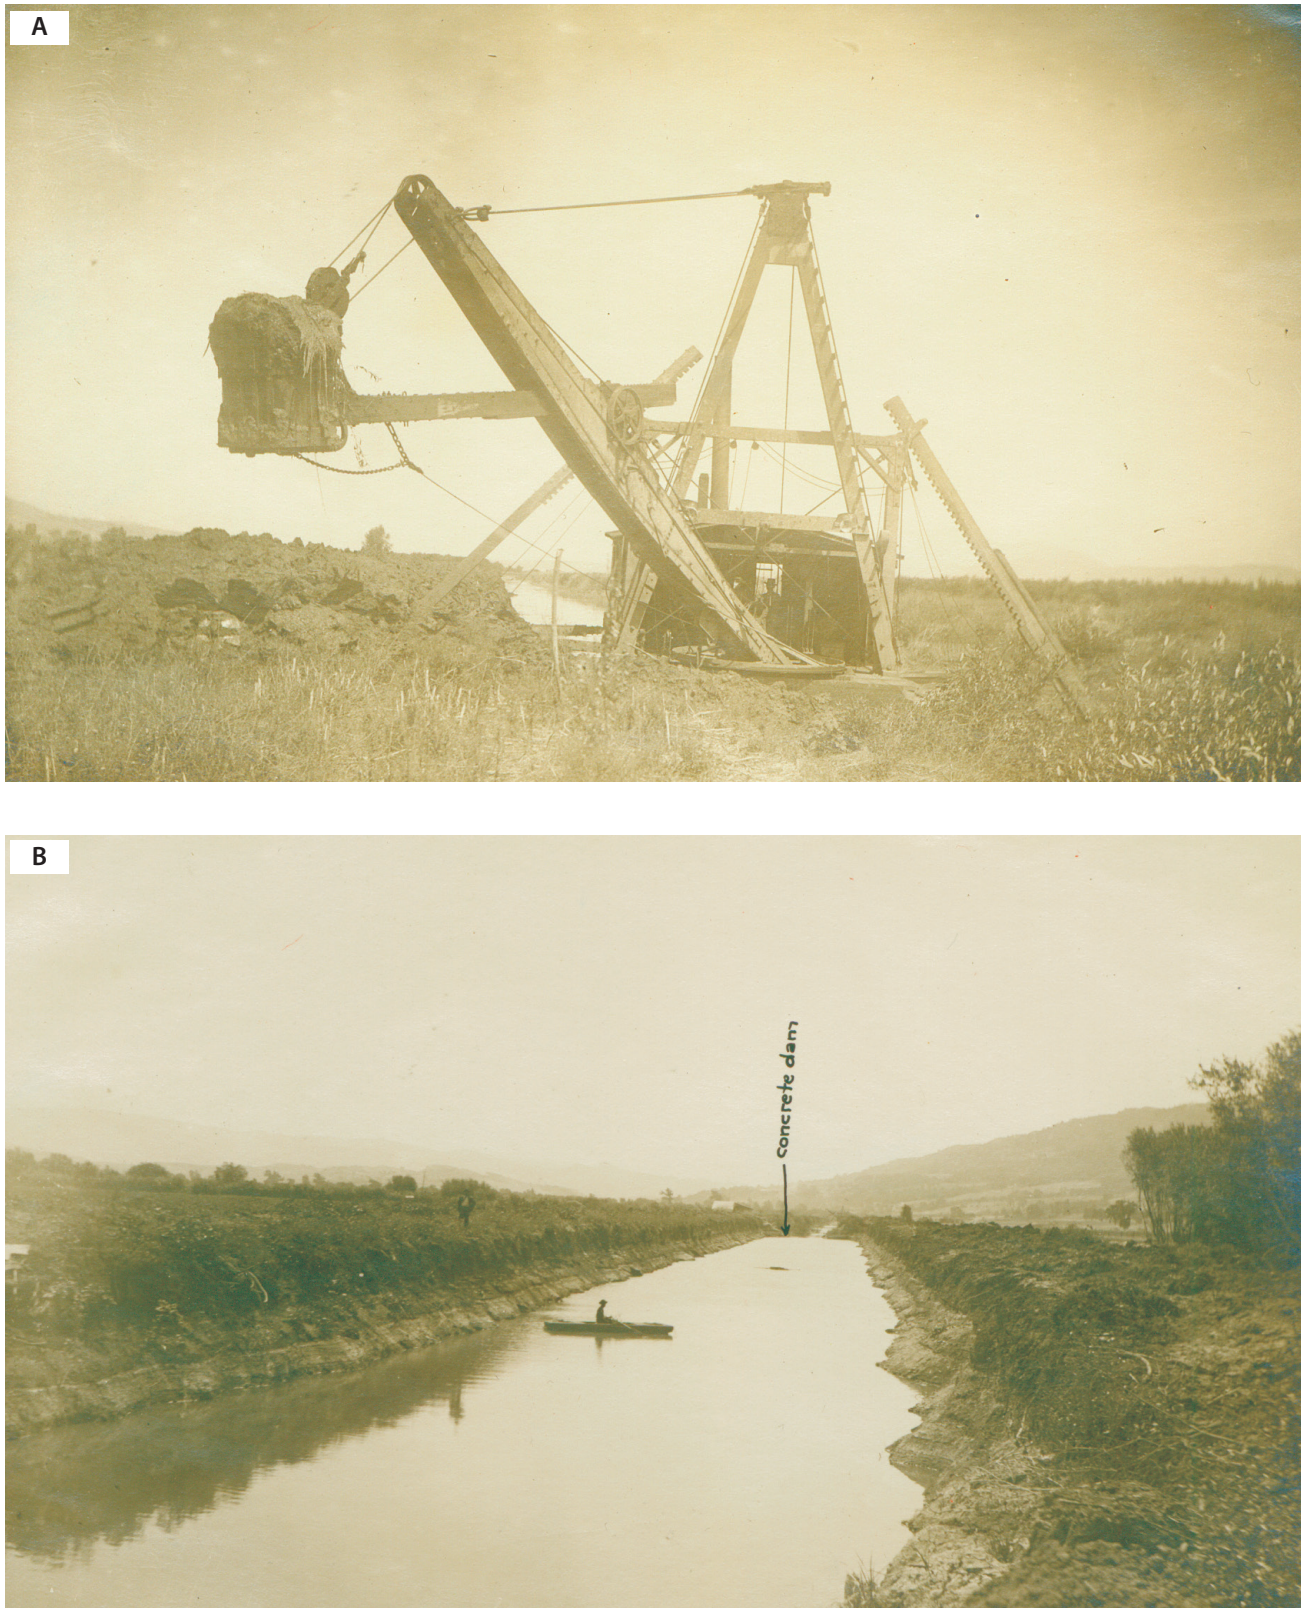
Figure 2.7. Ditching and draining of channels in Livermore-Amador Valley. These images show A. A dredger in action on Arroyo de la Laguna in the early 20th century, and B. The impacts of dredging as seen on the channel banks (Von Geldern 1907). This type of dredging and consequent impacts were widespread in the Livermore-Amador Valley from the 1880s onward into the 20th century.

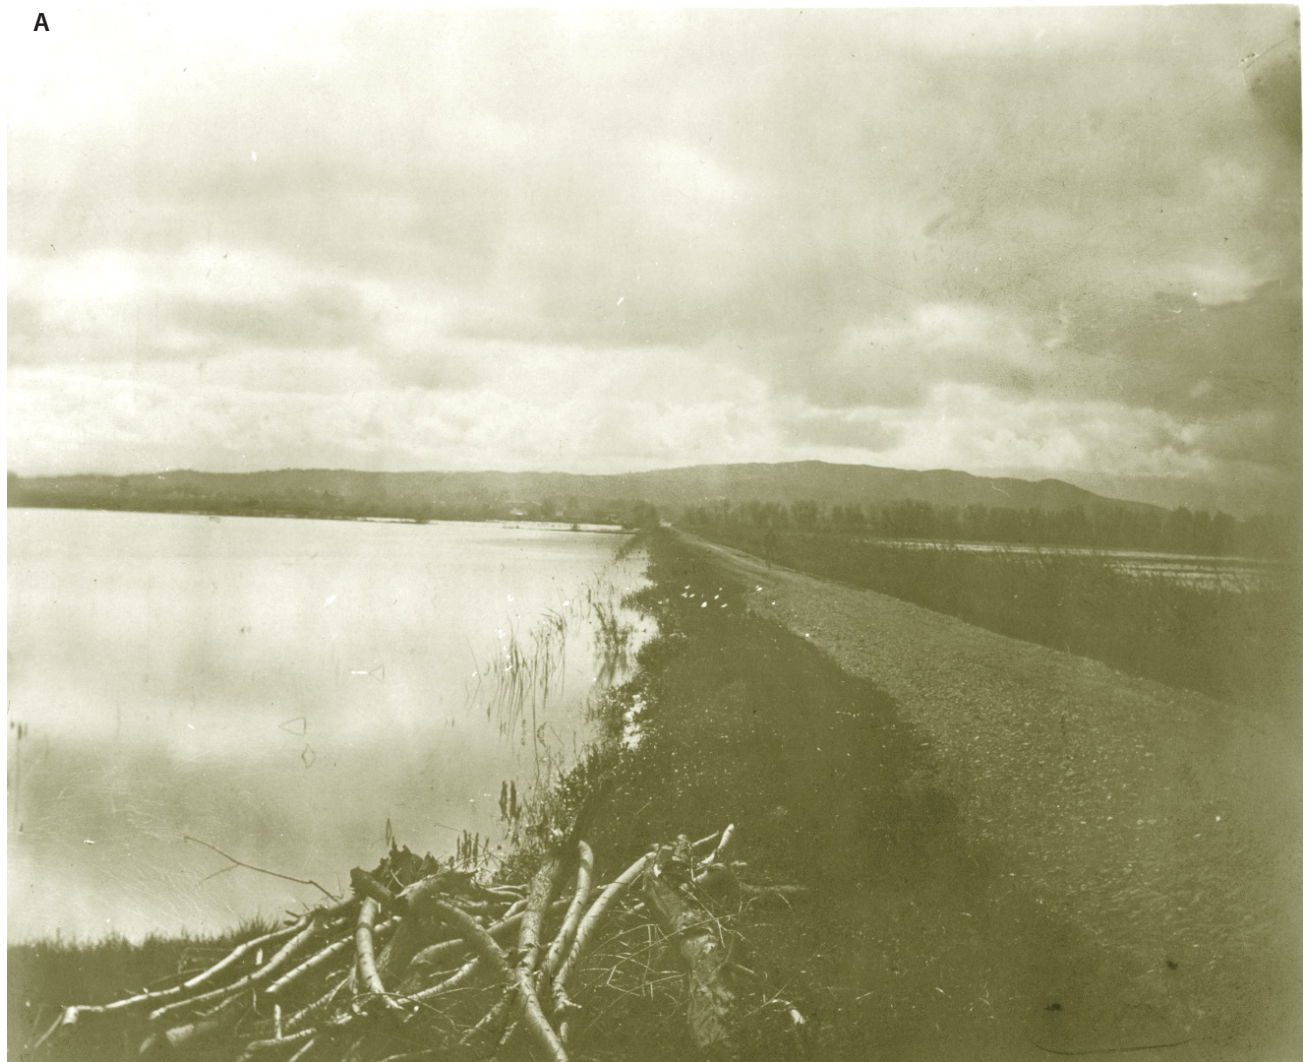
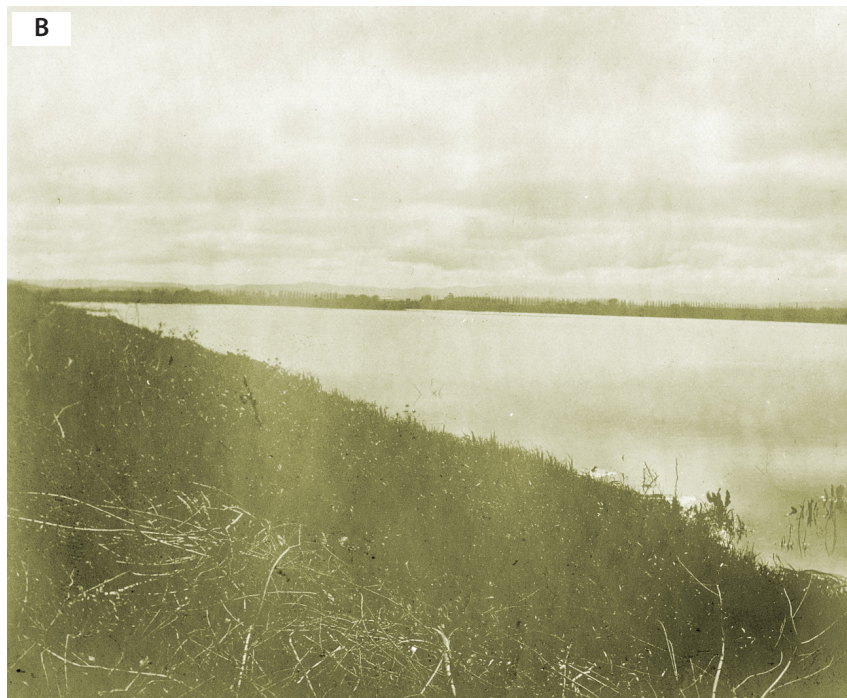
Figure 2.8. Photos of flooded Pleasanton valley in 1907. A. photograph from April 4, 1907, looking south from the bridge over the Chabot Canal. The caption on the original photograph reads, "Old Lake Pleasanton on the left, water two feet deep." B. Photograph from April 4, 1907 looking east along the levee of Chabot Canal from the same bridge (Von Geldern 1907). Flood waters frequently re-occupied the low lying areas of the "Old Lake Pleasanton" until the 1950s.

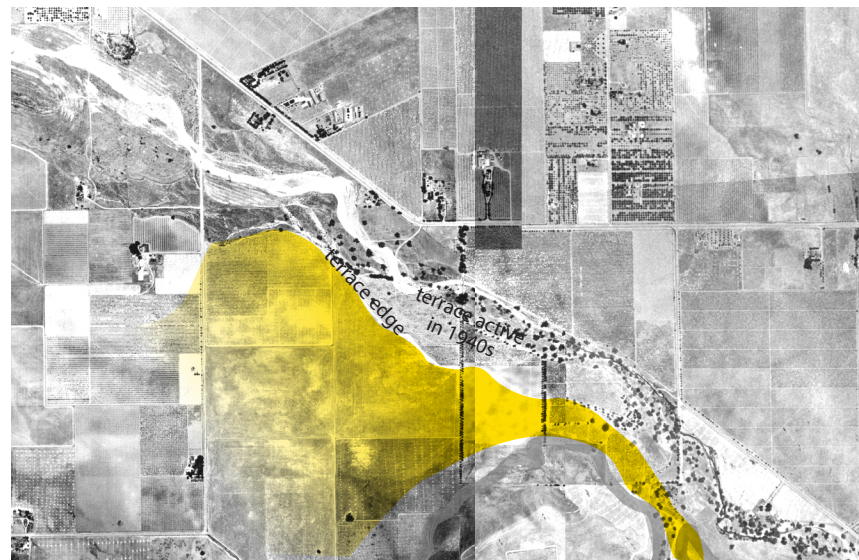
Figure 3.1. Terrace evident in 2007 LiDAR and 1940 imagery. A terrace surface on the south side of Arroyo Mocho is visible in the 2007 LiDAR digital elevation model (the edge of the terrace can be seen in yellow). The terrace is also evident in aerial photography from 1940, when the terrace boundary can be seen at the edge of the cultivated fields. Because Arroyo Mocho has been confined to a single-thread channel, the terrace is no longer active, but the signature of a formerly shifting channel still persists. (USDA 1940, Sanborn Mapping 2007)

Sycamores likely occurred on in-channel bars as well as banks and terraces within the active floodplain, which are discernible in LiDAR images (Figure 3.1). The sycamores themselves reinforced the braided channel form by stabilizing banks and in-channel bars. The width of the riparian corridor ranged from approximately 200 to 1300 ft (60 to 400 meters) (Table 3.1).

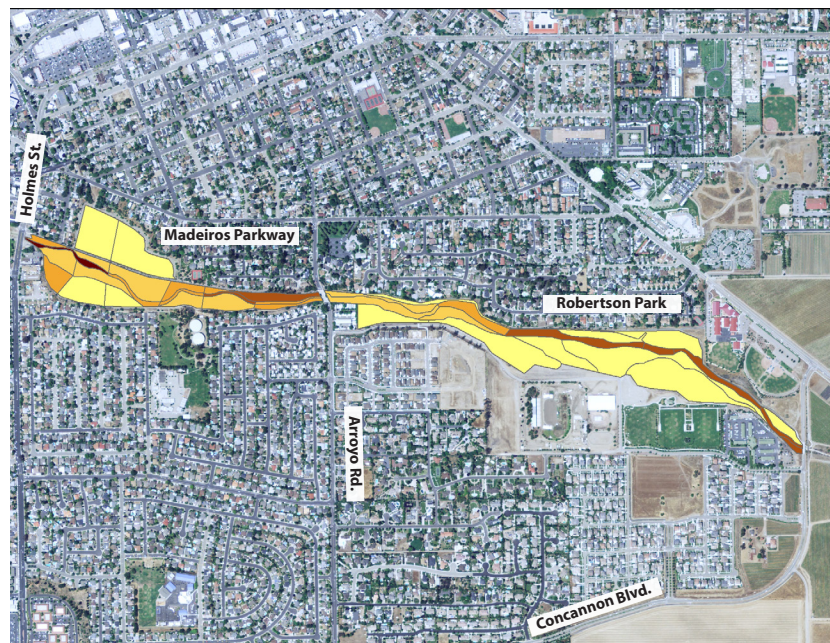
Figure. 3.8. Tree density by geomorphic zone on Arroyo Mocho. We mapped tree density by species type and age class along Arroyo Mocho, focusing on Robertson Park and Madeiros Parkway. Early results showed that while there is a wide corridor of potential riparian habitat, the density of trees is highest in the channels in Robertson Park, with a slightly more even distribution of densities in Madeiros Parkway. For more detail see Appendix B. (USDA 2009)

Trees per acre

was a mix of sycamores, oaks, willows, and shrubs, today willows dominate the low flow channel, accounting for 81% of recorded trees. Seedlings or saplings account for 99% of these willows (see Appendix B). The benches contain a more even mix of (mostly native) tree species, including black walnut, California buckeye, Fremont cottonwood, valley oak, sycamore, eucalyptus, and ornamentals. Mature sycamores have persisted in a number of locations on the inner and outer benches of this reach, most notably in the southwestern portion of Robertson Park near the Del Valle Mobile Home Park and in the southwestern portion of Madeiros Parkway near Holmes Street (Figure 3.9). Mature sycamores were also observed in the backyards of private homes and in the parking lot of Roberston Park, often up to 100 m from the active channel; these trees most likely established during past floods when these areas were part of the active floodplain. Though these sycamores are no longer connected to the hydrologic regime of the channel, we might assume that they are being supported by adequate levels of groundwater. We also observed some sycamore regeneration, concentrated in the inner benches within Madeiros Parkway and several other locations, though regeneration rates appear to be fairly low (Appendix B, Figure B8).

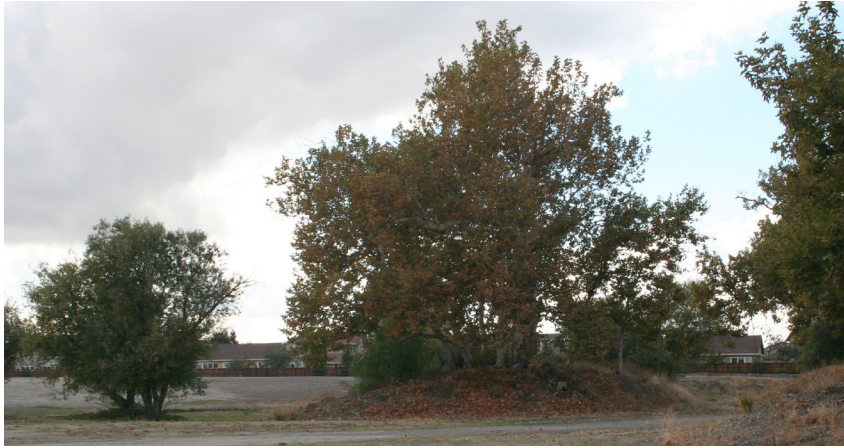
Figure 3.9. Sycamores observed on mounds in parking lot of Robertson Park. Sycamores (*Platanus racemosa*) were observed growing up to 100 m away from the current low flow channel, but within the bounds of the historical extent of mapped riparian habitat (Stanford et al. 2013). Dendrochronology might be used as a tool to reconstruct disturbance regimes in this reach. (photo by Sean Baumgarten, November 1, 2012)

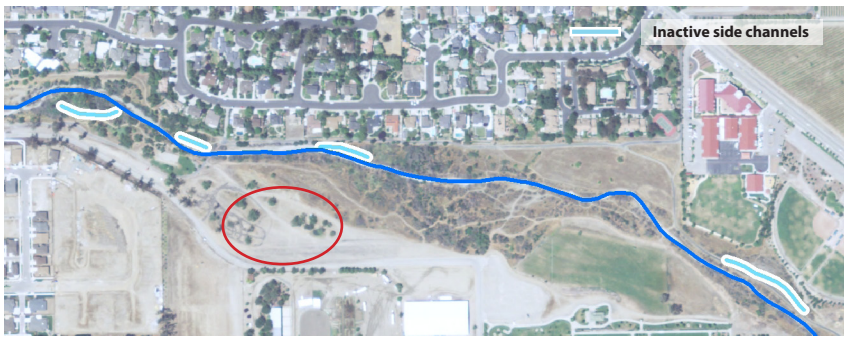
Figure 3.10. Field-observed inactive side channels. Light blue lines indicate the location of several swales or inactive side channels that were observed at low flow conditions in the field (November 1 and 13, 2012). Further observations should be made as to whether these are activated in high flows, or if they could be reconnected with the main stem without the context of future park design and management. (Sycamores shown in Figure 3.10 are circled in red)

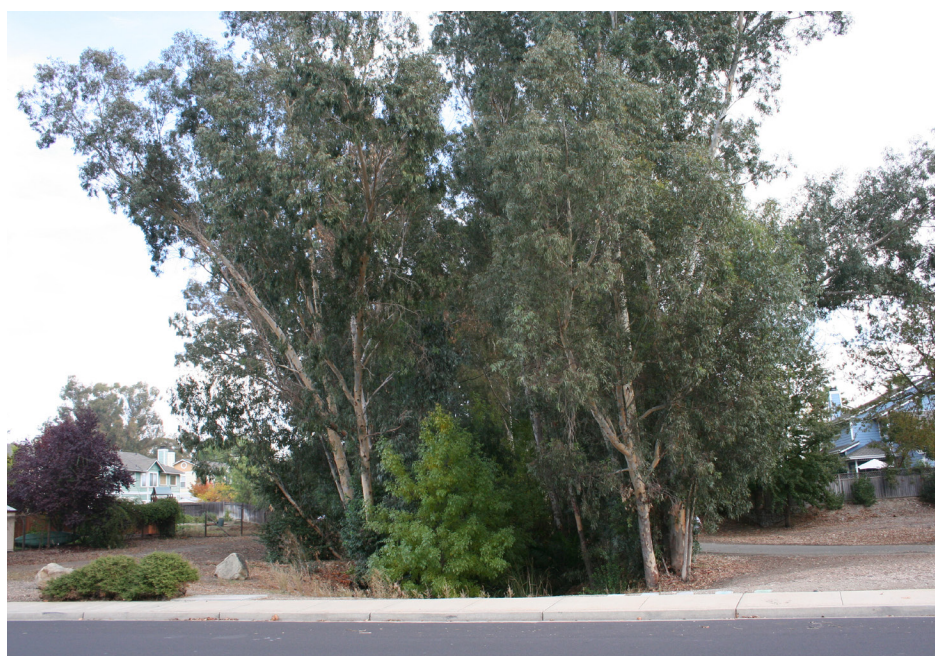
Figure 3.12 View of northern alternate channel (taken from Rockrose Street facing east). This small channel is densely wooded with mixed native riparian trees and eucalyptus (Photo by Sean Baumgarten, November 15, 2012).

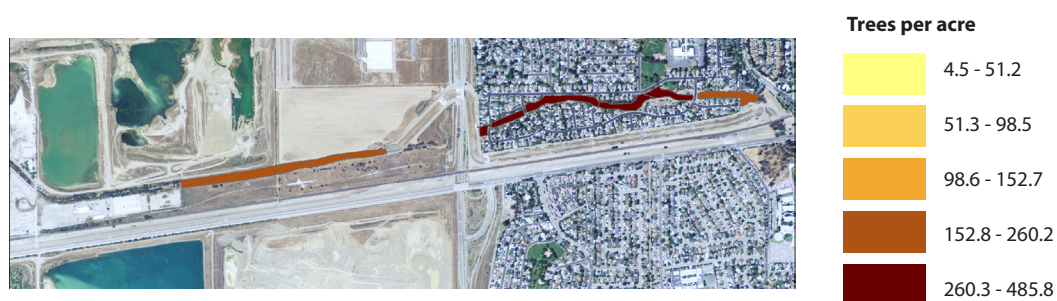
Figure 3.17. Mapped tree density in Case Study 3. We mapped tree density by species type and age class along the Stanley reach of Arroyo Mocho. The side channel (north of the flood control channel) was particularly dense with a mix of native and non-native riparian trees. The downstream reach was still fairly dense by historical standards, but was composed of mostly non-native stands of eucalyptus. See Appendix B for more detail.

The riparian vegetation cover in this reach has undergone dramatic changes over the past century. Historically, the distributaries discharged into grassland dotted with occasional oaks. Aerial photographs from 1940 show a sparsely vegetated channel closely bounded by farmland (Figure 3.16a). Today, the flood control channel east of Isabel Avenue is dominated by non-native grasses and has little habitat value. The alternate channel to the north supports a dense riparian forest of native and non-native species, which we calculated has an average tree density of 358.1 trees/acre. West of Isabel Avenue, the channel is lined by rows of mature eucalyptus, which account for more than 80% of the recorded trees along this portion of the riparian corridor (though we did observe occasional native riparian trees). Figure 3.17 shows the densities of

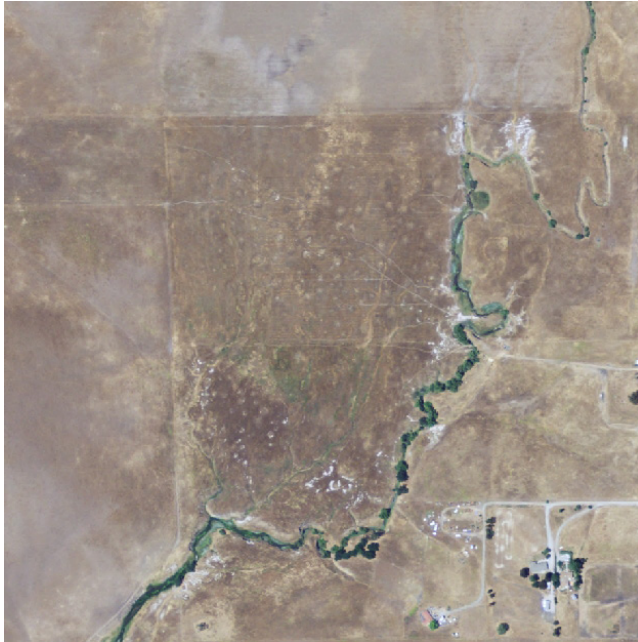
Figure 3.24. Remnant vernal pool complex near Cayetano Creek.

The vernal pools can be identified by a mottled pattern of pools, swales, and mounds visible in the aerial photograph, and their presence was confirmed by local experts (Bartosh pers. comm).

Finally, a privately-owned remnant patch of vernal pool habitat exists along Cayetano Creek, approximately 1/3 mile upstream of the confluence with Arroyo Las Positas (Figure 3.24). Despite its high conservation value, this area is unprotected and at risk from development.

Surprisingly, amidst the quick expansion of urban development in this portion of the Valley and the surrounding hills, an area of high quality vernal pool habitat has been left undeveloped and unplanted along Cayetano Creek (see Figure 3.24). Vernal pool habitats are increasingly rare

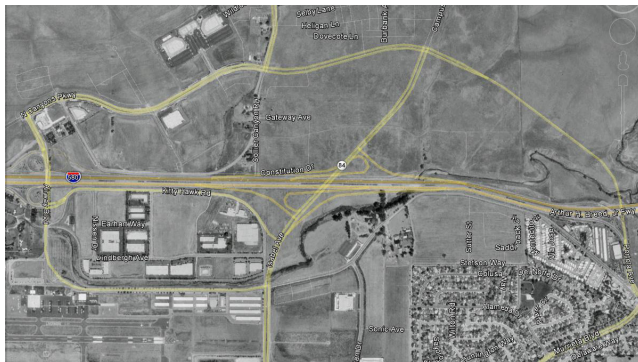
Figure 3.25. Comparison of Isabel Avenue area development between 1993 (top) and 2010 (bottom) showing rapid urbanization throughout the 1990s and 2000s in the northern hills above Arroyo Las Positas. (Google Earth 1993, 2010)

Extensive urbanization has occurred in this area, and along much of this reach Arroyo Las Positas is now bordered by roads, highways (I-580), shopping centers, or other urban development. Much of this development has occurred quite recently. For example, in 1993, much of the area between I-580 and Las Positas Road was still undeveloped (Figure 3.25). The increase in impervious surfaces and surface runoff associated with this widespread urban development has likely contributed to increased streamflow in Las Positas.

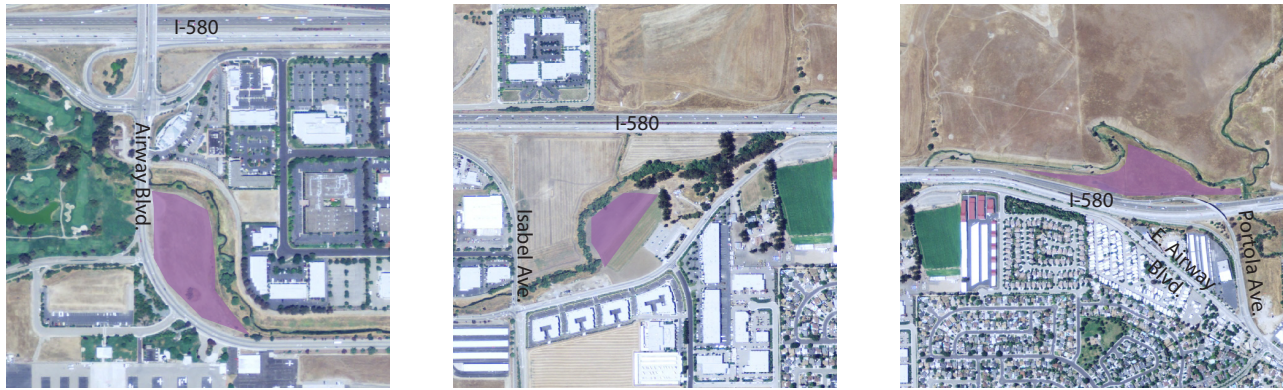
Figure 3.26. Potential locations for new surface water storage, and inset floodplain habitat (in purple). These sites on the valley floor need to be evaluated for land ownership, slope, and contaminants, but are some of the rare creekside open space still remaining that could be conserved for sediment retention or wetlands to mimic historical wet meadow/willow grove floodplain functions. These sites would need to be excavated down to allow for reconnection to the channel, and thus re-use of the removed dirt will need to be evaluated. These sites are also not the only potential places for inset floodplains on Arroyo Las Positas, and other sites should be evaluated as well. (USDA 2009)

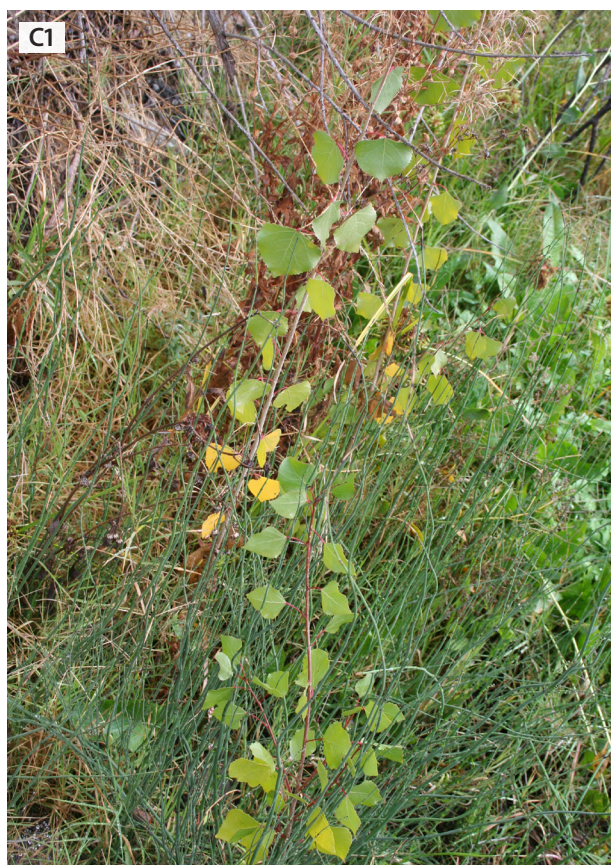
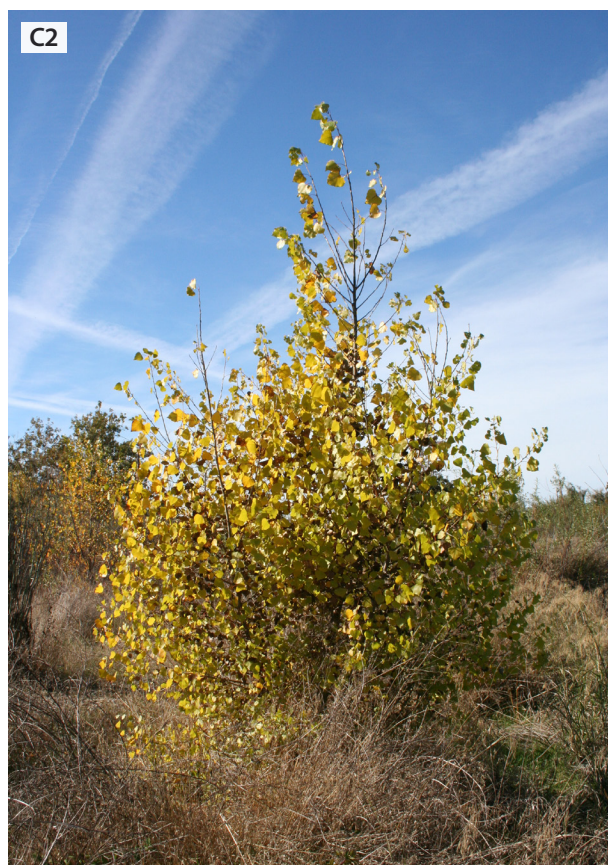
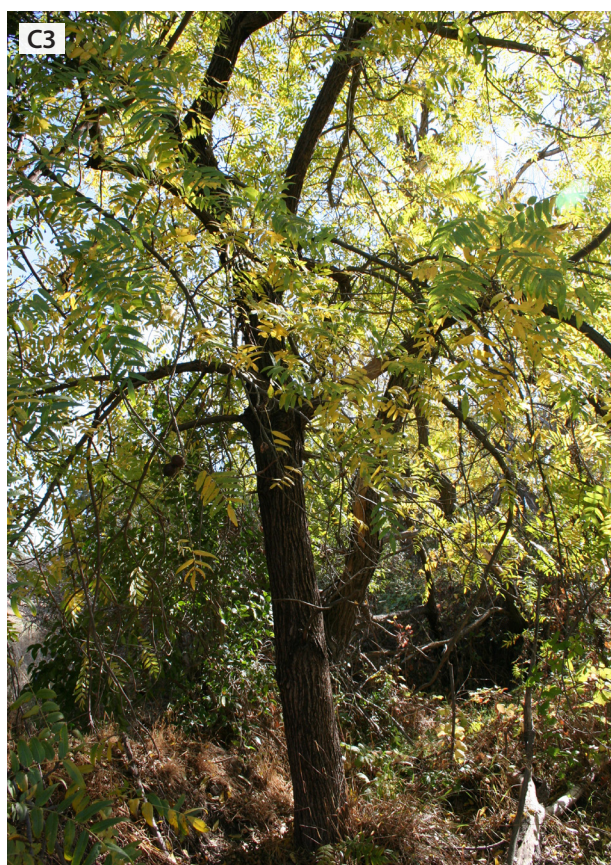
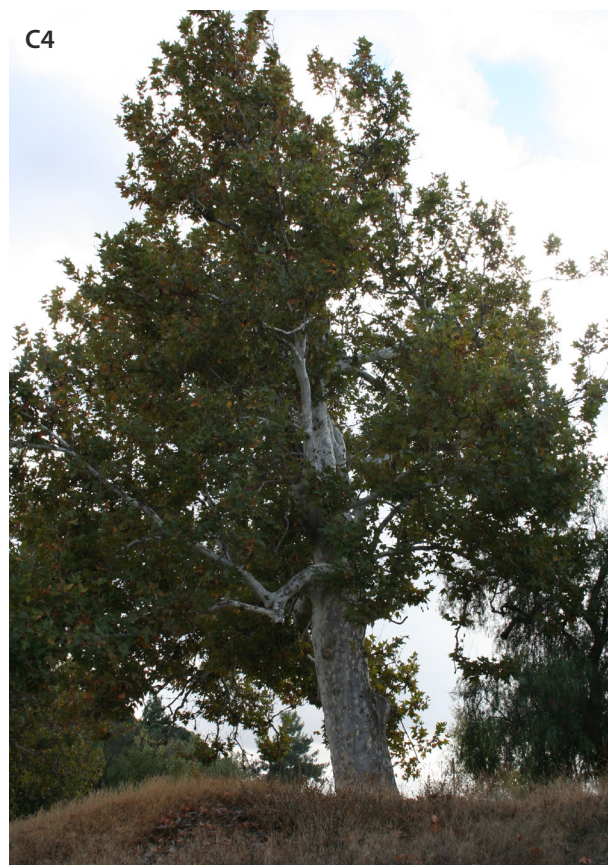
Figure B1. Representative photographs of trees in each of the four size classes used in the field surveys. C1 includes seedlings and small saplings, C2 includes medium to large size saplings, C3 includes small to medium-sized trees, and C4 includes mature trees. (photos by Sean Baumgarten and Julie Beagle, November 2012)
