HISTORICAL ECOLOGY RECONNAISSANCE FOR THE LOWER SALINAS RIVER

Prepared for The Nature Conservancy

Monterey County Project

August 2009

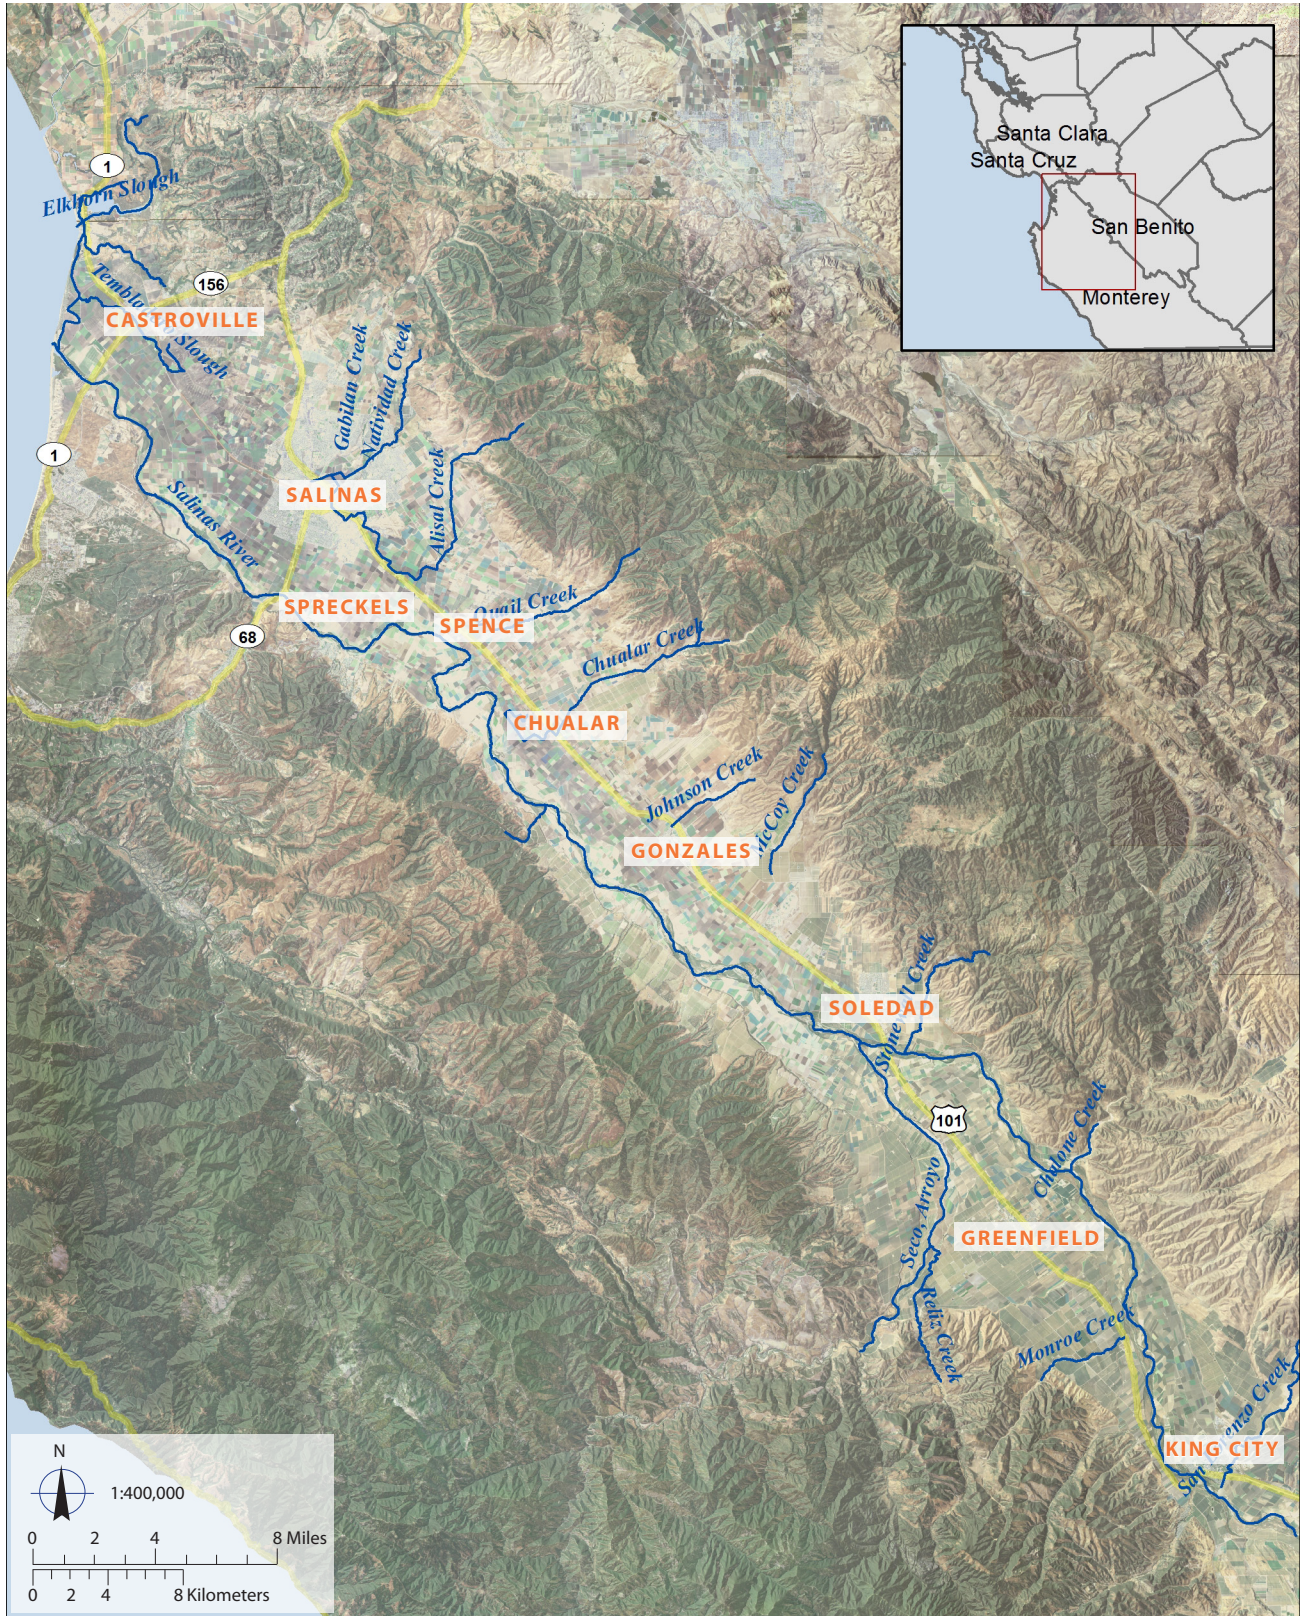
Figure 1. The study area for the Salinas River reconnaissance extends from its confluence with Arroyo Seco downstream to Monterey Bay. Place names mentioned in the report are shown in orange. (Aerial imagery courtesy of NAIP)

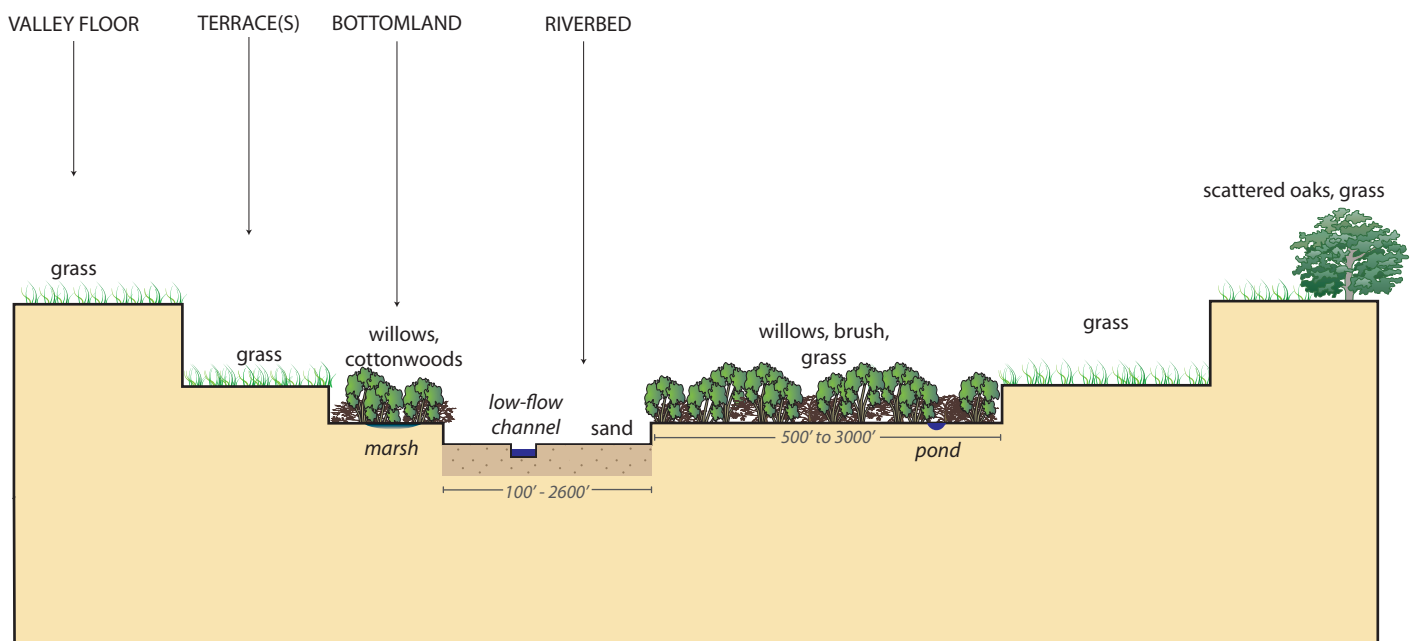
Figure 3. Preliminary conceptual model of channel morphology and riparian habitat along the Salinas River. The sandy active channel is flanked by bottomland riparian forest on one or both sides of the river. Riparian forest included willows, cottonwoods, and other trees (plus brush, grass, lakes, and wetlands). Abandoned terraces (of variable number, depending on the reach) were characterized by drier vegetation, such as grasses and scattered oaks. Characteristics varied by reach; in some instances, broad bottomland occurs on only one side of the channel (see fig. 4).

The morphology of the Salinas River seems to have been broadly consistent over much of its lower course (figs. 3-5). Sets of bluffs and broad benches bounded the river. These benches were often called “bottoms” or “bottomland” by surveyors and travelers, who distinguished between “low bottoms” or “first bottoms” immediately adjacent

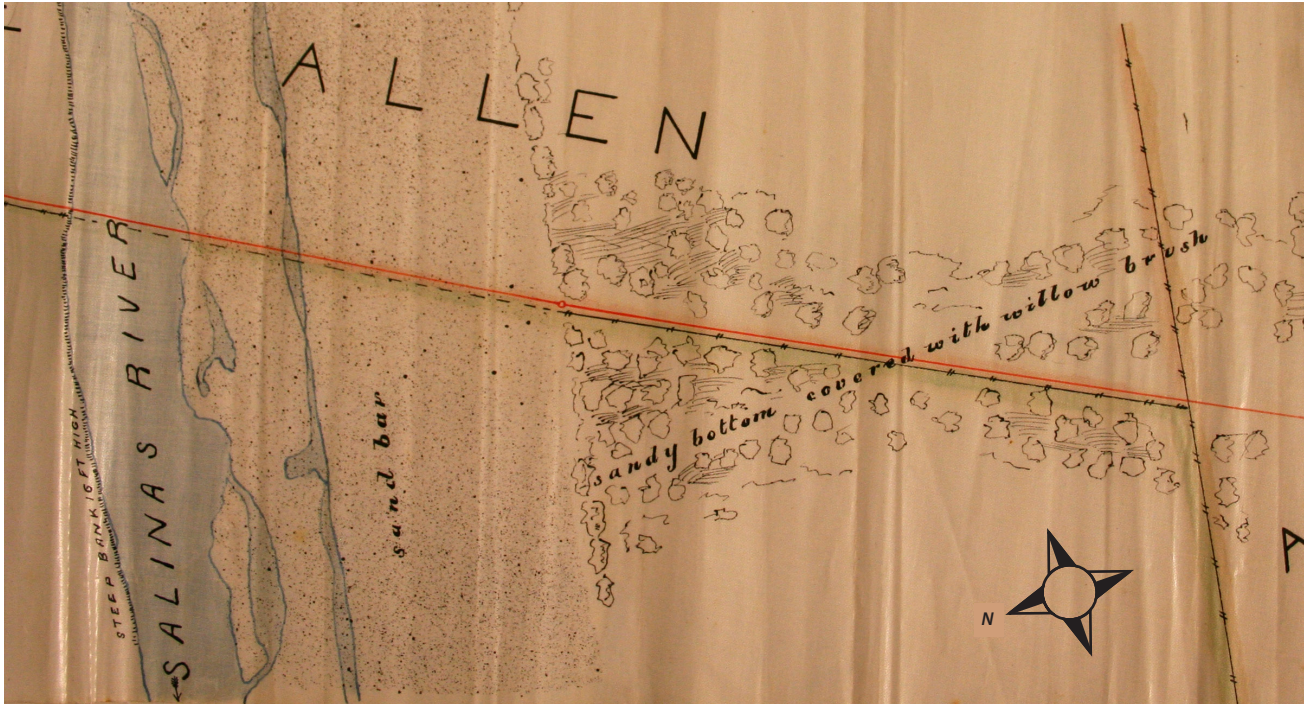
Figure 4. Salinas River near Soledad, 1895. The preliminary conceptual model in figure 3 is supported by many historical documents, such as this 1895 map. The map depicts the river morphology in plan form: a steep bluff bank on the right bank, and a sand bar in the riverbed below the left bank. The bottomland along the left bank is covered with willows. (Hare 1895, courtesy of Monterey County Department of Public Works)

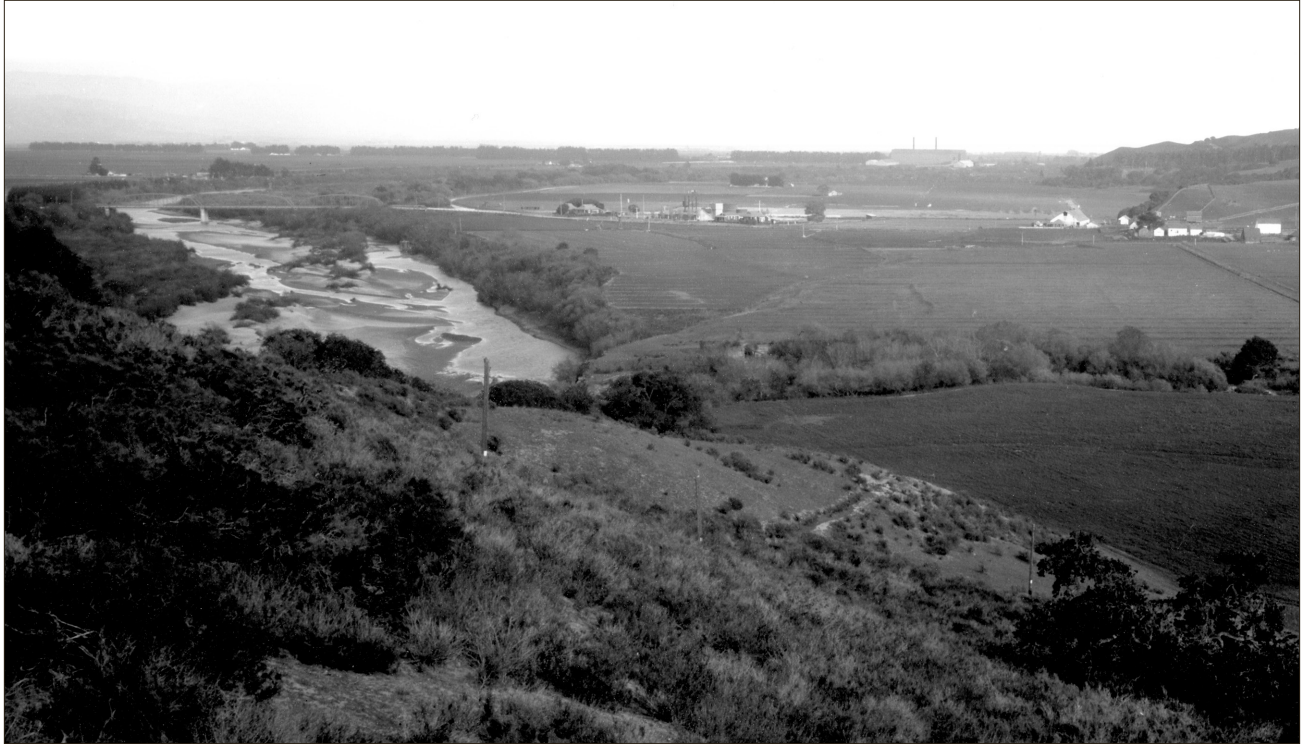
Figure 5. Salinas River downstream of the Highway 68 bridge, looking upstream, ca. 1900. In contrast with the reach depicted in figure 4, this birdseye view shows the river in an area with relatively narrow riparian forest. Dense riparian vegetation occupies the bottomland between the plain and the riverbed, while the riverbed itself is sandy, mostly unvegetated, and not far below the level of the plain. (Unknown ca. 1900, courtesy of California Views)

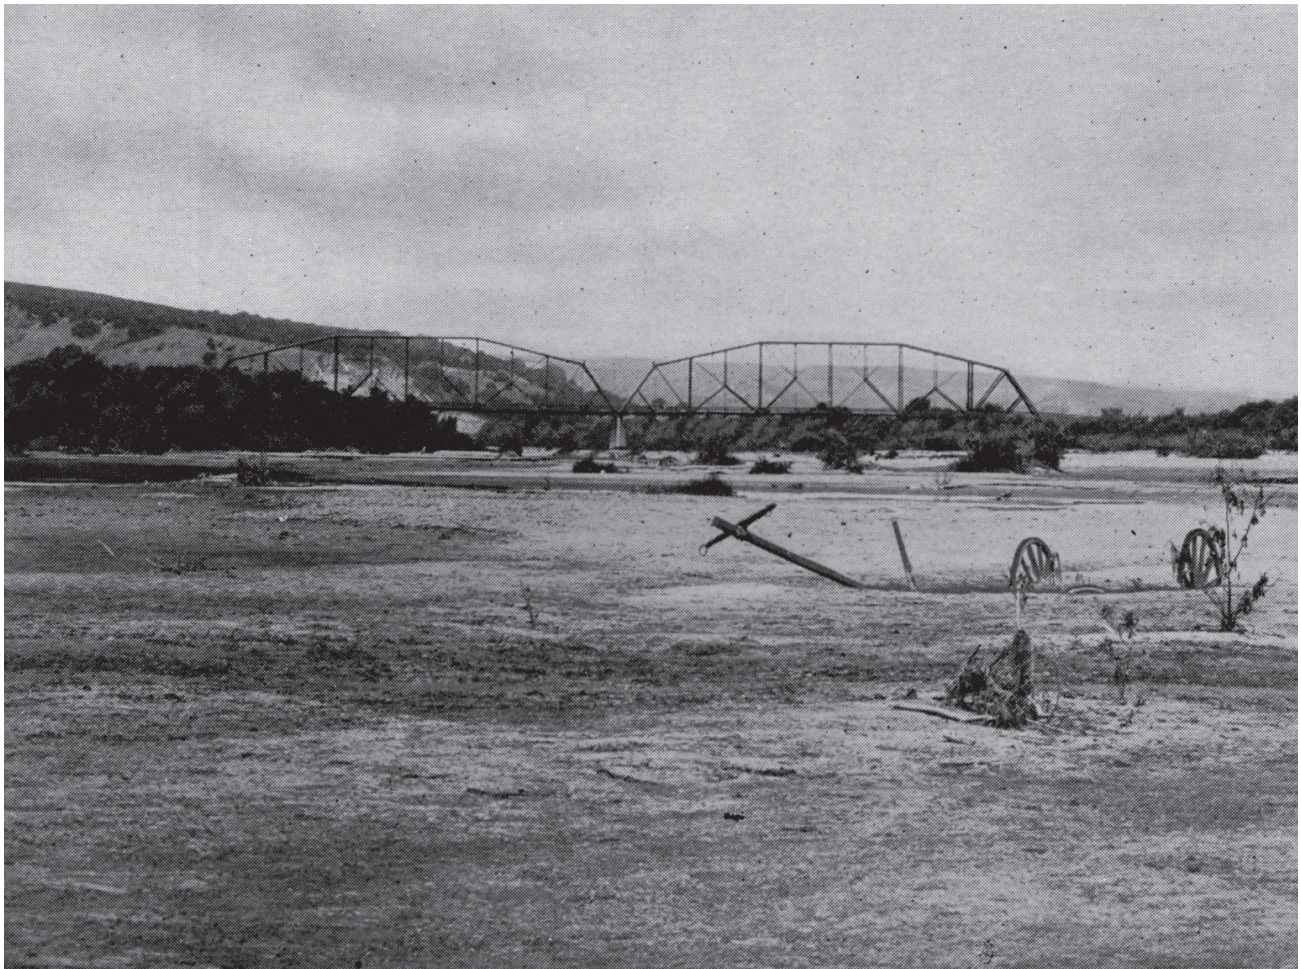
Figure 6. “Salinas River above gaging station at Monterey Road bridge, near Salinas — shows quicksand in bed of stream,” ca. 1901. This photograph shows the bare, nearly unvegetated sandy bed of the river. The vegetated bottomland is visible in the background. (Hamlin 1904)

mile wide, bare or sparsely vegetated with willows and grasses (Lapham and Heileman 1901, Carpenter and Cosby 1925; fig. 6). Low-flow channels occupied a small portion of the riverbed. Unlike the extremely sandy bed of the Salinas River, the sediment load of Arroyo Seco was coarse. Arroyo Seco was described as a “broad wash of gravel and sand” (Hamlin 1904), and surveyors encountered granite boulders in its bed just west of Greenfield (Freeman 1855).

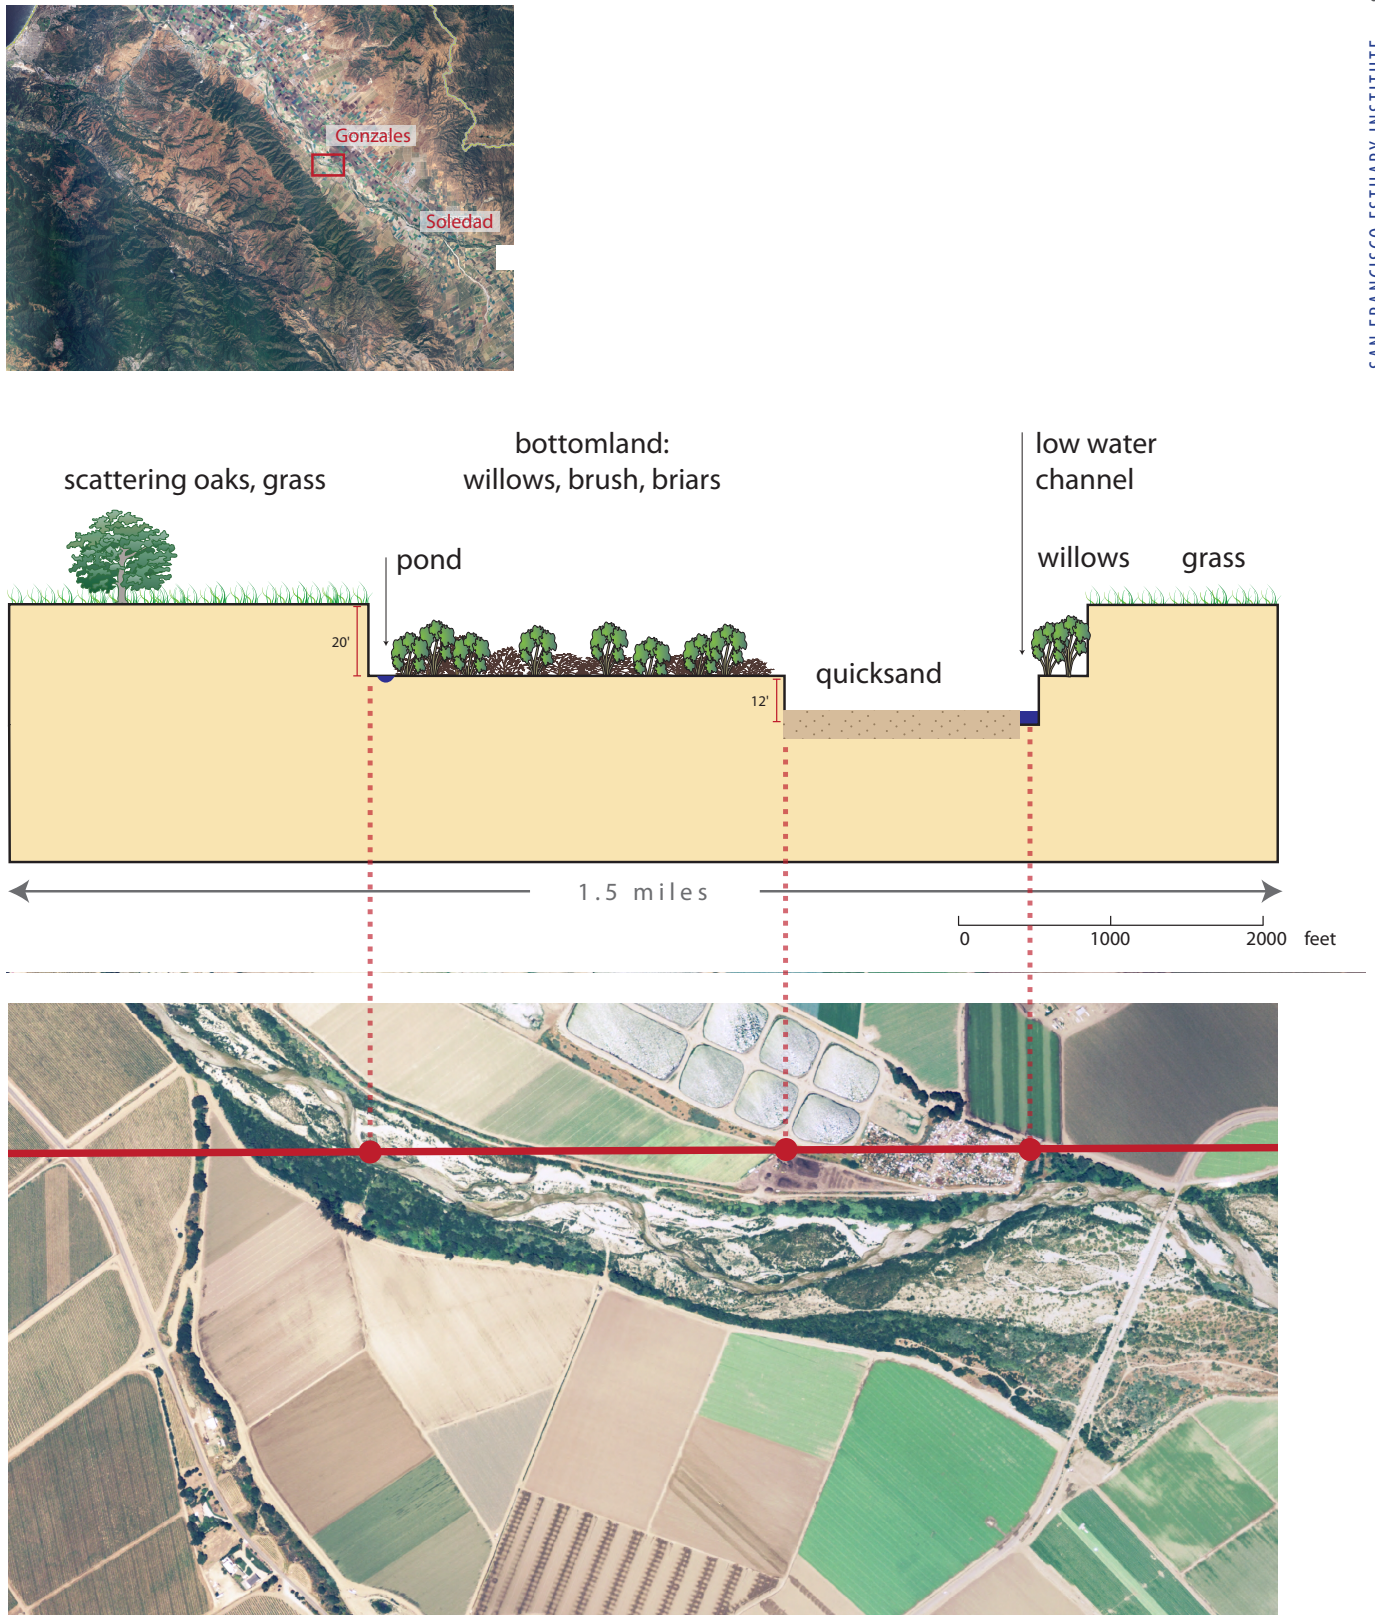
Figure 10. Cross section across the Salinas River southwest of Gonzales, based on 1855 GLO survey data. Willows, brush, briar, and a pond occupy the broad bottomland twelve feet above the left bank, while the riverbed itself is sandy and bare. While the channel appears to have shifted in the contemporary aerial (2005), the riparian vegetation is substantially narrower, though still broader on the left bank. (Freeman 1855; USDA 2005, courtesy of NAIP)

Extensive, often dense riparian vegetation along the Salinas River occurred on low bottomland benches adjacent to the sandy, high-flow river channel. These areas were colonized predominantly by willows and other riparian species in large areas of mixed riparian forest or willow scrub. Riparian forests were common along one or both sides of the river, commonly 500 to 3,000 feet wide (fig. 10).

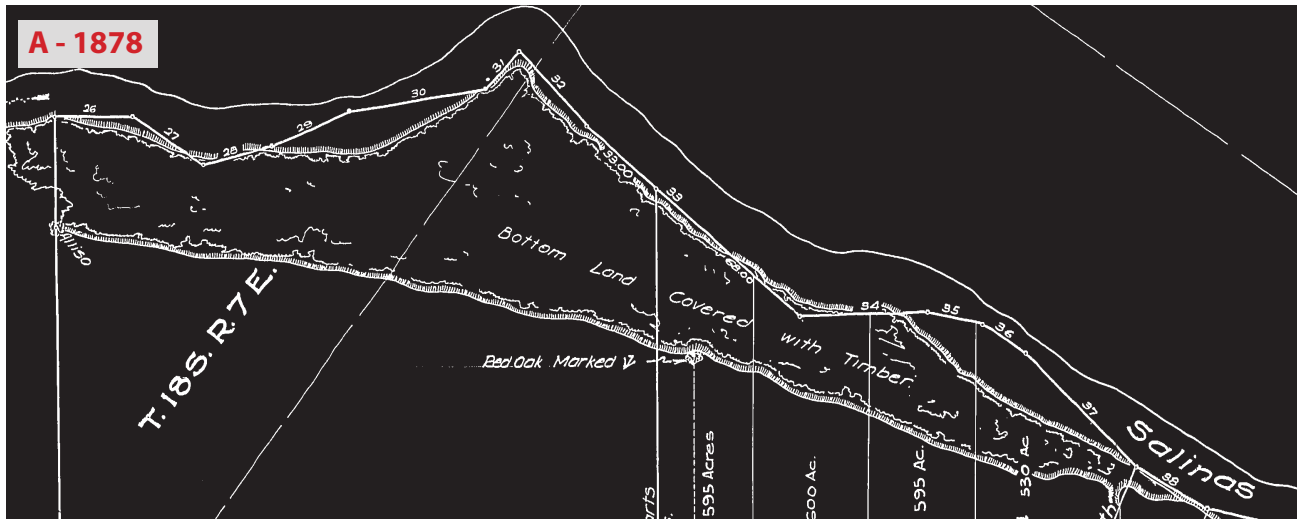
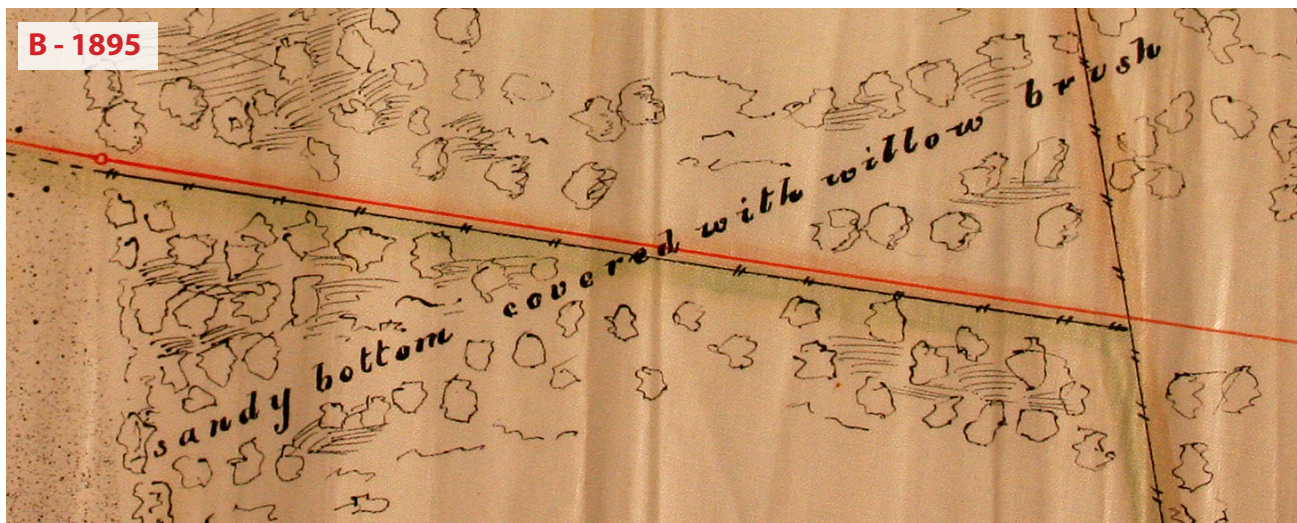
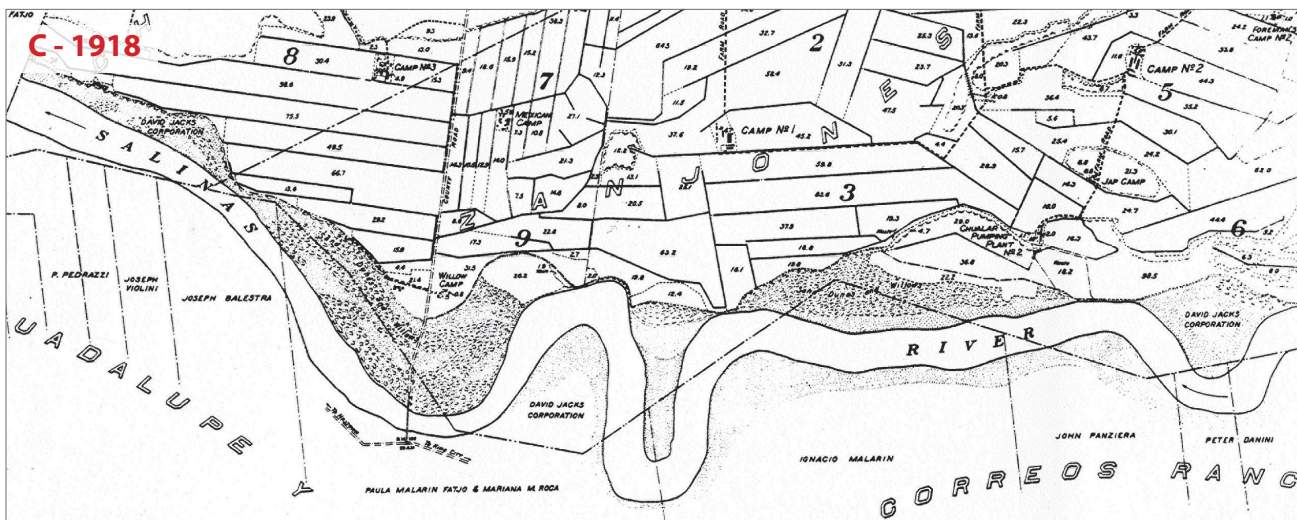
Figure 11. Depictions of extensive riparian timber along the Salinas River. Maps often specified riparian characteristics with labels such as “willow brush,” “sand dunes and willows,” “bottom land covered with timber,” or “willow and cottonwood grove.” (A: Cahill 1878, courtesy of the Monterey County Assessors Mapping Department; B: Hare 1895, courtesy of Monterey County Department of Public Works; C: Unknown 1918, courtesy of the Monterey County Historical Society)

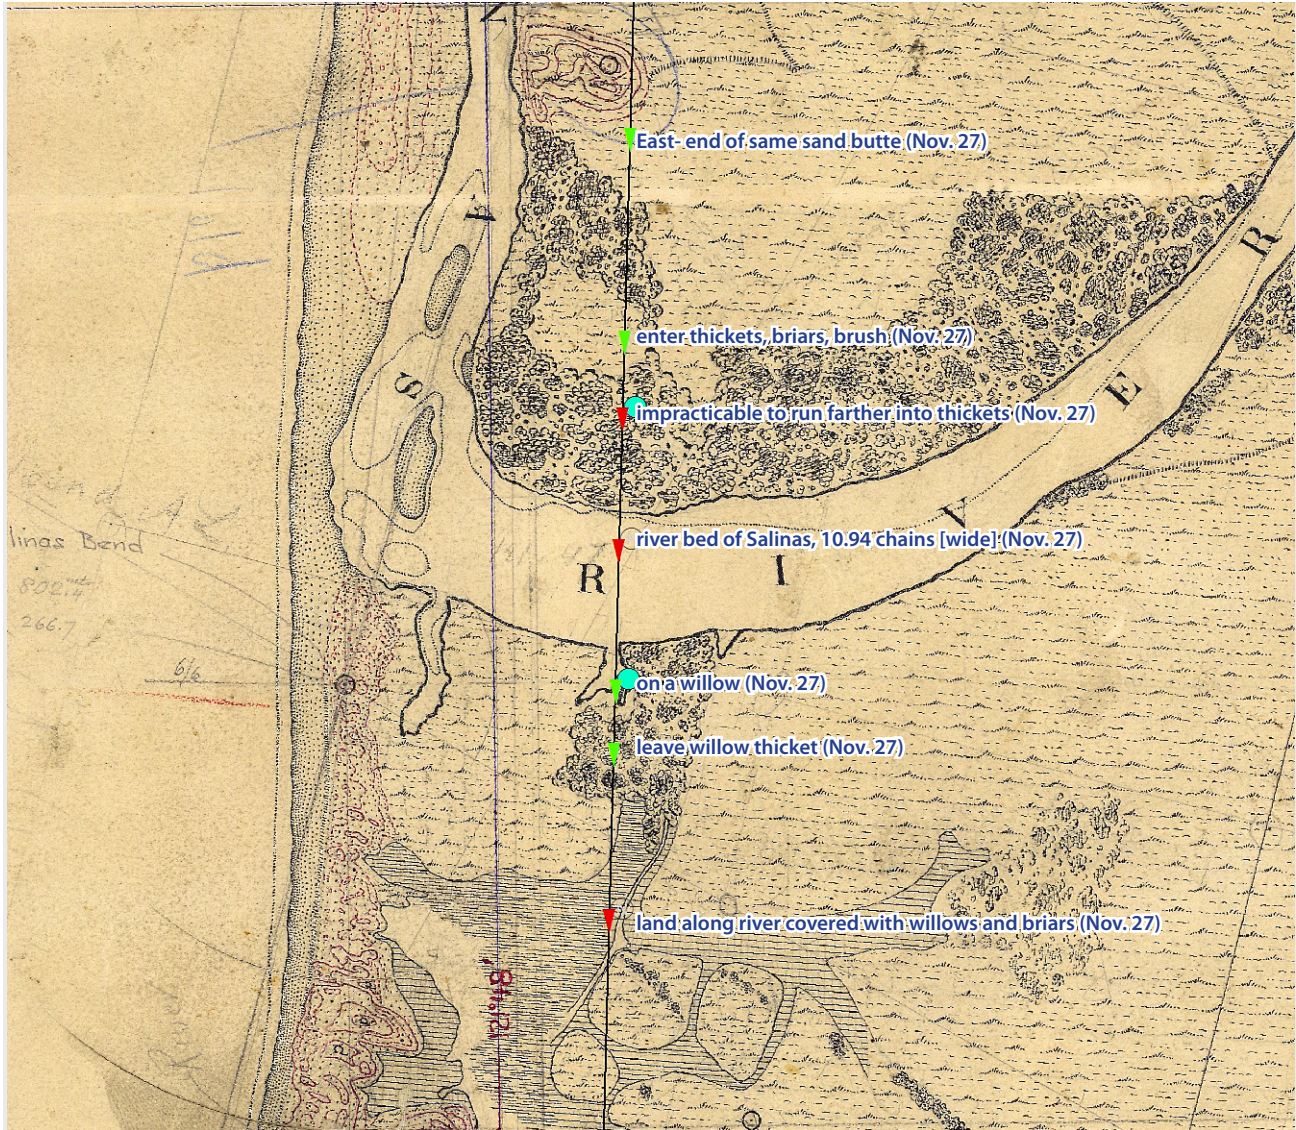
Figure 12. Salinas River mouth, 1854. Dense willow thickets were shown on the lower Salinas River where it was deflected north by the sand dunes on the shores of Monterey Bay. Both the U.S. Coast Survey (June) and the GLO (November) surveyed this area in 1854, five months apart, affording an opportunity for independent validation of the datasets. The GLO descriptions of “willow thicket” correspond closely to the tree symbol mapped by the USCS. The georeferenced positions of these historical datasets match well in the east-west direction, but are misaligned by about 250 feet in the north-south direction (as can be seen by the location of the “sand butte” near the top of the image). (USCS: Johnson 1854b, courtesy of the National Oceanographic and Atmospheric Administration; GLO: Freeman 1855)

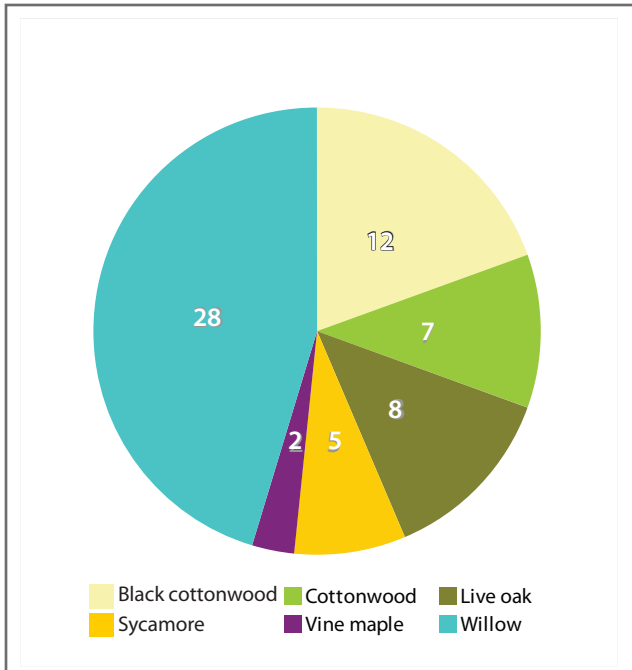
Figure 13. Number and proportion of tree species from the General Land Office bearing tree dataset. Willows represented almost 50% of the riparian trees encountered, black cottonwoods (“Balm of Gilead”) were 20%, Fremont cottonwoods and live oaks were each just over 10%, sycamores were 8%, and vine maples were 3%.

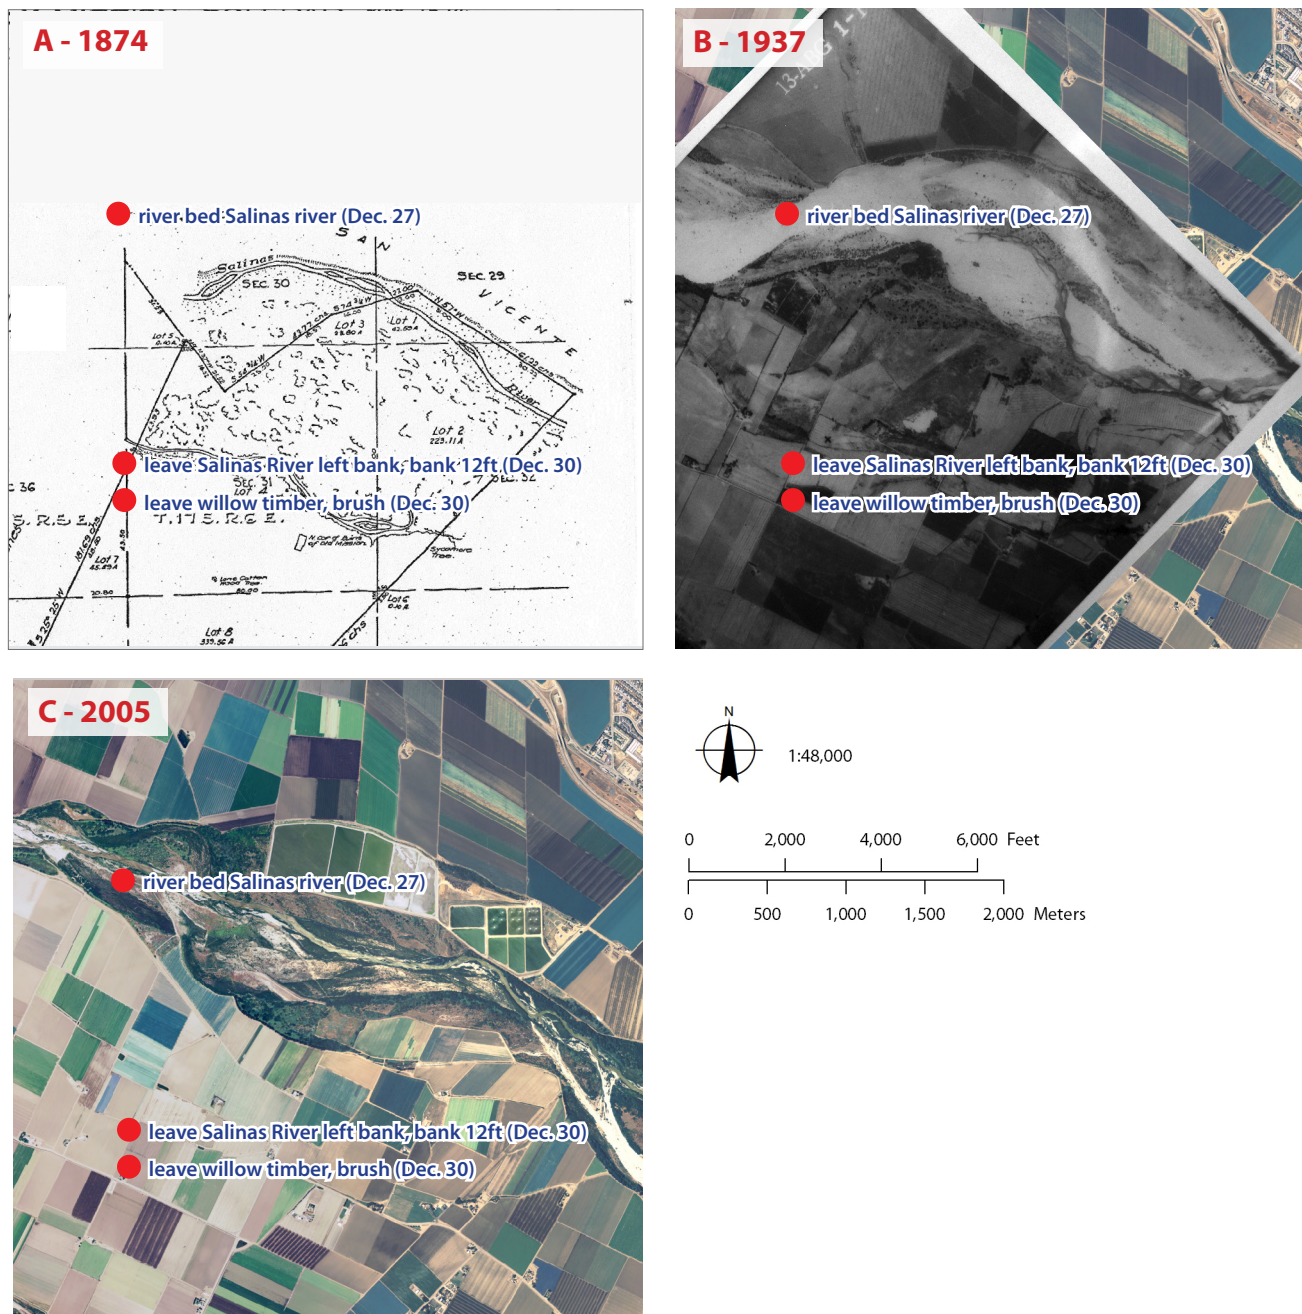
Figure 14. Change in riparian vegetation along the Salinas River, near Soledad. This was one of the widest areas of riparian forest we encountered in historical records, with dense willows and multiple side channels (A). It illustrates loss of riparian vegetation along the lower bottomland, largely by 1937 (B). Narrowing of the riparian corridor has likely occurred over many areas along the river (C; Gordon 1985). (A: Von Leicht 1874, courtesy of the Monterey County Assessors Mapping Department; B: USDA 1937, courtesy of the Science & Engineering Library Map Room, UC Santa Cruz; C: USDA 2005, courtesy of NAIP; GLO: Freeman 1854)

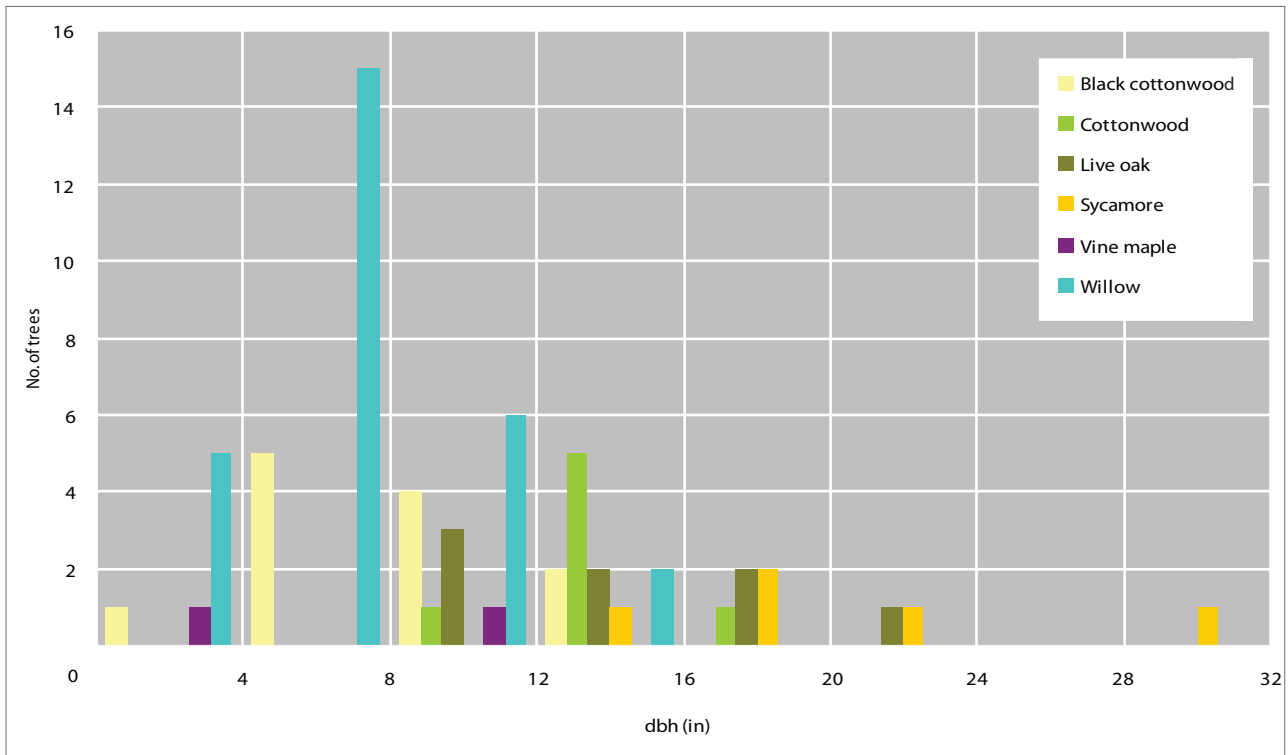
Figure 15. Histogram of tree diameter at breast height (in 4 inch bins) for General Land Office bearing trees located within riverwash and floodplain sands. The extent was determined by the Metz soils of the 1925 soils map (Carpenter and Cosby 1925).

To better understand the time frame for riparian forest development, we examined tree trunk diameters as recorded for bearing trees in the GLO surveys. We assembled trunk diameter data within the likely riparian zone. Both willows and maples had an average diameter of 7 in. Black and Fremont cottonwoods had average diameters of 9 in and 16 in, respectively. The average live oak diameter was 16 in, and the average sycamore diameter was 21 in. Only three diameter measurements (of any species) exceeded 24 in. Tree species that likely represent a more mature riparian forest, such as live oaks and sycamores, were larger than those species dominant in younger forests, such as willows (fig. 15).

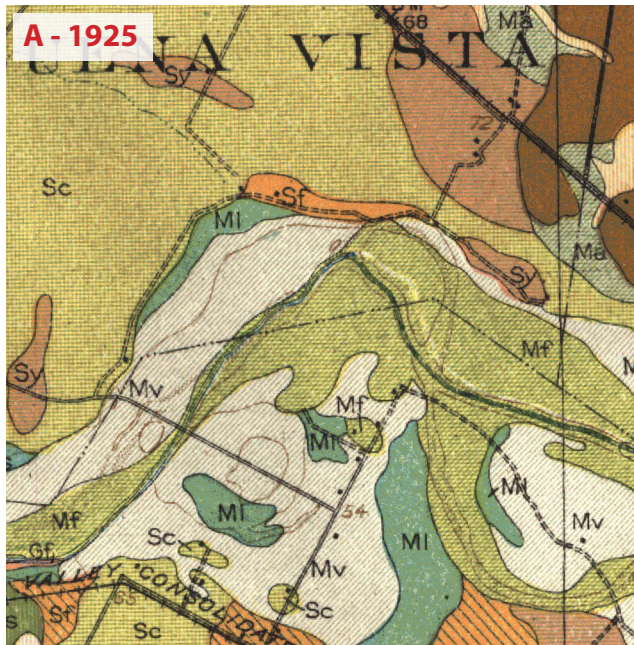
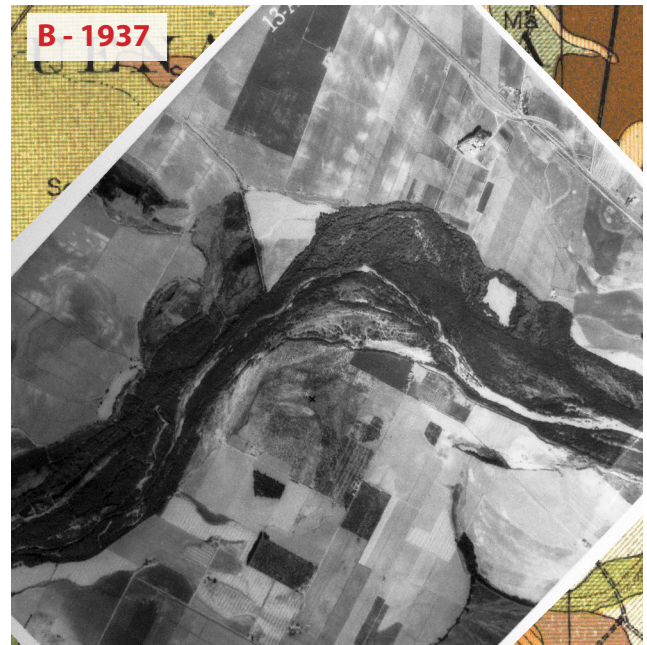
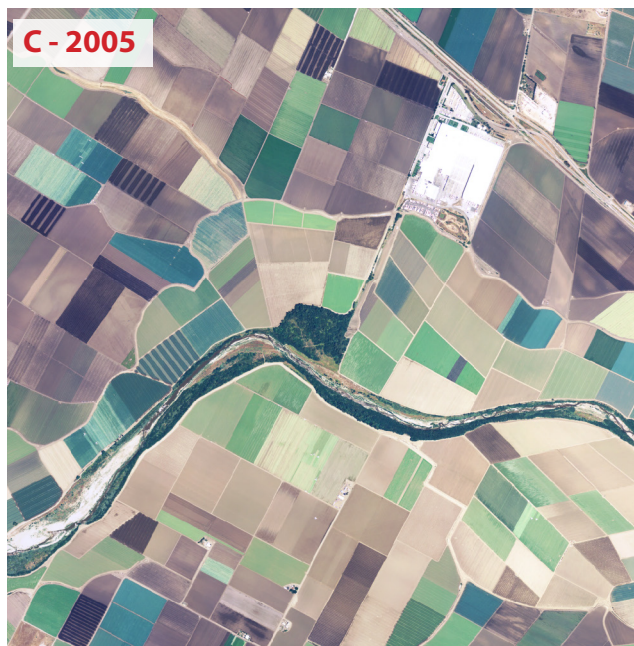
Figure 16. Change in dense riparian forest along the Salinas River, near Spreckels. Areas shown by MI, Mf, and Mv soil types were reported as dense willows by the 1925 soil survey (A), much of which can still be seen in the 1937 aerial (B). Bottomland bluff boundaries and a relatively large riparian remnant can be seen in 2005 (C). (A: Carpenter and Cosby 1925; B: USDA 1937, courtesy of the Science & Engineering Library Map Room, UC Santa Cruz; C: USDA 2005, courtesy of NAIP)

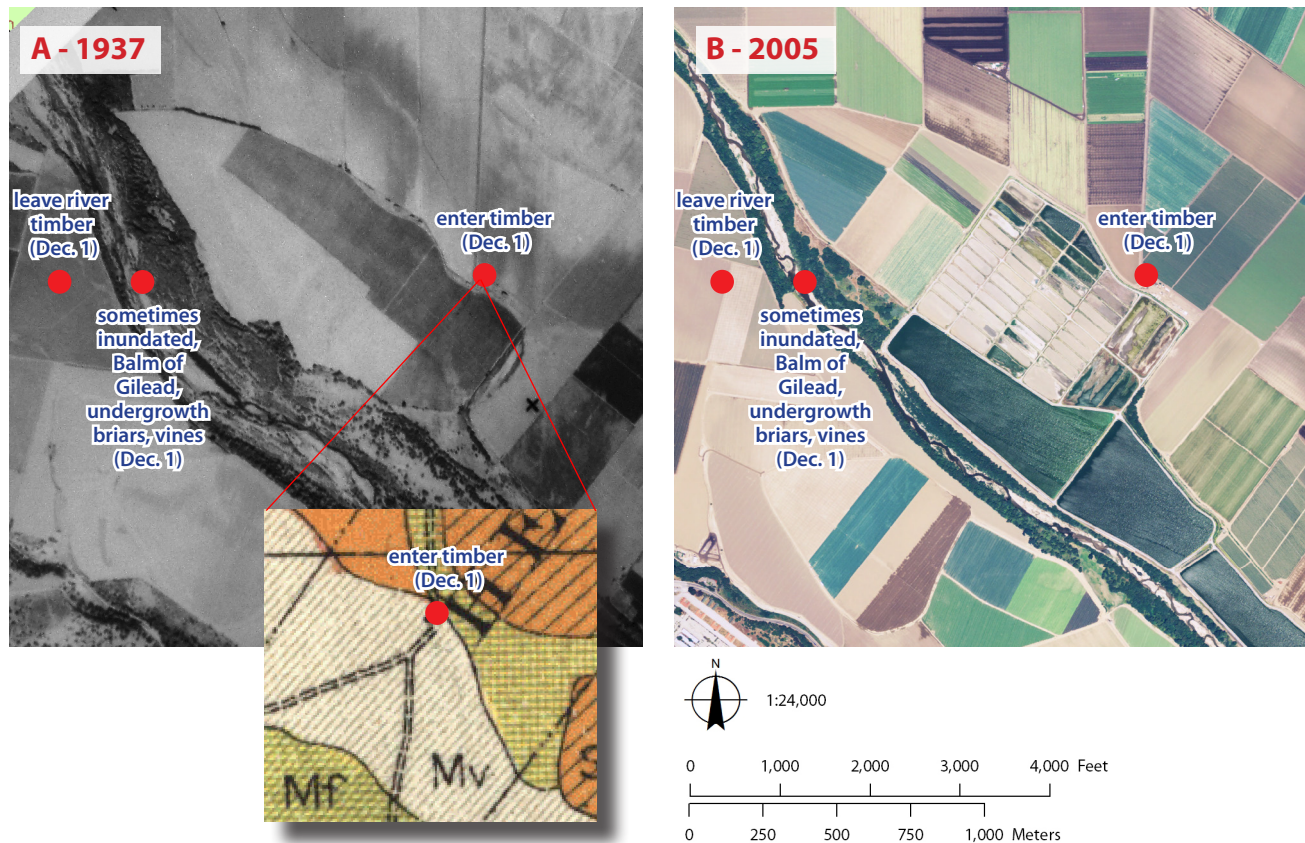
Figure 17. Change in riparian vegetation along the Salinas River, near Salinas. In 1854, a GLO surveyor noted willow timber (“enter timber”) far before it occurs in either the 1937 (A) or 2005 (B) aerial imagery. This coincides with the bottomland boundary of the river, visible on each aerial, and with the Mv soils boundary (inset). (A: USDA 1937, courtesy of the Science & Engineering Library Map Room, UC Santa Cruz; B: USDA 2005, courtesy of NAIP; inset: Carpenter and Cosby 1925; GLO: Freeman 1854)

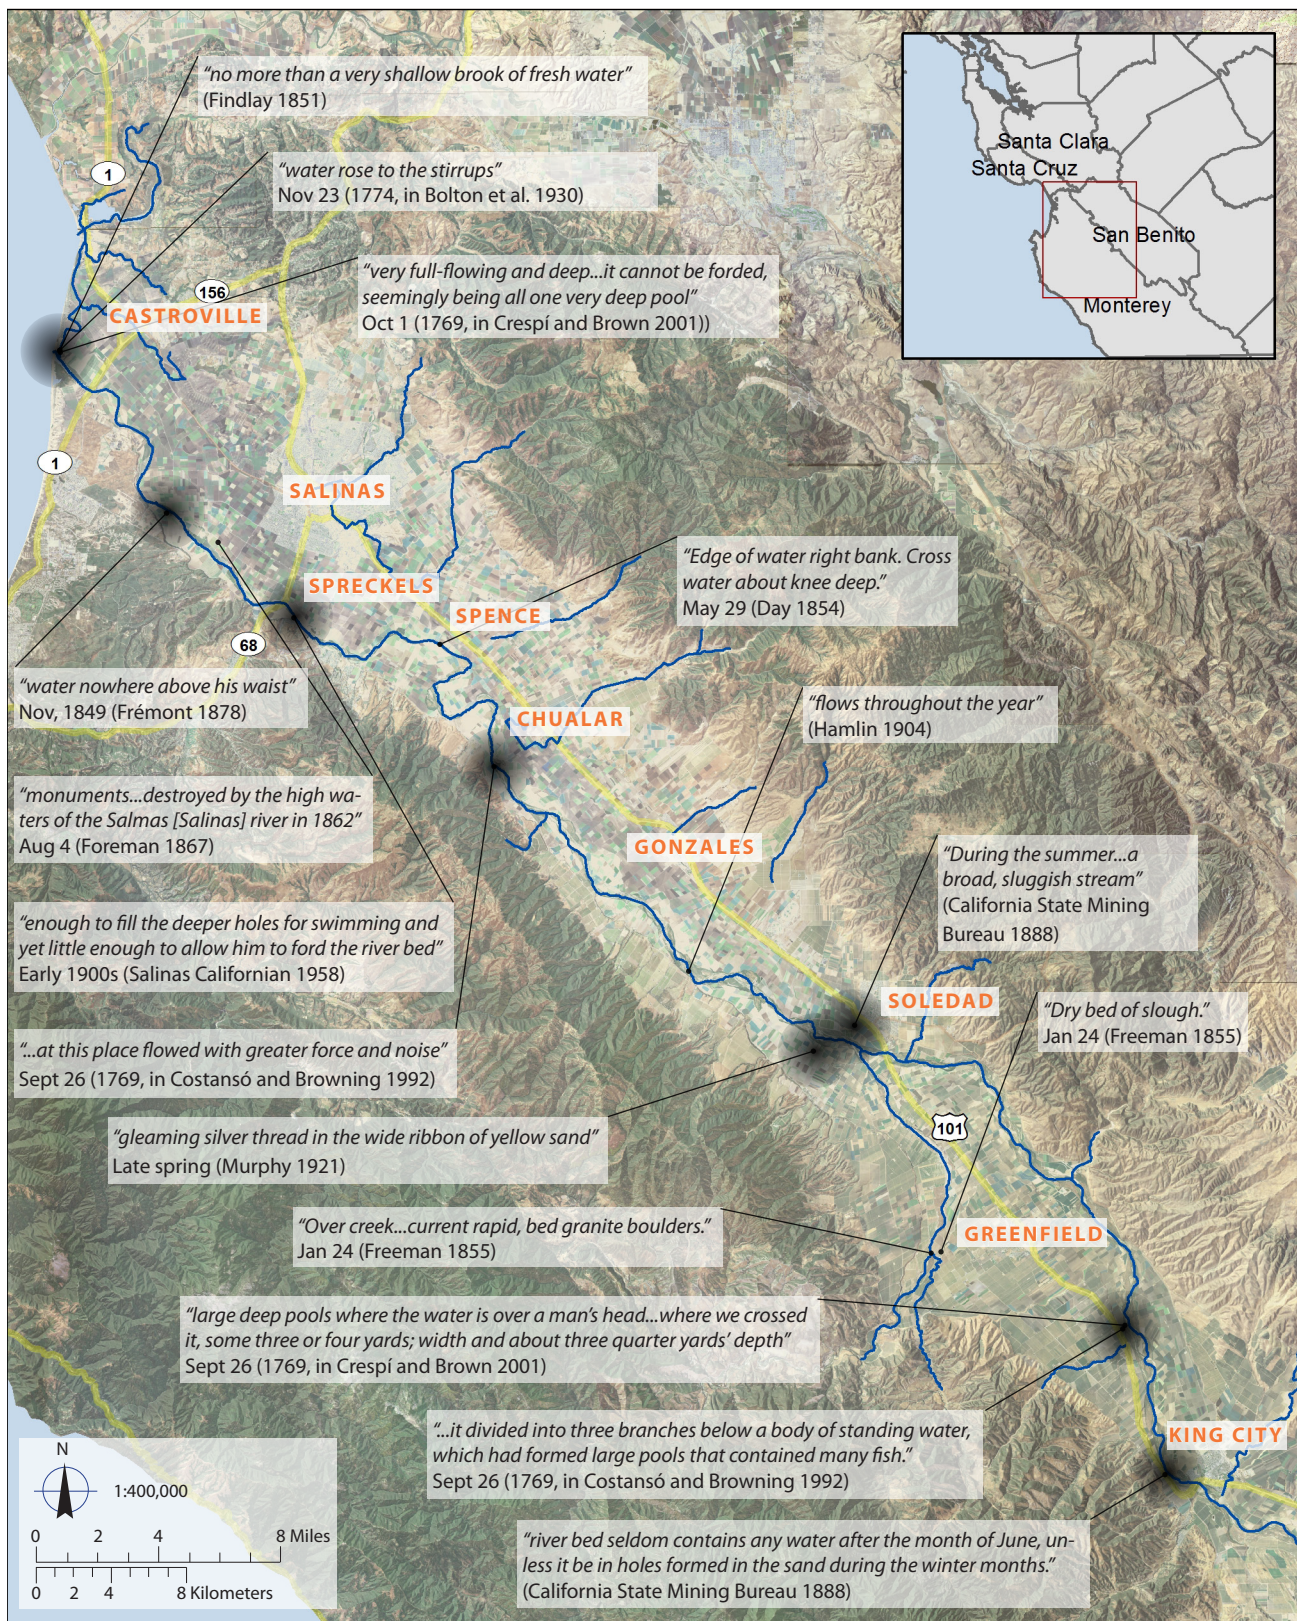
Figure 18. Historical evidence of flow conditions and water depth along the Salinas River. Solid dots represent location-specific information, and dissolved points are more general descriptions of an area.

We found little early (pre-1890) evidence that the Salinas River completely or consistently dried out in the summer, although flow was restricted such that much of the active channel surface was exposed sand. Overall, preliminary evidence suggests that the Salinas may have maintained substantial summer baseflow in many reaches, though this would have varied greatly based on inter-annual variations in rainfall (fig. 18).
