HISTORICAL ECOLOGY RECONNAISSANCE FOR THE LOWER SALINAS RIVER

Prepared for The Nature Conservancy

Monterey County Project

August 2009

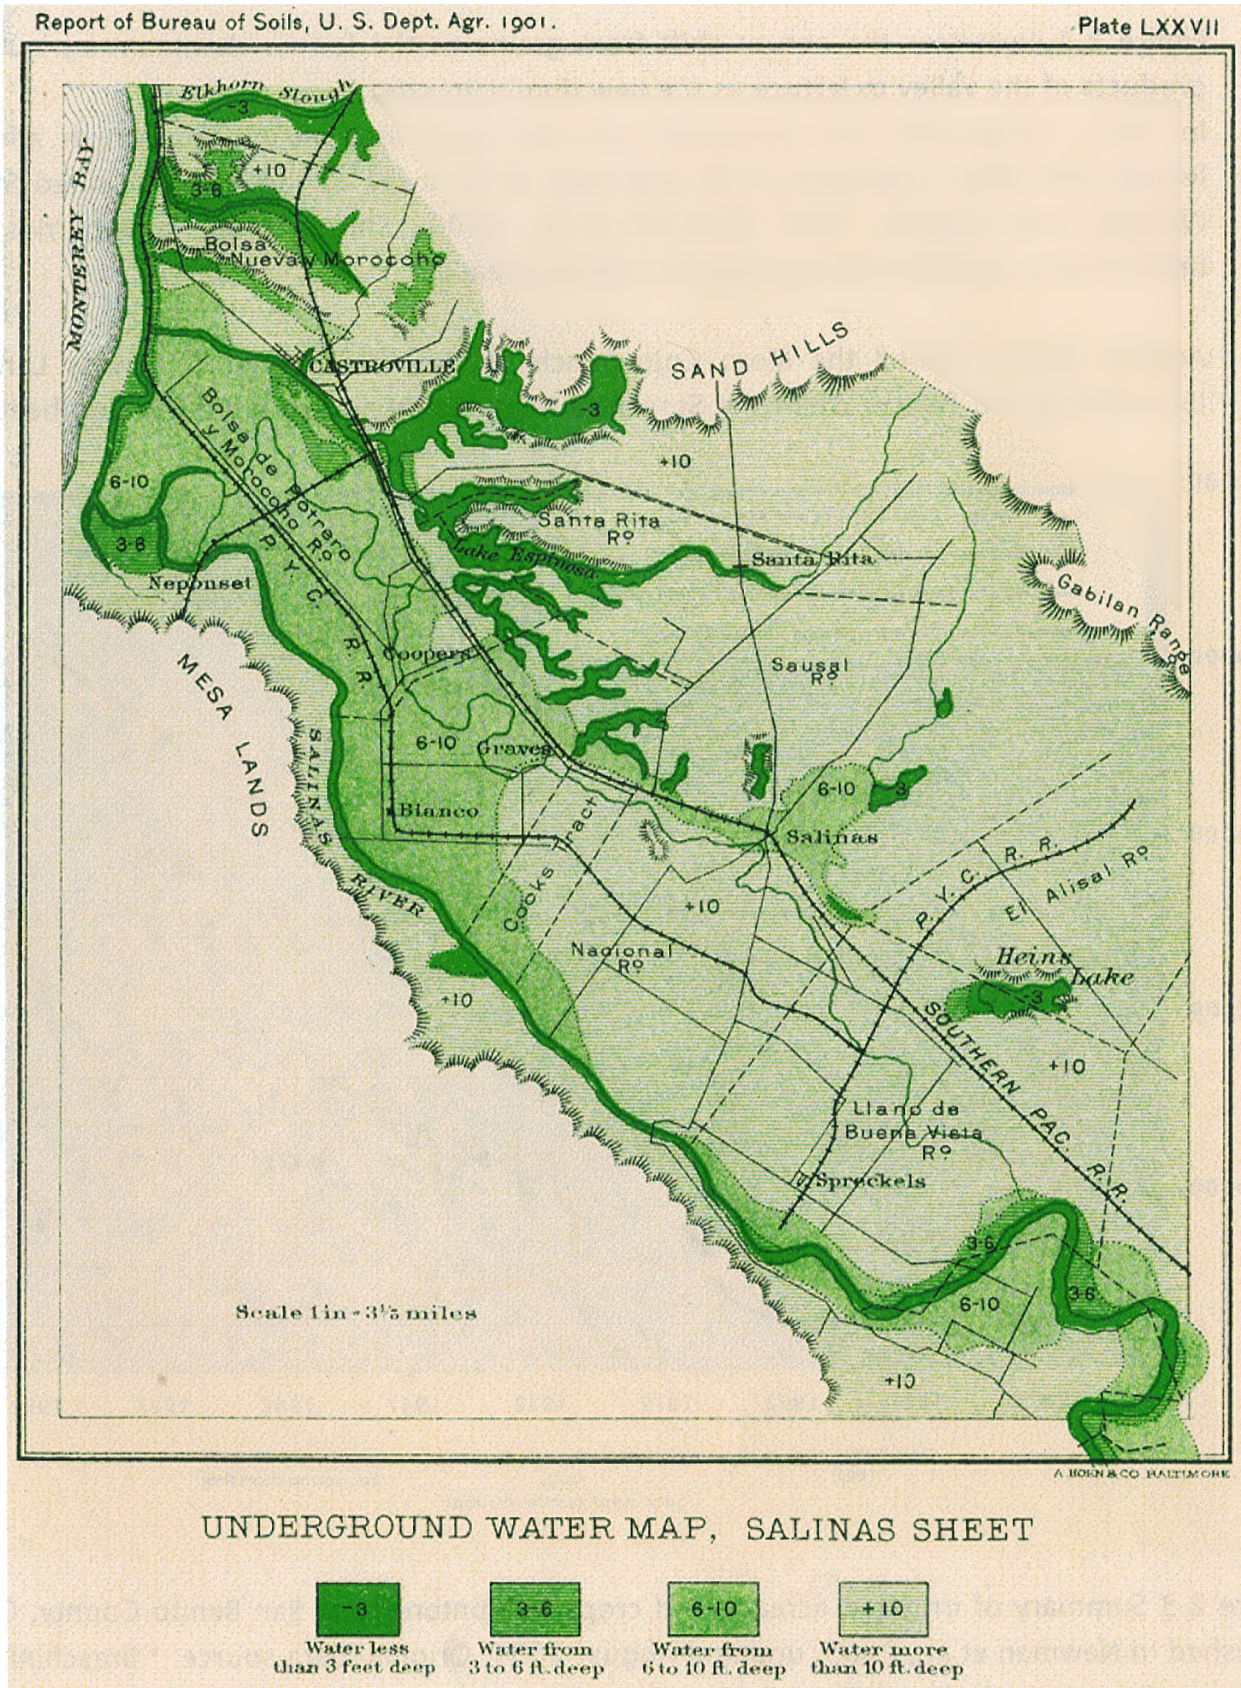
Figure 19. Map of groundwater conditions around 1901 shows a relatively high groundwater tables along the river downstream of Spreckels. (Lapham and Heileman 1901)
