Napa River Watershed Profile: Past and Present Characteristics with Implications for Future Management of the Changing Napa River Valley

by
San Francisco Estuary Institute

March 2012 · Contribution No. 615

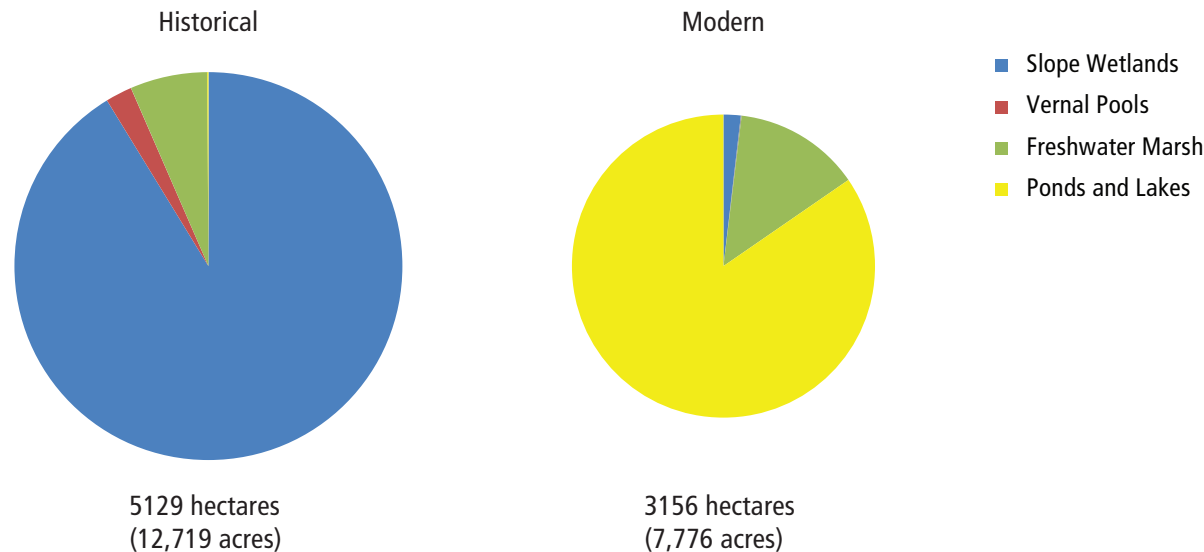
FIGURE 14. Change in wetland type and extent.

The reservoirs do not function the same as the historical, natural places of surface water storage. The dramatic change in wetland storage is illustrated in **FIGURE 14**. Reservoirs can have dramatic environmental upstream and downstream effects (Wetzel 2001). Effects of most concern are those downstream, since the focus on the river in the valley is downstream of most reservoirs. The magnitude of these effects is usually directly related to the size of the dam. The flow below reservoirs tends to have a reduced hydrograph with steeper rising and falling limbs and lower crests. This can have significant effects on downstream channel form and ecology, as discussed below in the sections on Channel Form and Riparian Area. In cases where the entire flow has been diverted, there may seldom be any flow immediately downstream. In the Napa River watershed, the fill-and-spill reservoirs lack facilities for deepwater (hypolimnetic) releases that could be used to reduce downstream water temperatures. Surface waters exiting the reservoirs during their spill could have elevated amounts of nutrients and dissolved salts, and lower amounts of dissolved oxygen depending on factors including reservoir size, water chemistry, and vertical mixing. Water losses due to evaporation can be greatly increased by reservoirs, especially for large reservoirs that lack vegetative or other cover in arid and semi-arid environments. Perhaps the greatest down-

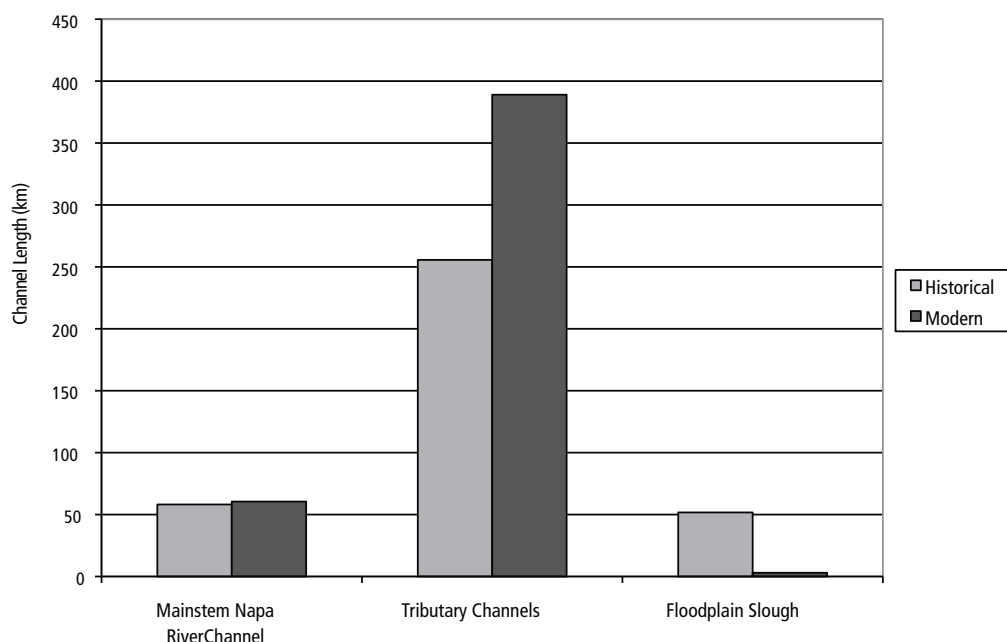
FIGURE 15. Historical change in the total length (km) of tributary channels confluent with the Napa River in Napa Valley. Overall connectivity between the river and its valley and tributaries has been artificially increased, mainly by ditching.

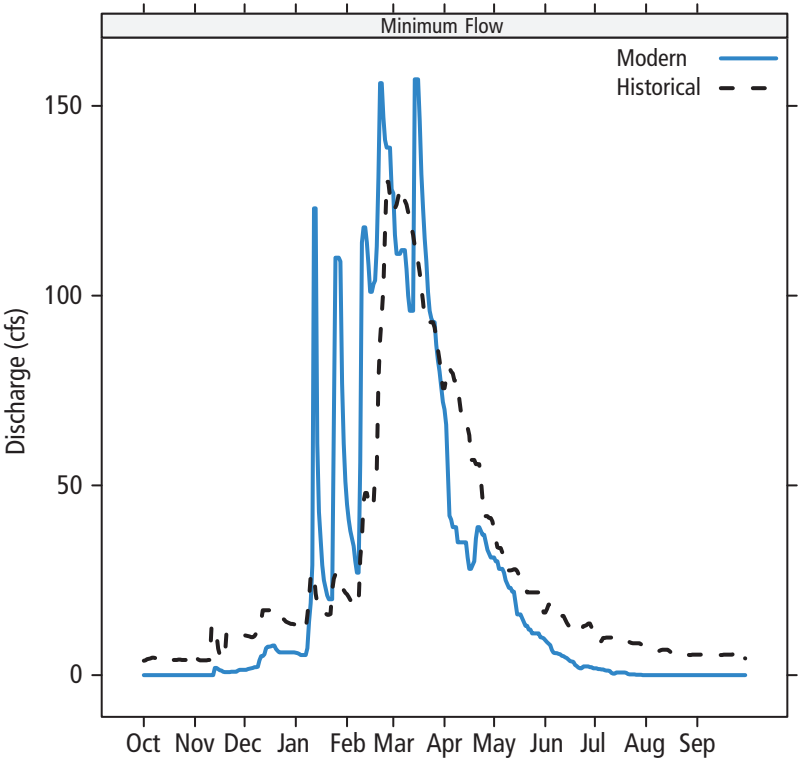
FIGURE 20. Reconstructed average minimum annual hydrograph for Napa River at Napa City based on historical conditions (dashed black line) and current conditions (blue line). Discharge values for the historical hydrograph are average daily minima for the period 1987 to 2006. Note that the peaks in daily minimum flow in the historical hydrograph are attenuated relative to the peaks in the current hydrograph, while the minimum historical base flow extends throughout the dry season.

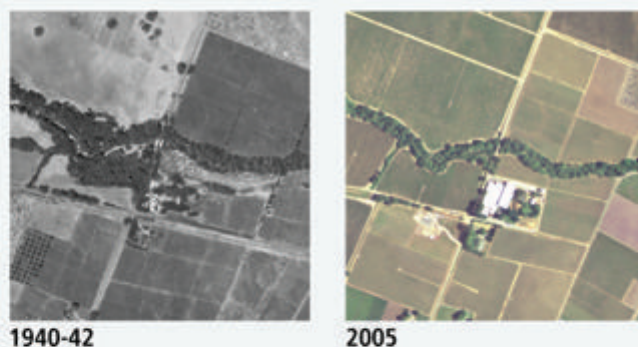
Remnants of a broad riparian forest are common north of St. Helena circa 1940 but are no longer evident by 2005.

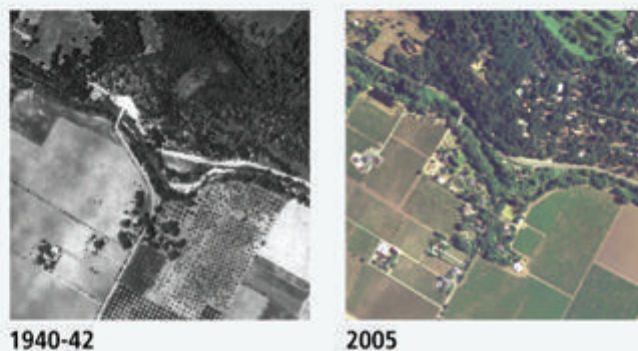
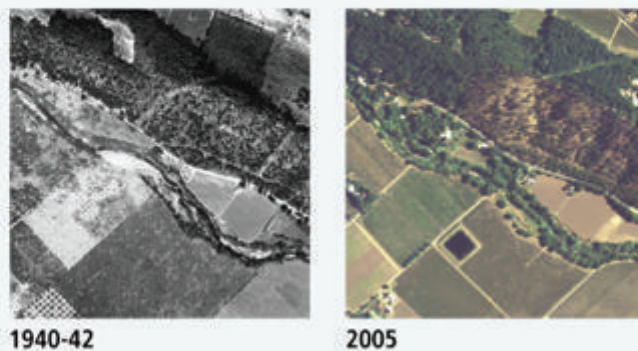
Naturally confined reaches have relatively narrow stream habitat zones in both historical and modern aerial photography. This pair of images shows the effect of Sulphur Creek alluvial fan at Pratt Avenue. The 2005 image shows encroachment of riparian forest onto the once-exposed gravel bars.

Large, unvegetated gravel bars are prominent immediately downstream of the Sulphur Creek confluence in historical but not modern imagery. The bar and flood plain topography are less accessible now.

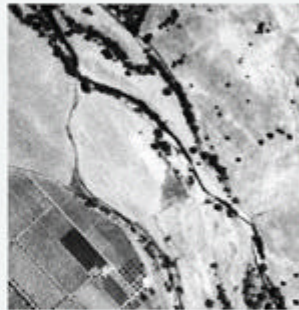
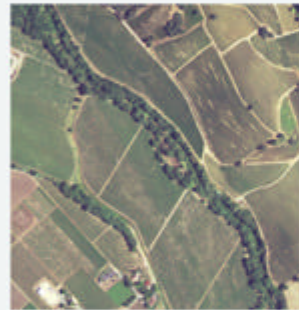
Mid 19th century records for the present-day location of Zinfandel Lane describe a broad reach with side channels, willow groves, and tule marshes. By 1940, the wetlands have been drained, willows are absent, and the river has abandoned the floodplain, but side channels persist. The river system is further simplified by 2005.

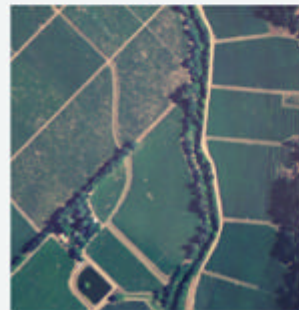
2005

Interconnected sloughs and side channels carved the floodplain and low terraces in large islands. The large side channel visible in 1940 is absent in 2005.

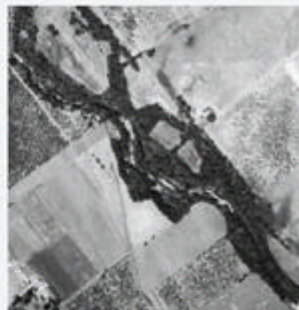
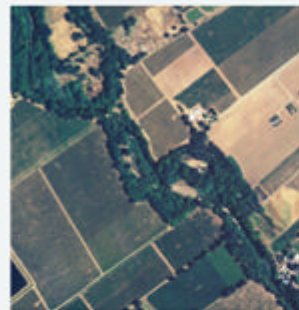
The reach downstream of the Dry Creek confluence remains characterized by relatively wide areas of riparian forest with closely spaced side channels, although the channel has abandoned its floodplain.

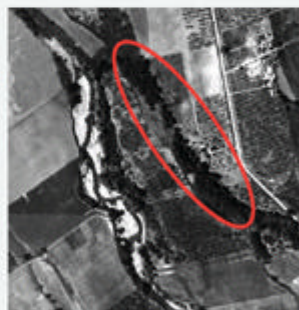
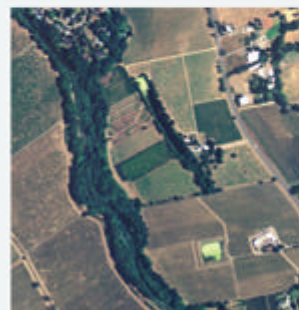
Large gravel bars evident in 1940 have been colonized by riparian trees. The prominent side channel has mostly been removed.

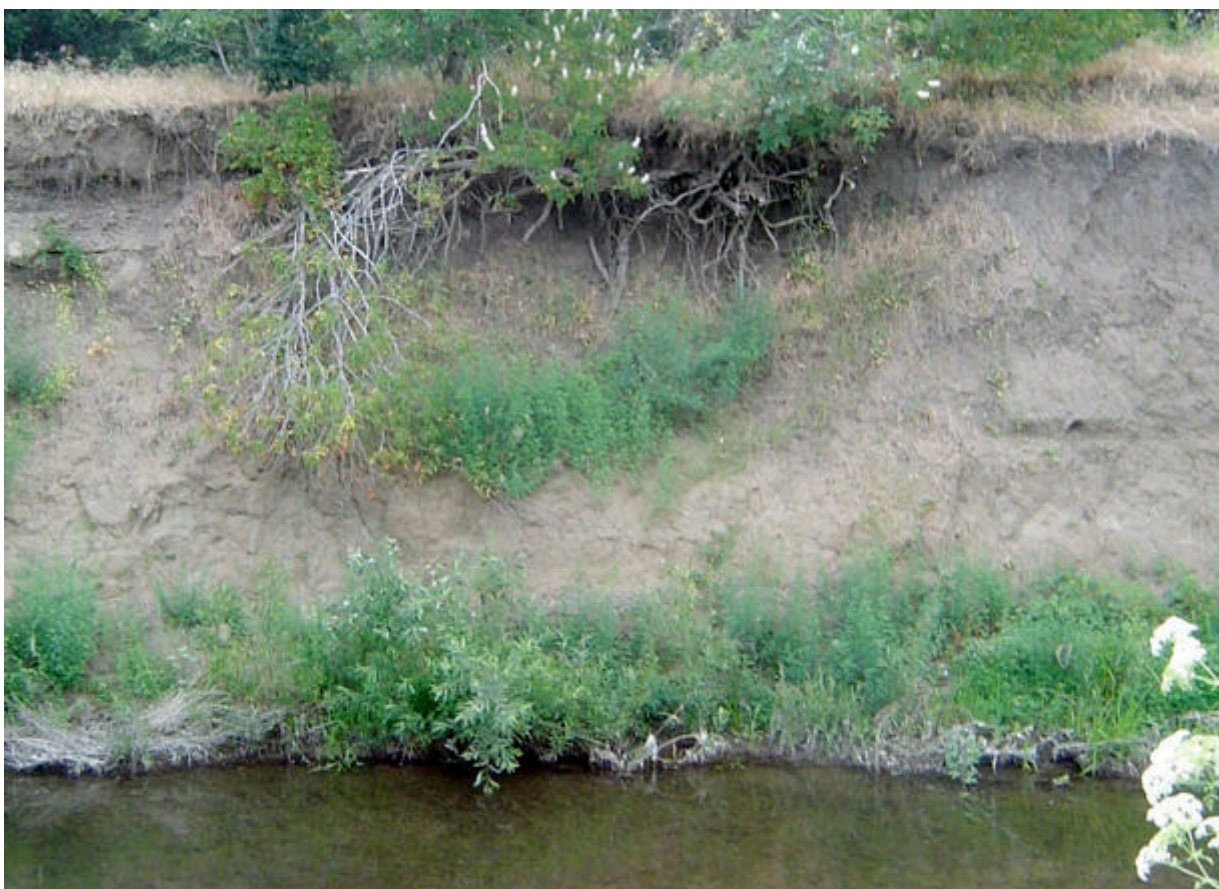
.....
Severe incisions along Napa River.
Photography courtesy of Gretchen E. Hayes.

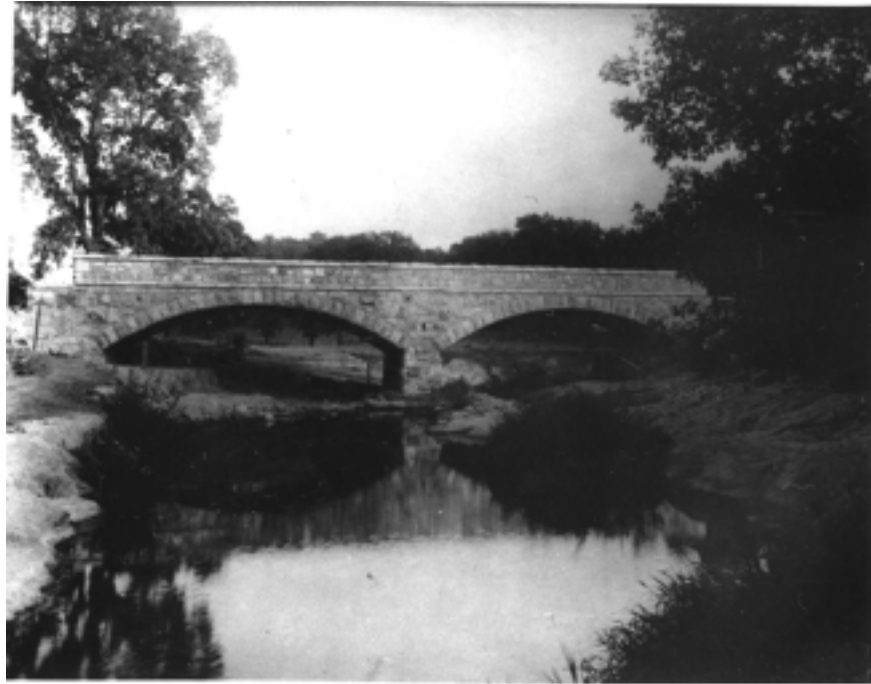
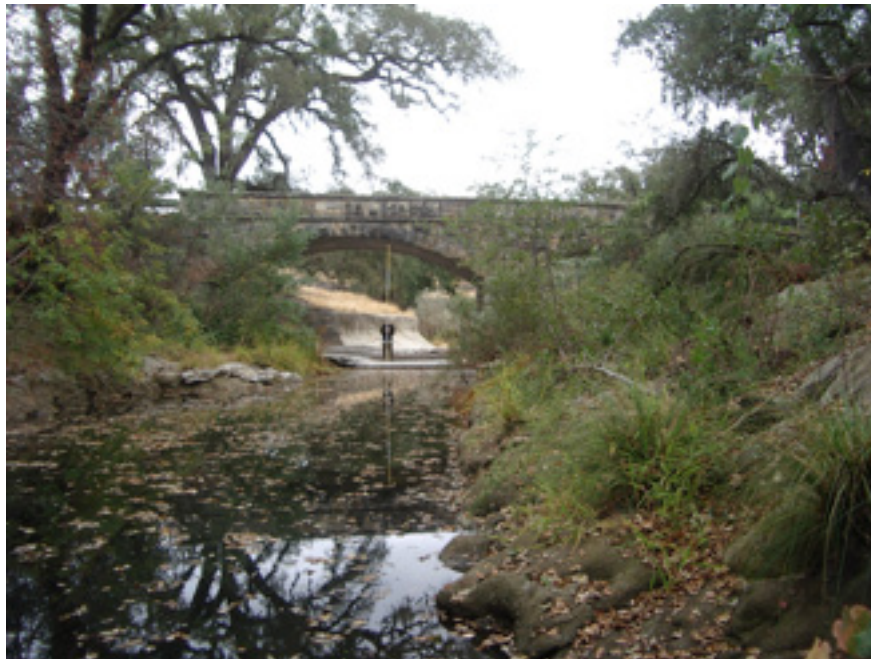
FIGURE 1. Photograph pair showing the historic photograph (upper) (courtesy of Al Edminster) and current photograph (lower) looking downstream at the Zinfandel Lane bridge.

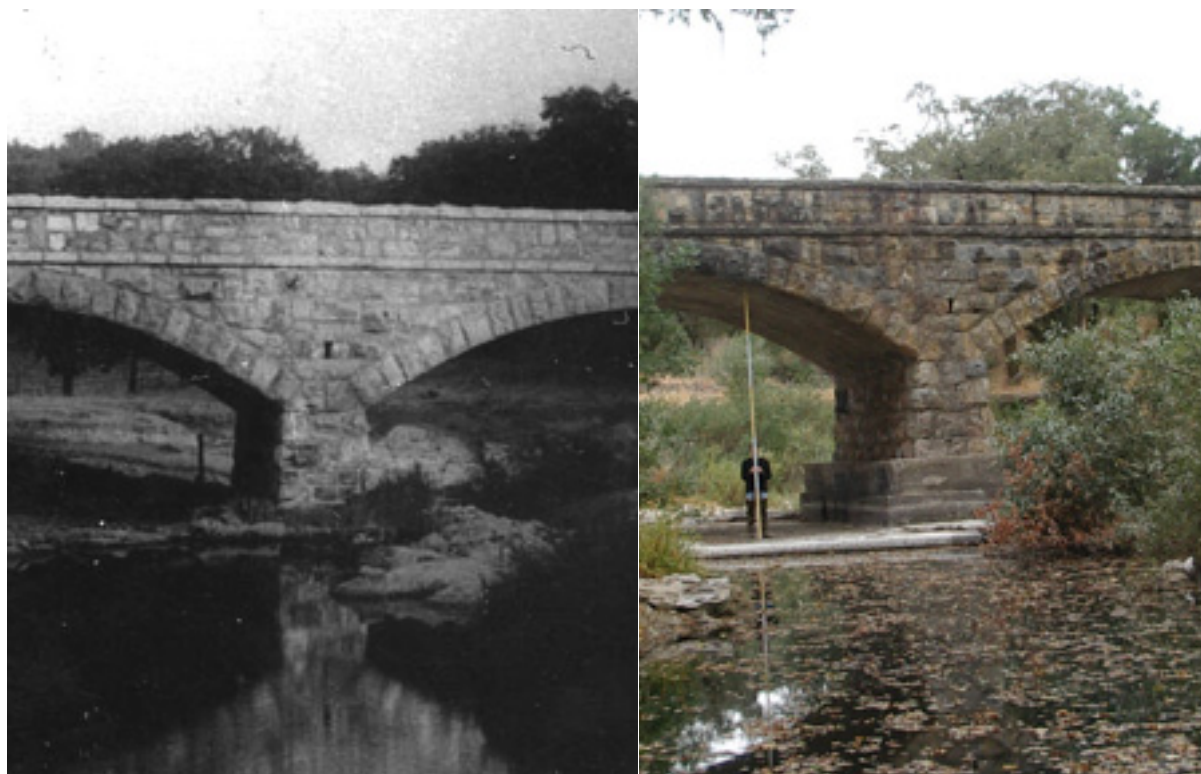
FIGURE 2. Close-up of the now-exposed bridge pillar concrete footer. The concrete portion of the footer is approximately 1.5 m in height.

This example also uses historic photographs to infer channel change through time. Because of the scale of the historic photo, we have less confidence in this estimate than that made at Zinfandel Lane. In the historic photo it appears as if the bed elevation is at the base of the stone portion of the footer, although the obvious construction modifications obscure the view. Presently the channel thalweg is located ~1.0 m below the stone portion, exposing a rough concrete base of the footer, which was likely not exposed post-construction.

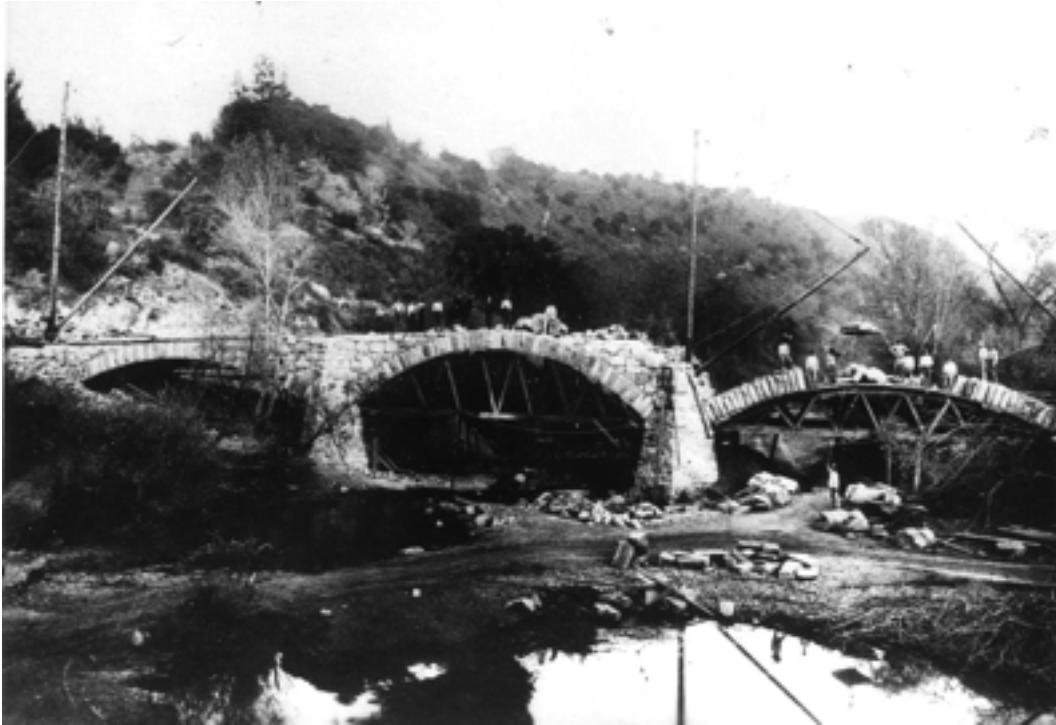
FIGURE 3. Historic photograph looking downstream at the construction of Pope Street bridge (courtesy of Al Edminster). Note the bed elevation in comparison to the center-right footer.

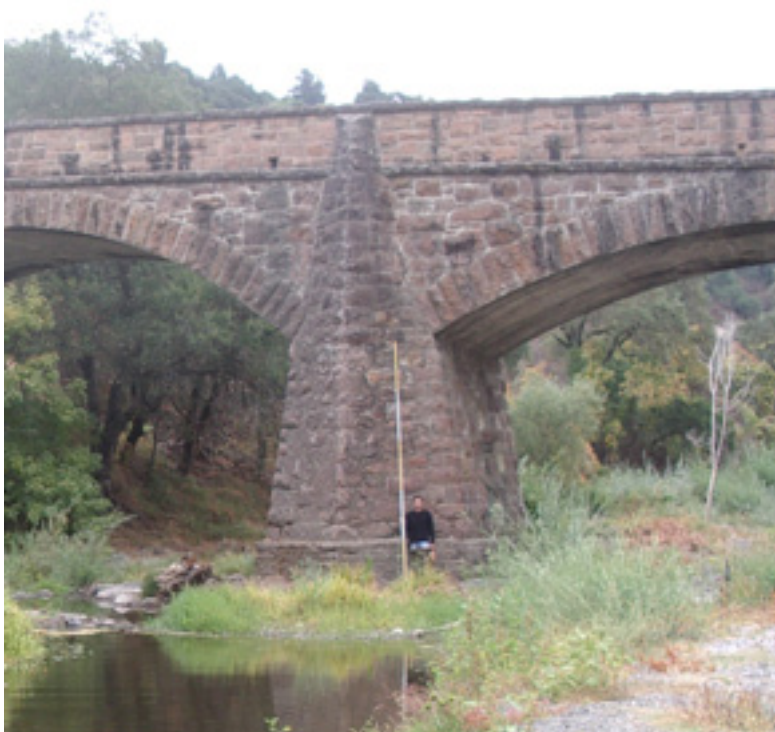
FIGURE 4. Photograph looking downstream at the center-right bridge footer. Note the exposure of the concrete base, approximately 0.9 m above the current bed elevation.

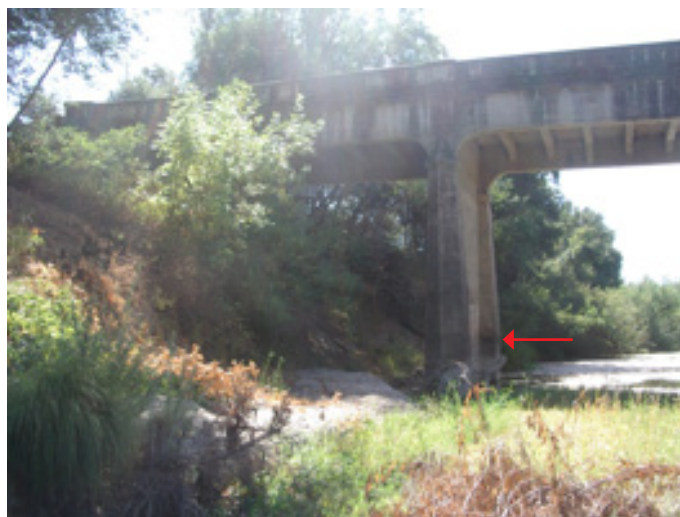
FIGURE 10. Photograph looking downstream at the left bank bridge footer. Arrow is pointing to the change in concrete texture representing “end of batter” shown on the as-built.
