Landscape History of the Trancas

Historical Ecology Research Summary for the Trancas Crossing Park and Napa River Trail, City of Napa

Technical Memorandum to
Design, Community & Environment

SAN FRANCISCO ESTUARY INSTITUTE

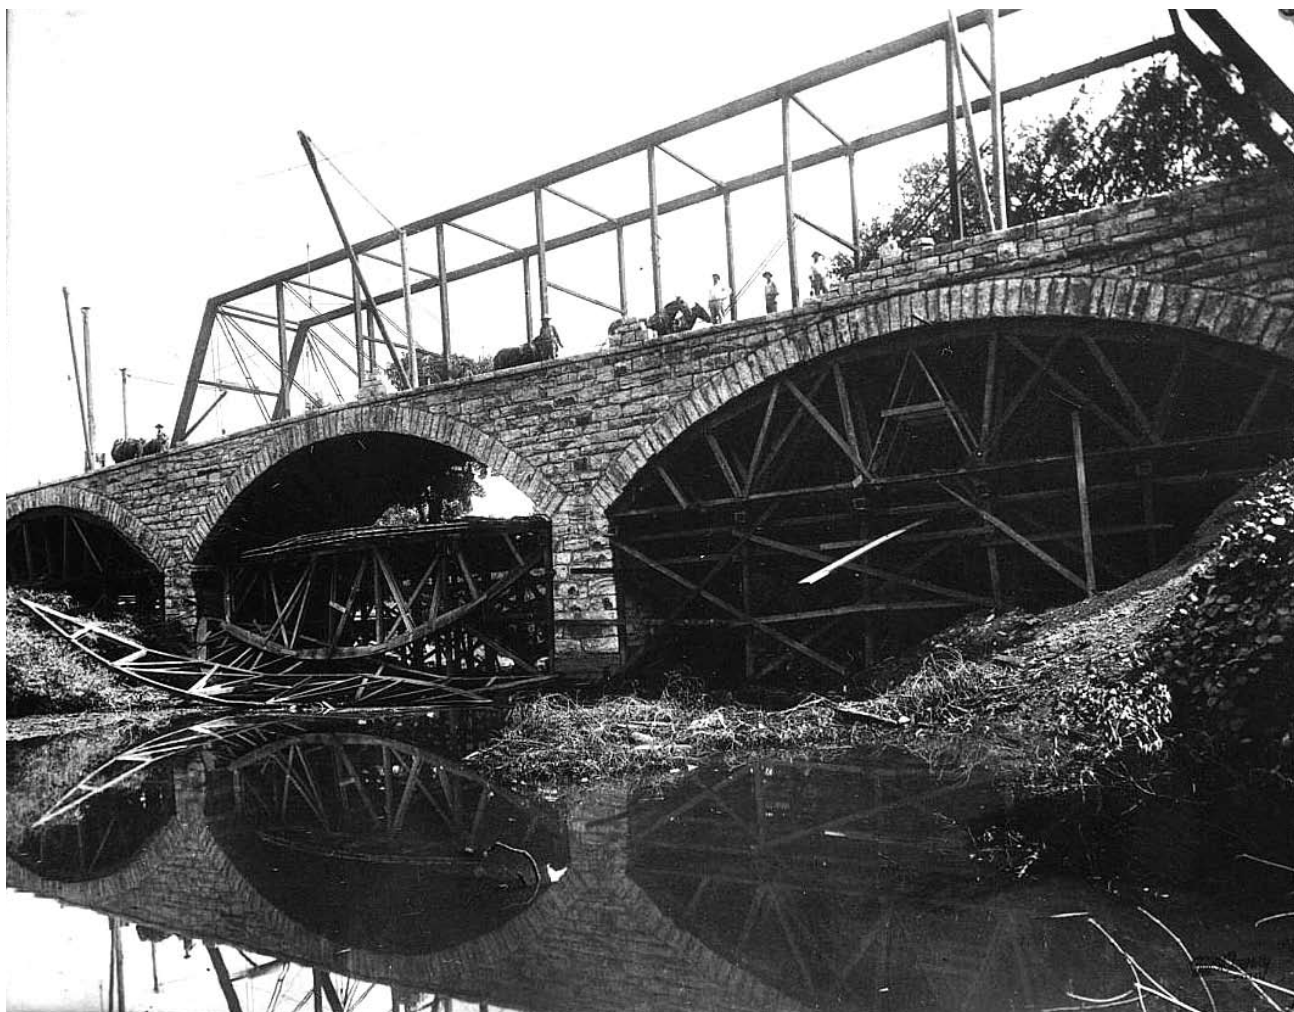
1.2 Construction of the Trancas Bridge.

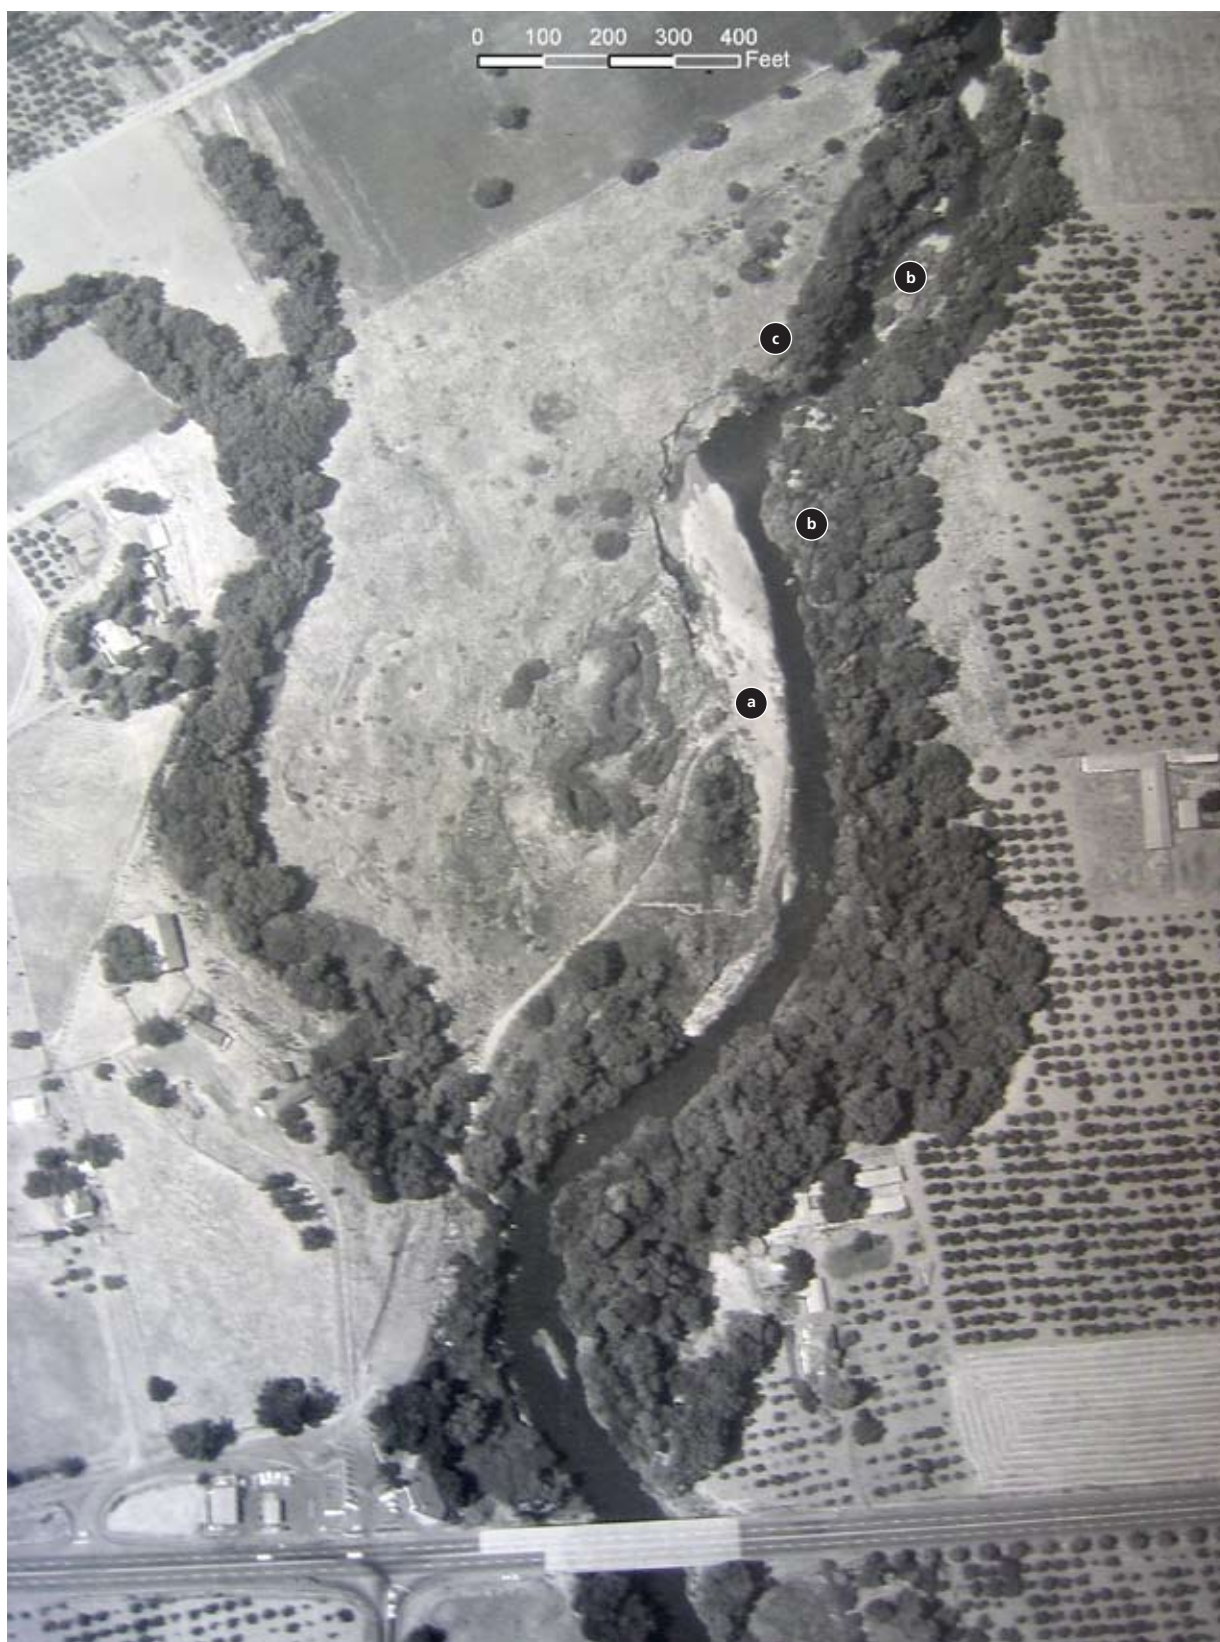
1.4B. 1965 aerial photograph of the Trancas Crossing Park site. While this image is not georeferenced, substantial changes can be seen. The mainstem has straightened and a large bar has been deposited on the west side **a**. Riparian forest has expanded onto former gravel bars **b**. The likely site of the former Napa River Dam is shown at **c**. Courtesy Earth Sciences and Map Library, University of California at Berkeley.

Comparison of 1940, 1965, and contemporary aerial photography also indicates substantial lateral channel movement (1.4). For example, comparing the river position between 1940 and 2005, we observe a loss of approximately 40 m (132 feet) at the large, currently eroding bend on the east side of the park site (1.4).

Assuming a constant rate of change over 65 years, annual land loss at this point would be ~0.6m/yr (2ft/yr). Comparison with 1965 imagery indicates that channel movement has not been constant, and recent lateral migration rate has probably been greater than the longer term trend.

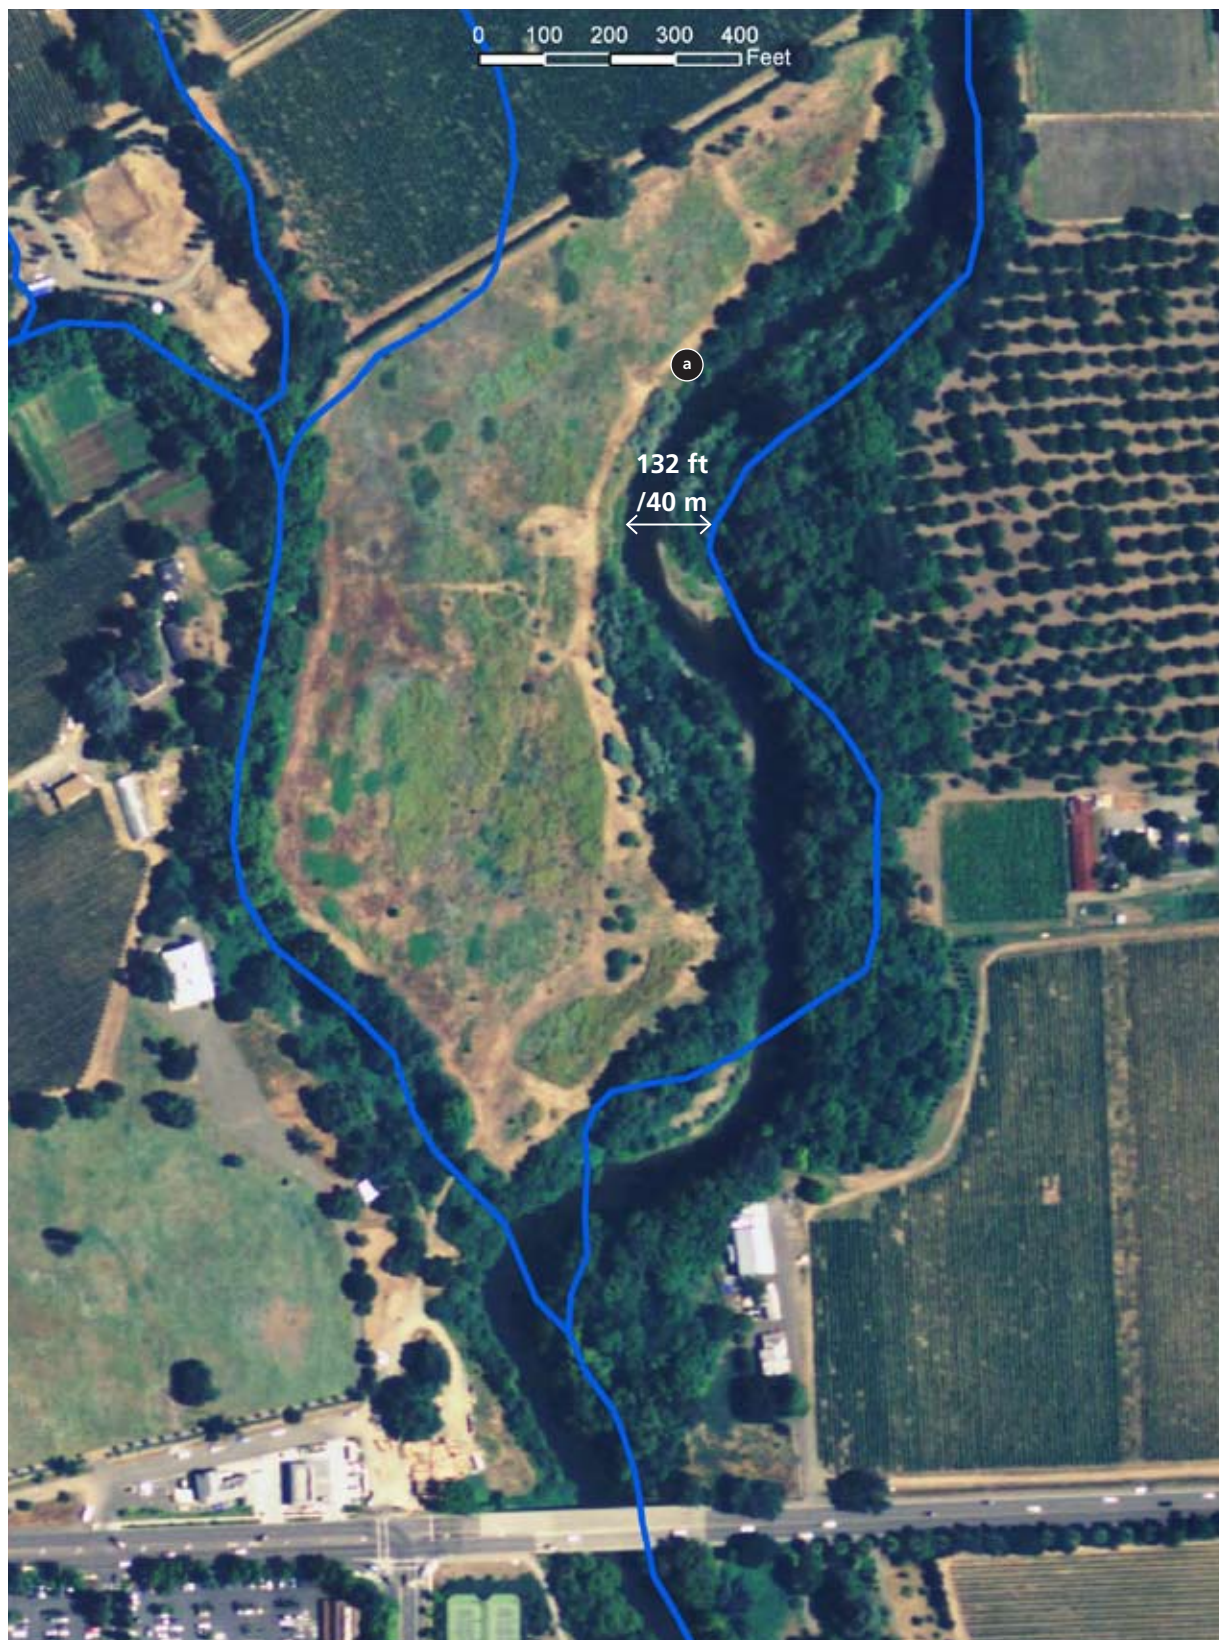
1.4C. 2005 aerial photograph of the Trancas Crossing Park site. The ca.-1940 channel network is shown in blue. The channel has exhibited substantial lateral migration and riparian forest expansion. The likely former site of the Napa River Dam **a** has probably been eroded on the west bank, but remnants may still be preserved on the east bank. Courtesy NAIP.
