Petaluma Valley

HISTORICAL HYDROLOGY and ECOLOGY STUDY

SAN FRANCISCO ESTUARY INSTITUTE PUBLICATION #861

March 2018

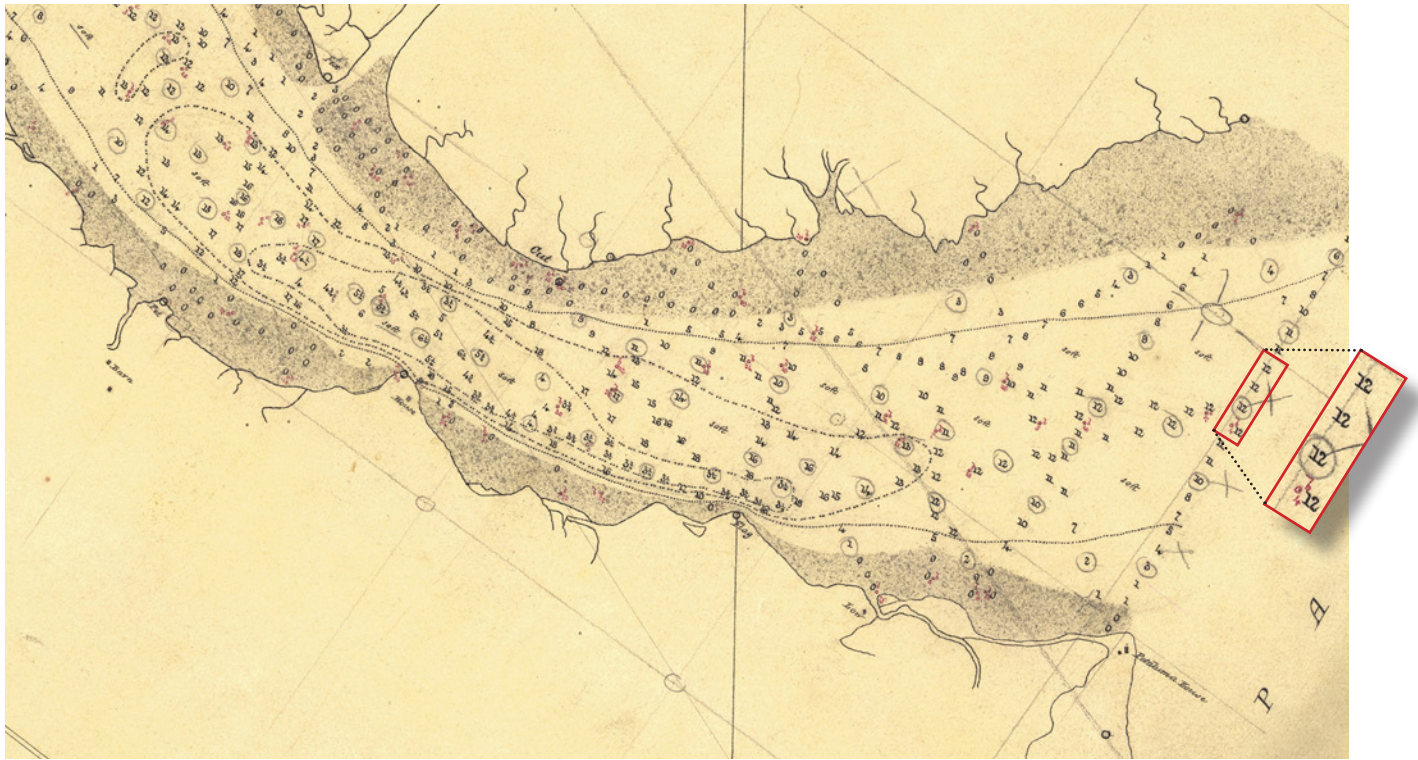
Figure 3.2. The channel geometry of the Petaluma River, recorded in feet and fathoms, was surveyed by the United States Coast Survey in 1860. This map shows a depth of 4 m (12 ft) at the San Pablo Bay inlet. Hydrographic sheets like this one were crucial navigational tools for mariners sailing up the meandering tidal channel. (*Alden 1860a, courtesy of NOAA*)

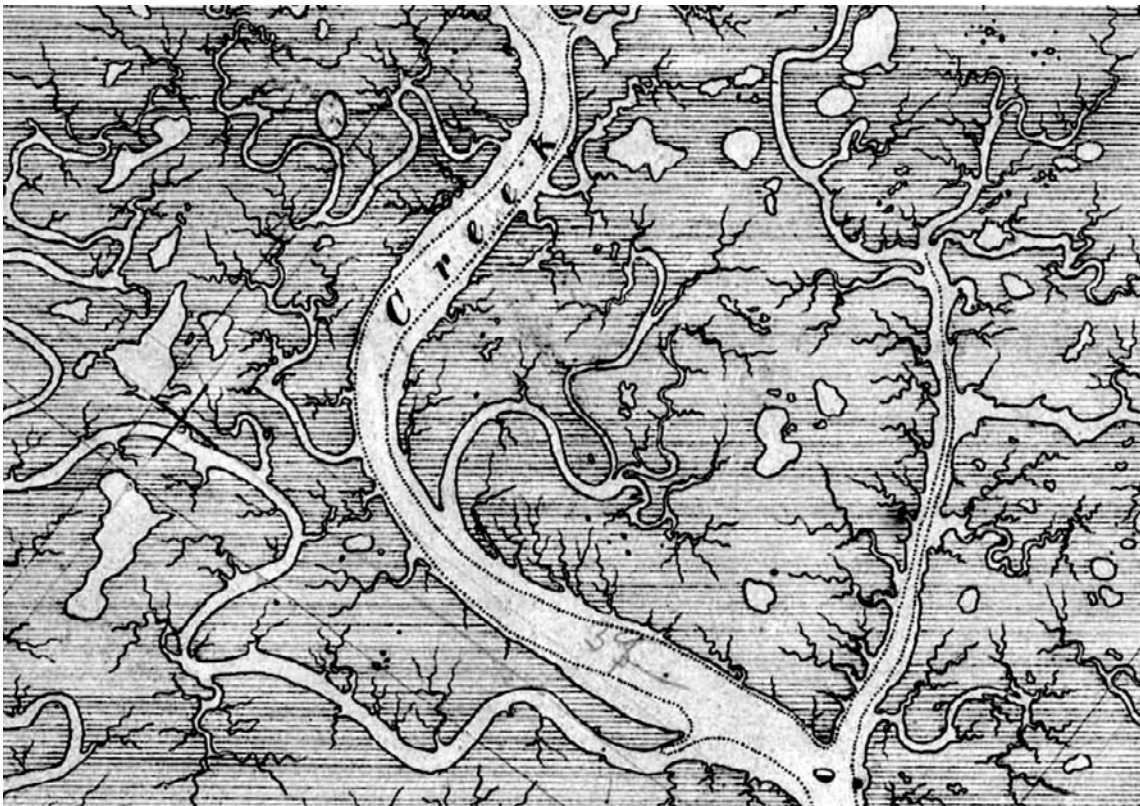
Figure 3.5. Highly detailed mapping by USCS surveyors captures the dense tidal channel network throughout the marsh plain. Tidal sloughs branched off into small channels that circulated the tides throughout the estuary. (Kerr 1860, courtesy of NOAA)

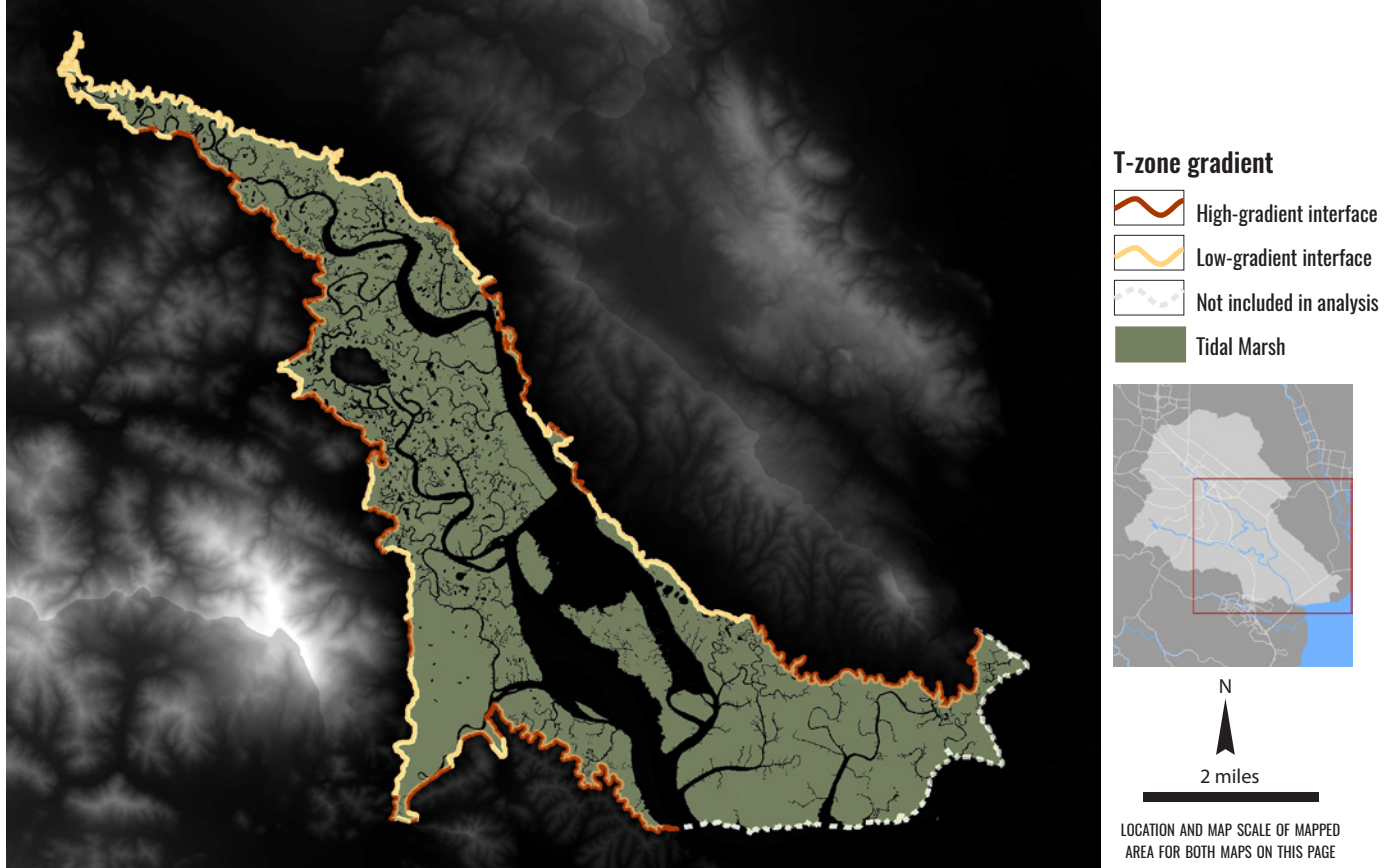
Figure 3.7. Contemporary LiDAR shows the T-zone gradient between the marsh edge and the surrounding habitats. Just over half of the marsh edge is met by steep upland habitat while the remainder is bordered by low-lying areas, 60% of which is wet meadow. (County of Marin 2015)

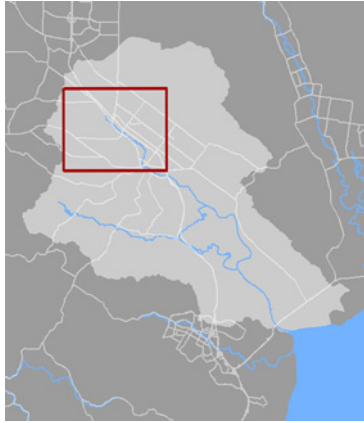
Figure 4.1. The Petaluma River maintained a relatively straight, single-threaded channel for most of its length upstream of the estuary. (map at 1:40,000) (NAIP 2016)

The fluvial portion of the Petaluma River extended approximately 6 km (3 mi) from its confluence with Lichau Creek downstream to the inland edge of the estuary (Fig. 4.1). Confined by bedrock on the west and bordered by extensive wet meadow on the east (see pages 56–59), the river maintained a relatively straight course towards the southeast over most of its length. Near the present-day confluence with Lynch Creek, the river turned towards the south and flowed through the City of Petaluma, where it entered the estuary. The mainstem was characterized by a single-threaded channel punctuated by numerous large in-channel pools that may have provided cold-water refugia for native fish. Floods were common along the mainstem during the winter, but during the dry season flows were likely quite low, and some reaches may have experienced an intermittent flow regime.

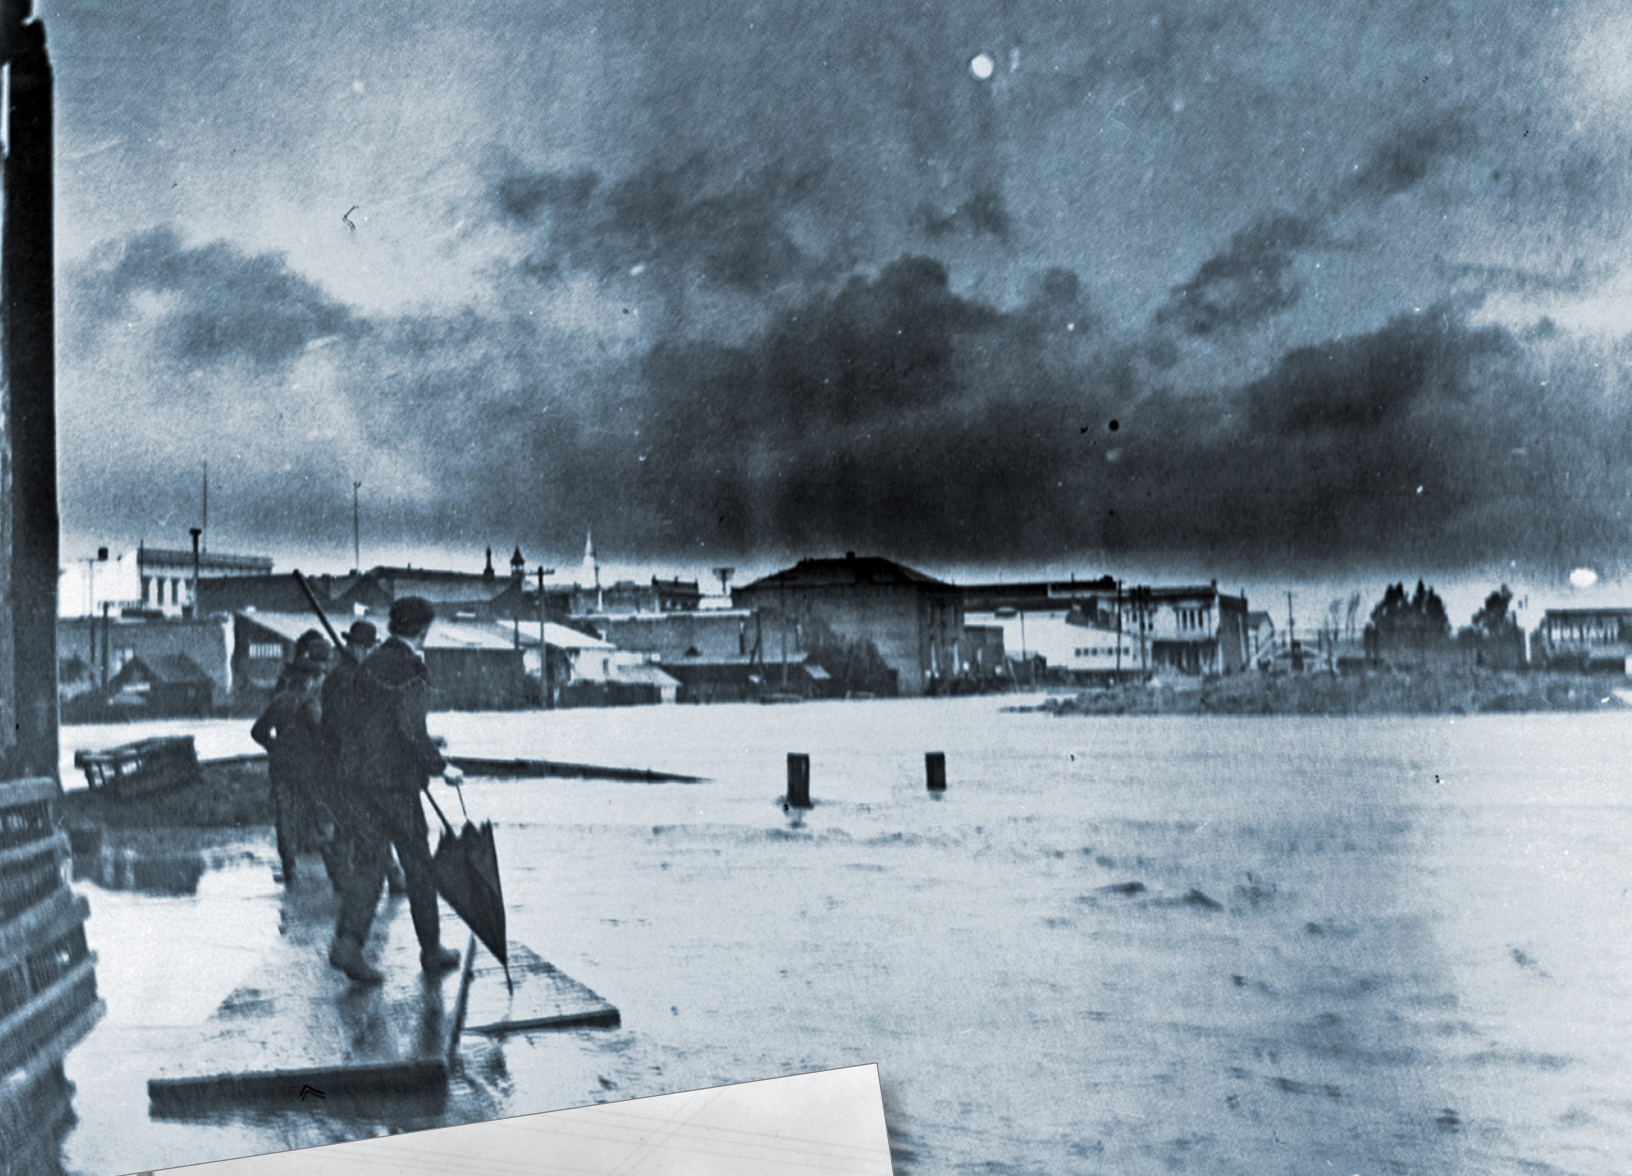
Figure 4.2. (above) This photo was taken during a 1904 flood from the present-day site of the Petaluma Yacht Club looking upstream towards Water Street. The original brick flour mill at 148 Petaluma Boulevard North and the bank flag pole can be seen in the background and are still visible today. (Photo ID # 1995-08-02, Negative 23-20, courtesy of Petaluma Historical Library & Museum)

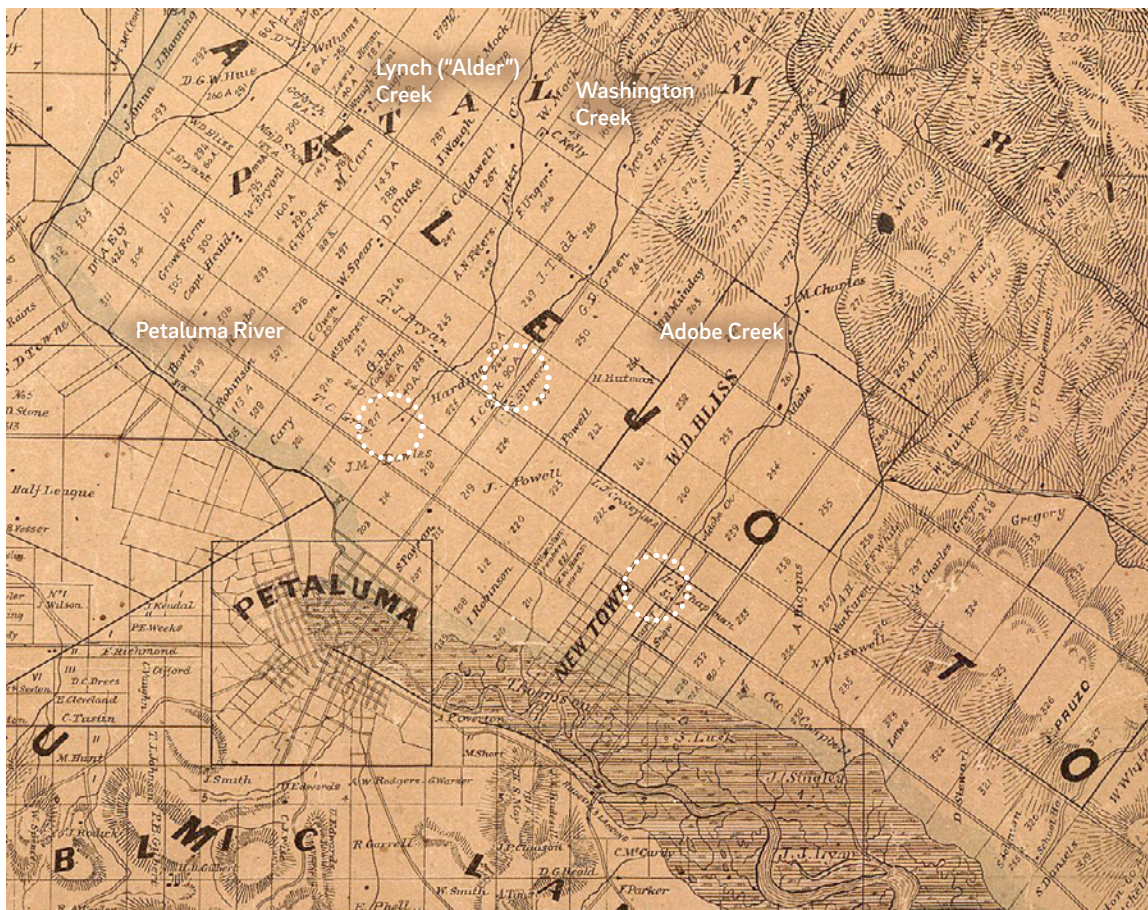
Figure 4.6. Most of the creeks draining the Sonoma Mountains lost definition before reaching the Petaluma River and estuary and dissipated in an extensive wet meadow that occupied the alluvial plain on the eastern side of the valley. This 1866 county map shows Lynch ("Alder"), Washington, and Adobe creeks terminating upstream of the estuary. (Bowers 1866, courtesy of David Rumsey Map Collection)

Historically, few streams within the watershed maintained defined channels directly into the Petaluma River mainstem or its estuary. Like many systems with low stream power around the Bay, smaller tributaries within the watershed dissipated on alluvial plains upstream of the estuary, often spreading into multiple distributary channels (SFEI-ASC 2017). For example, most of the streams that originated in the Sonoma Mountains on the eastern side of the Petaluma River, including Lynch, Washington, East Washington, Adobe, and Ellis creeks, lost definition as they reached the broad alluvial plain that bordered the mainstem corridor and much of the estuary (Fig. 4.6). To the northwest of the city, Hutchinson, Wilson, Marin, and Wiggins creeks flowed northward and dispersed into a wet meadow-vernal pool complex in the Denman Flat area between present-day Skillman Lane and Rainsville Road (see pages 57-58). Liberty Creek, which drained the northern part of the watershed west of Meacham Hill, also dissipated within this wetland complex (Fig. 4.7). These discontinuous tributaries provided freshwater and sediment input that would have helped sustain seasonal wetlands at their downstream ends. In many cases, shallow emergent sloughs transported flows through the wetland complexes downstream of channel distributaries (Fig. 4.8).

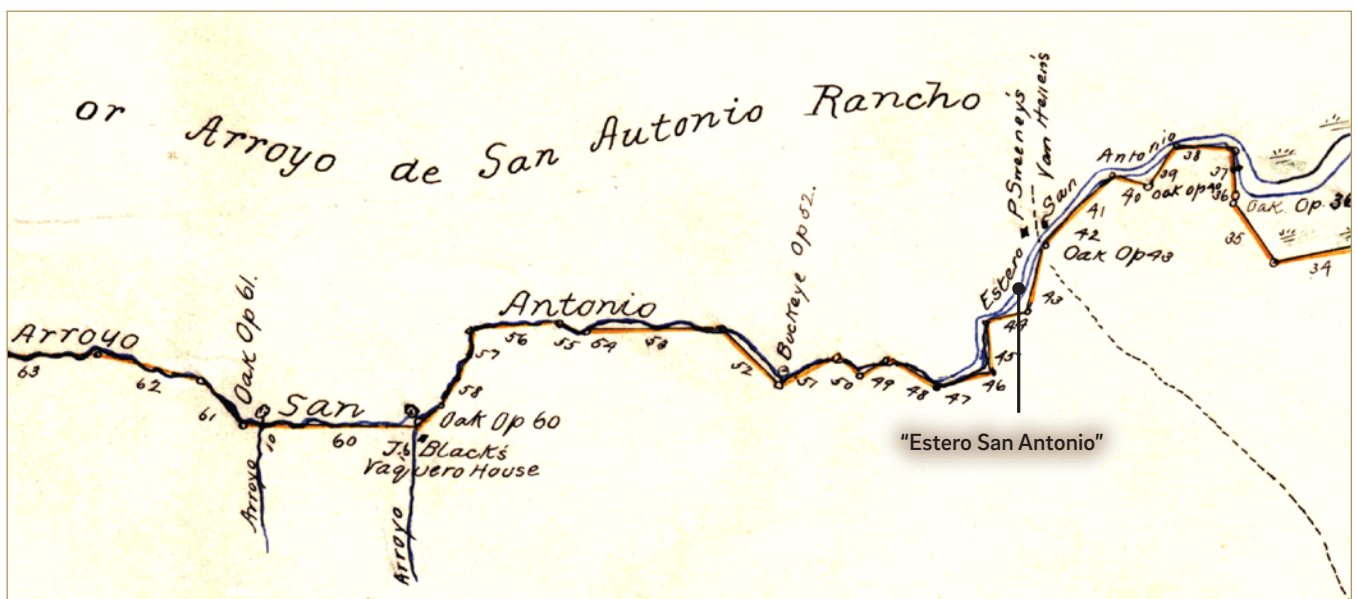
Figure 4.9. (below) Unlike many of the smaller tributaries in the watershed, San Antonio Creek maintained a defined channel that connected directly to the estuary. An 1859 plat of Rancho Olompali shows the connectivity between the fluvial portion of San Antonio Creek (labeled "Arroyo San Antonio") and San Antonio Slough within the tidal marsh (labeled "Estero San Antonio"). (Matthewson 1859b, courtesy of Bureau of Land Management)

San Antonio Creek, for instance, connected with the tidal wetlands at San Antonio Slough, which wound its way through the marsh for approximately 11 km (7 mi) and joined the tidal Petaluma River south of Neil's Island (Fig. 4.9). Upstream of the estuary, Lichau Creek was the principal tributary of the Petaluma River, and the only major stream that connected directly to the mainstem historically (Cardwell 1958). At times of high rainfall, Copeland Creek, which drains from Sonoma Mountain and typically flowed north toward the Laguna de Santa Rosa, overflowed into the Petaluma River watershed and joined with Lichau Creek (Fig. 4.10; Bowers 1866, Price and Nurse 1896, Holway 1907).¹ According to Holway (1907):

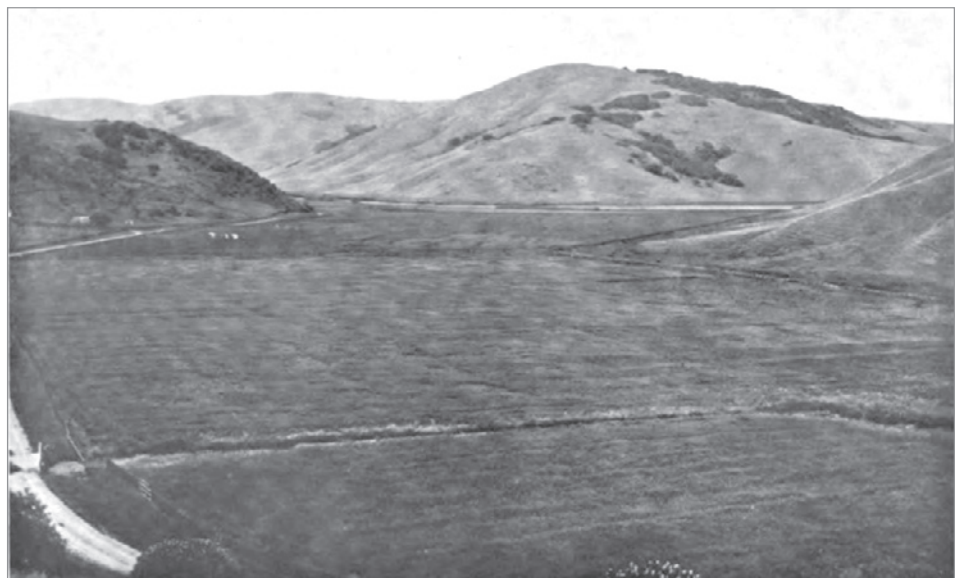
Figure 4.11. (left) The flat topography near the Laguna de San Antonio occasionally resulted in a hydrologic connection between San Antonio Creek and the Walker Creek watershed to the west. This 1877 county map shows the upper reach of San Antonio Creek above the Laguna flowing west across the drainage divide. (Thompson 1877b, courtesy of David Rumsey Map Collection)

Figure 4.12. (right) This ca. 1914 image, looking westward across the drainage divide at the head of San Antonio Creek, shows the extremely flat topography of the area. Upper San Antonio Creek, ditched by this time, is visible in the foreground, and Laguna Lake (in the Walker Creek watershed) is visible at the base of the hills in the background. (Holway 1914, Plate 15 [top], courtesy of University of California Publications in Geography)

the adjacent Walker Creek watershed. The relatively flat topography in this area made for a very subtle drainage divide which, during flood events, established connectivity between San Antonio Creek, Laguna Lake (in the Walker Creek watershed), and the Laguna de San Antonio (Fig. 4.11). Holway (1914) stated that this drainage divide "is so nearly level that according to the reports of residents the rivulets of the rainy season flow toward the bay or toward the ocean, according to the irregularities of the last plowing" (Fig. 4.12). Geologic evidence indicates that the upper reaches of the San Antonio Creek watershed may have formerly comprised the head of the Walker Creek drainage, and were "captured" by San Antonio Creek following a period of uplift during the late Pleistocene (Holway 1914, Dickerson 1922).

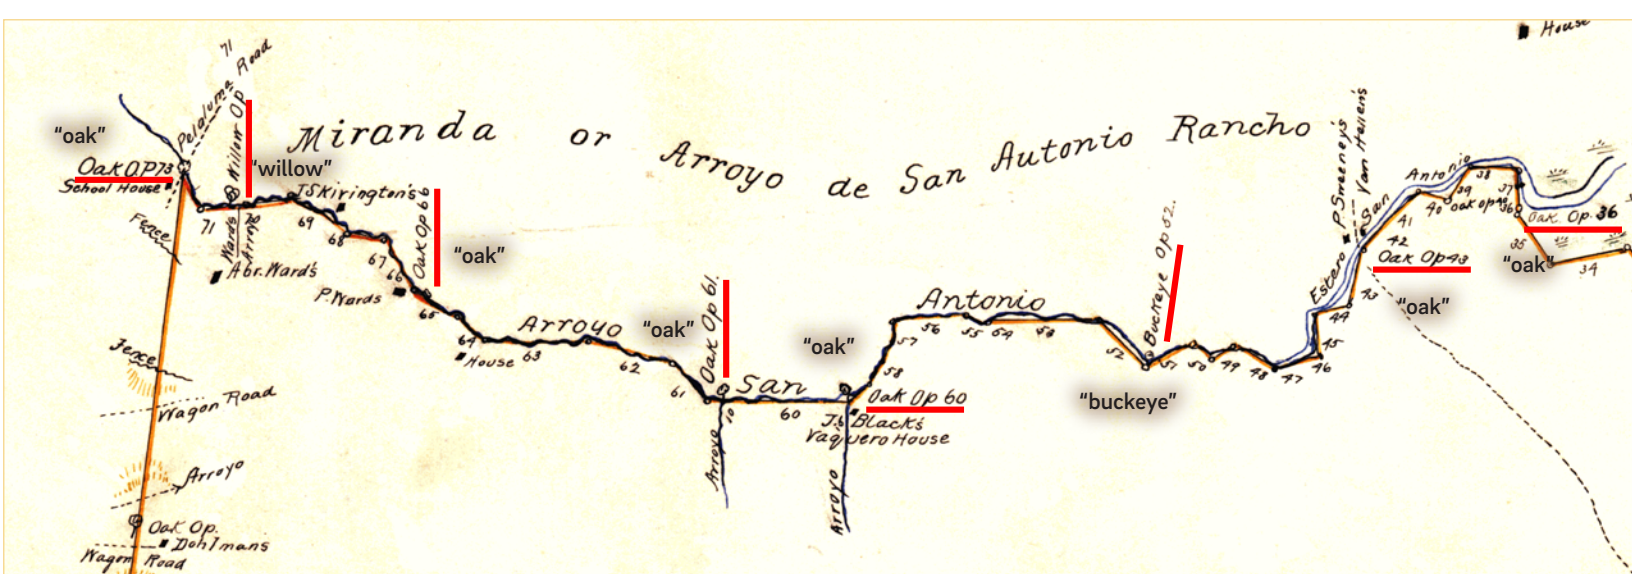
Figure 4.13. Oaks, California bay laurels, willows, and buckeyes were among the dominant riparian species observed along the San Antonio Creek in the 19th and early 20th centuries. These corridors provided important ecosystem functions including bank stability, riparian wildlife habitat, and shading. (Matthewson 1859b, courtesy of Bureau of Land Management)

Along San Antonio Creek, GLO surveyors recorded evidence of a mixed riparian corridor dominated by oaks, laurels, willows, and buckeyes along the entire length of the creek and its tributaries (Fig. 4.13; Matthewson 1859a,b). These early records are consistent with early photographs of the creek (Fig. 4.14) and with the vegetation type mapping (VTM) performed by Albert Everett Wieslander and the U.S. Forest Service in the 1930s, which lists willow, oak, and California bay laurel as the dominant species along downstream reaches of San Antonio Creek (Wieslander 1930). Abundant anecdotal evidence also supports this interpretation: Gelo Parker described willows and laurels along San Antonio Creek in the 1860s (see page 49), while in the early 20th century, zoologist Joseph Dixon recounted his day setting traps along the creek, noting that the foothill canyons were "well wooded with laurel, white and live oak" (Dixon 1908).

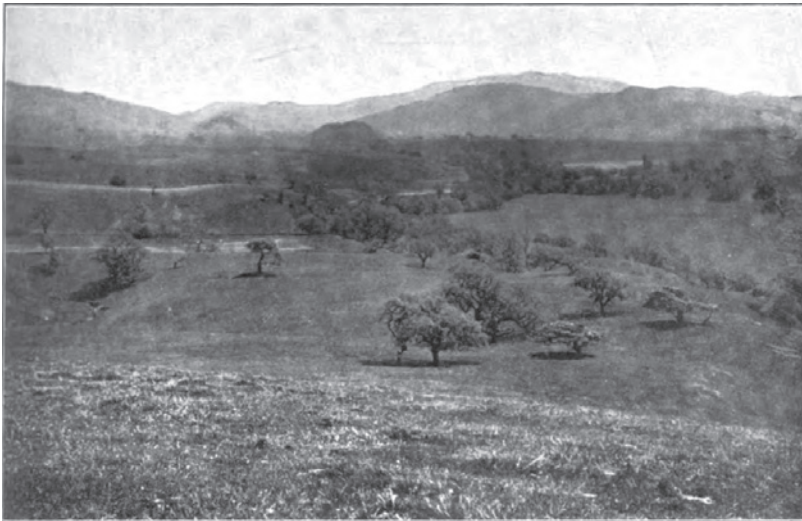
Figure 4.14. (left) A narrow mixed riparian forest is visible bordering San Antonio Creek in this view from ca. 1914, which is looking downstream approximately 3–5 km (2–3 mi) below the top of the watershed. (Holway 1914, Plate 17 [top], courtesy of University of California Publications in Geography)

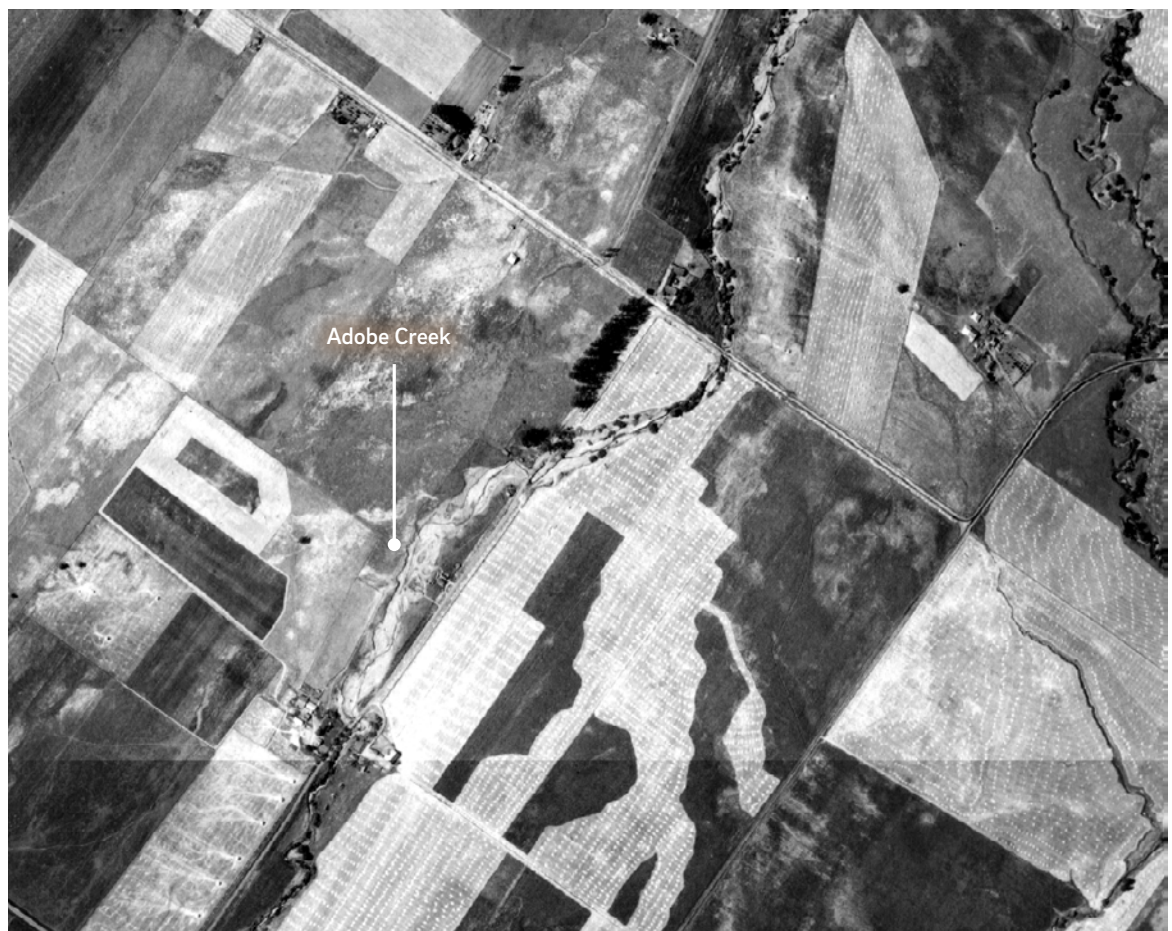
Figure 4.17. Sections of braided channels are visible in the 1942 aerial photos of Adobe Creek. The steep gradient of the Sonoma Mountains, high sediment loads, and substantial flow variability may have established this distinctive pattern. (USDA 1942)

also document many riparian trees and understory species within the watershed, such as Oregon ash, narrowleaf willow, red willow, mule fat, honeysuckle, and California rose (Table 4.1). The lower portions of Adobe Creek appear to have been characterized by a sparsely vegetated braided channel (Fig. 4.17), which may have also been the dominant channel morphology of other discontinuous tributaries on the alluvial plain.

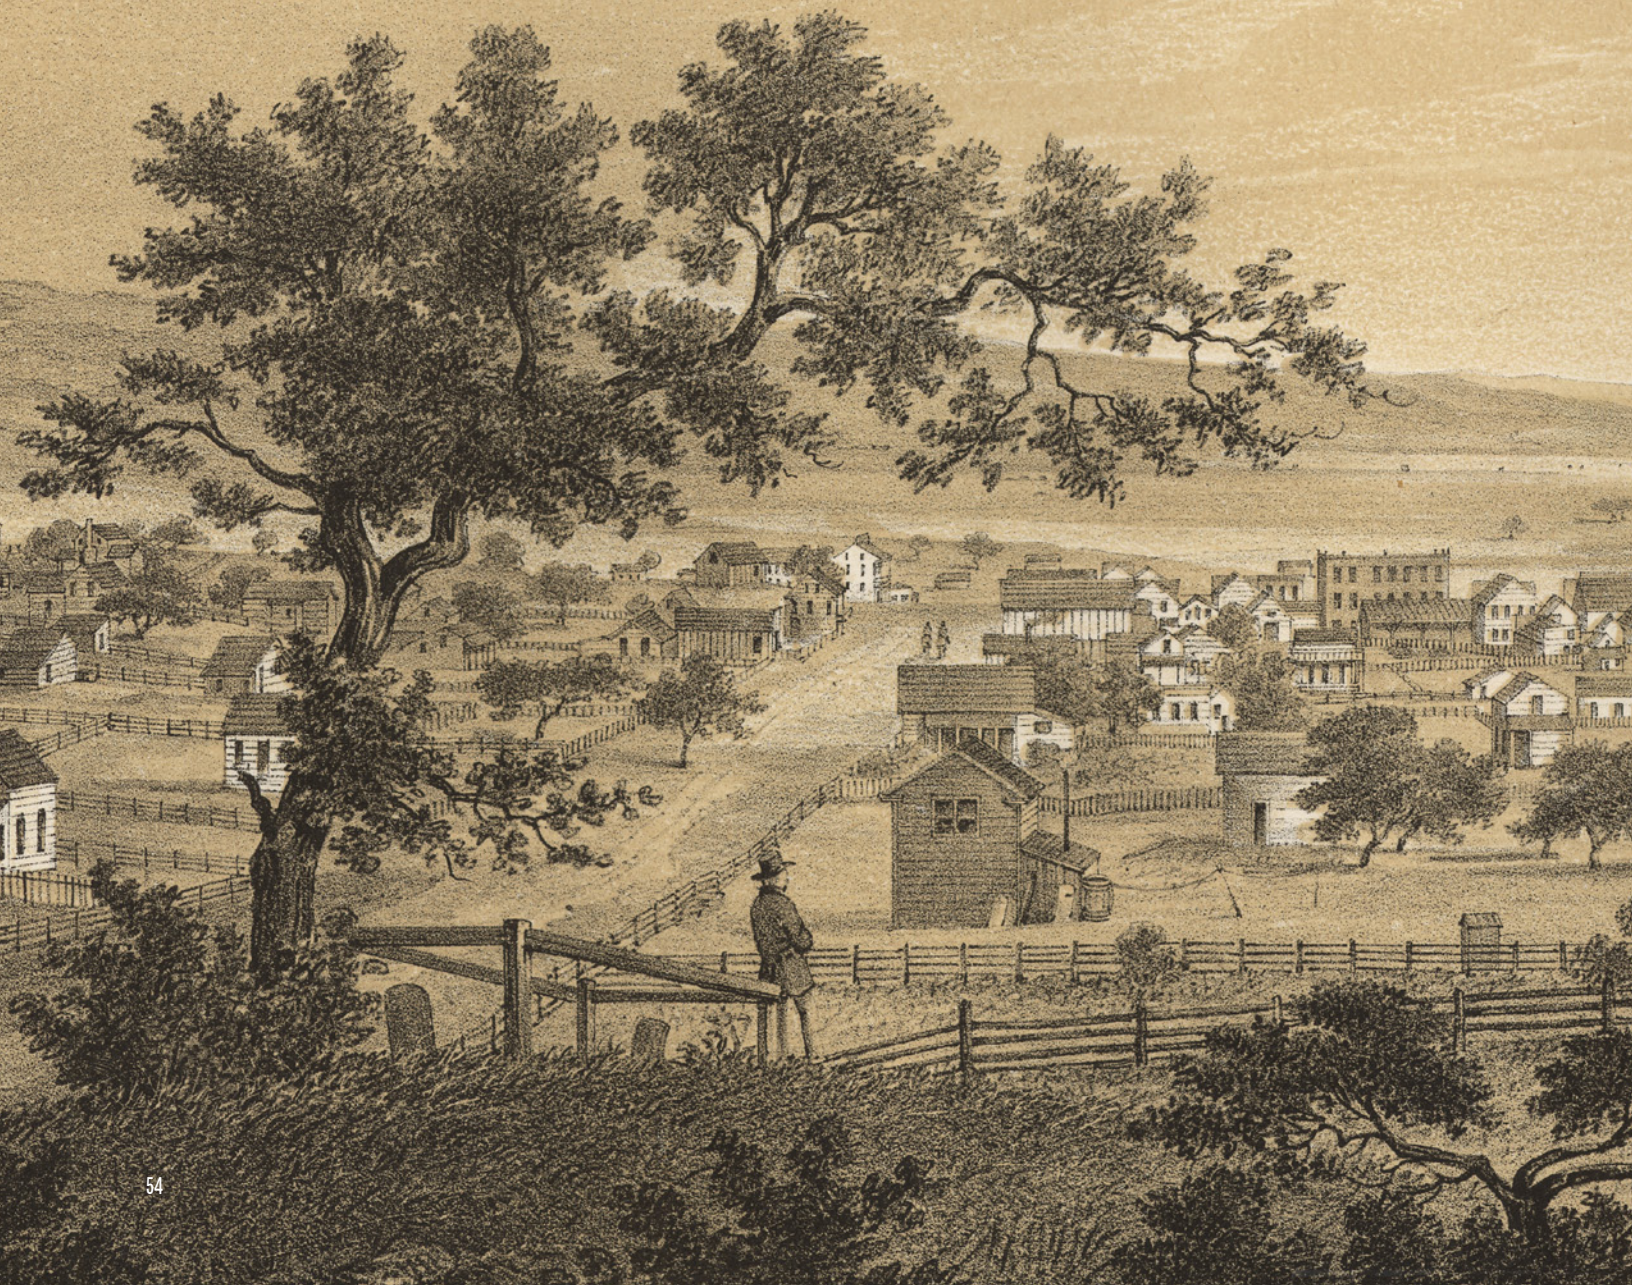
Figure 4.19. John R. Stone Sr. sketched the location of the swimming holes he remembers as a child. According to his account, these deep pools were full of fish. The water retained by in-channel pools may have provided important cold-water habitat for native fish, especially during the dry summer months. (Stone and Curme 1975, courtesy of Sonoma State University Special Collections)

residents describe the presence of additional pools, or “swimming holes,” further downstream. For example, resident John Stone remembered Big Green’s and Little Green’s holes near the output of Lynch Creek, and a big pool they called Ike’s Hole close to the old Highway 101 bridge (Stone and Curme 1975; Fig. 4.19). As Stone recalled, the water ran through the deep pools, which were so full of fish—trout, splittails, and stickleback—that they used to catch “whole sacks of fish” (Stone and Curme 1975). Other accounts describe similar swimming holes under the Northwestern Pacific Railroad trestle, and a spot near the Cinnibar school in which the schoolchildren’s grandparents swam in 1874 (Boivin 1998).

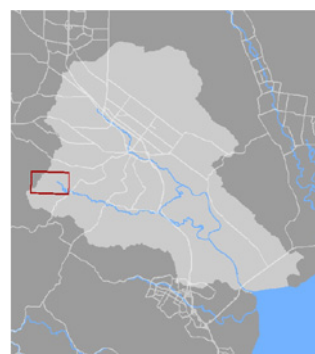
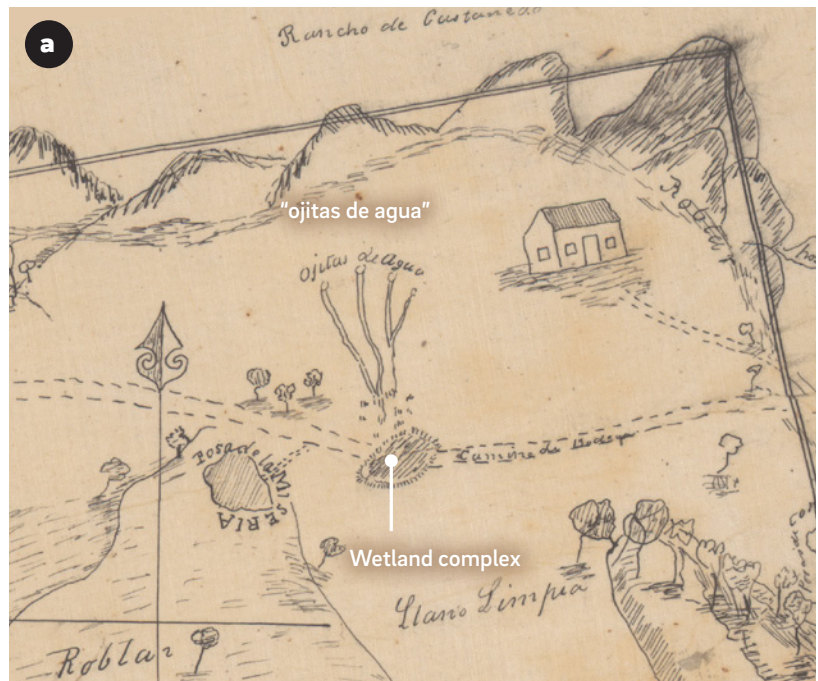
Figure 5.3. Seeps and springs ("ojitas de agua") on Meacham Hill (a) provided freshwater input that helped sustain wet meadows and vernal pool complexes within the Denman Flat basin downstream of Liberty, Marin, Hutchinson, and Wilson creeks (b). (a: USDC 1845, courtesy of The Bancroft Library; b: NAIP 2016)

In addition to rainfall and seasonal flooding, springs, seeps, and high groundwater levels helped sustain seasonal wetlands in some locations. For example, approximately 200 ha (500 ac) of wet meadow and vernal pool complex occupied the Denman Flat basin where Liberty, Marin, Hutchinson, Wiggins, and Wilson creeks converged, near the head of the Petaluma River. While these wetlands were clearly supported in part by streamflow from these creeks, springs and seeps provided additional freshwater input: an 1845 *diseño* of Rancho Roblar de la Miseria shows several “ojitas de agua” (small springs) flowing from Meacham Hill into the wetland complex (Fig. 5.3). On the east side of the river between Petaluma and Lakeville, where the largest expanse of wet meadow occurred, the water table was reported to be approximately 12 feet below the surface in the late 19th century (Ireland 1893), though seasonal fluctuations likely brought the water higher during the rainy season. Groundwater levels had likely already declined in this area by the late 19th century as a result of groundwater pumping for agricultural use (Cardwell 1958). In addition, substantial stream channel incision had already occurred in some areas, such as along Ellis Creek, which may have further contributed to declines in groundwater levels on the plain (Ireland 1890).

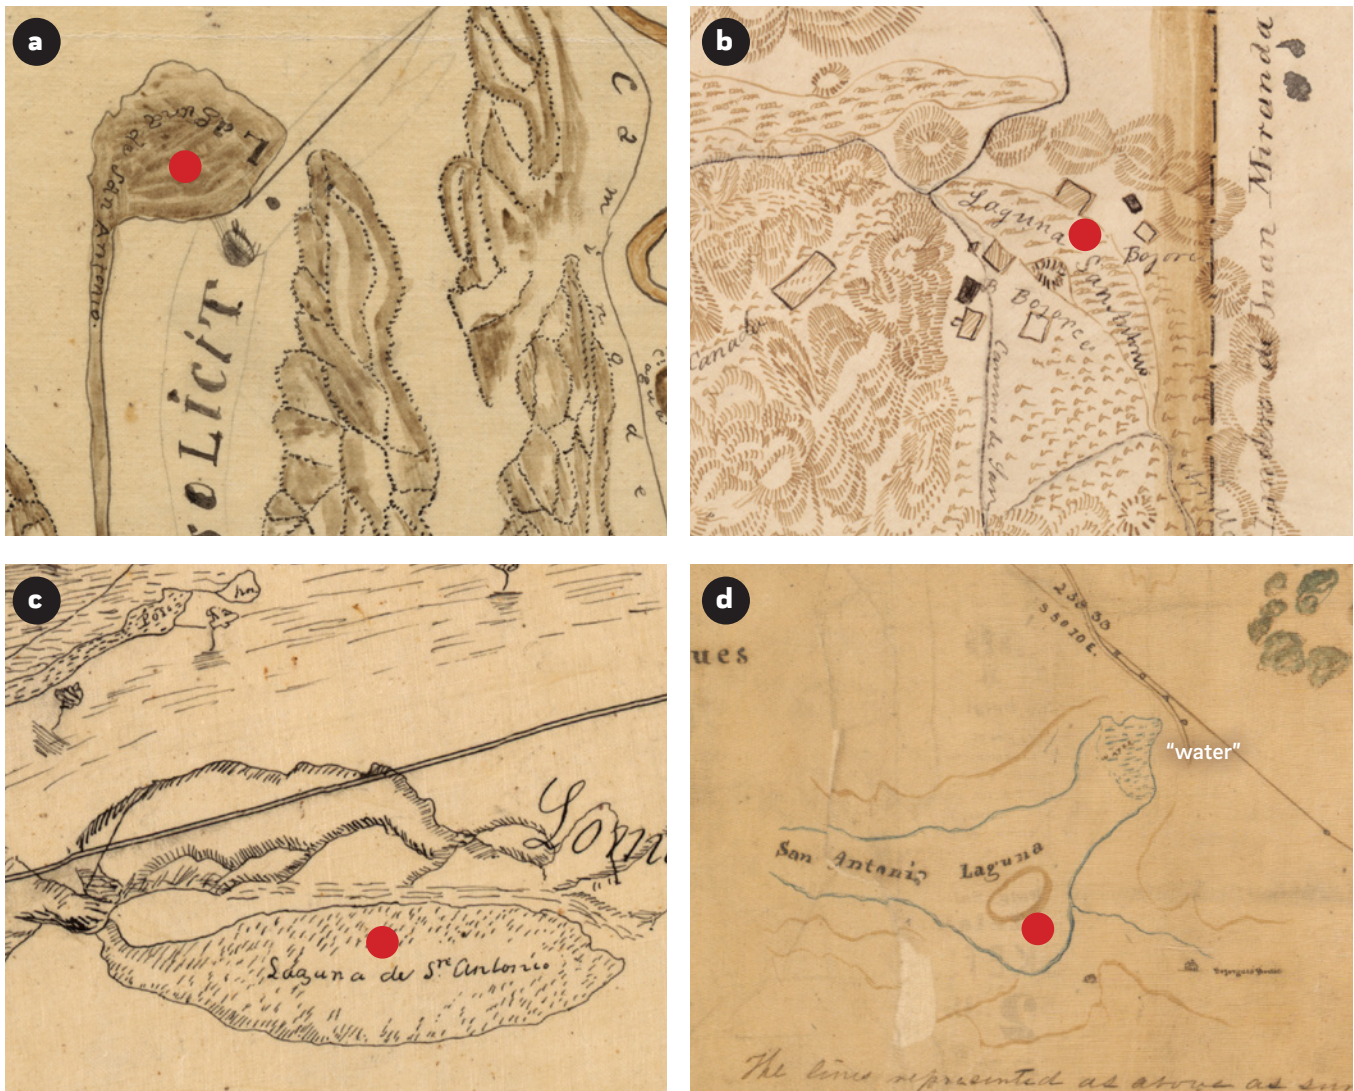
Figure 5.9. These diseños of Rancho Arroyo de San Antonio (a), Rancho Laguna de San Antonio (b), and Rancho Roblar de la Miseria (c,d), drawn ca. 1840, provide some of the earliest cartographic depictions of the Laguna de San Antonio. In two of the diseños (b,c), the Laguna is drawn with a conventional marsh or wetland symbol, suggesting that it was dominated by emergent vegetation such as tule. In one diseño (d), the northeastern portion of the Laguna is differentiated and labeled "water," while another (a) appears to depict the entire Laguna as an open water body. These differences hint at the spatial and temporal variability in the extent of flooding and open water habitat within the Laguna historically. Note that several diseños also show Laguna Lake, just over the drainage divide in the Chileno/Walker Creek watershed. (a: USDC ca. 1856, courtesy of The Bancroft Library; b: USDC ca. 1844, courtesy of The Bancroft Library; c: USDC 1845, courtesy of The Bancroft Library; d: USDC 1852b, courtesy of The Bancroft Library)

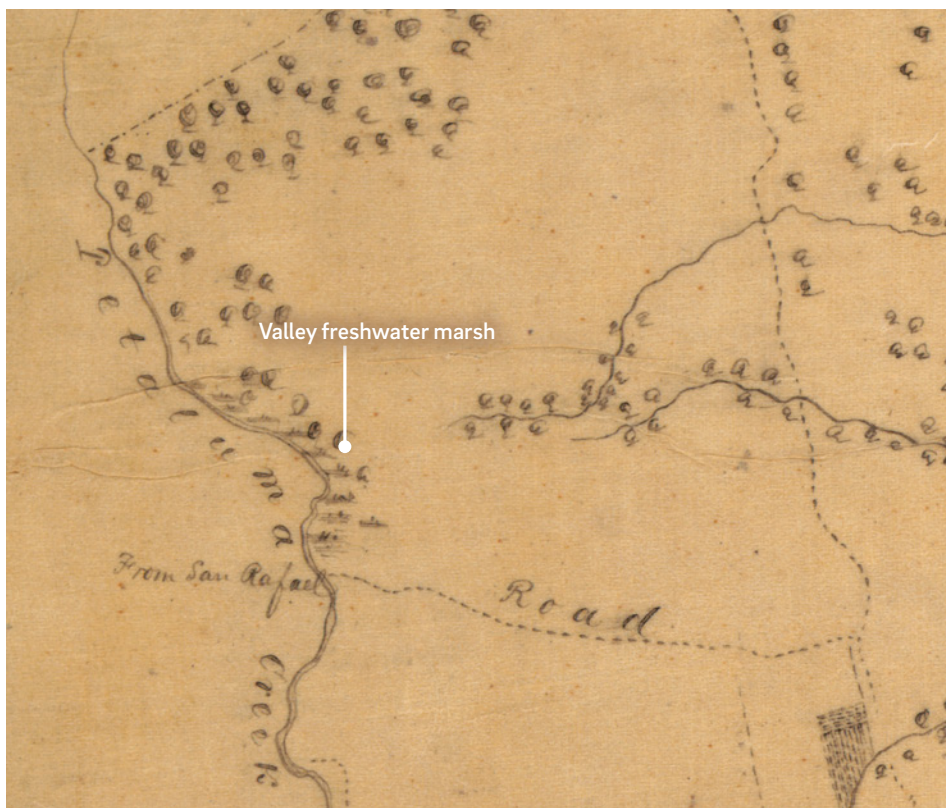
Figure 5.11. (left) This 1852 map of Rancho Petaluma shows several patches of perennial freshwater marsh alongside the mainstem of the Petaluma River a short ways up-stream of the estuary. (*USDC 1852a*, courtesy of *The Bancroft Library*)

In addition to the perennial wetlands in the Laguna at the head of San Antonio Creek, additional pockets of valley freshwater marsh occurred along the northeastern side of the Petaluma River mainstem to the north of the present downtown area (Fig. 5.11). Freshwater marshes in the watershed likely supported a wide range of birds and other wildlife, including tricolored blackbird, a California Species of Special Concern (Mailliard 1879).

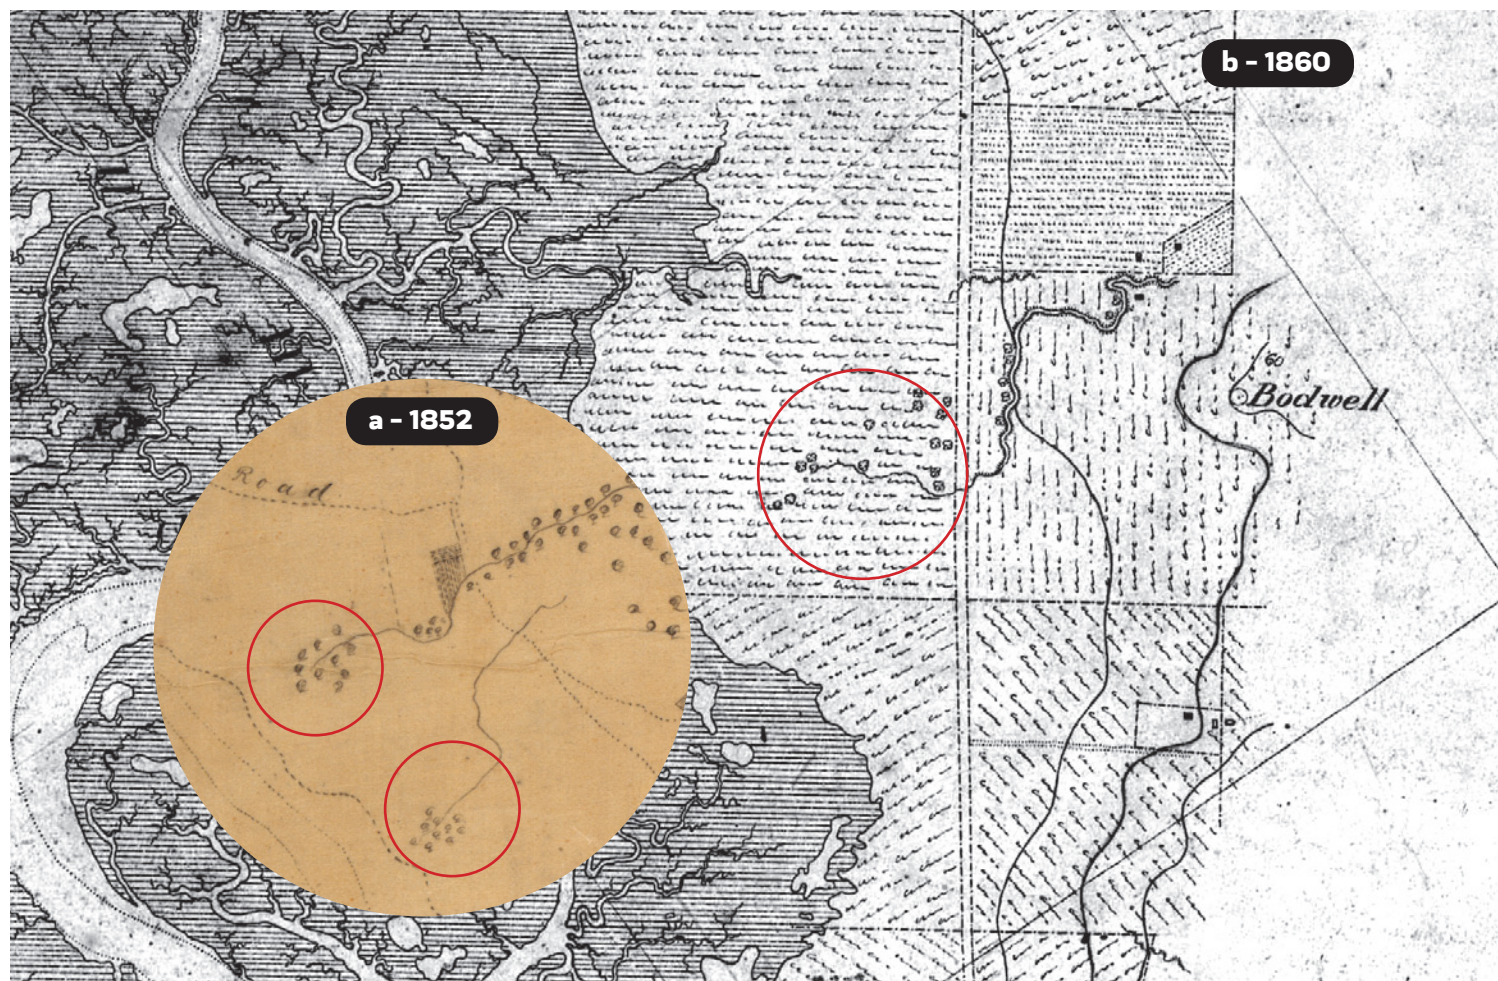
Figure 5.12. The 1852 map of Rancho Petaluma (a) shows several clusters of trees at the downstream ends of Adobe and Ellis creeks; based on landscape position, these are interpreted to represent depictions of small willow groves at the ends of the channels, just upstream of the estuary. Though USCS surveyors did not focus on landscape features beyond the extent of tidal influence, the 1860 T-sheet (b) also indicates the presence of a willow grove at the end of Ellis Creek. (a: USDC 1852a, courtesy of The Bancroft Library; b: Rodgers and Kerr 1860, courtesy of NOAA)

The historical evidence for willow groves in the Petaluma River watershed is limited, especially in comparison to the well-documented groves elsewhere in the Bay Area. Their presence is inferred primarily from their landscape position in several mid-19th century maps, which depict the willow groves as distinct clusters of trees at the downstream ends of Ellis and Adobe creeks (Fig. 5.12). Zoologist Chester Lamb also reported finding an “extensive willow bottom 4 mi. S of town” while collecting specimens near Petaluma in September of 1927, though this may have been a reference to a particularly extensive patch of riparian forest along San Antonio Creek (Lamb 1927).

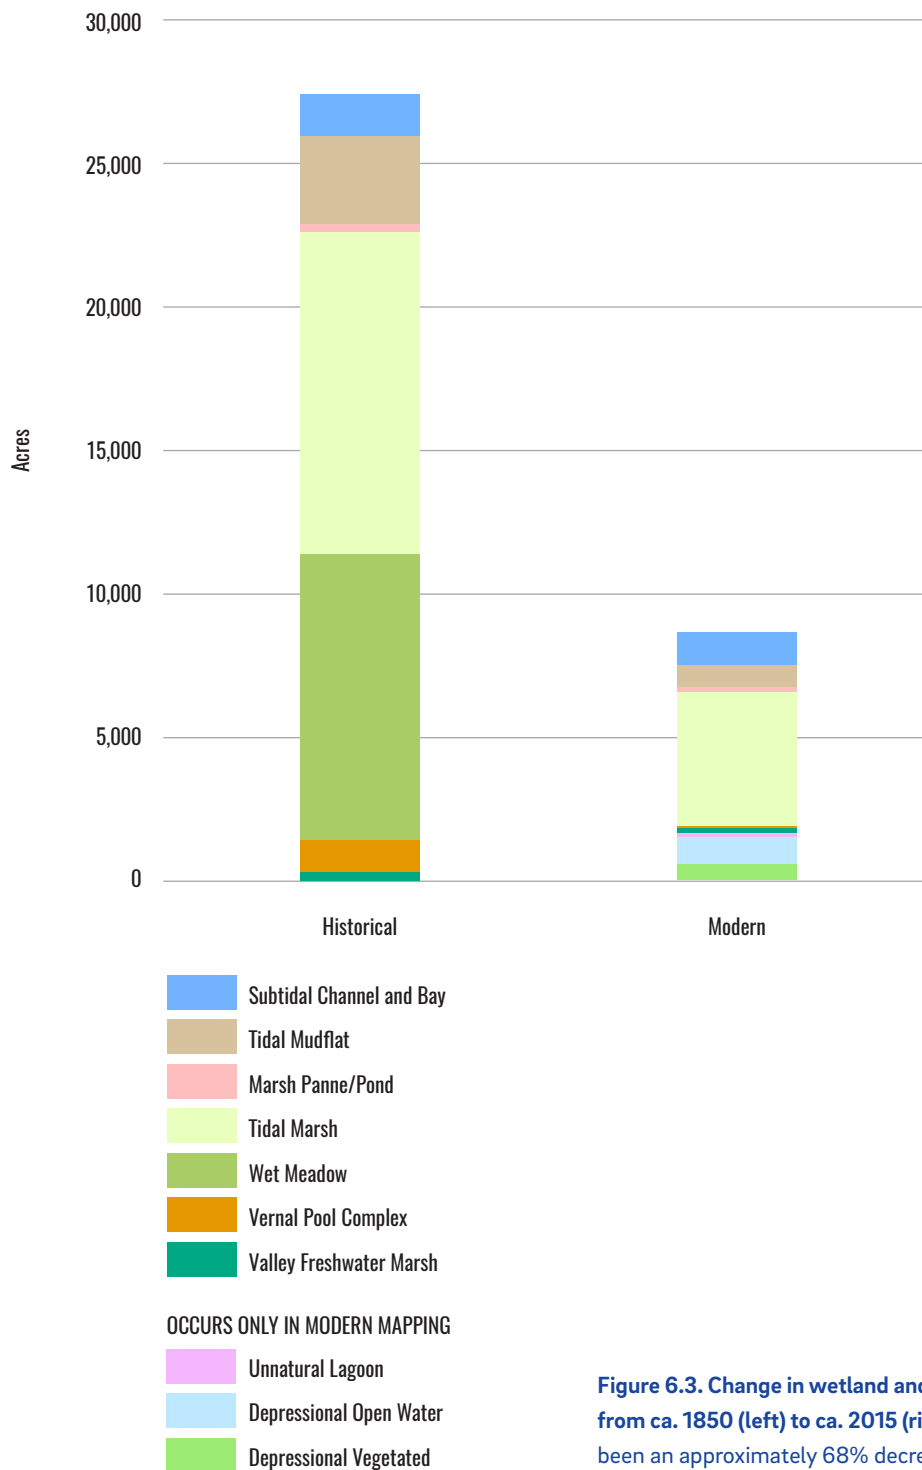
Figure 6.3. Change in wetland and aquatic habitat area from ca. 1850 (left) to ca. 2015 (right). Overall there has been an approximately 68% decrease in habitat extent.
