Petaluma Valley

HISTORICAL HYDROLOGY and ECOLOGY STUDY

SAN FRANCISCO ESTUARY INSTITUTE PUBLICATION #861

March 2018

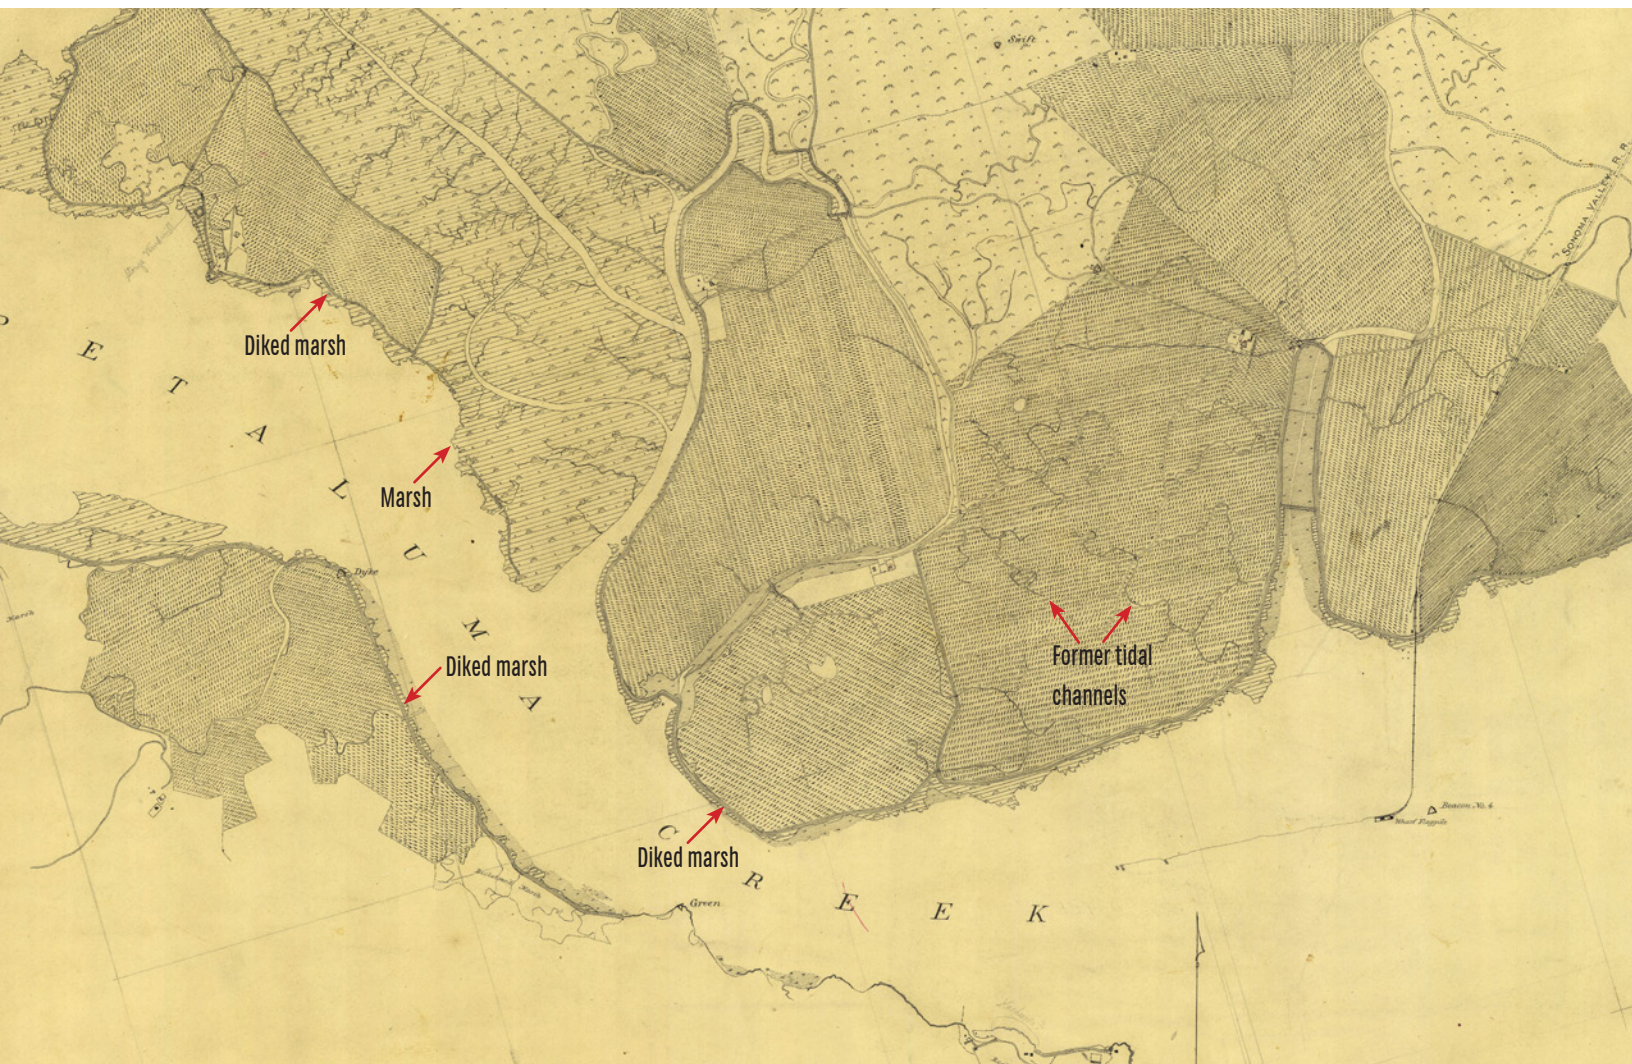
Figure 6.5. This 1871 map shows a “flood gate” and “dam” regulating tidal flows within Duncan Slough, just east of the Petaluma River mouth. The SF&NPRR line (originally part of the Marin and Napa Rail Road Company) was not constructed until 1887-8, and was apparently added on to the map at a later date. (Thompson 1871, courtesy of Curtis & Associates, Inc.)

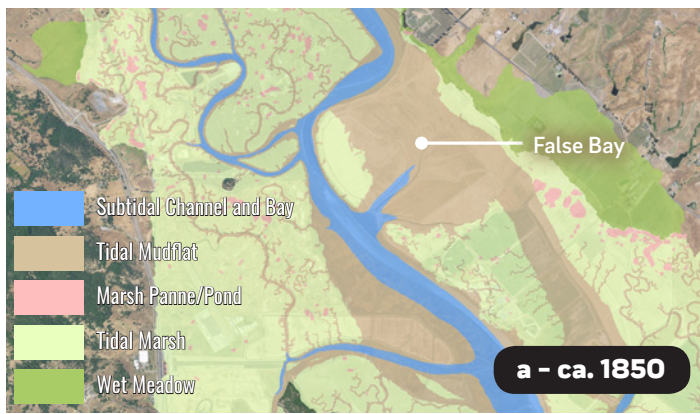
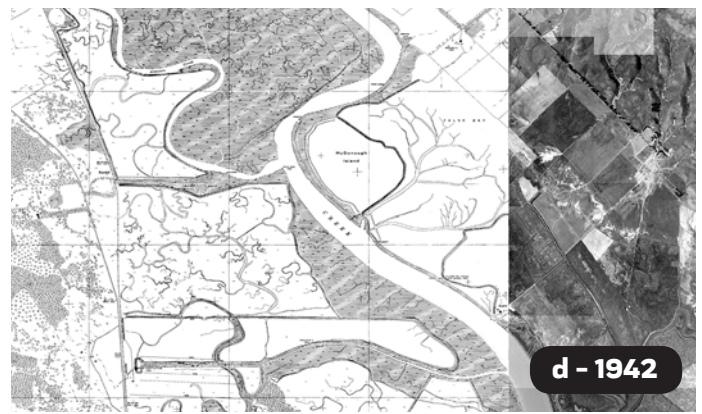
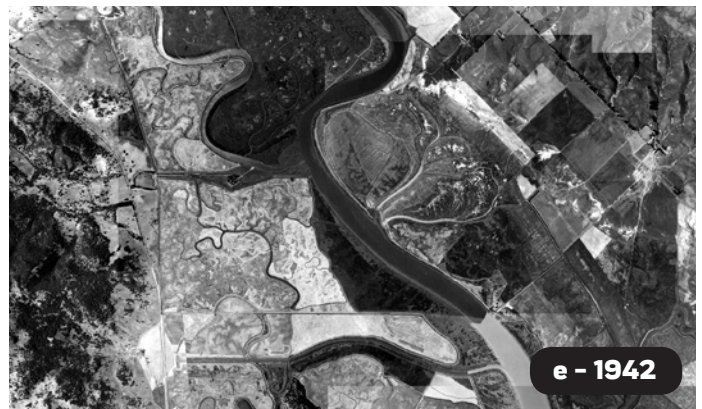
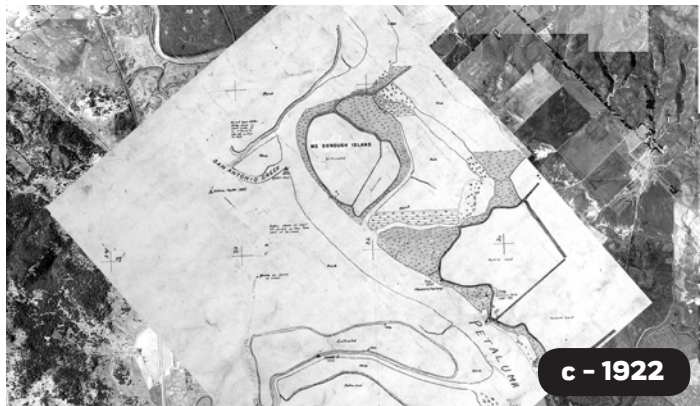
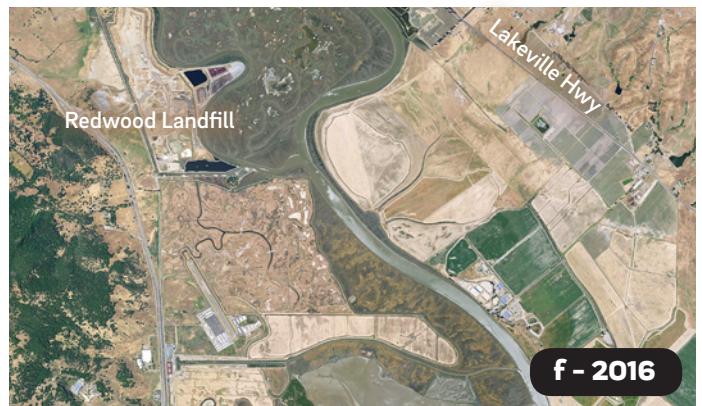
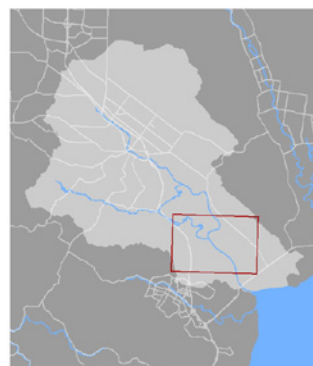
Figure 6.6. This sequence of images shows the gradual filling of False Bay over the late 19th and early 20th centuries. Historically a shallow tidal mudflat (a,b), by 1922 sediment accretion had caused much of the area to be converted to vegetated marsh (c). By 1942, much the area had been leveed (d,e), but was not yet heavily cultivated as it is today (f). (a: NAIP 2016; b: Kerr 1860, courtesy of NOAA; c: Swainson et al. 1922; d: USCGS 1941-2, courtesy of NOAA; e: USDA 1942; f: NAIP 2016)

False Bay, which was a large tidal mudflat at the time of the earliest USCS surveys, has experienced several distinct changes over the past 150 years. By the early 20th century, sediment accretion had caused much of the mudflat at False Bay to be converted to vegetated marsh. Though still referred to as a “high water lagoon” as late as 1917 (Heuer 1917), by 1922 UCSGS surveyor O.W. Swainson reported that “False Bay has filled up to a great extent” (Swainson 1922). The area remained as an undiked marsh for a period during the 1920s and 30s, though by 1942 much of the area was surrounded by levees and was being brought into cultivation (Fig. 6.6).

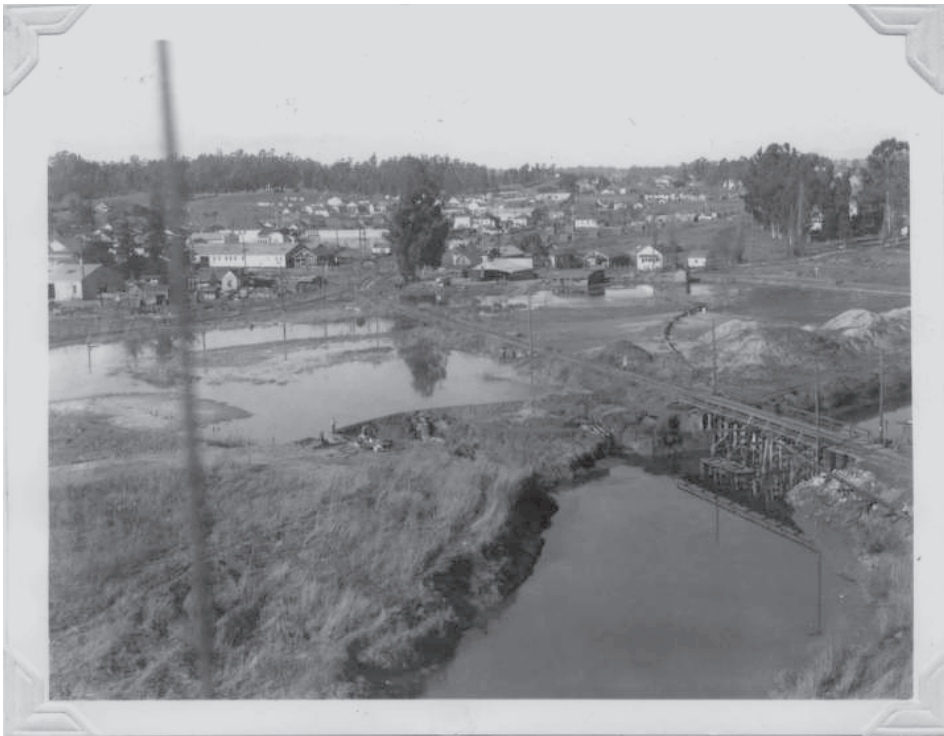
Figure 6.8. The caption of this 1937 photograph, looking north from the top of the grain elevator on East Washington Street, says, "Dredge pipe line delivering a fine sand from the bottom of the Petaluma River to low land in the north." The dredge pipe is visible just beyond the railroad bridge over the Petaluma River, and appears to be depositing the sediment in a low area that was a former meander of the river. (Annex photo 33380, courtesy of Sonoma Heritage Collection)

In 1880, the Army Corps initiated its first large-scale dredging operation in the river, which created three cut-offs, deepened the river to 1 m (3 ft) at low tide, and widened it to 15 m (50 ft) (Schulz 1927; Fig. 6.7). Additional dredging, straightening, and maintenance occurred during the late 19th and early 20th centuries, including the creation of McNear Canal in 1893 and the dredging of the turning basin from 1918–21 (Heuer 1917, Schulz 1927, Roop and Flynn 2007). Another major Army Corps dredging project was conducted in 1931, which increased the channel's width to 30 m (100 ft) and its depth to 2 m (8 ft) from the river mouth up to Western Avenue (United States Army War Department 1933). Dredged sediment was often used to fill parts of the surrounding tidal marsh or former tidal channels (Mendell 1883, Stone and Curme 1975; Fig. 6.8). In an interview conducted in 1975, for instance, John Stone, a long time resident of Petaluma, described how dredged sediment was used to fill old channels in the 1920s and 30s:

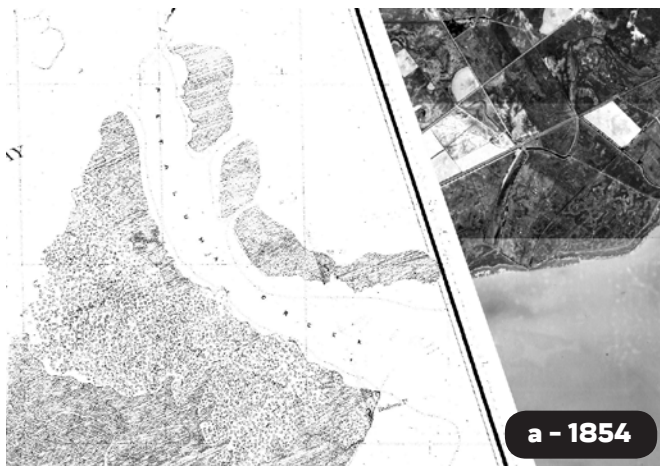
a - 1854

Figure 6.10. (left) Comparison of the 1854 T-sheet (a), the 1942 aerials (b) and 2016 NAIP imagery (c) illustrates the progradation of tidal marsh on the margins of the Petaluma River channel. Sediment accretion resulting in conversion to vegetated marsh has decreased the width of former mudflats and tidal channels near the mouth of the river by up to 600 m (2,000 ft). (a: Rodgers 1854, courtesy of NOAA; b: USDA 1942; c: NAIP 2016)

Sediment accumulation within the river necessitated periodic dredging on an ongoing basis (Fig. 6.9). Between 1908 and 1927, for instance, an estimated 28,290 m³ (37,000 yd³) of sediment were removed from the channel annually above Haystack Landing in order to maintain existing channel dimensions (Jackson 1927). Increased sediment accumulation within the Petaluma River channel was the result of multiple factors, including erosion stemming from grazing, farming, and other land uses within the watershed; loss of tidal prism due to diking and filling of the surrounding marsh; and the influx of sediment from hydraulic mining following the Gold Rush (Jackson 1927, USACE 1974, Atwater et al. 1979). Sediment accumulation resulted not only in decreased channel depth, but also progradation of the marsh at the mouth of the river and along the margins of the channel. Marsh progradation rates at the mouth of the river averaged 1–2 mm/yr (0.04–0.08 in/yr) between ca. 1855 and 2010 (Beagle et al. 2015), and in the lower reaches of the river the width of the subtidal channel and tidal mudflat has decreased by up to 600 m (2,000 ft) over the past 150 years (Fig. 6.10).

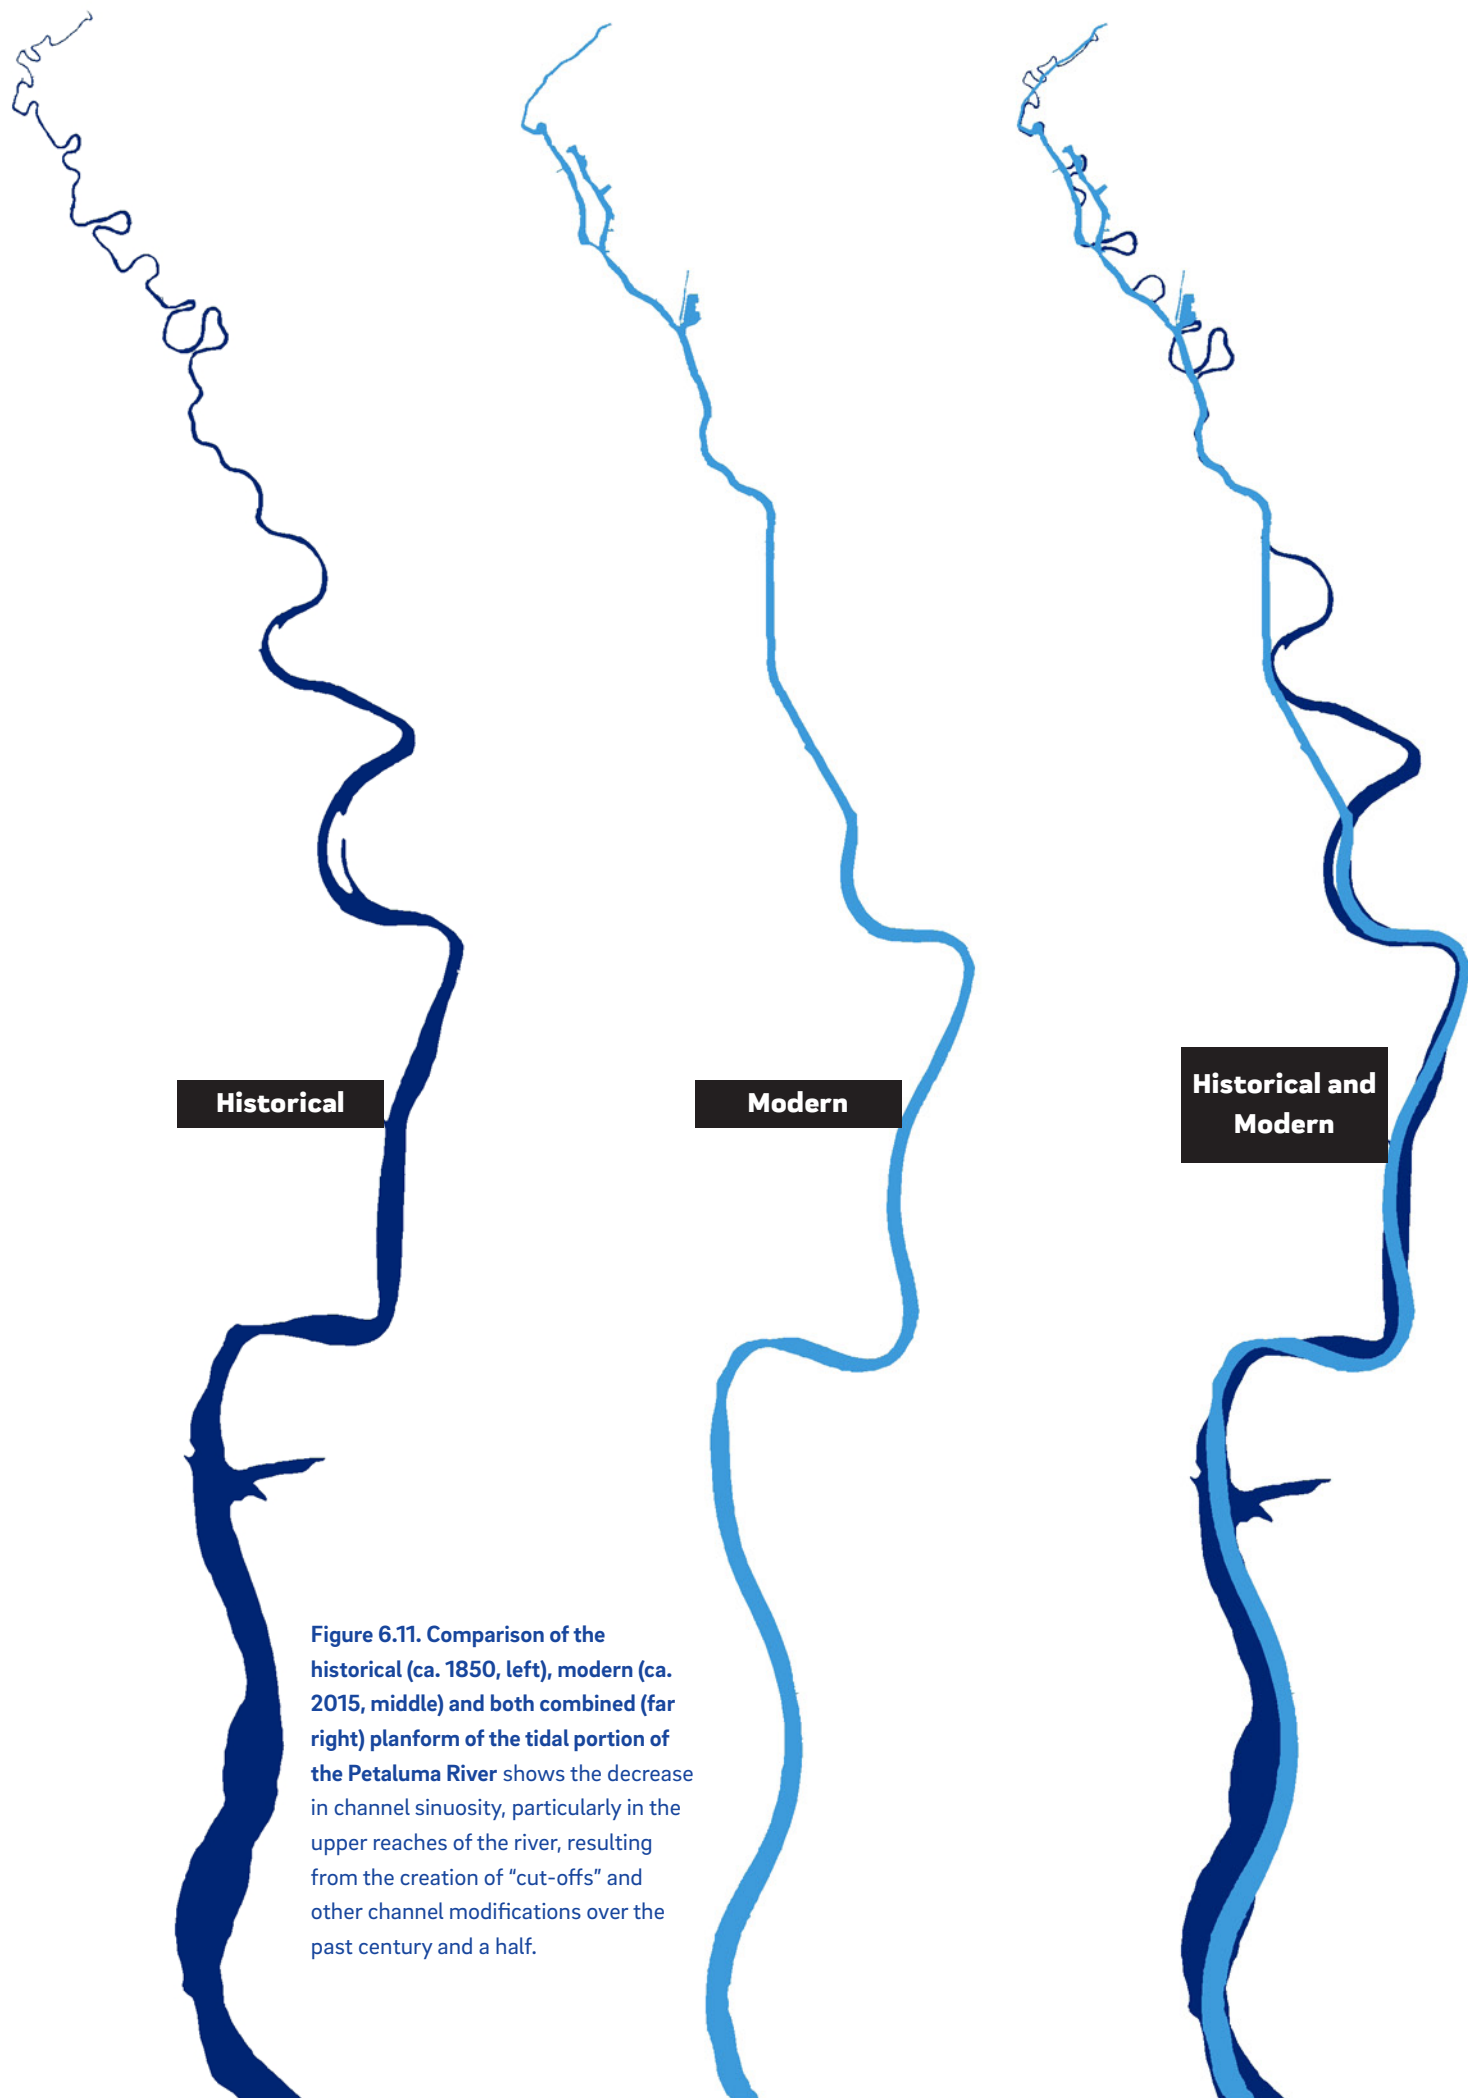
Figure 6.11. Comparison of the historical (ca. 1850, left), modern (ca. 2015, middle) and both combined (far right) planform of the tidal portion of the Petaluma River shows the decrease in channel sinuosity, particularly in the upper reaches of the river, resulting from the creation of "cut-offs" and other channel modifications over the past century and a half.

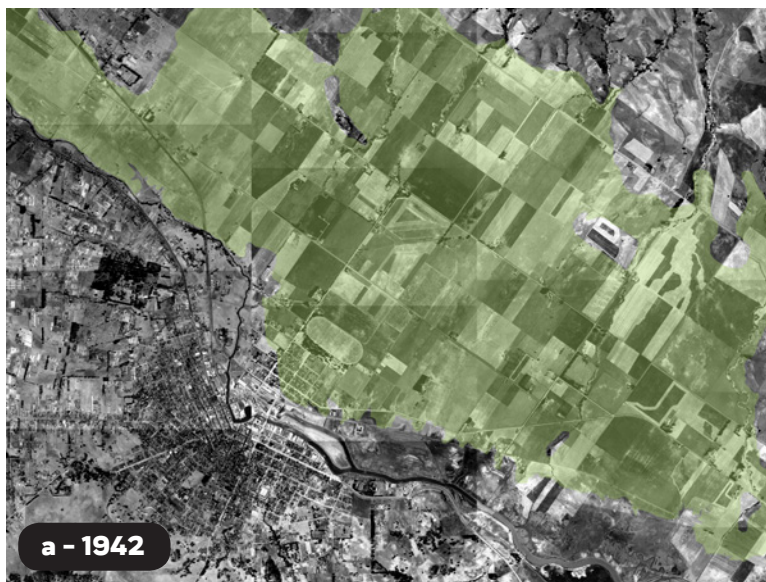
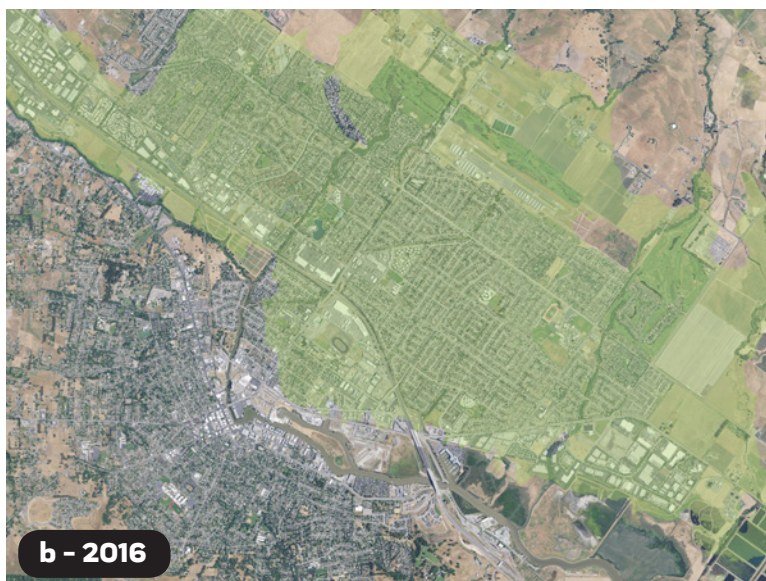
Figure 6.12. Historical wet meadow habitat on the valley floor east of the Petaluma River (indicated in green) was initially converted to agricultural land uses (a), though today this area is dominated by urban development (b). (a: USDA 1942; b: NAIP 2016)

Virtually all of the large, contiguous expanse of wet meadow that historically existed on the northeastern side of the river has been eliminated. The initial loss of this habitat was largely due to conversion to agricultural land uses (Fig. 6.12a). Today, however, much of this area is dominated by urban development (Fig. 6.12b). Small remnants of wet meadow exist in a number of locations throughout the watershed, most notably at the head of San Antonio Creek, along the San Antonio Creek mainstem and tributaries, and along Wiggins Creek.

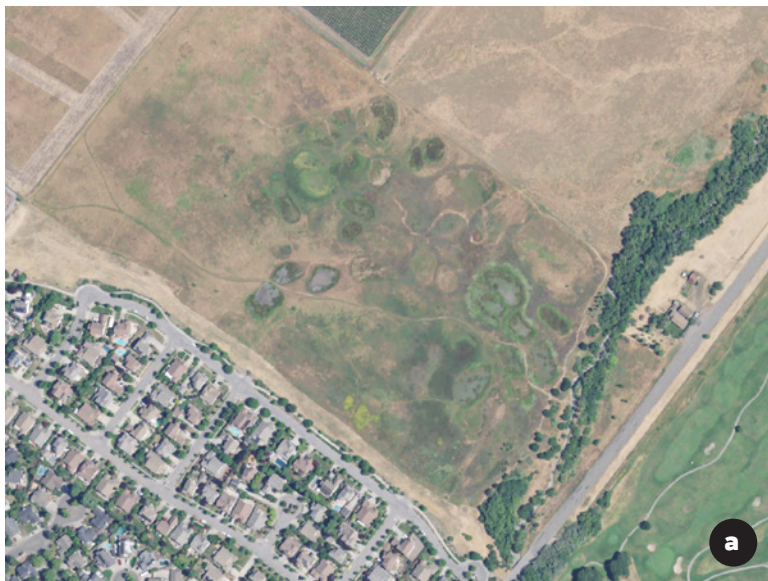
Figure 6.13. Though 95% of historical vernal pool extent has been lost, small remnants of vernal pool habitat exist in several locations throughout the watershed, including patches adjacent to Adobe Creek (a) and Willow Brook Creek (b). (NAIP 2016)

Most of the vernal pools that existed within the watershed historically have been eliminated by urban and agricultural development, though small remnants of vernal pool complex still exist on the valley floor just west of Adobe Creek and near Willow Brook Creek (Fig. 6.13). In a number of areas where land use and hydrologic changes have destroyed or degraded vernal pool habitat and ecological function, the topographic features that supported vernal pools historically—mounds and depressions—are still present in some form and can be discerned in LiDAR imagery (see Fig. 5.7 on page 61).

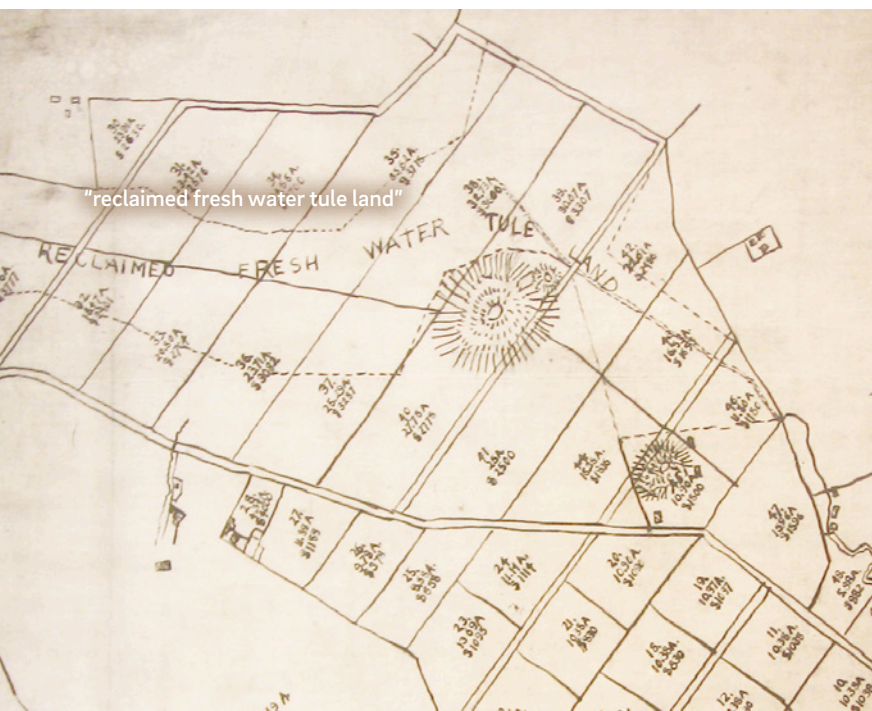
Figure 6.14. The Laguna de San Antonio was ditched and drained in the late 19th century and used for agricultural production. This 1890 map of the “Walker Villa Tract” labels the Laguna as “reclaimed fresh water tule land.” (Unknown 1890, courtesy of Marin County Surveyor)

By 1880, the Laguna wetland complex at the head of San Antonio Creek was ditched and drained, and former wetland areas had been brought into agricultural use (Alley, Bowen & Col. 1880; Fig. 6.14). Wheat, barley, and potatoes were among the first crops to be cultivated on the newly drained lands (*Marin Journal* 1878; Alley, Bowen & Co. 1880; *Petaluma Weekly Argus* 1886), which were also subsequently used to cultivate hay and corn and as pasture for dairy cows (Dolcini Family 1984, 2006, 2007). Despite being ditched and drained, the area continued to provide some function as aquatic habitat: a *Marin Journal* article from February of 1901 reported that “the upper and lower laguna are well filled with water since the last rains and duck hunting is quite the rage” (*Marin Journal* 1901). Today, depressional and seasonal wetlands still occupy approximately 55 ha (140 ac) at the head of San Antonio Creek, within the footprint of the historical Laguna, though these wetlands are highly modified, and do not provide habitat quality comparable to the large wetland complex that existed in the past (Fig. 6.15).

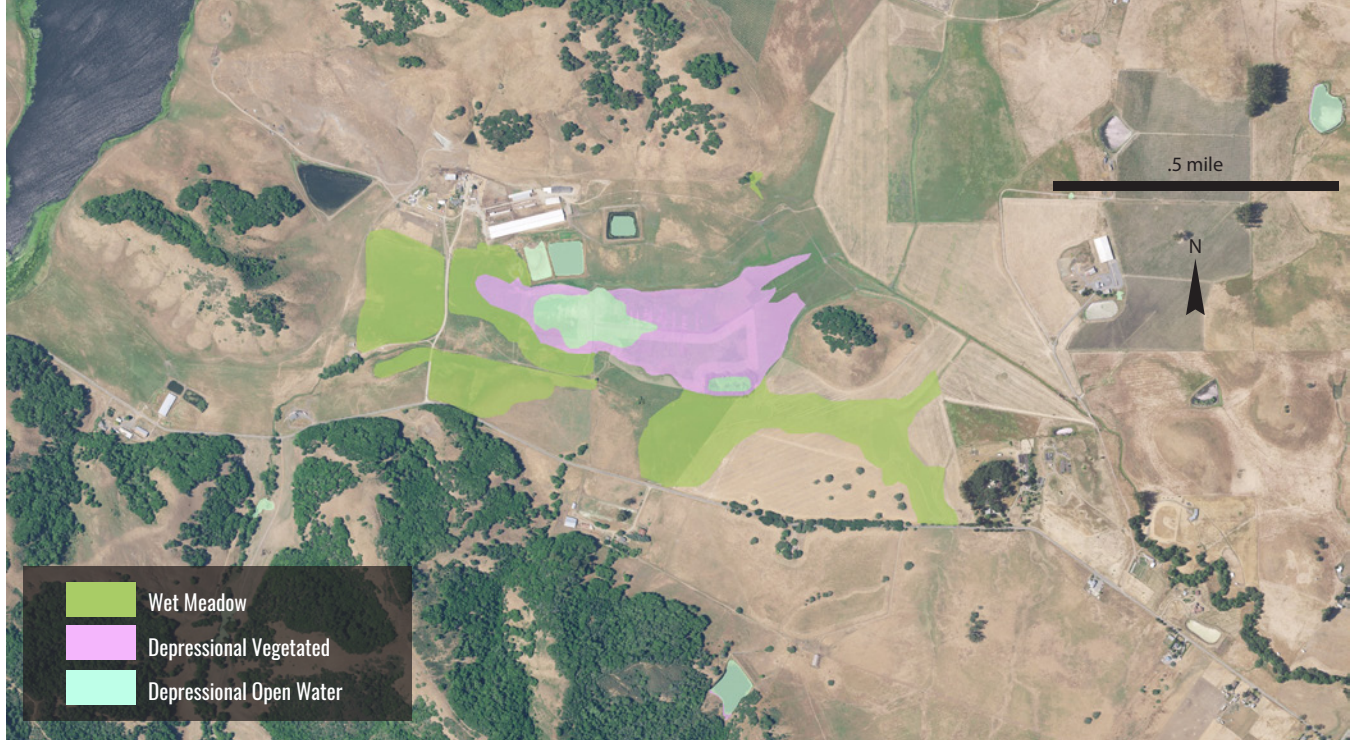
Figure 6.15. Though used for a variety of agricultural purposes over the past 140 years, wet meadow and depressional wetlands still cover a substantial area of the former Laguna footprint. These wetlands are highly modified, however, and do not provide the same ecological functions as the historical Laguna. (NAIP 2016)

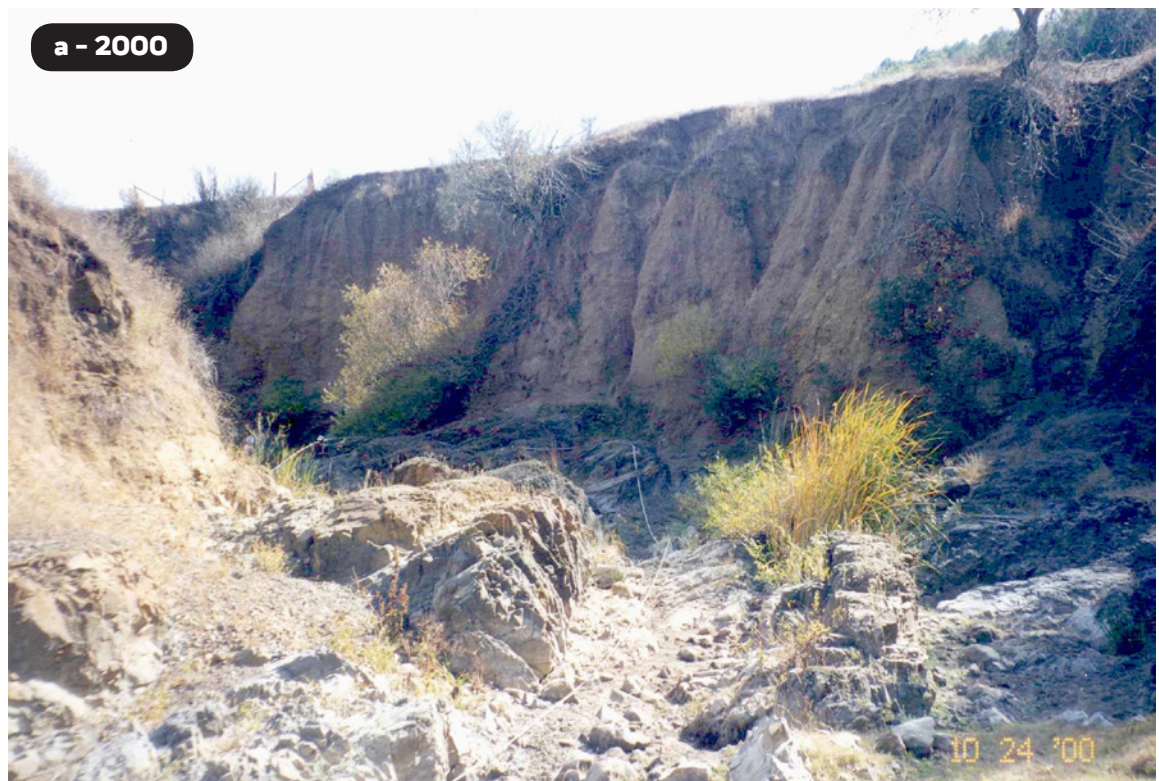
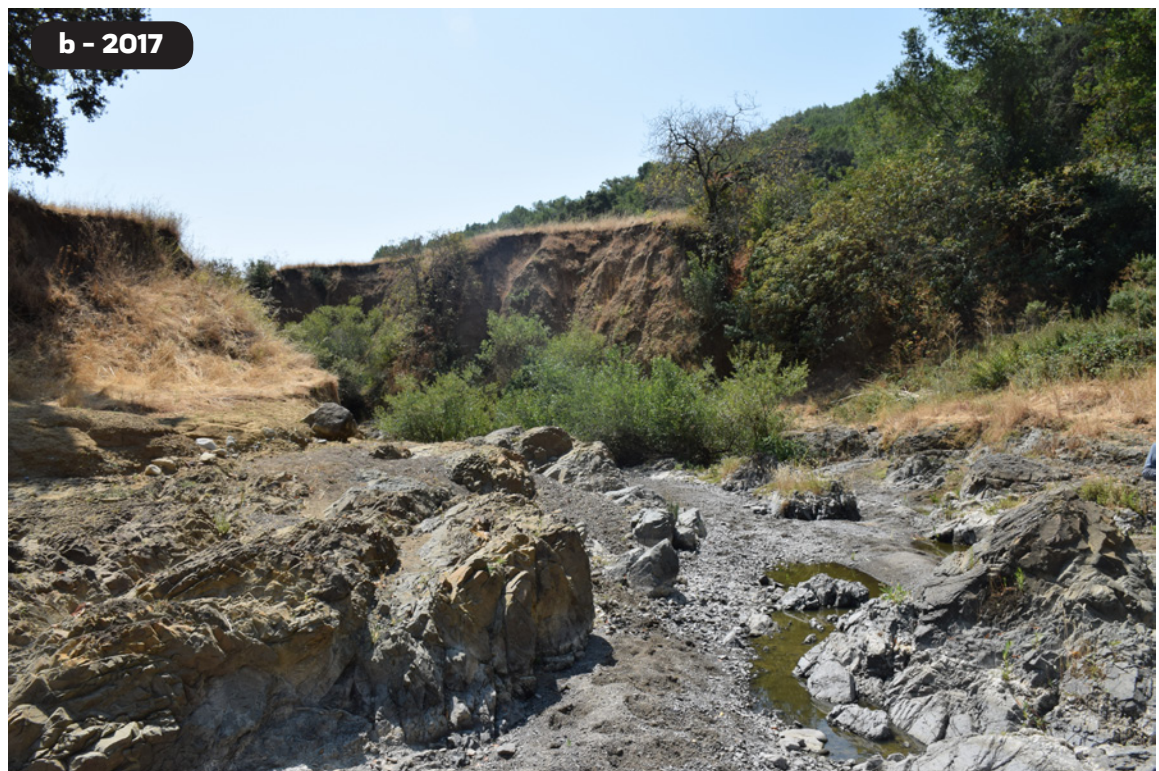
Figure 6.17. Photographs from 2000 (a) and 2017 (b) showing the progression of bank erosion at a location in San Antonio Creek just south of the confluence of San Antonio Road and I Street. Based on a visual inspection of the photographs, it is estimated that 12 feet or more of bank erosion has occurred in some parts of this reach over this 17 year period. (a: Photo by Laurel Collins October 24, 2000; b: Photo by Sean Baumgarten August 10, 2017)

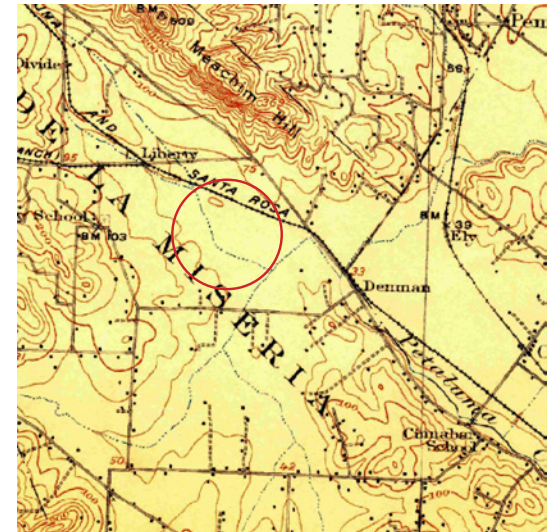
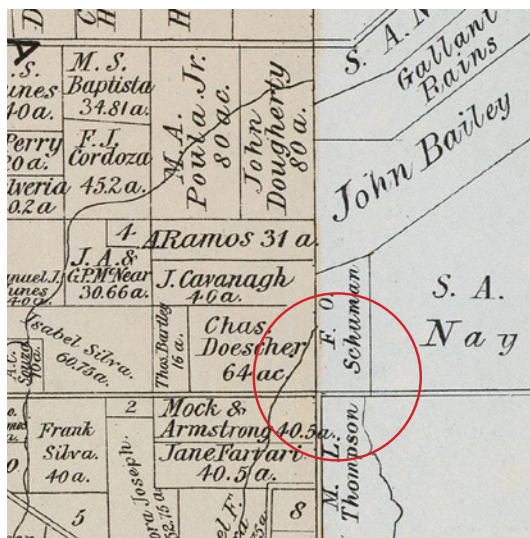
Figure 6.19. Many creeks that historically terminated in a distributary upstream of the tidal marsh or of other channels were lengthened and channelized in order to increase drainage efficiency. (a) By the late 1870s, Adobe Creek had been lengthened to connect with the tidal wetlands just south of Newtown. (b,c) By the early 20th century, Liberty, Marin, and Wilson creeks had been lengthened to connect with the Petaluma River mainstem. (a (left): Rodgers and Kerr 1860, courtesy of NOAA; a (right): Thompson 1877b, courtesy of David Rumsey Map Collection; b (left): Unknown 1857, courtesy of Curtis & Associates, Inc.; b (right): USGS [1914]1916; c (left): Reynolds and Proctor 1898, courtesy of David Rumsey Map Collection; c (right): USGS [1914]1916)

In addition to the loss and modification of tidal and non-tidal wetlands, land and water use changes have also had major impacts on the channel network throughout the watershed. One notable change has been the channelization and lengthening of many streams, particularly in downstream reaches on the valley floor and within the former baylands (Fig. 6.18). Among mapped streams (higher order channels within alluvial areas), total channel length has increased by approximately 50%. Many streams that historically terminated in a distributary upstream of the baylands or of other channels (e.g., Adobe, East Washington, Washington, Lynch, Marin, Hutchinson, Wilson, and Liberty creeks) were lengthened in order to increase the efficiency of drainage or control flooding, often as early as the late 19th or early 20th centuries (Thompson 1877a; Fig. 6.19). Thus, where streamflow and sediment historically spread out across distributary networks and helped sustain non-tidal wetlands in many locations, today flows and sediment loads are conveyed further downstream through artificial channels.

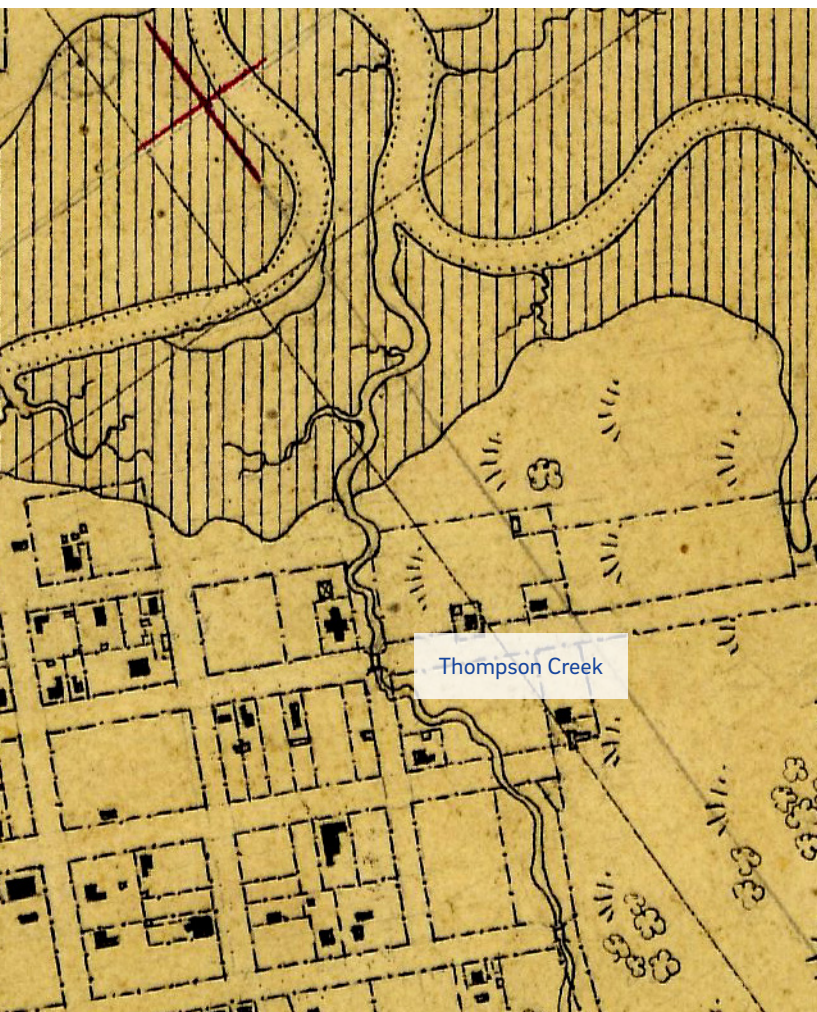
Figure 6.20. By 1883, the lower portion of Thompson Creek was channelized to flow through a storm drain beneath F Street to its confluence with the Petaluma River. (Left: Rodgers and Kerr 1860, courtesy of NOAA; Right: Sanborn Map and Publishing Co. 1883, courtesy of Earth Sciences & Map Library, UC Berkeley)

In addition to the overall lengthening of the channel network, the alignment of stream channels has been changed in a number of locations. For instance, the lower portion of Thompson Creek, which historically connected with the Petaluma River near present-day F Street, was straightened and confined to a storm drain sometime during the 1860s or 70s (Fig. 6.20). Portions of many other creeks throughout the watershed, such as Hutchinson, Marin, Washington, and Adobe creeks, and tributaries of San Antonio Creek, have also been ditched and straightened.

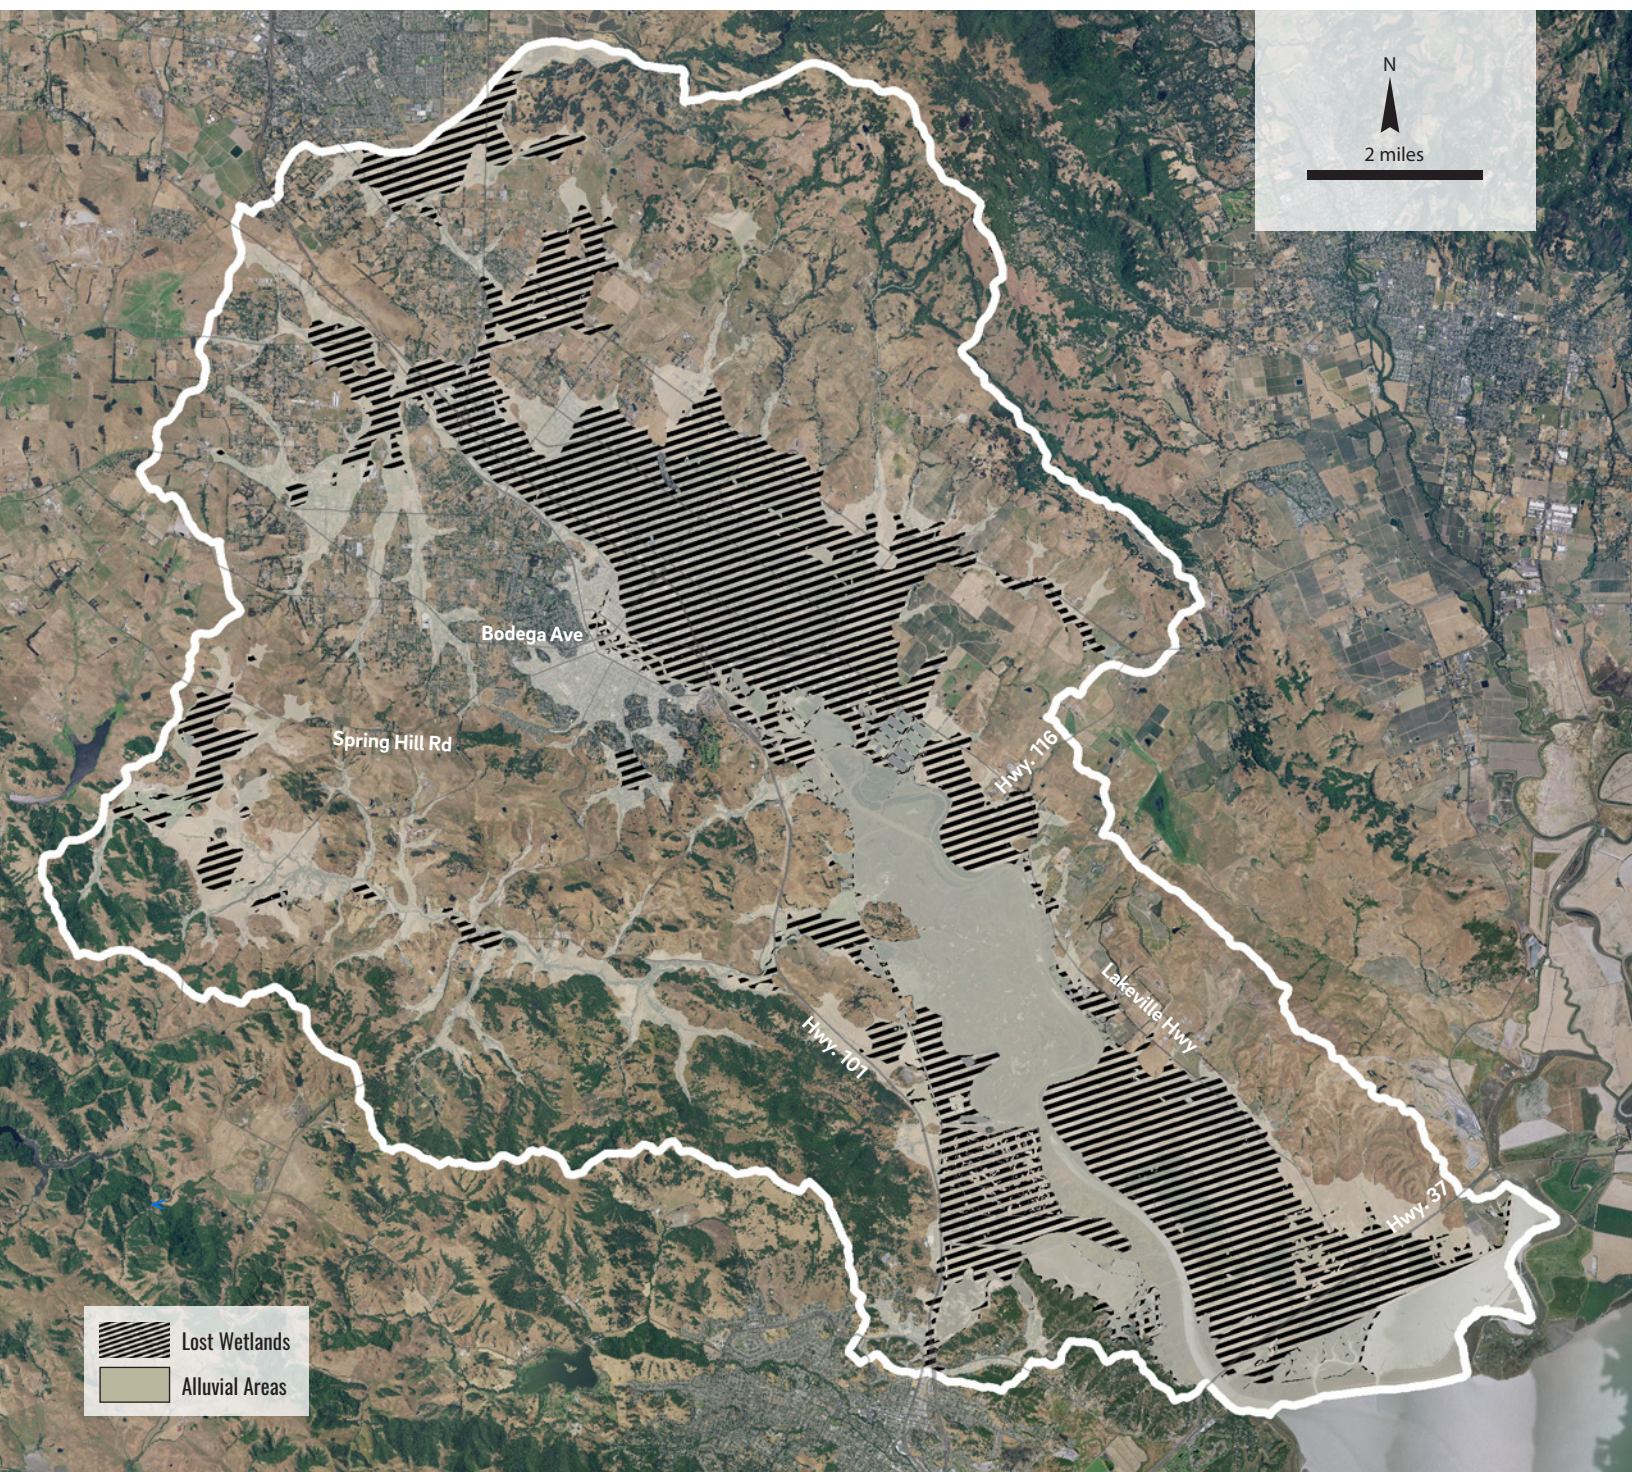
Figure 7.1. The extent of tidal and non-tidal wetlands in alluvial areas has decreased by 7,340 ha (18,130 ac) within the **Petaluma River watershed** over the past two centuries. Wetland loss has greatly reduced habitat for numerous plants and animals, and has also impaired numerous ecosystem services such as floodwater storage and fine sediment retention. (NAIP 2016)

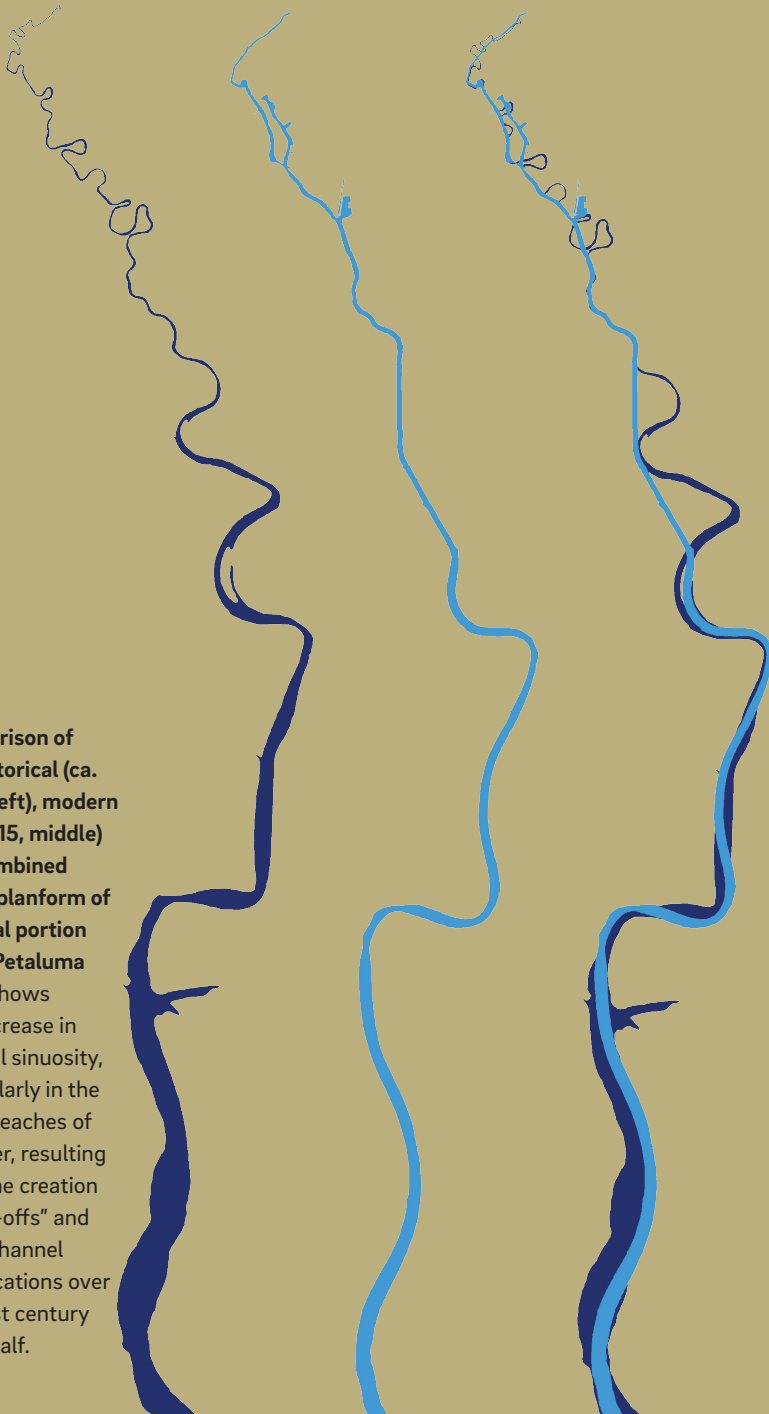
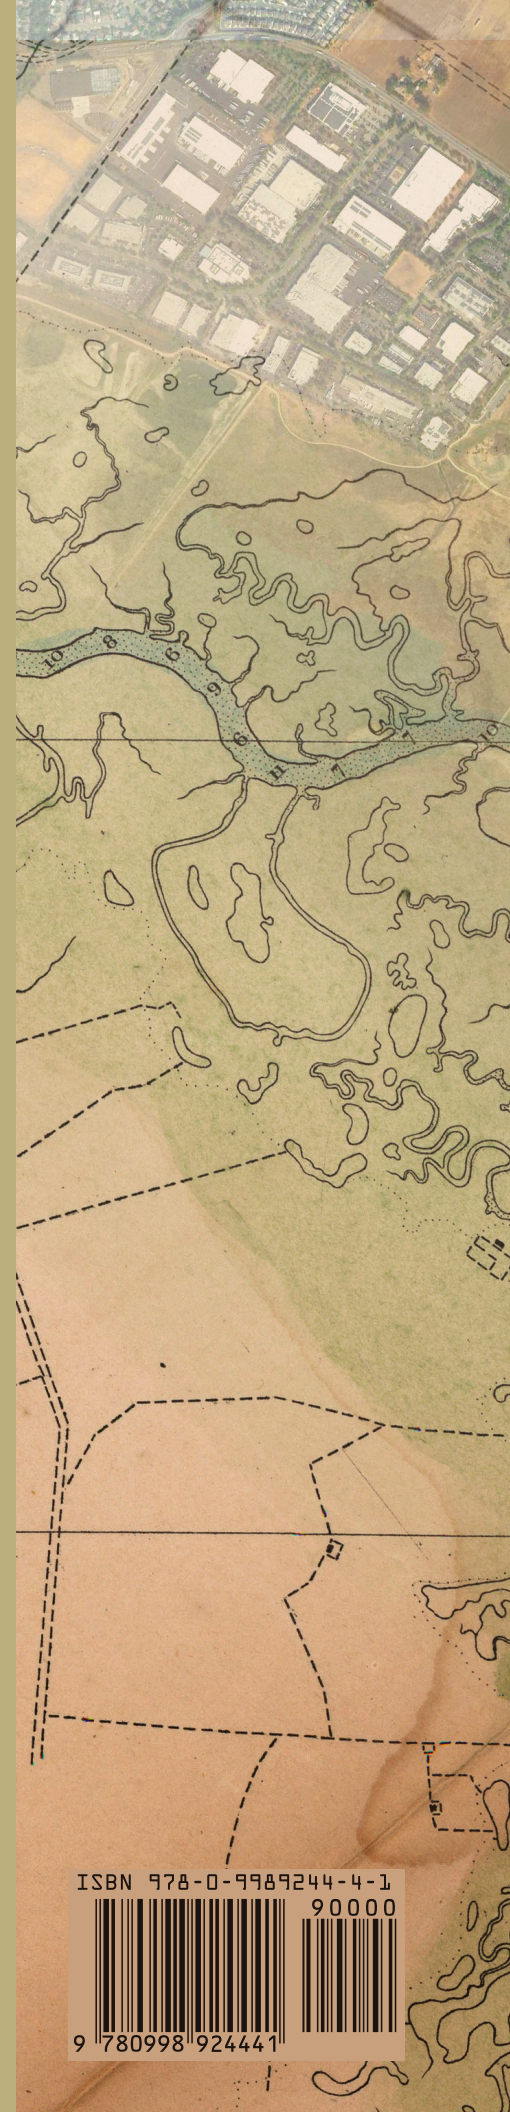
Comparison of the historical (ca. 1850, left), modern (ca. 2015, middle) and combined (right) planform of the tidal portion of the Petaluma River shows the decrease in channel sinuosity, particularly in the upper reaches of the river, resulting from the creation of "cut-offs" and other channel modifications over the past century and a half.
