2020-2021 North Bay Selenium Study

CONTRIBUTION NO. 1052 / May 2021

Cruise Report

2020-21 RMP North Bay Selenium Study

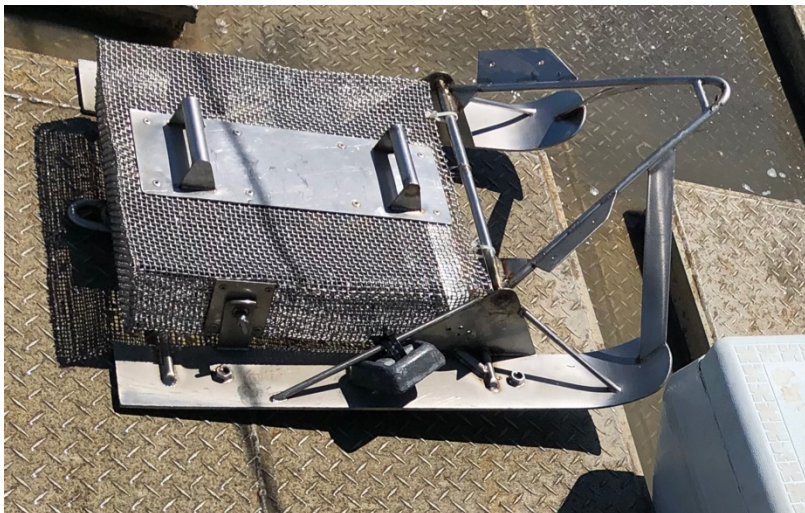
Figure 1. Stainless steel clam dredge

Clams were collected with a stainless-steel dredge (Figure 1). The device was slowly dragged along the bottom until the dredge met refusal, or a sufficient time or distance had been achieved that warranted inspection. AMS personnel then returned the dredge to the vessel deck and deposited collected material into clean coolers for inspection and collection of clams. Sampling occasionally required multiple repetitions to achieve the target biomass for analysis of selenium in tissues (minimum of 100 clams). At locations with high densities, this target was achieved with a single deployment. Once a sufficient number of target species were collected, AMS personnel transferred the clams to a large HDPE plastic jar filled with near-bottom site water and placed on ice for transport to AMS facilities.

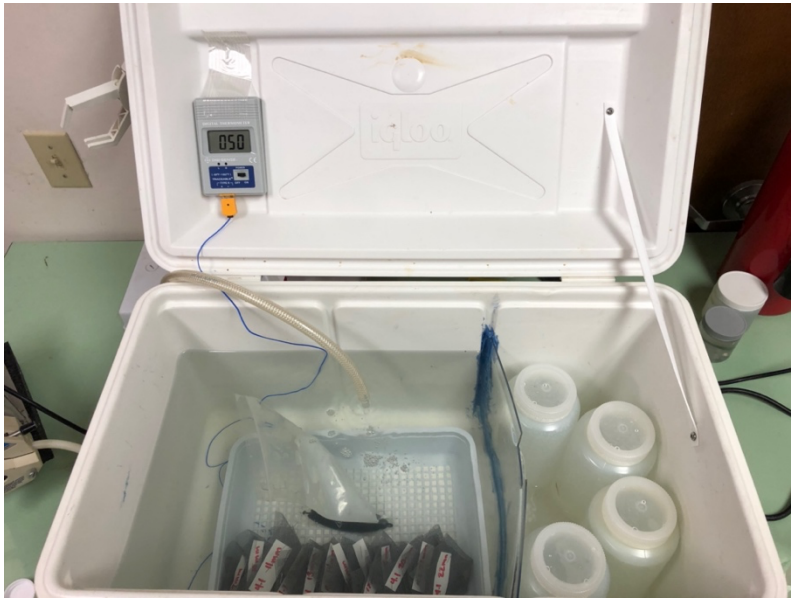
Figure 2. *P. amurensis* clams in filtered site water for depuration at AMS facility.

AMS staff prepared water for the depuration process by filtering near-bottom site water collected in equal parts from the two stations through a new, trace metal-clean filter. The resulting composite filtrate was placed into a large cooler and maintained at 10° C with a recirculating water chiller. Aquarium air stones were used to aerate the depuration tank. AMS staff sorted clams from each site into size bins based on maximum anterior–posterior shell length and placed them into individual mesh (vinyl-coated fiberglass screening) bags. Standardized size classes for the 2020-2021 sampling year include: 8–11 mm, 12–15 mm, and 16–20 mm. The mesh bags were then placed into the tank and clams were left to depurate for a minimum of 48 hours (Figure 2). When depuration was complete, the clams were placed in plastic bags and immediately transferred to laboratory freezers. Upon completion of sampling for the year, frozen clams were batch-shipped overnight on dry ice to BAL.

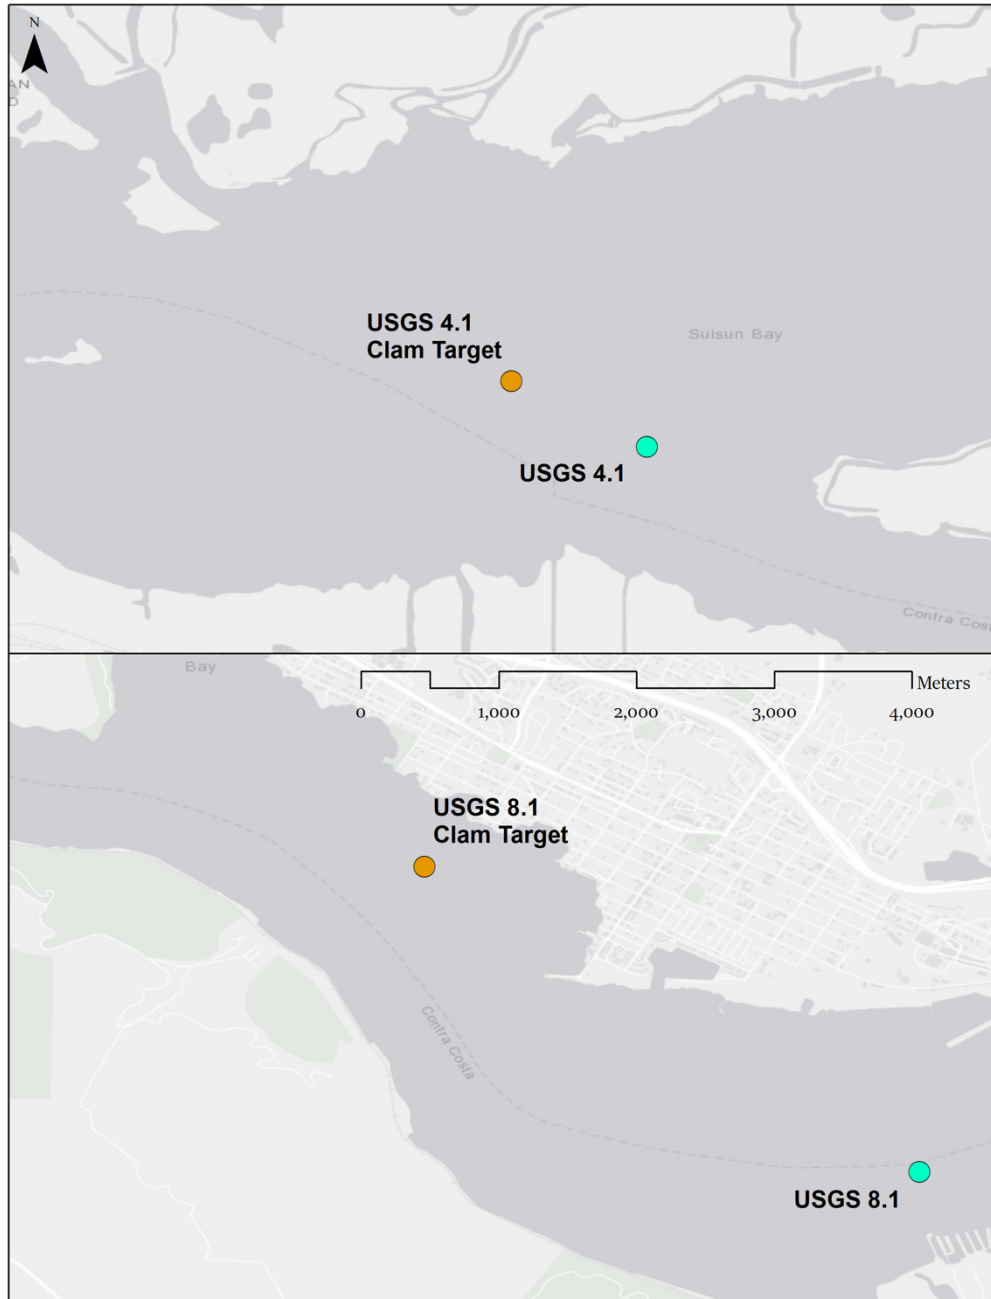
Figure 3. Project sites and nearby secondary locations, previously identified to have sufficient clam densities. In 2021, AMS staff noted that the density of clams at USGS site 8.1 appeared to have declined since 2020.

Locations with sufficient densities of *P. amurensis* were identified in the 2019 – 2020 sampling year (Figure 3). Similar densities were observed at these locations in July and August 2020. In January 2021, field staff noted a reduction in target species at USGS site 8.1. Multiple dredge runs were required to obtain the minimum number of clams. Future sampling events will identify a new dredge location at USGS site 8.1 as close to the water sampling target as practicable.
