WETLAND HABITAT CHANGES IN THE RODEO LAGOON WATERSHED, MARIN COUNTY, CA

**PREPARED FOR
THE NATIONAL PARK SERVICE: GOLDEN GATE NATIONAL RECREATION AREA**

October 2004

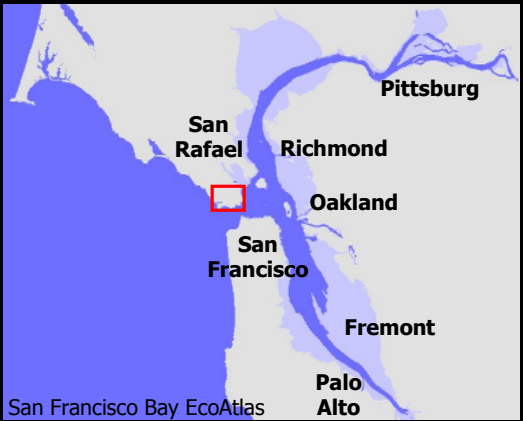
Figure 1. Rodeo Lagoon Geographic Setting

A. Major sub-watersheds of the Rodeo Lagoon watershed.

B. Location within the San Francisco Bay Area.

C. Facilities of the Golden Gate National Recreation Area in the vicinity of Rodeo Lagoon.

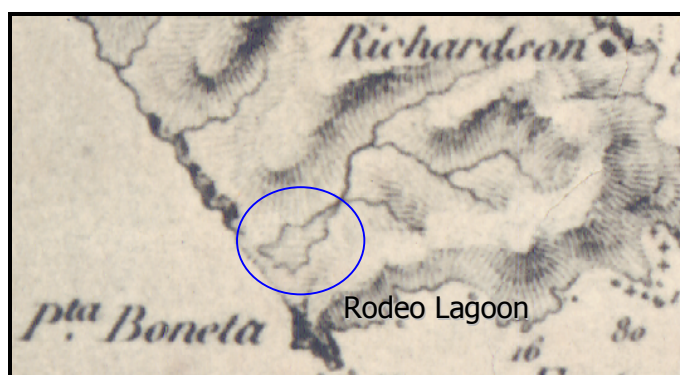
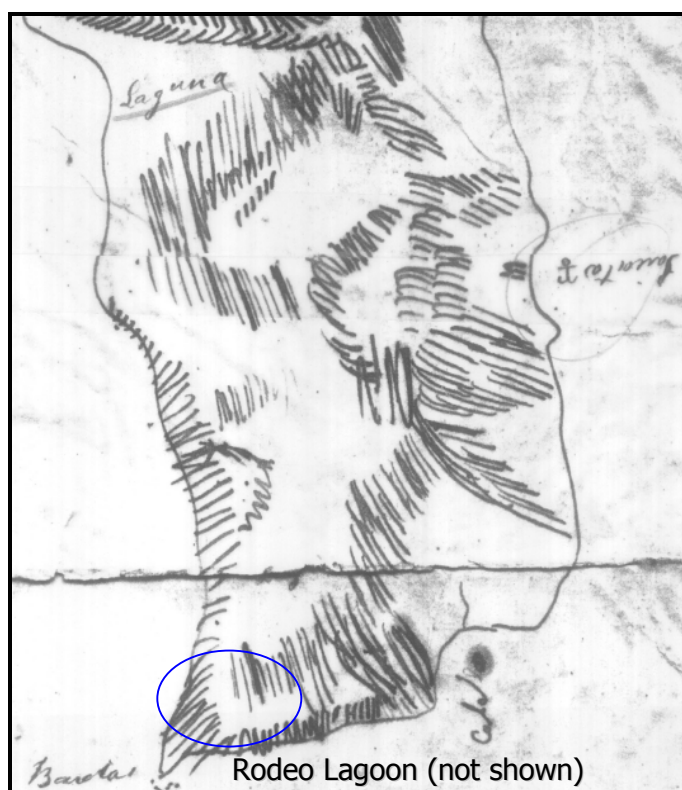
(a) 1828: Beechey

(c) 1844: Duflot de Mofras

(b) ca. 1830: Spanish Diseño

Figure 2: Early depictions of the Rodeo Lagoon area. These maps feature Rodeo Lagoon at varying levels of detail. Maps (a) and (c) depict the Lagoon fairly accurately, making note of the associated sub-watersheds and hills. These depictions were produced by European visitors to the Mexican-controlled region. The latter map (c), by Duflot de Mofras (French), may well have been copied or updated from Beechey's (British) relatively detailed 1828 survey of the San Francisco Bay.

The diseño, or sketch (b), produced of the Marin Peninsula in support of Richardson's land grant claim is, despite its local focus, less detailed. While it notes the feature we now know as "Big Lagoon" at present day Muir Beach, it omits any reference to Rodeo Lagoon, suggesting its relatively minor importance at the time. The diseño does indicate the location of the anchorage at Sausalito (mid-right side of sketch). Also note that neither map (a) nor (c) indicate an outflow from the Lagoon.

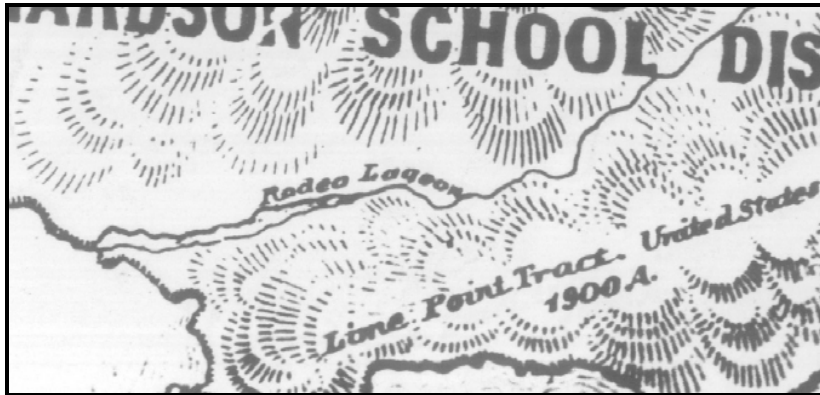
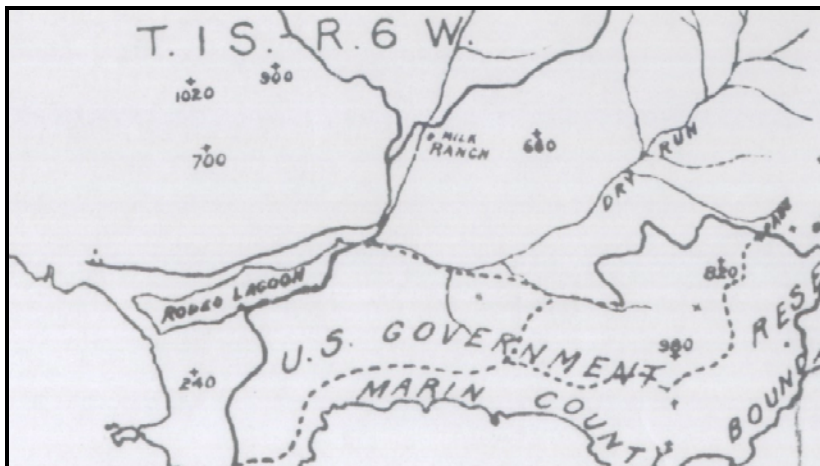
Figure 4: Mid-Late 19th Century Maps depicting Rodeo Lagoon. As with all historical sources, these maps may display variations in accuracy, yet each contains pertinent information.

(a). A "confirmation survey" produced by the U.S. Surveyor General, while displaying little detail besides the shoreline and Lagoon, does indicate an outlet on the southwestern corner of the Lagoon, in contrast to it's position in (c) and Figure 3.

(b). This county map identifies various local place names, and indicates that by 1873, "Rodier" Lagoon had been replaced by the name "Rodeo."

(c). The first USGS map of the area clearly indicates a lagoon outlet on the north side of the beach, as opposed to earlier maps (and Figure 3). It also depicts Rodeo Creek as "ephemeral" (dashed line).

Smaller creeks were not mapped until 1897, when the USGS developed the first 15-minute quadrangle for this area (Figure 4c). This map is also the first to note the ephemeral nature of Rodeo Creek. A map drawn the next year (Figure 4d) illustrates additional creeks, and also makes note of Rodeo Creek's relatively dry condition, with the label "Dry Run."

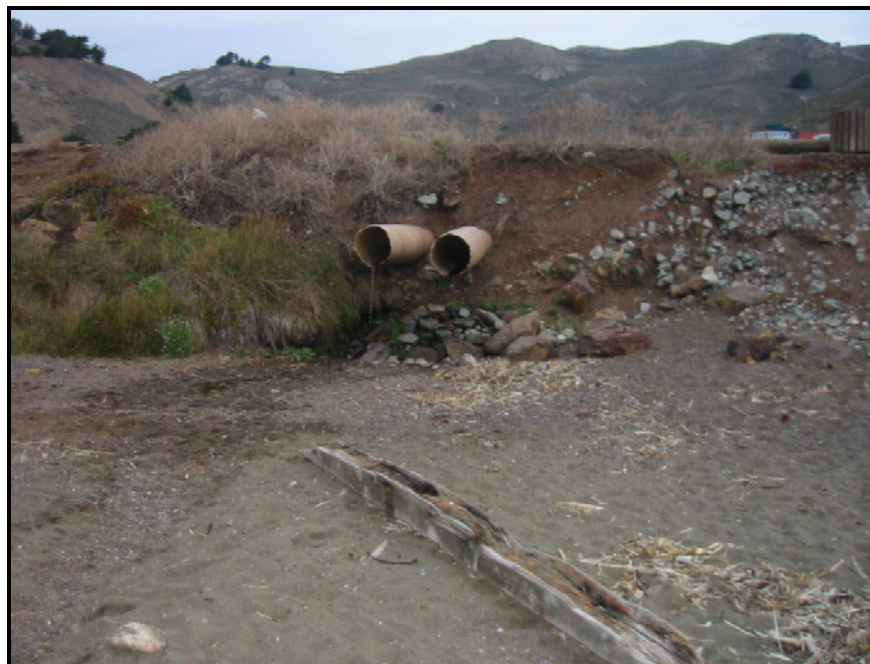
Figure 8: Culverts under the west end of Mitchell Road.

It should also be noted that a culverts installed on westernmost stream on the north side of the Lagoon (downstream of the "Surfer" parking lot) now create a channel after rain events. The 24" CMP "shotgun" culverts (shown below), delivering runoff from the "Surfer" parking lot, as well as the watershed above, were put in place after the severe "El Niño" floods of 1982-83. The extent of the washout can clearly be seen in the replacement red dirt visible in the fill bank (Figure 8). This structure replaced earlier culverts that may have been in place as early as 1925 (see Figure 6).²³

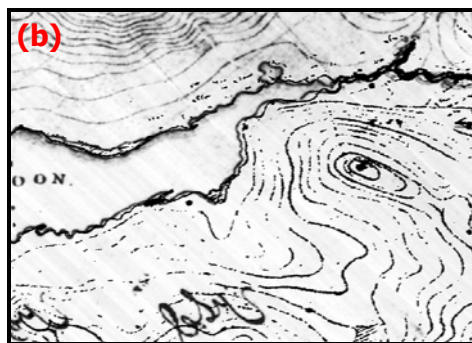
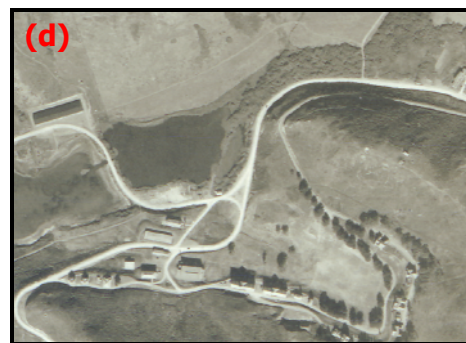
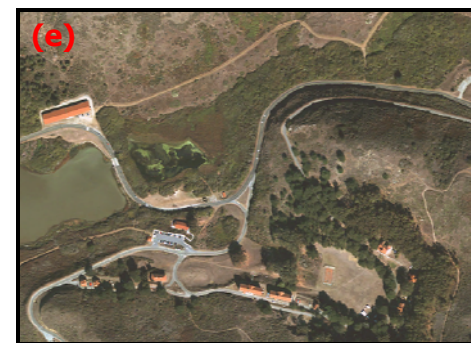
Figure 13: Changes in lagoon fringe, 1850-2001. Map (a) shows changes in upper Rodeo Lagoon and the relationship between the Lagoon and its main tributaries, Rodeo and Gerbode Creeks. In the early 1850s (b), Rodeo Lagoon was dominated by open water, with only a few small fringing marshes. By 1925 (c), about 5 acres of brackish marsh/delta had developed at the top of the Lagoon, likely as a result of increased sediment delivery from the creeks associated with intensive ranching. With the construction of a road, levee, and weir across the Lagoon in the mid-1930s, the Lagoon was separated into two distinct systems: a smaller tidal lagoon with reduced fluvial connectivity, and a freshwater pond influenced by the lower reaches of Gerbode and Rodeo creeks. Photography from 1946 (d) shows the new freshwater system dominated by open water, and the invasion of willows into the previous semi-tidal brackish marsh. Comparing the 1946 imagery with recent aerial photography, map (e) shows that the proportion of open water in the freshwater system has greatly decreased as a result of sedimentation behind the levee, with continued expansion of willows and other freshwater wetland vegetation.

The tidal lagoon and freshwater systems are now functionally disjunct, and the base level of the lowest reach has been altered with the key relation of sediment in place of an open semi-tidal outlet. Figure 13 describes the chronology of this modification, illustrating the gradual conversion of an open-water, semi-tidal system to a slowly-infilling freshwater reservoir. In-stream modifications (i.e. stream crossings at Gerbode Ranch, trampling by milk-cattle, and development of springs for cattle troughs – see Figure 7) are likely responsible for substantial sedimentation of the upper lagoon observed even prior to the construction of the crossing in 1937. The 1925 COE map clearly indicates the development of wetlands at the Lagoon fringe just downstream of the confluence of the two major creeks (Figure 7). Severe incision of these waterways upstream supports this assumption.³⁰

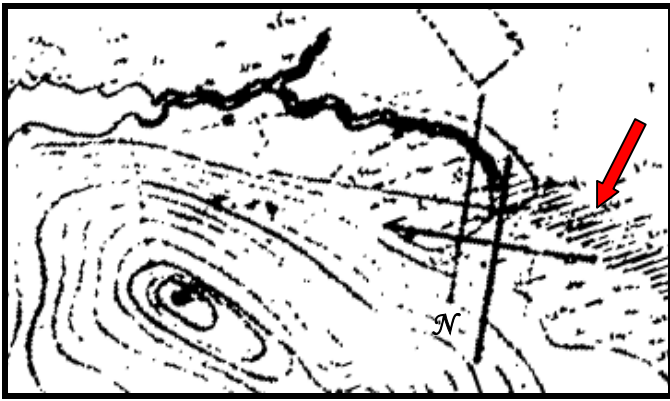
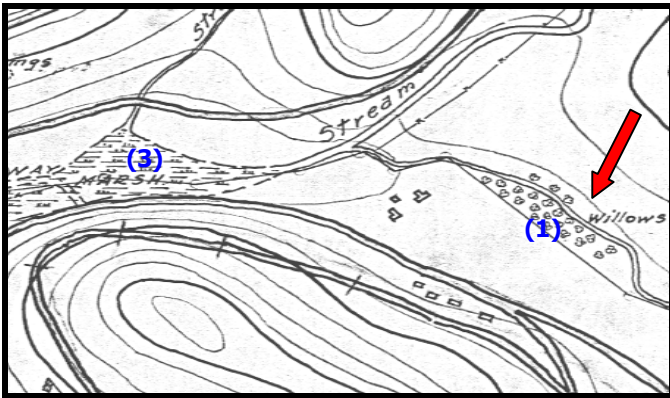
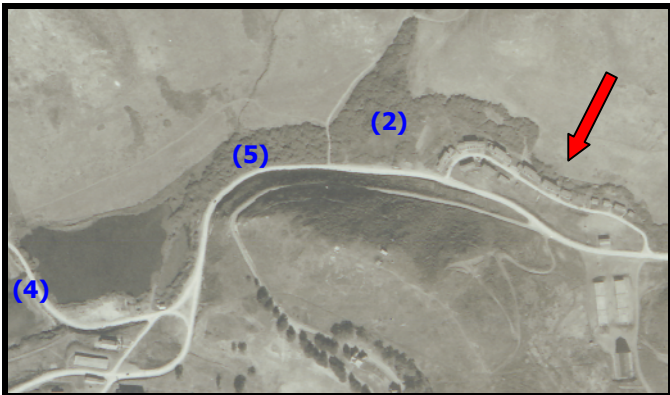
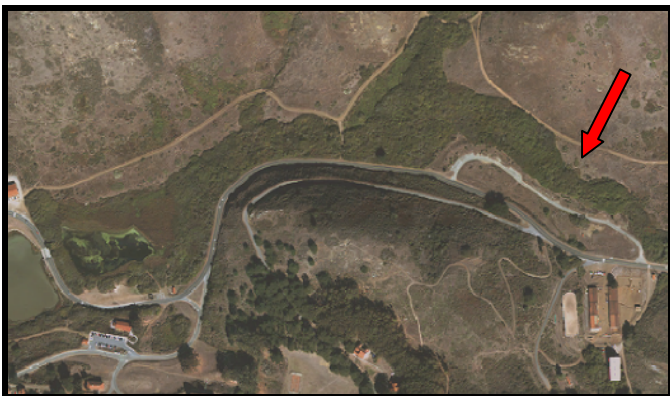
Figure 14: Changes in stream morphology, marsh extent, and riparian character of lower Rodeo Creek.

In the 1850s, Coast Survey maps distinctly show the channel of Rodeo Creek stopping just upstream of the Lagoon, fanning out into a wet meadow complex (cross-hatching) with no riparian trees [Note: the same map depicts riparian trees present at other sites; see Fig. 3]. By 1925 (b), a narrow channel had developed with a significant riparian canopy (1). By 1946 (c), structures had been built on fill along the creek (Smith Sheet area), with the riparian trees now present just on the north side of the creek, and having expanded downstream past the confluence of Gerbode Creek (2). In 2001 (d), the structures are gone, and the riparian corridor has continued to expand on the north side of the creek, merging with willow groves developed at the bottom of the watershed between the pond and the confluence of Rodeo and Gerbode Creeks.

This series also illustrates the development of a brackish/freshwater marsh at the head of the Lagoon (3 in 14b), most likely in response to grazing-related sediment deposition. In the mid-1930's, the military installed a dam, culvert, and road across the upper lagoon (4 in 14c), creating a permanent, freshwater marsh and lake, and allowing further encroachment of willows (5). By 2001 (d), emergent freshwater vegetation has developed around the circumference of the lake, filled some of the open water areas, and a wide swath of willows had expanded around the entire perimeter of the original head of the Lagoon.

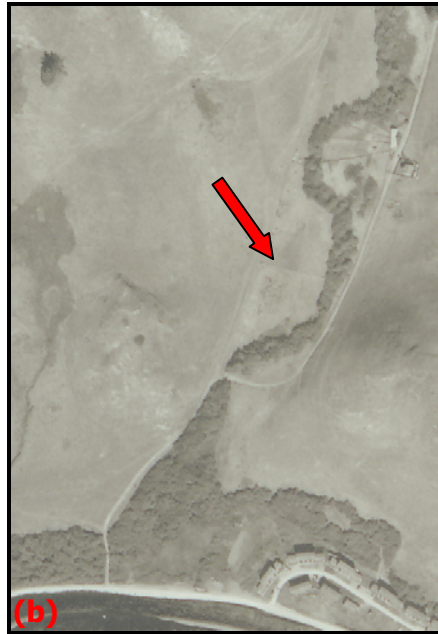
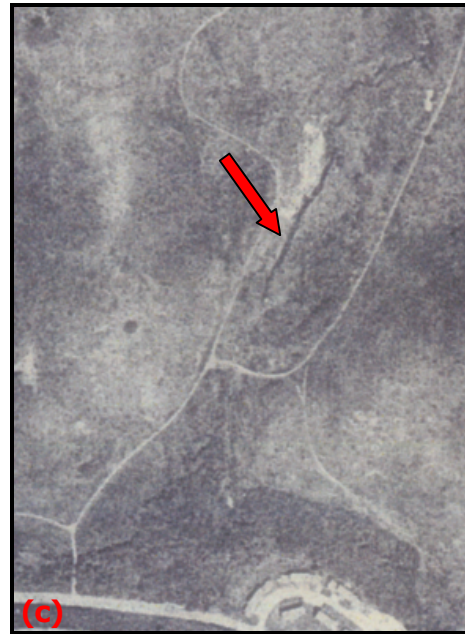
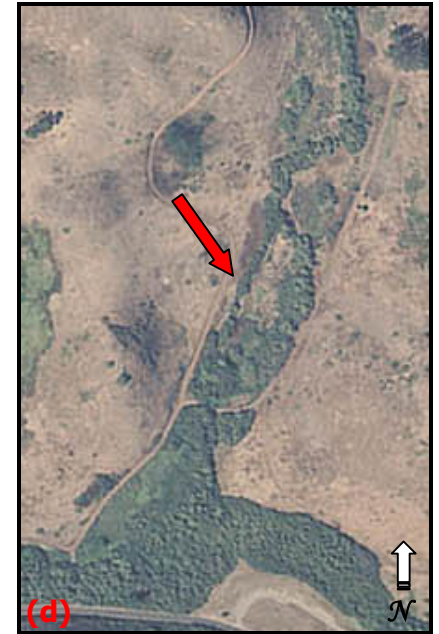
Figure 15: Changes in stream morphology on lower Gerbode Creek. This set of images illustrates a change to the stream configuration in lower Gerbode Creek. Map (a), from 1925, shows no channel where a faint evulsion channel (see red arrow) is evident in 1946 (b), which was apparently not noteworthy during the 1925 US Army Corps of Engineers surveys. By 1978 (c), this side channel had been excavated into a more distinct, permanent feature that, by the early 1990s (d) had established riparian vegetation. When compared to maps of the 1850s (e), which indicate an absence of riparian vegetation in the mid-lower Gerbode Creek, more recent maps indicate that riparian habitat has expanded significantly in this area of the watershed.
