# **SYCAMORE ALLUVIAL WOODLAND**

**Restoration and Enhancement Suitability Study**

**VERSION 1.0 July 2023**

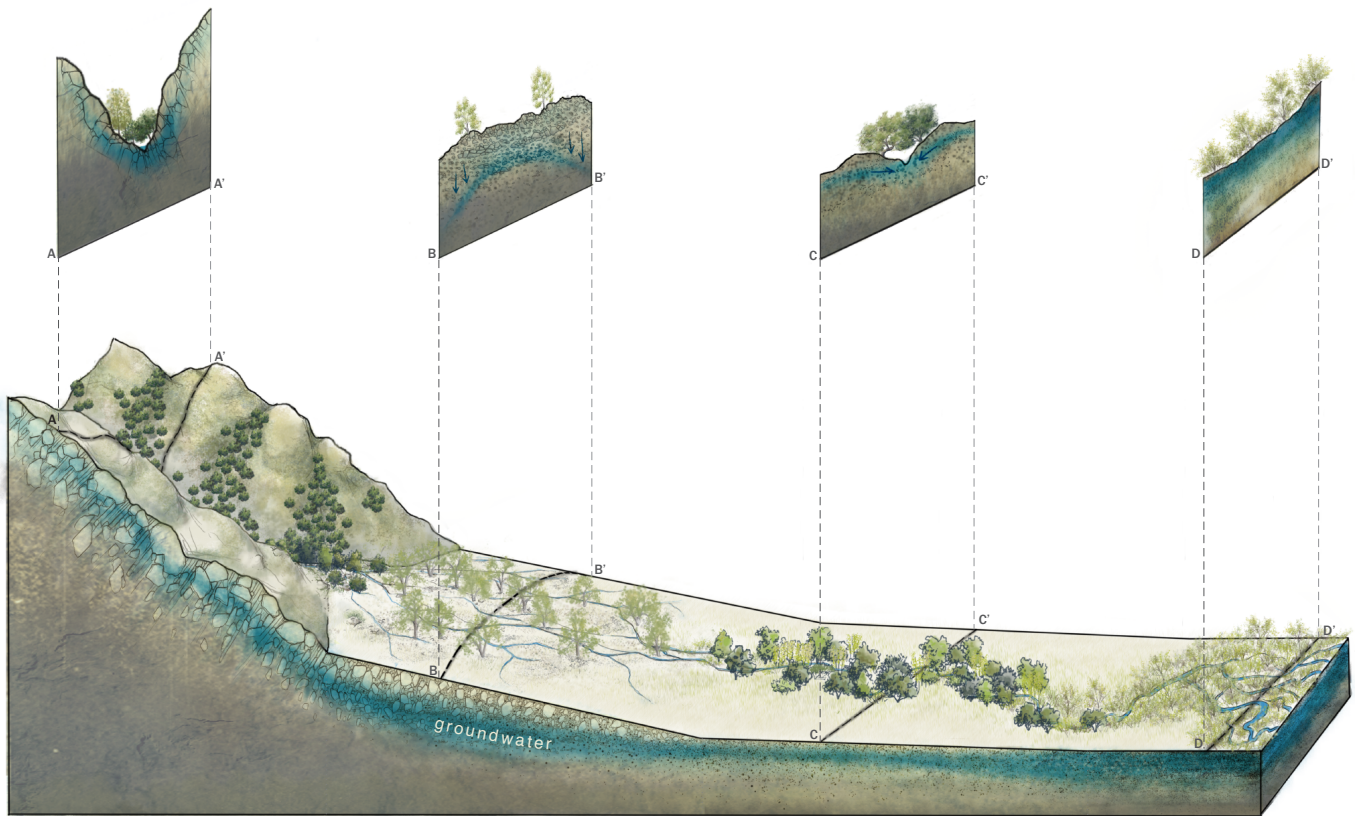
**Figure 1.** Conceptual illustration of longitudinal profile and physical characteristics of streams supportive of SAW, along multi-thread channels along alluvial reaches at the base of canyons (reproduced from Stanford et al., 2013). SAW is best supported in the multi-thread alluvial fan reach (cross-section B), but individual sycamores are also found in the canyon reach (cross-section A) and the single-thread reach (cross-section C).

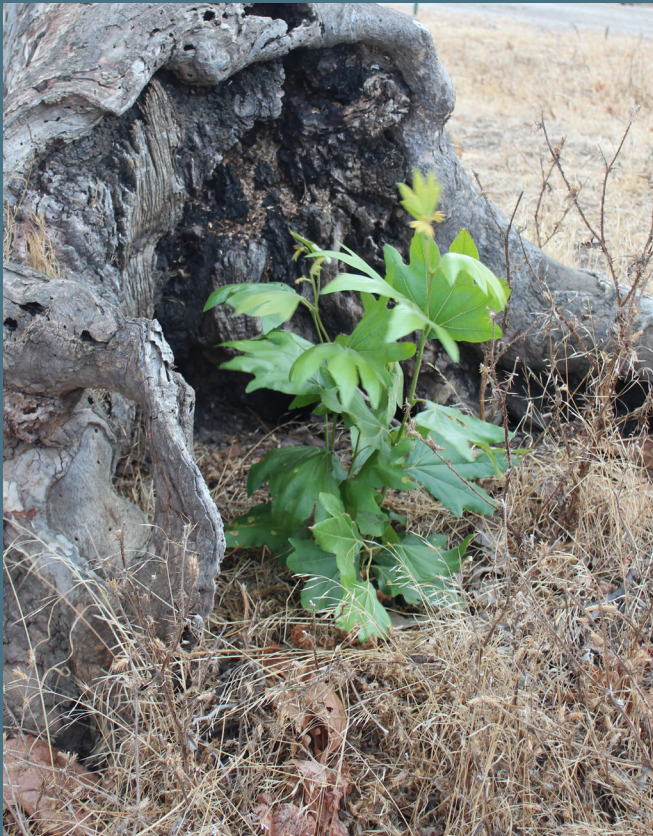
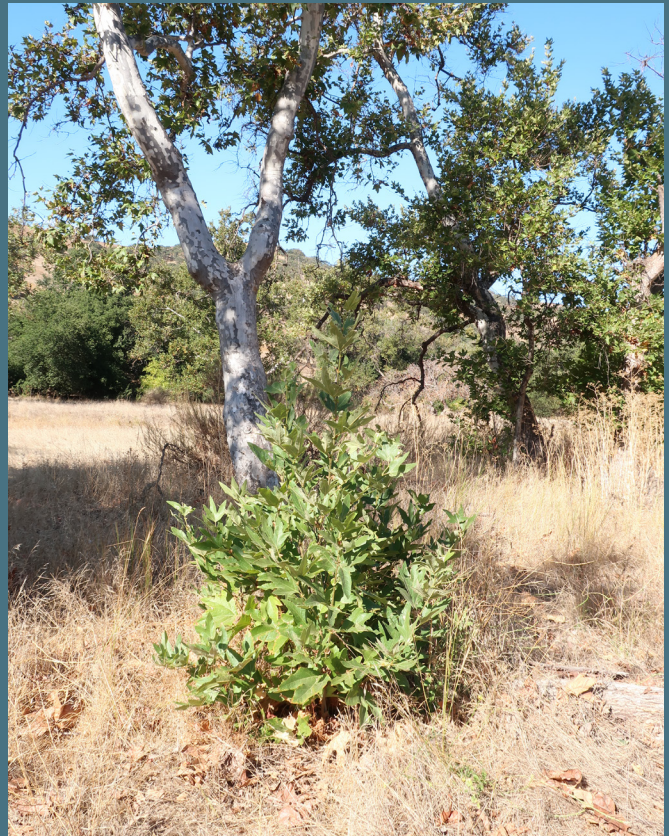
Sycamores also have the ability to regenerate from completely downed trees or large, somewhat intact trunks or branches. This type of regeneration is often seen when a large tree or trunk is downed during a flood or other disturbance and subsequently partially buried in a location where hydrologic conditions remain in place. This type of reproduction is often associated with main trunks or large branches that are still completely or somewhat connected to the rootball, providing access to essential belowground resources through the intact root network.

Many instances of basal sprouting are observed in this and previous sycamore studies. Observations of spouting from downed branches occurred after the large floods of 2017 in the Pacheco Creek and Coyote Creek watersheds (SFEI-ASC, 2018).

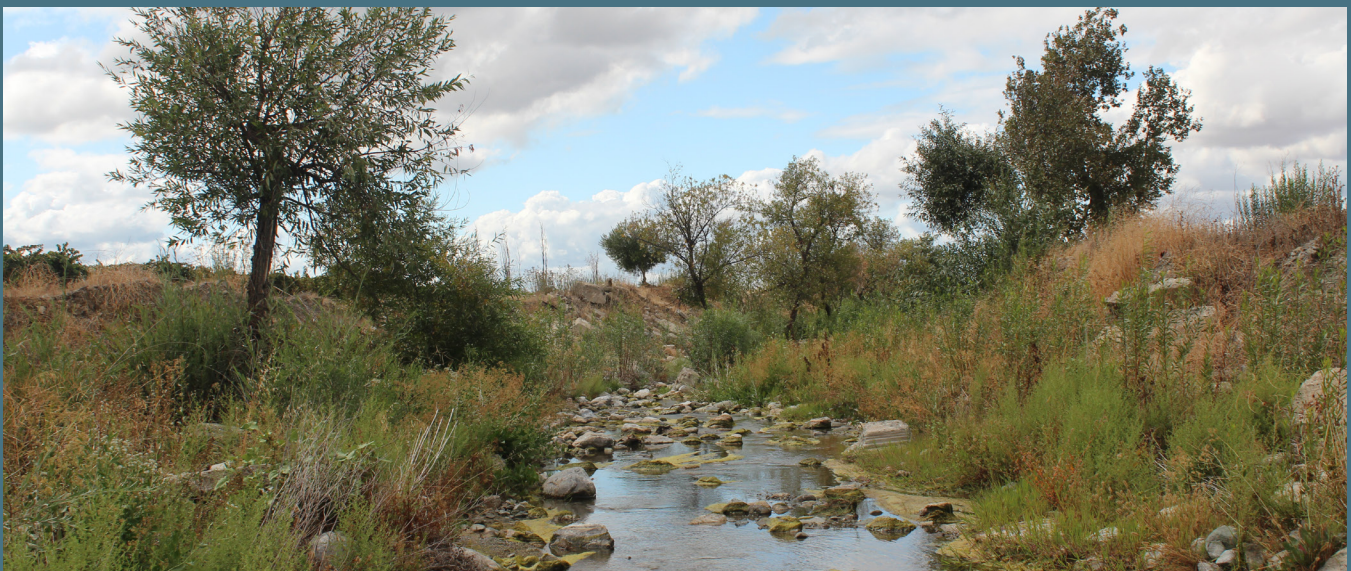
**Figure 2.** The “Constellation of Drivers” conceptual model describes the four stages of sycamore regeneration where physical and ecological processes must align spatially and temporally for natural regeneration to occur (reproduced from H. T. Harvey et al., 2020).

The first stage of the conceptual model is **setting the physical template**. California sycamore recruitment from seed requires suitable substrate and hydrologic conditions, and appears to be associated with relatively large winter flood events (e.g., with recurrence intervals of approximately 10 to 50 years) occurring within broad, multi-thread stream systems. The high fluvial energy during floods reworks the streambed and floodplain area, setting the template for sycamore regeneration. This energy scours, transports, and deposits sediment and generates fresh coarse alluvial sediment that is necessary for sycamore colonization. Additionally, seeds require adequate soil moisture when they are establishing their root network. Finer-grained soils are likely to better retain adequate soil moisture through the growing season, particularly important with faster-receding groundwater tables.

The third stage of the conceptual model is **establishment**. This stage covers germination and the first five years of a tree’s development. The appropriate groundwater and/or soil moisture must be present to support germination and survival during root development. Root development will ideally keep pace with receding groundwater. If groundwater levels are too low or drop

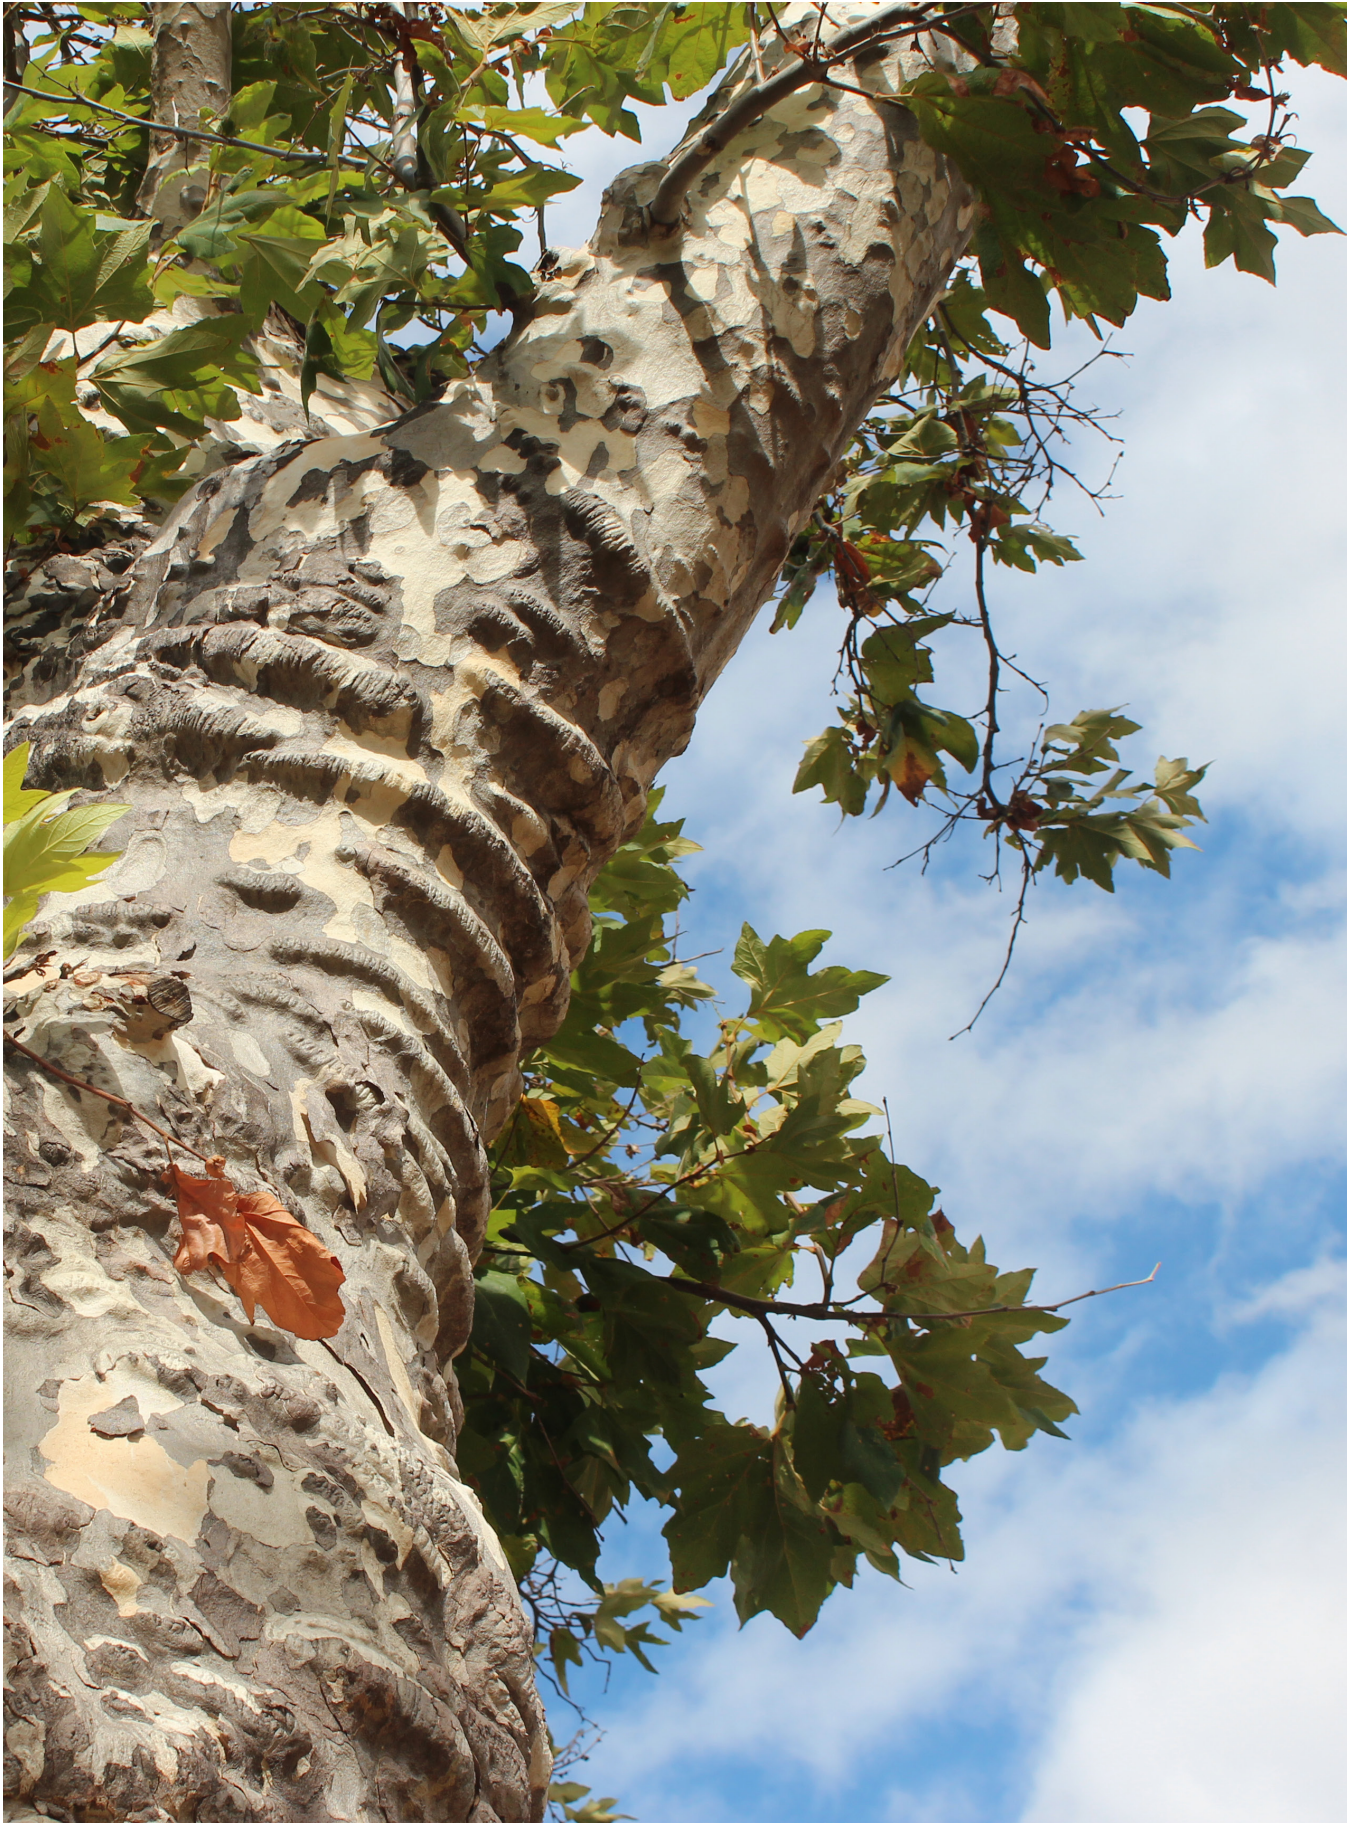
**Figure 5.** Conceptual historical channel cross section illustrating common features of stream segments that supported actively regenerating SAW.

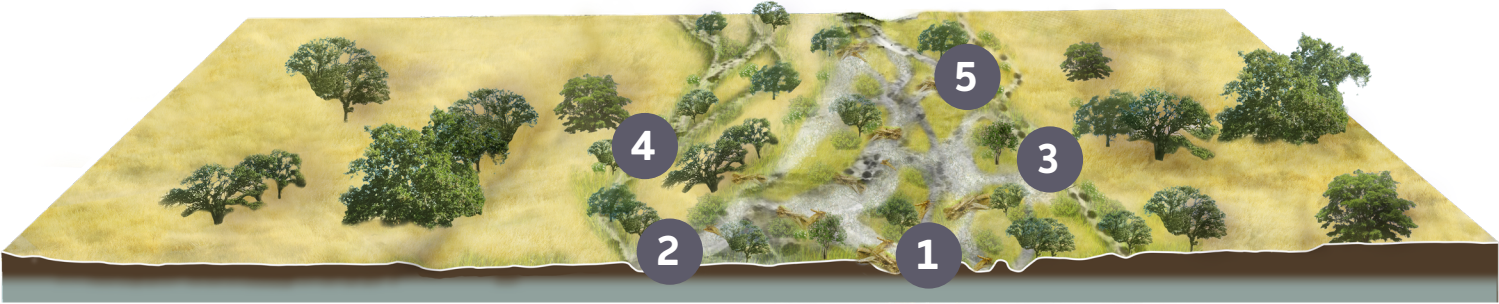
**Figure 5 (continued).** Conceptual historical channel cross section illustrating common features of stream segments that supported actively regenerating SAW.

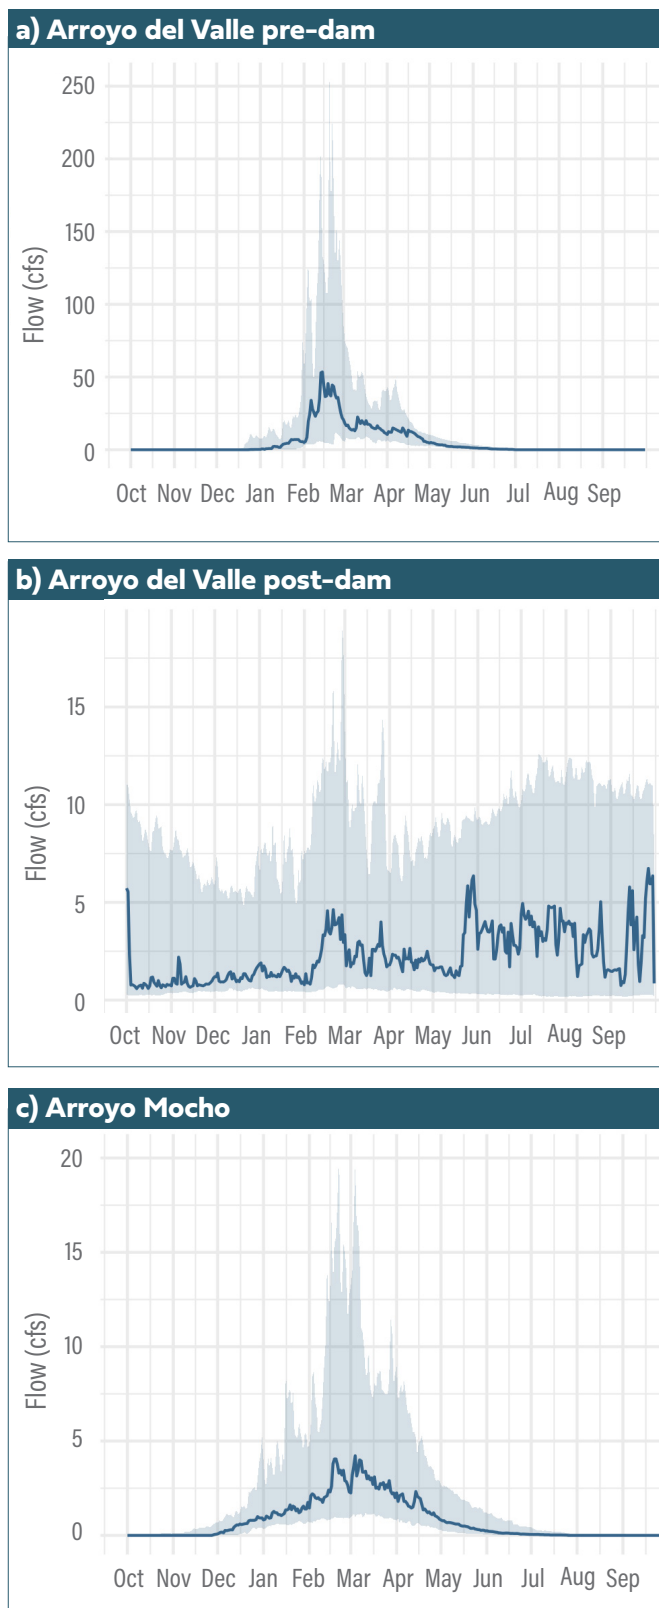
**Figure 6.** Annual hydrographs for Arroyo del Valle and Arroyo Mocho, where the solid line shows median daily flow and the light blue shading represents the 25th to 75th quantiles. In a), the pre-dam hydrology for Arroyo del Valle is shown, compared to the post-dam (after 1968) hydrology in b). The annual hydrograph for Arroyo Mocho is shown in c).

flows are now managed such that winter peak flood events are largely eliminated, and summer low flows are augmented with releases of water either from the dam or from the South Bay Aqueduct turnout that is located at the base of the dam. Based on the 1913 to 1930 water years, the flow regime prior to the dam was characterized by mean daily flows of  $0.8 \text{ m}^3/\text{s}$  (30 cfs), a median annual maximum flow of  $322.1 \text{ m}^3/\text{s}$  (11,375 cfs), and a mean of 190 zero-flow days during the dry season (note median daily flows are shown in Figure 6). Post-dam (1964-

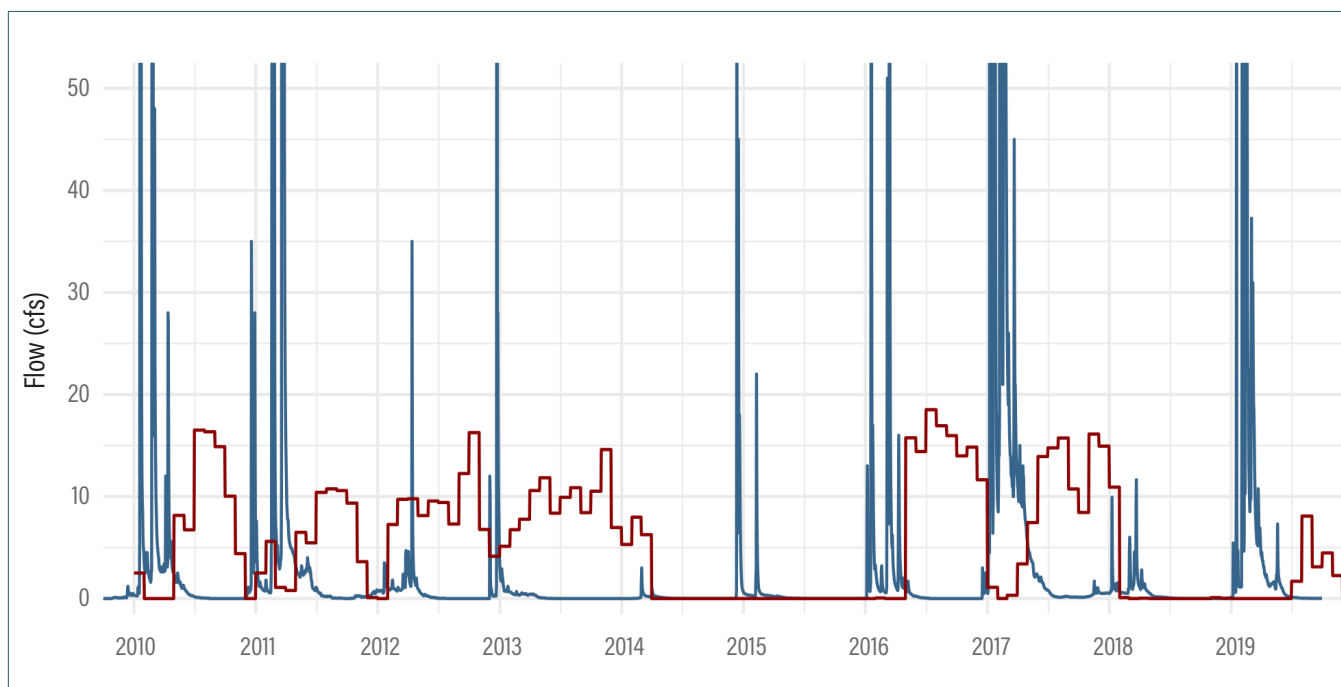
**Figure 7.** Arroyo Mocho daily flow (blue) with monthly mean daily flow augmentation (red) via the South Bay Aqueduct, based on information provided by Zone 7. Note that flows above 50 cfs are not shown.

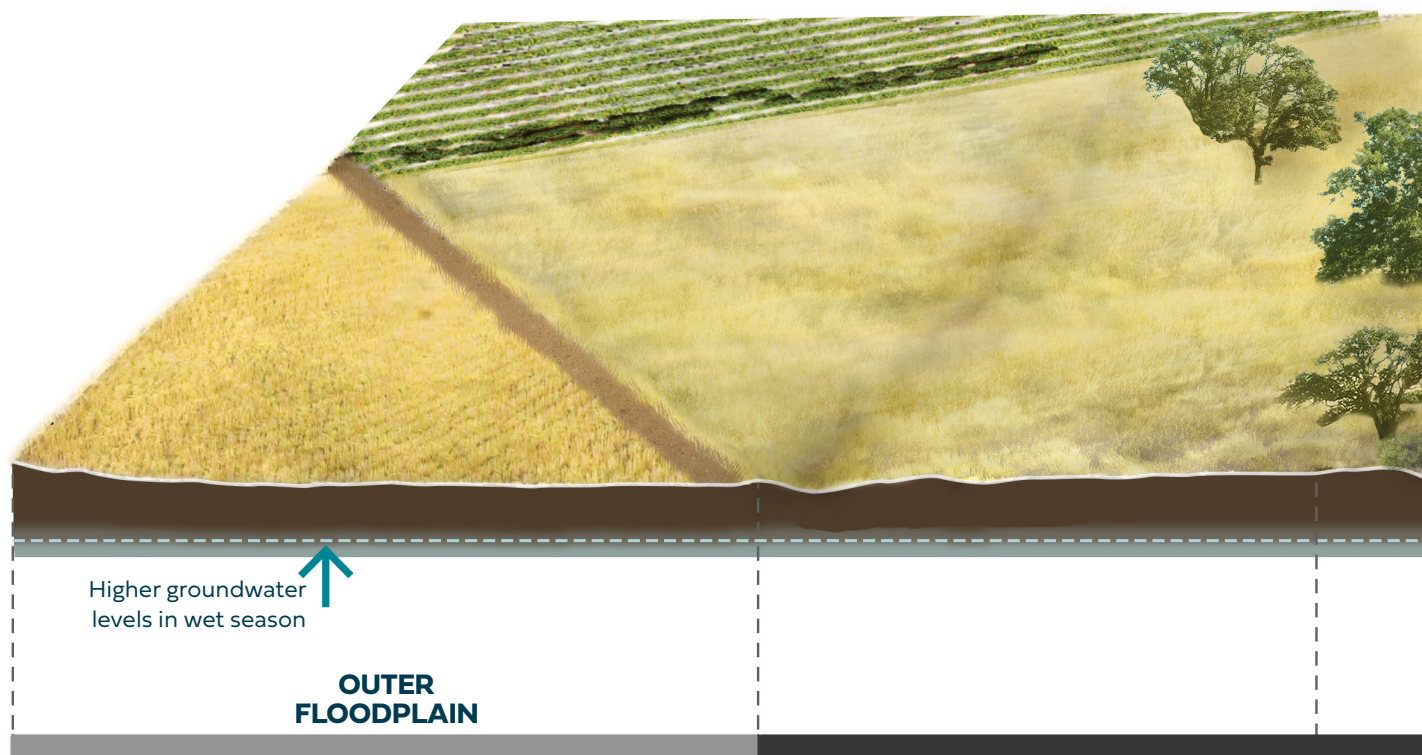
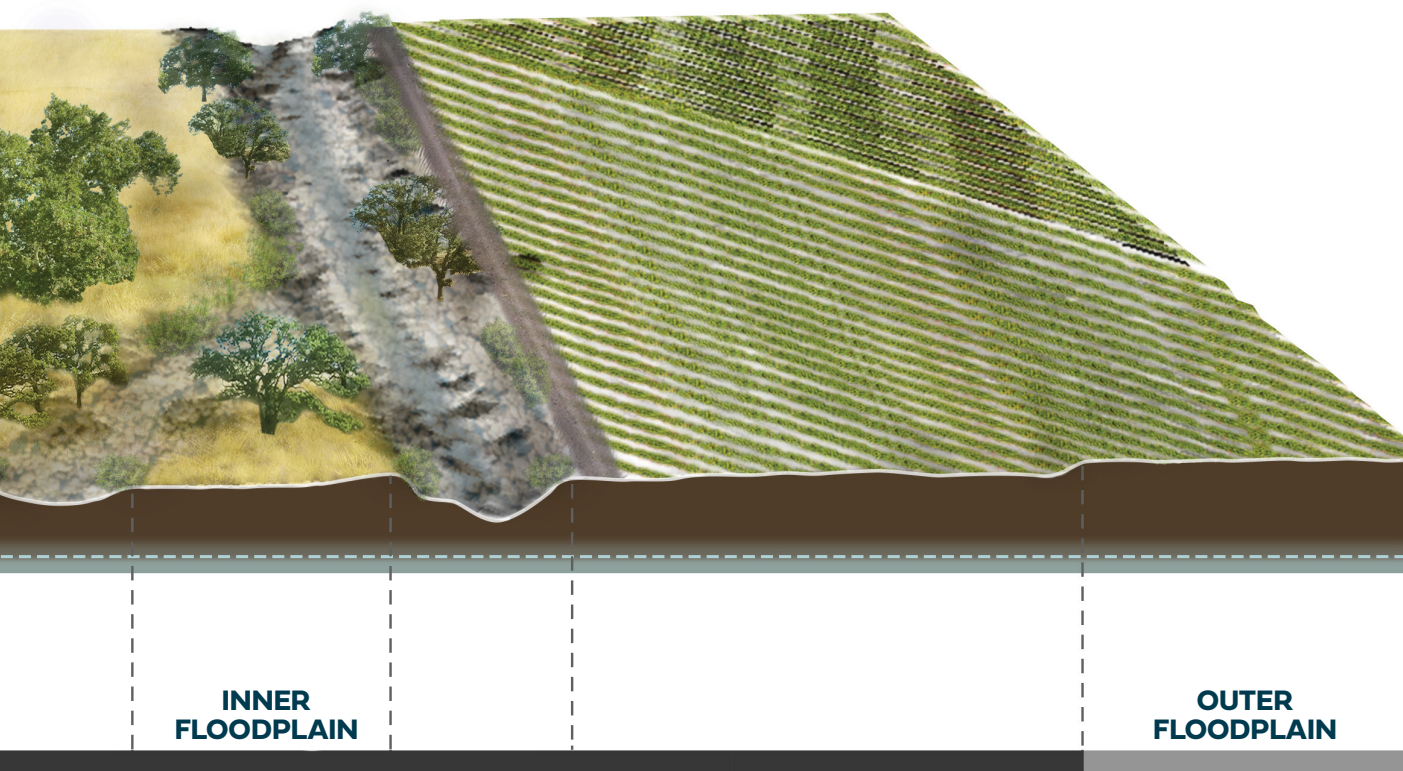
**Figure 8.** Conceptual current conditions channel cross section illustrating common features of stream reaches with remnant SAW.

The characteristics and physical processes currently present and those potentially possible along these stream segments are essential factors in considering the appropriateness for supporting the recruitment and establishment of sycamores and the maintenance and resilience of SAW under current and future conditions. The current segments that still support SAW are reliant upon many of the physical characteristics of the channel that existed historically, but, as described above, have typically experienced significant land use, channel, and watershed-scale change (Figure 8).

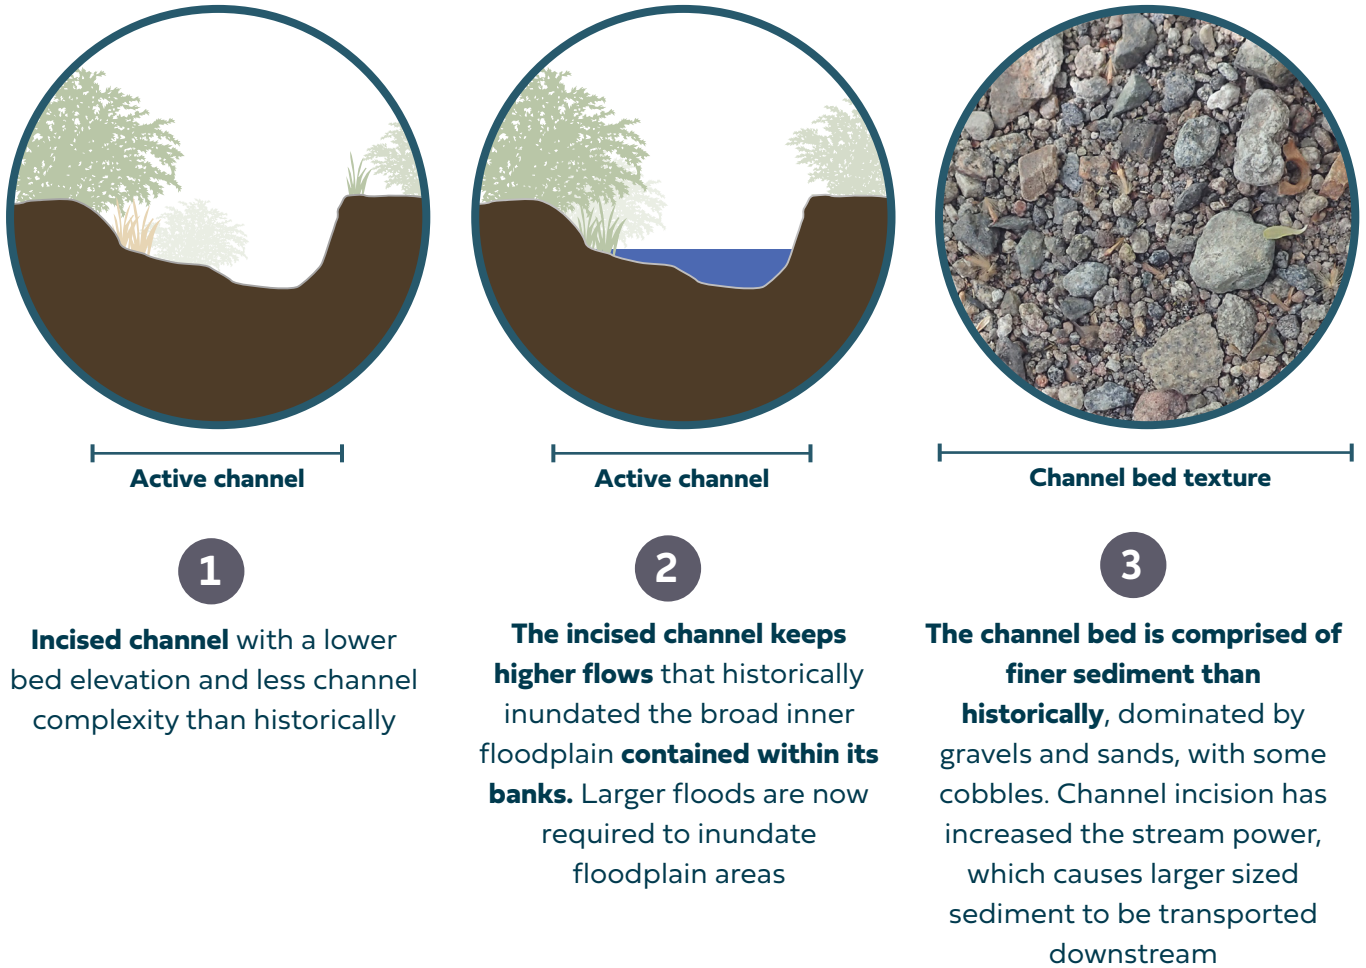
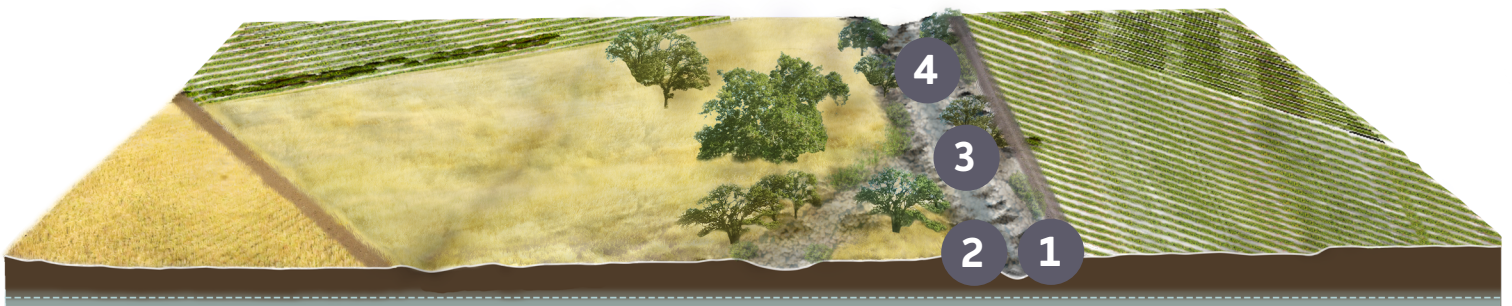
**Figure 8 (continued).** Conceptual current conditions channel cross section illustrating common features of stream reaches with remnant SAW.

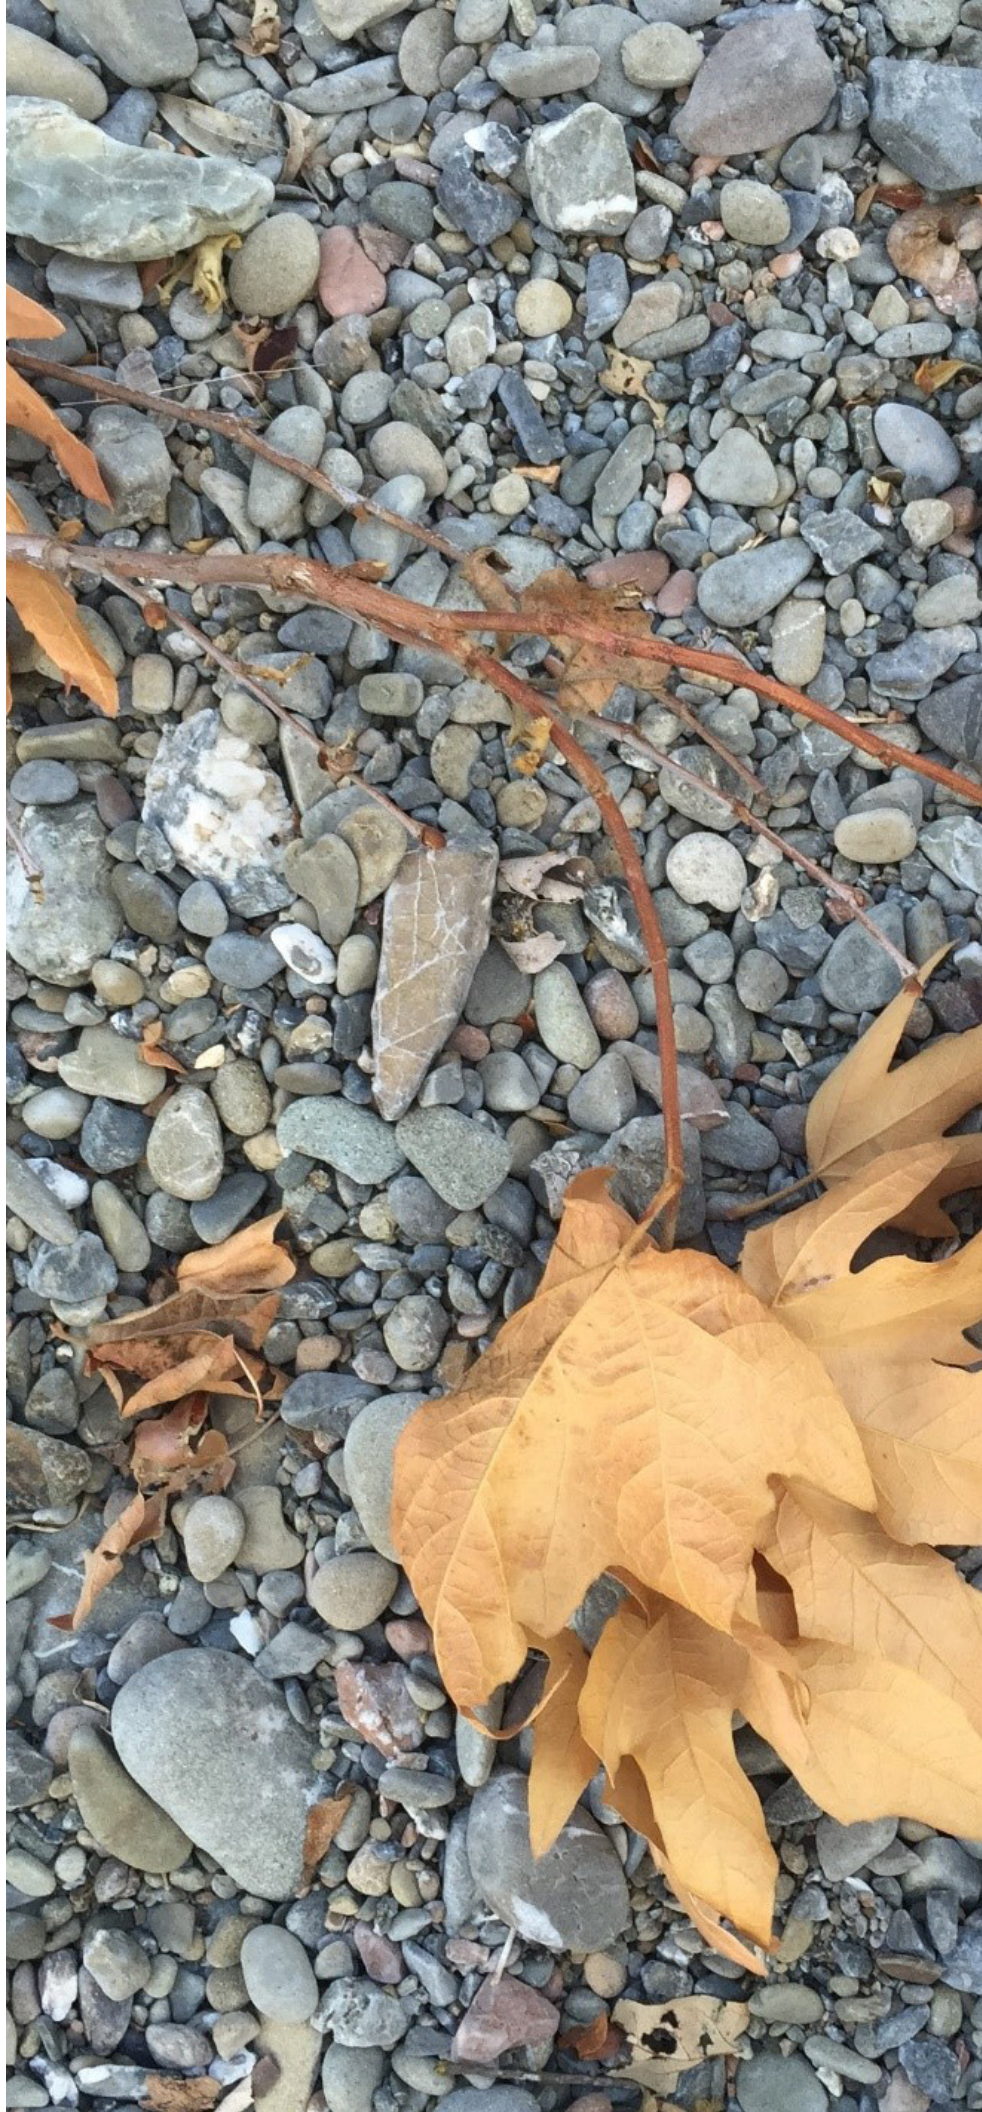
**Figure 9.** (left) Map of the five Study Sites on the Arroyo del Valle and the Arroyo Mocho within the Livermore-Amador Valley. (right, detailed views of each site) Sycamore Grove Park (a, control site) is located on Arroyo del Valle, while Mines Road (b, control site), Wentle Vineyards Upstream (c, control site), Wentle Vineyards Downstream (c, suitability site), and Medeiros Parkway (d, suitability site) are located on Arroyo Mocho.

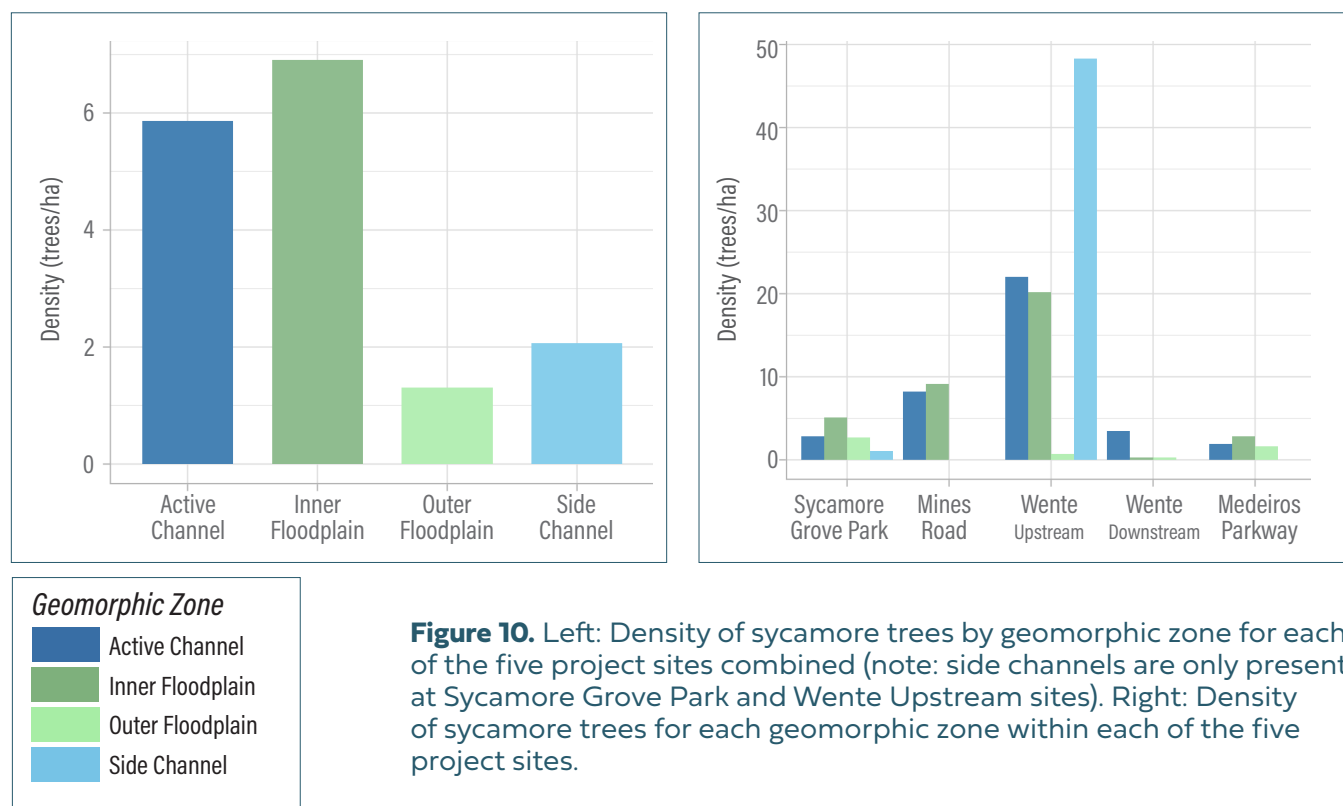
**Figure 10.** Left: Density of sycamore trees by geomorphic zone for each of the five project sites combined (note: side channels are only present at Sycamore Grove Park and Wente Upstream sites). Right: Density of sycamore trees for each geomorphic zone within each of the five project sites.

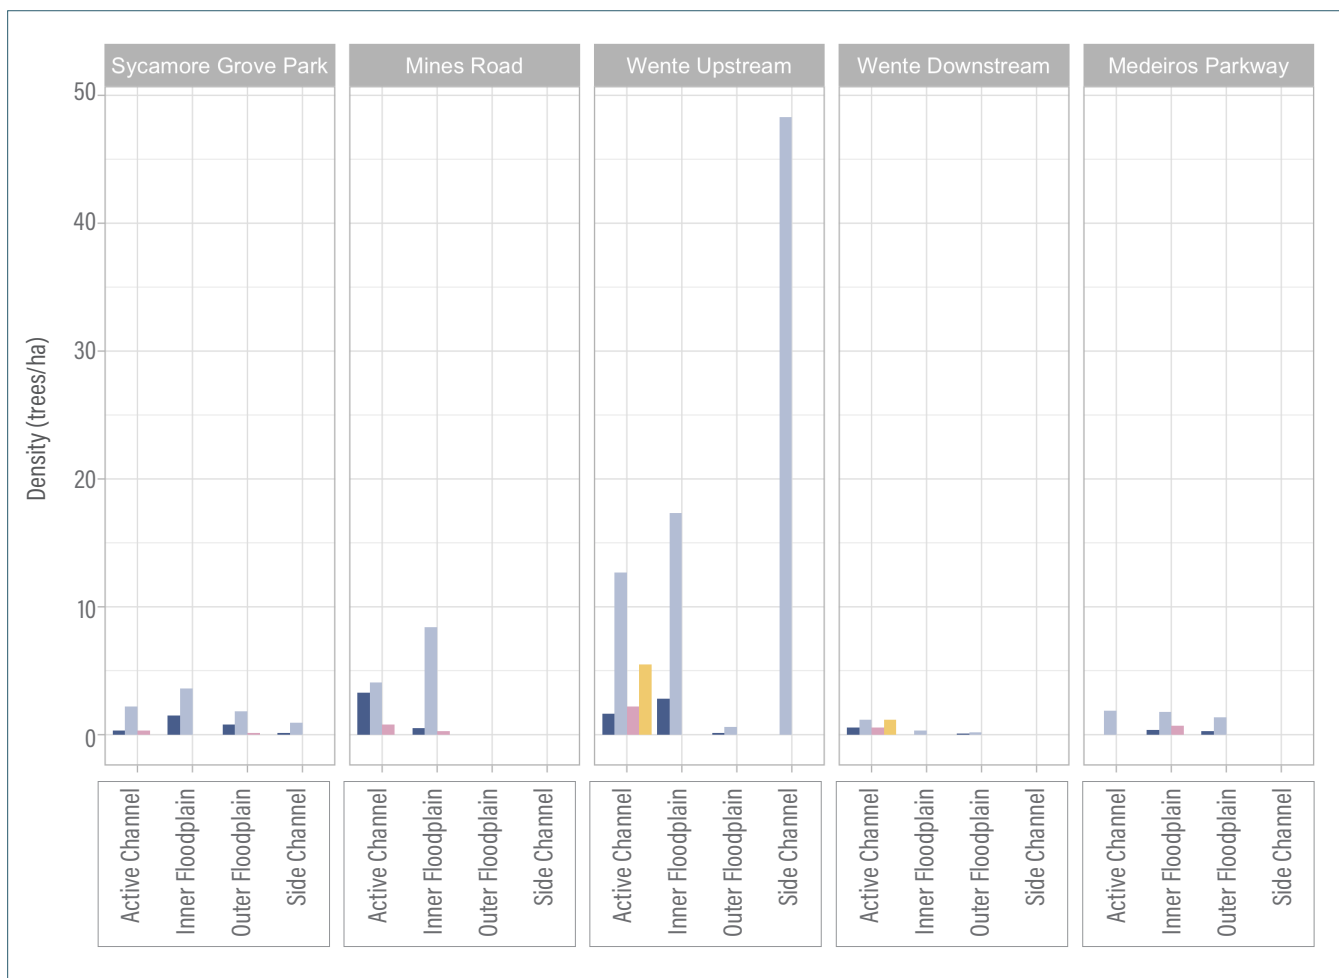
**Figure 12.** Below: Density of sycamore trees by size class and geomorphic zone for the five study sites.

As with the total number of sycamores, due to the differences in spatial area of each site and geomorphic zone, the density provides more comparable information. Figure 12 shows the density of trees in each size class for each of the four geomorphic zones. Size classes are designated by the trunk diameter at breast height (DBH), and grouped into seedlings (up to 2.5 cm, 1 in), saplings (5-10 cm, 2-4 in), medium (13-99 cm, 5-39 in) and large (100-254 cm, 40-100 in). The density of medium sized trees in the side channel in the Wentz Vineyards Upstream control site stands out, as density is approaching 50 trees/hectare. This high density is attributable to the fact that a number of trees were closely aligned along a relatively narrow side channel. It is likely that these trees were established at a time when the side channel was flooded. Determining actual tree ages could point to a flood or sequence of wet years that may have established suitable conditions for sycamore recruitment. The density of trees in the active channel and the inner floodplain of the Wentz Upstream site is the next highest, varying between 2 and 17 trees/hectare for all size classes. The most noticeable aspect is that the tree density for the other sites are all fairly consistent, typically less than 5 trees/hectare. This low density overall, and especially the low densities found in the active channel zone, supports the finding that regeneration and establishment of sycamores at these sites is low (Figure 13).

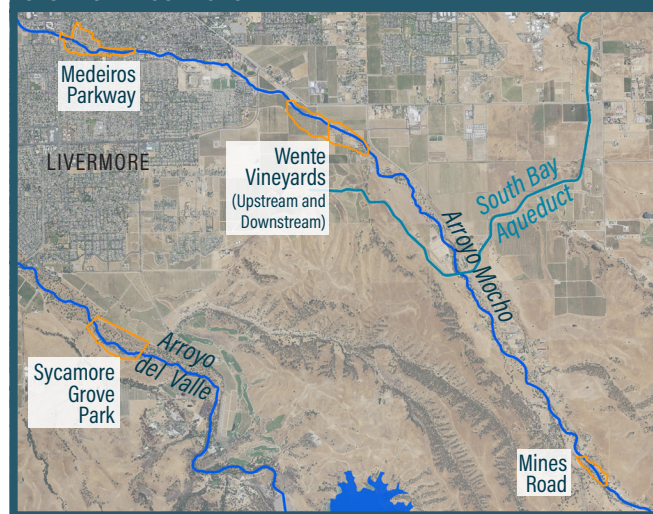
**Figure 13.** Maps of the five sites showing the geomorphic zones and size classes for each individual sycamore tree.

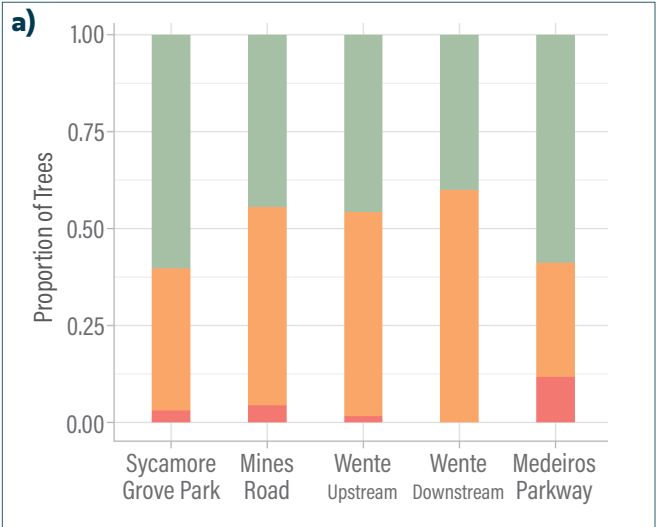
**Figure 14.** Top Left: a) Proportion of total trees in each health condition class for each site. Top Right: b) Percentage of sycamore trees by size class for each of the health condition categories, across all five sites combined.

The patterns described above can also be observed in the map showing the distribution of trees in each health class and geomorphic zones, helping to visualize patterns between sites and between zones (Figure 16). Each site visually has a mix of good and fair condition trees, with only a small number of poor condition trees, as shown in Figures 14 and 15

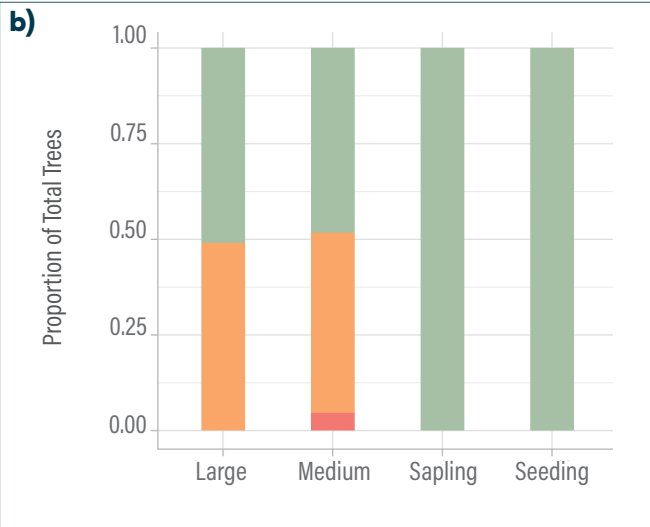
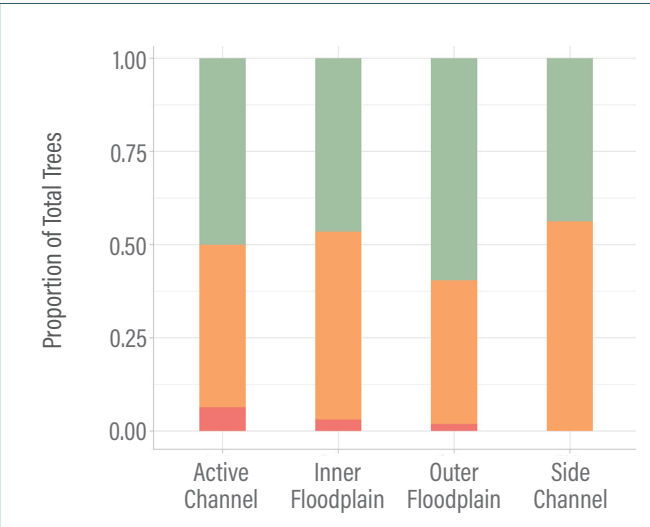
**Figure 15.** Right: Proportion of sycamore trees in each health condition class for each geomorphic zone.

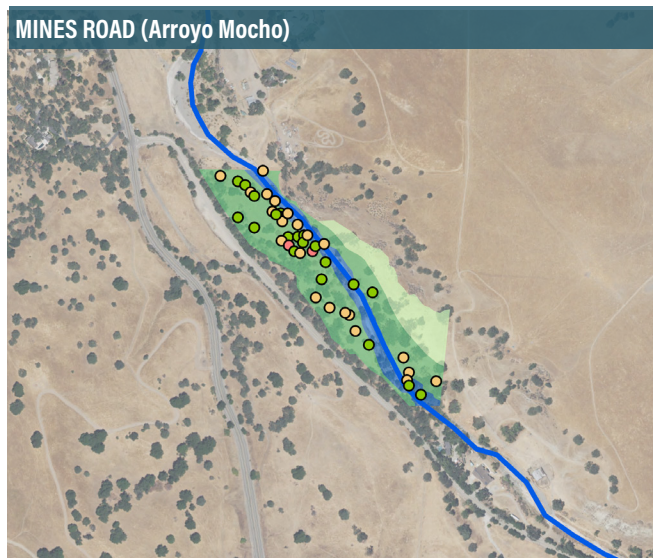
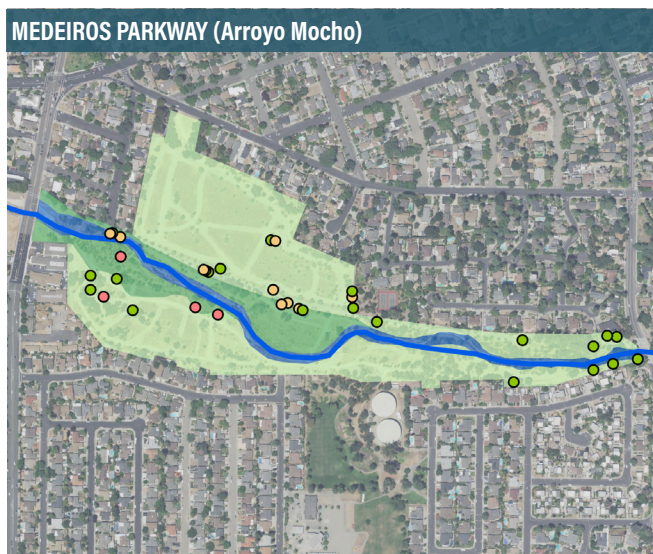
**Figure 16.** Maps of the five sites showing the geomorphic zones and health classes for each individual sycamore tree.

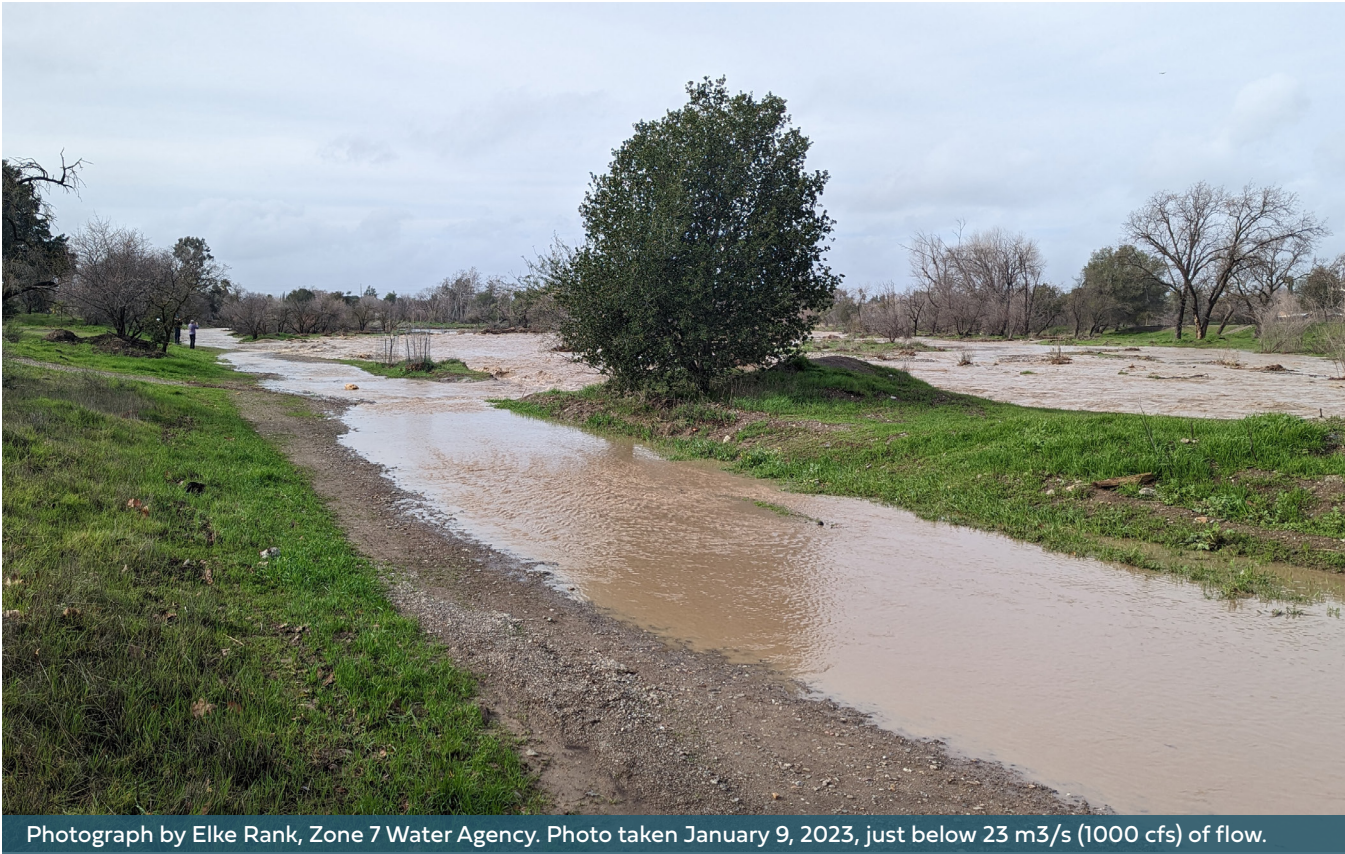
**Figure 19.** Arroyo del Valle annual maximum daily mean flow for the 1913–2019 water years with dashed horizontal lines representing return interval flows (#11176500, USGS 2020b), labeled in green. The gray shading represents years of reconstructed flows using the Alameda Creek at Niles gage (#11179000, USGS 2020a). The break at 1964 represents altered hydrology due to the construction of Del Valle Dam.

The annual maximum daily flow time series shows the interannual variability (Figure 19 and 20). For Arroyo del Valle hydrology, pre- and post-dam hydrology is shown. Del Valle Dam has substantially reduced peak flood flows, with most peaks captured by the dam and larger floods occurring during managed releases from the reservoir, which appear to be approximately the 10-yr return period flow, or ~55 m<sup>3</sup>/s (~2,000 cfs). However, peak flows up until the 2022 water year have not been above 67 m<sup>3</sup>/s (2,400 cfs) since the construction of the dam (based on the mean daily flow record). Only the recent New Year's Eve 2022 and subsequent storms prompted higher releases at 84 m<sup>3</sup>/s (~3,000 cfs) for a day. This means that historically intermediate floods (e.g., pre-dam 5-yr recurrence interval) have not been experienced by the stream and floodplain since the construction of the dam, illustrated conceptually in Figure 21a and b. Thus, flows that regularly inundated, eroded and deposited sediment at the Sycamore Grove Park site now only occur rarely. This difference is likely reflected in the absence of the braided channel planform and large areas of bare sediment that can be seen in the early (1939-1940) aerial photography in comparison to more recent imagery (Figure 22). This change may be a factor contributing to the general absence of young sycamores at this site.
