# **SYCAMORE ALLUVIAL WOODLAND**

**Restoration and Enhancement Suitability Study**

**VERSION 1.0 July 2023**

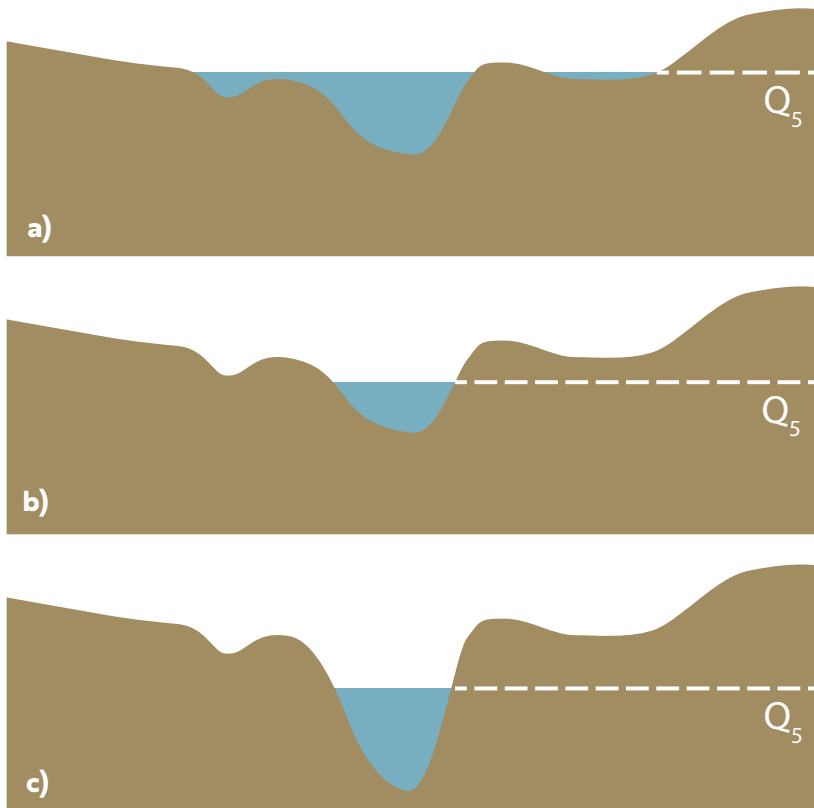
**Figure 21.** Conceptual illustrations depicting differences between typical “natural” conditions as shown in a), and an altered flood regime as a result of altered hydrology that reduces the magnitude and/or frequency of high flow events (e.g., via a dam) as shown in b), or altered channel geometry, such as channel incision, that limits the ability of high flows to access floodplain areas, as shown in c).

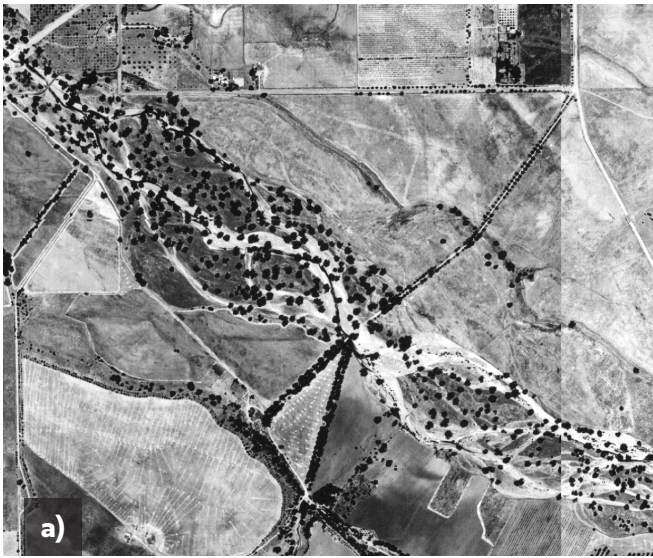
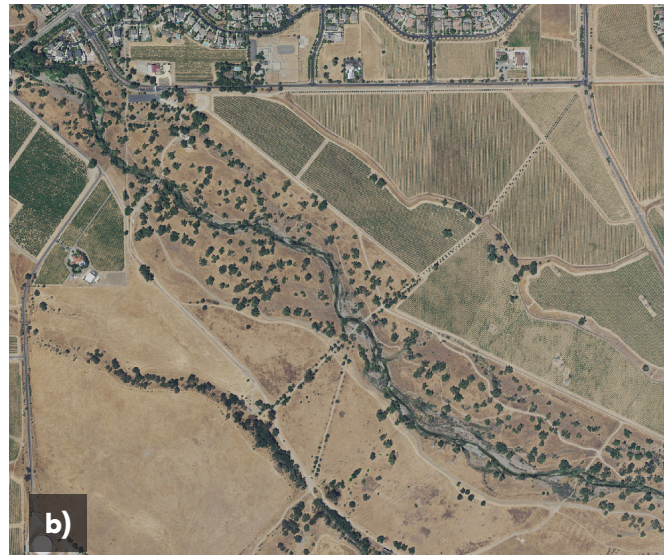
**Figure 22.** Aerial imagery comparison for the area that is now Sycamore Grove Park along Arroyo del Valle. In a), the 1939-1940 imagery shows a braided channel pattern with large areas of bare sediment (light signature), indicating regular disturbance by high flows. These signatures are largely absent in the post-dam imagery (2018, courtesy NAIP).

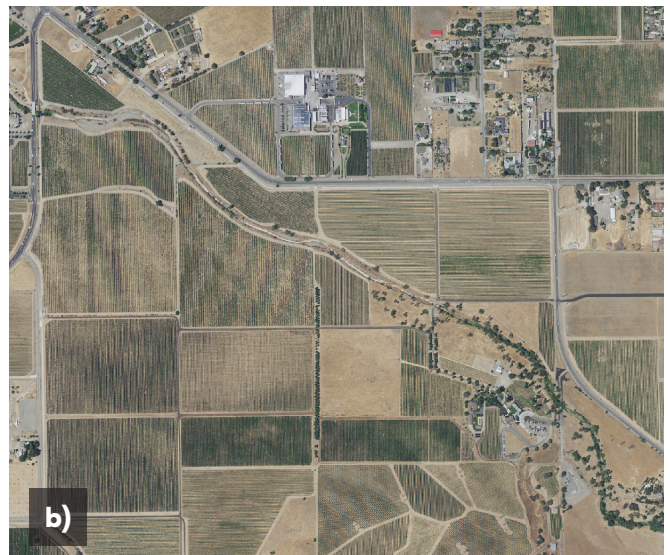
**Figure 23.** Aerial imagery comparison for the reach where the Wente Vineyard sites are located along Arroyo Mocho. In a), the 1939-1940 imagery shows the wider active channel, evidence of meandering, and side channels in comparison to a narrower stream corridor in the contemporary imagery (2018, courtesy NAIP).

area for potential sycamore recruitment is thus diminished along the lower Arroyo Mocho reaches. For example, even the recent 2022-2023 floods, which may have been approximating a 20-yr flood recurrence interval flow, do not appear to have fully activated the inner floodplain along the reach near the Wente sites (based on preliminary examination of satellite imagery). It is unclear how much of the Mines Road site was activated, and whether its less-incised channel translated to greater disturbed area and areas for sycamore recruitment. Also, active channels in today's farmed and developed valley floors are less likely to be allowed to meander, which is apparent in the aerial comparison shown in Figure 23. While historically the active channels and side channels shifted in space over time,

way for agricultural uses (see Figure 23). But because the land use is agricultural, there is opportunity to adjust the channel morphology and planform and increase the frequency of floodplain inundation. Also of note, this site does not have any side channels present, which also offers an opportunity for future creation of side channels during restoration efforts because side channels are important locations for recruitment. Also, the presence of seedlings and saplings suggests that current conditions can support establishment, and efforts to increase the total number of sycamores within the active channel via active planting would likely be successful.

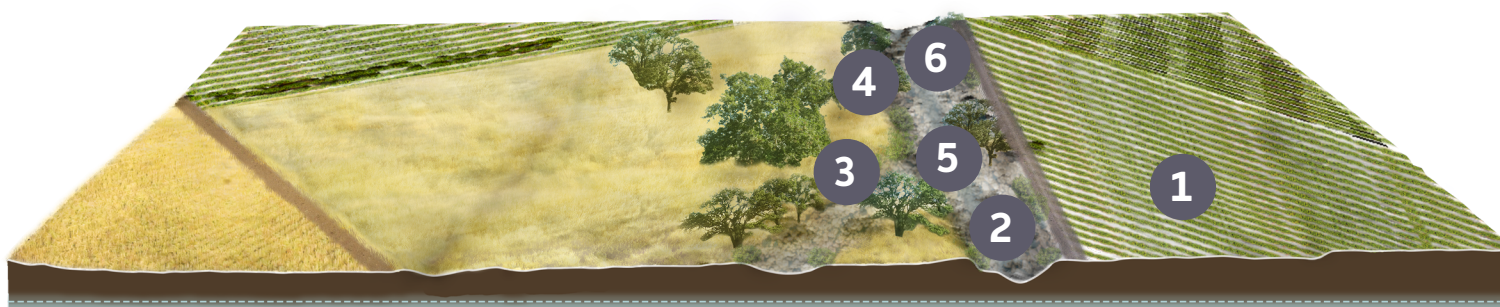
**Figure 24.** Example process-based restoration and enhancement actions.

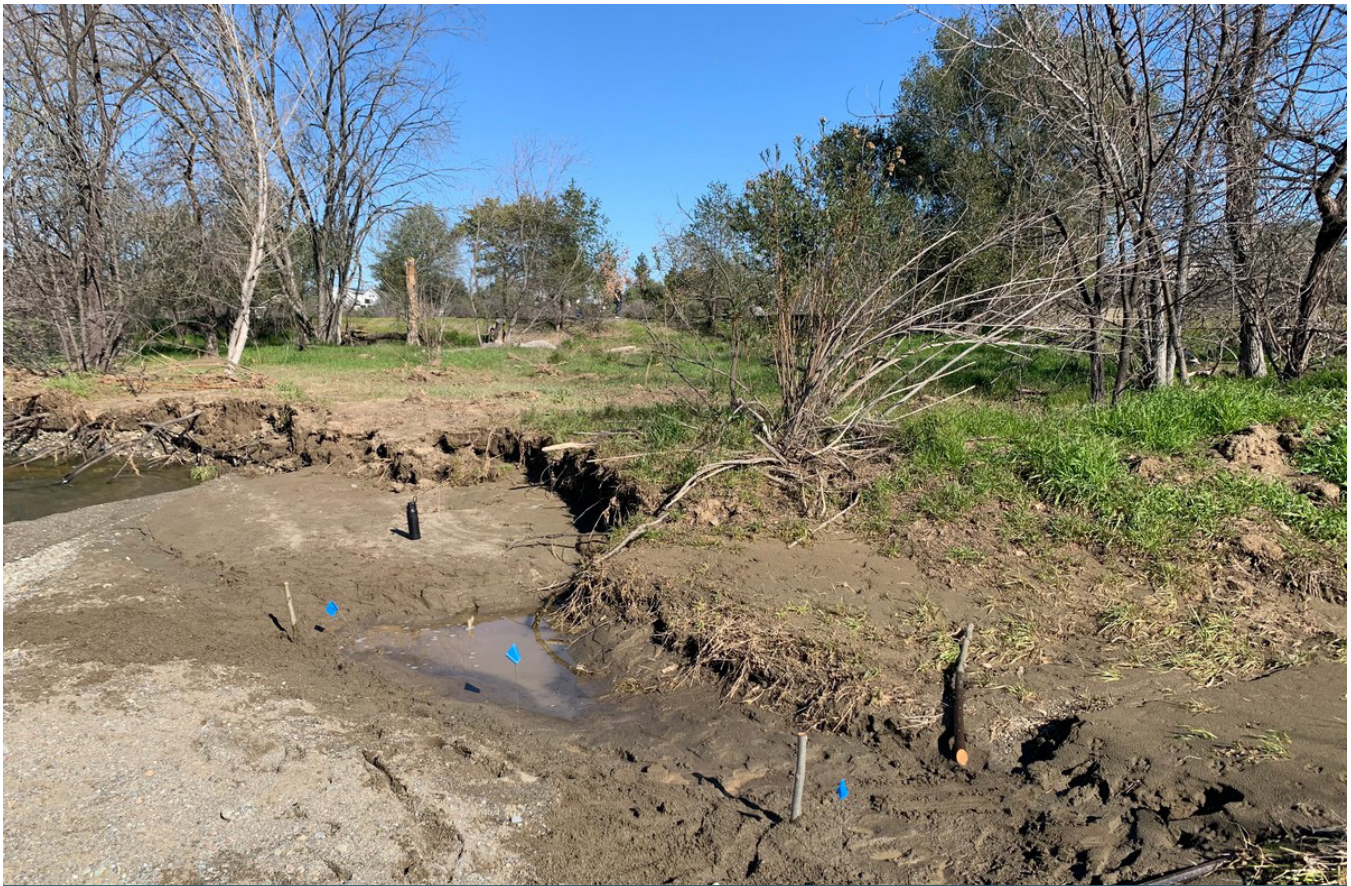
Sycamore stakes at Medeiros Parkway. Photograph by H. T. Harvey.
