**Historical Ecology of South Santa Clara County: Preliminary Findings**  
A Technical Memorandum to the Santa Clara Valley Habitat Conservation  
Plan/Natural Community Conservation Plan

**San Francisco Estuary Institute**  
April 2007

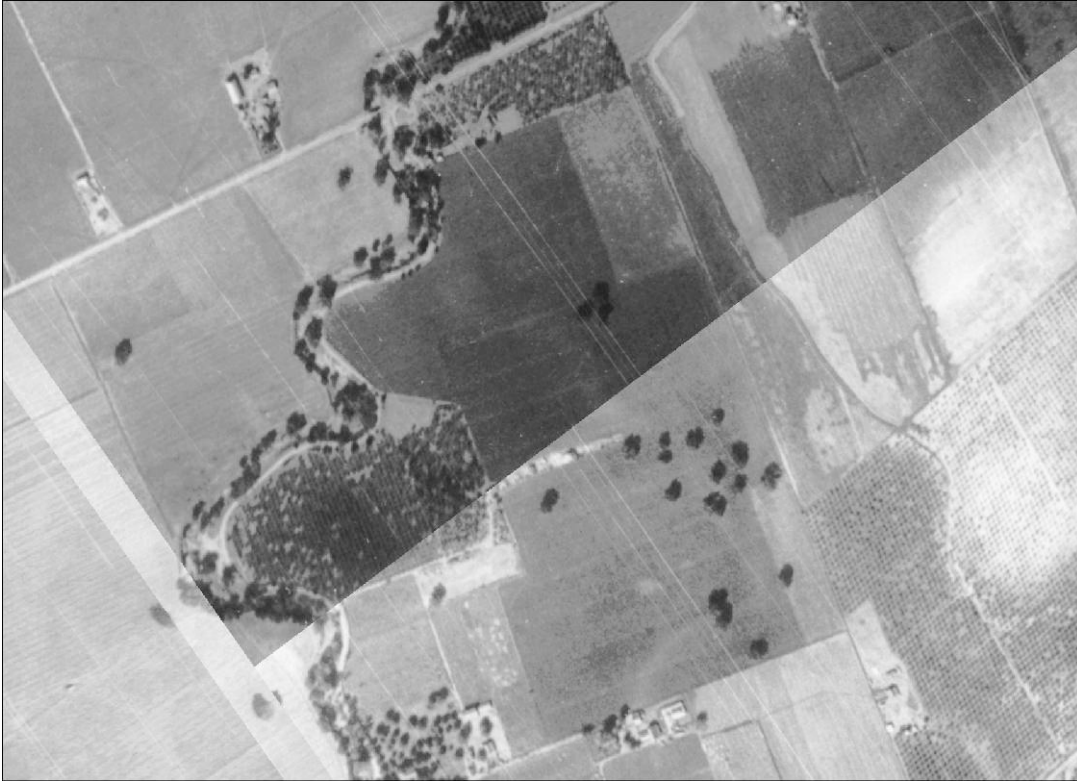
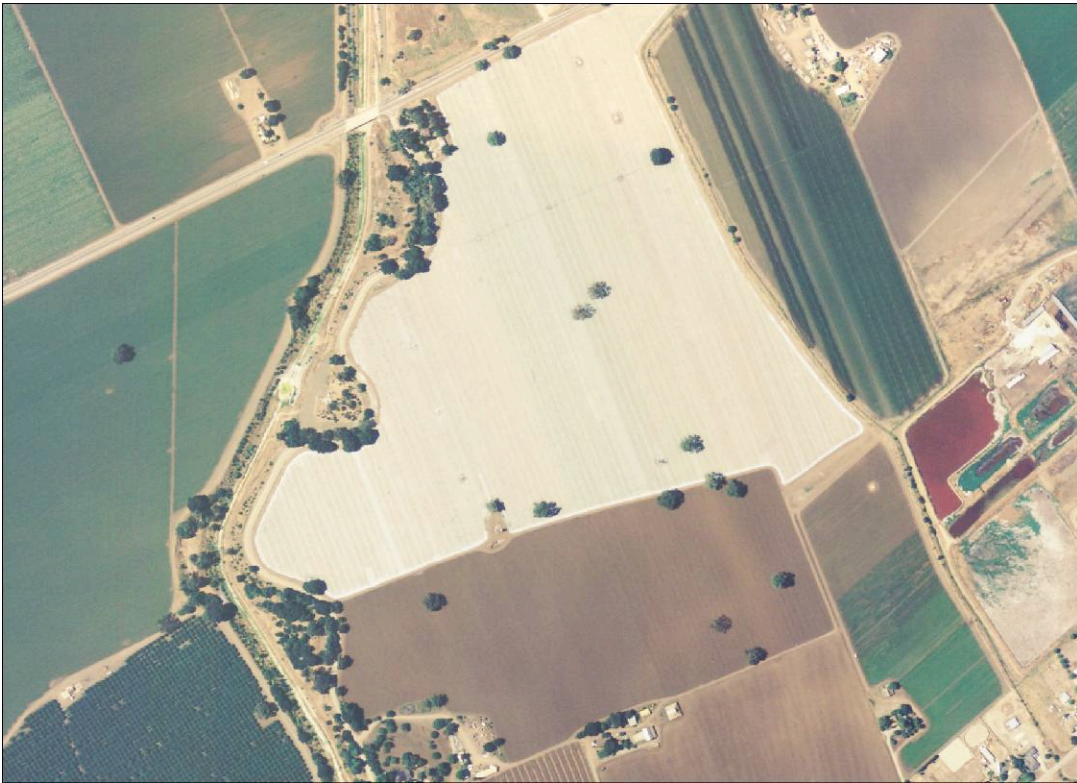
**Figure 2.** A grove of valley oak trees in agricultural fields in 1939, above, and 2005, below. Remnant meanders and riparian forest of Llagas Creek can also be seen in the contemporary image.

About 2,000 large (>12 m canopy diameter), probable valley oak trees can be identified in the study area circa 1939 from aerial imagery, presumably a large reduction from the 19<sup>th</sup> century total. A preliminary estimate of those of that vintage remaining, based upon contemporary (2005) imagery, would be less than half. Significant remnants can still be found in places (Figure 2).

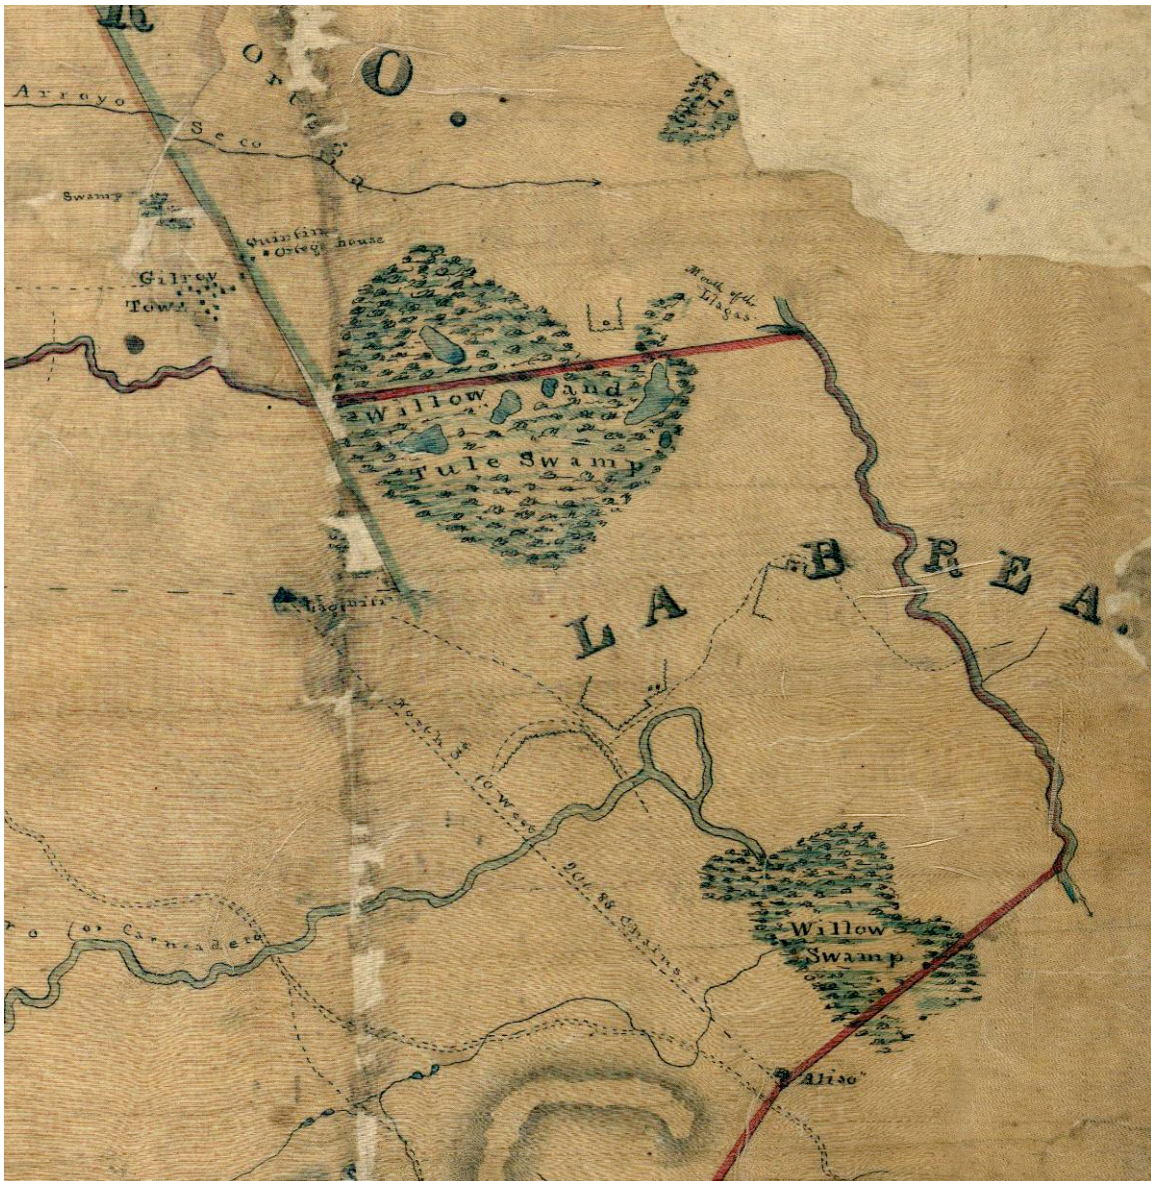
**Figure 4.** Freshwater wetlands and willow swamps at the confluences of Llagas Creek and Carnadero Creek with the Pajaro River. Llagas Creek enters a “Willow and Tule Swamp” with significant freshwater ponds at top; Carnadero Creek spreads into a “Willow Swamp” below. The Pajaro River flows from top to bottom at right. U.S. District Court, Northern District, 186-?. Courtesy of The Bancroft Library, UC Berkeley.

Large and small perennial freshwater marshes were found throughout lower Santa Clara County and northern San Benito County. For example, Surveyor Dyer (1861), writing in September, recorded “low marshy land covered with tule and flags” in the area of the present day Llagas Creek flood control channel and South County Regional Wastewater Plant. A map of the Las Animas Rancho confirms tule swamps here (Figure 4). Healy

Large willow groves, or *sausals*, were documented at the mouth of Llagas Creek (e.g. “dense willow thicket”, Wallace 1858; Figure 4), the mouth of Carnadero Creek (“Willow Swamp”), and the eastern side of San Felipe Lake. The area's willow groves may have been important habitat for the willow flycatcher (*Empidonax traillii*), and least Bell's vireo (*Vireo bellii pusillus*). Substantial remnants of the willow grove at Llagas Creek were present as recently as 1939 (Figure 5).

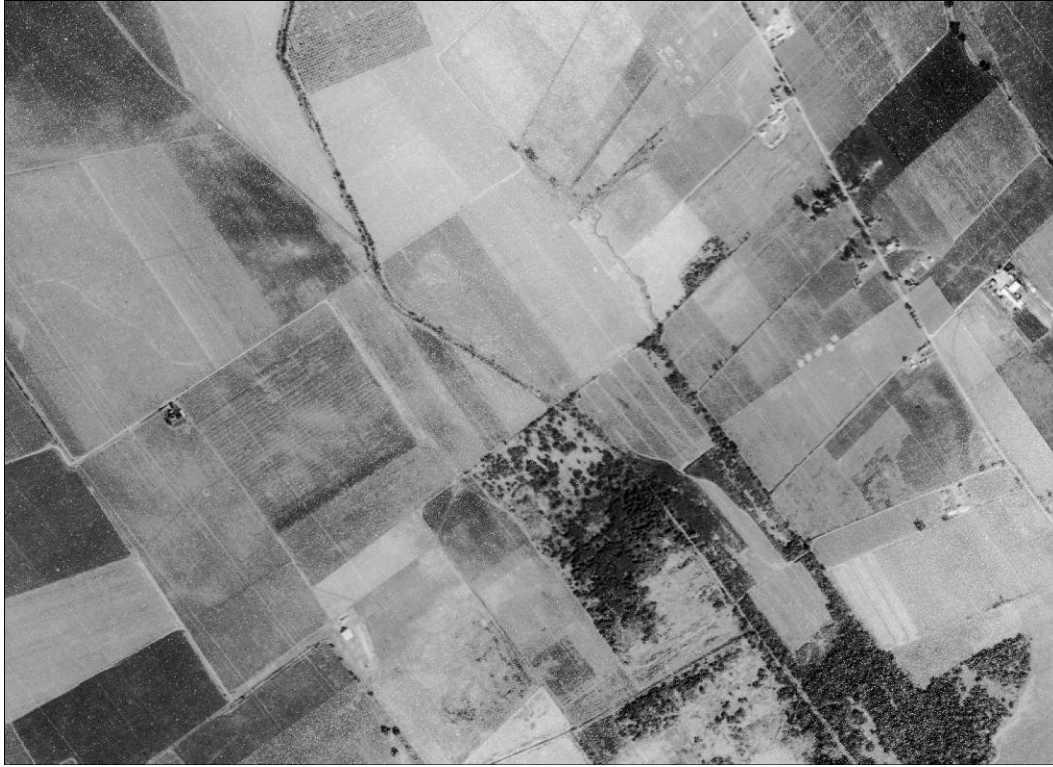
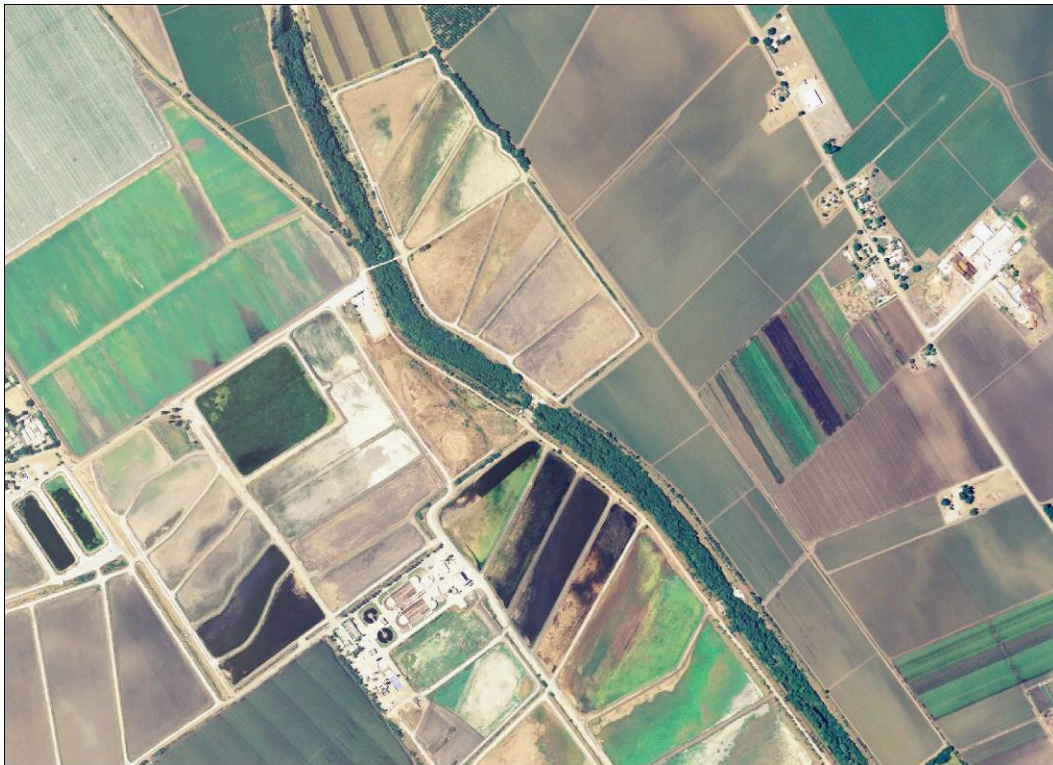
**Figure 5.** Lower Llagas Creek in 1939, above, and 2005, below. Remnants of the earlier willow grove can be seen in 1939; there are relatively few trees along the creek in the cleared area to the north. In the contemporary image, willow riparian forest has expanded within the flood control channel. The South County Regional Wastewater Plant occupies the lower left portion of the 2005 image.

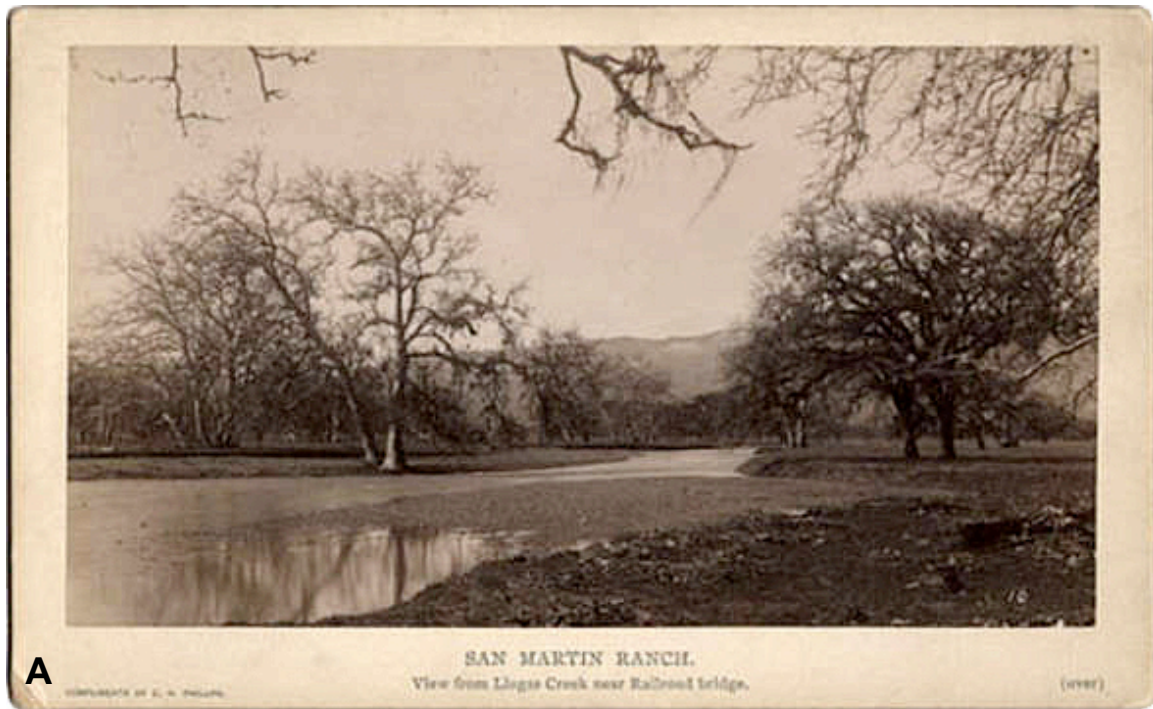
**Figure 6.**

**A.** Llagas Creek near the Highway 101 and railroad crossings, circa 1895. This view shows a broad and shallow, gravel-bedded channel with occasional sycamores on gravel bars and terraces. (Hill circa 1895, courtesy of California Room, San Jose Public Library)

Information about riparian habitat is less complete at this time. It appears that braided channels supporting sparse riparian forests with relatively open canopy structure were common on the valley floor portion on streams such as Pacheco, Uvas, and Llagas, upstream of their dissipation into wetlands (Figure 6; Kondolf et al. 2001). Bearing trees in GLO surveys and early aerial photography, as well as present-day remnants, suggest that sycamore alluvial woodland was common (Figure 6).

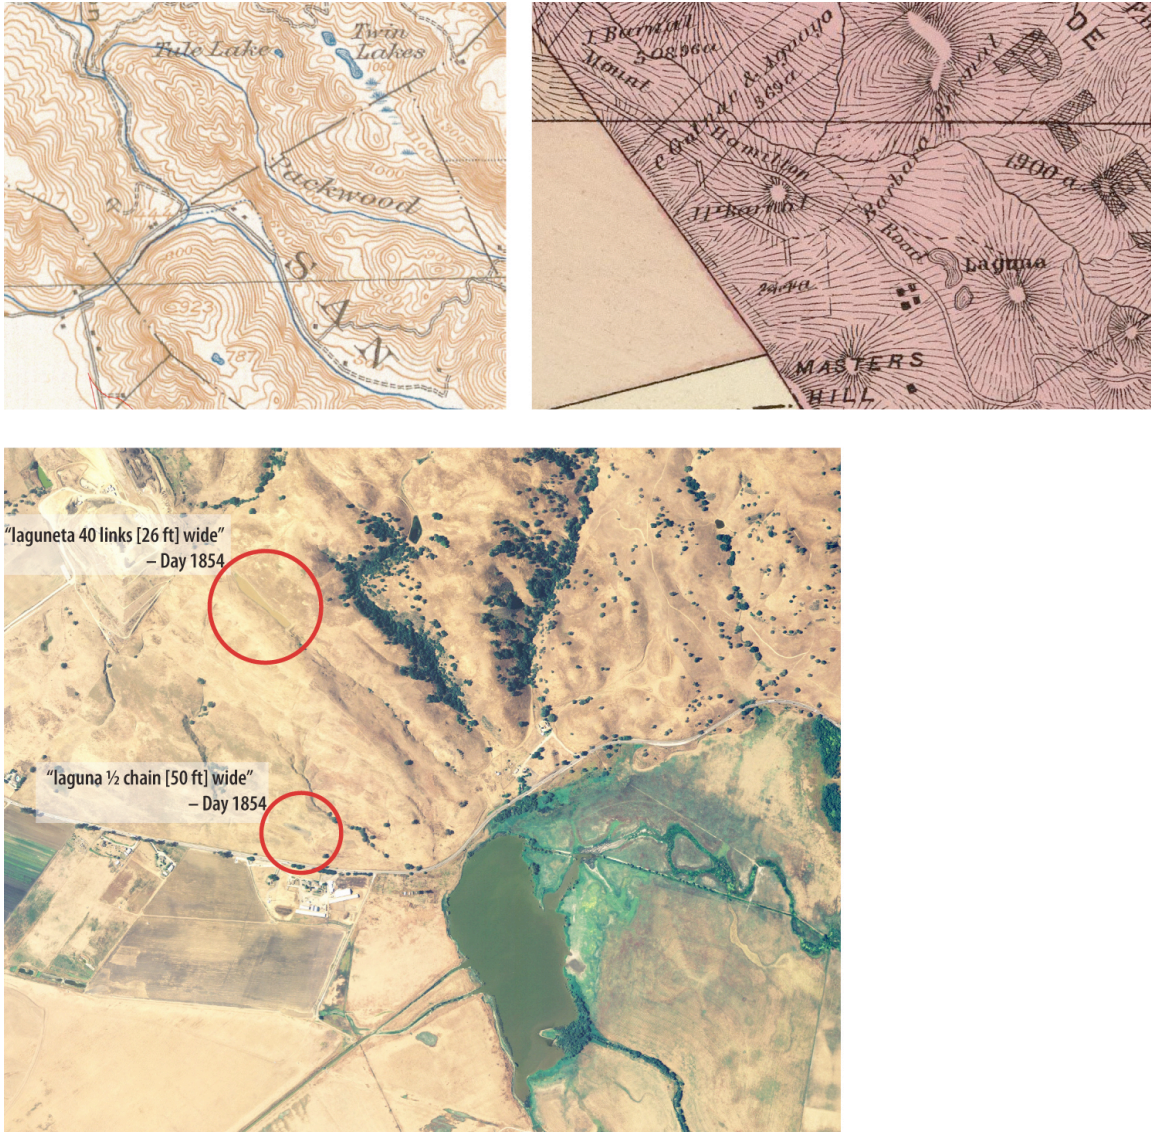
**Figure 8.** At upper left, USGS (1917) shows Twin Lakes and surrounding wetlands. At upper right, Thompson and West (1876, courtesy of David Rumsey Associates) document lagunas along Mount Hamilton Road. The bottom image shows two wetland features near San Felipe Lake that were documented by Sherman Day (1854) and appear to still be present.

recorded by Day (1854) just north and west of San Felipe Lake appear to still be intact, based upon contemporary aerial photography (Figure 8).
