Erin Beller¹, Robin Grossinger¹, Ruth Askevold¹, Sarah Pearce¹, Josh Collins¹, Lester McKee¹, Rainer Hoenicke¹, Shari Gardner²
¹ San Francisco Estuary Institute ² Friends of Napa River

Streams, Wetlands, and Woodlands in the Napa Valley: New Perspectives from Old Maps

How Historical Landscapes Can Guide Restoration and Conservation

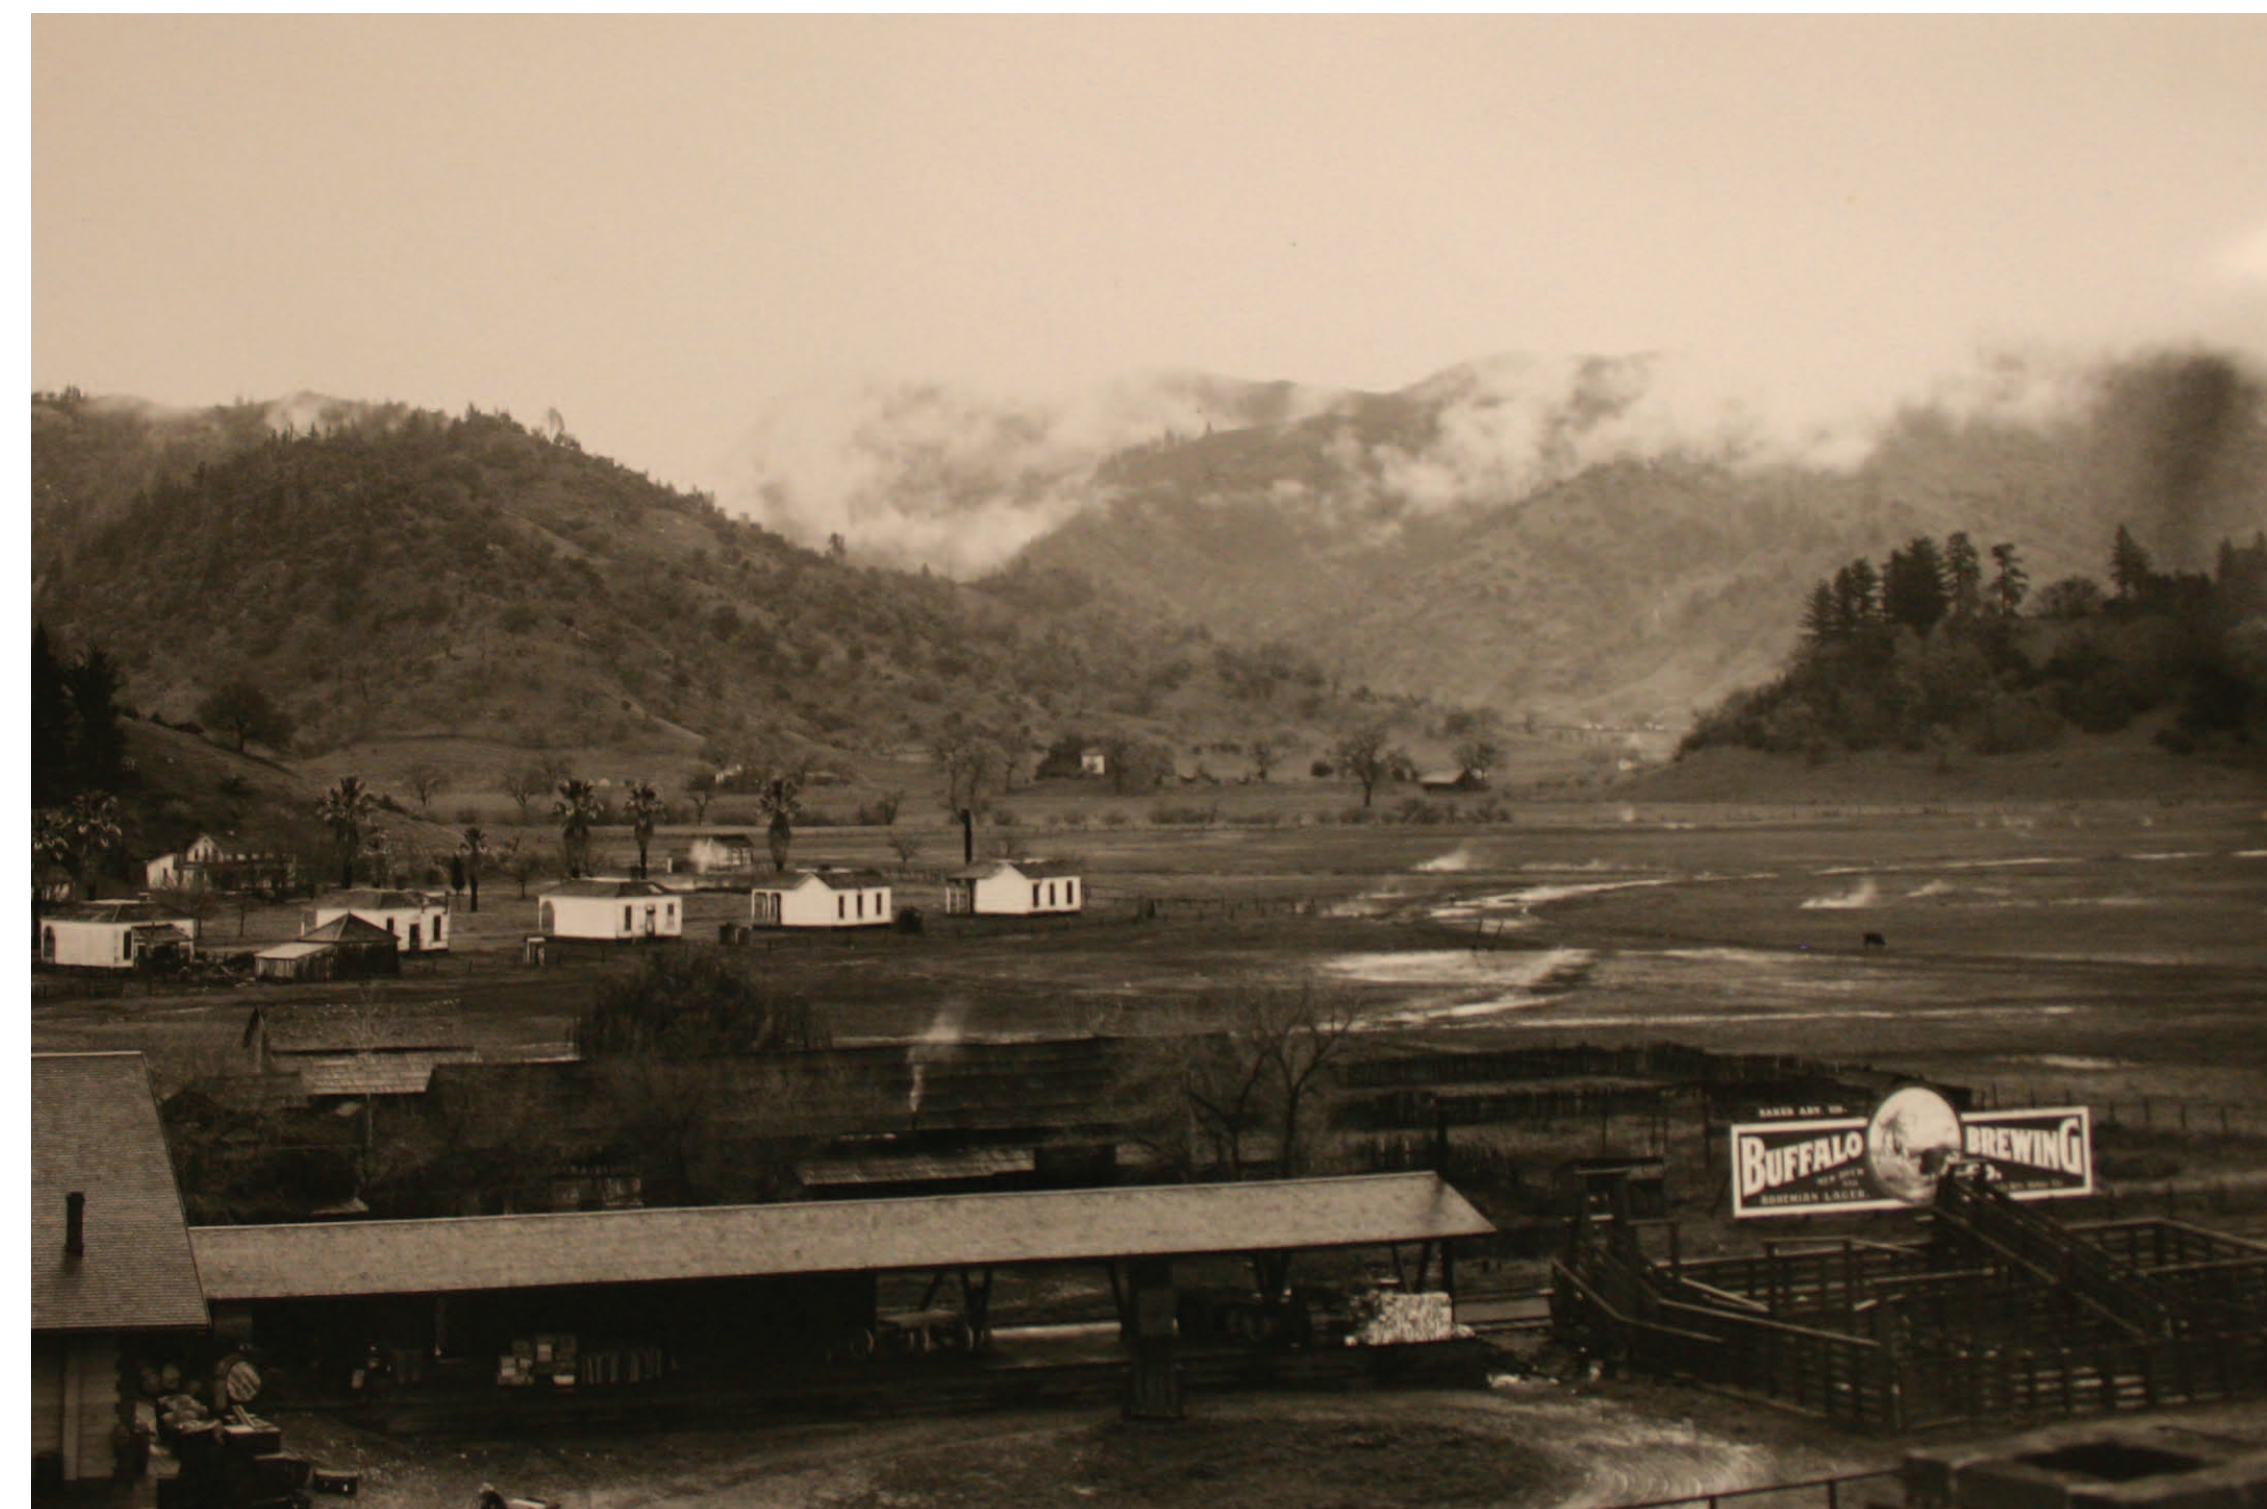
Figure 1
Steam spouts show the wetlands associated with Calistoga Hot Springs (note water-logged ground and standing water to the right of the row of white houses). The thermal springs and surrounding area were described by Bartlett in the mid-1850s; “they [the springs] are in a plane near the base of a small hill of conglomerate rock; but owing to the wet and boggy condition of the valley, we were unable to approach within thirty feet of them. Columns of steam were rising from them on all sides.” (Bartlett [1854]1965), Turrill and Miller, n.d. [circa 1880]. Courtesy of the California Historical Society

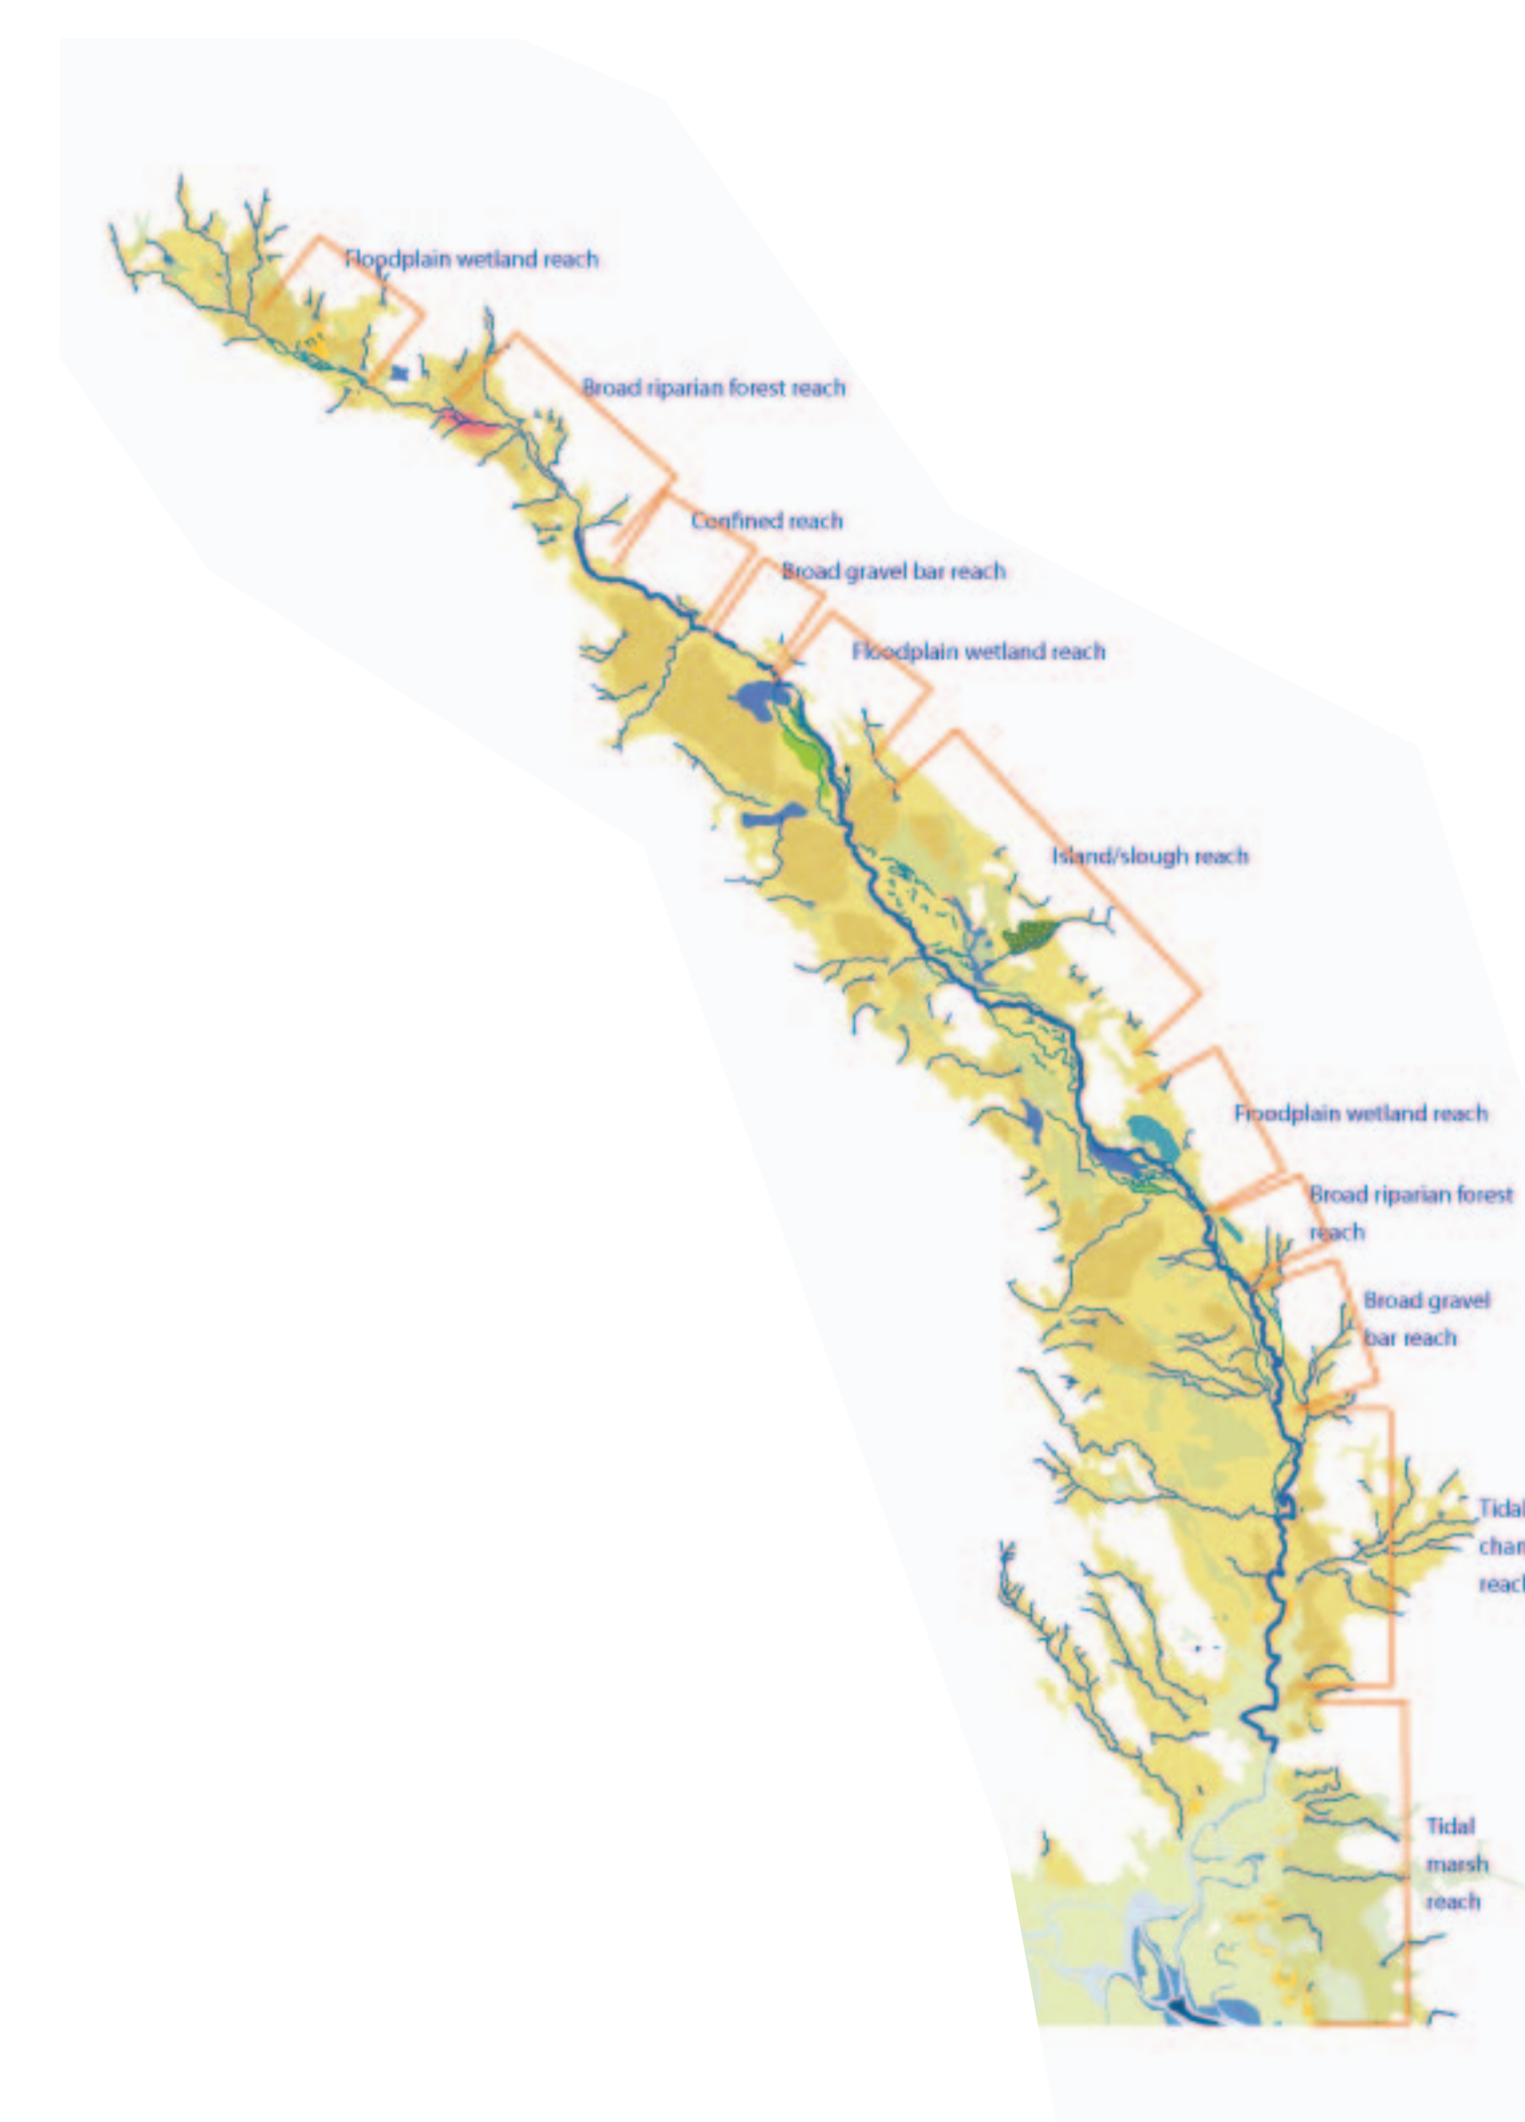
> While Napa River is presently a relatively homogenous, single thread channel with a narrow adjacent riparian corridor, in earlier times there were distinct river reaches with differing function for fish and wildlife habitat, sediment transport or storage, and flood conveyance. The river responded to the surrounding landscape, spreading into floodplain wetlands where the valley was wide, changing course at confining topographic and geologic barriers, and picking up sediment and water at major tributary confluences.

Figure 5
Distinct Napa River reaches, based on historical evidence

These variations in historical stream function were related to basic physical characteristics of the valley floor that are relatively unchanging. They suggest different strategies and target functions may be appropriate for different reaches of the river.
