HISTORICAL ECOLOGY INFORMING RESTORATION IN EAST CONTRA COSTA COUNTY Alison Whipple In Stanford In the Contract of the Contrac

WETLAND RESTORATION OPPORTUNITIES ON A TRIBUTARY TO BRUSHY CREEK (SOUZA II PROPERTY) Son Francisco Estuary Institute, Oakland,

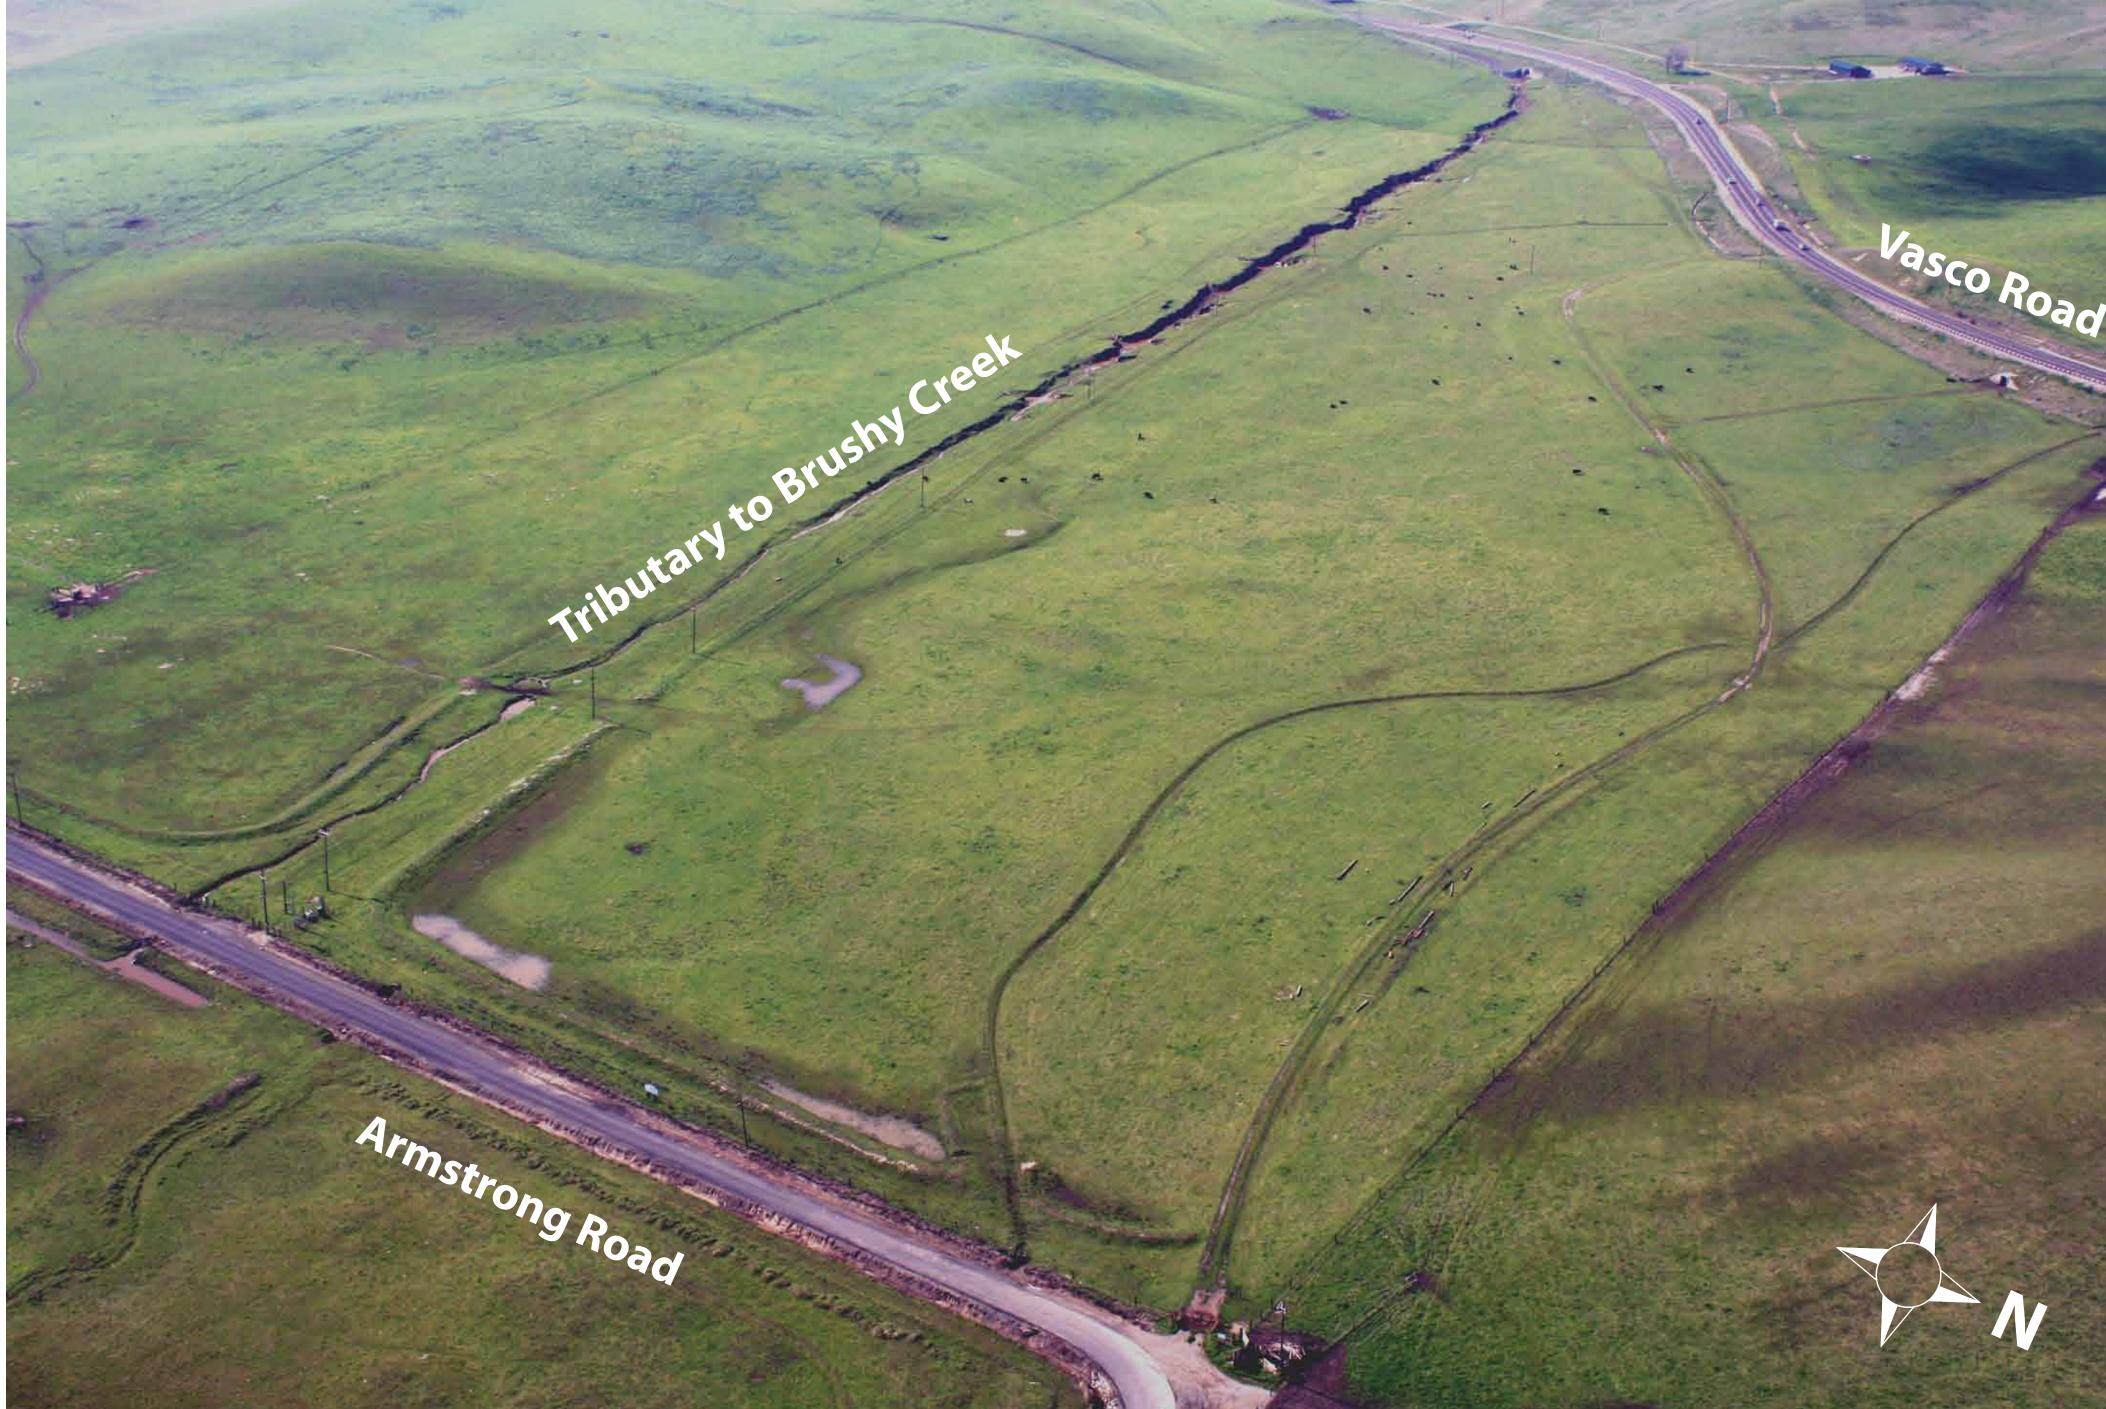
Historical evidence suggested that the project area was a diffuse, seasonally flooded drainage system with alkali wetlands, possible vernal pool features, and a discontinous channel. It appeared that the system was converted to a relatively straight artifical channel in the early 20th century, presumably to improve drainage characteristics.

The maps to the right show how the channel was mapped as a discontinous system until 1916, when the tributary appears as a straight channel. By the time the 1939 aerial photographs were taken, the straightened channel appears deeply incised.

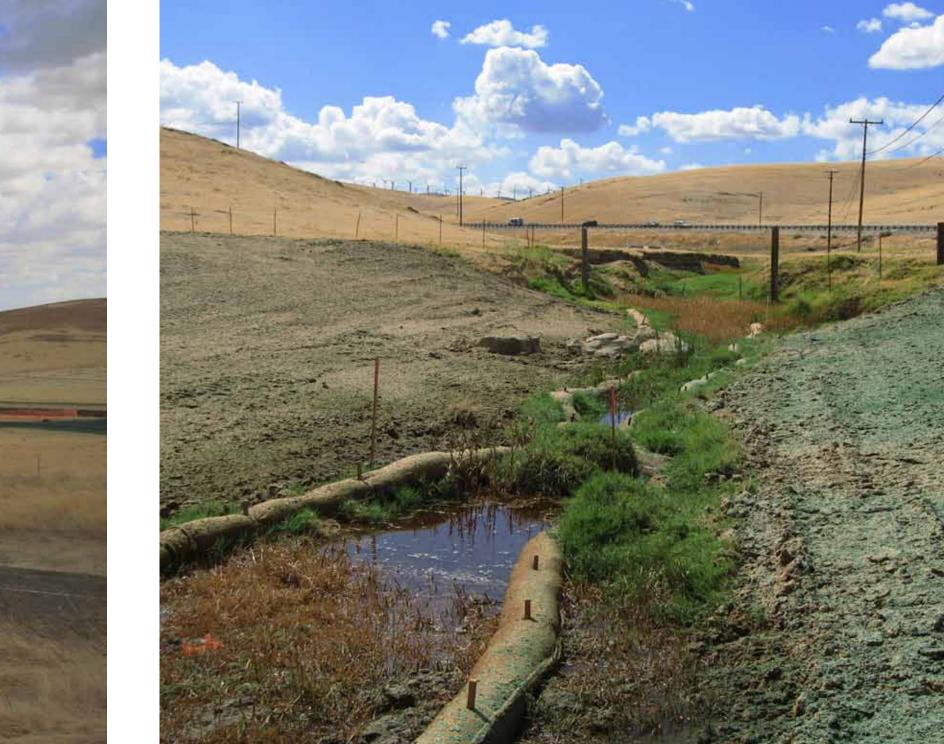
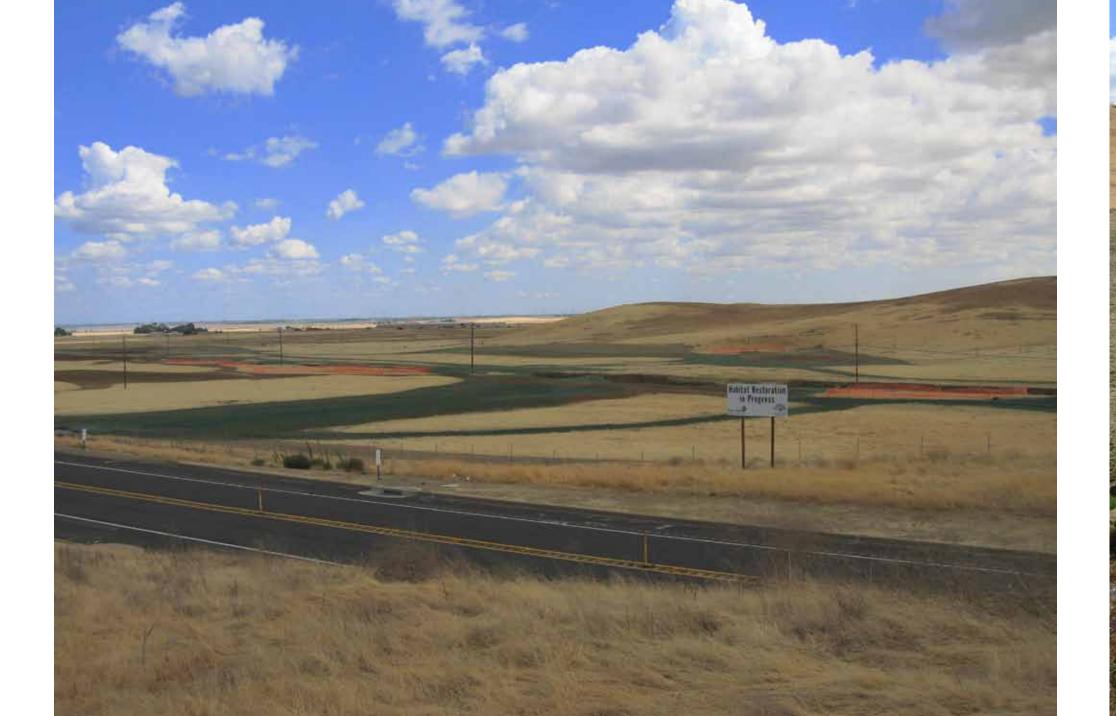
ouza II Restoration Project: Schematic of Restoration Design -- Road to Be Removed/Revegetated

Souza II Wetland Restoration and Creation Project

8.5 acres (wetland creation) 0.18 acres (pond creation) Ponds

Intermittent Streams 0.38 miles (channel restoration and creation

Grassland Restoration 15.1 acres (grassland restoration)

When construction is complete, the project will create an extensive seasonal swale and wetland complex on the eastern side of the parcel that echoes historical land cover and hydrology. Because of modern changes to the landscape (straightened and incised channel, Vasco Road drainage, and upstream ponds) the created and restored habitats needed to reflect modern constraints while still providing the habitat for targeted endangered species that existed prior to disturbance. Features that did not historically exist were added to the design including a seasonal pond and a 'treatment' swale to catch water run-off from Vasco Road.

Construction began in mid-August, 2009 and earthwork was completed the 1st week of September. The earthwork involved moving approximately 11,000 cubic yards of dirt to create wetlands and swales, lay back creek banks and create a new pond. The restoration will improve habitat conditions for California red-legged frog and California tiger salamander through creation of a seasonal pond and enhanced channel complexity. Several vernal pools were lined with potential vernal pool fairy shrimp innoculum. Rare plant species will be propagated in the restored habitats.
