FINAL REPORT

SOUTH SANTA CLARA VALLEY HISTORICAL ECOLOGY STUDY

INCLUDING SOAP LAKE, THE UPPER PAJARO RIVER, AND LLAGAS, UVAS-CARNADERO, AND PACHECO CREEKS

PREPARED FOR THE SANTA CLARA VALLEY WATER DISTRICT
AND THE NATURE CONSERVANCY
MAY 2008

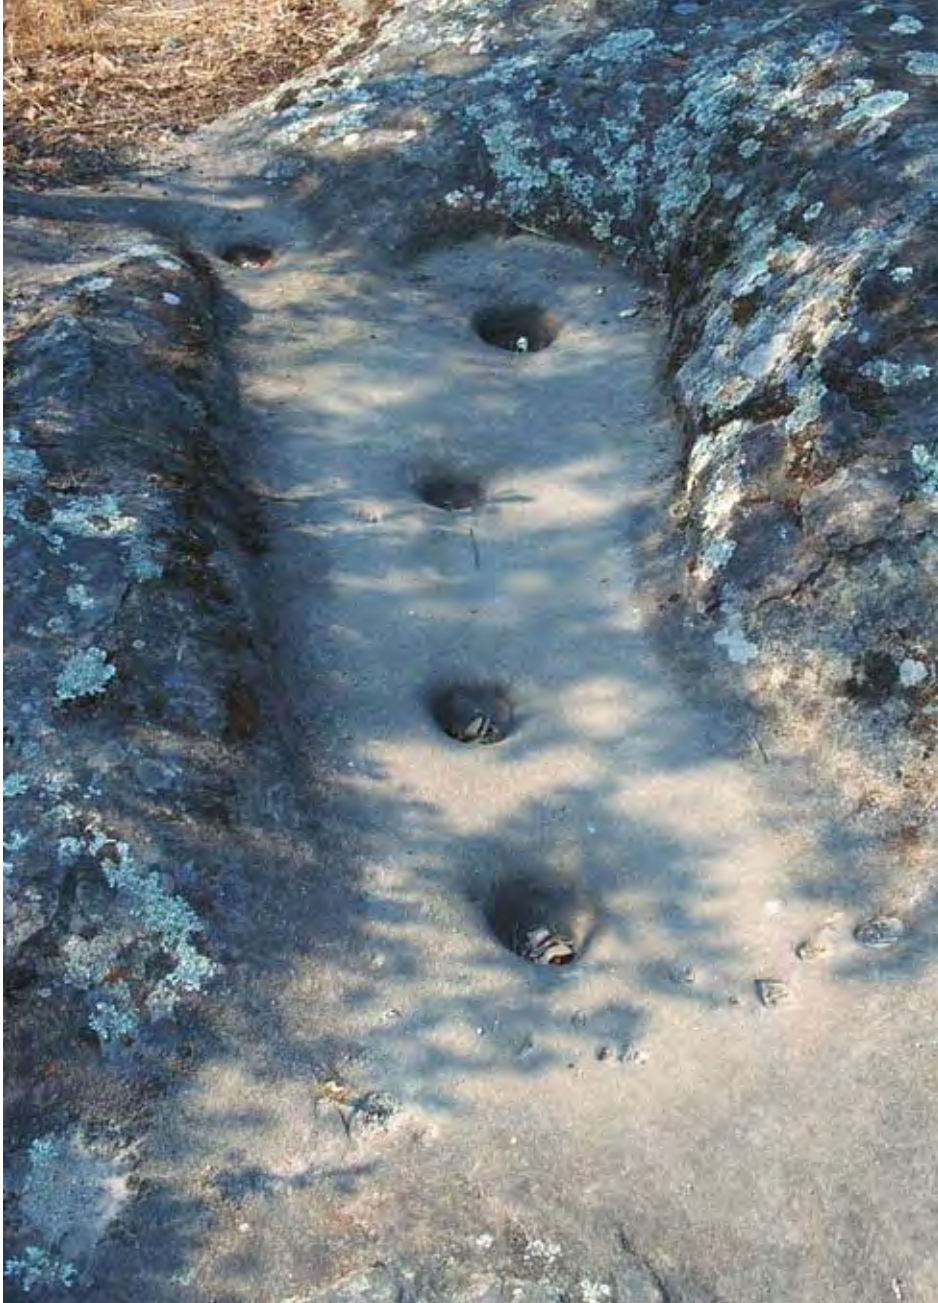
Figure 3.2. Bedrock mortars along the perennial portion of Uvas-Carnadero Creek are evidence of Ohlone use of the Chitactac site, now part of Chitactac-Adams County Park. (Photograph by Ed Ketchum)

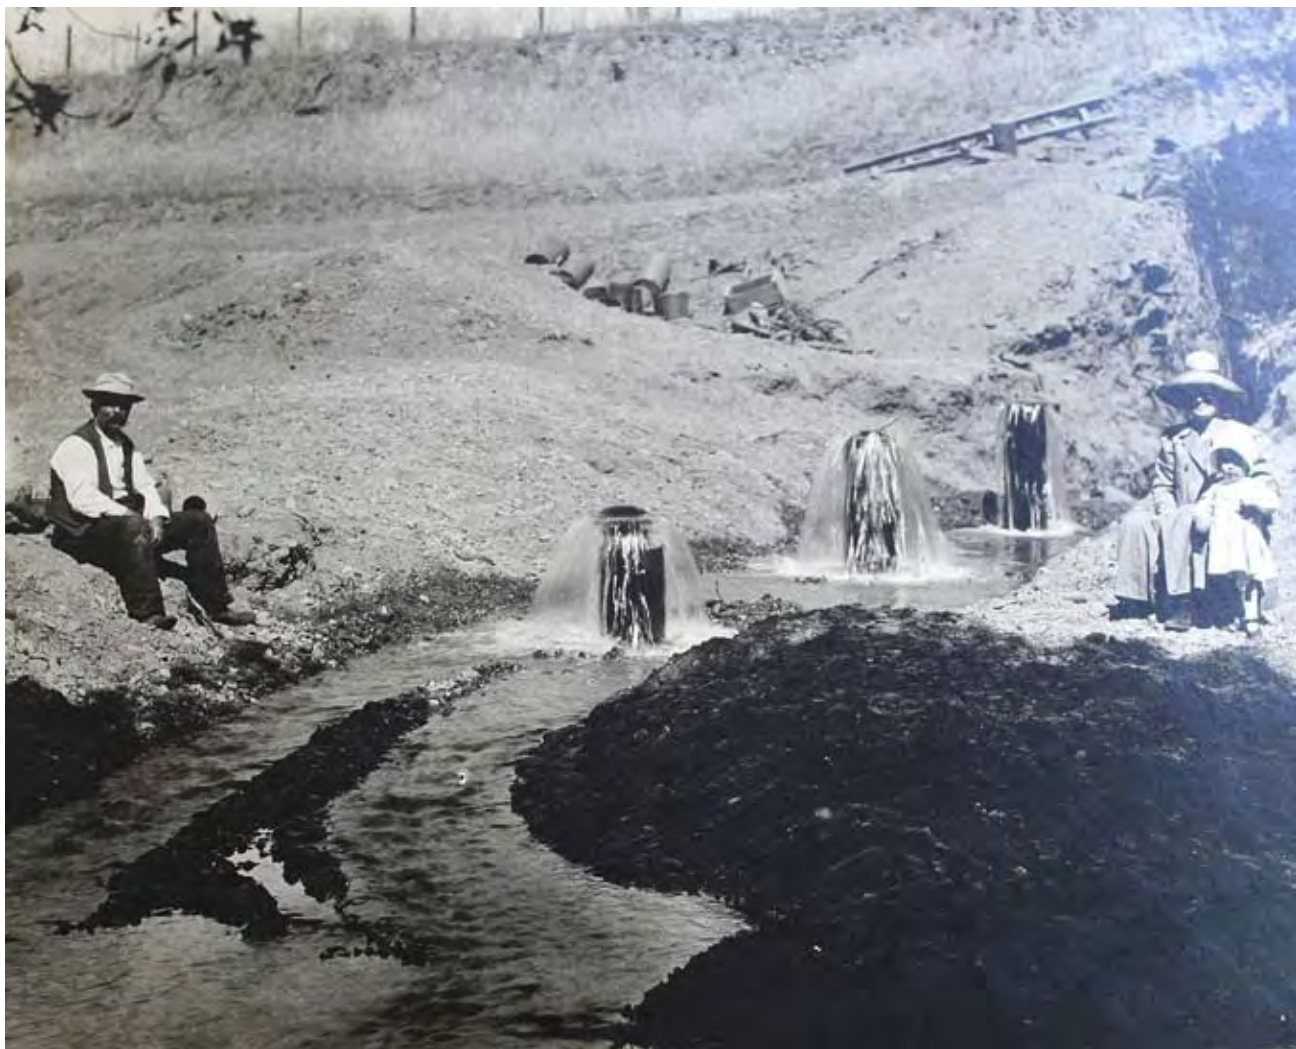
Figure 3.5. "Artesian wells on the Ausaymas Ranch, drilled June 1912." Since the 1870s, groundwater has been an important source of water for crop irrigation in South Valley. (Unknown ca. 1912c, courtesy of the San Benito County Historical Society)

The most notable section of the artesian belt was located in the San Felipe district northeast of the Bolsa, where, as a member of the San Benito Well Boring Company bragged in 1889, they could “strike artesian water anywhere between San Felipe and Poverty Hill [near the Hillcrest/Sunnyslope area of Hollister]” (Hollister Free Lance 1889). By 1886, there were over 75 artesian wells in the small San Felipe district alone (Hollister Free Lance 1886b). By 1888, there were at least 150 artesian wells in the Gilroy area and another 119 in northern San Benito County (fig. 3.5; Harrison ca. 1888; U.S. Census Bureau 1894, in Kilburn 1972).

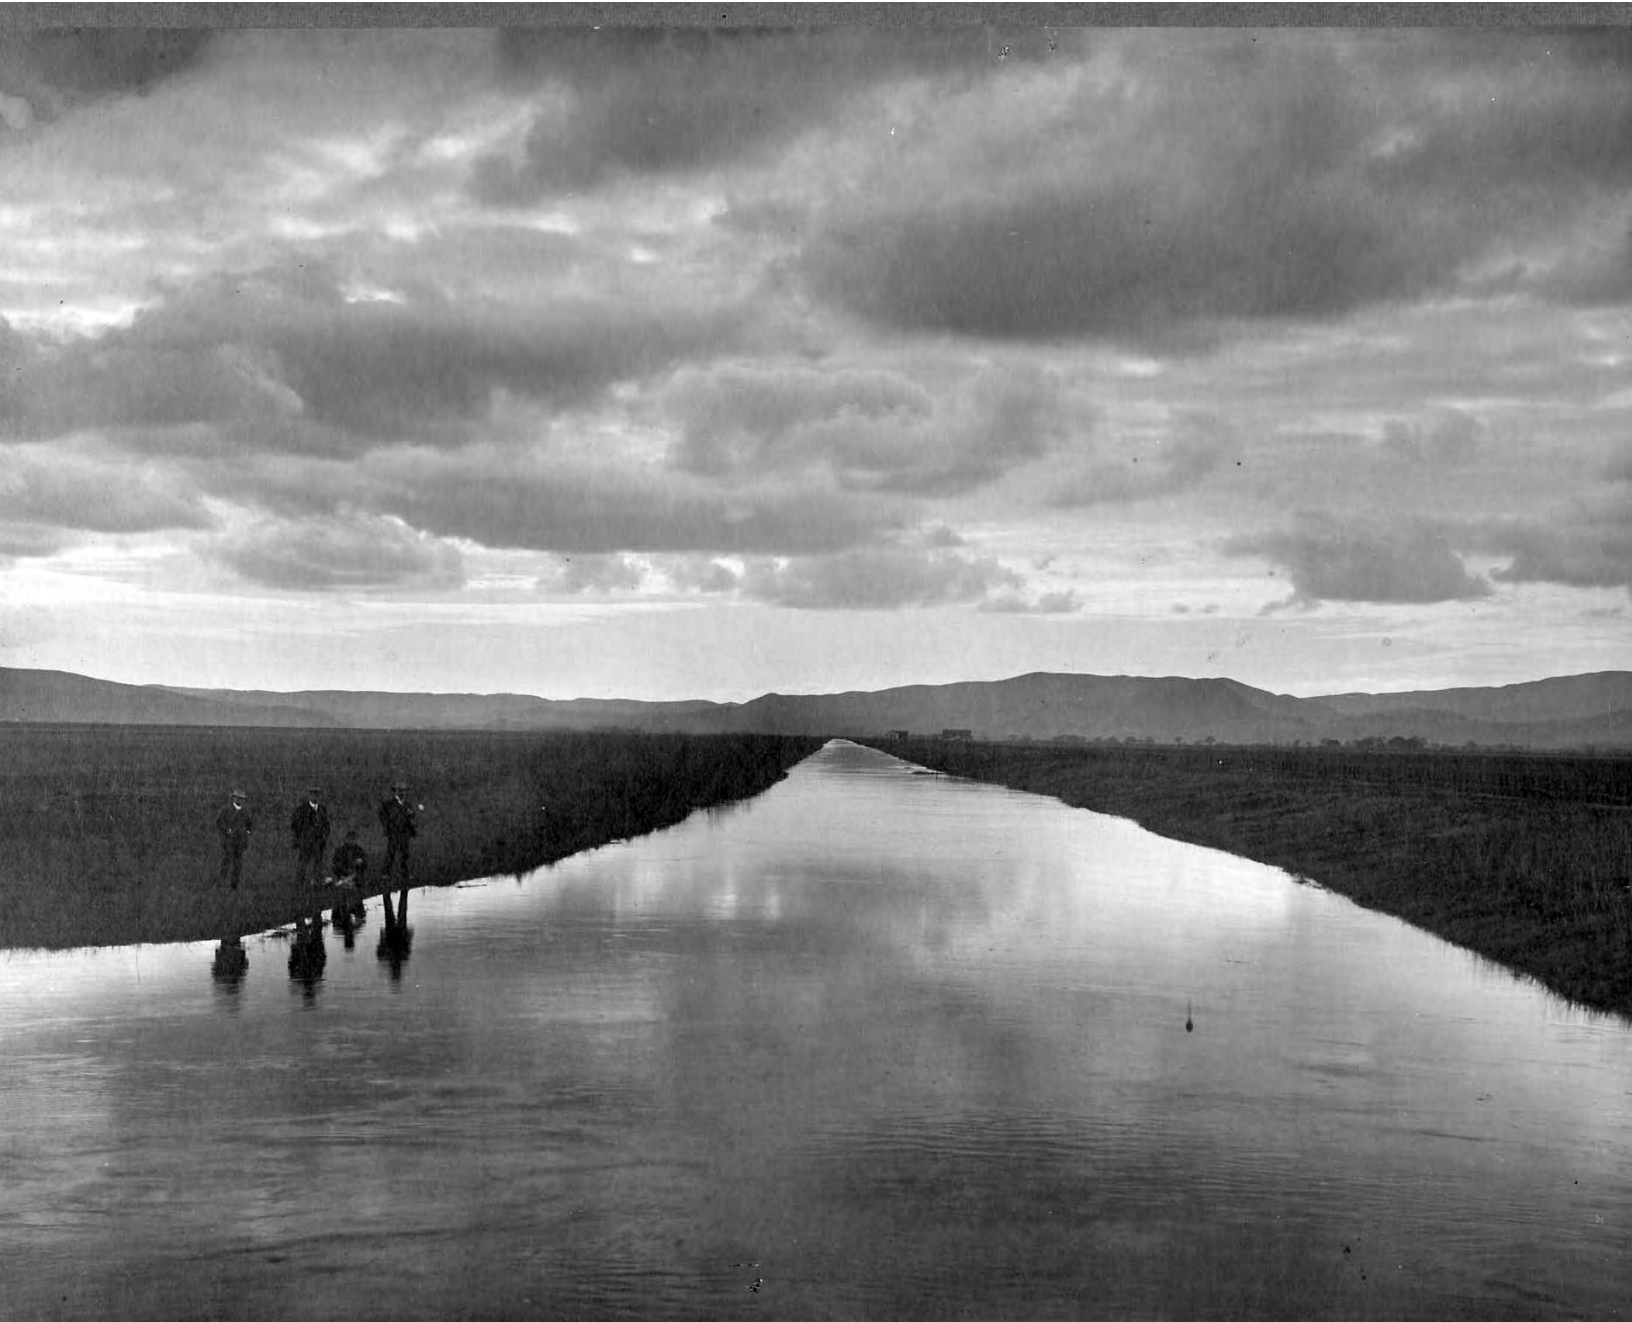
Figure 3.10. "Irrigation canal on Emery Ranch, Soap Lake, looking downstream," ca. 1900. This is likely the same canal as depicted in Figure 3.9. Interestingly, the image is labeled "Irrigation Canal," suggesting that it was not just used for drainage. (Unknown ca. 1900b, courtesy of the San Benito County Historical Society)

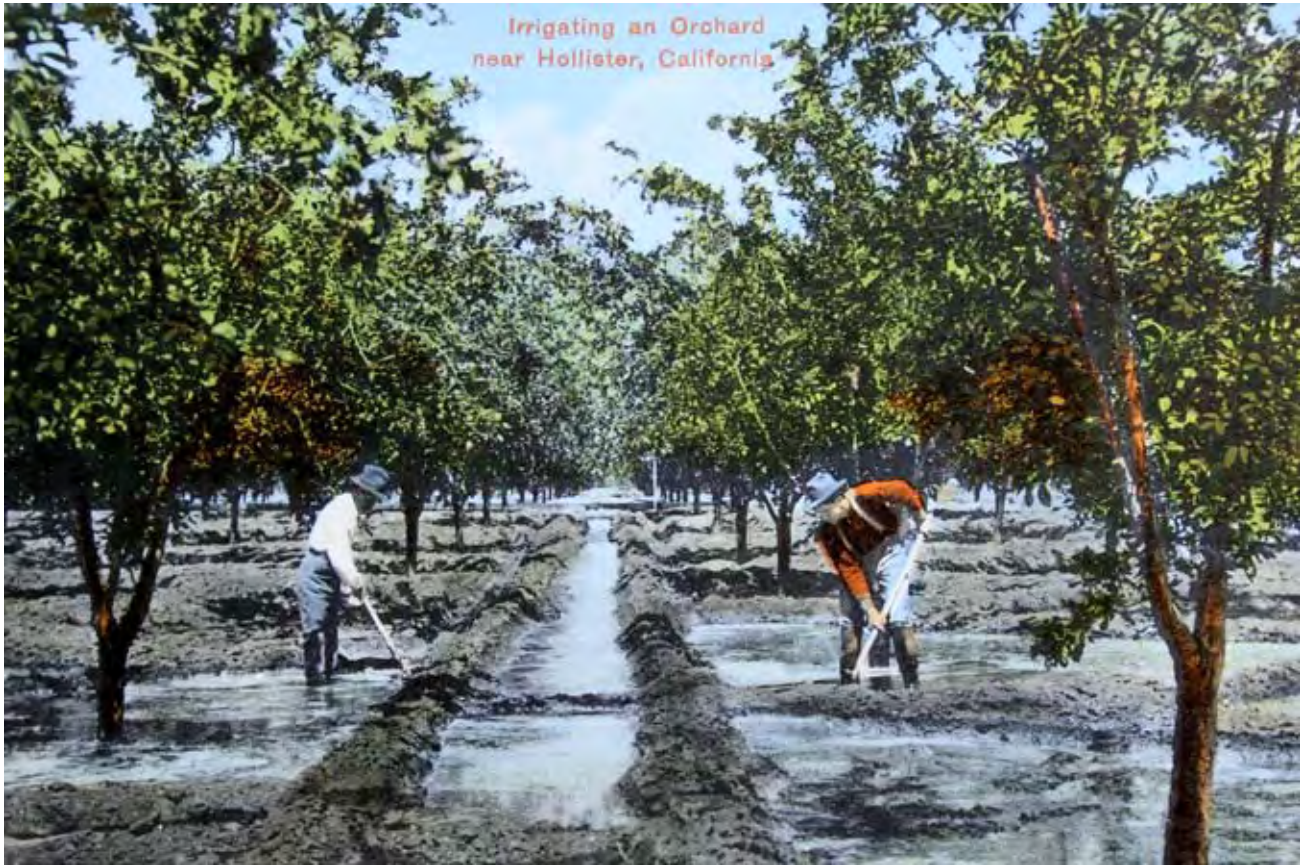
Figure 3.11. "Irrigating an Orchard near Hollister, California," ca. 1910. (Unknown ca. 1910a, courtesy of the San Benito County Historical Society)

With a few exceptions (for example, early dry farming on orchards near Morgan Hill; Clark 1924), orcharding on the valley floor was an irrigated enterprise (Cosby and Watson 1927a; fig. 3.11). T.S. Kenderdine, observing the ranch of a friend of his on the Carnadero near Gilroy, remarked that "without irrigation orcharding would be a poor business" (Kenderdine 1898), and Clark (1924) noted that "without

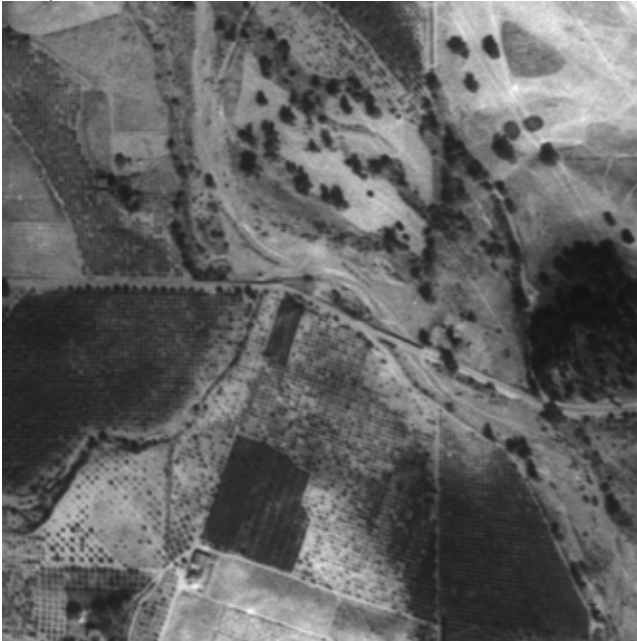
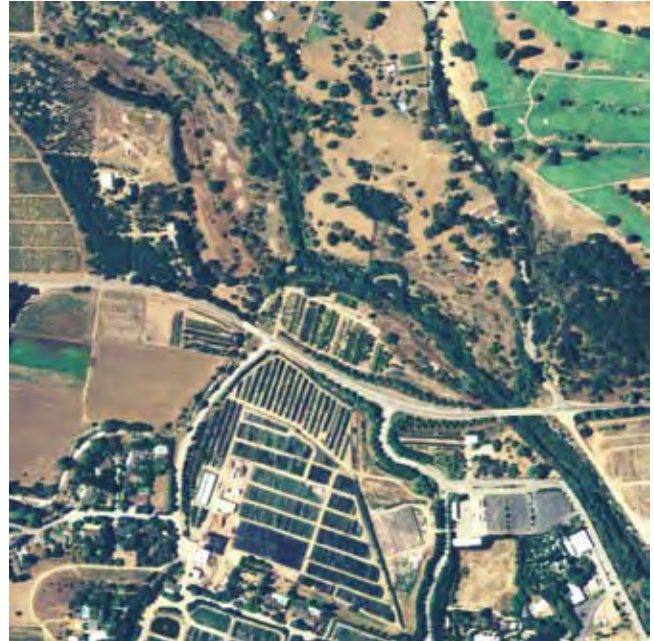
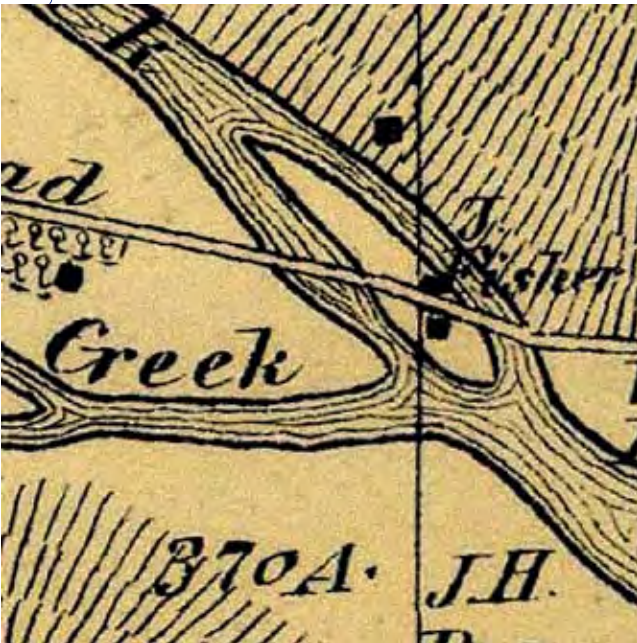
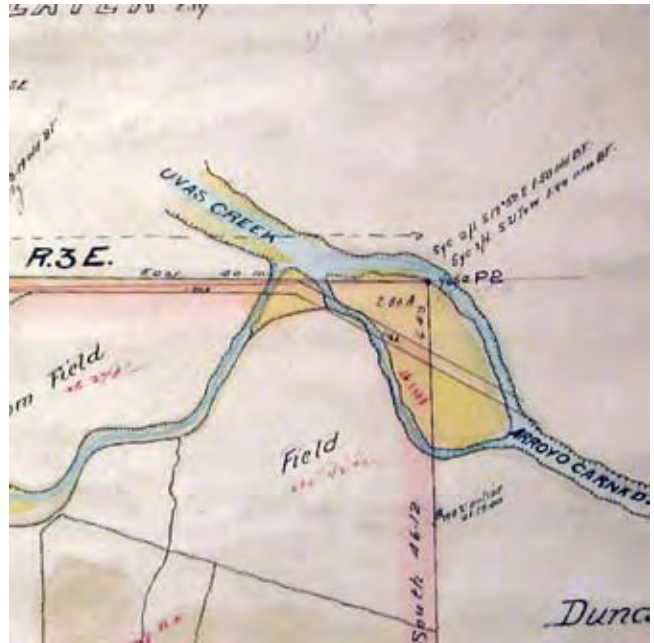
Above. Uvas-Carnadero Creek at the Hecker Pass Road crossing; images from 1939, 2005, 1884, and 1876 (clockwise from upper left).

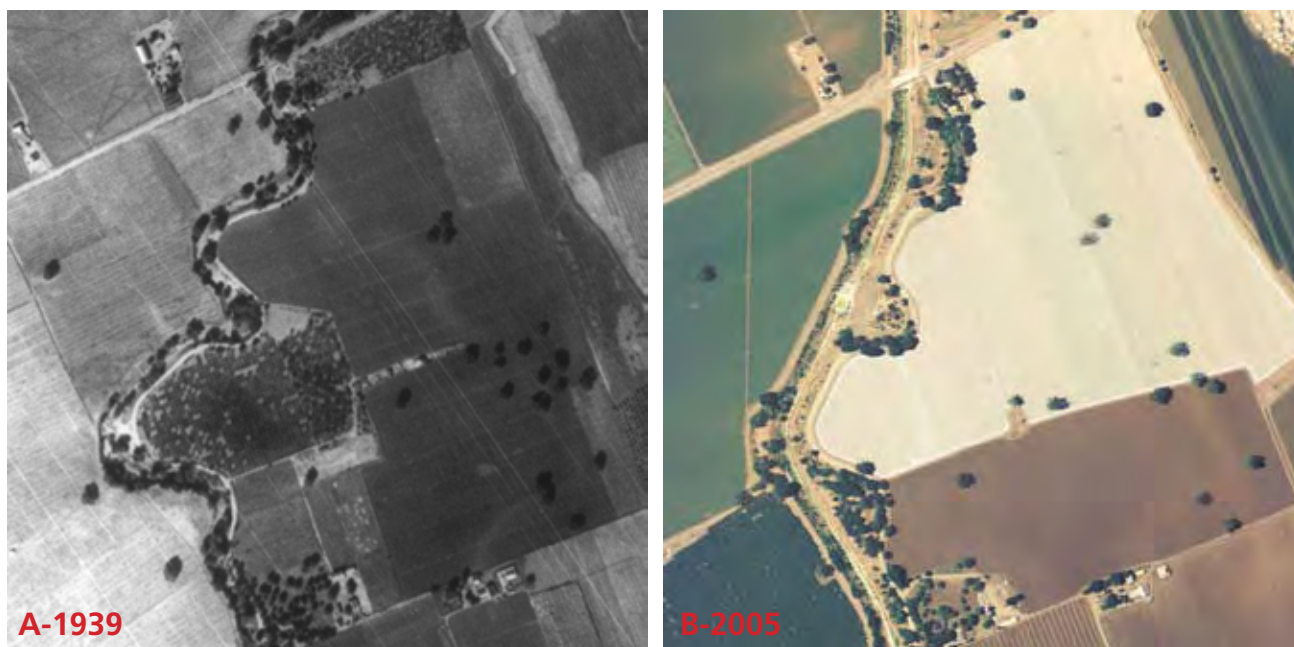
Figure 4.3. Former channel meanders of Llagas Creek. Over 60 km (40 mi) of historical streams (A) have been straightened or rerouted (B). Excavation of Llagas Creek in the early 1970s for gravel to construct Highway 101 and flood benefits produced these isolated oxbows along the current flood control channel (B; USDA 1982). (A: USDA 1939, courtesy of the Science & Engineering Library Map Room, UC Santa Cruz; B: USDA 2005, courtesy of NAIP)

Of the 165 km (100 mi) of newly constructed drainage, 64 km (40 mi; 39%) is the result of straightening or rerouting (fig. 4.3). The remaining 101 km (60 mi; 61%) were created to drain seasonally flooded lowland areas, rather than to straighten or reroute existing channels. Of that total, 63 km (40 mi) of channel drains areas that naturally had little or no surface drainage and 38 km (23 mi) connects formerly discontinuous creeks to the major streams (Llagas, Uvas-Carnadero, Pacheco creeks and the Pajaro River) or their tributaries.

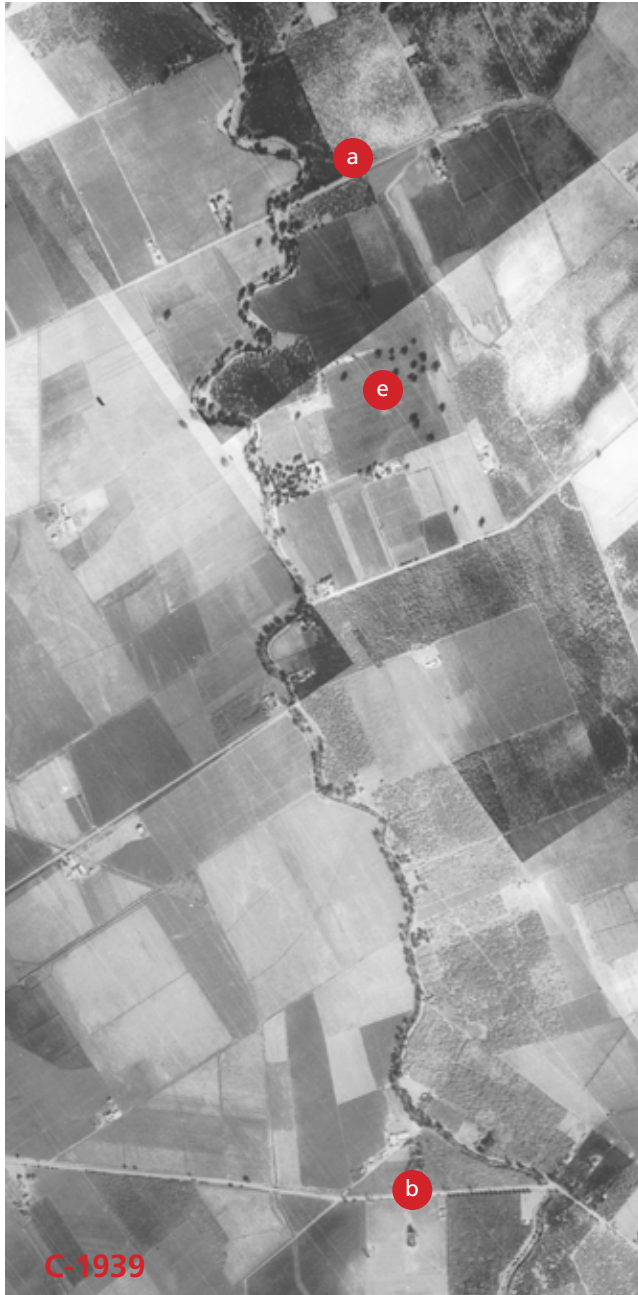
Figure 4.4. Llagas Creek between Leavesley Road (a) and Pacheco Pass Road (b). Maps of Llagas Creek by McDonald (A-1852) and Herrmann (B-1875) match later aerial photography meander for meander (C-1939 and D-2005). Former meanders on Llagas Creek can be seen upstream and downstream of Leavesley Road. The 1875 map also shows former distributaries of Llagas Creek spreading into wetlands (c) and several mid-channel bars (d). Oak savanna in the valley around the creek is suggested by the scattered trees in 1852 map; some remnant trees (e) are visible in 1939 (C)

and 2005 (D). The wetlands adjacent to the creek (c) suggest a relatively high water table in this area, as does the large willow grove just to the south of Pacheco Pass Road (b). (A: McDonald 1852(?)a, courtesy of The Bancroft Library, UC Berkeley; B: Herrmann 1875b, courtesy of the Office of the Santa Clara County Surveyor; C: USDA 1939, courtesy of the Science & Engineering Library Map Room, UC Santa Cruz; D: USDA 2005, courtesy of NAIP)

generally match closely (fig. 4.4). Within braided channels, however, the position of mainstem and side channels has been highly dynamic (e.g., figs. 4.20, 4.25, and 4.30).

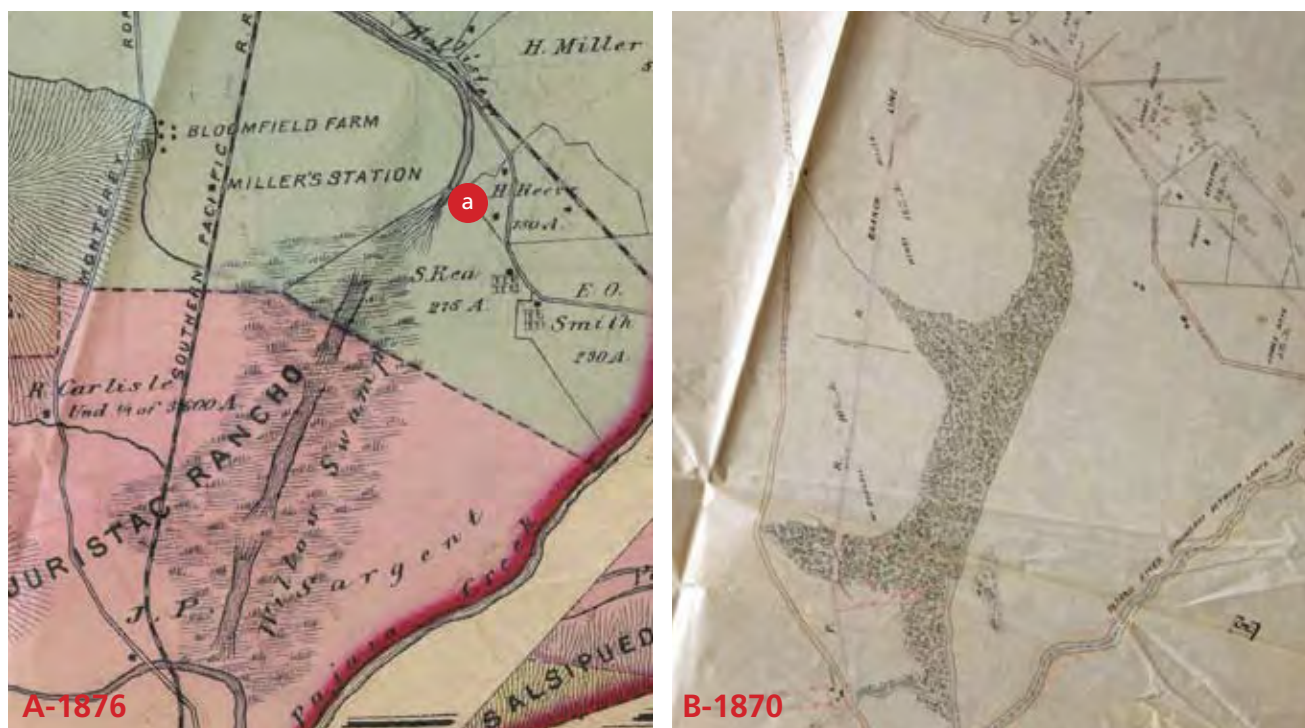
Figure 4.5. (A) The elegant Thompson and West atlases were commercial products produced by a traveling team. Created primarily by compiling existing information, they can show substantial detail but can also be inaccurate or imprecise in their depictions (Askeveld 2005). The northern boundary of the Rea property (a) was defined by “the point where the ‘arroyo del Carneadero’ begins to branch into several channels” (Lewis 1851), leading to an unusual plat shape. (B) This county survey shows Carnadero Creek and Tar Creek spreading into multiple channels as they enter the Carnadero willow grove. (A: Thompson and West 1876, courtesy of the David Rumsey Map Collection; B: Herrmann ca. 1870, courtesy of the Office of the Santa Clara County Surveyor)

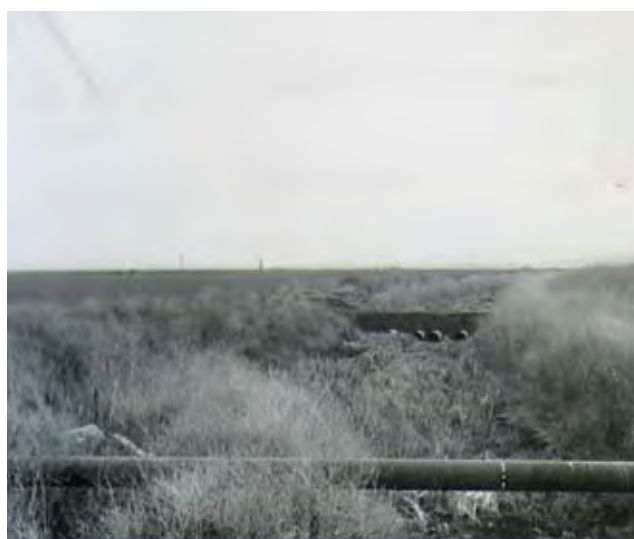
Figure 4.6. “Llagas Creek channel looking south from Bloomfield Road bridge,” January 1955. Despite decades of ditching by this time, the channel remains shallow and narrow. The present-day flood channel can be seen in figs. 4.16 and 5.16. (Soil Conservation Service 1955, courtesy of the Gilroy Museum)

bridge.” Farmers would create ditches to drain the water, but the channel was not made larger until after World War II (Sturla pers. comm., Sanchez pers. comm.).

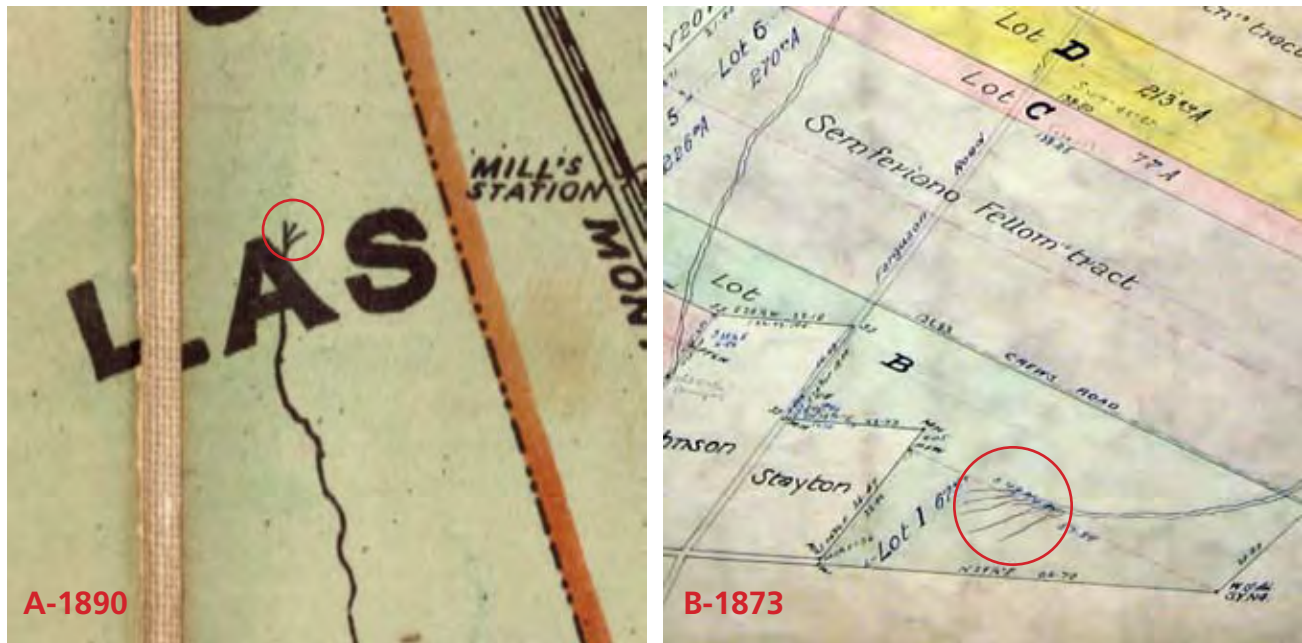
Figure 4.7. Historical maps commonly use the “crowfoot” symbol to show the point at which streams lose definition. (A: Herrmann Bros. 1890, courtesy of Branner Earth Sciences Library and Map Collections, Stanford University; B: Herrmann ca. 1873b, courtesy of the Office of the Santa Clara County Surveyor)

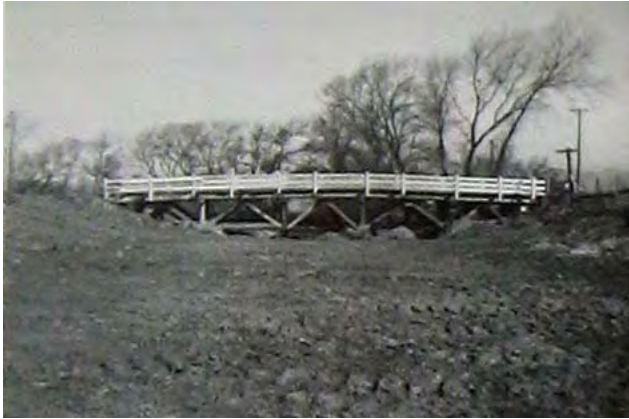
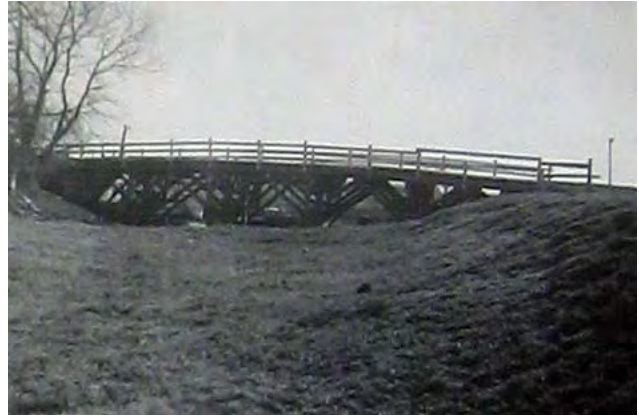
Figure 4.9. Rare photographs of a relatively unmodified, broad and shallow floodplain slough: Tequisquita Slough at Shore Road, February 1949. (Unknown 1949a, courtesy of San Benito County Public Works)

These images correspond to Broek’s 1932 description of broad, formerly perennial sloughs:

In the east [of the Bolsa]...several wide, shallow sloughs carry the winter flow from the Mount Diablo Range and are tributary to the San Felipe Lake... Formerly, when less water was used for irrigation in the orchards and dairies encircling the Bolsa,

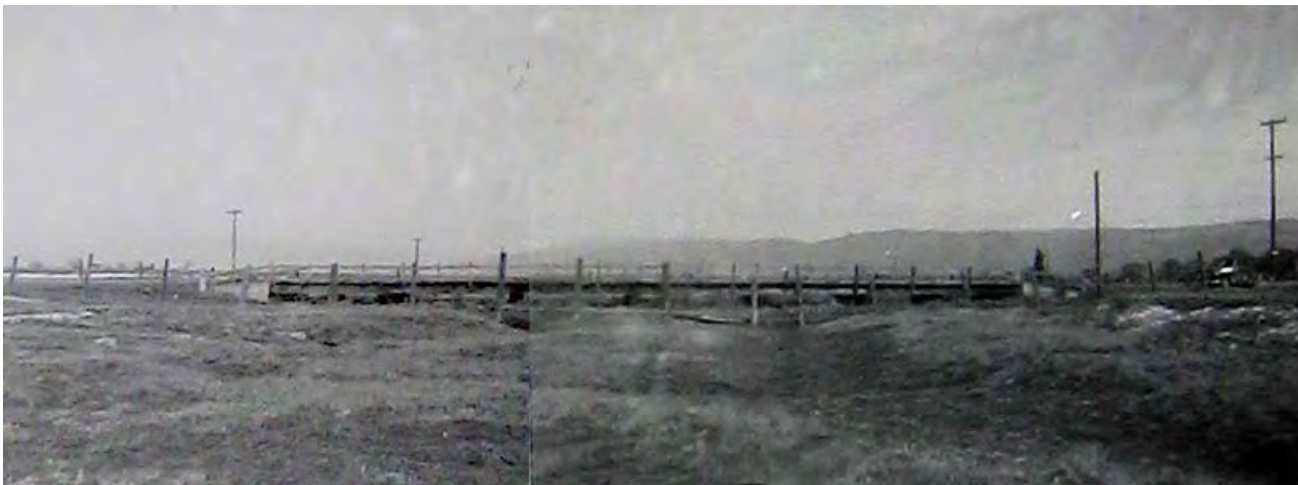
Figure 4.10. "Trestle, Shore Rd. Tequisquita slough overflow, before widening. Upstream looking north." The mosaicked 1949 images of the "overflow" channel or swale show the patches of vegetation associated with the microtopography of a shallow drainage: the darker, slightly lower and wetter patches, and the lighter, slightly higher and drier patches. (Unknown 1949b, courtesy of San Benito County Public Works)

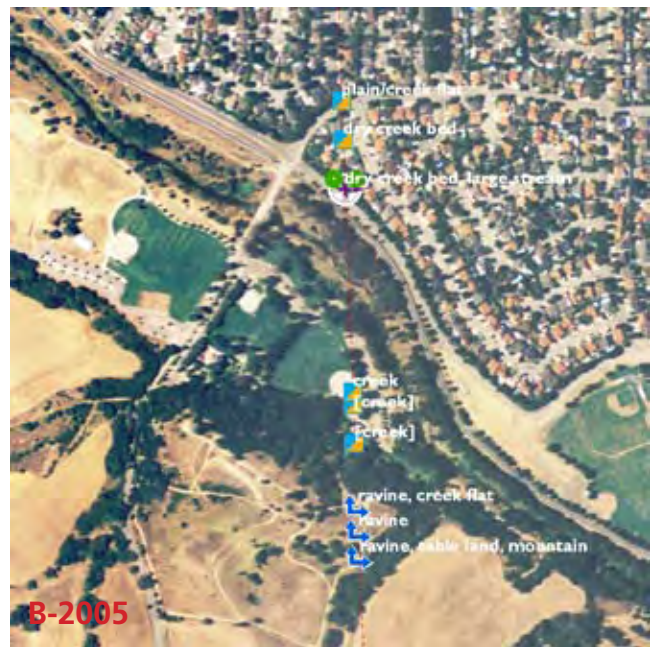
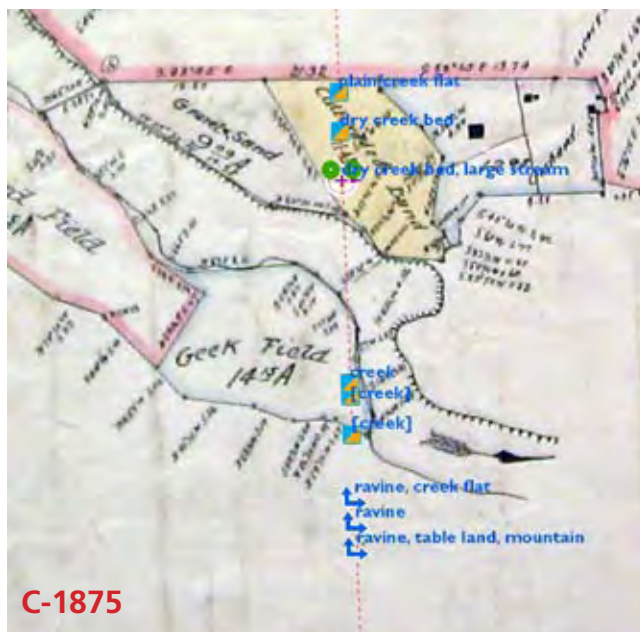
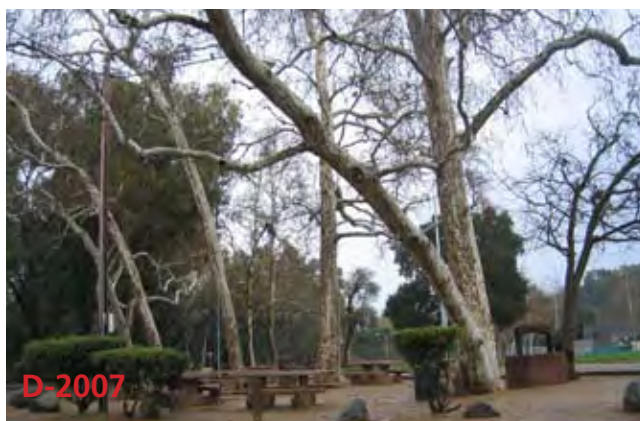
Figure 4.14. Historical reclamation of the Uvas-Carnadero Creek channel at Miller Avenue. This sequence of images compares information from four different eras. The base images are aerial photography from 1939 (A) and 2005 (B), and a county survey by Herrmann from 1875 (C). Overlaid on each of the images are survey notes from GLO surveyor Richard Howe in 1851. Howe documents a broad active channel area with side channels and adjacent stream benches ("creek flat") before development. By 1875 some of these areas are labeled "Cultivated Land" and "Creek Field." In 1939 aerial photographs, the area of former stream benches can still be distinguished within orchard patterns; a levee protects the orchards occupying the north portion of the former active channel. Presently, residential development occupies the points on the north side of the creek previously labeled "dry creek bed," and sycamore trees from the former riparian corridor (D) can be found in the Uvas Creek Preserve parking lot and picnic area. (A: USDA 1939, courtesy of the Science & Engineering Library Map Room, UC Santa Cruz; B: USDA 2005, courtesy of NAIP; C: Herrmann 1875(?), courtesy of the Office of the Santa Clara County Surveyor)

Some of these changes occurred prior to 1900, as farmers reclaimed some of the higher stream benches and terraces for agriculture (fig. 4.14). These areas can be seen in transition on early maps, where they are labeled with phrases such as “Creek Field” or “Bottom Field” (Herrmann 1875(?), Herrmann Bros. 1884). Agricultural reclamation continued in the 20th century, with these areas visible in early aerial photography as orchards on former stream surfaces (fig. 4.14). Most of the riparian corridor narrowing, however, has occurred since 1970 as a result of more recent flood protection projects. Flood

protection efforts have consistently reduced the extent of broad, braided multithread channel morphology by excavating the main channel and constructing levees that separate the channel from adjacent bars and terraces (e.g., USDA 1982; figs. 4.14 and 4.15).

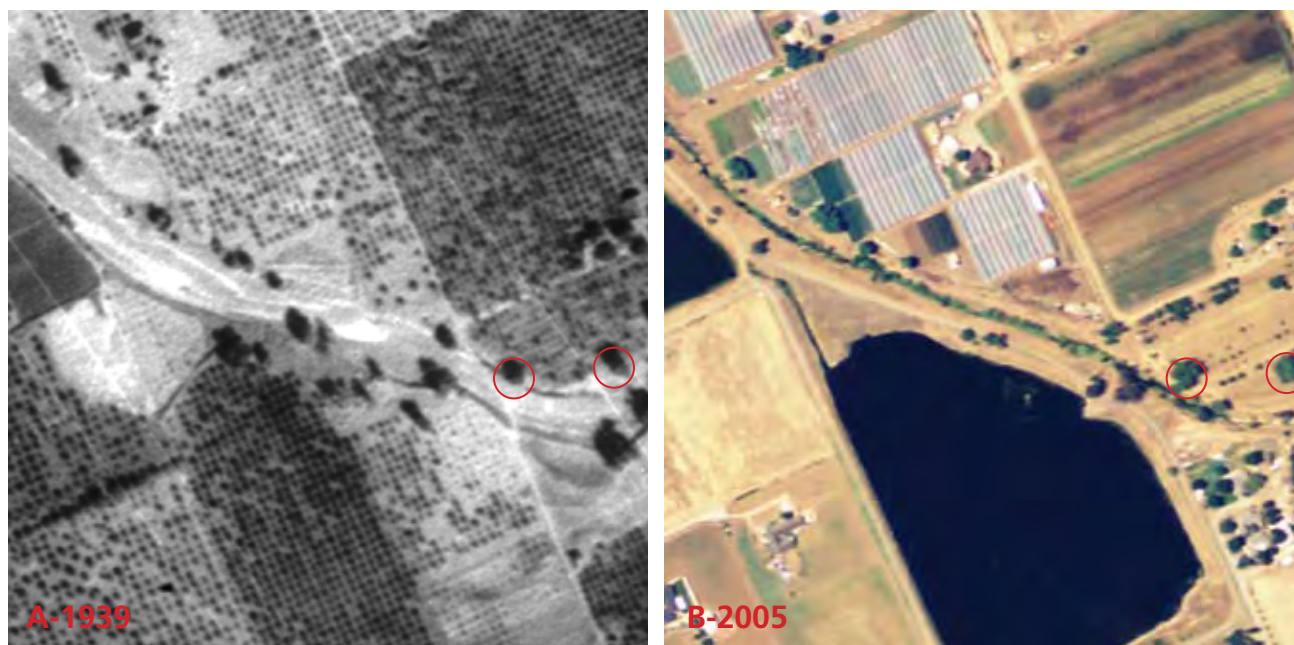
Figure 4.15. Llagas Creek at Church Street percolation ponds. To reduce flooding, the channel has been excavated and levees constructed on the former alluvial benches. Some of the riparian sycamore trees visible in 1939 (A) persist in 2005 (B), now isolated from the channel and floodplain. (A: USDA 1939, courtesy of the Science & Engineering Library Map Room, UC Santa Cruz; B: USDA 2005, courtesy of NAIP)

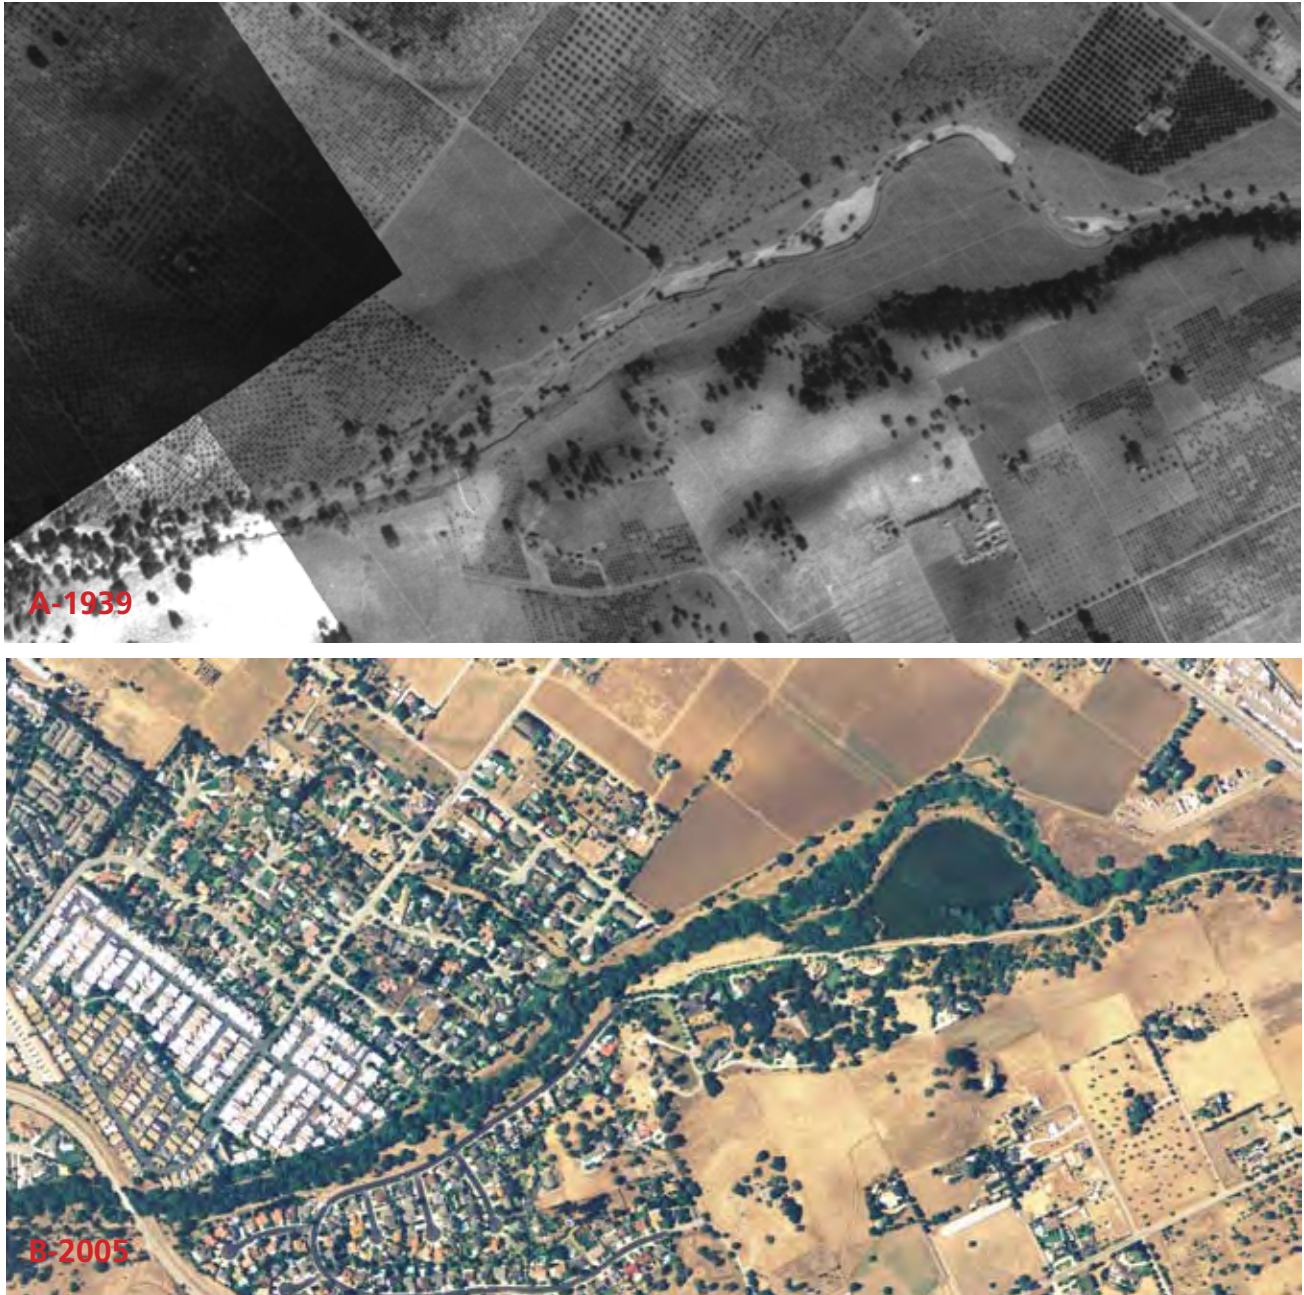
Figure 4.17. Llagas Creek between Santa Teresa Boulevard and Monterey Road. Historically, this reach was the transition point between a densely wooded riparian corridor and a more open or scattered riparian canopy. This transition corresponds to the shift from relatively narrow, meandering channel to a braided channel morphology as the stream outwashes onto the broad alluvial plain. Stream flow regulation has converted this reach to densely forested in the past few decades. (A: USDA 1939, courtesy of the Science & Engineering Library Map Room, UC Santa Cruz; B: USDA 2005, courtesy of NAIP)

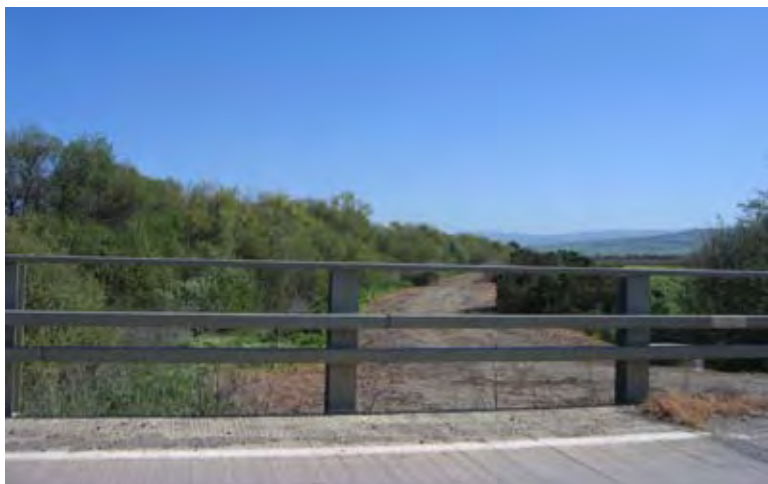
Figure 4.18. Dense riparian corridor of willow trees on the lower Llagas Creek flood control channel. The trees have established in the past few decades, within the historical extent of a much larger willow grove.
