FINAL REPORT

SOUTH SANTA CLARA VALLEY HISTORICAL ECOLOGY STUDY

INCLUDING SOAP LAKE, THE UPPER PAJARO RIVER, AND LLAGAS, UVAS-CARNADERO, AND PACHECO CREEKS

PREPARED FOR THE SANTA CLARA VALLEY WATER DISTRICT
AND THE NATURE CONSERVANCY
MAY 2008

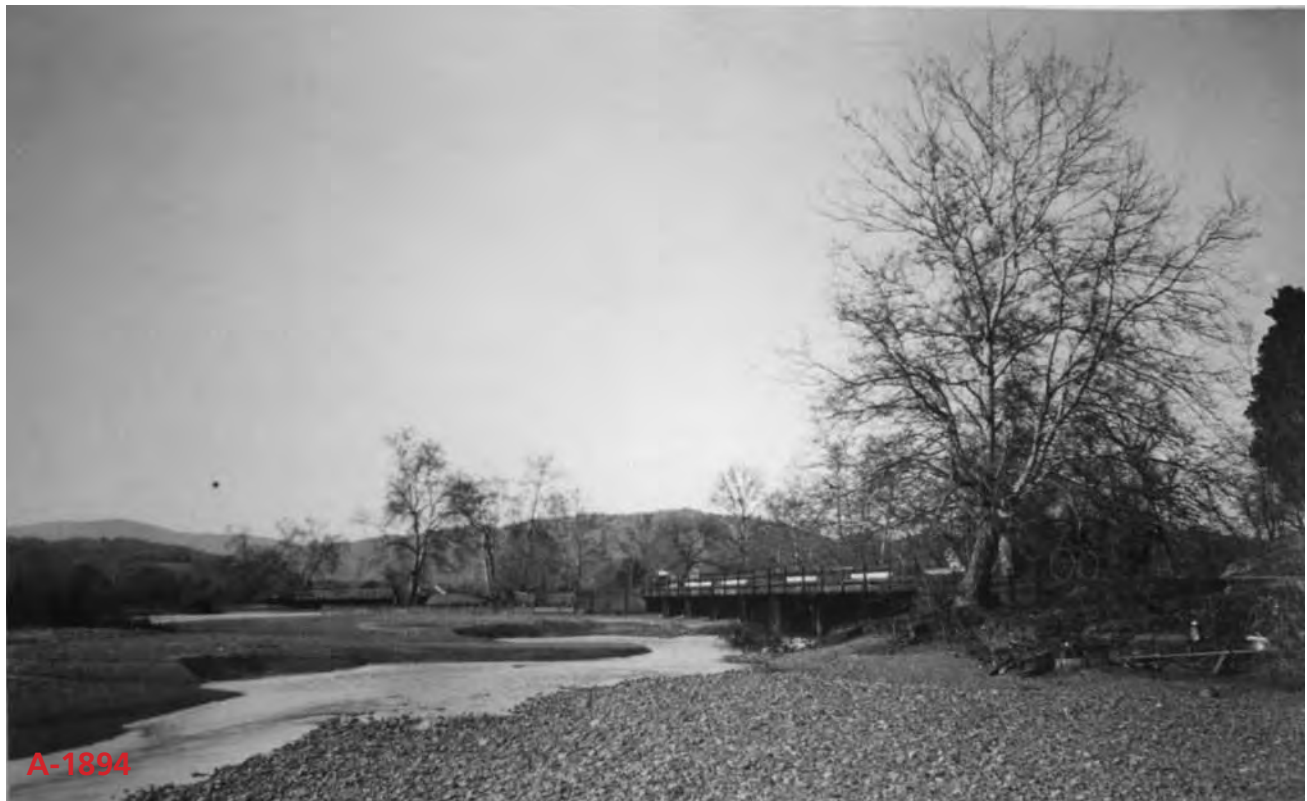
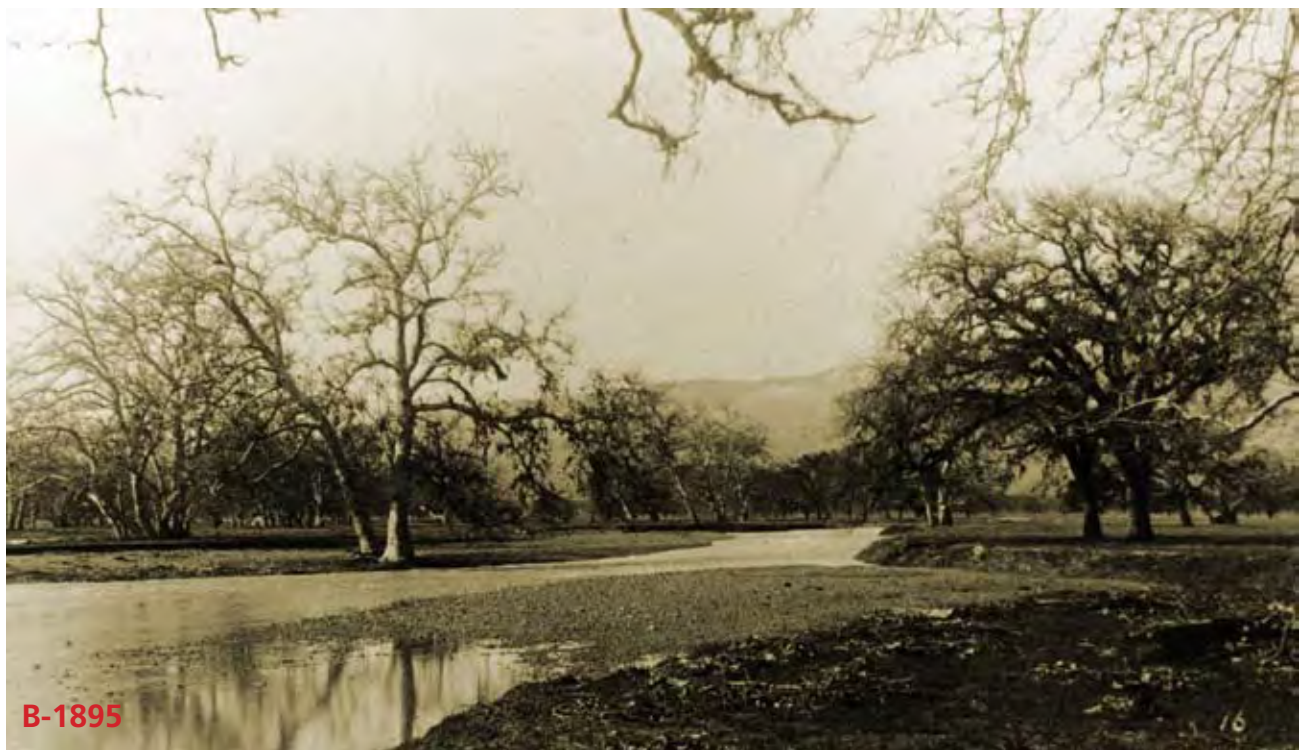
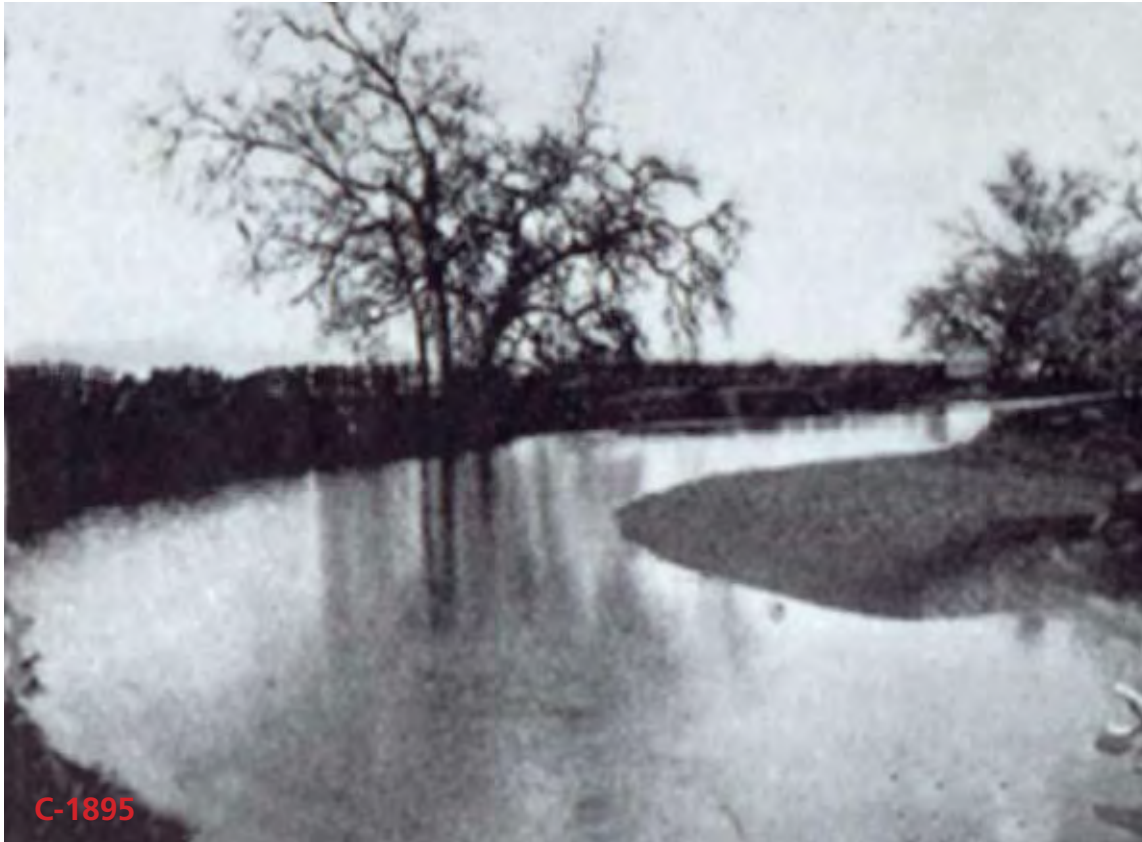
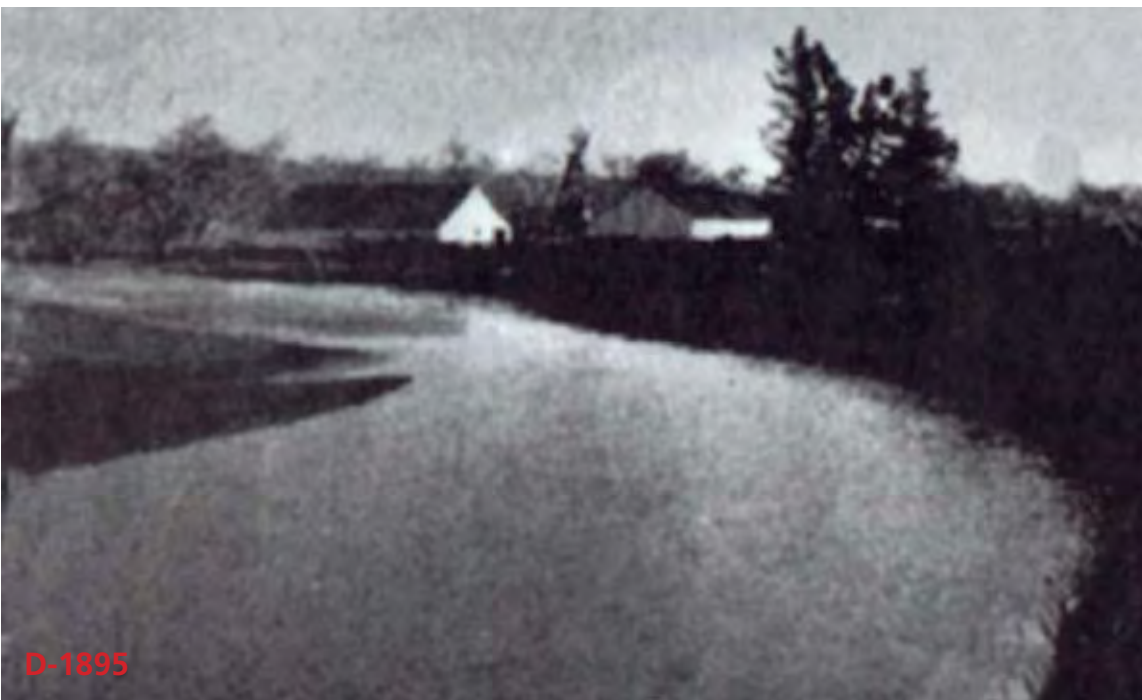
Figure 4.20. Historical landscape photographs of braided, gravelly, sycamore-dominated South Valley streams. Each shows wintertime flow in the mainstem channel, stand-alone sycamores without leaves, and limited other vegetation. These photos can be positioned as follows: (A) Uvas Creek looking towards the Hecker Pass Highway Bridge near the Bodfish Creek confluence, 1894; (B) Llagas Creek near the Monterey Road/Southern

Pacific Railroad crossing, 1895; (C) Llagas Creek north of Gilroy, 1895; and (D) Llagas Creek between Buena Vista and Rucker avenues, 1895. (A: Unknown 1894a, courtesy of Matt Kondolf and the Gilroy Museum; B: Hill & Yard ca. 1895, courtesy of the Morgan Hill Historical Society; C: Unknown ca. 1896a, courtesy of History San José; D: Unknown 1895, courtesy of the Gilroy Museum)

Historical landscape photographs (1890s) illustrating these stream reaches consistently show broad, mostly unvegetated low bars and terraces occupied by occasional large sycamore trees (fig. 4.20). These illustrations and 19th-century textual accounts are extremely consistent with the patterns observed in 1939 aerial photography, which shows the same reaches several decades later but prior to the construction of the dams and flood control projects. Despite increasing modification, general patterns remain similar in 1950 and 1963 aerial photography. The consistency across many decades suggests that these general vegetation patterns are not the result of short-term flood disturbance.

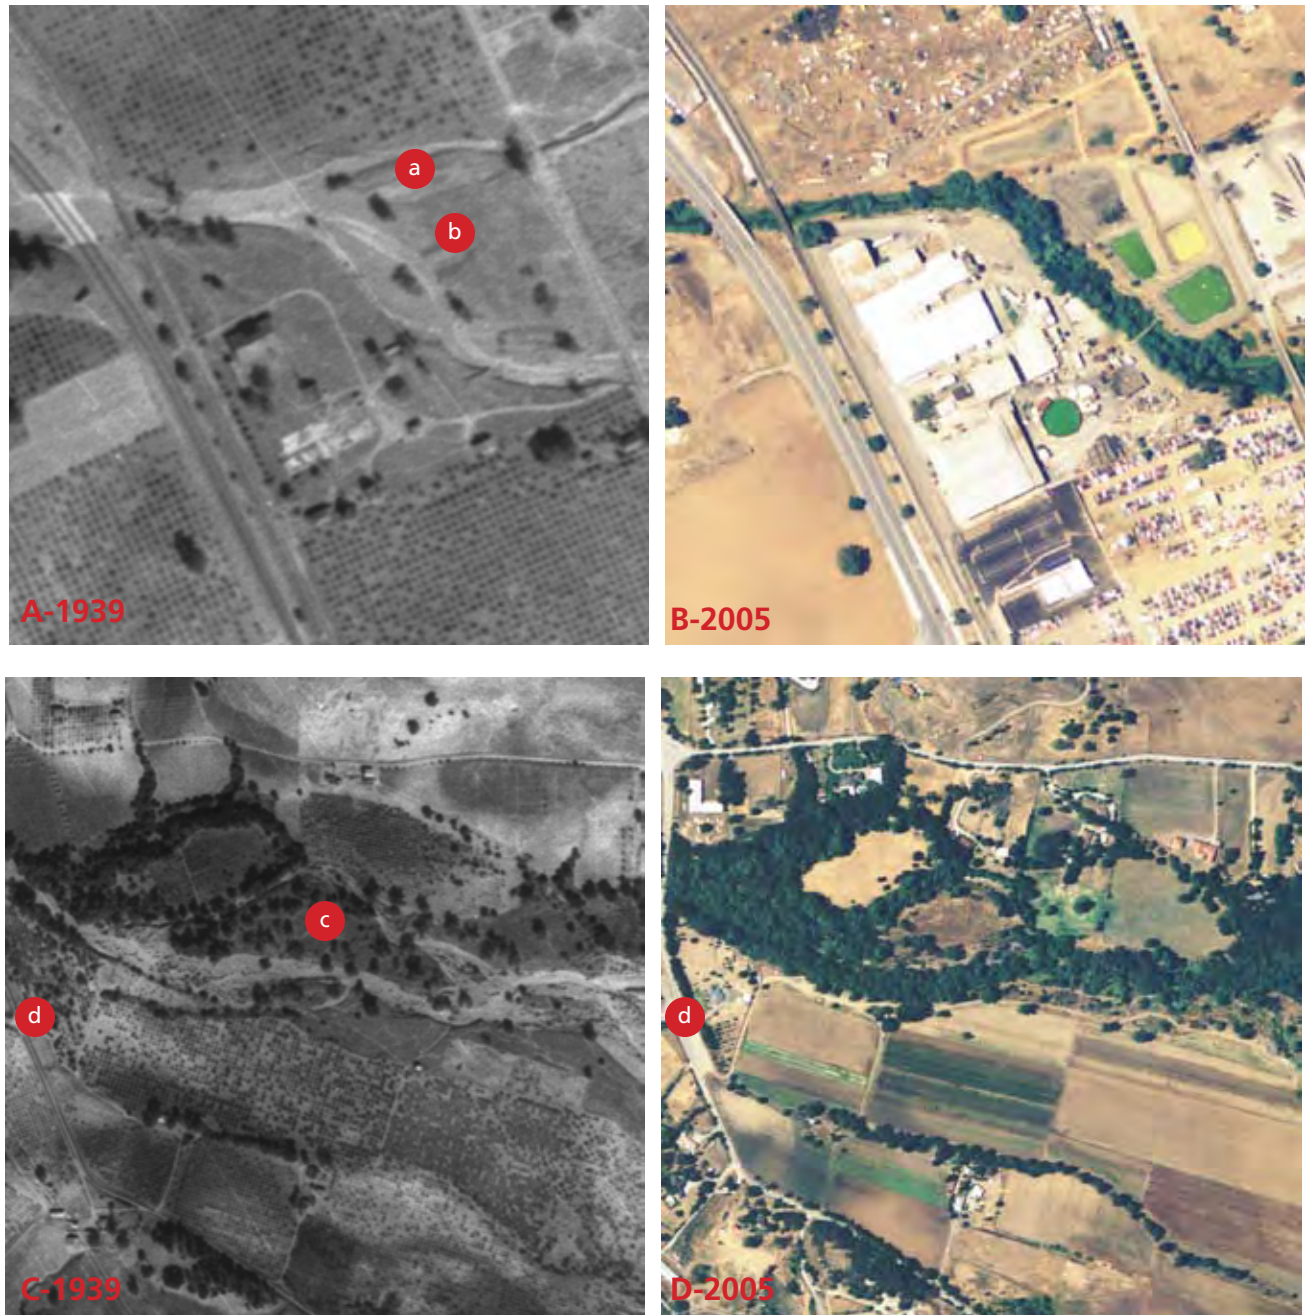
Figure 4.21. (A, B) Widely spaced sycamore trees (a, b) along the shallow, multithread Llagas Creek channel immediately downstream of the Monterey Road and railroad crossing. (C, D) A grove of sycamore alluvial woodland (c) on a mid-channel bar in Uvas Creek at Watsonville Road (d). In both cases, riparian forest has expanded within a narrower active channel during recent decades. (A and C: USDA 1939, courtesy of the Science & Engineering Library Map Room, UC Santa Cruz; B and D: USDA 2005, courtesy of NAIP)

bars or islands. For example, Llagas Creek maintained for much of its length a braided channel with relatively narrow islands and bars often supporting one to several trees (figs. 4.21 and 4.15). In contrast, Pacheco Creek, and some reaches of Uvas-Carnadero, formed much broader islands and benches providing habitat for many mature trees (figs. 4.21 and 4.22).

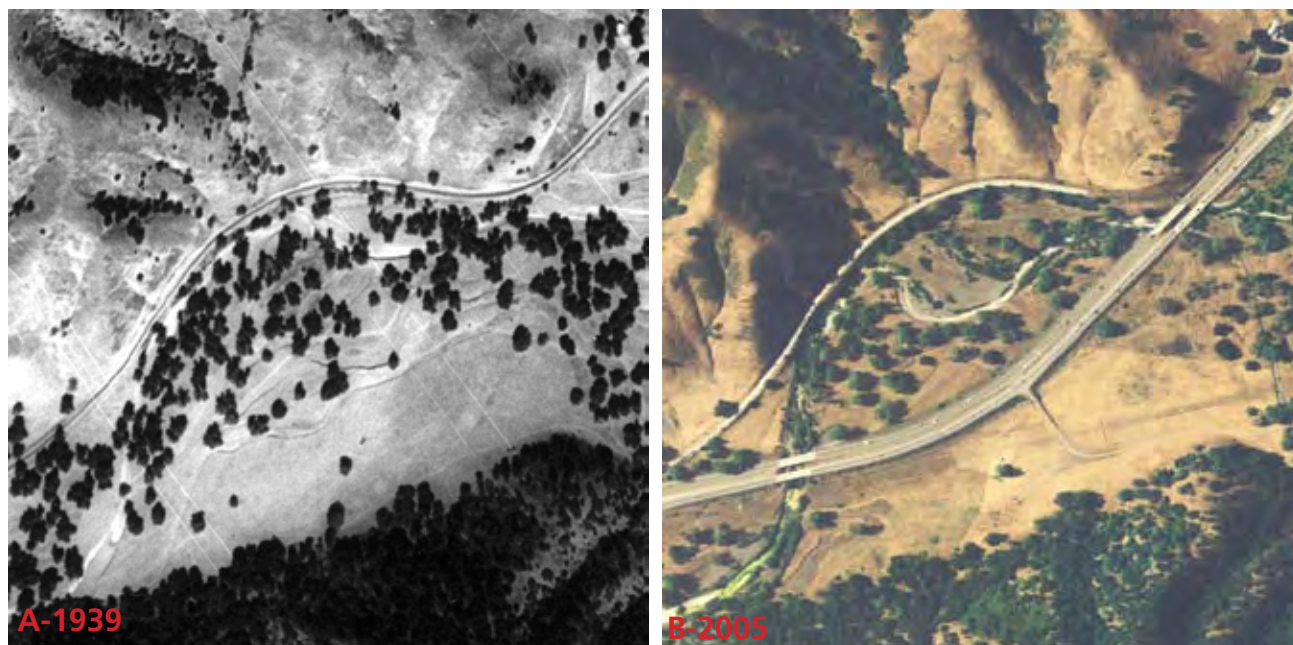
Figure 4.22. Sycamore alluvial woodland on the braided Pacheco Creek channel. Between 1939 (A) and 2005 (B) the main channel has migrated substantially. (A: USDA 1939, courtesy of the Science & Engineering Library Map Room, UC Santa Cruz; B: USDA 2005, courtesy of NAIP)

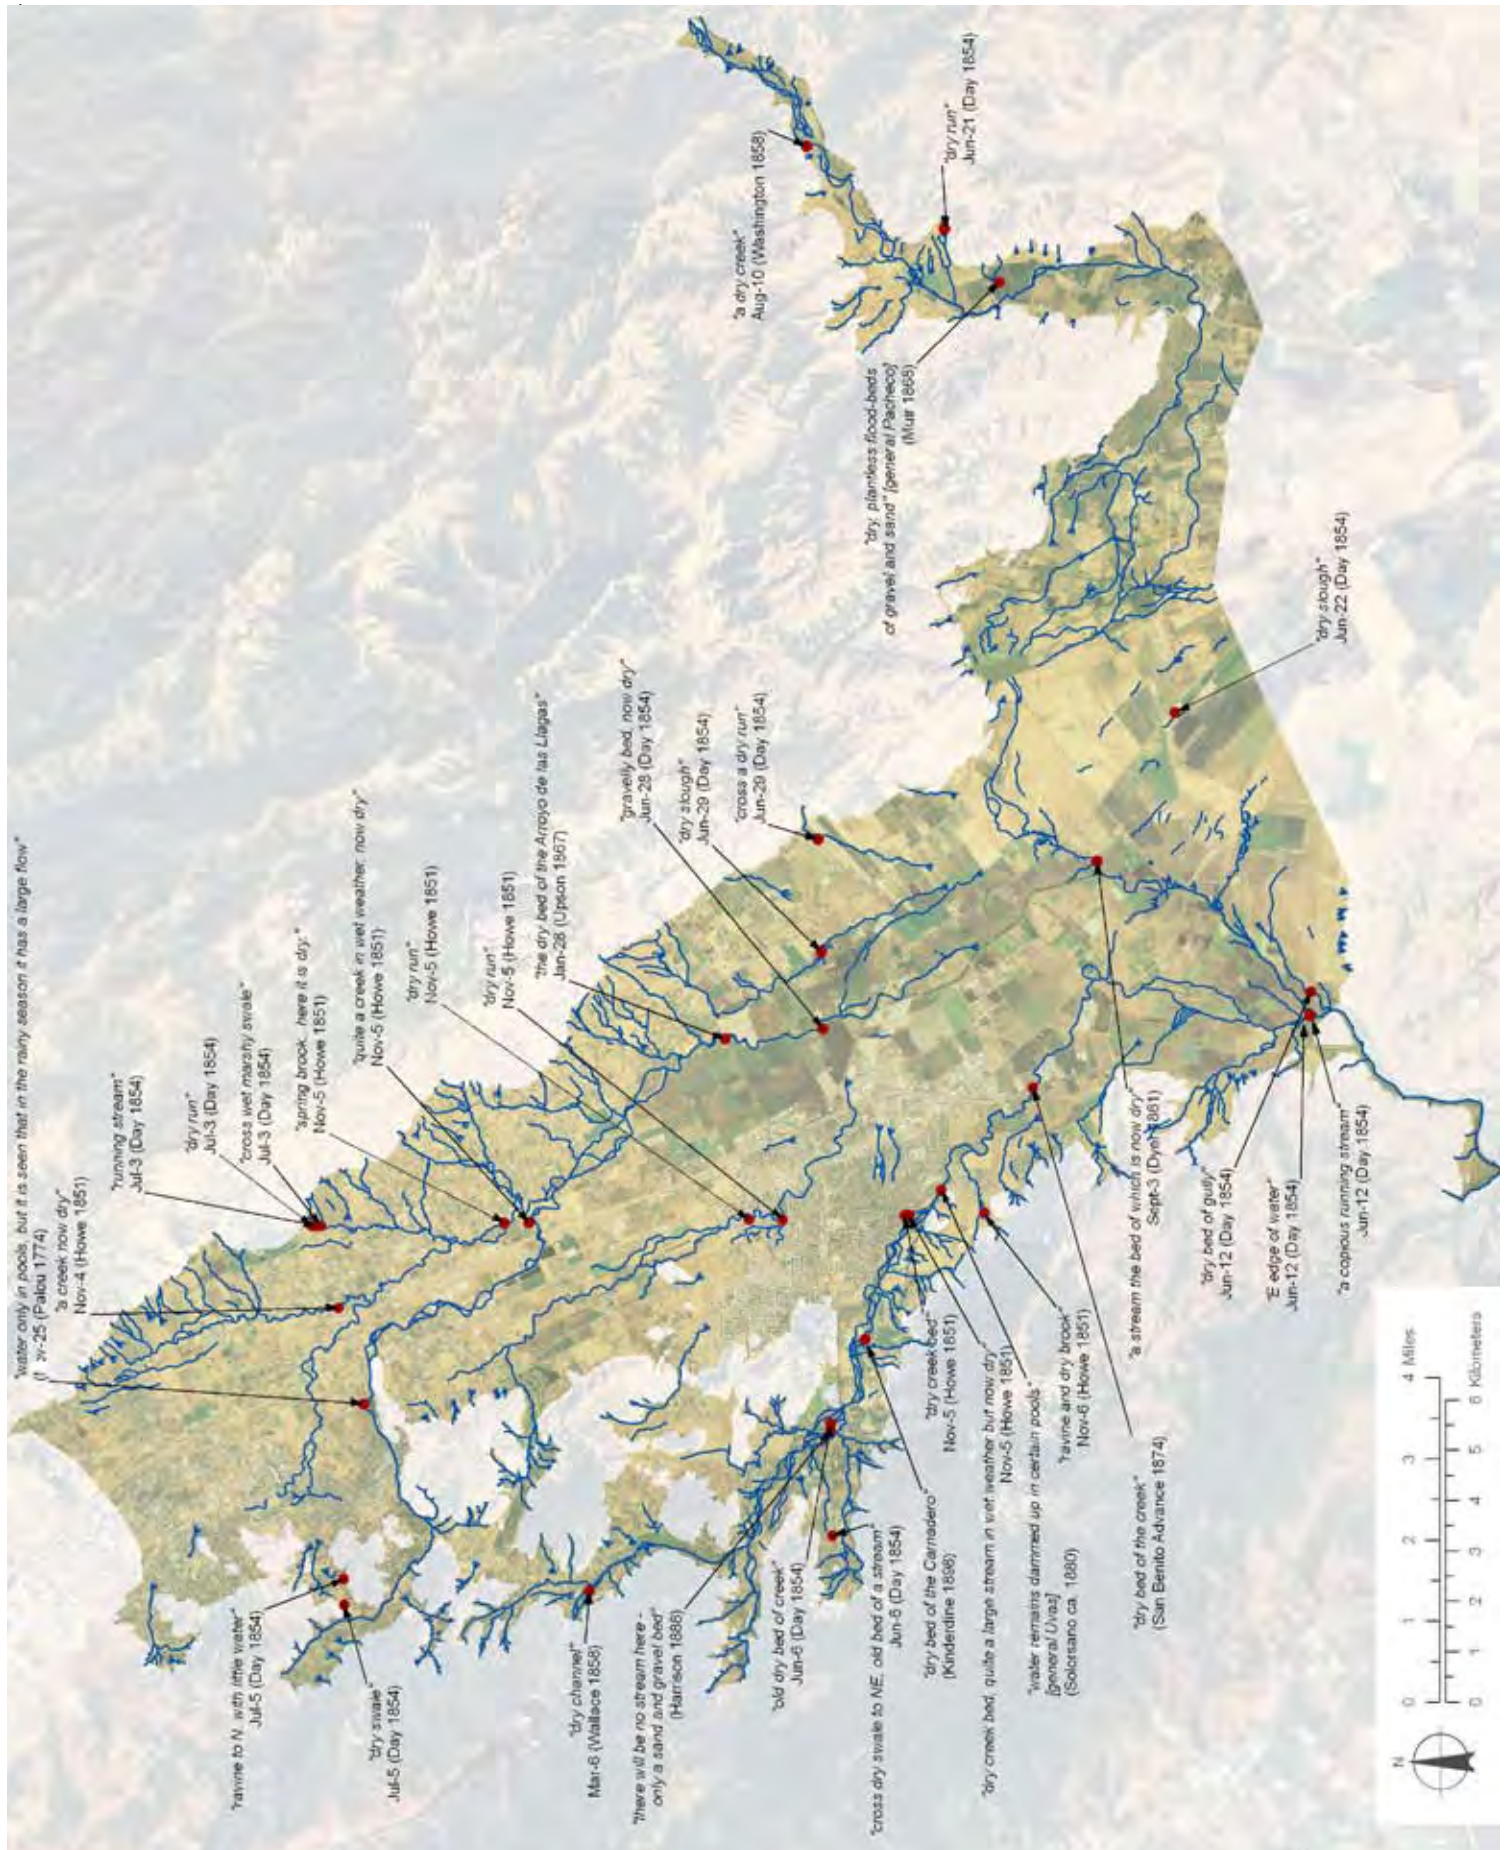
Figure 4.23. Historical evidence for dry season stream flow.

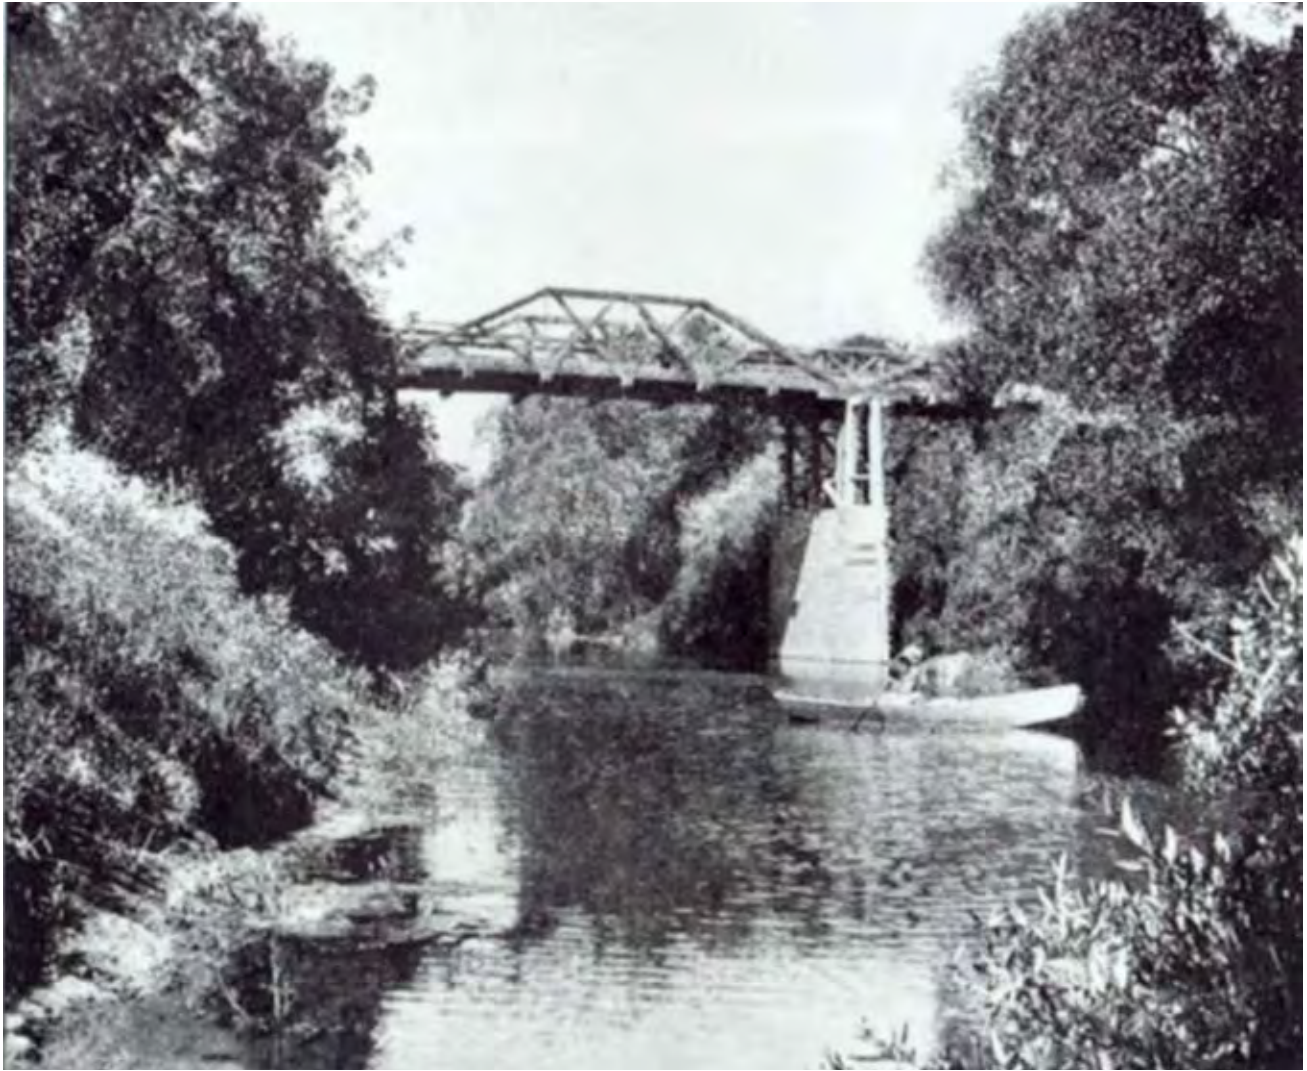
Figure 4.24. "Scene on Pajaro River, near Sargents." This photograph and the following (fig. 4.25) both show the Pajaro River between Sargent and Betabel Station. Substantial summer water is suggested by navigable conditions while deciduous trees are in leaf. (Unknown ca. 1896b, courtesy of History San José)

In contrast to the uniformly consistent accounts of intermittent streams throughout the rest of south Santa Clara Valley, the Pajaro River stands out as having different characteristics. Near Sargent, Pajaro is described as “softly-flowing” with its banks “covered with alders and willows” (Shortridge [1896]1986). Shortridge notes that the river “can be navigated with row boats a distance of 2 miles below the [Sargent] station (approximately to the San Benito confluence),” a recreational activity indicating substantial summer water (figs. 4.24 and 4.25).

The Pajaro River was historically a low-gradient, densely wooded perennial stream from its confluence with the San Benito River to its confluence with Llagas Creek (see figs. 4.24 and 4.25). Early fish collections from the Pajaro River confirm the presence of an assemblage dominated by lowland forms. Species collected from or likely to have occurred in the mainstem Pajaro River before significant environmental modifications include Pacific lamprey, Sacramento blackfish, hitch, thicktail chub, Sacramento pikeminnow, California roach, Sacramento sucker, threespine stickleback, prickly sculpin, Sacramento perch, and tule perch (Snyder 1912, Smith 1982, Gobalet 1990, Smith 2007a,b, CASICD 2008). The mainstem Pajaro River fish assemblage is similar to those found historically in similarly situated lowland riverine environments within the Central Valley and tributaries to the San Francisco Bay estuary (Moyle 2002, Leidy 2007).

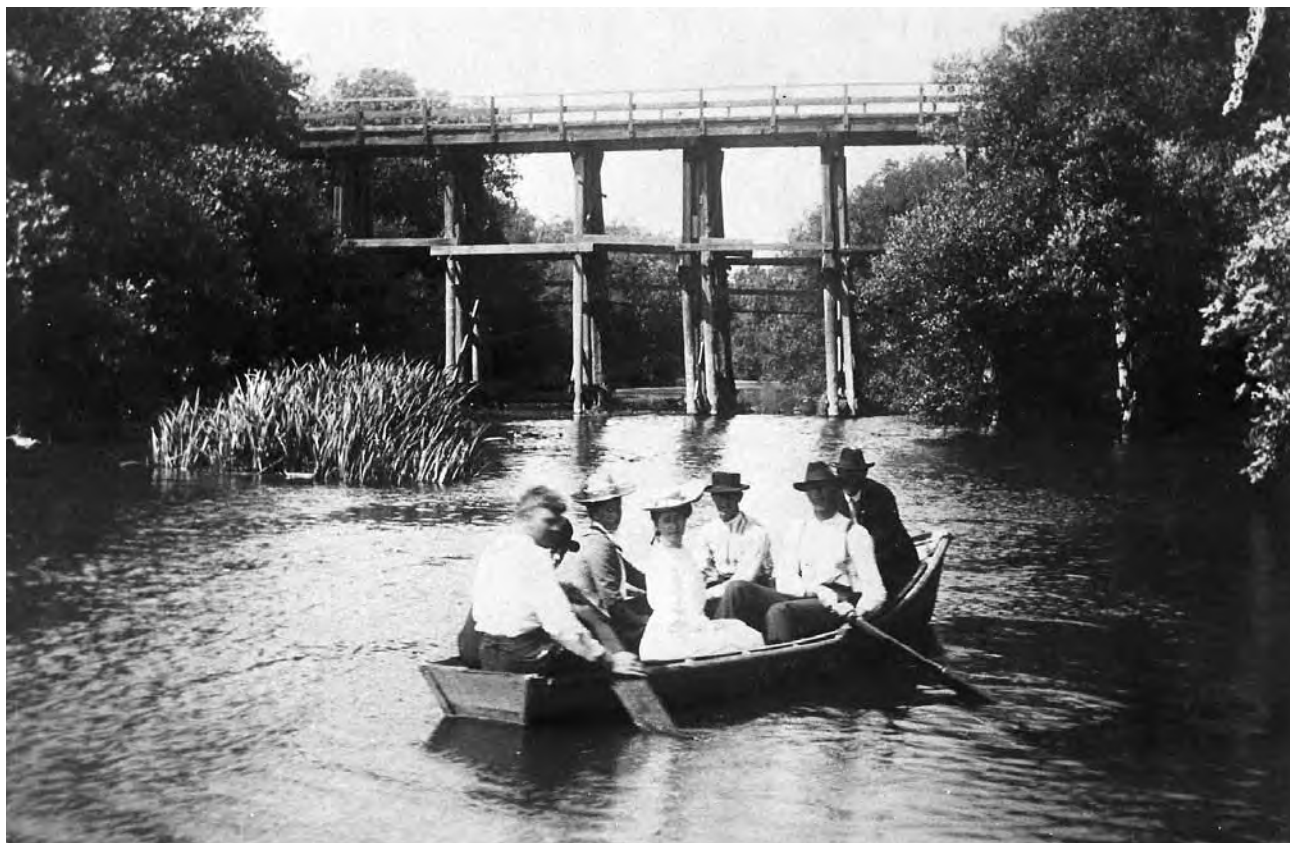
Figure 4.25. "Pajaro River near Sargent and Betabel station." (Unknown ca. 1890c, courtesy of the San Benito County Historical Society)

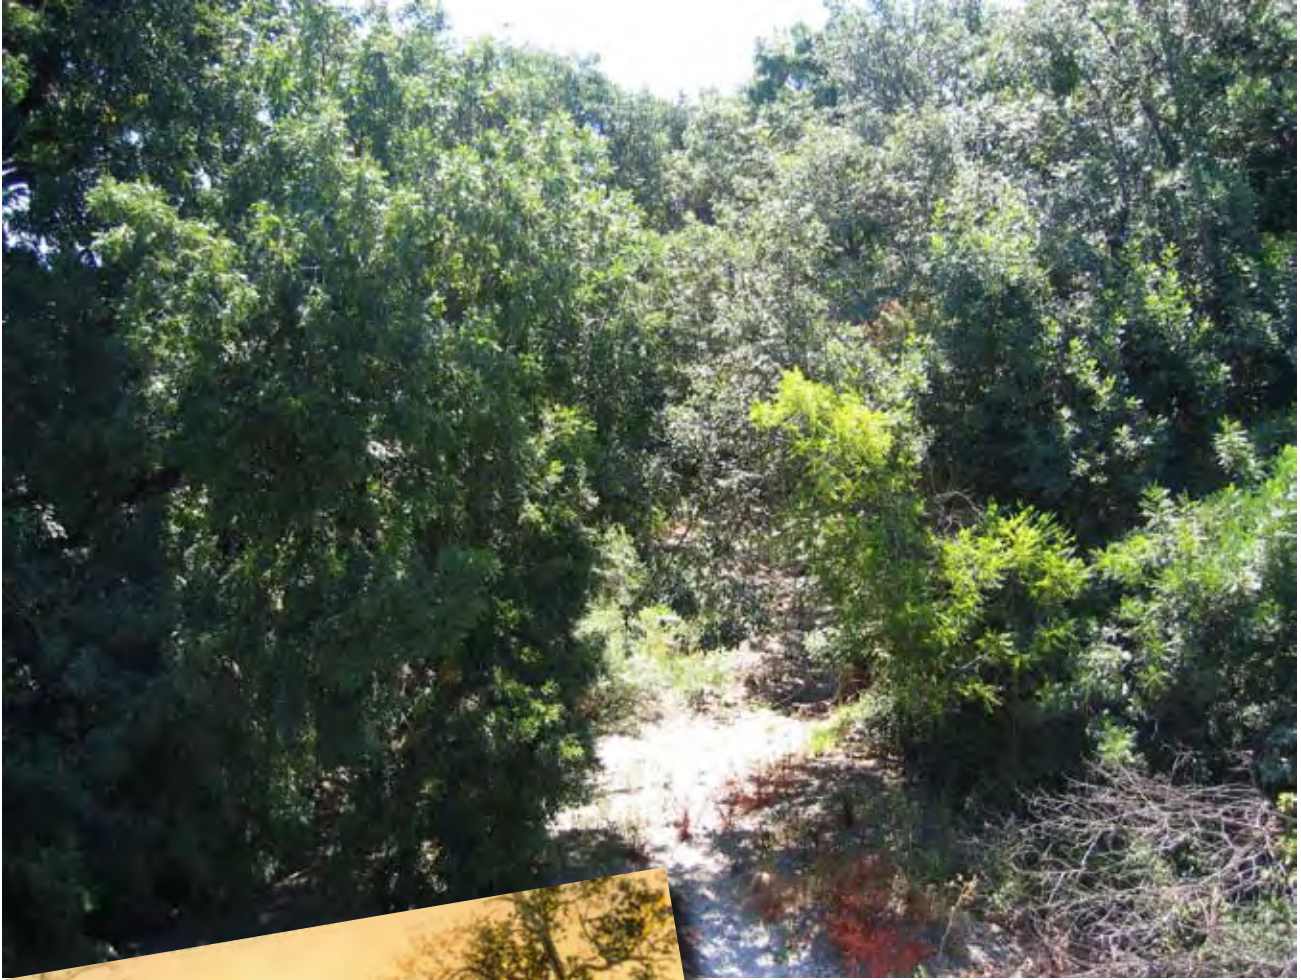
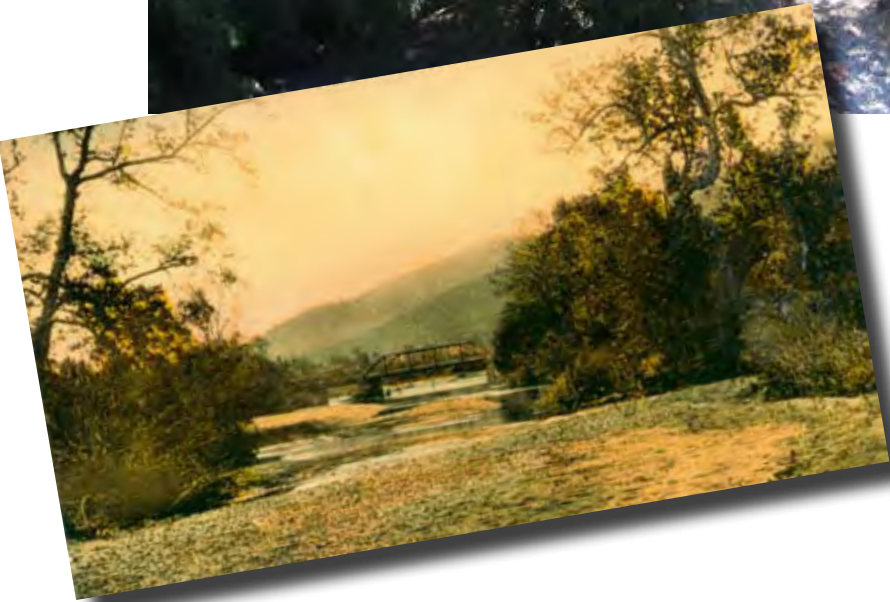
Figure 4.26. Two views of Uvas-Carnadero Creek near the Southern Pacific Railroad crossing. In-channel vegetation has increased between the postcard view, ca. 1912 (looking towards the railroad bridge) and the contemporary photograph, taken from the bridge. (Unknown ca. 1912a, courtesy of the California Historical Society)

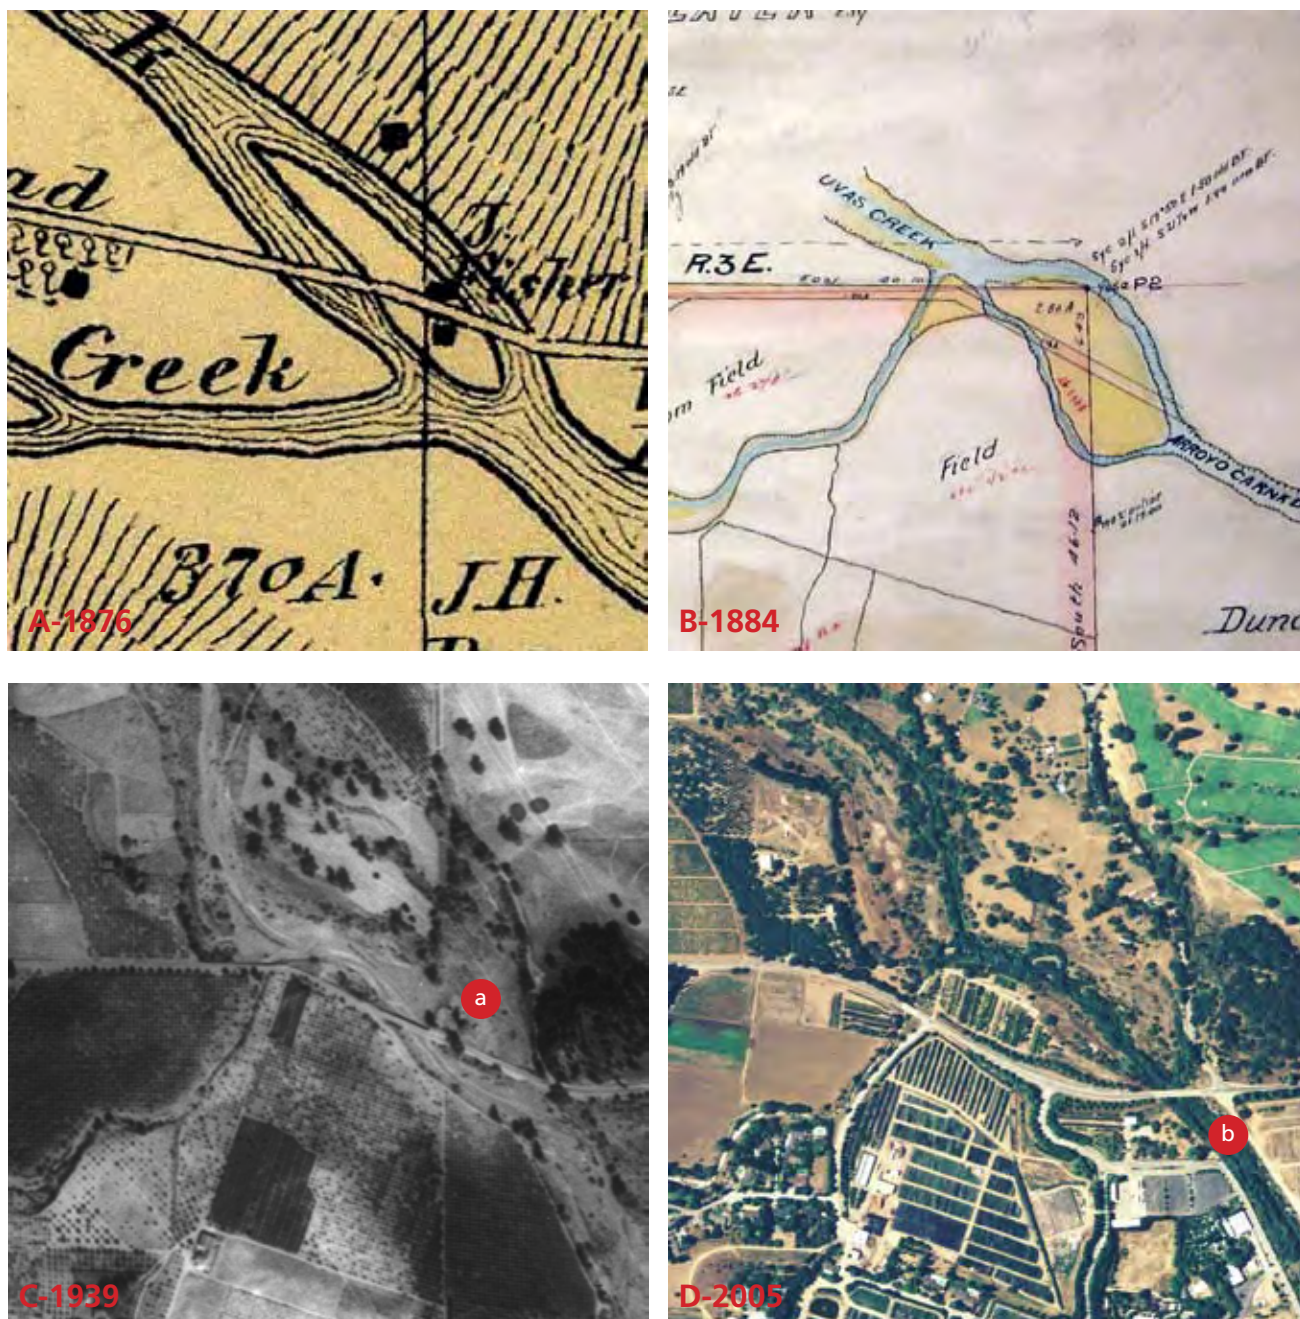
Figure 4.27. The well-documented Hecker Pass crossing gives a good overview of historical stream characteristics and change. Hecker Pass Road (Highway 152 West) crosses Uvas-Carnadero Creek at the Bodfish Creek confluence, near Gilroy (formerly Bonfante) Gardens. Views from 1876 (A), 1884 (B), and 1939 (C) show how the creek naturally split into two channels around a large bar, crossed by the “Twin Bridges.” In recent decades the braided channel has been narrowed, presumably by excavation and filling. This is particularly noticeable at the crossing, where the bridge now follows a more perpendicular route across a smaller channel (D). Trees at (a) can be seen in the 1894 landscape photograph in fig. 4.29. The viewpoints of this image and modern re-photographs are shown at (b). (A: Thompson and West 1876, courtesy of the David Rumsey Map Collection; B: Herrmann Bros. 1884, courtesy of the Office of the Santa Clara County Surveyor; C: USDA 1939, courtesy of the Science & Engineering Library Map Room, UC Santa Cruz; D: USDA 2005, courtesy of NAIP)

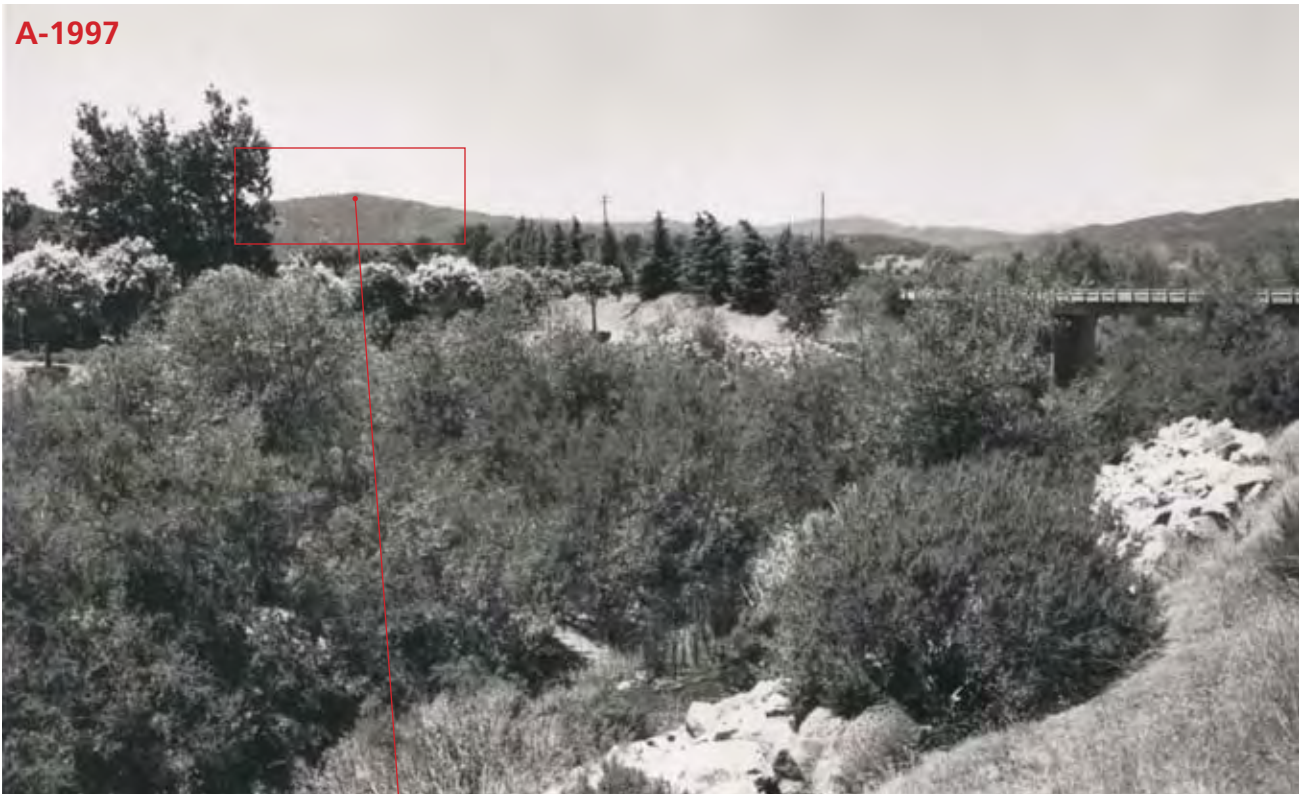
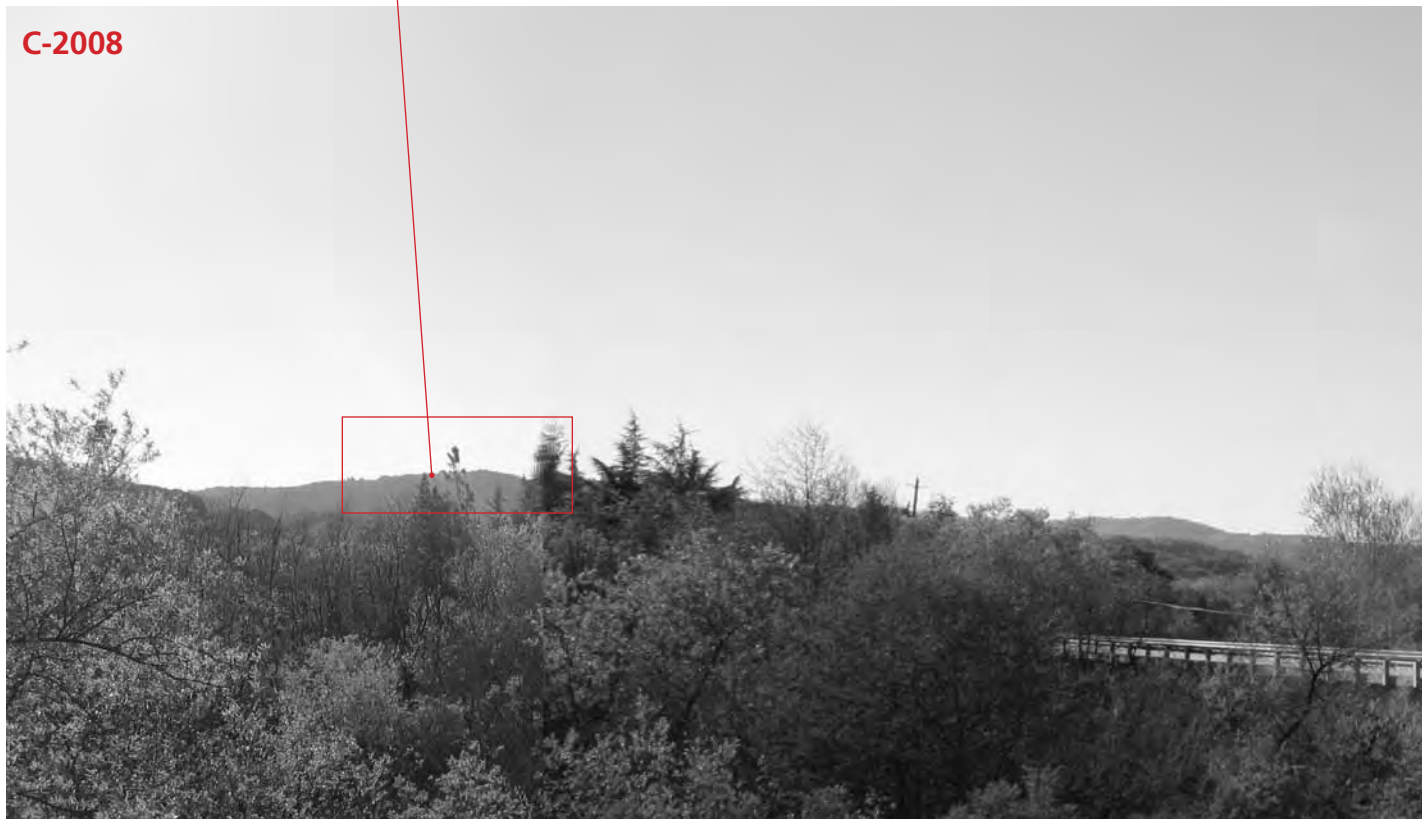
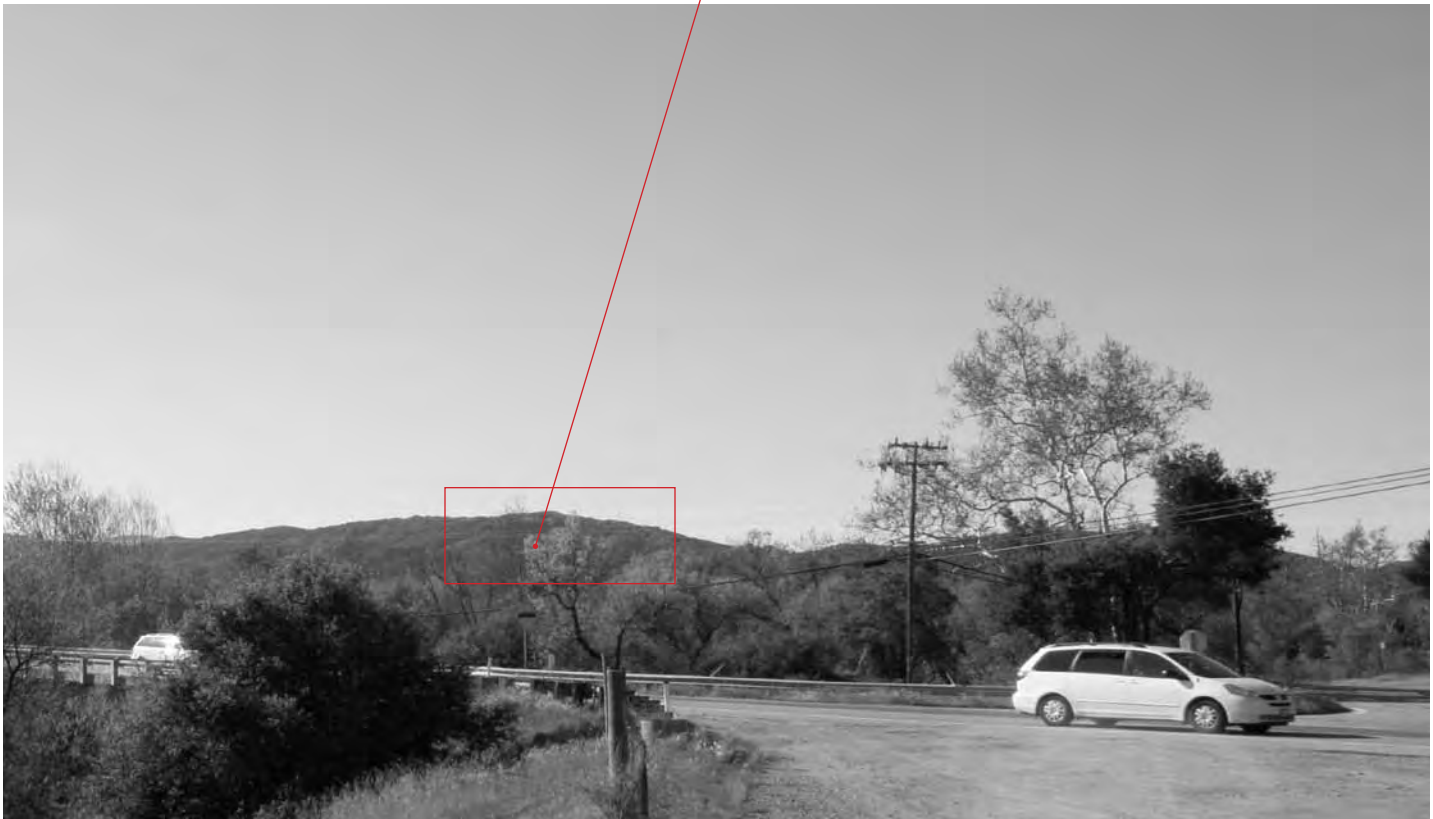
Figure 4.29. Renowned local painter/photographer Andrew P. Hill probably took the 1894 picture looking upstream from a gravel bar on Uvas Creek, titled “Twin Bridges from creek bed — 1894” (B). The image shows the large mid-channel sand and gravel bar, two main channels, and pair of bridges (illustrated in fig. 4.28). Several sycamores and other riparian trees, and large freshly scoured gravel surfaces, can be seen. (A horse and carriage heading west from the bridge are obscured by the tree on the right.) Precise re-occupation of the site is difficult because of the great expansion of vegetation in the channel

in the century since the photograph was taken (A), and also in the decade since (C). In addition, the right-hand margin of the channel has been filled (as part of modern bridge construction) so the original creek bed location of the photographer is now dry landfill. In concert with fig. 4.28, this unusually well-documented location illustrates the common trajectory of braided streams within the region, including channel narrowing, loss of fresh gravel surfaces, and riparian habitat conversion (A: courtesy of Matt Kondolf; B: Unknown 1894a, courtesy of Matt Kondolf and the Gilroy Museum).

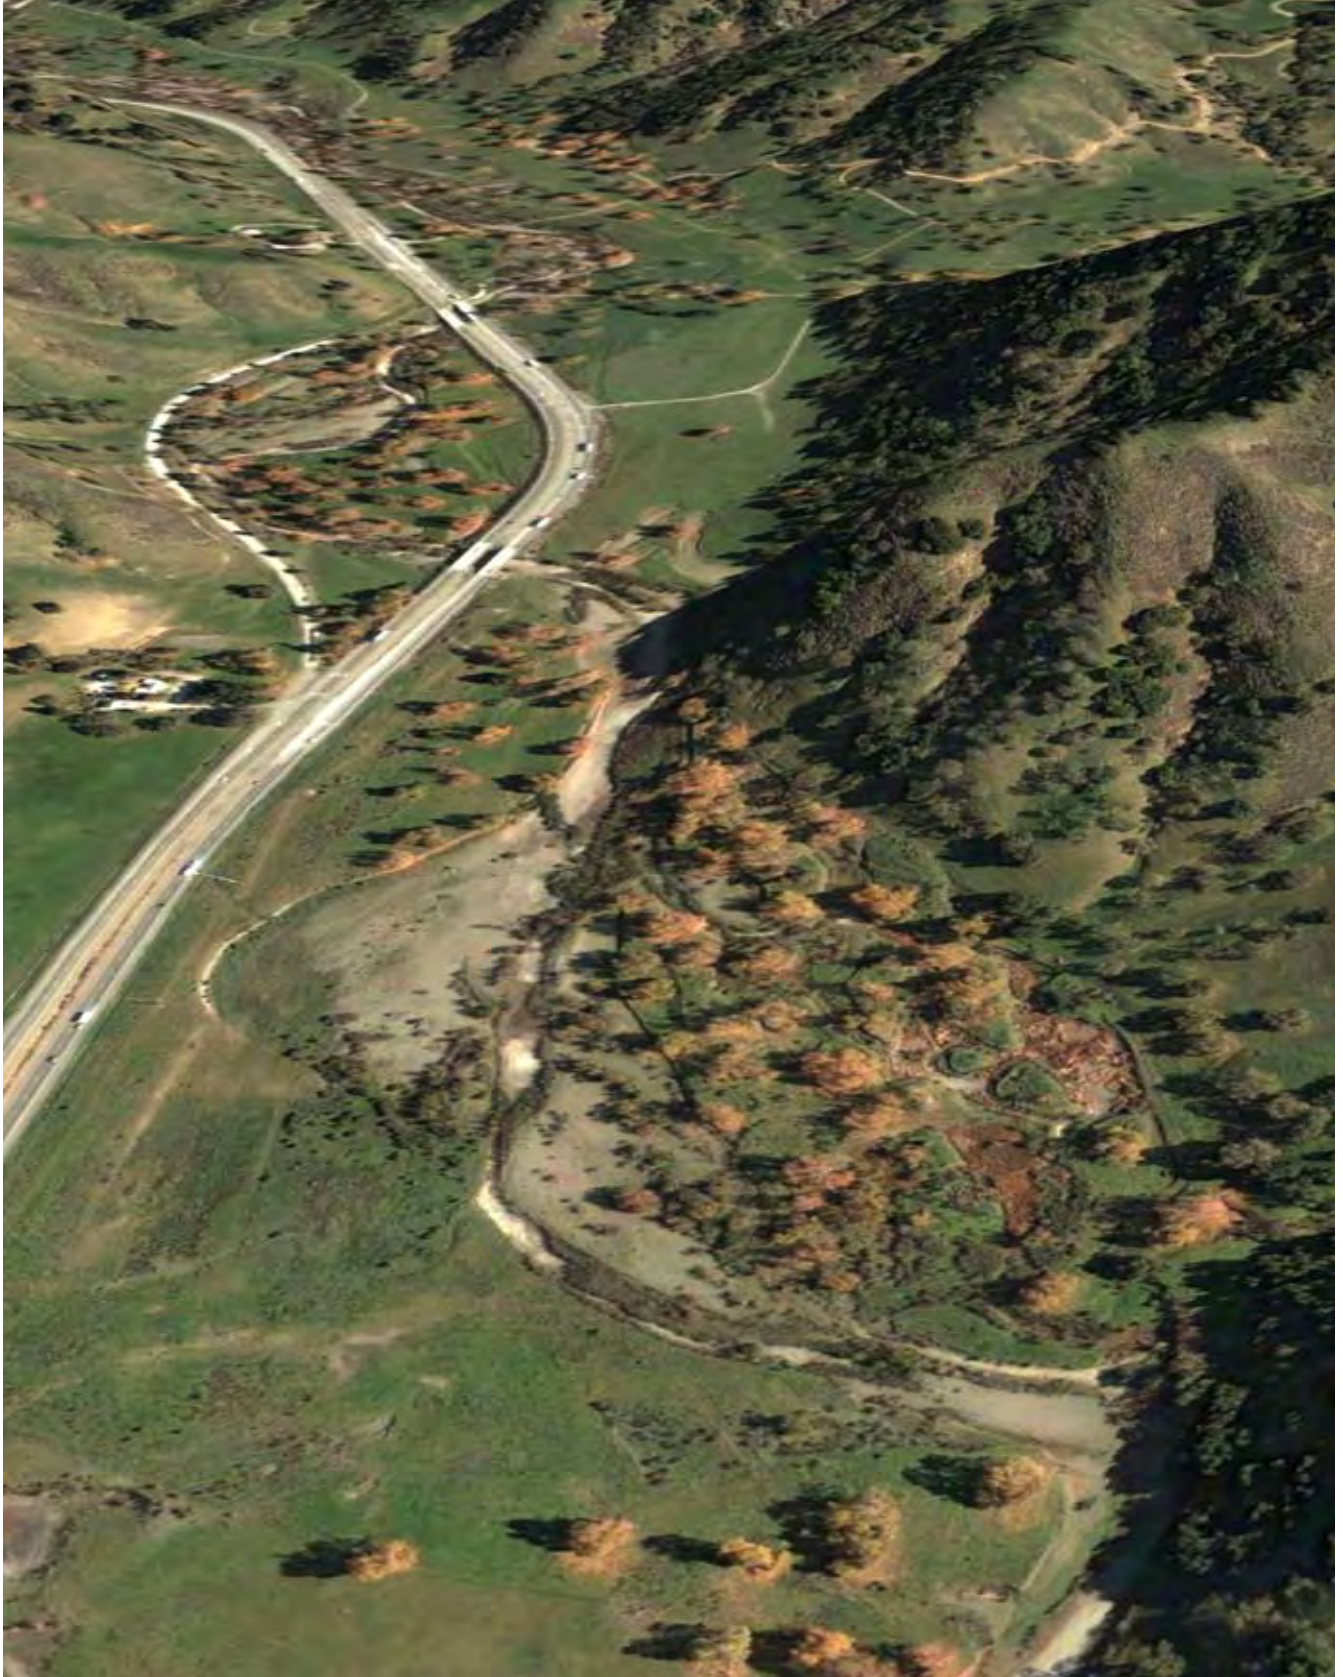
Figure 4.30. California sycamores along Pacheco Creek are particularly distinct in this Google Earth image. While the deciduous sycamores are in fall color, evergreen live oaks on the hillsides remain green. (Courtesy of Google)

In a statewide assessment (Keeler-Wolf et al. 1996), the five-mile Pacheco Creek sycamore alluvial woodland (figs. 4.30 and 4.31) was found to be one of the most important of the 17 surviving remnants. At the time of the study, Pacheco Creek was the sixth largest instance of CCSAW in the state, and the second largest outside of the Central Valley. Two different ranking approaches were developed to evaluate the quality of each stand, considering factors such as size, fragmentation, hydrology, and other human impacts. Pacheco Creek was ranked sixth and eighth within the state according to this evaluation. Within the San Francisco Bay-Monterey Bay area, it was judged to be either the first or third most important site, depending upon the ranking criteria. (Alameda Creek supports the other highest ranking local remnants.) Sycamores here are in the northern part of their range; however, that range might be expected to expand northward given climate change predictions (Kueppers et al. 2005; CCCC 2006).
