FINAL REPORT

SOUTH SANTA CLARA VALLEY HISTORICAL ECOLOGY STUDY

INCLUDING SOAP LAKE, THE UPPER PAJARO RIVER, AND LLAGAS, UVAS-CARNADERO, AND PACHECO CREEKS

PREPARED FOR THE SANTA CLARA VALLEY WATER DISTRICT
AND THE NATURE CONSERVANCY
MAY 2008

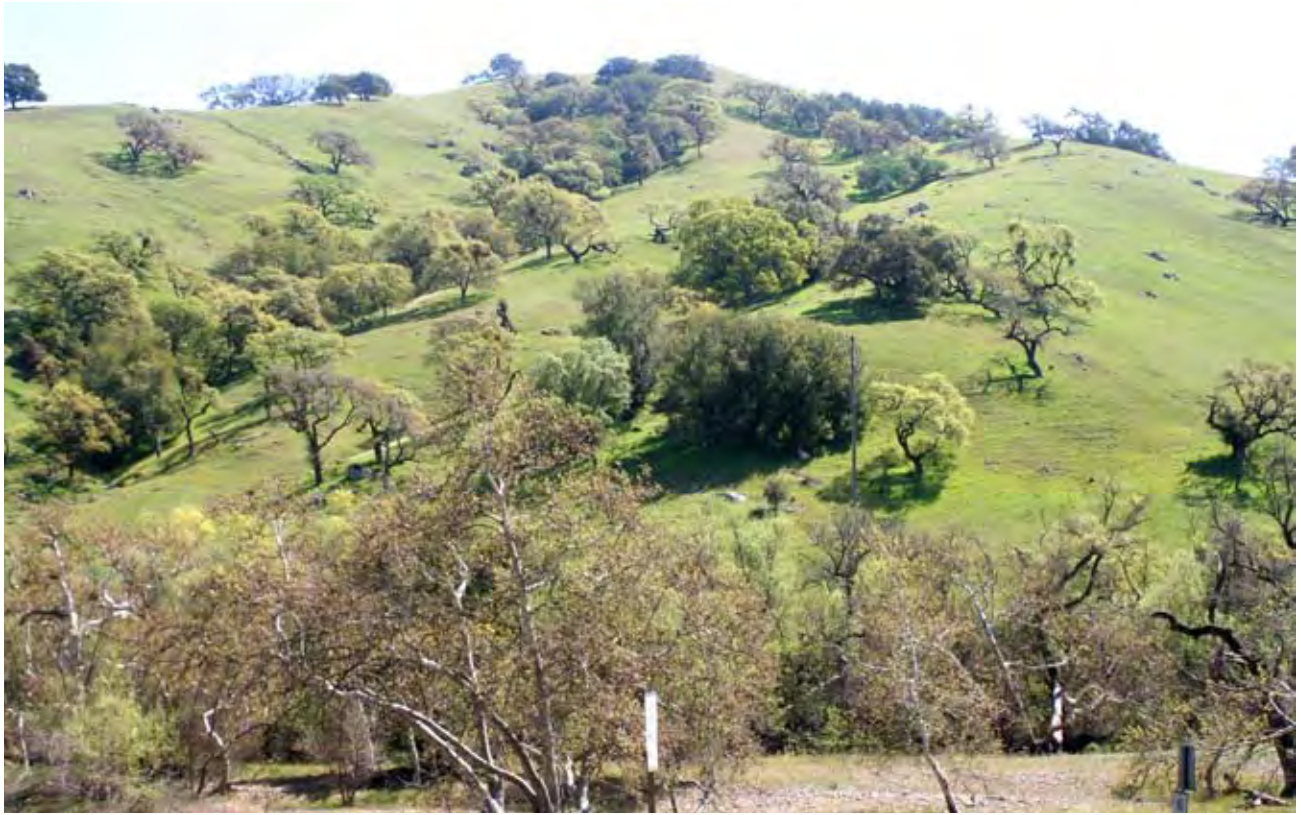
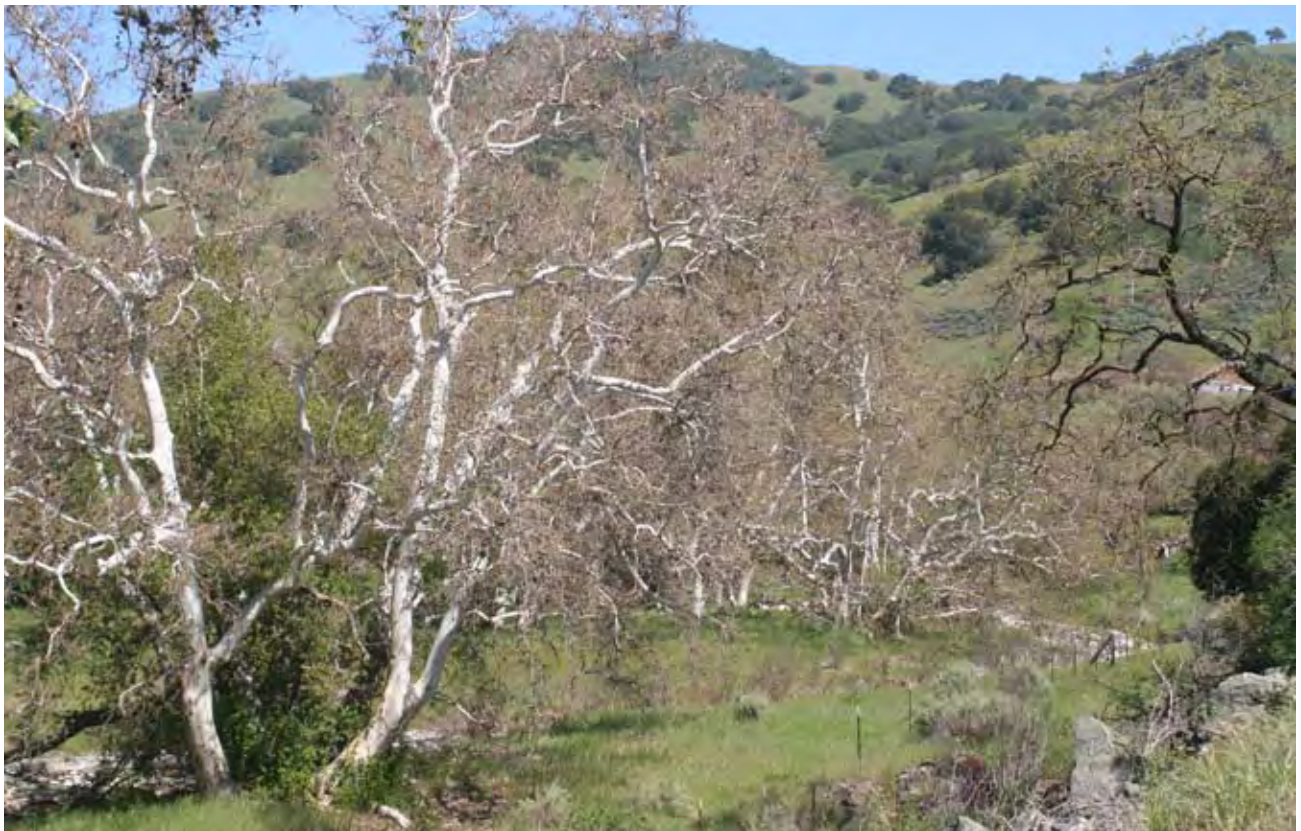
Figure 4.31. The relationship between sycamores and low-elevation, frequently scoured channel surfaces can be seen on Pacheco Creek just downstream from the North Fork Pacheco Reservoir.

In a statewide assessment (Keeler-Wolf et al. 1996), the five-mile Pacheco Creek sycamore alluvial woodland (figs. 4.30 and 4.31) was found to be one of the most important of the 17 surviving remnants. At the time of the study, Pacheco Creek was the sixth largest instance of CCSAW in the state, and the second largest outside of the Central Valley. Two different ranking approaches were developed to evaluate the quality of each stand, considering factors such as size, fragmentation, hydrology, and other human impacts. Pacheco Creek was ranked sixth and eighth within the state according to this evaluation. Within the San Francisco Bay-Monterey Bay area, it was judged to be either the first or third most important site, depending upon the ranking criteria. (Alameda Creek supports the other highest ranking local remnants.) Sycamores here are in the northern part of their range; however, that range might be expected to expand northward given climate change predictions (Kueppers et al. 2005; CCCC 2006).

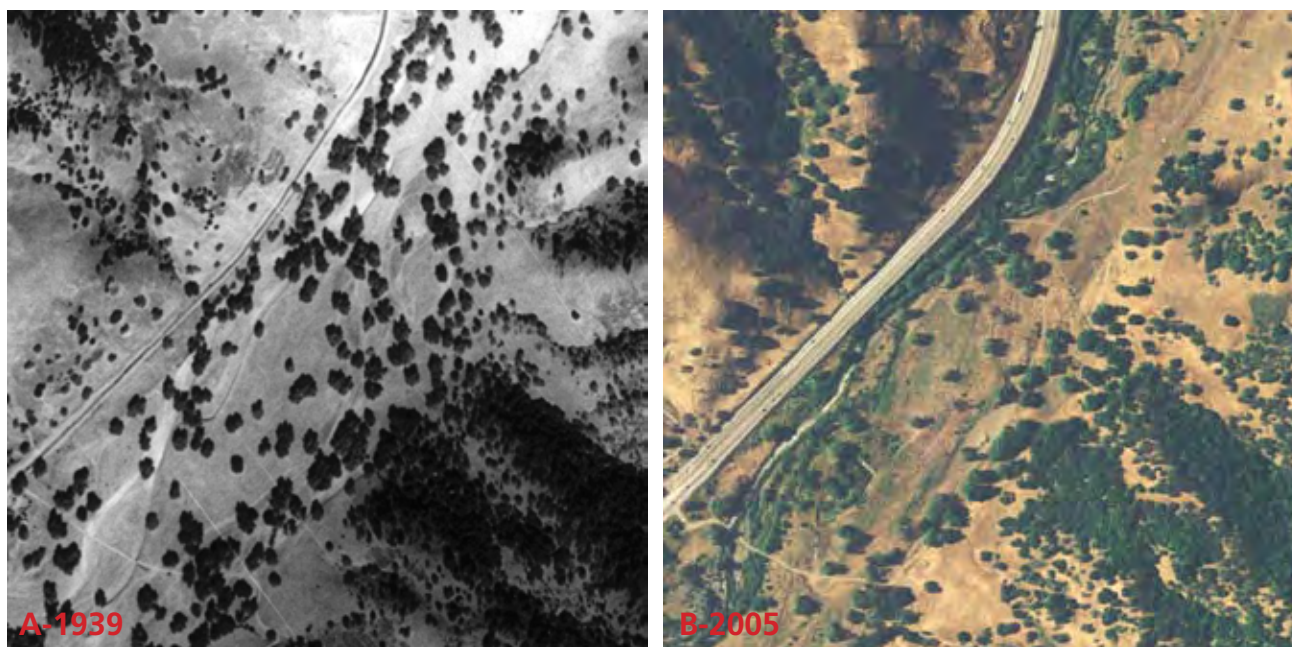
Figure 4.32. Several changes can be observed in these images of sycamore alluvial woodland on Pacheco Creek along Highway 152. In the contemporary image (B), there are fewer sycamores, less evidence for active side channels and floodplain scouring, and more riparian growth immediately along the low flow channel than in the historical image (A). (A: USDA 1939, courtesy of the Science & Engineering Library Map Room, UC Santa Cruz; B: USDA 2005, courtesy of NAIP)

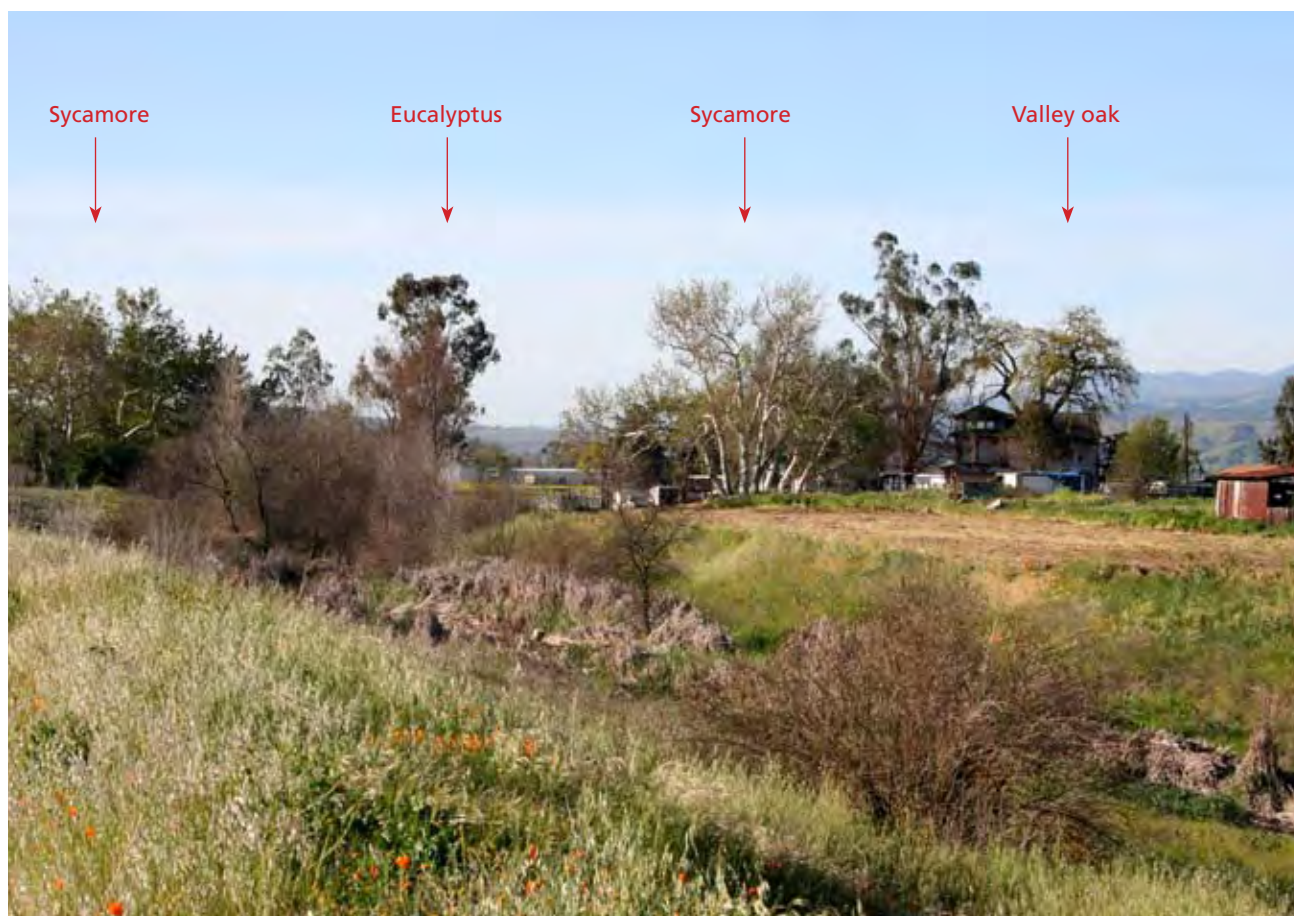
Figure 4.33. Llagas Creek between Highway 101 and Pacheco Pass Road is a narrow, excavated channel that nevertheless mostly follows its historical course. As a result, mature California sycamores and other riparian trees are frequently found alongside the channel on former bars, terraces, and banks of the historical channel. This pattern can be seen here near the Church Street percolation ponds. Eucalyptus trees are a common component of the new channel banks, dominant in places. A remnant tree of the adjacent valley oak savanna can be seen on the right.

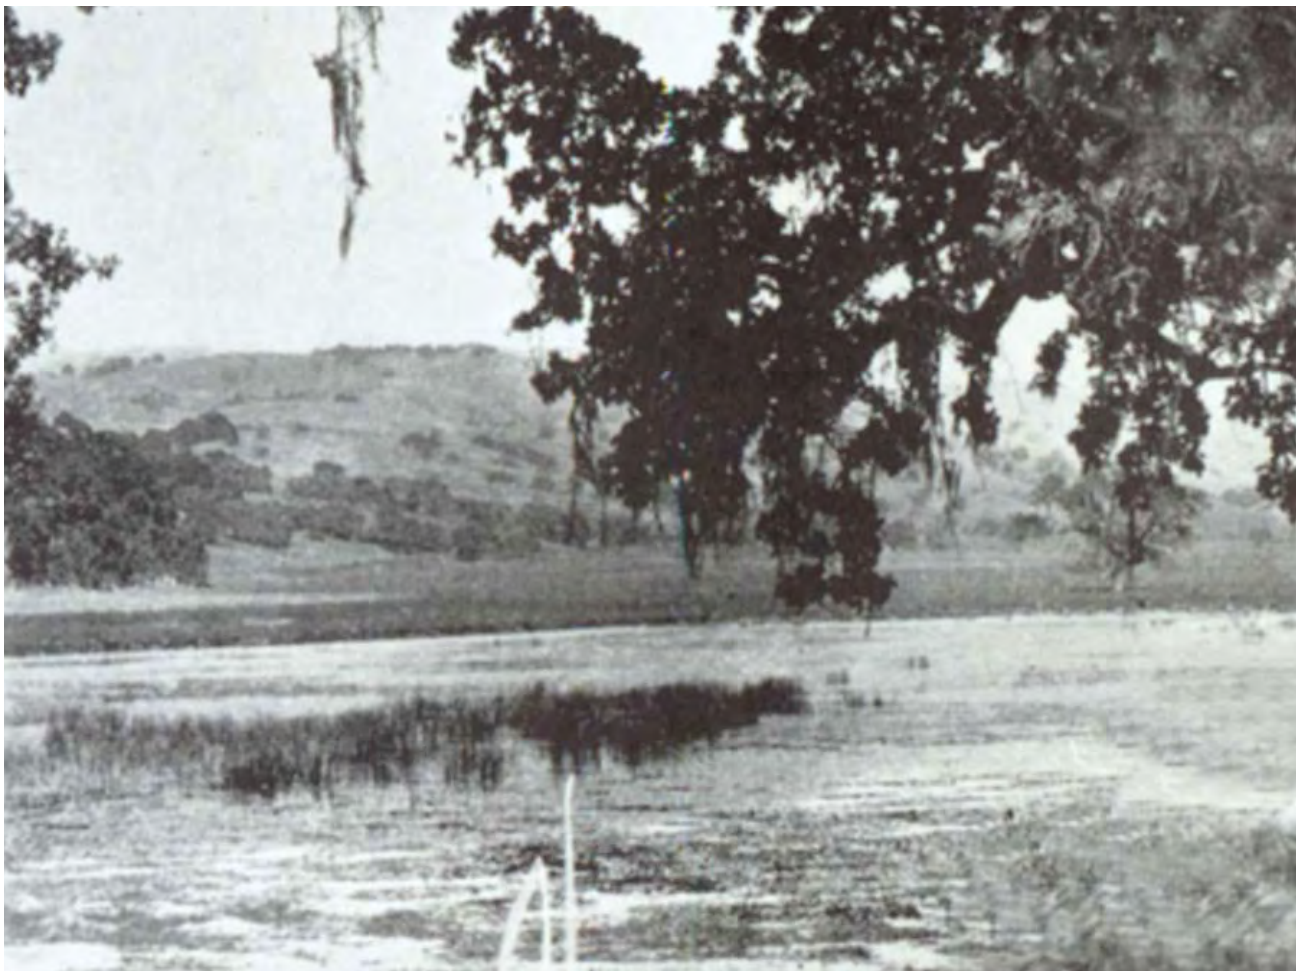
Figure 5.3. Historical landscape photographs of wetlands are not common, but this “Scene on the San Martín Ranch” shows a seasonal pond in the wet meadows on the east side of Morgan Hill. (Unknown ca. 1896c, courtesy of History San José)

Wet meadows are characterized by poor drainage conditions associated with dense clay soils and nearly flat topography, and are flooded for days or weeks depending upon rainfall events and their landscape position (fig. 5.3). These lands typically retain nearly all of the water that falls as rainfall and receive additional surface runoff or seepage from adjacent uplands (USDA 1951). As a result of high water retention and/or high groundwater level, these areas stay moist longer than adjacent, more well-drained lands.

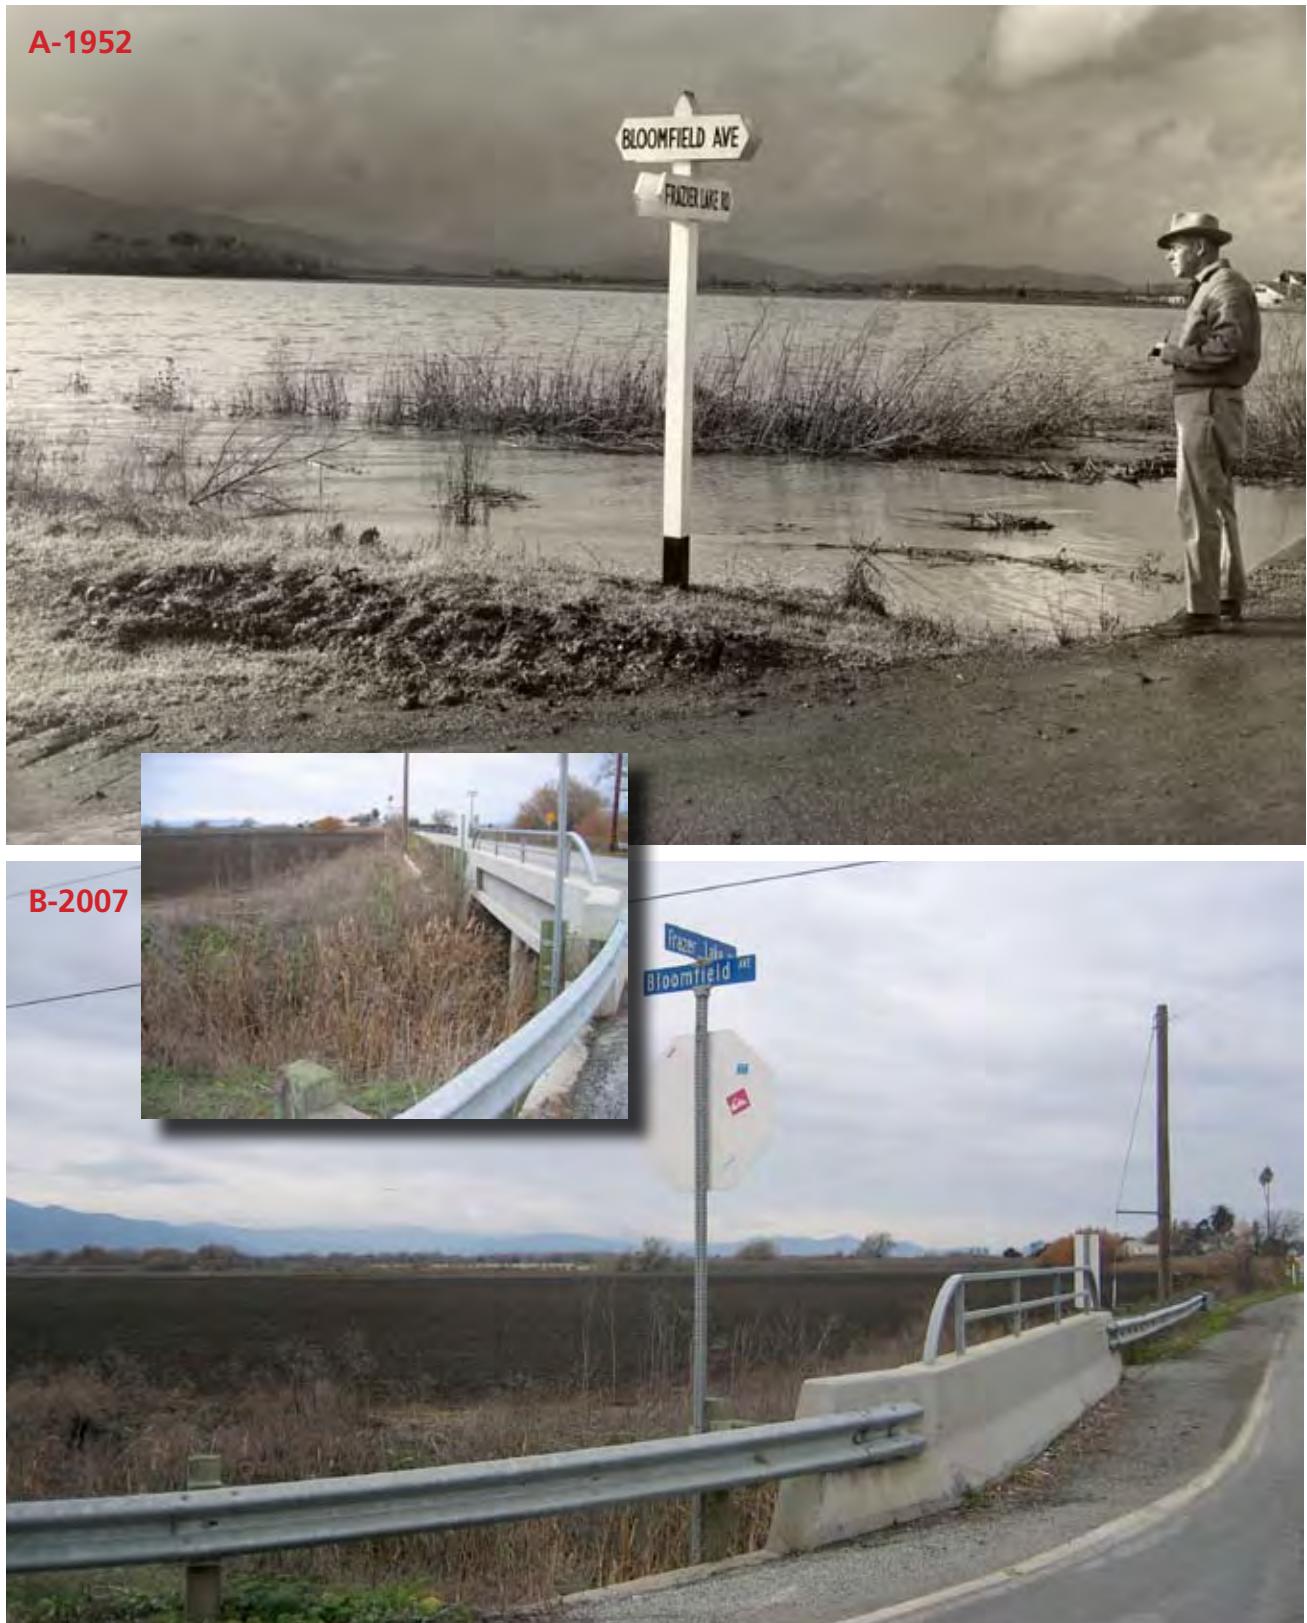
Figure 5.4. The former wet meadows east of Llagas Creek, flooded in February 1952 (A) and the same site in 2007 (B). Modifications to reduce overflow (inset) include drainage channel (note cattails in foreground), culvert under bridge crossing, and raised roadway. (A: Unknown 1952, courtesy of the Gilroy Museum)

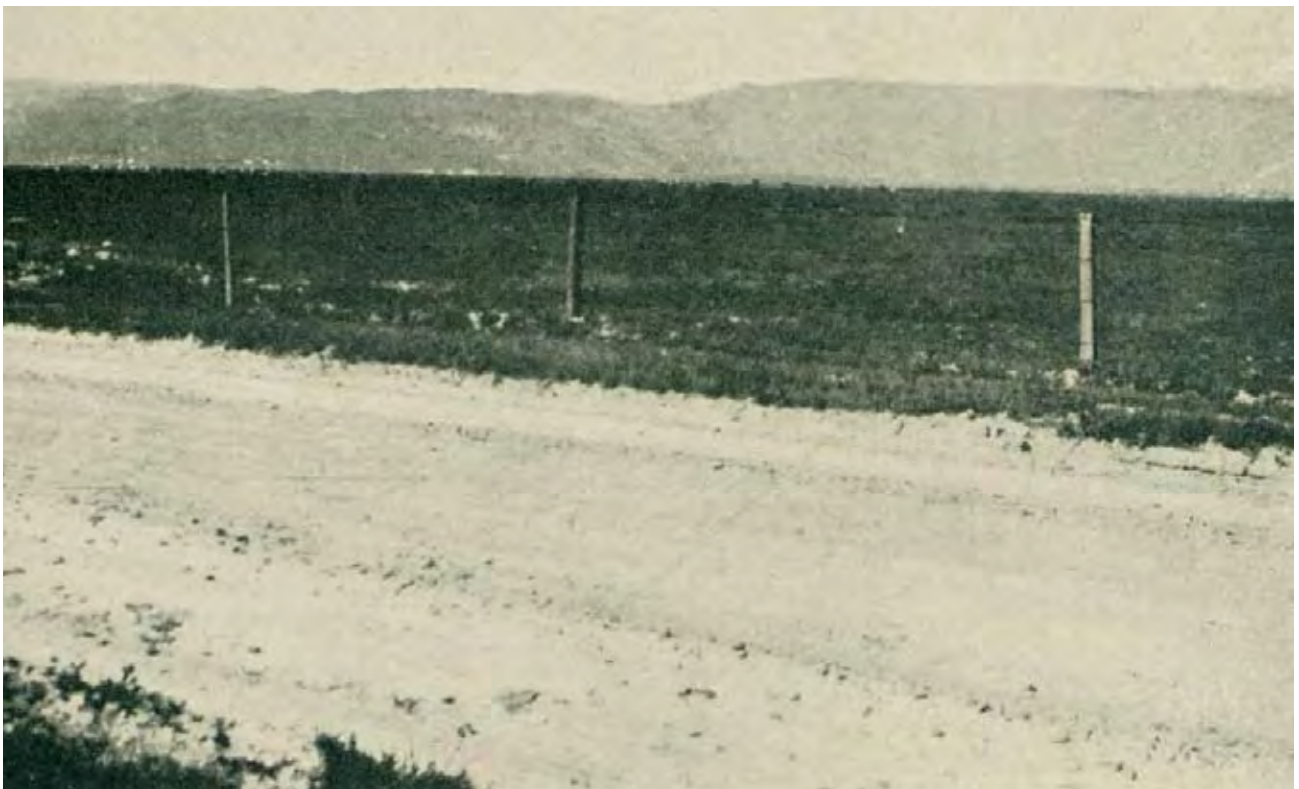
Figure 5.6. Jan Otto Marius Broek took this photograph in 1931 to illustrate the salt effects in the Bolsa. The caption reads “View towards the northeast over the alkali flat of the ‘Bolsa’; the dirt road covered with a white salt crust.” (Broek 1932)

A white alkali crust was common on the surface after rains: “During the winter most of this ‘Bolsa’ is wet, evaporation after the rains leaving a white alkali cover on the fields and roads” (fig. 5.6; Broek 1932). These areas may have had shorebird habitat value similar to the playa-like salt

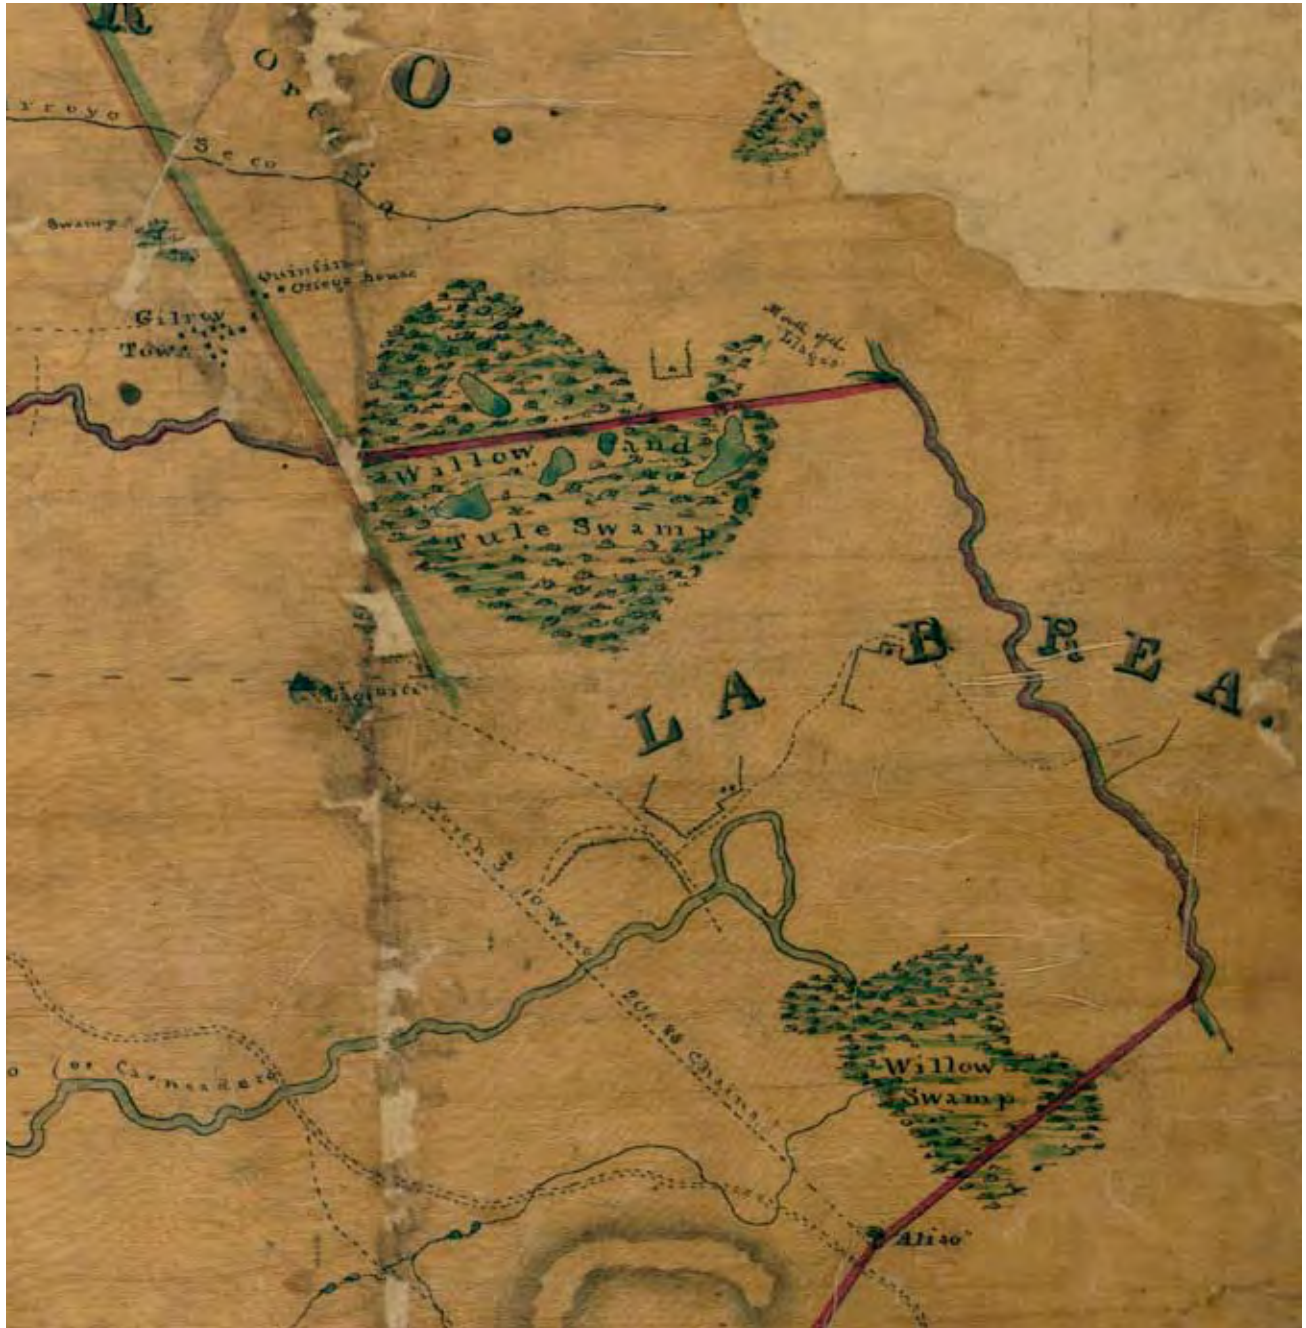
Figure 5.8. Freshwater wetlands and willow swamps at the confluences of Llagas Creek and Uvas-Carnadero Creek with the Pajaro River. Llagas Creek enters a "Willow and Tule Swamp" with significant freshwater ponds at top; Uvas-Carnadero Creek spreads into a "Willow Swamp below". The Pajaro River flows from top to bottom at right. (MacDonald 1852(?)c, courtesy of The Bancroft Library, UC Berkeley)

Valley freshwater marshes commonly included open waters too small to map. For example, surveyor Day described “a tulare pond ½ chain diameter [10 m/33 ft]” in a “marsh” encountered while crossing the Soap Lake alkali meadows (Day 1854). Similarly, the *diseño* of Rancho de Las Animas shows several ponds within the large willow grove/tule marsh at the bottom of Llagas Creek (McDonald 1852(?)c; fig. 5.8).

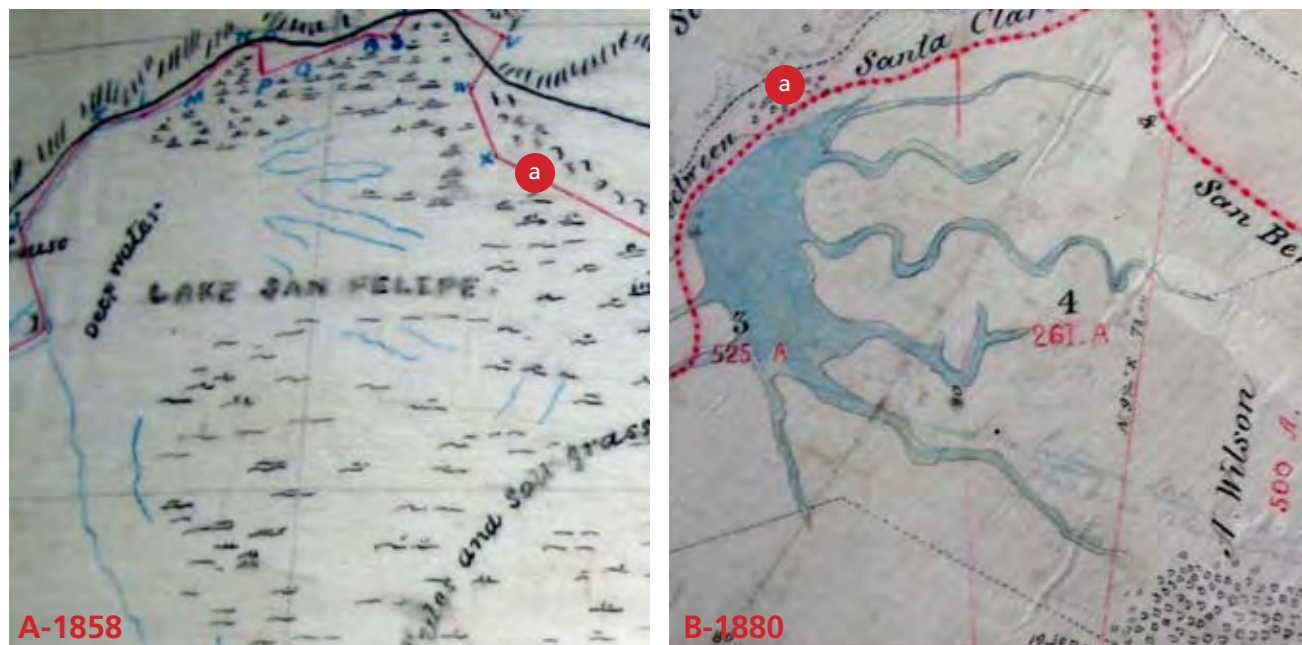
Figure 5.9. The history of San Felipe Lake is shown in a series of maps and aerial photographs. The lake is shown as substantially larger in 1858 (A) than in the subsequent views, with prominent sloughs in both 1858 and 1880 (B). Digitizing the open water areas from the georeferenced sources allows a comparison of area (right) and in the bar chart (facing page). The lake appears to have receded substantially in 1939 (C), following drought; lake bottom sediments were exposed and willow trees invaded the lake margin at that time. Apparent expansion of willows into the former “Tules and Salt grass” between 1858 and 1880 can be seen in the lower right of those images. Several historic willow groves that have maintained their position through time are identified at (a). (A (Healy 1858b) and B (Healy 1880a), courtesy of the San Benito County Recorder’s Office; C: USDA 1939, courtesy of the Science & Engineering Library Map Room, UC Santa Cruz; D: USDA 2005, courtesy of NAIP)

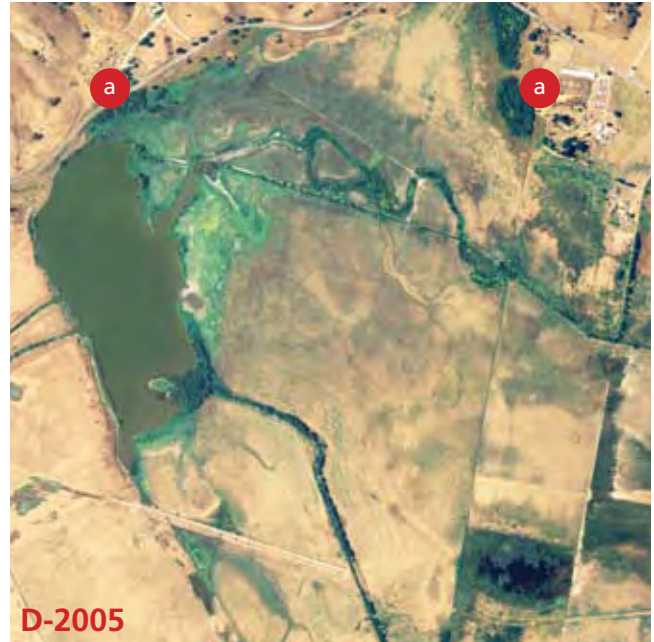
San Felipe Lake area over time, with estimated measurement error

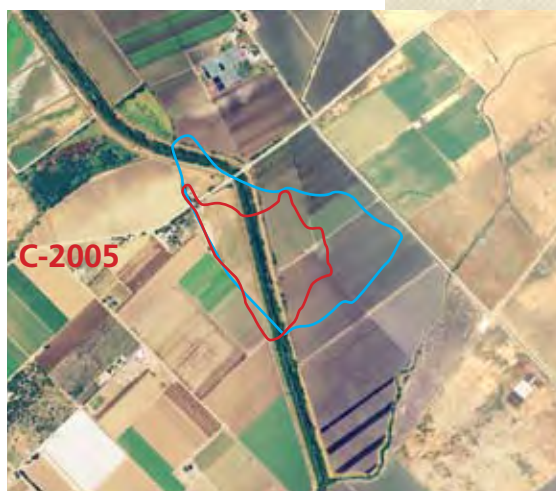
Figure 5.10. Seasonal variation of the "Pajaro Lake." The large seasonal lake or lagoon on lower Llagas Creek at Bloomfield Road was a unique feature in the region. Called "Pajaro Lake" by Sherman Day, it formed the boundary between the Las Animas and the San Ysidro ranchos, which is still evident in contemporary property lines. Maps made by Wallace in March (A) and April-May (B) of 1858, in which he showed the decreasing size of the lake, are shown at right. Some of the survey points are labeled with his field notes. Willow grove and marsh are shown along the survey line as it

extends towards the upper left. The outlet forming the Pajaro River can also be seen. In the diagram on the facing page, repeated surveys describe the site in different seasons and years. The lake was sufficiently large and persistent to be seen from several miles away in June of an average water year and serve as a grant boundary (see Chapter 7). Yet by September (in another average water year), the area was dry enough to be referred to as "a level plain." (A (Wallace 1858a) and B (Wallace 1858b), courtesy of The Bancroft Library, UC Berkeley)

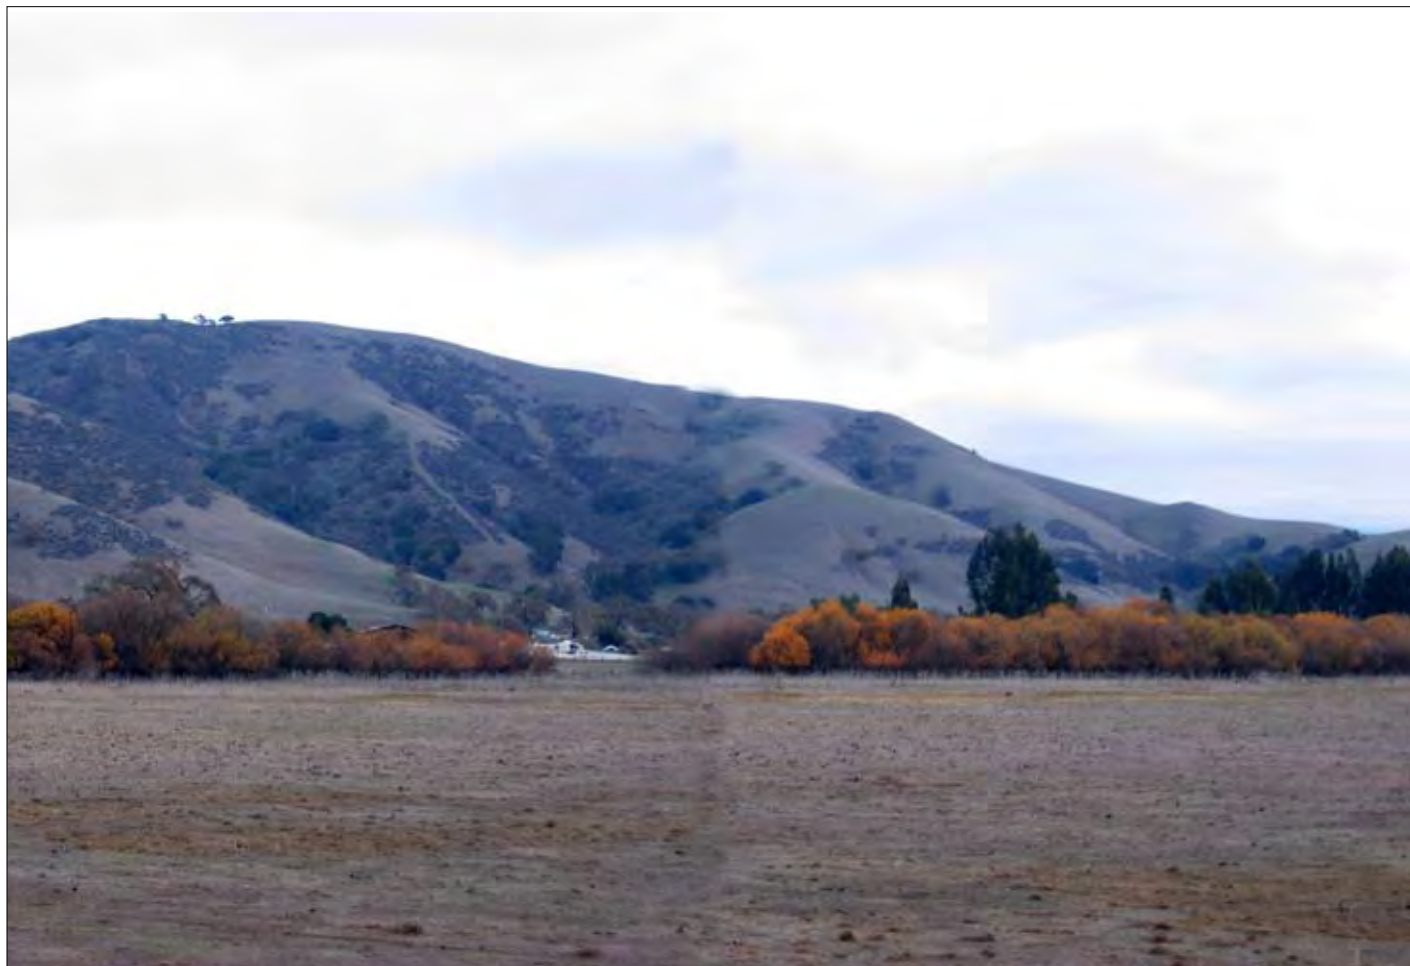
Figure 5.11. This willow grove appears similar in size and location in historical documents since 1858 (see fig. 5.9). Here the leaves of these deciduous trees (arroyo

willow, *Salix lasiolepis*) are changing color in December. Note the well-defined “browse line” in the willows’ lower canopy, as nibbled back by cattle and deer.

example, significant remnant willow stands occupy their precise historical position and appear to be thriving on the northern margin of San Felipe Lake (fig. 5.11). San Felipe Lake also represents a partial remnant of a major and unique geographic feature in the region – a large natural lake. Patches of alkali meadow vegetation persist in places throughout the Bolsa, indicating the persistence of alkali soil conditions (PWA 2008), and native wildflowers have returned in recent years under particular disturbance regimes (disking or plowing; Morgan pers. comm.).

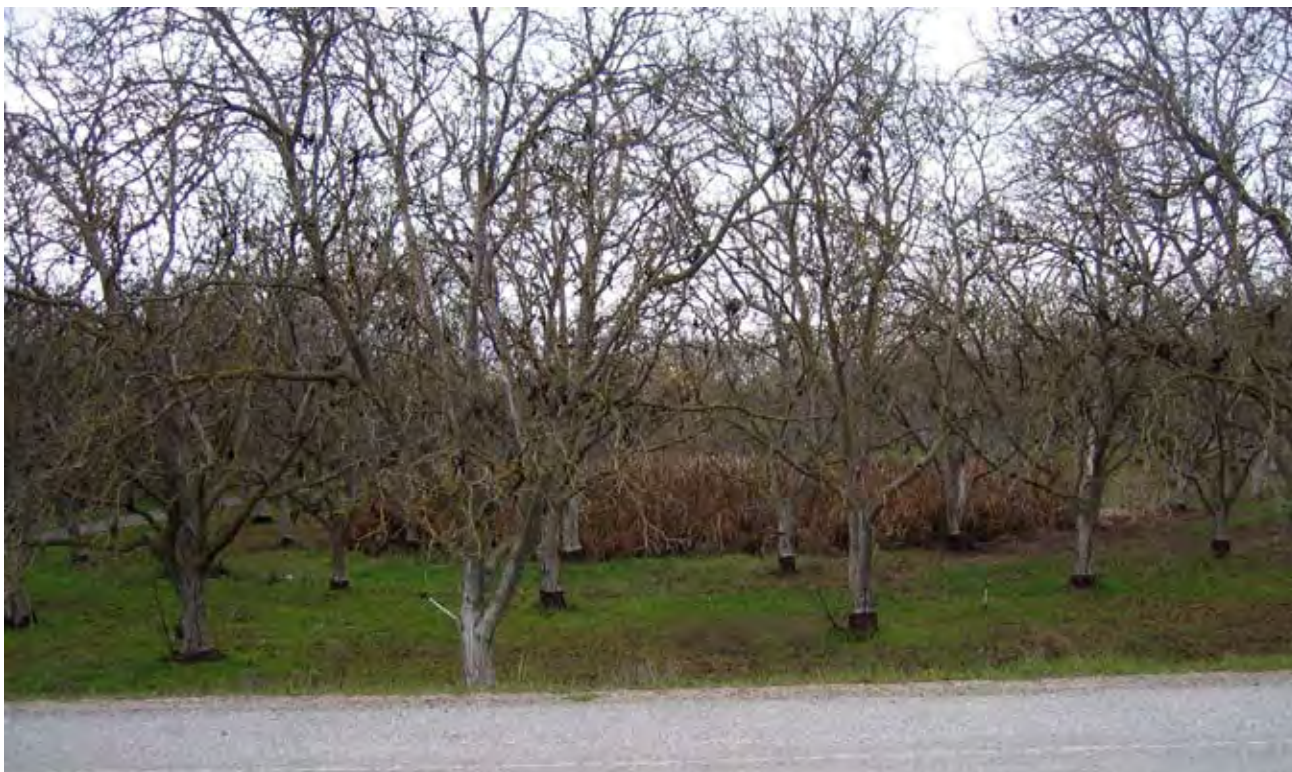
Figure 5.12. Wetlands such as this small marsh in an older orchard on Lovers Lane (planted when groundwater levels were lower) are an indicator of changes in near surface groundwater levels in the past two decades.

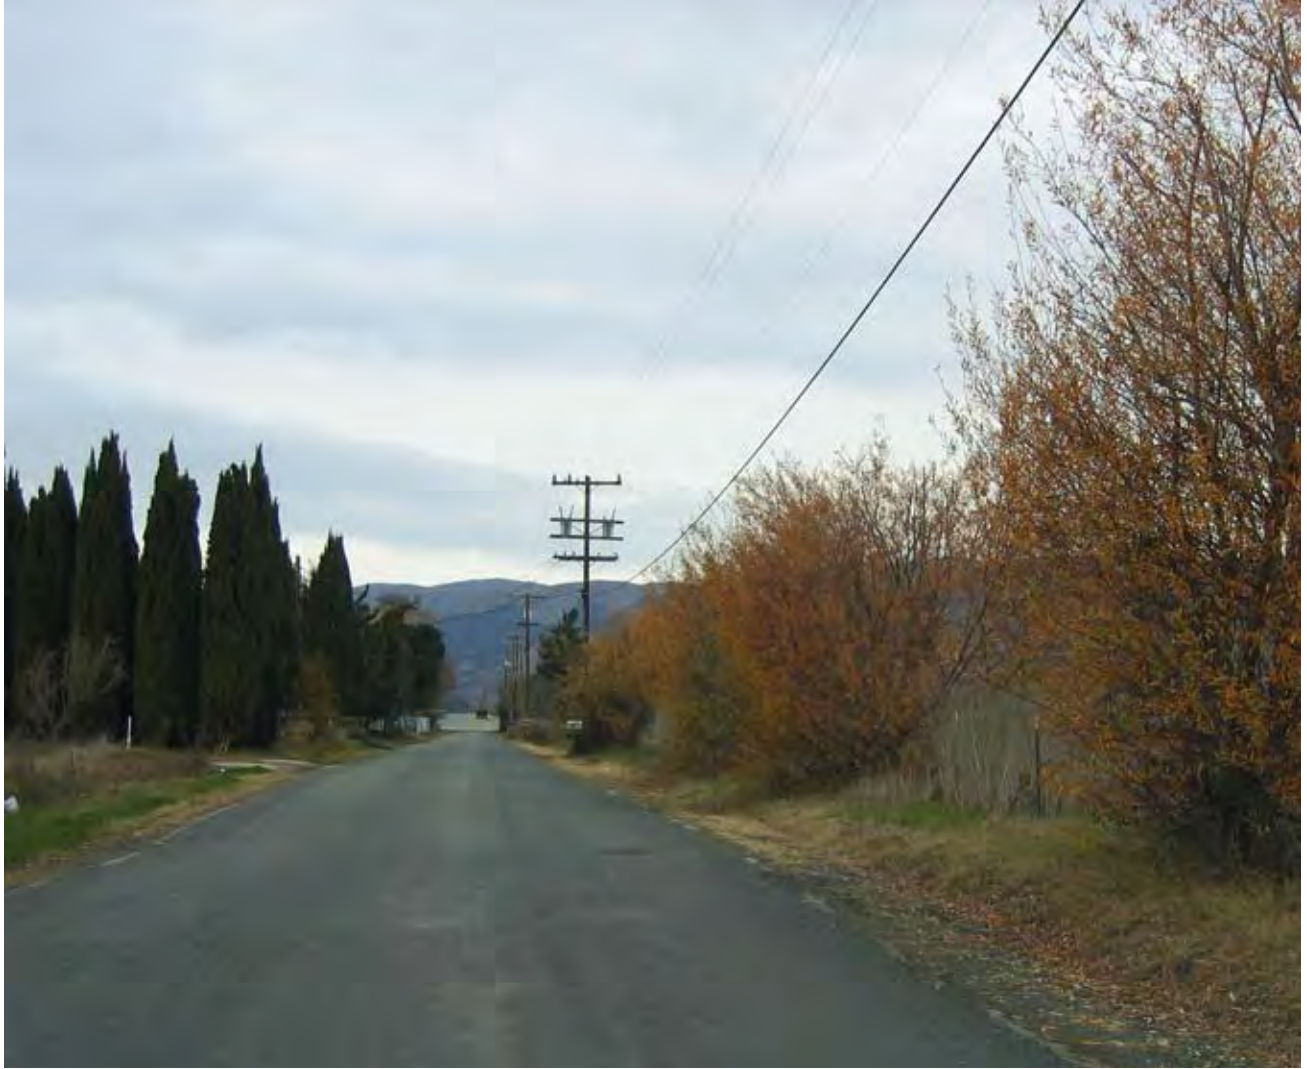
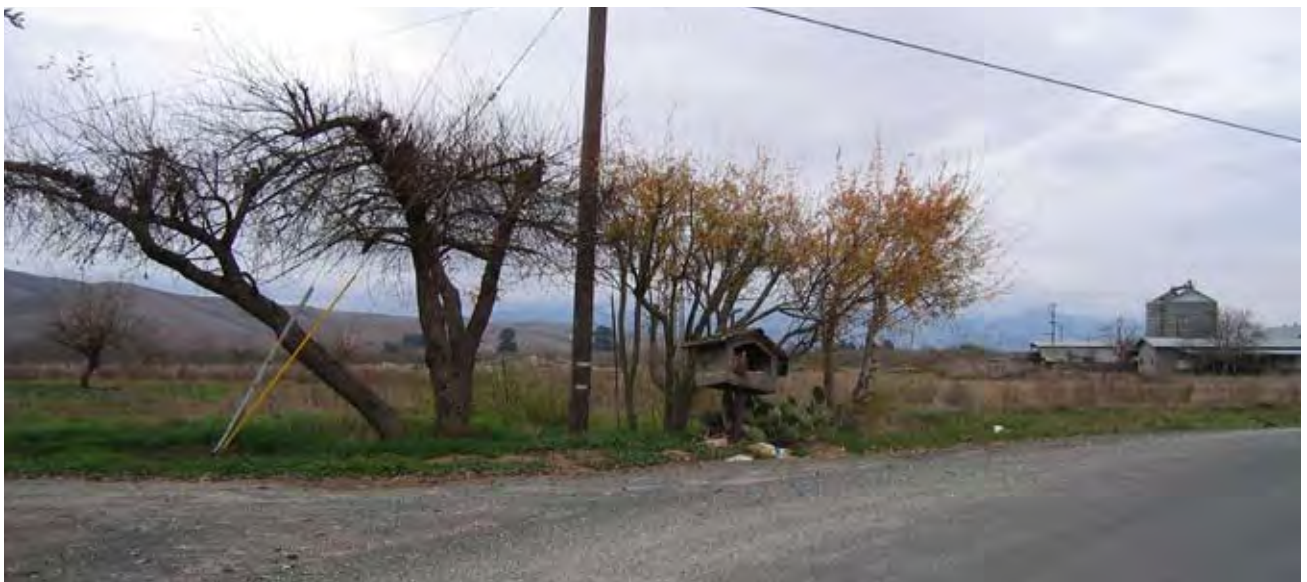
Figure 5.13. Reestablished willow grove at the South County Regional Wastewater Plant.

In addition to these residual habitat features, we encountered several sites where portions of former wetlands have returned in the past several decades. Since water imports began in 1987, groundwater levels have recovered, enabling the recovery of wetlands in some places (figs. 5.12 and 5.13). Extra efforts to drain water or remove vegetation have been required to prevent reversion to wetlands in other places.

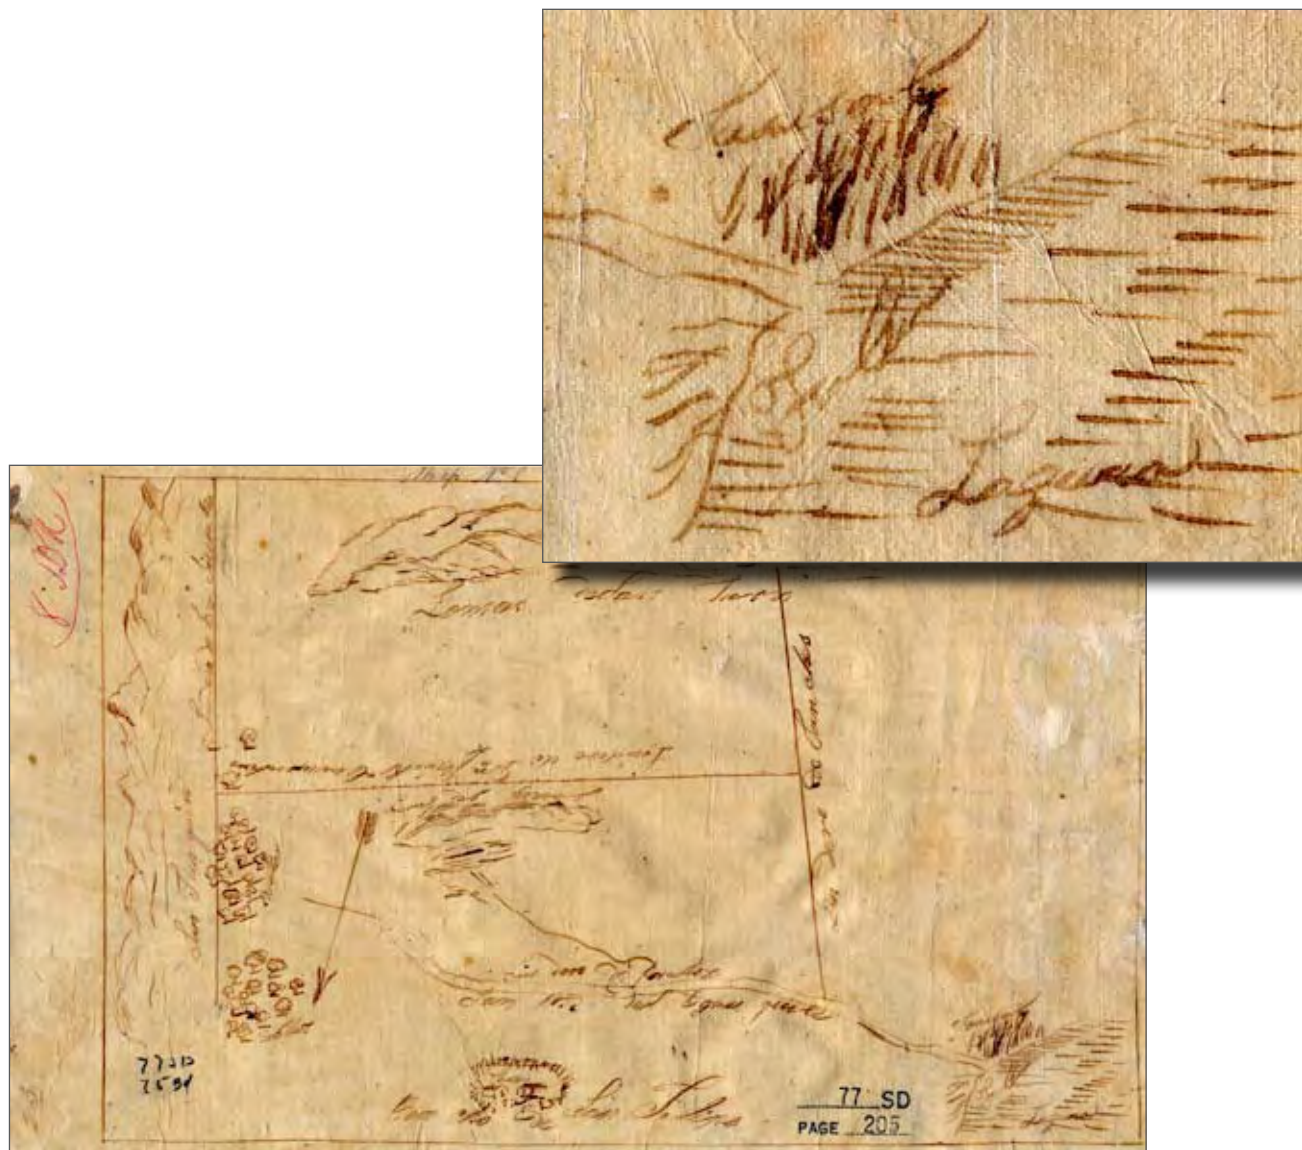
Figure 5.14. In the former Pacheco Creek willow grove, willows remain part of the landscape, alongside roads and houses.

Mature willow trees can also be seen along Bolsa Road, within the historical Llagas Creek willow grove, and Lovers Lane, within the extent of the historical Pacheco Creek willow grove. Along Lovers Lane, many of the street trees and yard trees are also willows (fig. 5.14).

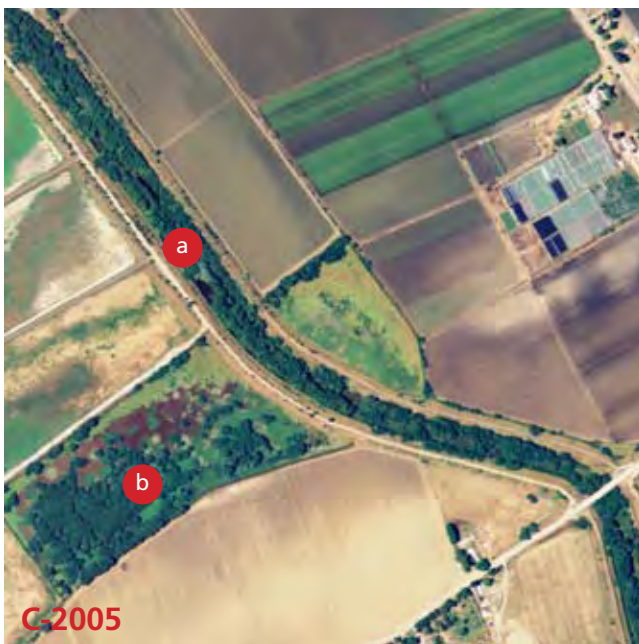
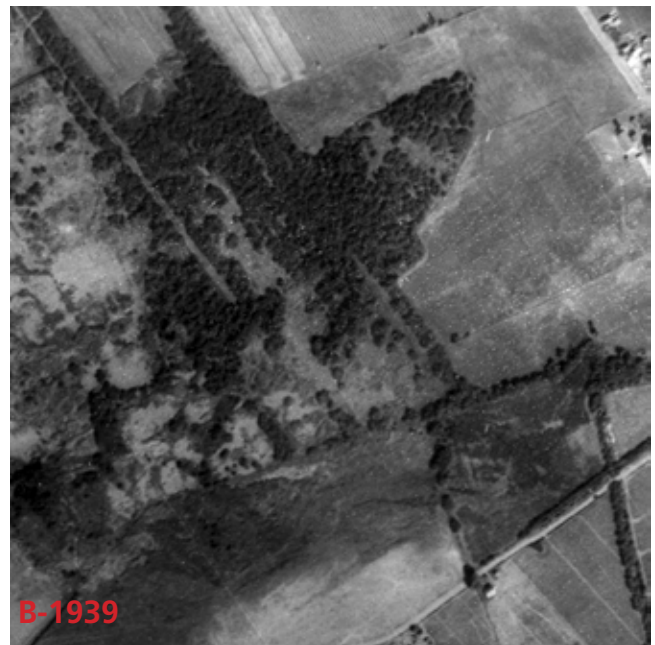
Figure 5.16. The history of the "Willow and Tule Swamp" at the downstream end of Llagas Creek can be seen in this series, starting with McDonald's ca. 1852 map. This map shows willows (hatch marks), freshwater marsh (parallel lines), and ponds (concentric circles). Independent surveys along the red grant line confirm these features. Remnants of the willow grove are still visible in 1939; these were subsequently cleared from the area as part of continued agricultural expansion and the construction of the South County Regional Wastewater Authority Treatment Plant and the Llagas Creek flood control channel. In recent years, willow thickets have returned within the flood control channel (a) and the south pond of the wastewater treatment plant (b). (A: McDonald 1852(?); b, courtesy of The Bancroft Library, UC Berkeley; B: USDA 1939, courtesy of the Science & Engineering Library Map Room, UC Santa Cruz; C: USDA 2005, courtesy of NAIP)

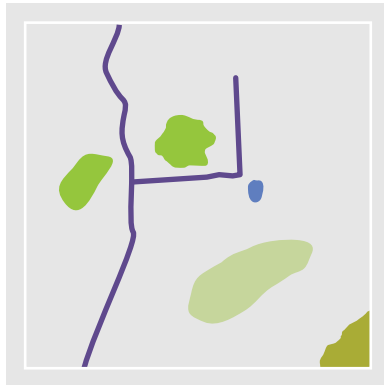
Pre-World War II: Most of the wetlands have been drained for agriculture. Remaining wetlands are impacted by grazing.
