FINAL REPORT

SOUTH SANTA CLARA VALLEY HISTORICAL ECOLOGY STUDY

INCLUDING SOAP LAKE, THE UPPER PAJARO RIVER, AND LLAGAS, UVAS-CARNADERO, AND PACHECO CREEKS

PREPARED FOR THE SANTA CLARA VALLEY WATER DISTRICT
AND THE NATURE CONSERVANCY
MAY 2008

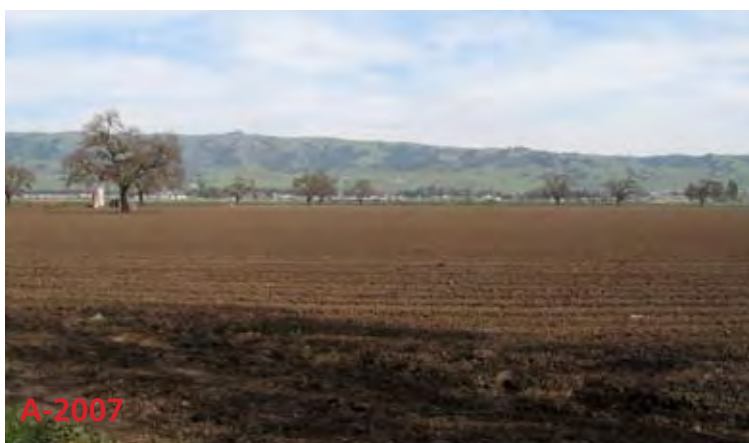
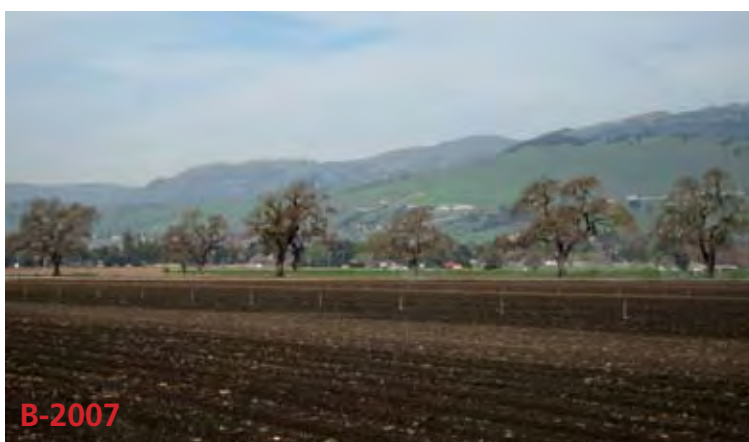
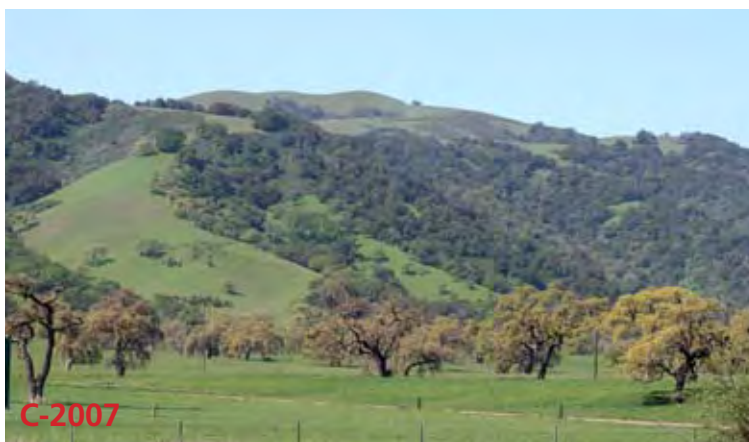
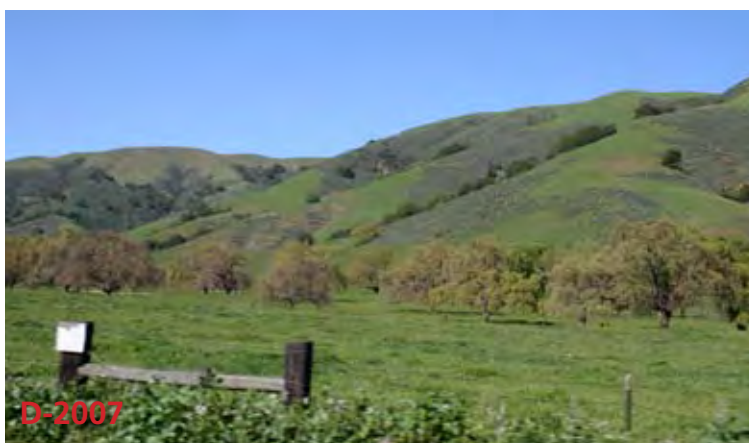
Figure 6.4. Contemporary landscape photographs of valley oak savanna and woodland. The first two images show the same small savanna (7 trees in 0.8-1.2 ha/2-3 ac) from two vantage points. From a distance (A), the relatively wide distance between trees can be seen; a closer view (B) captures the combined effect of the trees despite the wide spacing (generally 50-100 m/160-330 ft apart). In the foreground of C, valley oaks in a savanna setting leaf out in early spring. Clumps of valley oaks can be seen on the valley floor and live oaks are common on the hillside behind. A rare remnant grove of valley oak woodland (D) is found along Highway 152. This is the same site as the 25-30% cover 1939 example in fig. 6.3 (bottom).

such as those along Highway 152 (near San Felipe Lake and along Pacheco Creek, see figs. 6.4C and 6.4D) represent the best remaining local examples of these habitat types. In contrast to oaks within an urban environment, such areas have added ecosystem benefits with the associated understory vegetation as well as other components such as riparian areas and connections to upland habitats. These features can serve as reference systems for regional restoration efforts and may also be reservoirs of local genetic diversity, with larger genetic neighborhoods and connection to upland populations. Facilitating oak seedling recruitment in these areas (e.g., through enclosures, grazing management) could aid their long-term persistence.

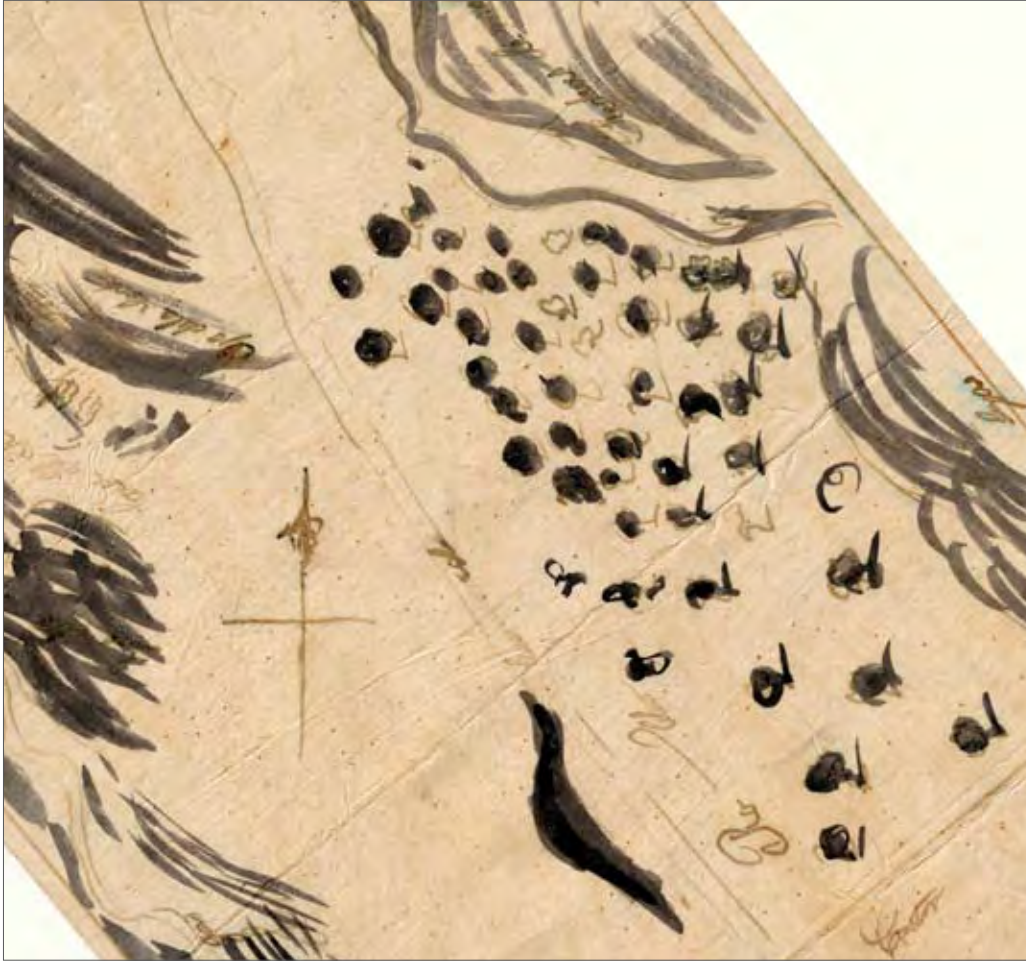
Figure 6.5. (Left) Early diseño of the Ojo de Agua de la Coche Grant depicts a fan-shaped oak woodland area on the eastern side of the valley, just south of where Coyote Creek bends northward. The land grant confirmation map of this same land grant depicts widespread trees within the valley. (U.S. District Court, Northern District [184-?]a, courtesy of The Bancroft Library, UC Berkeley)

In addition to determining that “scattered” timber referred to what we would today call oak savanna, we found that denser woodlands were also consistently identified by surveyors, written descriptions, and visual evidence. Indicators of higher stand density included descriptions such as “valley land covered with oak timber,” “a heavy growth of oak timber,” or “densely timbered” (Thompson 1857a, Harrison ca. 1888). In particular, the terms “woodland” and “grove” appear to have described what was a fairly recognizable or self-evident pattern of higher density areas on the valley floor. Wooded regions shown on maps consistently corresponded to areas reported as woodlands or groves by GLO surveyors. For example, a *diseño* from the 1840s likely depicts a large oak woodland, or “roblar,” in the shape of a fan on the eastern side of the valley across from Morgan Hill (fig. 6.5). Two accounts of this area confirm the feature:

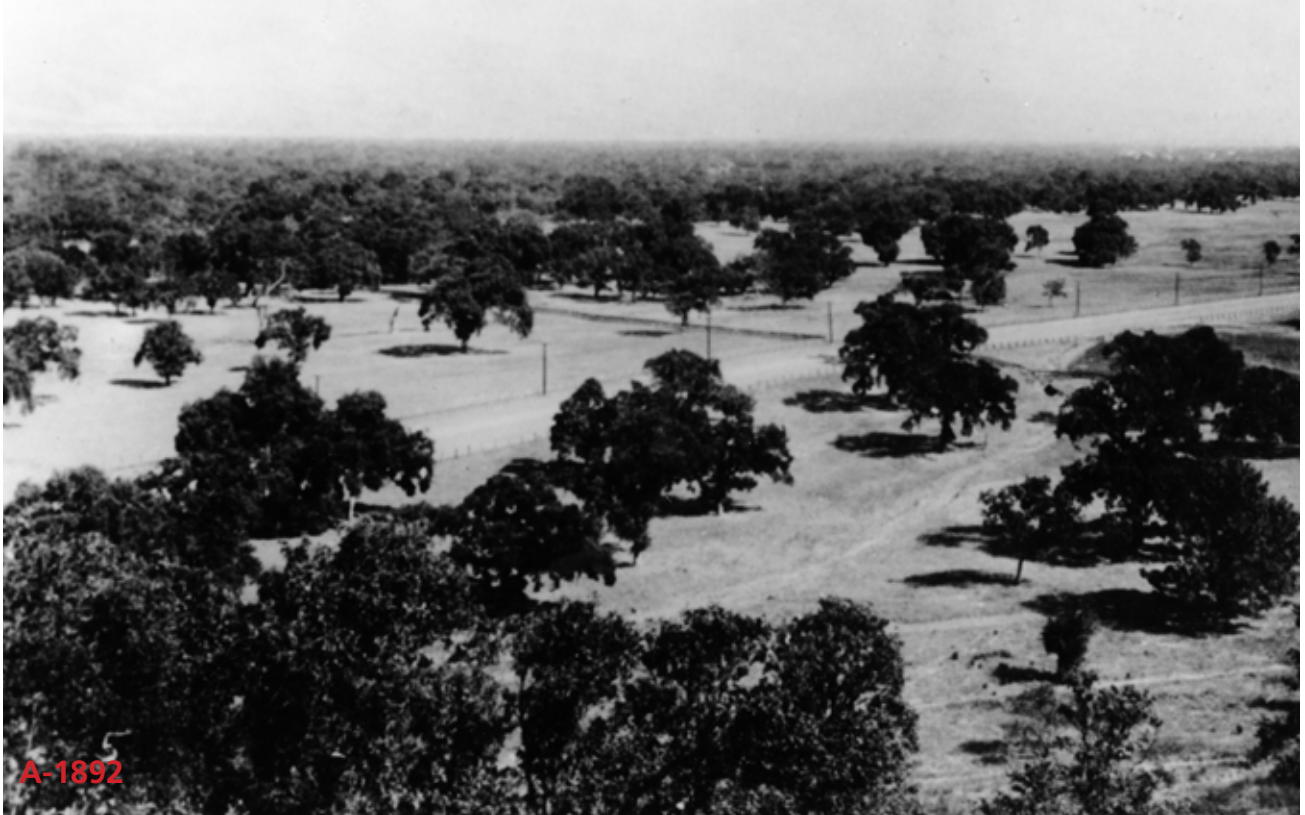
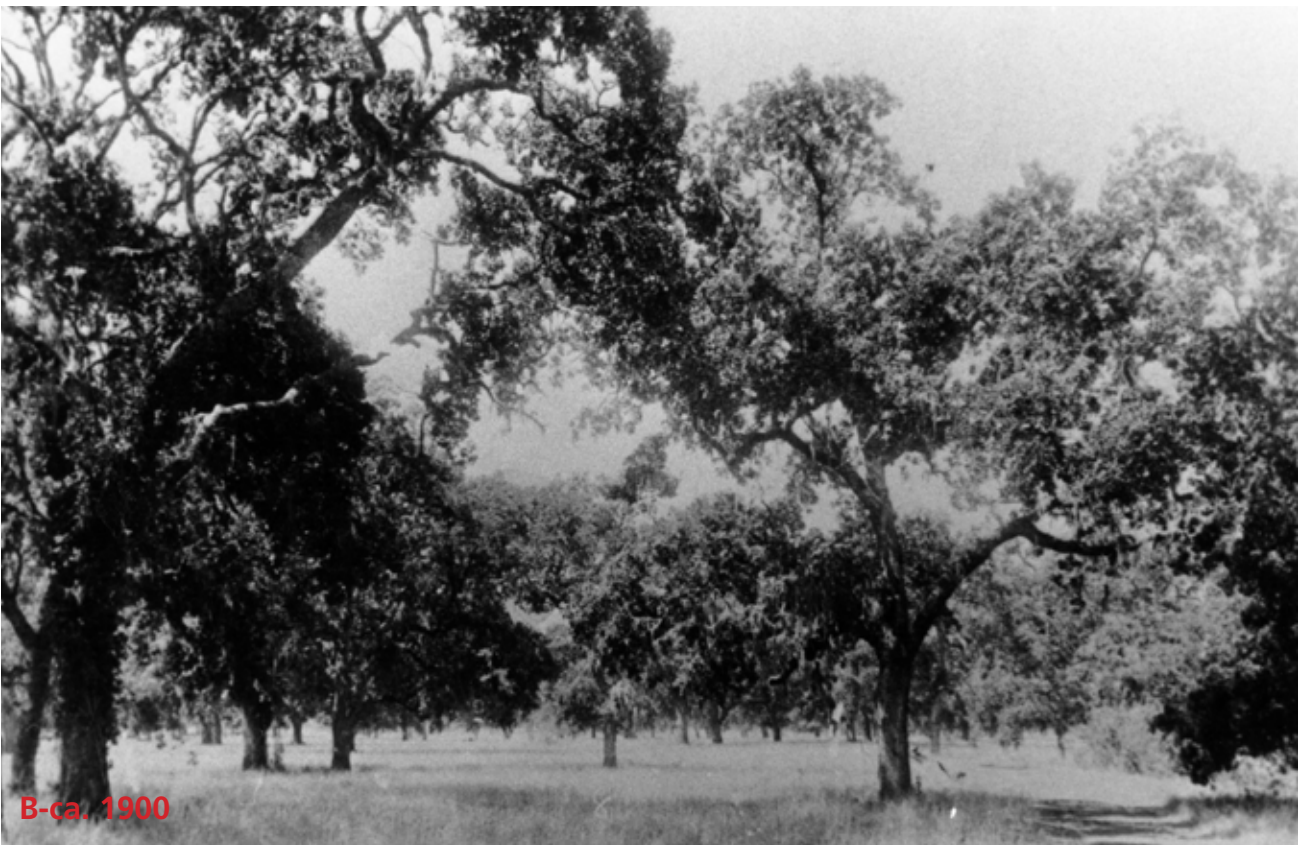
Figure 6.6. (Right) Late 19th-century views of the oak woodlands that dominated south Santa Clara Valley near Morgan Hill. (A (Unknown 1892) and B (Unknown ca. 1900c): courtesy of the Morgan Hill Historical Society)

corresponding to the high densities calculated from GLO data (fig. 6.6). These data correspond with observations from an explorer “that the timber grew more plentiful and the trees larger” moving north from Gilroy (Manly 1894). Surveyor Richard Howe (1851) characterized an area near Morgan Hill as “low scrubby mossy oak timber,” which still connotes the idea of dense woodland, but perhaps suggests smaller and younger trees. Additionally, a confirmation map drawn from the survey for the Ojo de Agua de la Coche rancho land grant (encompassing Morgan Hill) shows a continuous tree cover across the grant line in this part of the valley (fig. 6.7). The trees in this area correlate with the inactive fan of historical gravelly soils shown by both historical and modern soils maps. While it is difficult to quantify these depictions of the landscape individually, the volume of these data and their close correspondence with the GLO bearing tree data and to each other contributes to a consistent view of the distribution and character of oak savanna and woodland.

fig. 6.6). Given this rapid transition, it is not surprising that our estimate of relict valley oaks in 1939 is just 3% of our estimate for oaks present in the 1850s.

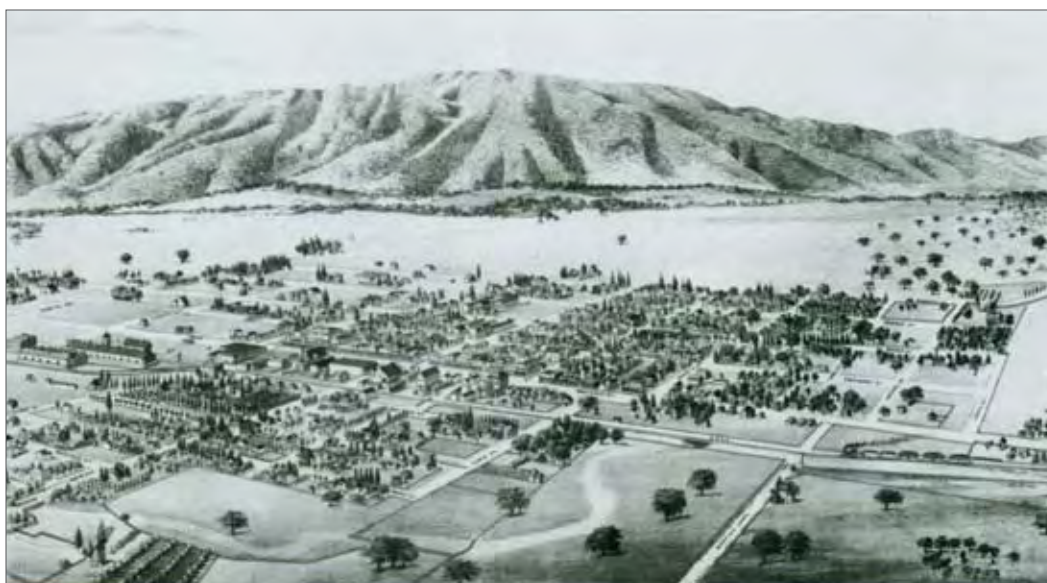
Figure 6.8. The oak grove west of Gilroy shown on this 1885 lithograph was also noted by GLO surveyor Richard Howe, who recorded “left the woodland” in his 1851 field notes. Sherman Day (1854) also noted a “point of timber” close to his survey line in this area. (Blake 1885, courtesy of the Gilroy Museum)

Another account from 1896 referred to the valley in the Gilroy area as “formerly covered with groves of magnificent oak trees” (fig. 6.8; Shortridge [1896]1986). Farther north in 1850, “magnificent clusters of oaks” created “one continuous vista of unexampled beauty” (Wise 1850). We expect that, although we were only able to map the location of several of the most notable small-scale groupings (on the order of 10 ha/25 ac), these small stands or groves were common within the larger savanna setting. Differences in density distribution are also addressed through glades, openings, or “abras” that occur in overall denser woodland areas (Lewis 1850a,

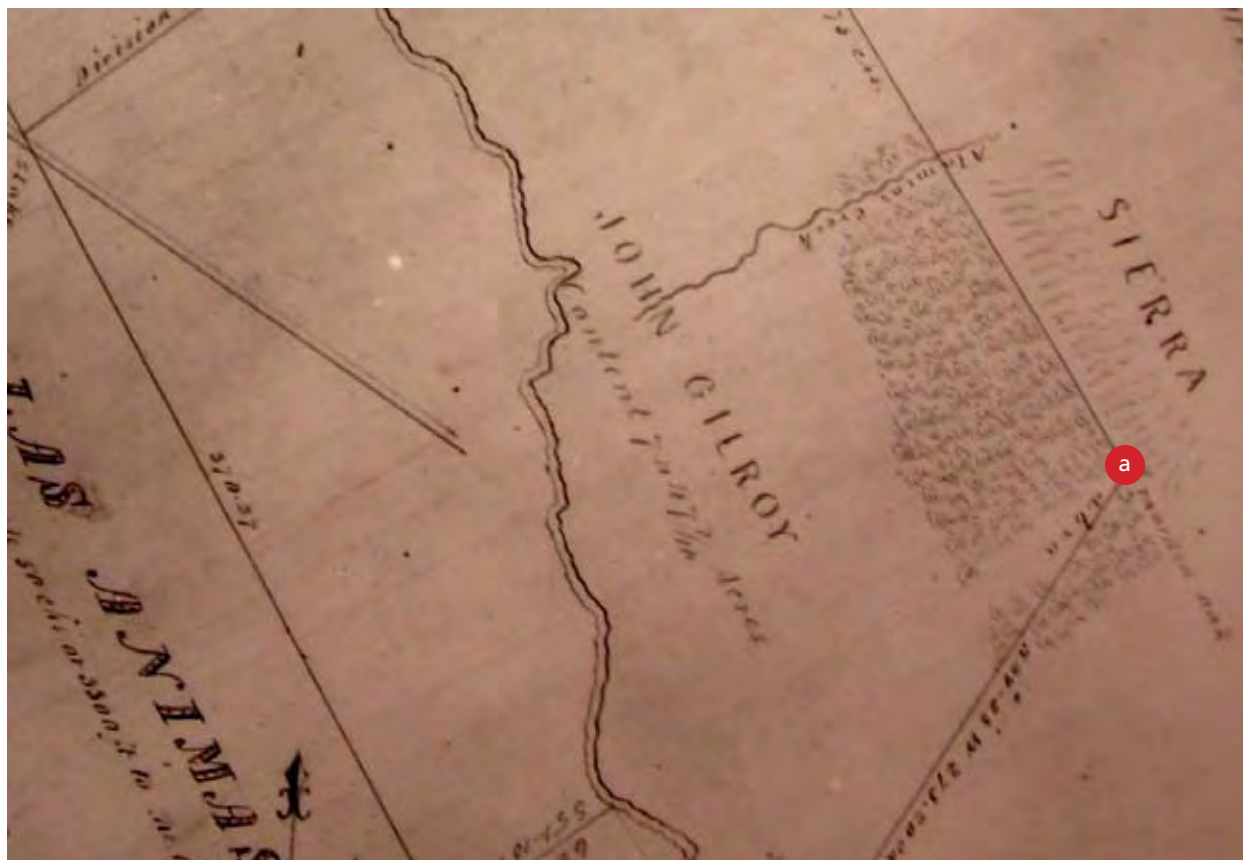
Figure 6.13. GLO surveyor Sherman Day intersected the feature drawn by county surveyor Lewis (1850a) on the right side of this map. Day (1854) noted “Enter timber — white oaks,” corresponding with Lewis’ representation of a densely wooded area. The distinctive “abra,” or opening, is labeled at (a). (Lewis 1850a, courtesy of the Office of the Santa Clara County Surveyor)

Day 1854; see fig. 6.13). Thus, while it may be difficult to imagine a continuous expanse of evenly distributed trees at a density of 11 oaks/ha (45 oaks/ac), woodlands at the landscape scale may simply appear as more tightly spaced groves at the local scale. It is easy to imagine early settlers establishing roads, towns and small fields within the trees, but between groves.

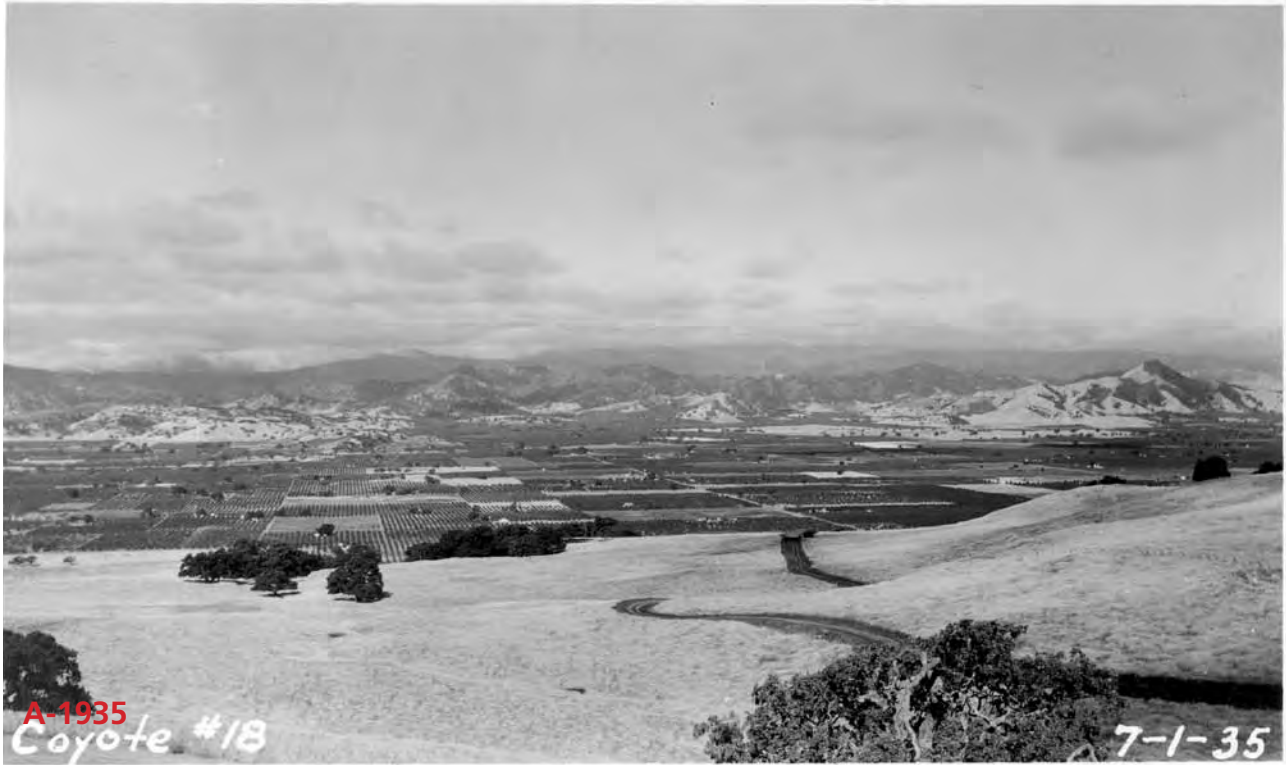
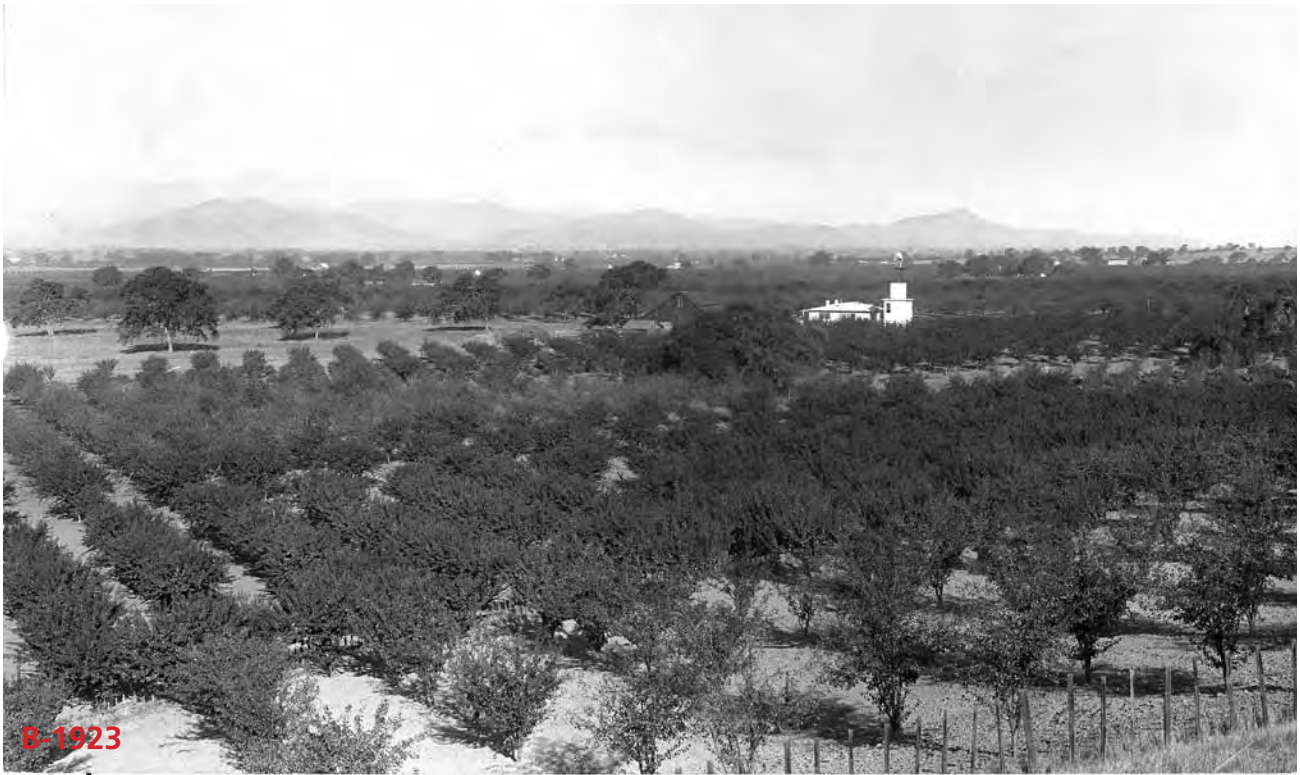
Figure 6.14. In the 1935 image (A), orchards cover most of the formerly wooded Morgan Hill area. Remnant isolated trees are mostly associated with farm homesteads. In the far right background, and in the picture below, groups of oaks can be seen in remnant pasturelands. (A: Unknown 1935, courtesy of the Santa Clara Valley Water District; B: Unknown ca. 1923, courtesy of the Gilroy Museum)

The conversion to orchards resulted in a dramatic loss of valley oaks during this period. By the beginning of the 20th century, in most of the former oak lands only scattered trees remained along orchard margins or as remnant stands within homesteads or small pastures (fig. 6.14). Fortunately, several large ranches, such as the Dunne Ranch in the Morgan Hill-San Martin area, were subdivided relatively late (Harrison ca. 1888, Sharma 2005), allowing them to be documented in landscape photography of the 1890s (see

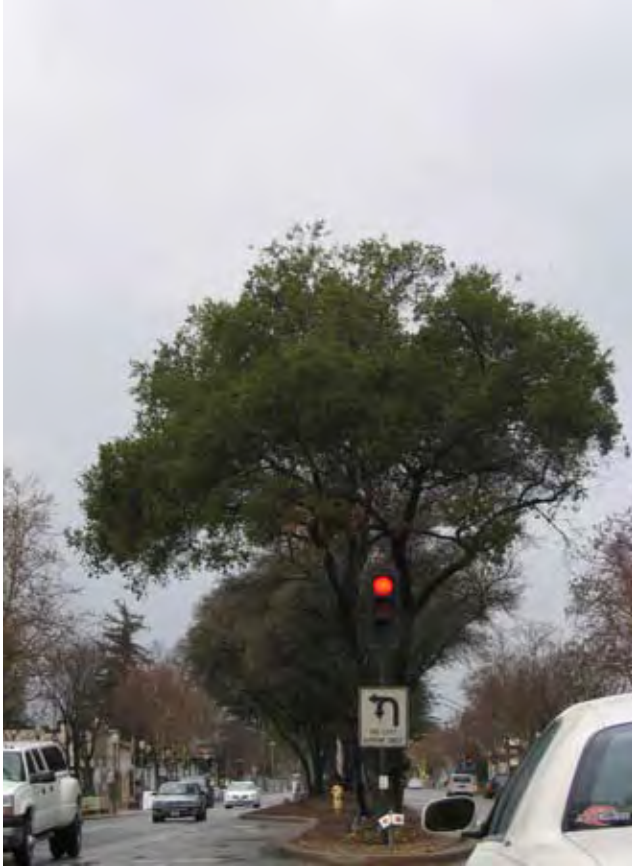
Figure 6.16. Street medians in Morgan Hill are frequently planted with live oaks because of their ability to tolerate the harsh site conditions.

The oaks represent a significant part of the cultural and natural heritage of the region. Some modern land uses, including residential housing, pose less direct conflict with oaks than do orchards. While oak trees compete with orchard trees for sunlight, oaks can function as shade trees and aesthetic features within urban and residential settings. Valley oaks and live oaks are recognized as suitable street trees in a number of California cities (e.g., Los Angeles, Davis, Morgan Hill) and, because of their size, are particularly effective for medians, yards, and parks. The city of Morgan Hill has successfully planted live oaks in medians for a number of years because of the trees' tolerance of drought and high temperatures (Beale pers. comm.; fig. 6.16). The utility and cultural appeal of the oaks have been noted for over a century:

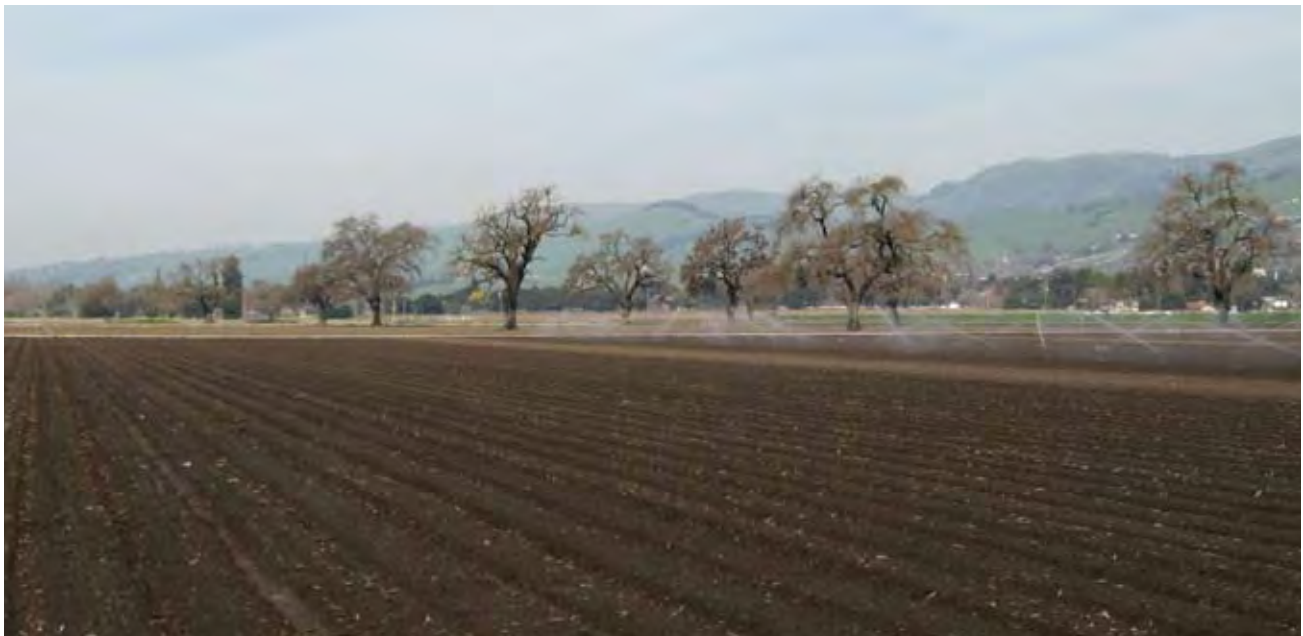
162 Figure 6.17. This rare group of valley oak trees east of Gilroy has been preserved through a century or more of agricultural land use. However, there is no evidence of recruitment and more intensive irrigation practices may be deleterious to the continued persistence of existing trees.

Despite their relatively sparse coverage in terms of percent canopy cover, oaks have a comparatively dominating presence in the landscape. While their numbers have declined dramatically since the 1860s, the majestic oaks of the valley have been much appreciated through the history of south Santa Clara Valley and remain well-recognized today. Remnant trees of the former savannas and woodlands are carefully preserved in yards, parks, housing developments, and even warehouse districts (fig. 6.15). A few larger stands can still be found in agricultural fields (see fig. 6.17) and on parcels of undeveloped land on the valley margins.

impossible. The trend towards more intensive summer irrigation in parts of the valley is likely to have negative effects on existing oak populations (fig 6.17). Development pressures also threaten existing trees. Without active stewardship to recruit new trees and conservation measures for those that exist, valley oaks are likely to disappear almost completely from the valley floor in coming decades as older trees die naturally or are removed.

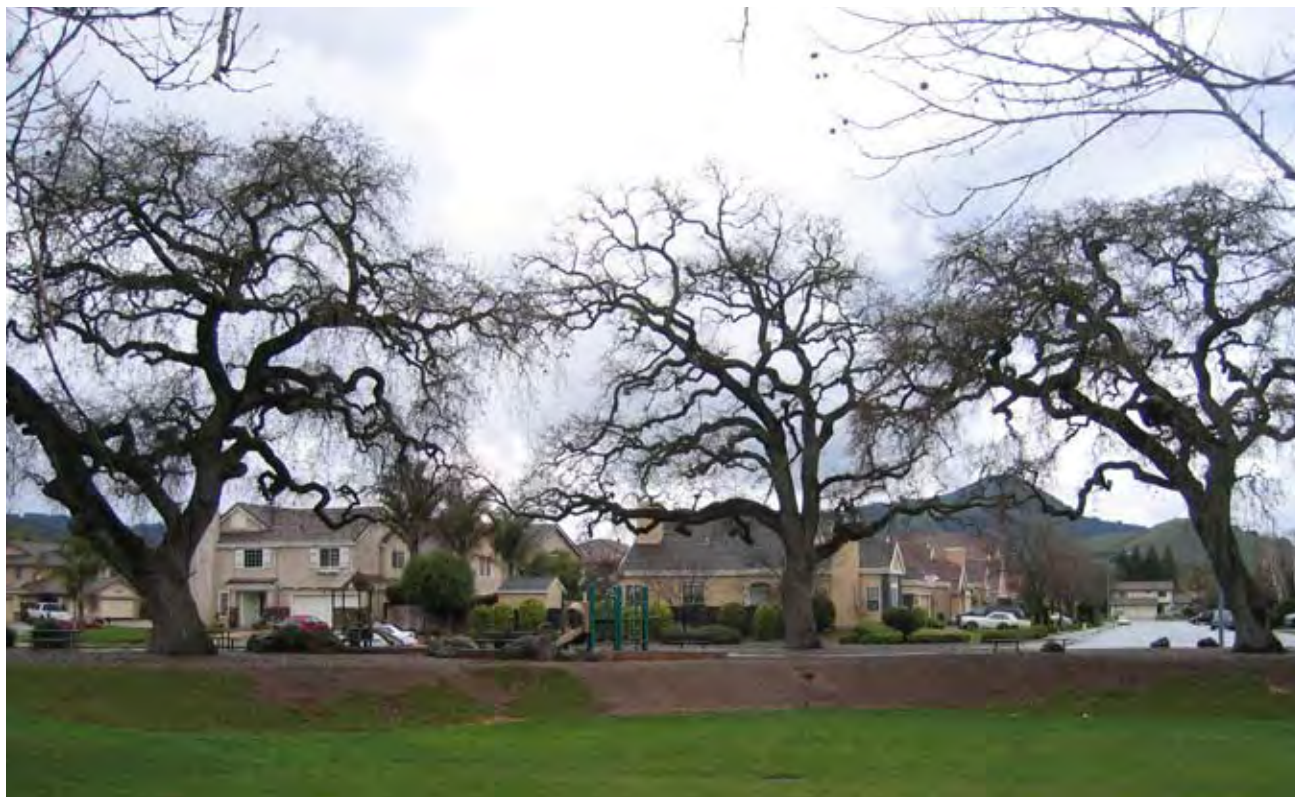
Figure 6.18. While these valley oaks in a Morgan Hill residential community have been well preserved and are fortunate to have some immediate neighbors, the lack of younger trees suggests that the future of the local valley oak population is uncertain.

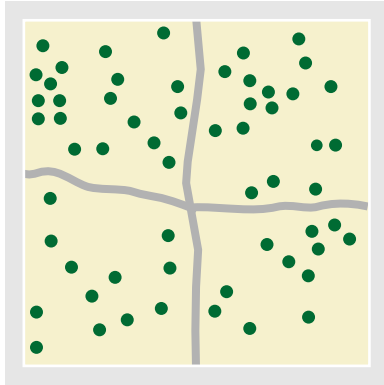
Circa 1800: Valley oaks occur in varying densities. Visitors identify dense groves, areas of "scattered" trees, and open "glades." Dirt roads go around trees and, for the most part, so do ranching and early agricultural activities.

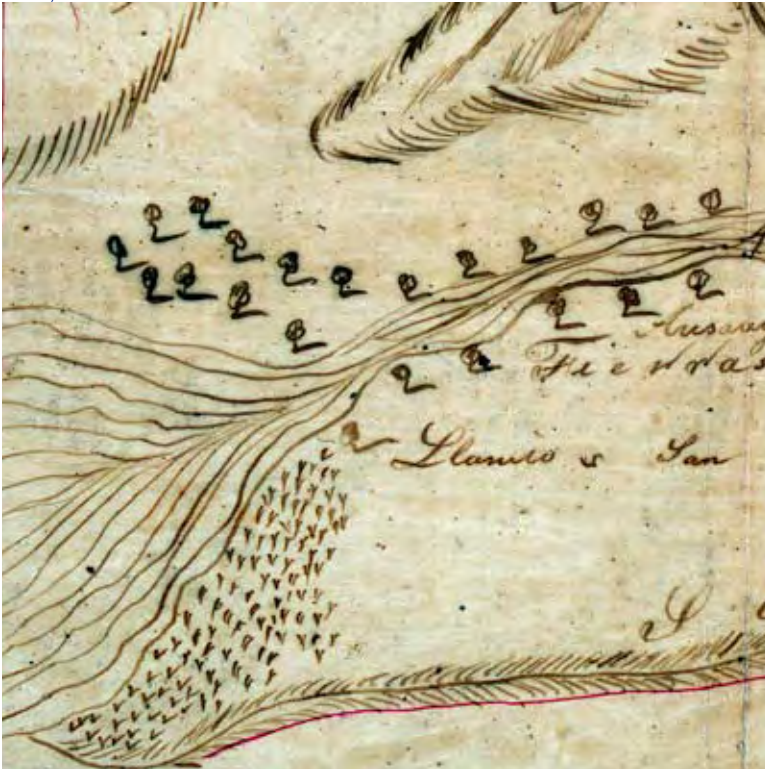
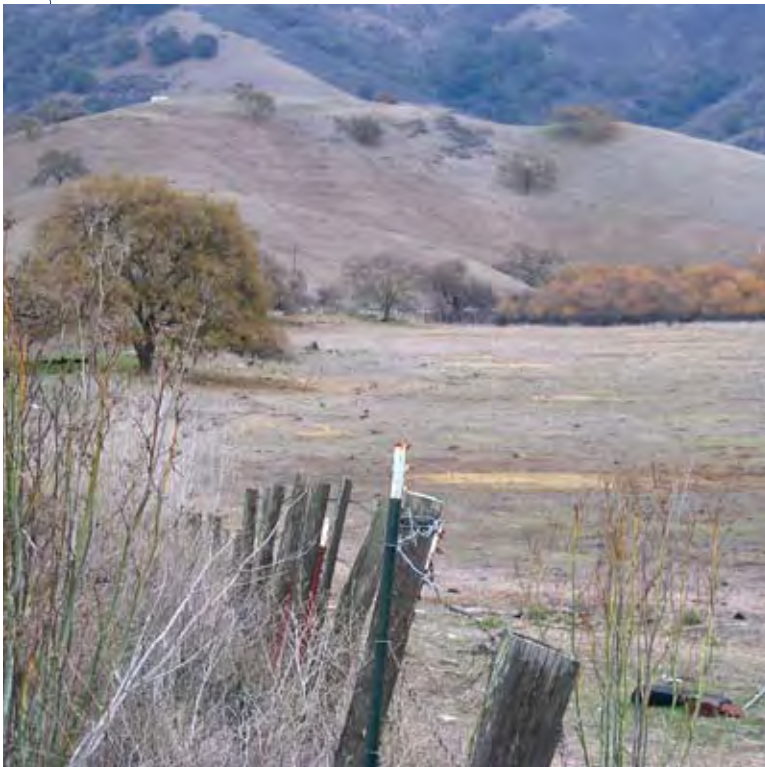
Above. Diseño showing willows and marsh along Pacheco Creek and San Felipe Lake. *Below.* A Valley oaks occupies alluvial deposits, slightly above the broad, flat, low basins (historically alkali meadow). Willow groves at the clay soil margin may be seen in the background.

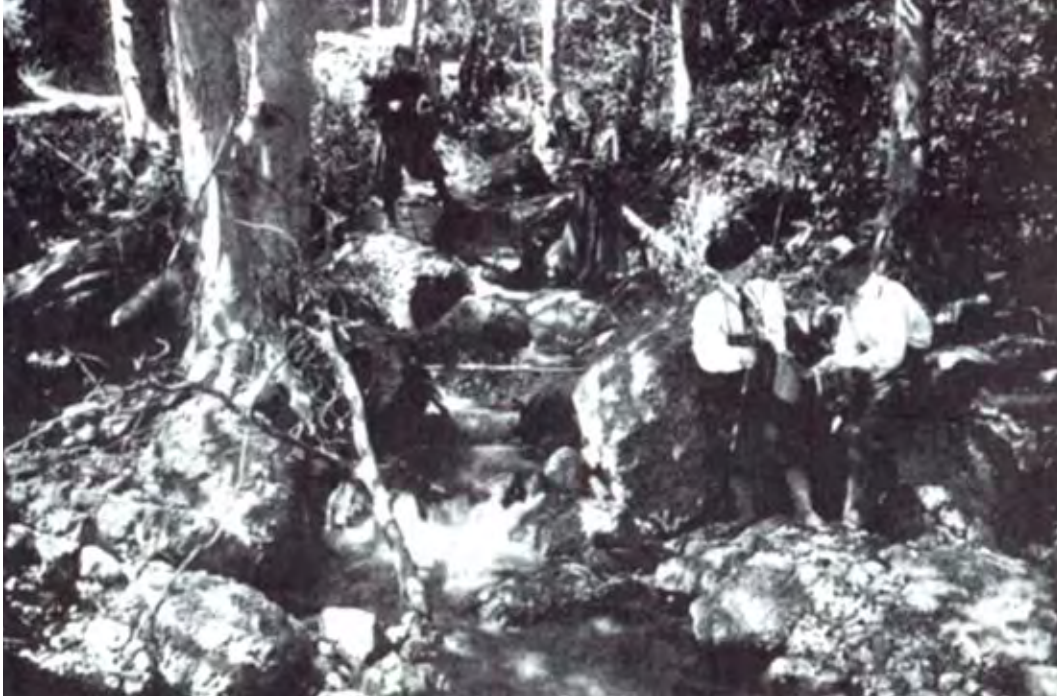
Figure 7.6. A photograph titled "Fishing on Llagas Creek," illustrates a dense riparian canopy with alders in a rocky stream bed on upper Llagas Creek. (Unknown ca. 1896d, courtesy of History San José)

habitat varied along a corresponding gradient from canyon to canyon mouth to the open alluvial plain (fig. 7.6). On smaller streams, a narrow line of trees at the top of the alluvial fan rapidly gave way to occasional trees or no riparian trees. Larger streams rapidly shifted from forest to woodland to open, sycamore-dominated riparian savannas as they reached the valley floor. Subsurface flows supported these sycamore savannas. The extent of persistent summertime fish pools is not known, but it is clear that they were common in at least some areas and supported substantial native fish resources.

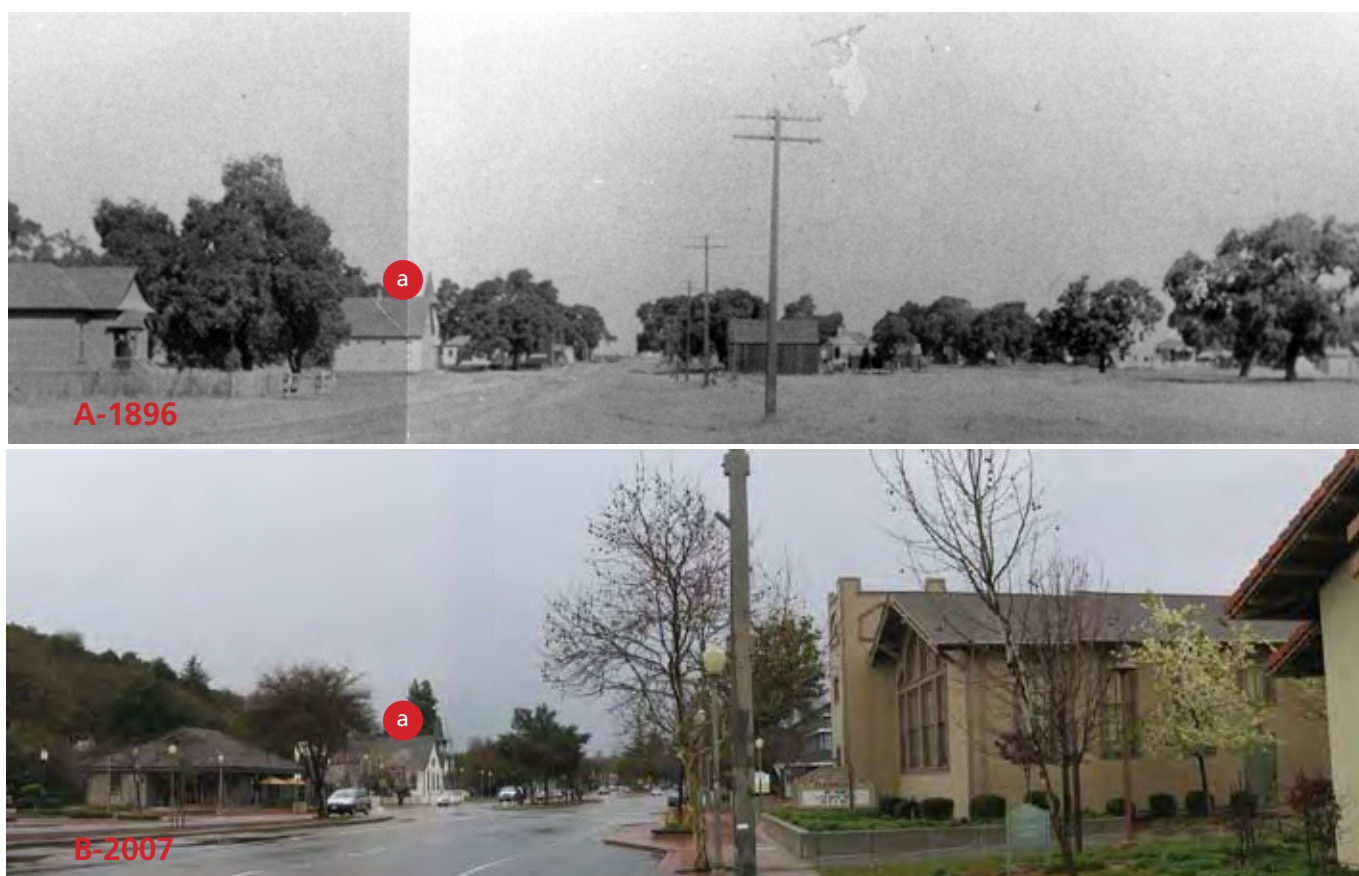
Figure 7.7. The 1896 view looking north along Monterey Road on July 25 shows some of the oaks remaining at that time (A). While few can be seen in the image from the same vantage point today (B), several large old trees are still found in Morgan Hill and younger live oaks can be seen in median strips along Monterey Road. Knob Hill, the vantage point for several of the Morgan Hill landscape photographs in Chapter 7, is on the left, behind the church which can be seen in both photos (a). (A: Unknown 1896, courtesy of the Morgan Hill Historical Society)

GLO surveyor Richard Howe (1851) described this area as a woodland, containing “low, mossy oak timber,” and landscape photography also shows closely spaced valley oaks (figs. 7.7 and 7.8; see Chapter 6). Progressing south toward the finer soils of the valley floor and higher

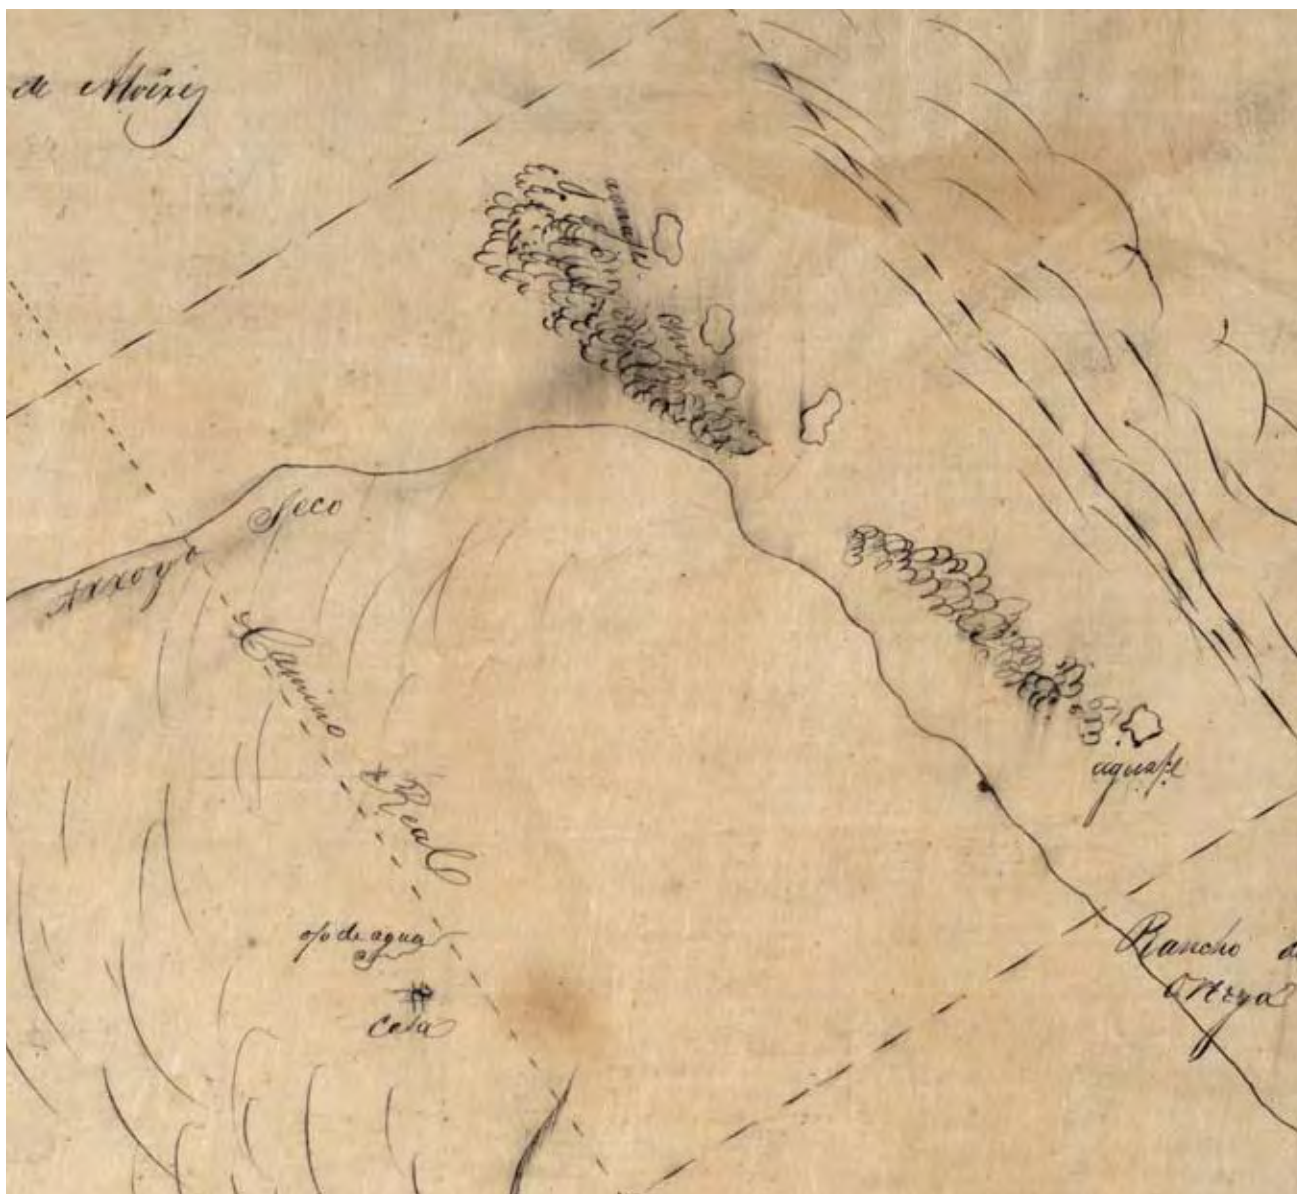
Figure 7.9. This 1840s *diseño* shows a series of *aguajes* (a potable water supply or spring) along Llagas Creek (here labeled “Arroyo Seco,” or dry creek) as it turns south along the valley floor. One is labeled “aguaje chupadero,” indicating saline conditions. Unlabeled vegetation is shown surrounding the *aguajes*. (U.S. District Court, Northern District [184-?]d, courtesy of The Bancroft Library, UC Berkeley)

early (1840s) map of the area, appear to have been part of a larger wetland complex (fig. 7.9). This map suggests that the aguajes were surrounded by (undefined) wetland vegetation and included multiple ponds. The top aguaje on this map is labeled "aguaje chupadero." Gudde and Bright (1998) defines "chupadero" as "a brackish pool where animals come to drink," implying that at least one of the aguajes shown was saline.

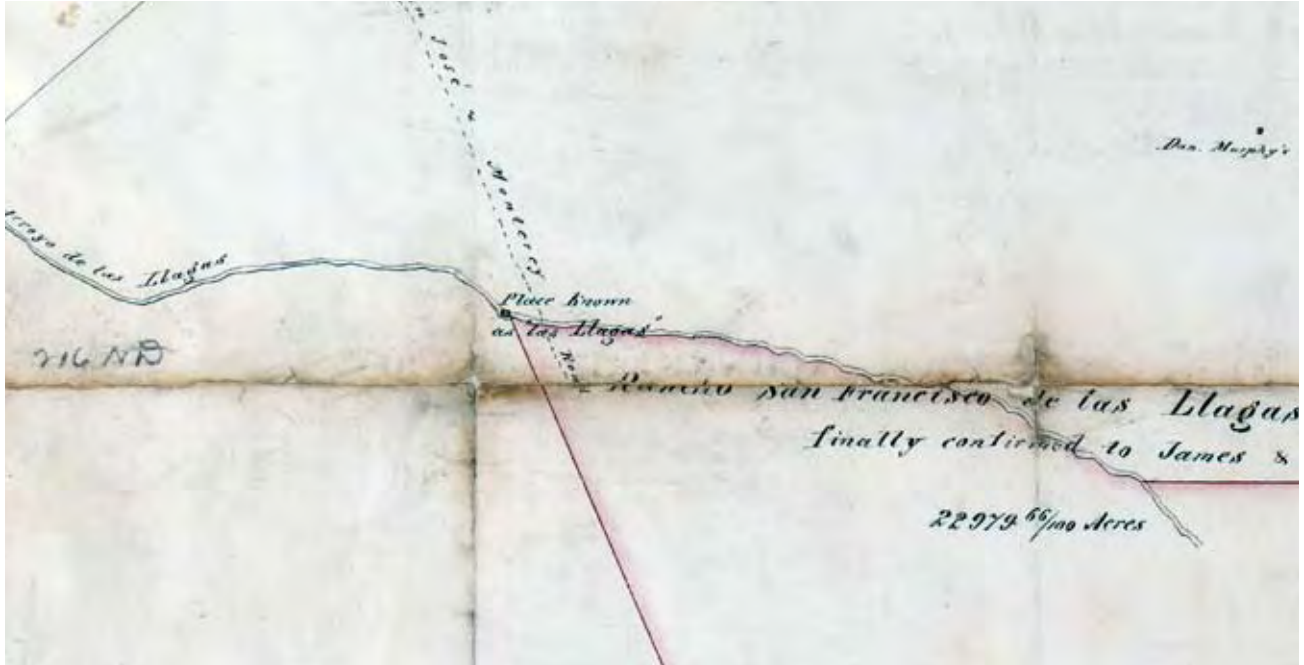
Figure 7.11. This early map shows the renowned pools (here labeled "Place known as 'las Llagas'") on Llagas Creek near the historical El Camino Real crossing. (U.S. District Court, Northern District 1860, courtesy of The Bancroft Library, UC Berkeley)

Just north of the low spur of hills jutting into the valley north of San Martin, and west of Monterey Road, was the “Poza de las Llagas” (the las Llagas pool). The place was so central as a stopping point and water source along Monterey Road that it was also referred to simply as “Las Llagas” (referring just to the poza, not the entire creek; fig. 7.11):

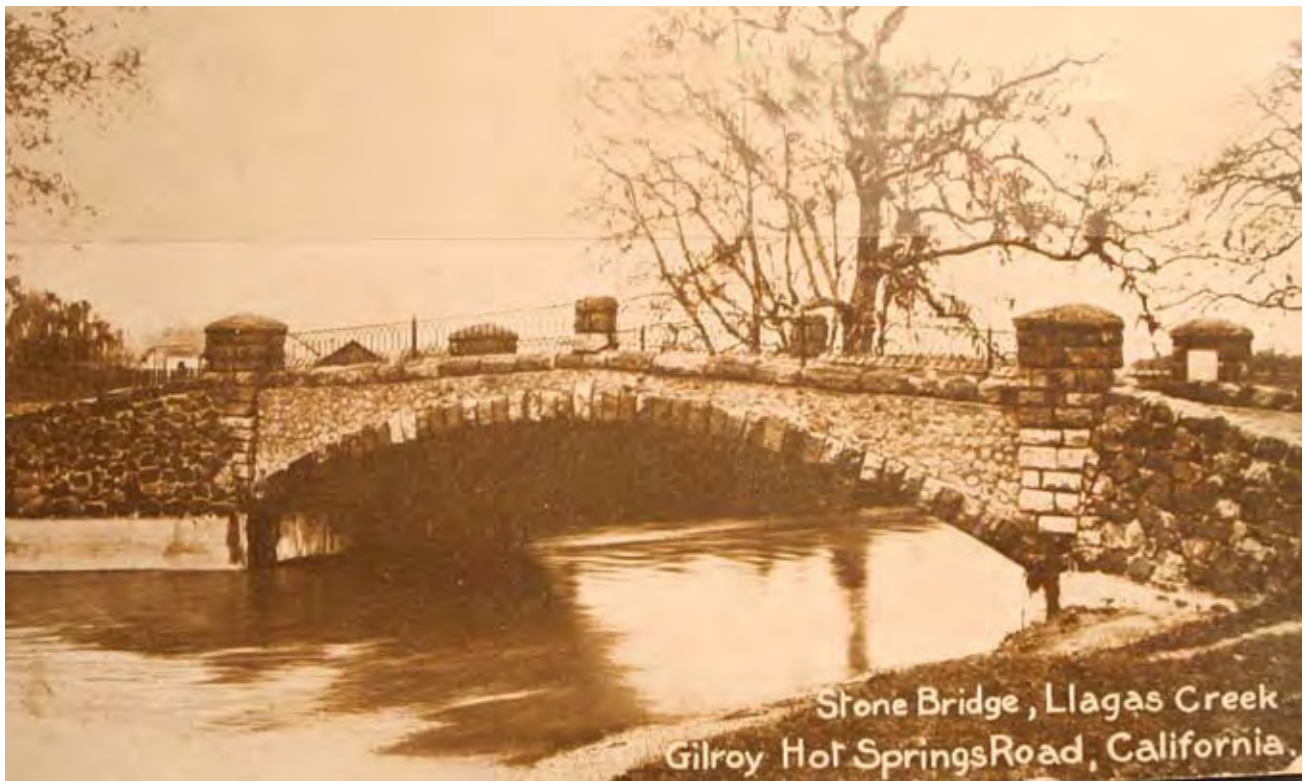
Figure 7.12. Llagas Creek, ca. 1908. This postcard shows the creek flowing in the winter with a sycamore without leaves on the bank. Gilroy Hot Springs Road presumably refers to present-day Leavesley Road. (Unknown ca. 1908 (Neg. no 13764), courtesy of the California Historical Society)

Further south, beyond the dominant effect of the Coyote Creek fan, the valley was shaped by smaller alluvial fans from tributary creeks and narrow strands of higher land following present and former natural levees of Llagas Creek. For example, lowlands lay along both sides of the present Llagas Creek position, forming long wetland strands stretching for several miles. Old Gilroy was located on a natural levee of Llagas Creek, but the city was moved to even higher ground along the Carnadero to the east around 1869. A lobe of Carnadero Creek's alluvial sediment blocked Miller Slough-lower Llagas Creek's drainage into Pajaro River, causing even more extensive wetlands to form. Llagas Creek shifted from a braided channel to a meandering, single thread channel (fig. 7.12), before spreading into sloughs and distributaries in the vicinity of Pacheco Pass Road.

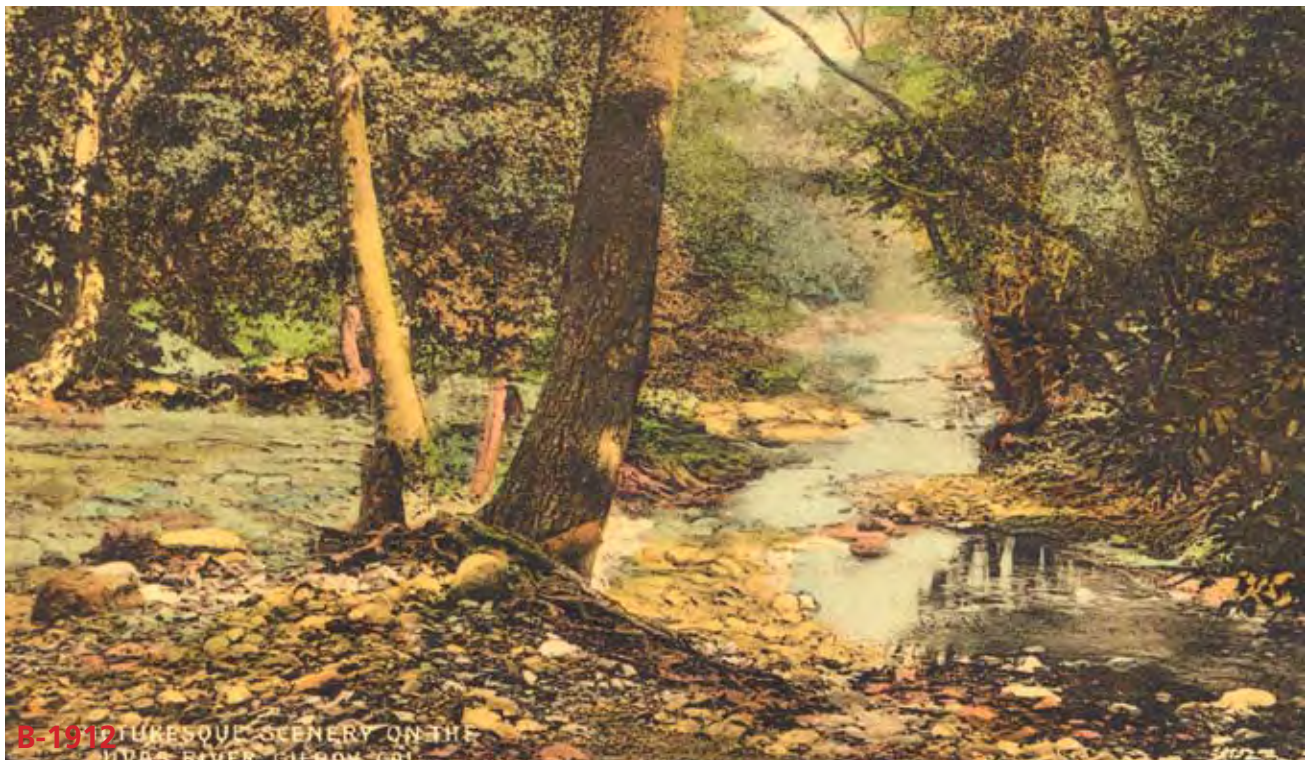
Figure 7.13. Uvas Creek, which historically referred to the reaches upstream of the Bodfish Creek confluence, is shown as a relatively densely vegetated, perennial stream in these two images. "Scene on Uvas Creek" (A), taken near Adams School in the vicinity of Adams-Chitactac County Park, shows large pools in the foreground and background, with a shallow riffle in between. An undercut alder can be seen on the bank at left. (A (Unknown ca. 1930) and B (Unknown ca. 1912b): courtesy of the Gilroy Museum)
