FINAL REPORT

SOUTH SANTA CLARA VALLEY HISTORICAL ECOLOGY STUDY

INCLUDING SOAP LAKE, THE UPPER PAJARO RIVER, AND LLAGAS, UVAS-CARNADERO, AND PACHECO CREEKS

PREPARED FOR THE SANTA CLARA VALLEY WATER DISTRICT
AND THE NATURE CONSERVANCY
MAY 2008

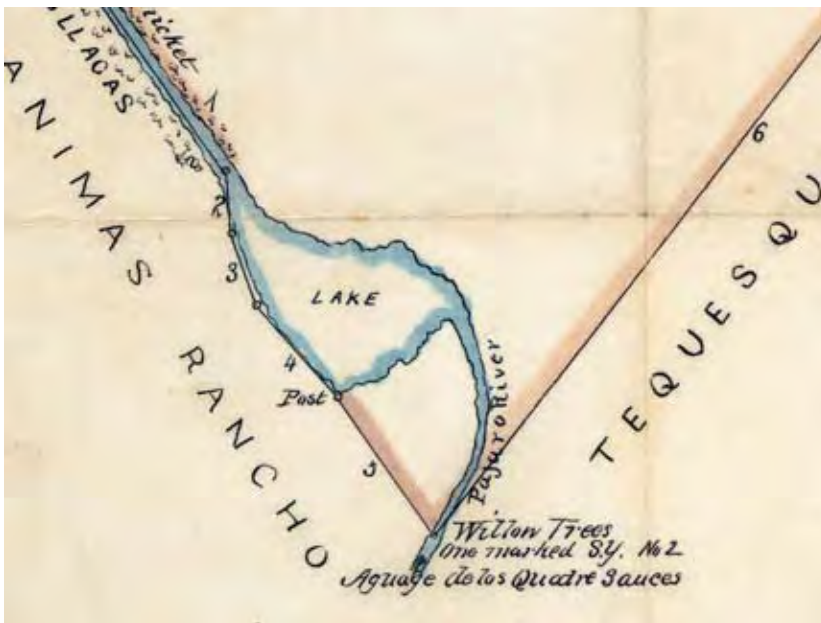
Figure 7.15. This map, from a March 1858 survey (Wallace 1858a), shows a schematic version of the connection between Pajaro Lake and the head of the Pajaro River. Here, the lake is shown as a connecting feature between the mouth of Llagas Creek and the origin of the Pajaro River. (Courtesy of The Bancroft Library, UC Berkeley)

The nature of the connection between the Pajaro River and Pajaro Lake remains unclear. Some maps (e.g., Wallace 1858a; U.S. District Court, Northern District 1860; Geological Survey of California 1873) show the lake as the beginning of the Pajaro, with a clear connection between them (fig. 7.15). This would fit well with Day's (1854) label of "Pajaro Lake" - the role that San Felipe Lake, not Pajaro Lake, plays for the Pajaro River today. However, Lewis (1850b), describing the survey of the Las Animas Rancho, makes no mention of a connection; rather, he follows a "small tributary" off the Pajaro to the tributary's head before heading northwest through the "intervening marshy ground" where others recorded the lake. This small tributary at the head of the Pajaro was likely the "Arroyito or Aguage [sic] de los Cuatro Sauces" - the little creek or spring of the four willows, named for the landmark grouping of four willow trees along the Pajaro River and mentioned in the San Ysidro (Ortega) land grant case file (Gonzales 1833). It is possible that in some years or seasons, the lake and river were not connected, while at other times they were connected through a shallow channel or system of swales.

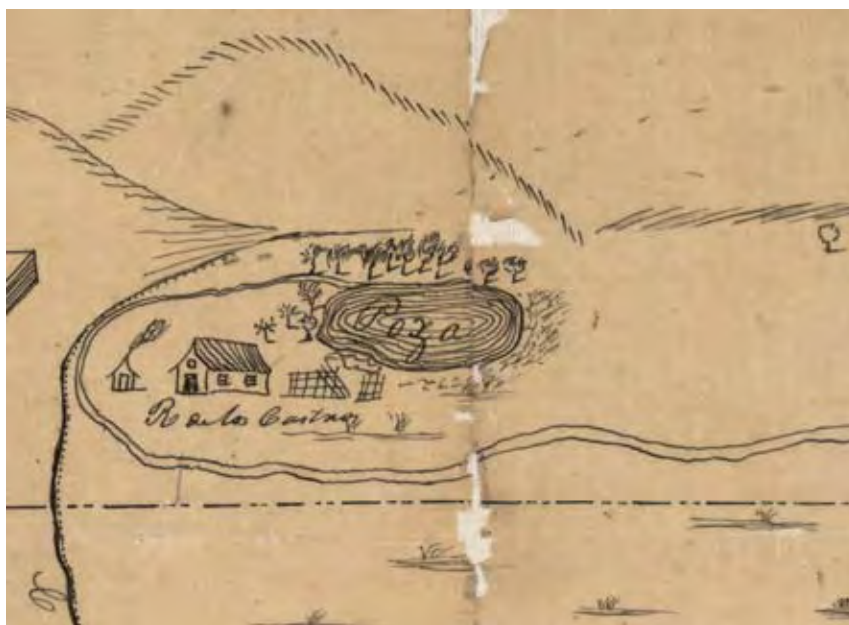
Figure 7.16. A detailed drawing of the "Poza de Carnadero" suggests surrounding wetlands and trees, as well as a direct connection to the creek. (U.S. District Court, Northern District [184-?]c, courtesy of The Bancroft Library, UC Berkeley)

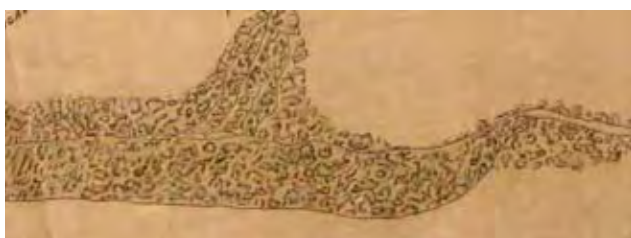
Figure 7.17. This close-up view of the Carnadero Creek willow grove shows multiple internal channels; such features were likely common in willow groves. (Herrmann ca. 1870, courtesy of the Office of the Santa Clara County Surveyor)

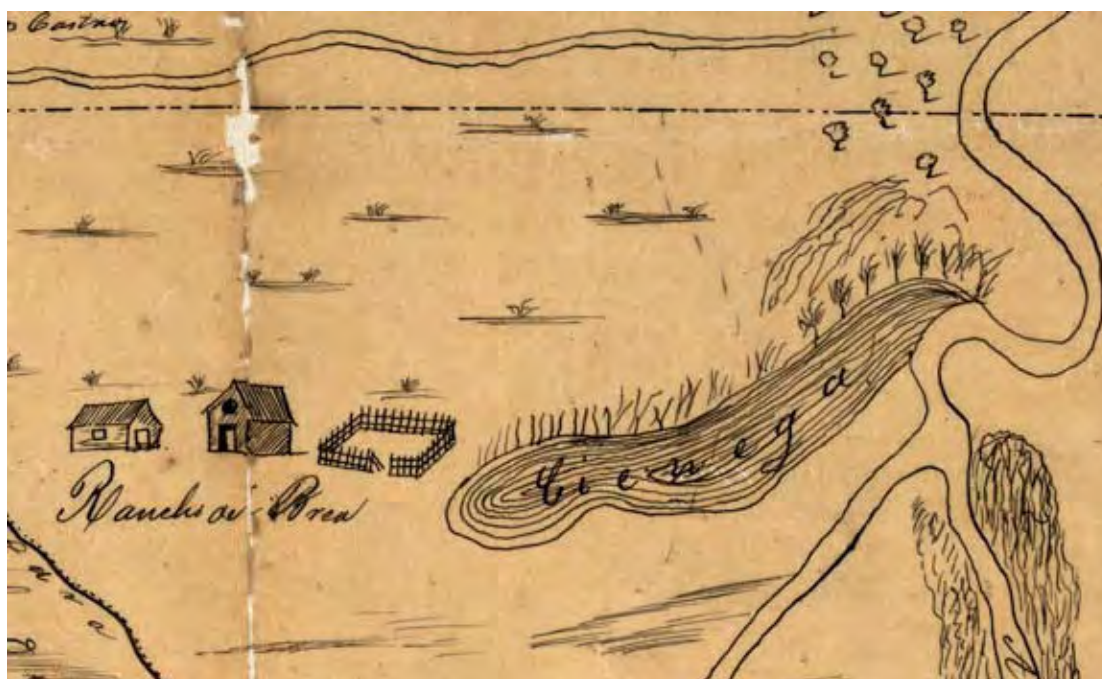
Figure 7.18. The ciénega, or freshwater marsh, near the mouth of Tick Creek. (U.S. District Court, Northern District [184-?], courtesy of The Bancroft Library, UC Berkeley)

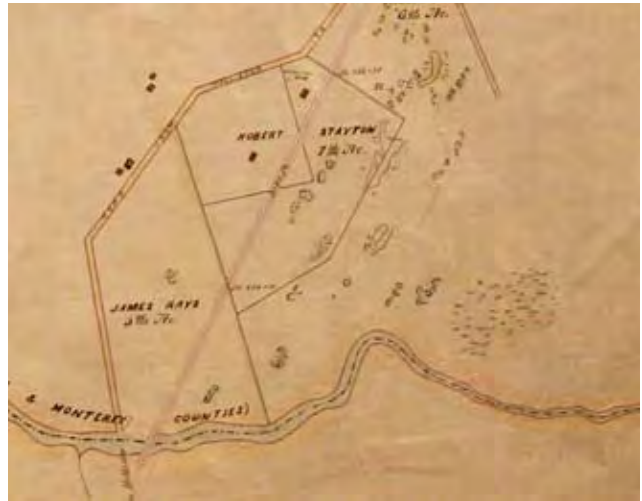
Figure 7.20. A detail from a ca. 1870 map of south Santa Clara County shows a series of willow groves, ponds, and wetlands northeast of the SPRR line (in red) and Bolsa Road (in yellow). These features likely marked a historical route of Carnadero Creek. A large wetland (indicated by a series of dashed lines) is shown at right. The Pajaro River runs at the bottom of the image. (Herrmann ca. 1870, courtesy of the Office of the Santa Clara County Surveyor)

Carnadero Creek to the Pajaro River, above the Carnadero willow grove, may provide a clue to the historical channel alignment. A series of elongate ponds with surrounding marsh and patches of willow grove are shown along this general alignment by Herrmann (ca. 1870; fig. 7.20). These may be remnants of wetlands along a defined Carnadero Creek channel, or may be evidence for a diffuse drainage of sloughs and wetlands that formed the bottom of Carnadero Creek. The odd angles of Bolsa Road in this area may have been designed to avoid these wetlands. Portions of the historical creek course may also have been preserved in the shape of a property boundary, shown by Thompson and West (1876) and Herrmann (ca. 1870). The oddly-shaped boundary follows the general trend of the willow groves, marshes, and ponds shown on the Herrmann map, and ends very close to the known location of the historical confluence with the Pajaro River.

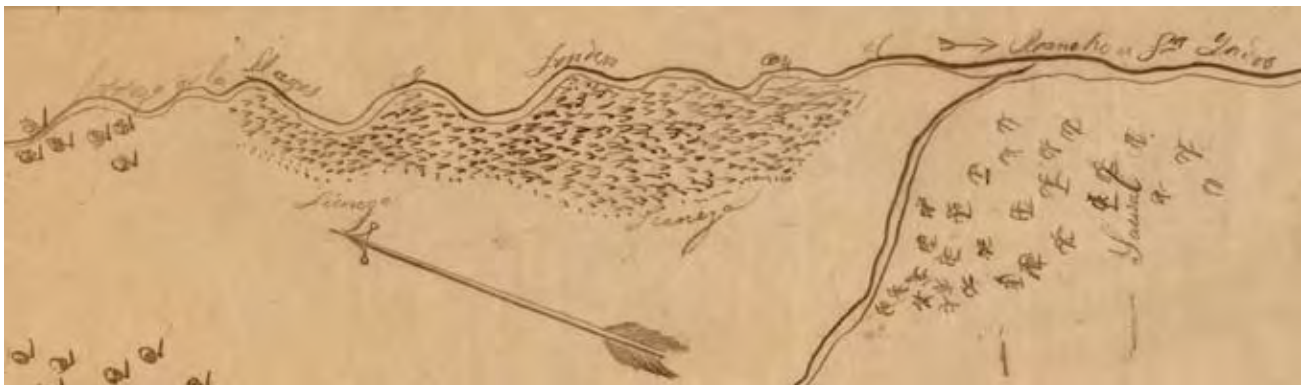
Figure 7.19. This early *diseño* shows Llagas Creek (horizontal, at top) and Carnadero Creek (vertical, at right). The large Carnadero Creek willow grove (labeled "sausal") is shown to the south of the old route of the creek. The large willow grove/wetland mosaic at the bottom of Llagas Creek (labeled "sienega [sic]") is shown with a different pattern than the Carnadero willow grove, indicating that the two features had distinct characteristics. Llagas Creek and Carnadero Creek are shown joining east of the Carnadero sausal, indicating that what is now called the Pajaro River – between the mouths of Llagas and Carnadero Creeks – was not associated with the Pajaro in the mid-1800s. (U.S. District Court, Northern District 1873b, courtesy of The Bancroft Library, UC Berkeley)

The earliest maps (Geological Survey of California 1873; U.S. District Court, Northern District 1873a,b) show Carnadero Creek continuing east to the Pajaro River, rather than turning south at Bloomfield Avenue (fig. 7.19). Instead of passing through the willow grove before joining with Tar Creek (as depicted in maps of the 1870s and 1880s), the old channel veered southeast just south of modern Bloomfield Avenue, departing from the current Carnadero Creek channel just south of where Lewis (1851) recorded that “the ‘arroyo del Carneadero’ begins to branch into several

Carnadero Creek flowing to the north of the large willow grove rather than through it (fig 7.19). These maps show the Llagas and the Carnadero joining east of the sausal, indicating that what is now called the Pajaro River (between the mouths of Llagas and Carnadero creeks) was much less clearly associated with the Pajaro River in the mid-1800s.

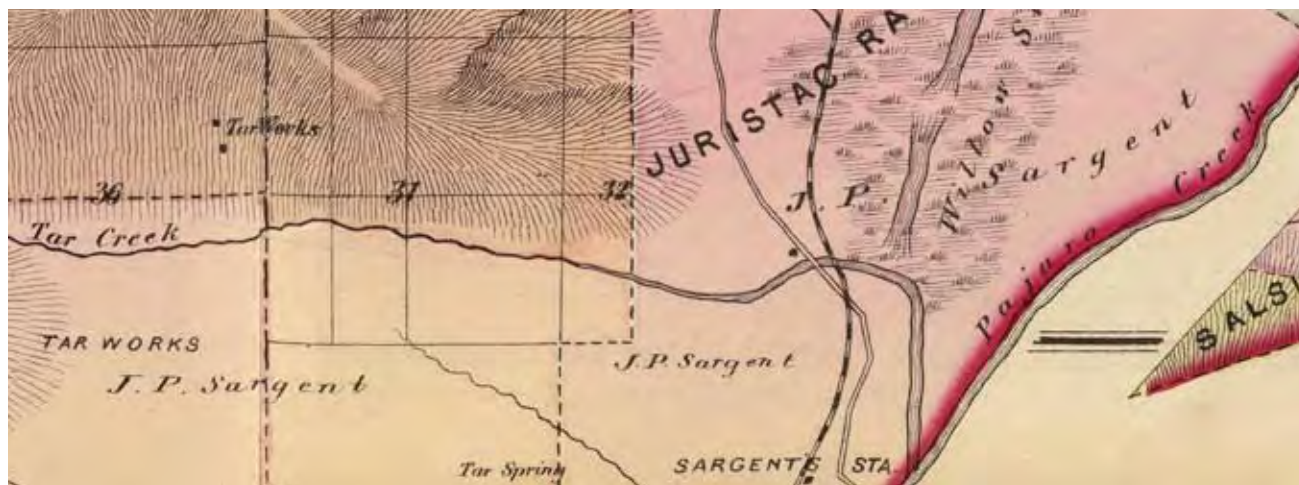
Figure 7.21. Historical evidence suggests that Tar Creek joined the Pajaro River near the present confluence of the Pajaro with Carnadero Creek. This Thompson and West (1876) map shows Tar Creek turning sharply south before joining the Pajaro. Carnadero Creek is shown to the north as broken, wide channels traversing the willow swamp. (Thompson and West 1876, courtesy of the David Rumsey Map Collection)

Thompson and West (1876) also show no confluence of Carnadero Creek with the Pajaro River. Instead, they show Tar Creek coming down from the west before veering sharply south at the bottom of the Carnadero willow grove to join the Pajaro River (fig. 7.21).

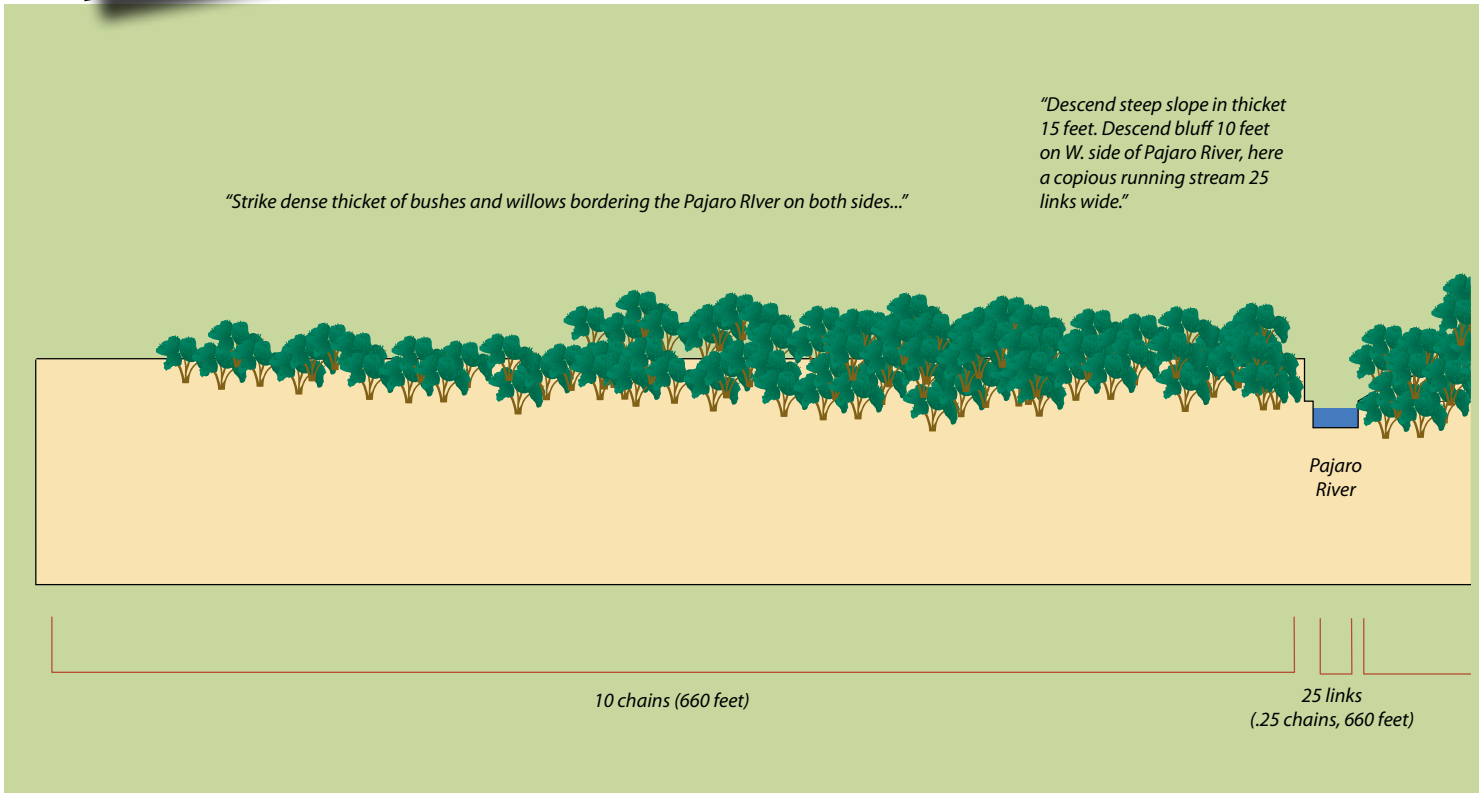
Figure 7.22. Riparian floodplain characteristics of the Pajaro River in 1854, as per Day’s 1854 survey notes (above left)

Day (1854) crossed the Pajaro River near its confluence with Tar Creek in 1854. He recorded both the channel geometry of the river at that point (with 3-5 m/10-15 ft steep bluffs, islands, ponds, and side channels) and the riparian vegetation along the floodplain (mostly dense willows). A detailed diagram of the river’s characteristics at this point is shown in fig. 7.22.

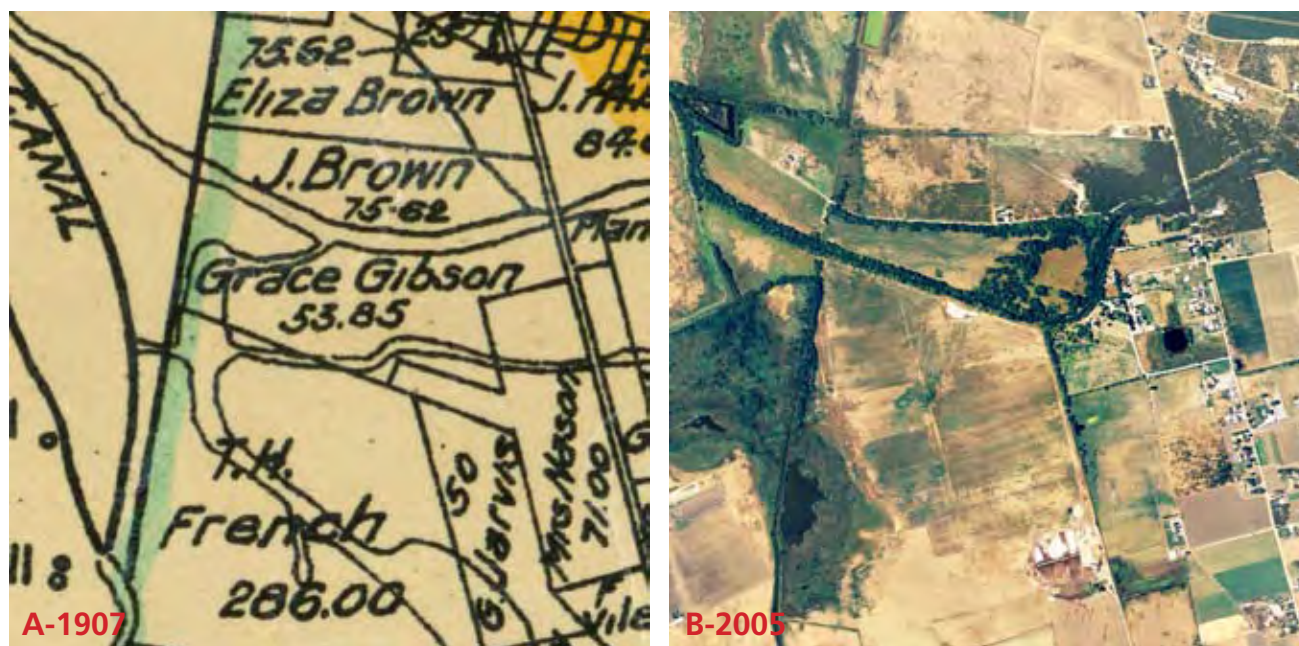
Figure 7.26. Remnants of complex slough patterns from 1907 (A) still function in 2005 (B). The boundary between Brown and Gibson appears to have been a slough; that boundary is still visible today. (A: McCray 1907, courtesy of the Earth Sciences and Map Library, UC Berkeley; B: USDA 2005, courtesy of NAIP)

Some evidence of historical sloughs is still visible in 1939 aerial imagery as well as in contemporary aerial photography. These residual features often correspond closely to the alignments indicated by historical maps, helping confirm the historical data. For example, sloughs entering the Tequisquita marshes from the east apparently served as the property boundary between two farms (McCray 1907) and now persist in the form of a narrow channel following the same alignment (fig. 7.26).

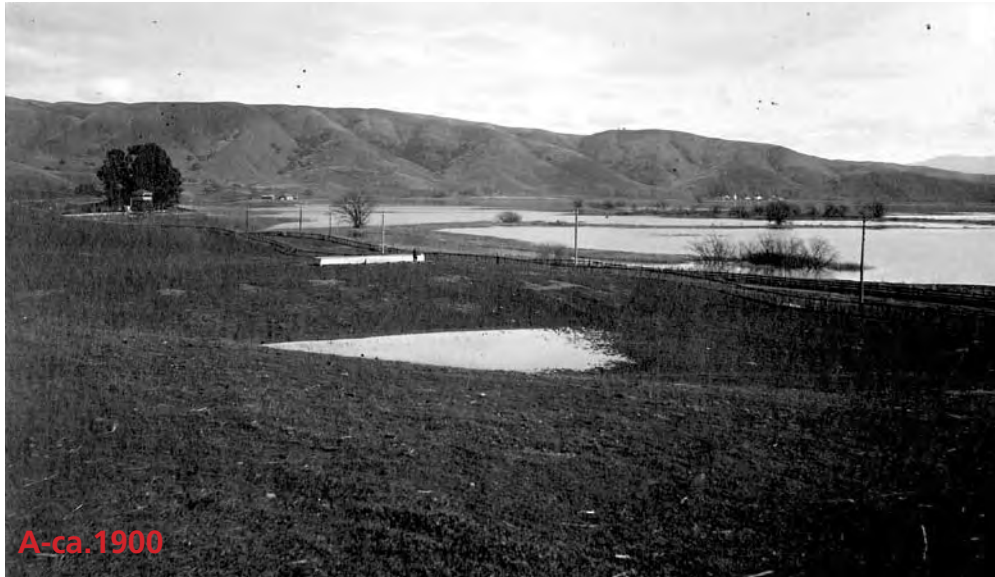
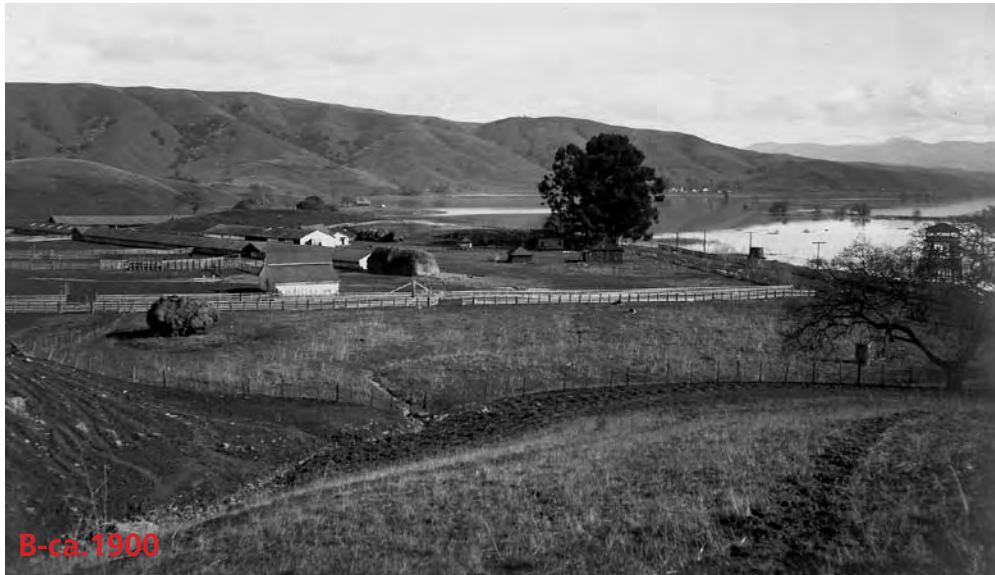
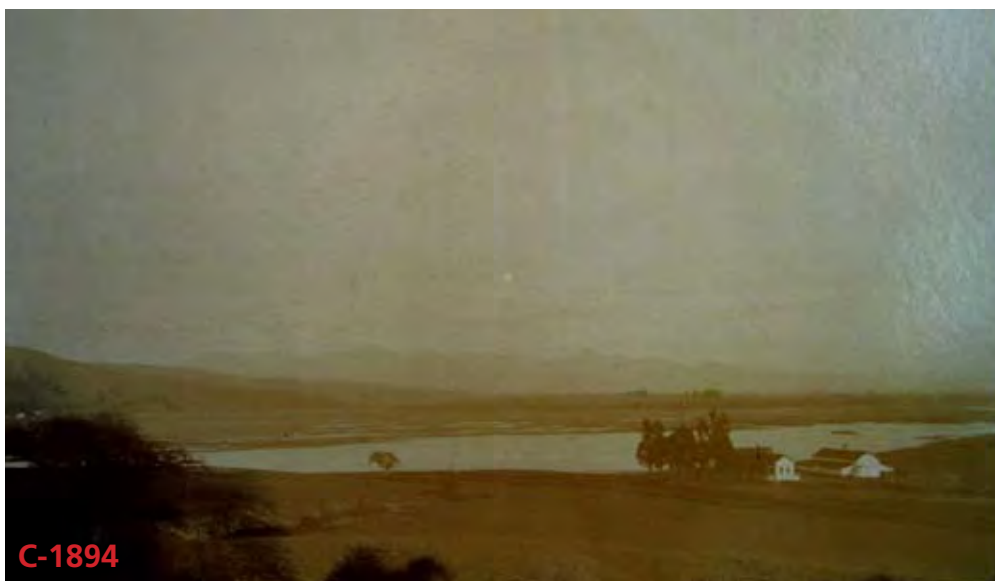
Figure 7.27. Three views of the Soap Lake floodplain from the northwest margin of San Felipe Lake. A and B were taken when the lake was in flood; submerged trees are evident. The lower image shows more average conditions, in 1894. While the image is somewhat indistinct, the white areas behind the far shore may be the sloughs and wetlands shown in 19th-century maps (see fig. 5.10). Parts of the lake's east (far) shore that are wooded today have no trees in the photograph, contributing to a picture of wetter conditions historically. (A (Unknown ca. 1900d) and B (Unknown ca. 1900e): courtesy of the San Benito County Historical Society; C: Unknown 1894b, courtesy of the Gilroy Museum)

large areas flooded north and east of the lake, extending nearly to the hills (fig. 7.27).

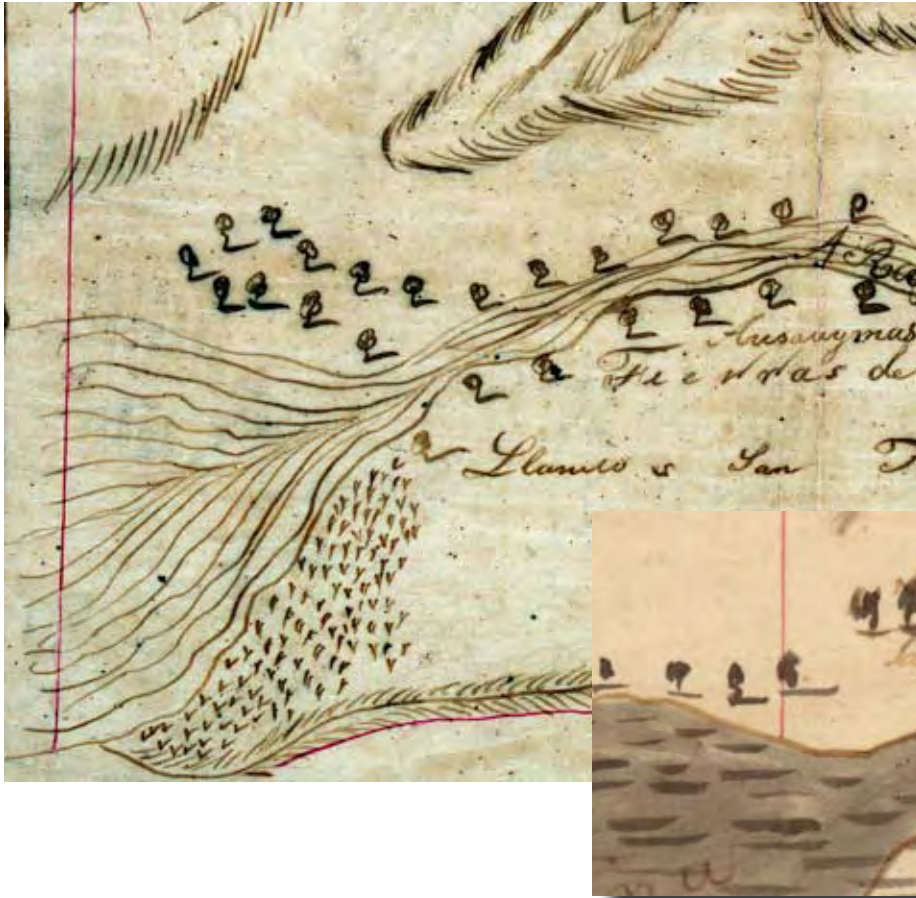
Figure 7.28. Riparian trees along Pacheco Creek give way to a willow grove (labeled “Sausal” in the inset), freshwater marsh, and open water, as the creek flows from right to left into the San Felipe Lake wetlands. Different versions of the same land grant map often show additional symbology or annotation that can help with interpretation. (U.S. District Court, Southern District [184-?]e and U.S. District Court, Southern District [184-?]d (inset), courtesy of The Bancroft Library, UC Berkeley)

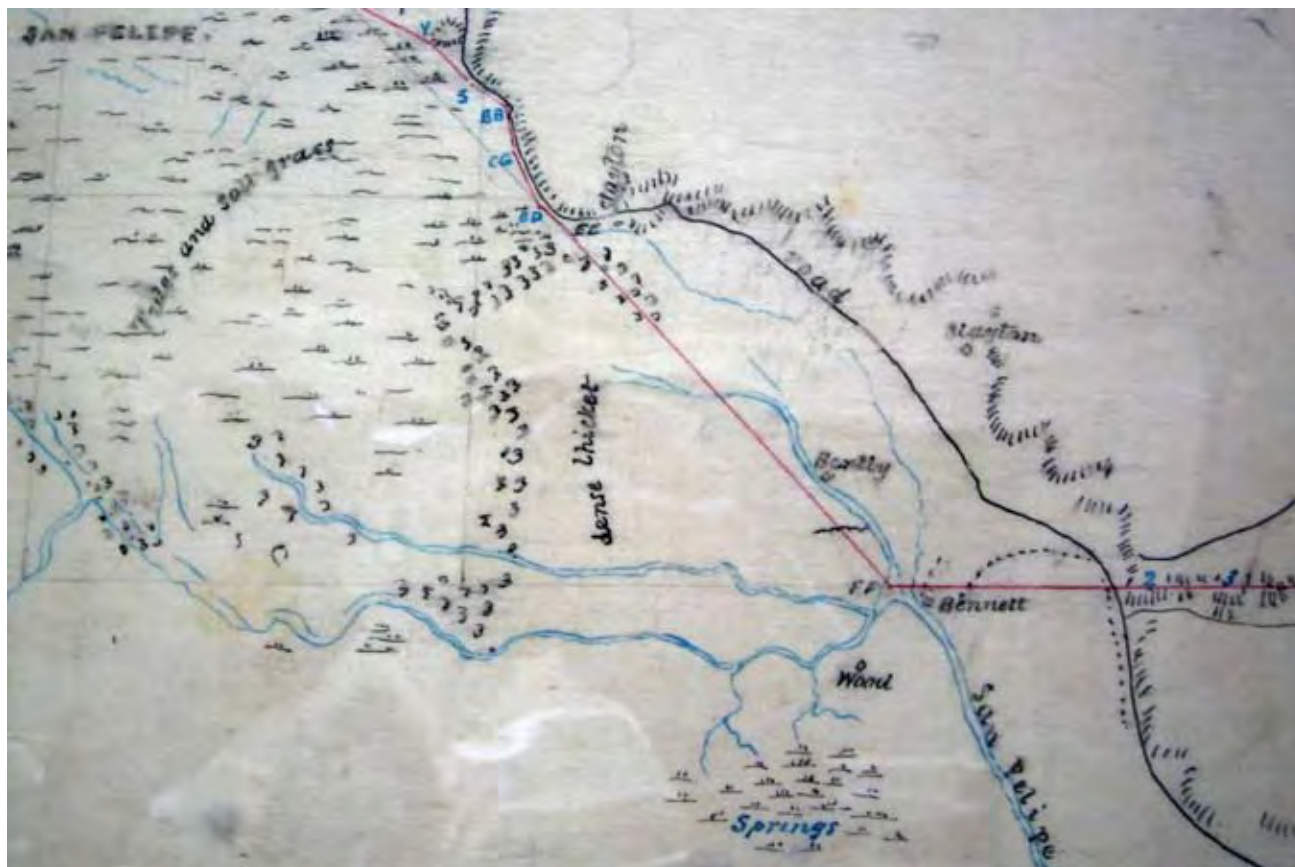
Figure 7.29. This portion of Healy’s 1858 map of the Santa Clara County line shows the spreading of San Felipe (Pacheco) Creek into the San Felipe Lake marshlands. (The edge of “Lake San Felipe” is shown at upper left.) Healy ran the boundary, drawn in red, around the edge of the “Tules and salt grass” and then made a straight line to the point at which the creek branched, before heading due east (on the right hand side of the map). The map also shows a spring-fed marsh (lower right) and willow groves, indicated by tree symbols and the phrase “dense thicket.” (Healy 1858b, courtesy of the San Benito County Recorder’s Office)

smaller channels (see fig. 7.29). Second, a significant channel appears to have initiated on the valley floor south of Pacheco Creek near Dunneville. This channel may have been a former Pacheco Creek channel during recent geologic times. In the historical era, it likely intercepted groundwater and surface runoff. Last, Tequisquita Slough connected to Santa Ana Creek and Arroyo de las Víboras and approached San Felipe Lake from the south.

There was a large area of valley freshwater marsh just west of Lovers Lane at Tequisquita Slough. Historically, Tequisquita Slough spread into this marshland, entering from the south. The land grant boundary between ranchos Llano de Tequisquita and Ausaymas y San Felipe, which follows the slough to this point, leaves the slough to follow a straight line northeast to the hills. Like the “mouths of Pacheco Creek” (see fig. 7.29), this point where the well-defined slough spread

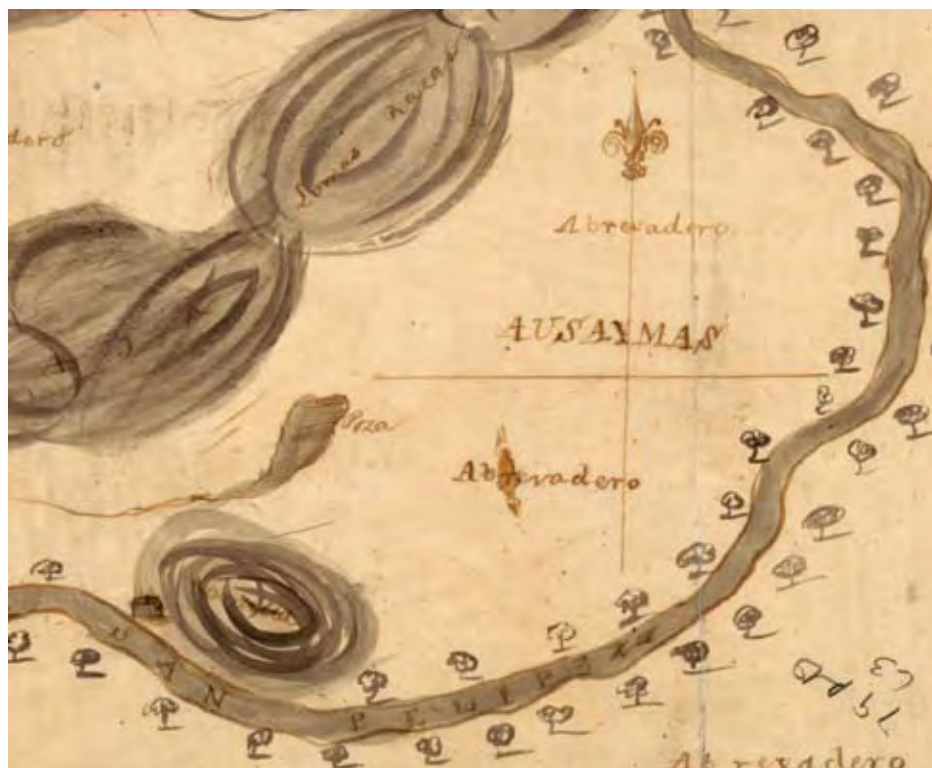
Figure 7.30. This circa late-1840s map shows a series of wetland-associated features between Pacheco Creek ("San Felipe") and the hills as the creek turns up into Pacheco Valley. An elongate poza (pool or lake) is shown, as well as large areas suitable for watering cattle (labeled "abrevadero"). (U.S. District Court, Southern District [184-?]d, courtesy of The Bancroft Library, UC Berkeley)

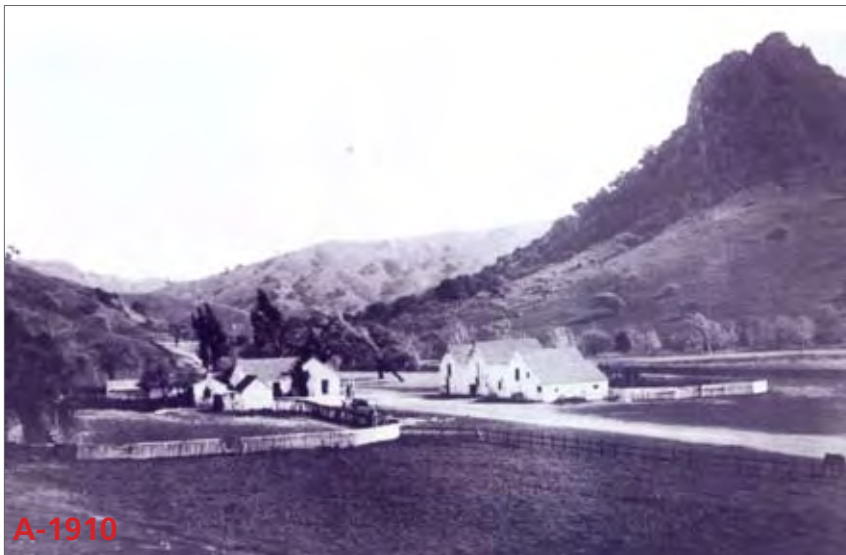
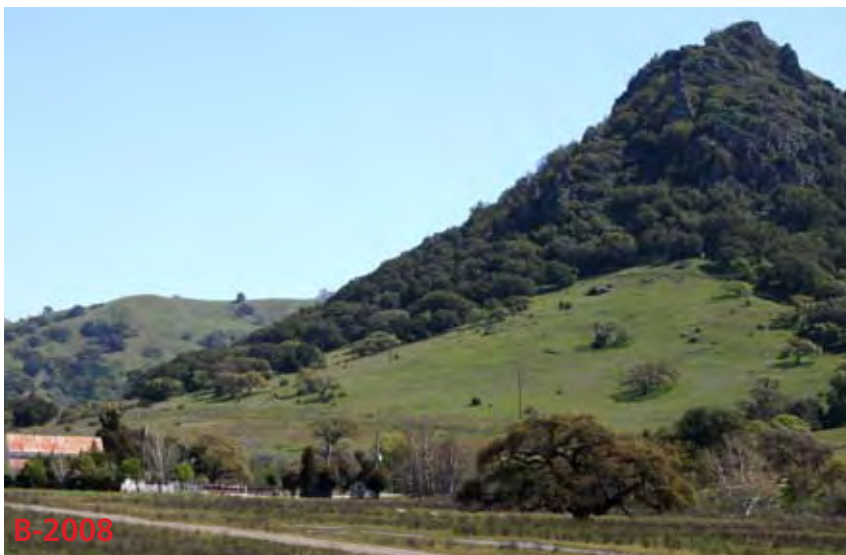
Figure 7.33. Pacheco Creek at Bell’s Station, ca. 1910 (A) and rephotograph, 2008 (B). Individual sycamore trees can be seen on the creek, which runs along the base of Lovers Leap (the prominent peak at upper right). (A: Unknown ca. 1910b, courtesy of the Gilroy Museum)

Above its confluence with Carmen Creek and below its split into north and south forks, Pacheco Creek was a broad, braided stream. The creek sometimes occupied nearly the entire valley floor with its multiple channels and broad, gravelly bars populated by sycamores and valley oaks (fig. 7.33).

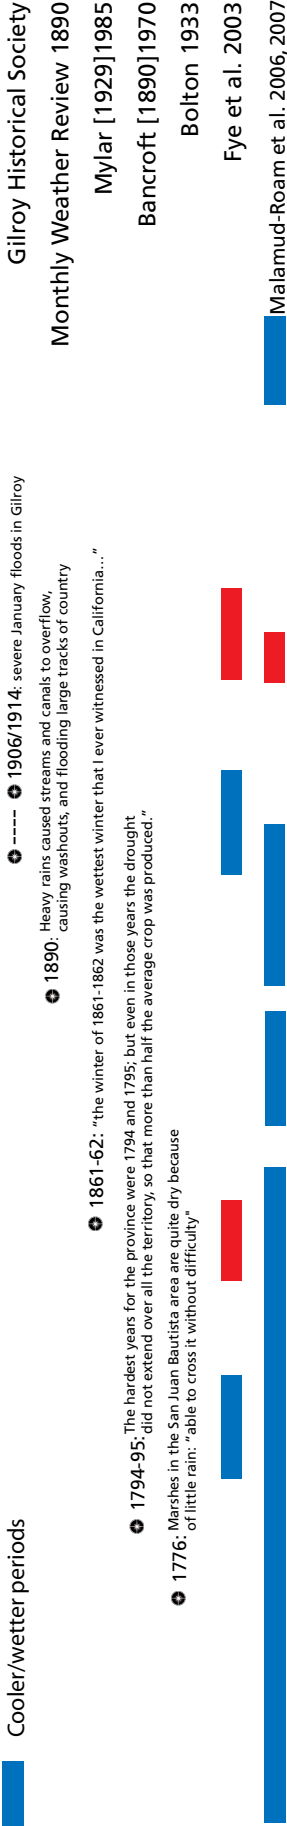
Figure C.2. Climate of the Historic Period: This diagram summarizes several lines of evidence describing the historical climate trends affecting the South Santa Clara County area. Rainfall records from Gilroy are depicted in the lower portion of the figure, and data from other climate proxies are illustrated via text and horizontal bars. Malamud-Roam et al. (2006, 2007) compared a large number of studies which utilized many different climate proxies, including tree ring evidence, accumulated sediment deposits, micro-fossil assemblages, geochemistry, and pollen cores. Fye et al. (2003) compared the Palmer Drought Severity index (PDSI) (based on nationwide tree ring evidence) with instrumental measurements of PSDI to reconstruct periods of decadal extremes in moisture regimes in the West. There is general agreement among the various proxies that outline trends of above and below average rainfall, incidents and periods of flooding and drought, going back thousands of years. These proxies yield year-to-year, decadal, and longer-scale information about moisture availability that span both historic and prehistoric eras. However, regional or larger-scale climate trends may not always reflect local conditions. For instance, analyses of sediment deposits may indicate an overall cool/wet period, but may not reveal small-scale punctuations of that period with extreme drought years. It is often preferable to use a number of proxies, including bay and lake sediments, flood plain stratigraphies, and instrumental data to generate localized historical climate information (Malamud-Roam & Ingram 2006, 2007). Local, testimonial evidence (several sample quotes are shown) can be used to refine a picture of specific, local impacts created by climate trends and events. Note: rainfall data for Gilroy prior to 1874 was extrapolated, via regression, from San Jose rainfall data using the formula $(\log_{10}(\text{Gilroy}) = 0.848 * \log_{10}(\text{San Jose}) + 319. \text{R}^2 = .73)$.
