Pinole Creek Watershed Sediment Source Assessment: Pavon Creeks Sub-Basin

July 2006

Prepared by the San Francisco Estuary Institute

**Contra Costa Resource Conservation District
And
USDA Natural Resources Conservation Service**

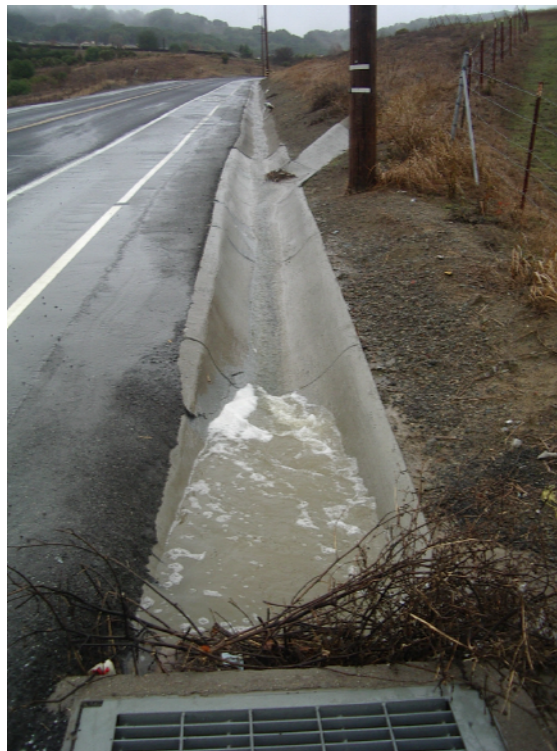
Figure 8. Photograph of runoff from Castro Ranch Road during a storm event.

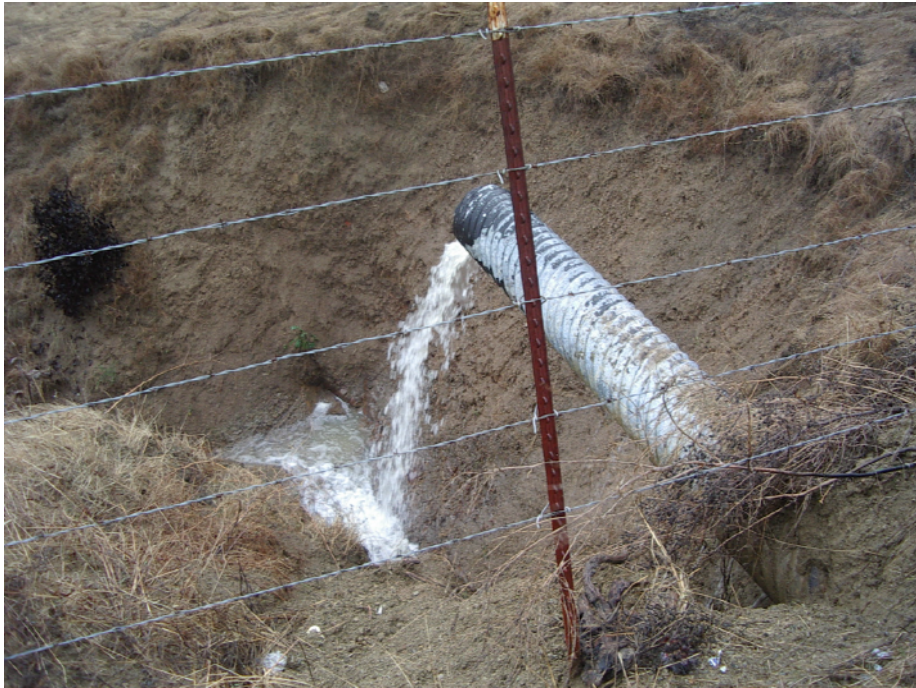
Figure 9. Photograph of the hanging culvert.

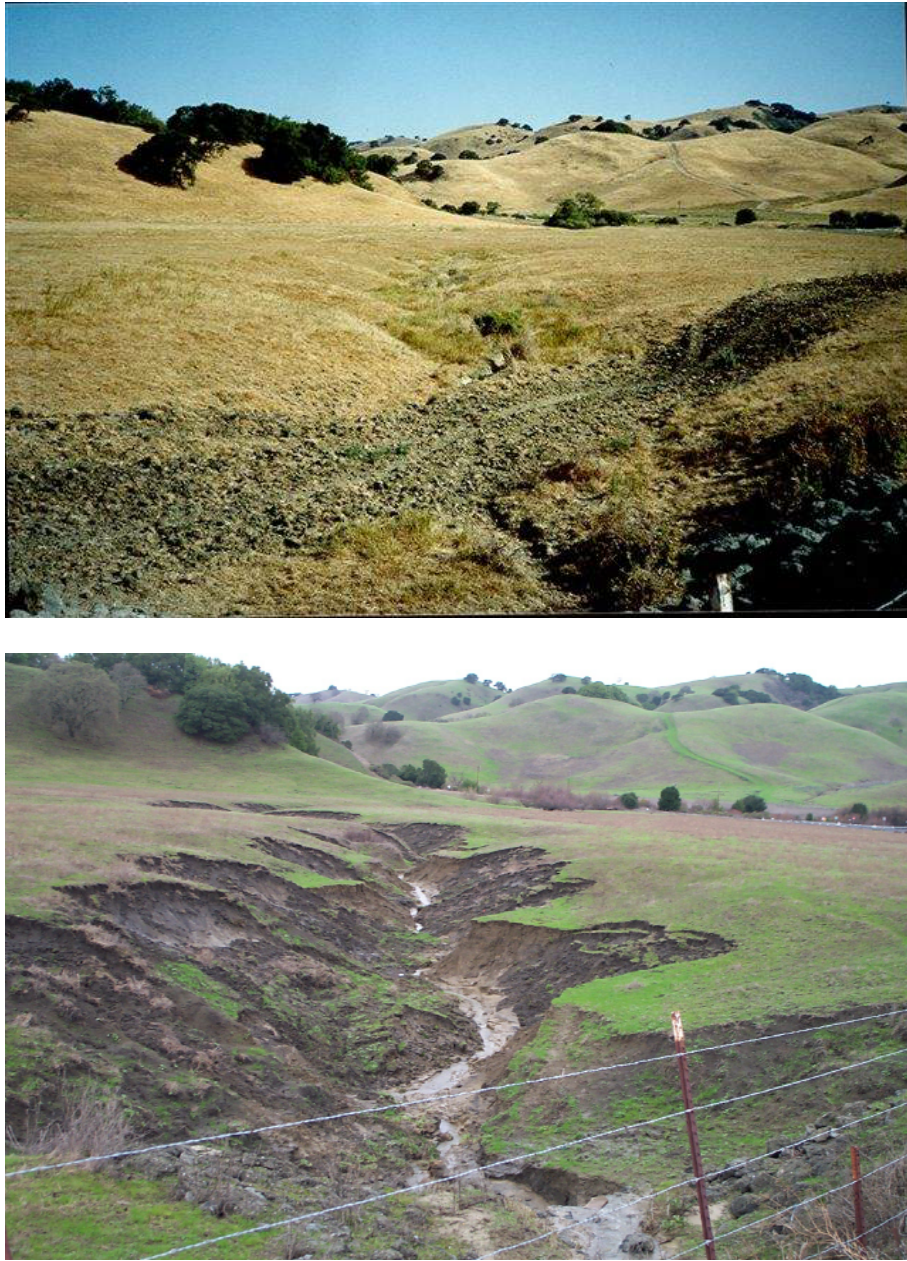
Figure 10. Photographic comparison of Gully A downstream of Castro Ranch Road from 1992 (upper photograph) and 2006 (lower photograph). 1992 photo courtesy of Jim Dunne (EBMUD).

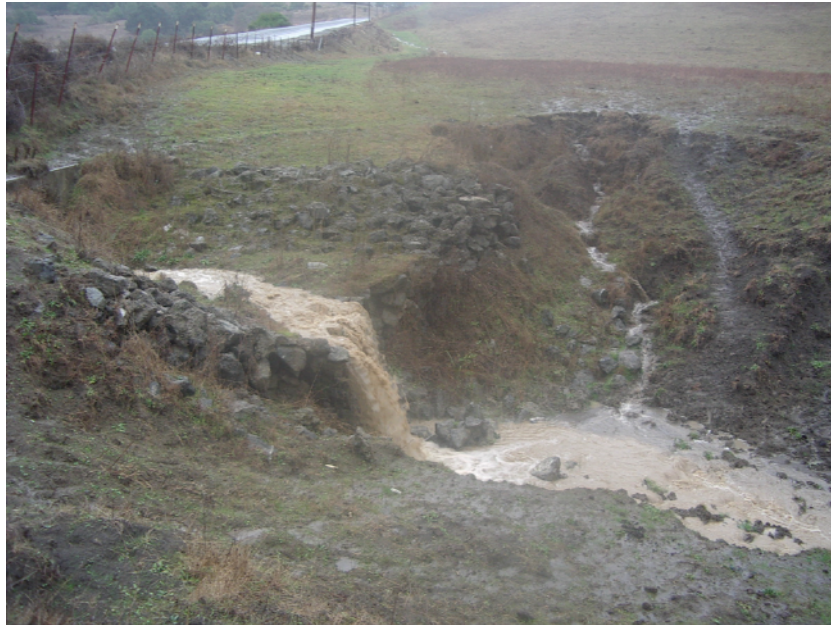
Figure 11. Photograph of large culvert apron on Gully A downstream of Castro Ranch Road.

The large culvert underneath Castro Ranch Road was installed at the channel bed elevation in 1986. A concrete apron and riprap were placed on the downstream side of the culvert to prevent undercutting and failure. However, during the 1993 wet season, Gully A significantly incised (Figure 10), leaving this culvert elevated approximately 3 m above the current bed elevation (Figure 11). The culvert is currently providing grade

control for the gully, and does not appear to be in any immediate danger of failure, but the county should watch and maintain this location to prevent a large failure of the road in the future.

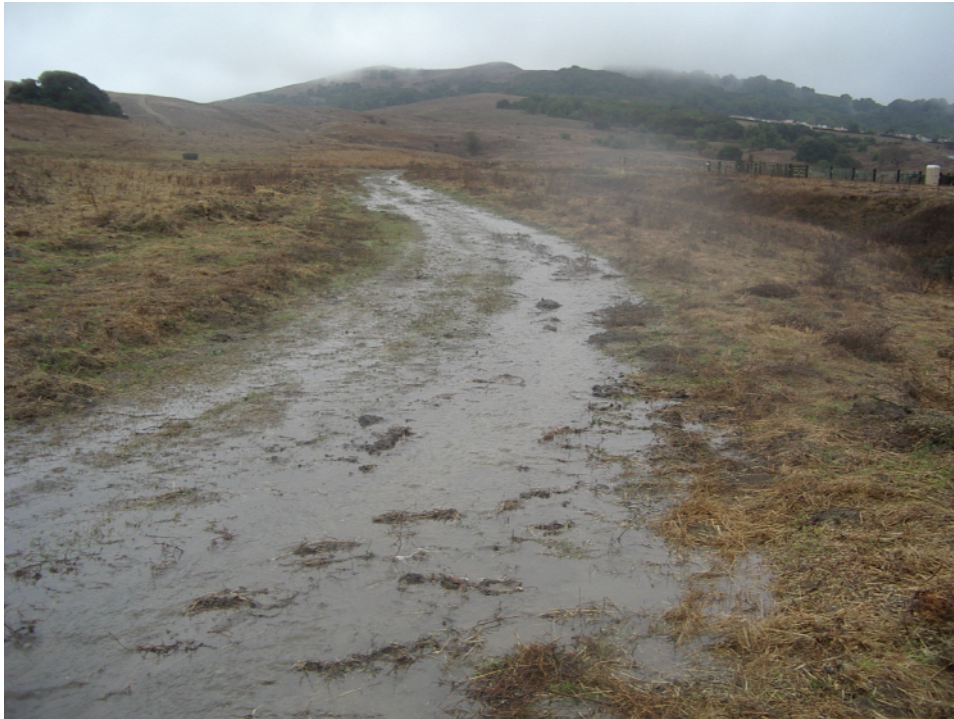
Figure 12. Photograph of surface runoff on a small ranch road during a storm event.

The smaller ranch roads and fire trails that are maintained by EBMUD are primarily on the east side of the basin, in the Nunes parcel. The ranch roads are graded and maintained annually by EBMUD staff. However, the single fire trail is not maintained and is used primarily for ranch ATVs. In general, these roads are in very good condition, with evidence of well-planned maintenance, including sloping the road surface in the correct direction, installation of water bars, and removal of any berms. Based upon the field team's observations during storm events of the 2006 Water Year, these roads transport little to no sediment during typical runoff events, and overall compared to other sources, supply relatively little sediment to the channels (Figure 12). A few very short reaches of road are showing minor evidence of erosion, but, targeted maintenance in these few locations would address any future problems. However, one ranch road location had an erosion problem during the 2005-2006 wet season, and should be addressed before the 2006-2007 wet season. Where Gully C crosses the ranch road, the culvert filled with sediment, contributing to sediment deposition both up and downstream on the pasture surface, and causing a late-season washout of the road surface (Figure 13).

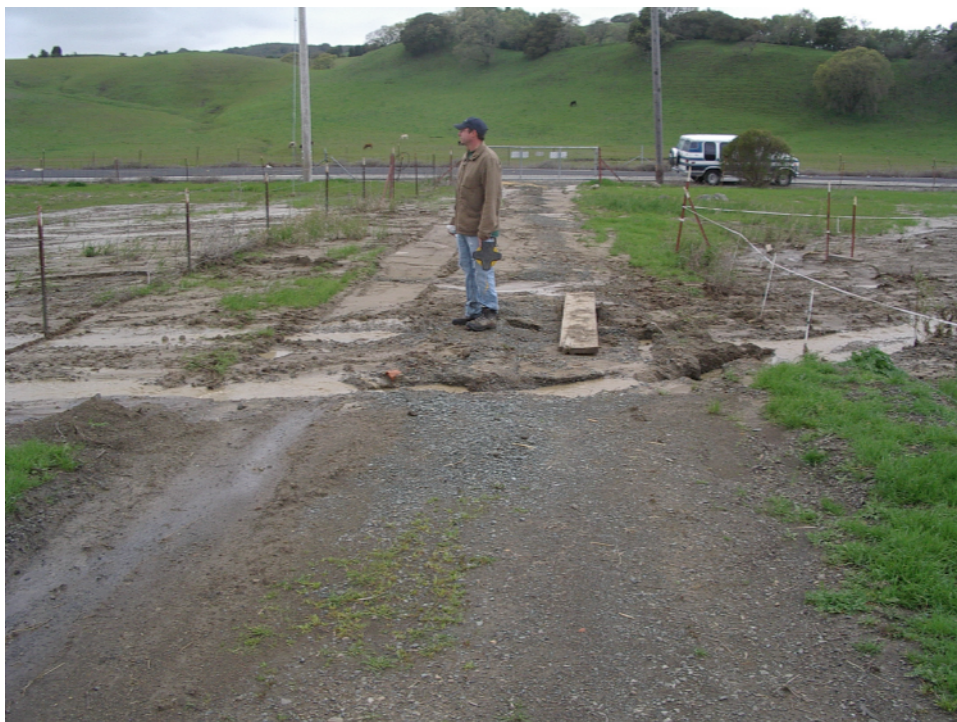
Figure 13. Photograph of clogged culvert, road erosion, and surrounding deposition of sediment on Gully C at the ranch road. Flow is from left to right.

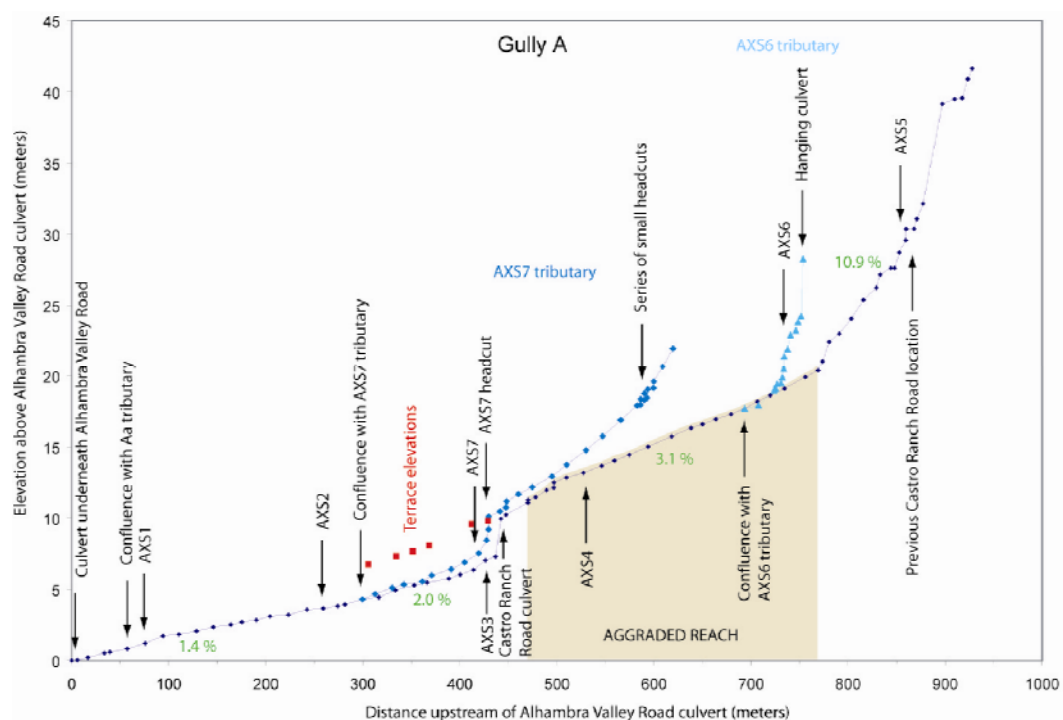
Figure 15. Longitudinal profile of Gully A. Scale in meters. Royal blue is the AXS7 tributary. Light blue is the AXS6 tributary. Red dots are terrace elevations downstream of Castro Ranch Road. Green numbers are the average reach slope (in percent). Note, the profile ends at Pinole Valley Road, not the Pinole Creek thalweg.

The longitudinal profile for each of the four gullies is shown in Figures 15-18. The profiles were used to illustrate changes in channel gradient and to determine reaches that may not be in equilibrium, the effects of road crossings, culverts, or grade controls, and to determine areas of aggradation or sediment deposition. It is important to note that none of the channels are at grade with the Pinole Creek mainstem. Each gully drops in elevation immediately at its mouth, whether controlled by culverts (as in Gullies A and C) or by steep, well vegetated, stepped reaches (as in Gullies B and D). Although not conclusive, this observation supports the hypothesis of recent incision of the Pinole Creek mainstem, a potential driver for the Pavon Creeks rejuvenation and instability.

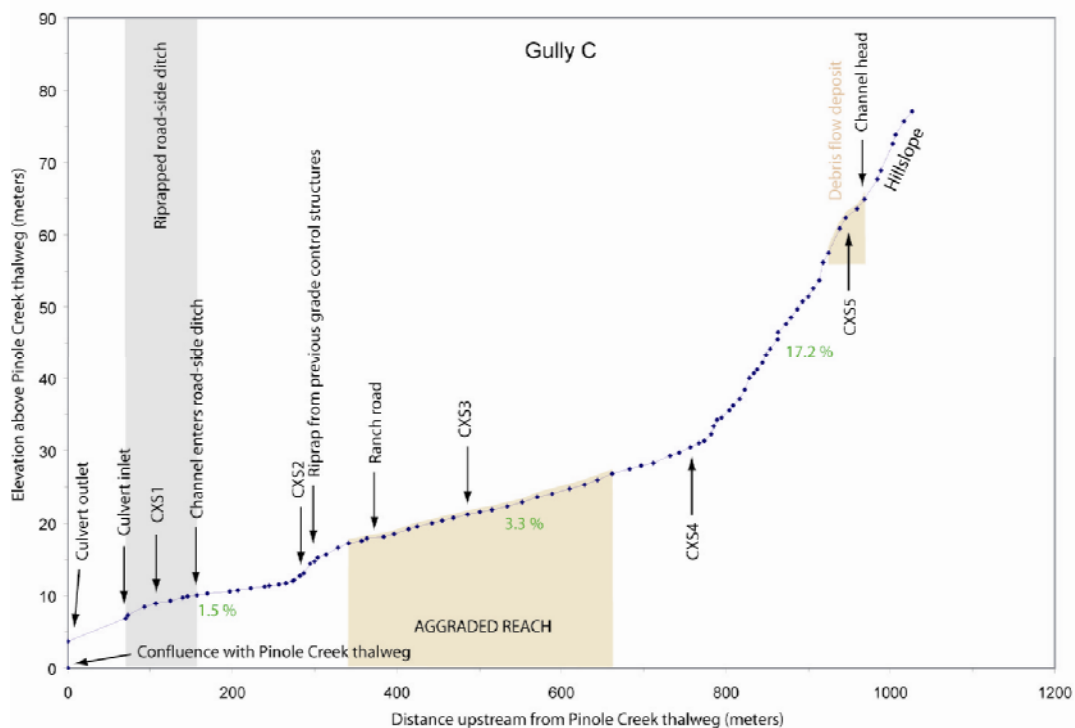
Figure 17. Longitudinal profile of Gully C. Green numbers are the average reach slope (in percent).

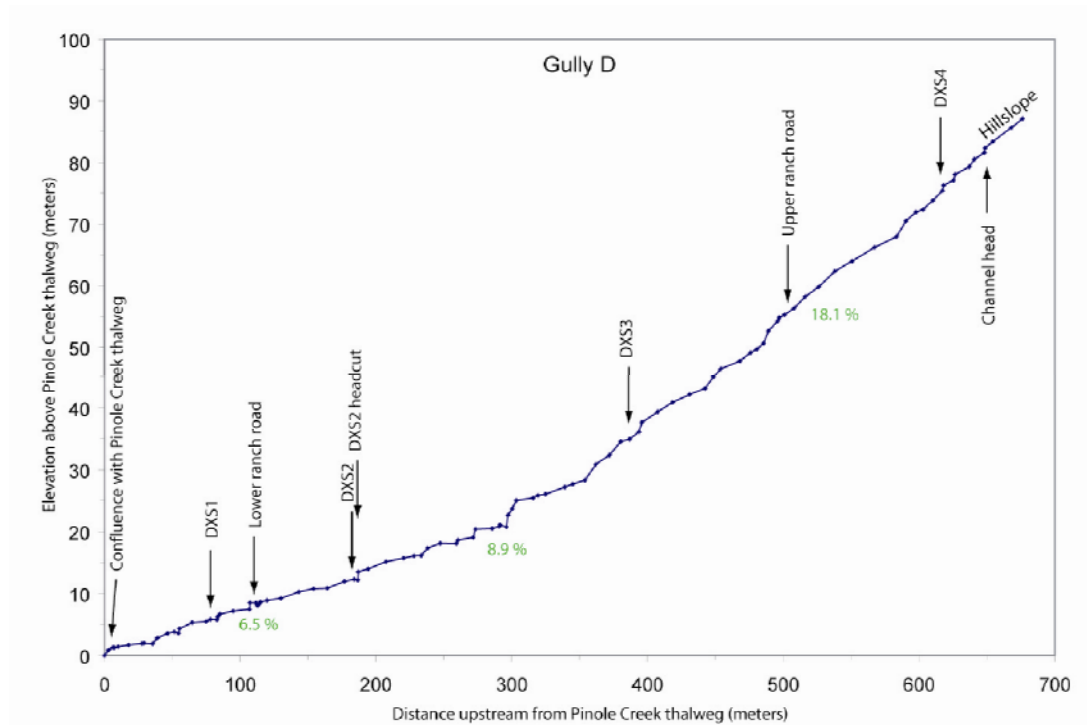
Figure 18. Longitudinal profile of Gully D. Green numbers are the average reach slope (in percent).

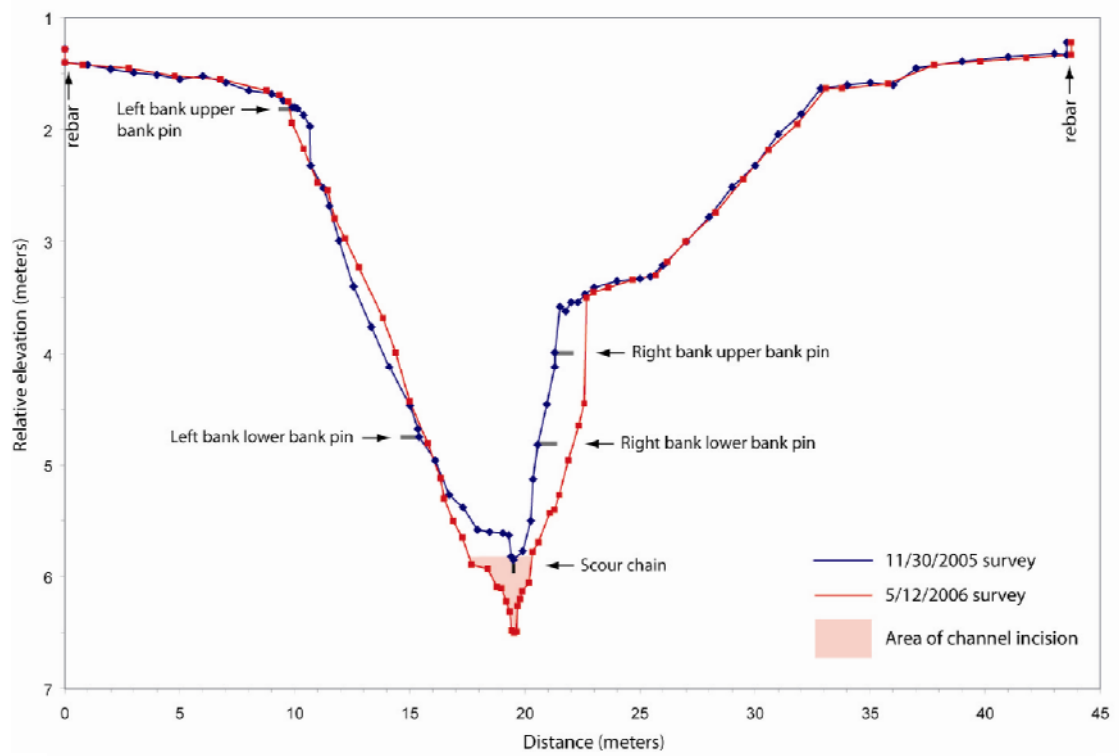
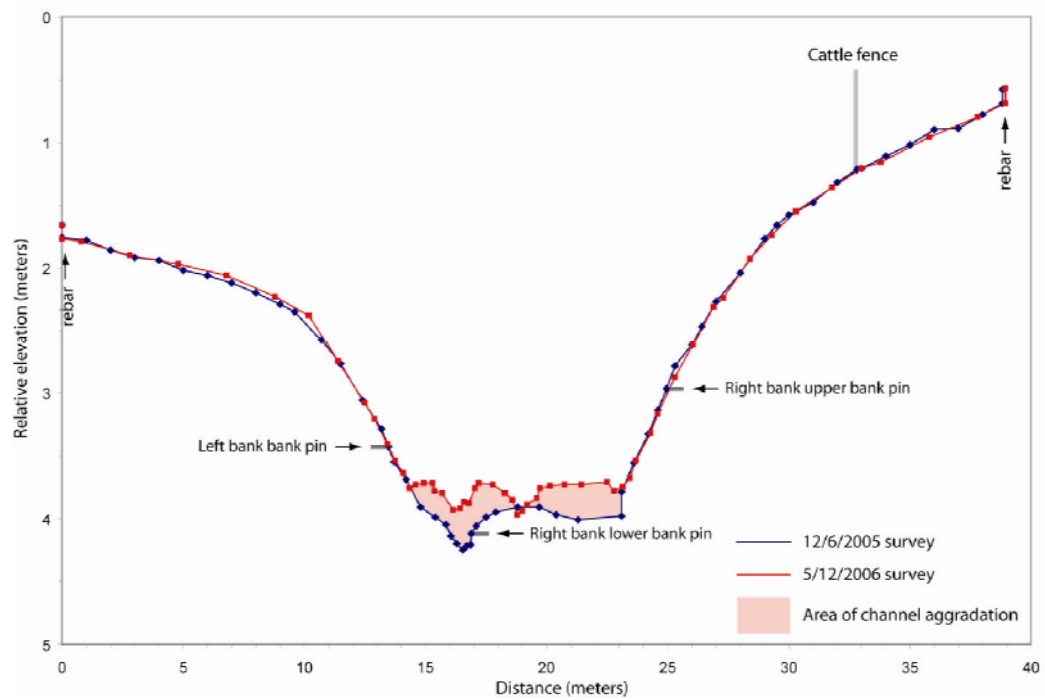
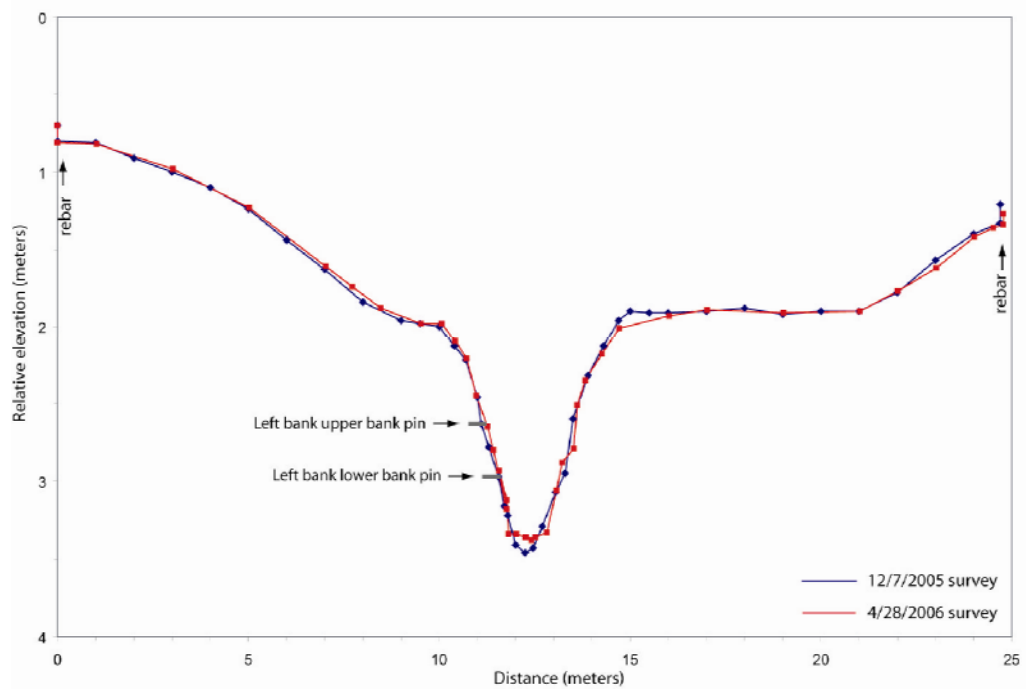
Figure 20. Examples of channel change observed in pre- and post-wet season cross-section surveys. The blue profile is pre-wet season, while the red profile is post-wet season. A) channel incision at AXS3 B) channel aggradation at AXS4 C) bank erosion at DXS2 D) no change at BXS1. Scale in meters, with variable vertical exaggeration, ranging between 6x and 8x exaggeration.

In comparing the pre- and post-wet season surveys from the entire 22 cross-section dataset, we observed many types of change at each of the locations (including channel incision, channel aggradation, bank erosion, and little to no change) (Figure 20 and Table 3). The full dataset of all 22 cross-sections are shown in Appendix E, Figures A-10 through A-31. In general, most cross-sections demonstrated an increase in cross-sectional area (shown by negative numbers in Table 3), whether it be through bed incision or bank erosion. All of the cross-sections on Gully A downstream of Castro Ranch road displayed incision, with AXS3 and AXS7 the most significant. AXS7 incised approximately 75 cm deep as the knickpoint immediately upstream extended headward, and the channel deepened to match the downstream gradient. AXS3 incised 65 cm, creating a narrow notch channel in the hardpan that existed beneath the previous bed elevation (Figure 21). This reach also displayed significant bank erosion, as the banks laid back via large semi-circular slumps. Other reaches with incision include CXS2 (depth of 49 cm) likely due to the large amount of deposition immediately upstream, and direct input of pasture runoff over the bank at the cross-section. And finally, cross-sections DXS1 and DXS3 displayed 17 and 55 cm, respectively, of incision. DXS3 had a large portion of the bank erode, creating a large undercut, and likely de-stabilizing the local bed, causing the removal of sediment stored in one of the many small steps.

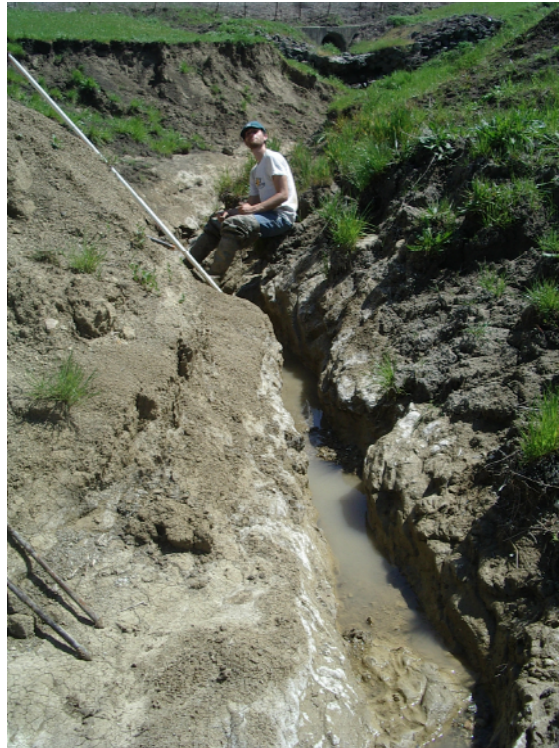
Figure 21. Photograph showing the newly-formed notch channel at AXS3.

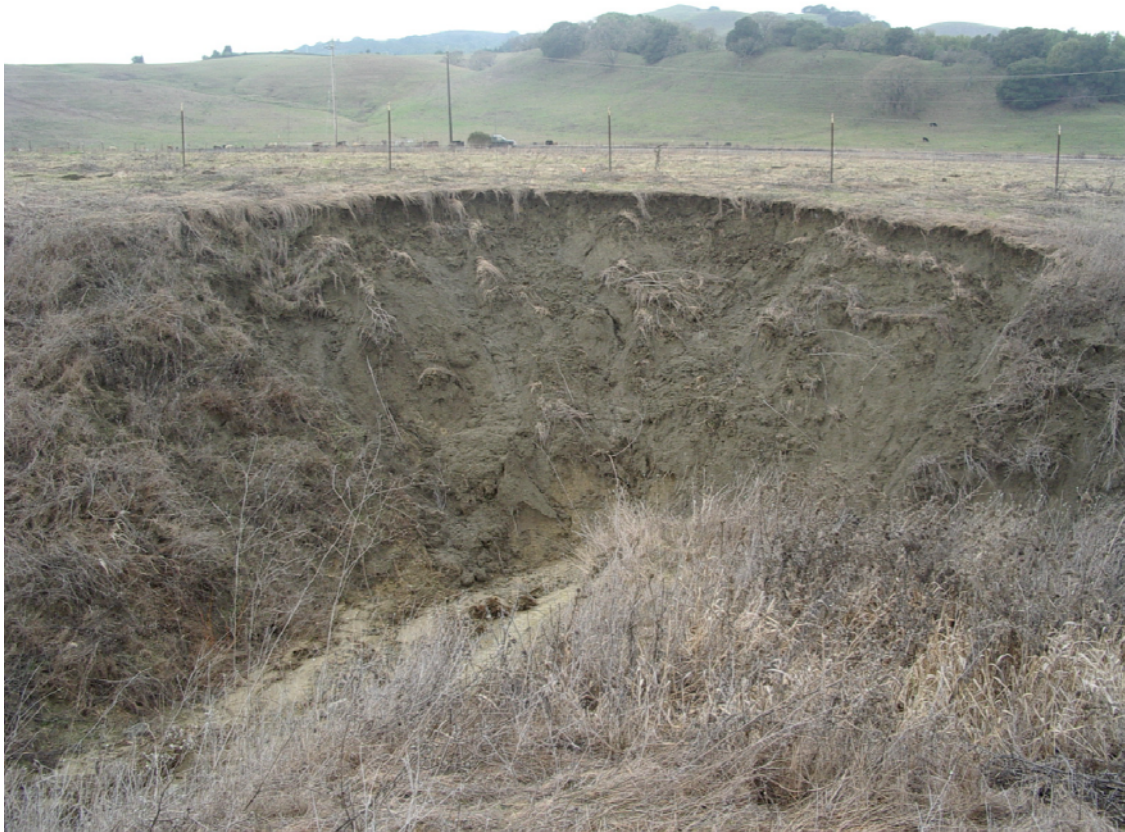
Figure 22. Photograph showing the bank erosion occurring on the left bank of BXS2.

Some cross-sections displayed primarily bank erosion, as oversteepened banks continued to lay back. Cross-section BXS2 experienced erosion on its left bank, as the bank continued to slump, and the toe of the slope was removed, especially during the high flows over New Years (Figure 22). Cross-sections BXS4 and CXS4 eroded as bank slumps occurred, sending entire blocks of material down onto the stream bed. The material from these blocks was slowly removed during the remaining flows of the wet season. Many other cross-sections display bank erosion, but in smaller volumes.

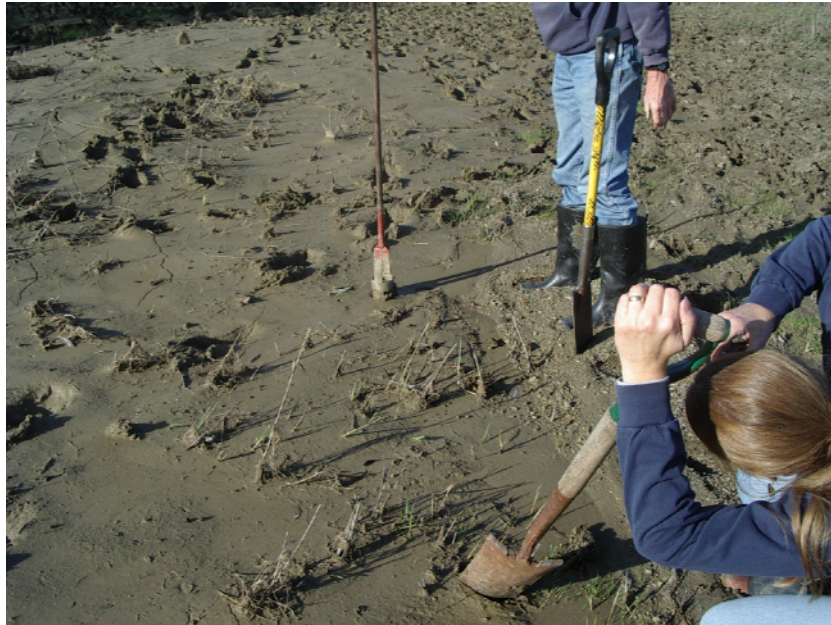
Figure 23. Silts and muds deposited at AXS1 during the New Years Eve storm.

Additionally, a number of cross-sections displayed both bank erosion and bed incision. For example, the change in profile for AXS1 shows channel incision of 15 cm, right bank erosion of 40 to 50 cm, and aggradation on the left bank terrace of 15 cm. This complex change reflects the cross-section's location in the watershed; the channel experienced widening and deepening due to the large flows that occurred this season, while the floodplain surfaces accumulated sediment supplied from the upper watershed, as flows backed up behind the culvert underneath Pinole Valley Road (Figure 23). Other cross-sections, including AXS2 and DXS2 show both incision and bank erosion, as the cross-section integrates water and sediment from the entire upstream watershed.

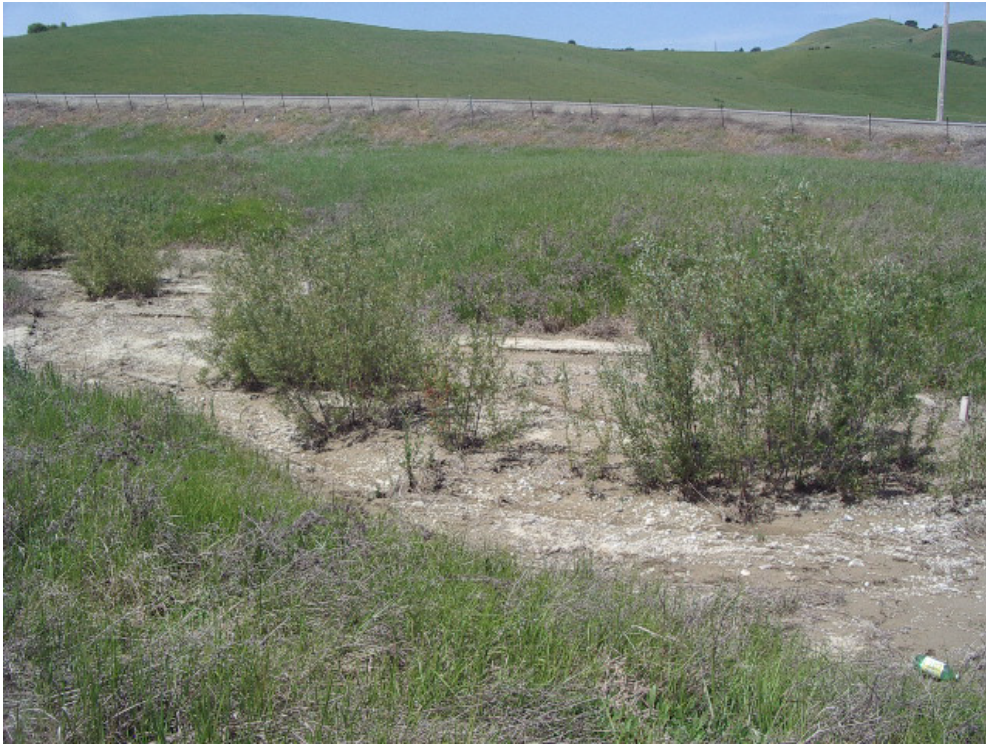
Figure 24. Photograph showing the aggradation that occurred at AXS4.

A zone of deposition is observed in the middle portions of the watershed, where cross-sections consistently display significant aggradation over this wet season. This zone includes cross-sections AXS4, BXS3 and CXS3 (Figure 24). The aggradation is likely due to a combination of both the decrease in valley and channel slope, and the backup caused by culvert constrictions (the culvert under Castro Ranch Road on Gully A, and the culverts under the ranch road on Gullies B and C). Alternatively, this zone may not be consistently experiencing aggradation year after year, but instead, experienced aggradation only this wet season. If this is the case, the aggradation represents a slug of sediment sourced from mass wasting and channel erosion in the upper watersheds. During the next wet season, this slug of sediment would continue to work its way downstream, incising this zone, and possibly depositing at a different location lower in the watershed. Continued observation will illuminate which is the more probable scenario.

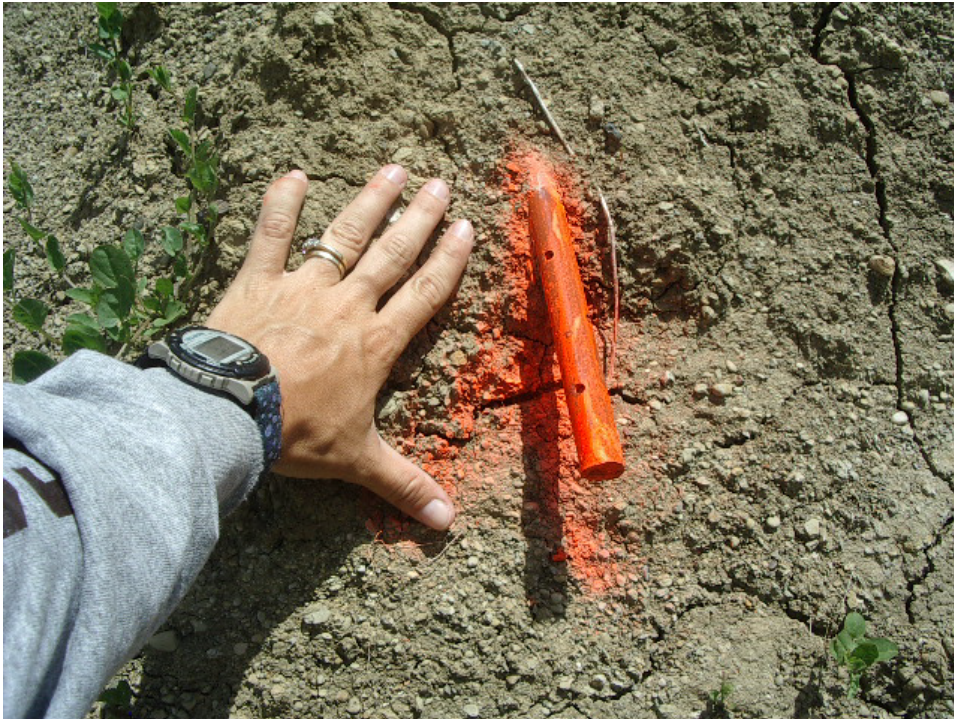
Figure 25. Photograph of exposed bank pin at AXS3, May 2006.

In many instances, banks were found to be very unstable, eroding more than 18 inches over the wet season (Figure 25). However, many observations of little to no bank retreat were also made including AXS4, AXS6, and BXS1. As it is no surprise, the aggrading reaches generally had little to no evidence of bank erosion, while the reaches transporting and sourcing sediment had significant and sometimes quite dramatic evidence of bank erosion. In general, Gullies A and B had the highest rates of bank erosion during this wet season. Although this dataset does not speak to the longer-term rates of erosion, the headwaters of each gully likely have very high, episodic rates of erosion, as mass-wasting events occur. Additionally, reaches that are experiencing a wave of incision and rejuvenation will also display very high rates as the wave passes, slowing as the cross-section widens, and returns to a more stable state.

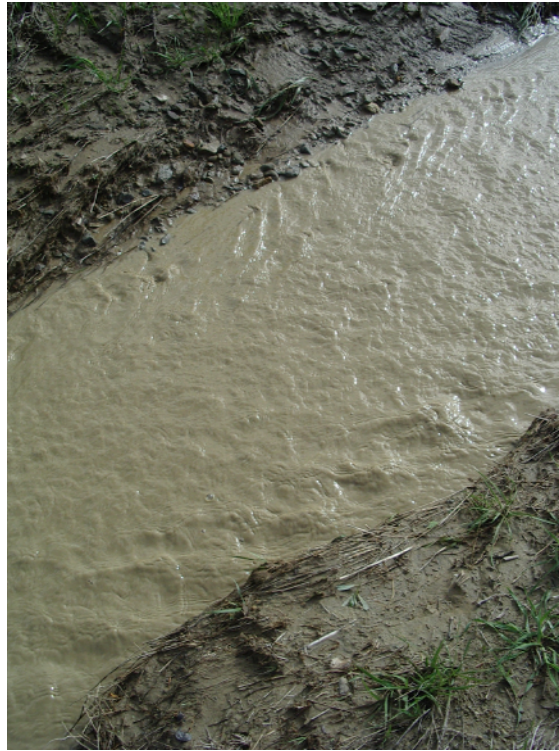
Figure 31. Photograph of storm event discharge in Gully B, 3/25/2006.
