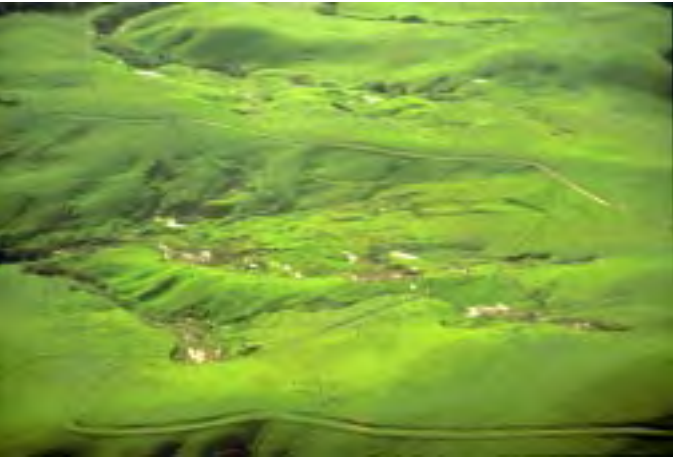
(Photo 17) February 1983, compound landsliding in the same area shown to the right, Site A.

Examples of climatic control on earthflow activity are apparent near Point A (Figure 39). The activity of these landslides has been observed in the field by Laurel Collins (SFED) for the last two decades. Analyses of historical aerial photos confirm the field observations.

Several very large, deep-seated earthflows have substantially increased in activity twice since the early 1980s. These slides have been most active during years of precipitation much greater than normal. Wet years of 1981-82 (150% of nor-

mal rainfall) and the 1997-98 ENSO (200% of normal rainfall) events reactivated very large deep-seated earthflows in this area. Some of the slides may not have previously moved for many centuries. One large earthflow severely damaged several homes situated at the ancient crown scarp. More landslide activity was actually associated with the earlier 1982-83 wet season than the later ENSO events of 1983 and 1998 because much of the rainfall occurred during a single storm that was very intense. Many debris slides also occurred at this time.

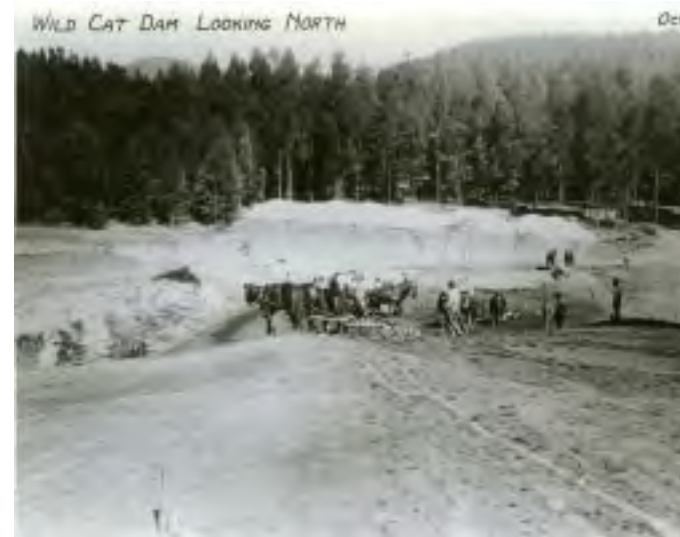
(Photo 19) Construction underway at Wildcat Reservoir (Jewel Lake) 1919. Consider the amount of sediment production and downstream impacts from these disturbed soils. Channel incision downstream of the dam and subsequent sediment production has been ongoing. Source: East Bay Regional Park District.

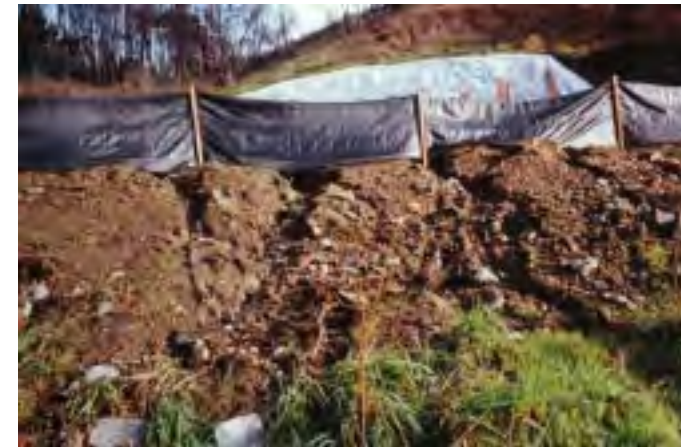
(Photo 20) Construction site erosion in disturbed soils. Soils that have been mechanically disturbed are more susceptible to erosion than soils that are bare but still have small rootlets intact. (Booker et al. 1993) Such a situation may occur after burning, grazing or application of herbicides.

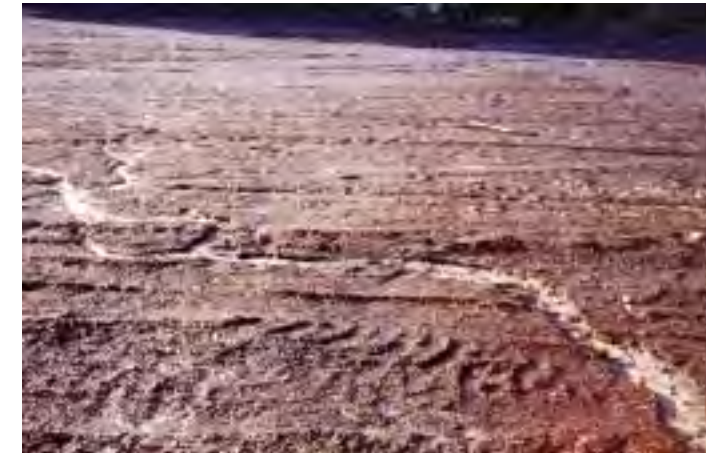
(Photo 21) An example of rill erosion in soils prepared for sod in Alvarado Park. Consider the amount of sediment production during preparation of the Tilden golf course during the late 1930s.

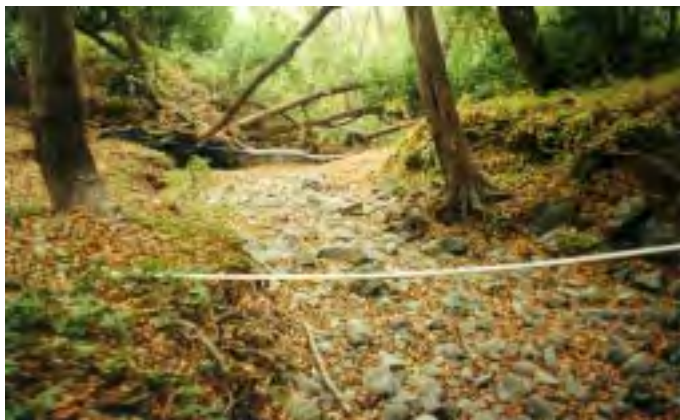
(Photo 22) (a) August 1994. A tree has fallen across the channel during the dry season. The bed is mostly coarse cobble due to a reduced supply of fine sediment during the previous 7 yrs. The banks are sharp-edged. The bed has been incising since 1986. (b) April 1995. Two significant flood flows occurred during January and March. The peak flow was the second highest in 33 yrs. Heavy rains activated landslides, providing large woody debris that were mobilized by floods. A debris jam has formed at the fallen tree (see photo a). The dominant bed material changed from cobble to sand. A gravel bar 4 ft high formed behind the jam. The standing alders are freshly scarred from being rammed by floating debris (see trunk left foreground).

The four photos below illustrate typical changes in mainstem channel conditions within the Canyon over a 5 yr period from 1994 through 1999. Each photo is looking downstream from approximately the same left bank position. Peak annual flows had been moderately low for 7 years preceding photo 22 for 1994. Flows greater than 1000 cfs occurred during 1995, 1996, 1997, and 1998.

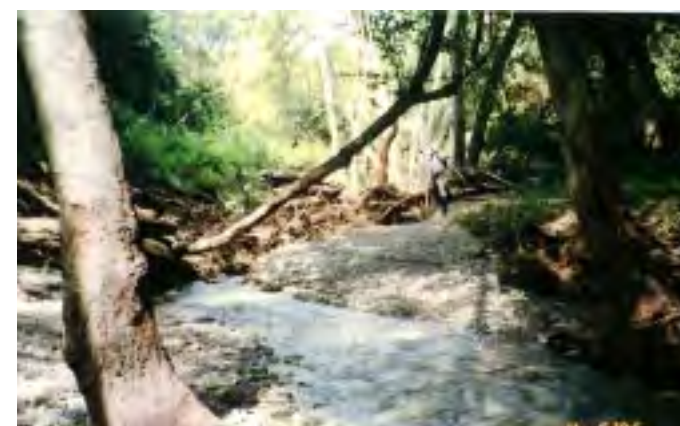
(Photo 23) (b) April 1995. Two significant flood flows occurred during January and March. The peak flow was the second highest in 33 yrs. Heavy rains activated landslides, providing large woody debris that was mobilized by floods. A debris jam has formed at the fallen tree (see photo 22). The dominant bed material changed from cobble to sand. A gravel bar 4 ft high formed behind the jam. The standing alders are freshly scarred from being rammed by floating debris (see trunk left foreground).

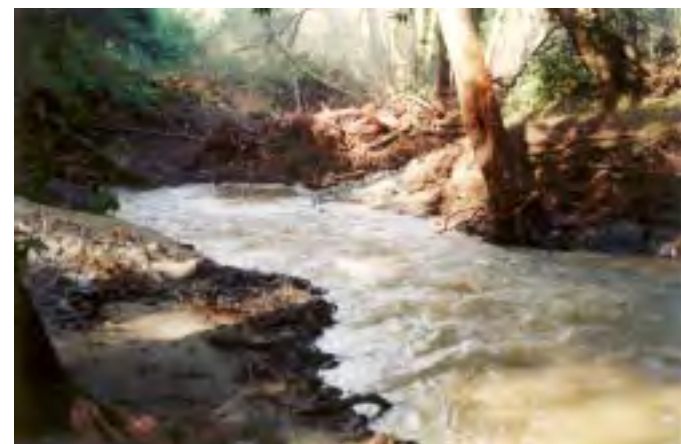
(Photo 24) (c) January 1997. The debris jam has collected more woody debris, but the channel has cut around the jam on the left, releasing the sediment that had deposited behind the jam. Much of the bar has eroded away. Sand from local landslides is beginning to cover remnants of the bar (see bar top left foreground).

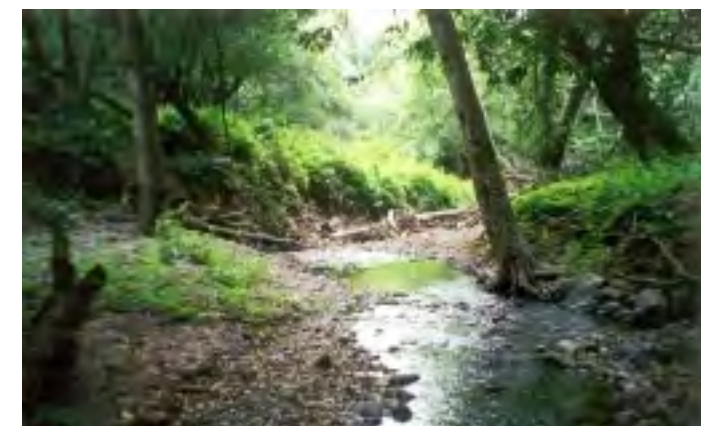
(Photo 25) (d) June 1999. The debris jam has almost completely deteriorated. The gravel bar and its sandy cover have mostly washed away. The bed material is generally finer and the bed is higher than in 1994 (see photo 22). The banks are not as steep. The large alder (see left foreground photo 23) has been broken at its trunk and washed downstream.

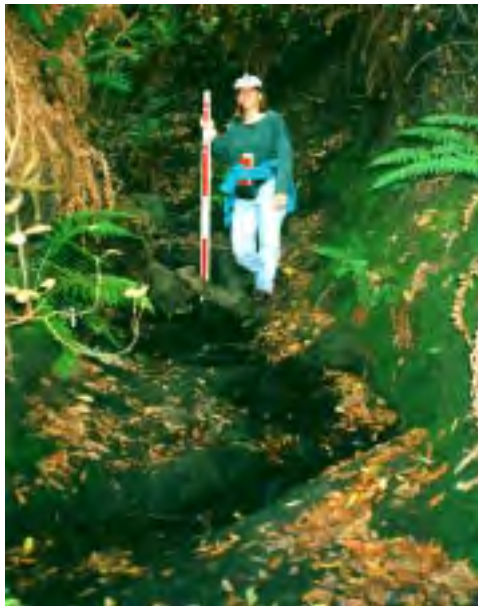
(Photo 26) An incised tributary channel in bedrock that drains the east-side grasslands.

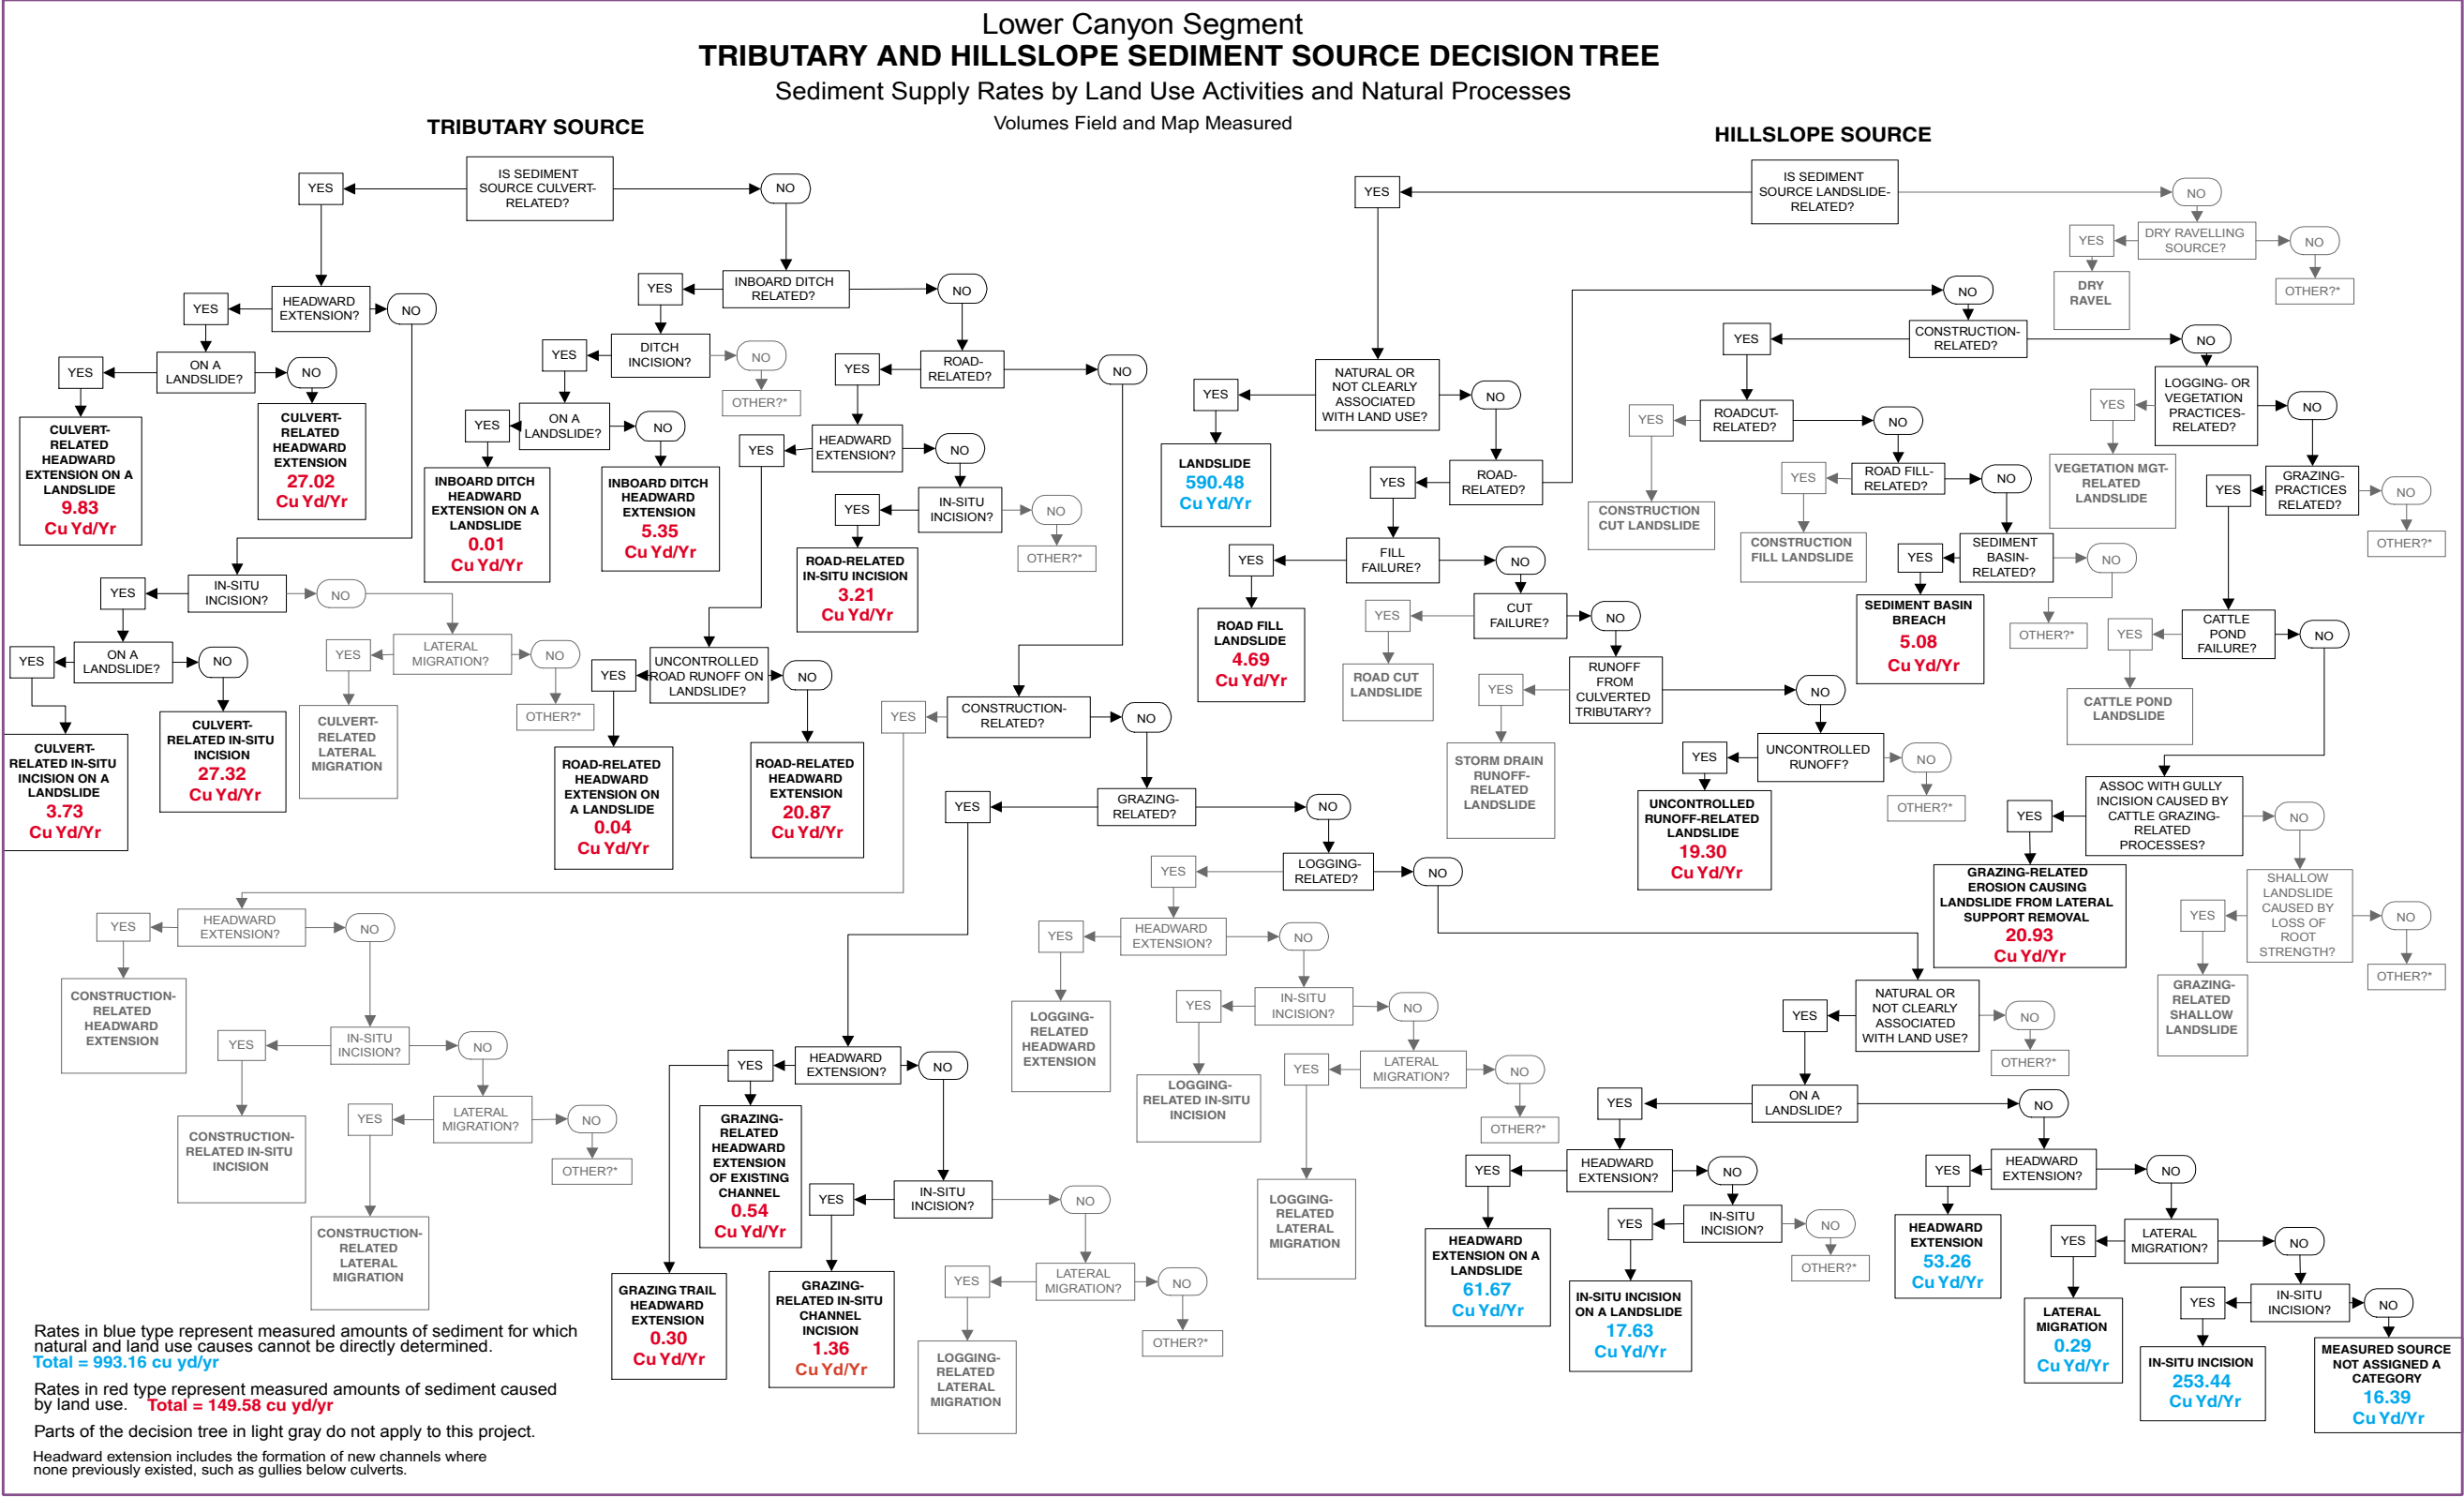
Figure 42

We developed a diagnostic tool for identifying and stratifying different sources of sediment and their causes in tributaries and hillslopes. The tool is called the Hillslope and Tributary Decision Tree (Figure 42). It defines sediment by sources and assigns it to natural, land use-related or uncertain categories of cause.

This Decision Tree was used in the hills and tributaries of the Lower Canyon Segment where we performed void measurements. A similar decision tree was used for the mainstem analysis of Wildcat Creek.

The completed Decision Tree shows the long-term sediment supply rates of various sources in the Lower Canyon. The total rate of supply from field and map measurement techniques is 1,143 cu yd/yr. To estimate channel incision rates, we had to identify a time when incision

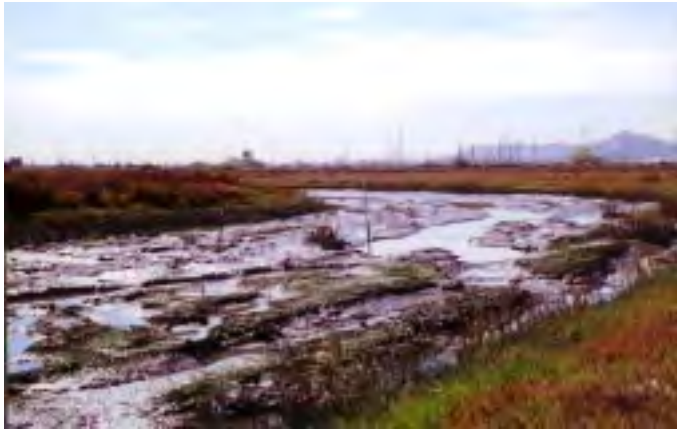
(Photo 28) Looking downstream at the tidal reach that has old levees along its banks. This reach is represented in cross section "B" in Figure A (see facing page).

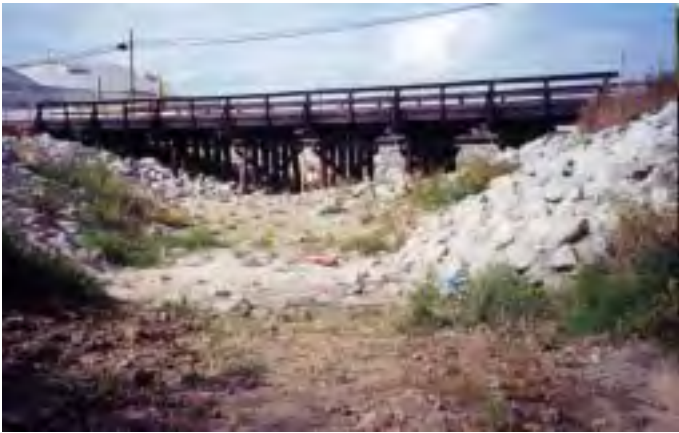
(Photo 29) Looking downstream at Santa Fe Railroad trestle and rip rapped trapezoidal banks of the flood control project, as represented in cross section "F" in Figure A (see facing page). The grouted rip rap bed corresponds to the aggradation shown in Figure 89, page 69.

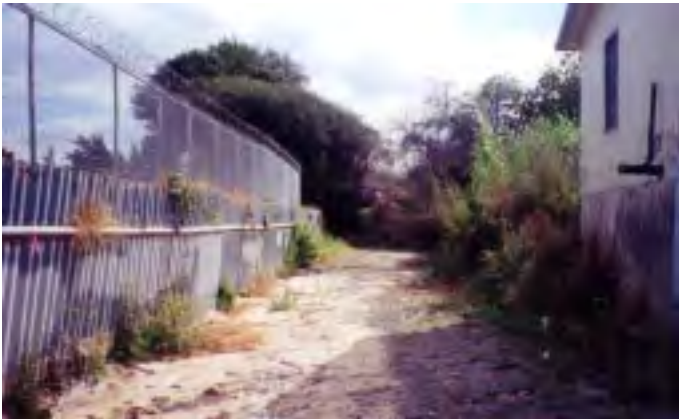
(Photo 30) Looking upstream from the Rumrill box culvert at the plain bed of the creek that lacks topography. This reach is represented in cross section "I" (which is drawn looking downstream) in Figure 49.

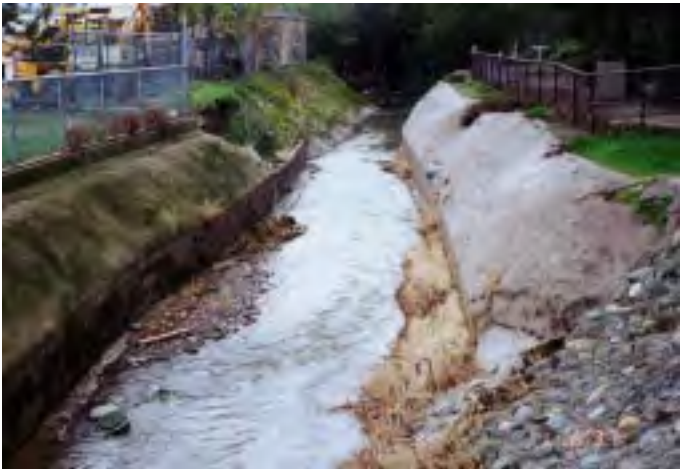
(Photo 31) Looking downstream at revetted channel at Davis Park, which floods with flows that have a recurrence interval of less than 10 yrs. This area is represented by cross section "K" in Figure 49 (see facing page).

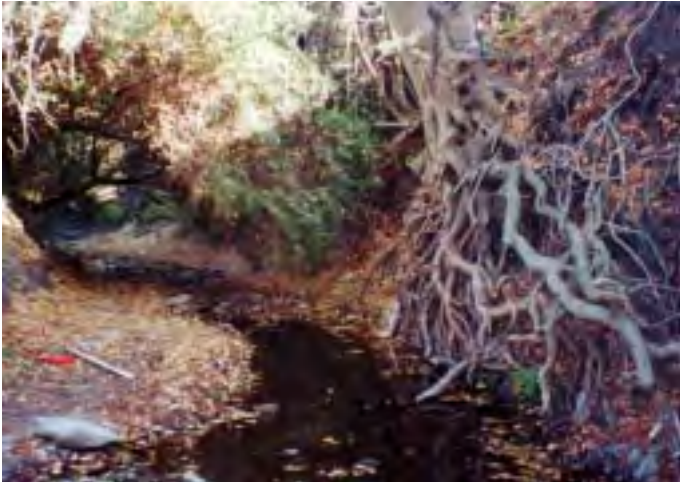
(Photo 32) Looking upstream at the exposed roots of a buckeye tree that indicates recent bank erosion, as represented by cross section "P" (which is drawn looking downstream) in Figure 49 (see facing page).

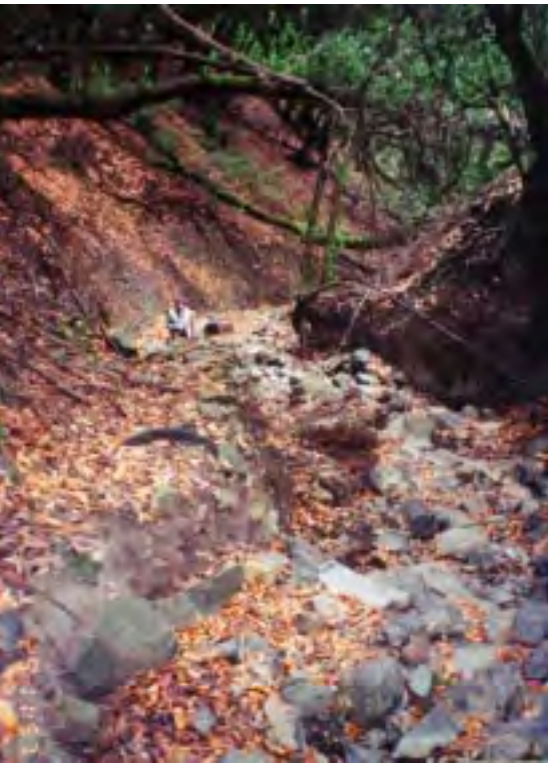
(Photo 33) Looking downstream at mainstem Wildcat Creek between cross sections Z1 and Z2 (Figure 49). The channel is dominated by volcanic cobble from debris flow deposits that armor the bed.

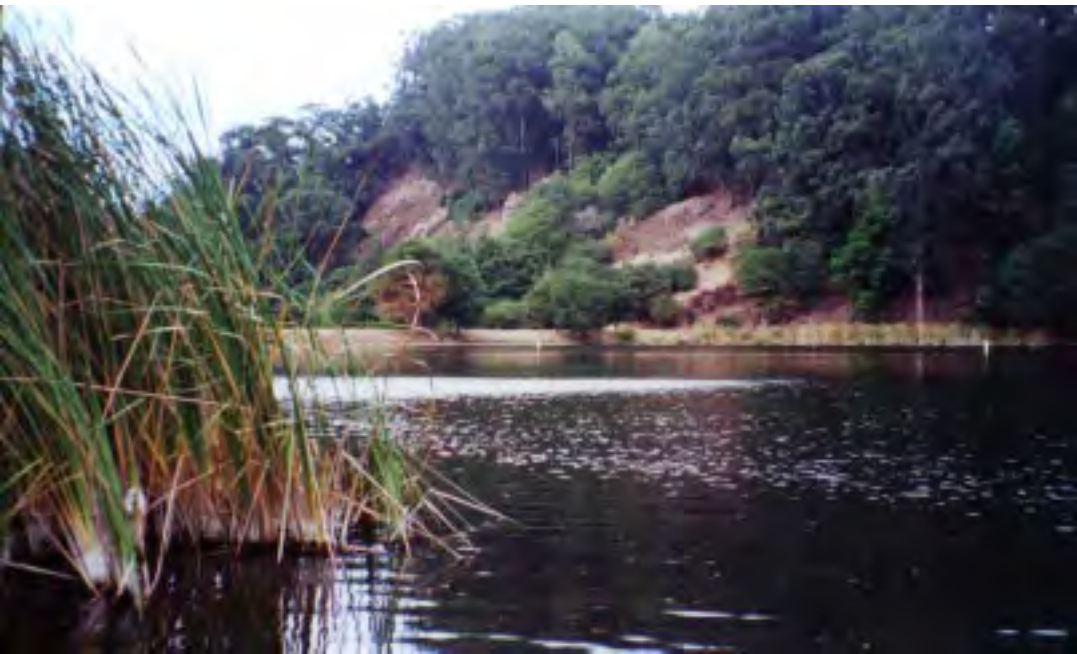
(Photo 34) Looking toward the dam at Lake Anza.

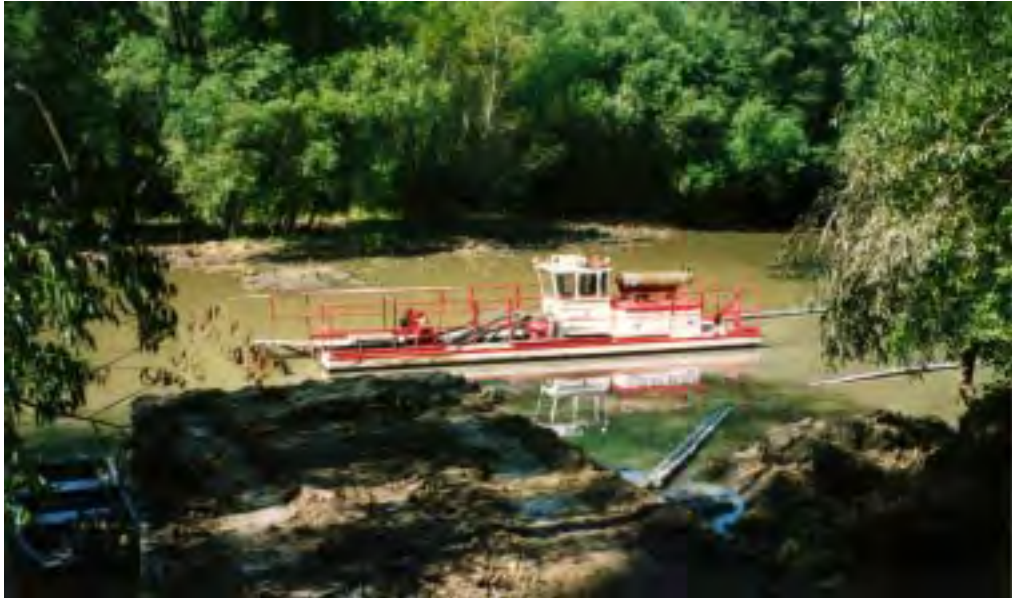
(Photo 35) Dredging Jewel Lake in 1991.

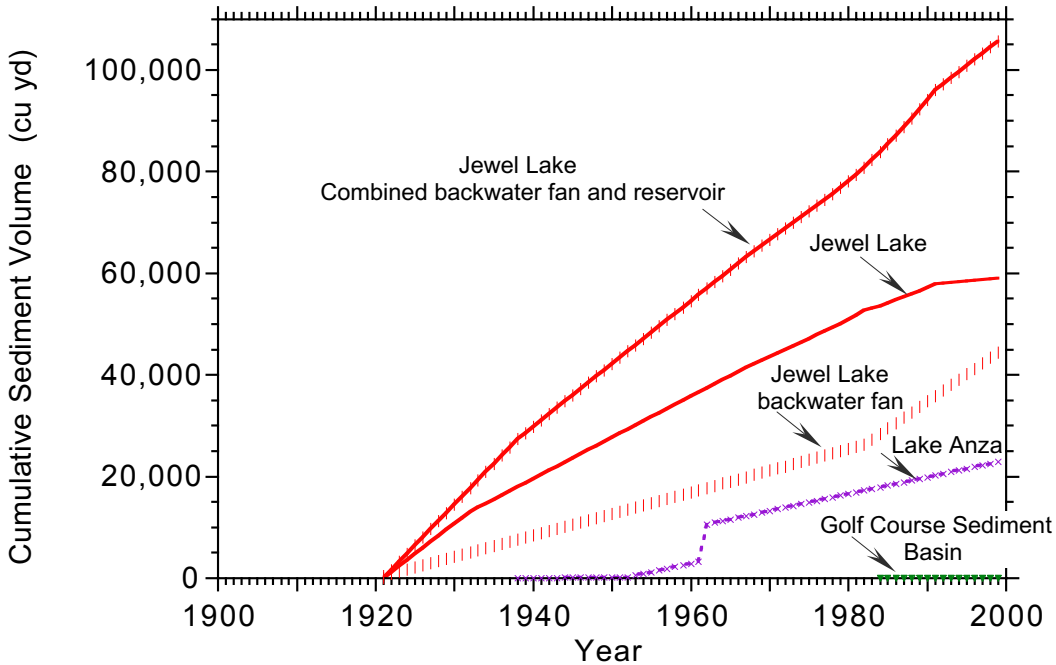
Figure 52
Jewel Lake and Lake Anza Sedimentation
1921-1999

Jewel Lake sediment volumes are based upon reservoir bathymetry, and survey of the backwater fan upstream of the reservoir. Changes in trap efficiency and the effects caused by Lake Anza (1938) are taken into account.

Figure 52 and Table 11 have been prepared to show changes in sedimentation rates and the long-term average rates of sedimentation for the two reservoirs and the small settling basin in the golf course. Lake Anza has a much slower rate of sedimentation than Jewel Lake. The rates for Anza and for Jewel Lake, following the construction of Lake Anza, are 375 cu yd/yr and 1,272 cu

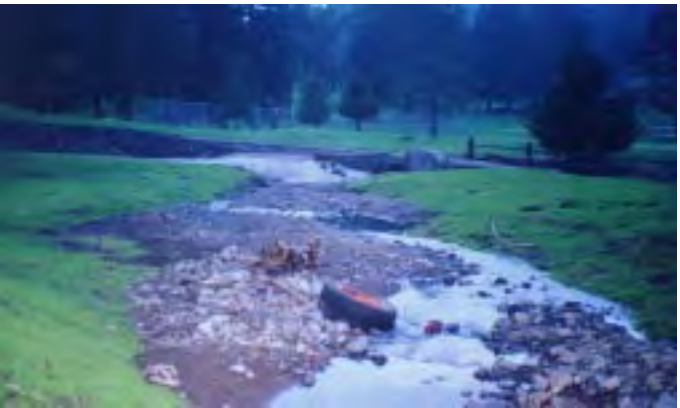
(Photo 36) Some sediment is deposited in the Tilden Golf Course upstream of the mainstem sediment basin.

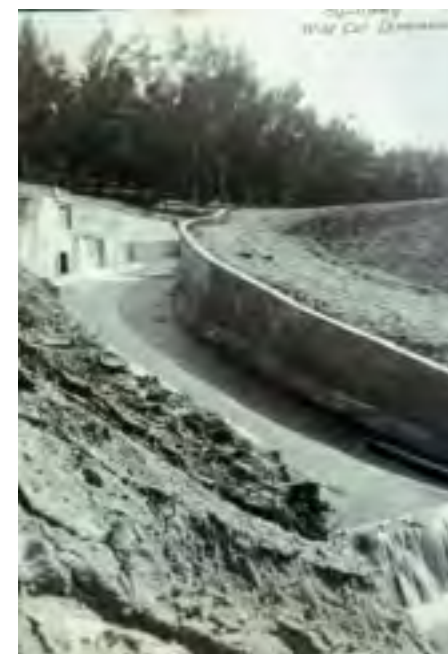
(Photo 36a) The edge of the newly constructed dam at Jewel Lake, 1922. Note there is about 2.5 ft of fall.

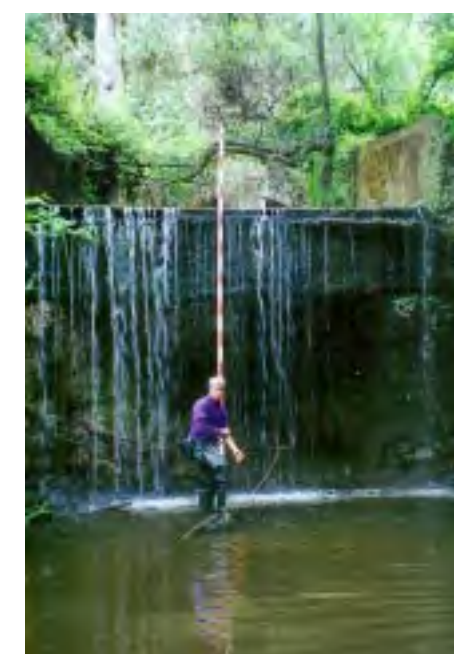
(Photo 36b) The edge of the spillway in 1999 has over 14 ft of fall.
