# Bank and Terrace Condition by Reach

# Left and Right Bank Conditions by Segment

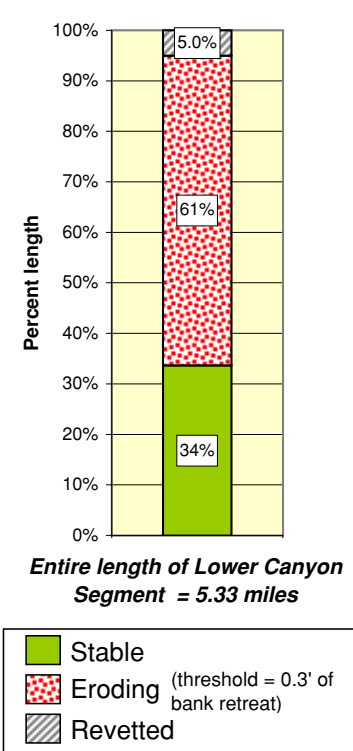
**Figure 56b**  
**Total Percent Length of**  
**Different Bank Conditions**  
**for Entire Lower Canyon**  
**Segment**

Amounts of eroding, revetted, and stable banks were measured and graphed for the Upper Alluvial Plain and Lower Canyon Segments. Bank erosion was measured wherever there was evidence of at least 0.25 ft of bank retreat, as indicated by exposed roots, the freshness of bank sediments, shape of the bank in plan view, and historical records. Note that even if the *banks* are shown as stable, the *channel* may be unstable if its bed is degrading or aggrading. The percents reported represent the total for four banks: right and left banks above and below bankful. Continuous bank conditions are shown in the Appendix Streamline Graphs. In Figures 55a and 56a, the data are summarized for individual reaches within each of the two respective segments. In graphs 55b and 56b, the percent length of bank erosion is totaled for each segment.

About 35% more revetments exist in the Upper Alluvial Plain than in the Lower Canyon, whereas the Canyon has 33% more length of erod-

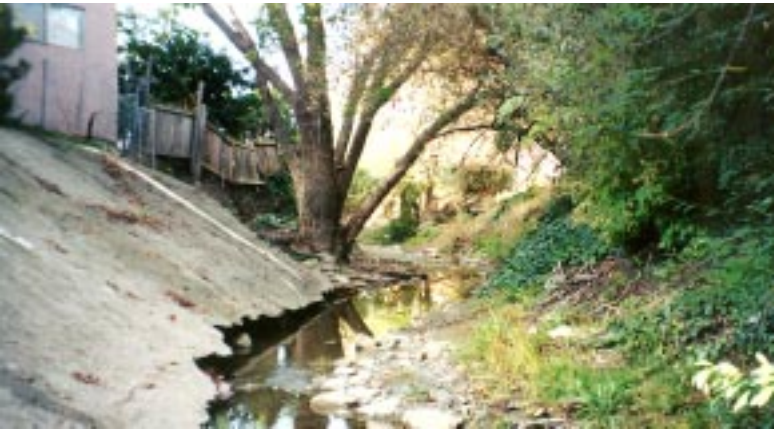
(Photo 38) A revetted bank and a natural bank oppose each other along the Alluvial Plain. Bed incision within the last 50 years is apparent along the base of the concrete and at the exposed roots on the right bank.

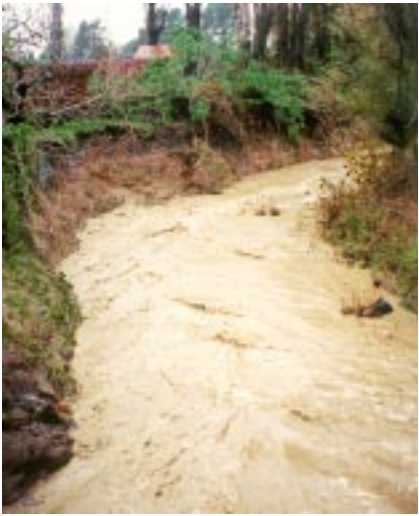
In the Lower Canyon, about 6% more of the left bank (west side) is eroding than the right bank (east side). This slightly greater amount of erosion on the west side could be due to the greater abundance of large complex earthflows on the steeper Berkeley Hills.

*(Photo 39) The waning flood flow of January 1997 exposes an eroding left terrace bank near Vale Road.*

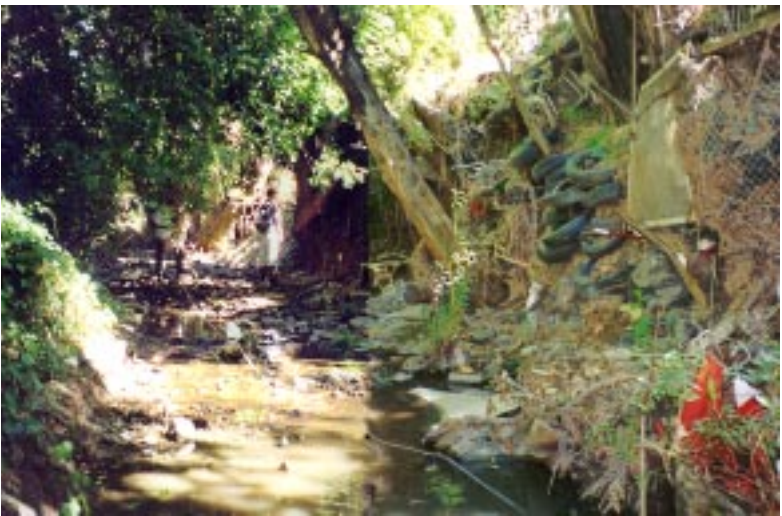
*(Photo 40) Non-engineered revetment is failing into Wildcat Creek.*

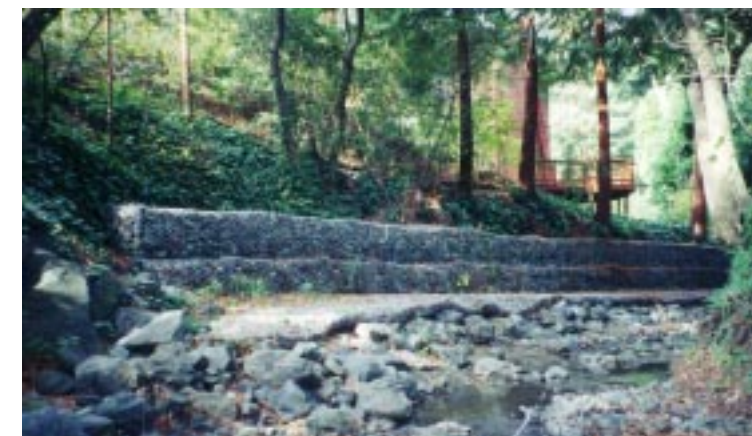
*(Photo 41)*  
*A new wire basket gabion and apron revetment in McBryde Reach, January 1998.*

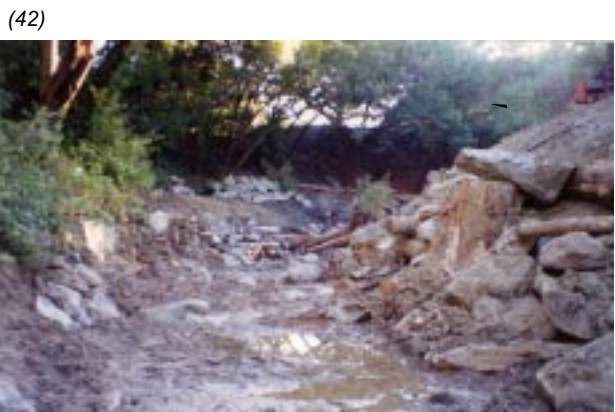
(Photo 42) 1997, root wad and boulder revetments were used in Alvarado Park for revision of the restoration project. Note the position of the boulder on the right bank tree stump at the arrow. Photo was taken shortly after construction.

In the Alvarado Reach of the Canyon, about 28% of the revetment length was in moderate to failing condition. During the 1993 fish barrier removal project, root wad revetments were placed along the channel banks to preserve the integrity of some historic rock walls along the creek bank that were being severely undermined. In 1997, four years

after the project was completed, a 60 ft-long portion of one of the walls failed. Just across the Creek from the failed wall, a landslide slumped into the Creek that was caused by poor drainage problems from a newly constructed playfield. Later that same year, a new 400 ft-long creek restoration project was conducted within the boundaries of the previous project. It widened and deepened the channel where the walls had failed, and along the active toe of the landslide. Root wad revetments were constructed along nearly all the banks within the 1997 project. In 1998, we noted that most of the new root wad revetments were in moderate to failing condition. They were slumping into the channel. This was due to the excessive weight of the structures on the existing landslide deposits and post project bed incision. Our data set includes a series of longitudinal profiles of this project area dating back to 1987 (Figure 88, page 71).

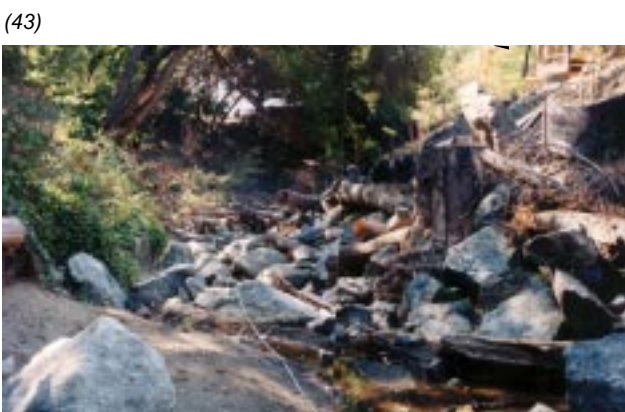
(Photo 43) 1998, same view as photo 1, but one year later. Right bank revetment has slumped about 4 ft into channel. Note the position of the boulder on the stump at the arrow.

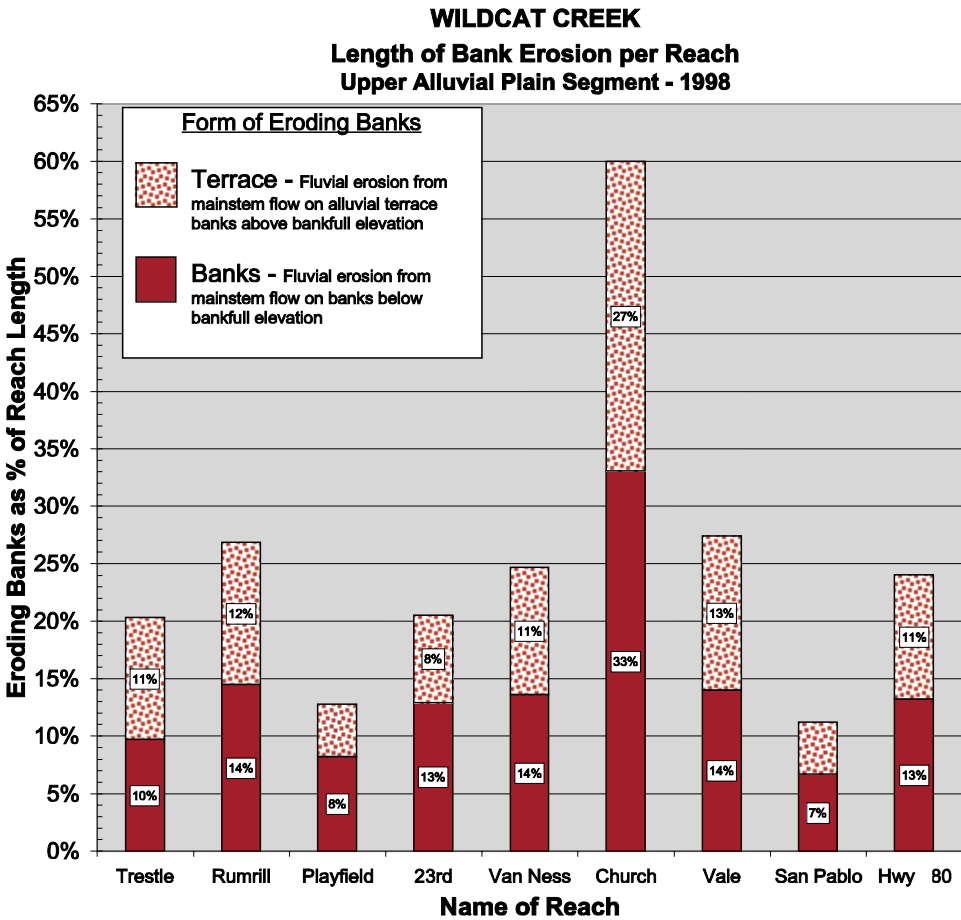
Figure 63a

Here we take a close look at the forms and lengths of streamside erosion for the reaches of the Alluvial Plain and Lower Canyon Segments. Figures 63 and 64 show the length of bank that is influenced by a particular process or form of erosion. For example, in Figure 63b the Upper Alluvial Plain has more length of bank below bankfull elevation that is dominated by fluvial erosion (55%) than fluvial terrace erosion (45%). The Lower Canyon Segment in Figure 64b shows a similar pattern of 43% length of bank being dominated by fluvial erosion of alluvial banks below bankfull, but terrace erosion is only 24% of the length. This is because 18% of the bank length also has fluvial erosion on canyon slopes and 15% of the length is mass wasting processes from landslides.

In Figures 63a and 64a, all the reaches show the similar trend of most bank erosion being from fluvial processes below bankfull height. Length of terrace bank erosion is less important in the Lower Canyon reaches because terraces are discontinuous. This is partly due to their local destruction by landslides. All the mainstem reaches along the Lower Canyon Segment are receiving some amount of sediment from mostly earthflow-type slides. One particular exception is a large debris slide in Dry Reach that caused massive deposition of sediments and woody debris into the channel (see Figure 90, arrow at distance station 27,000, page 71).

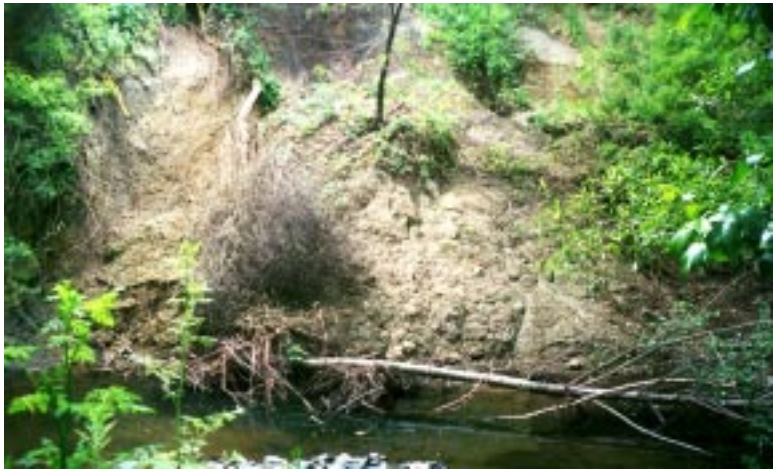
(Photo 45) Direct sediment input to the channel from the reactivated toe of an earthflow, June 1999.

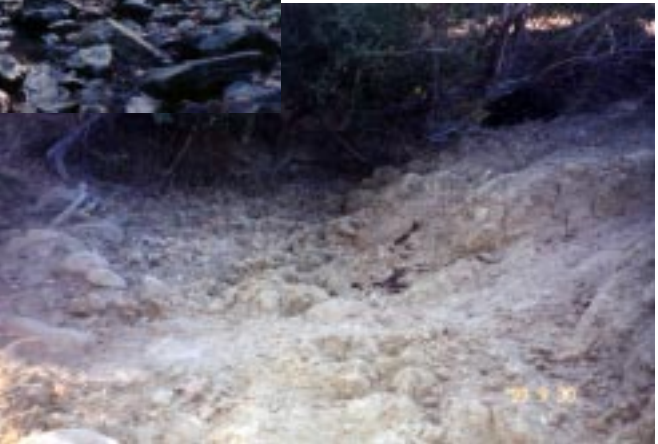
(Photo 46) A length of the mainstem Wildcat Creek in the Lower Canyon dominated by cobble-sized sediment.

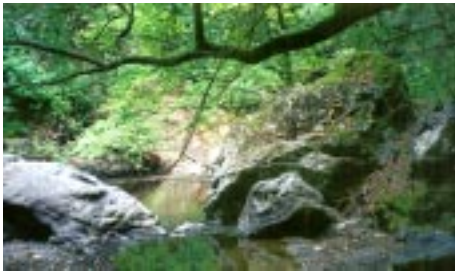
*(Photo 48)*  
*A deep pool is formed by scour around boulders.*

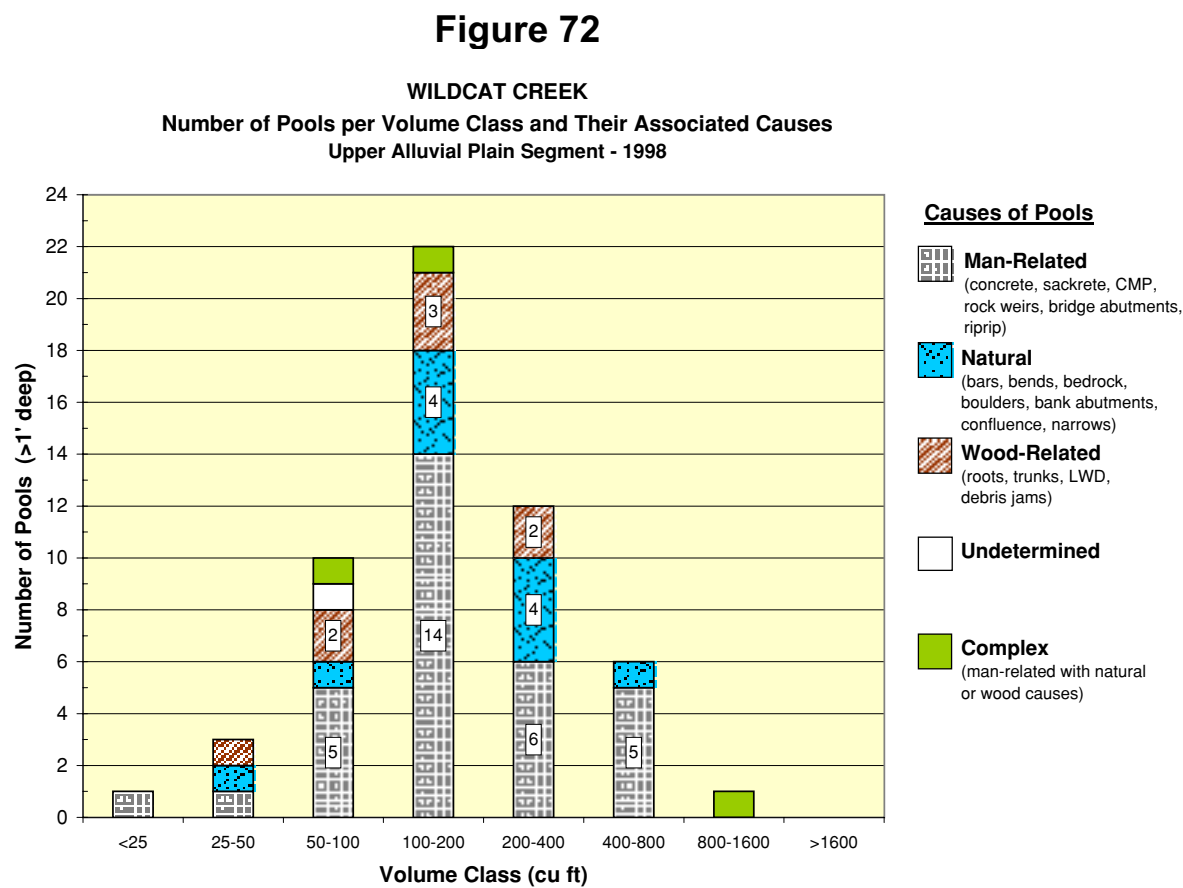
Figures 72a and 73a show the causes and numbers of pools per volume class for the Upper Alluvial Plain and Lower Canyon. Note the difference in vertical scales. Although individual causes were identified for each pool in the field, we have lumped them into 4 main categories: man-related, natural, wood-related, and “complex.” These are further explained in the legend for the graphs.

The number of man-related pools (65%) exceeds the number of natural pools on the Upper Alluvial Plain. In the Canyon, the number of naturally caused pools is greater than the number of man-related pools. Pool spacing for natural and “complex” pools combined is 195 ft, within 7 average bankfull widths. By having wood in the channel, pool spacing is reduced to 4 bankfull widths. Wood accounts for 33% of the pools in the Canyon and 16% in the Upper Alluvial Plain. The most common volume class for both segments is the 100-200 cu ft.

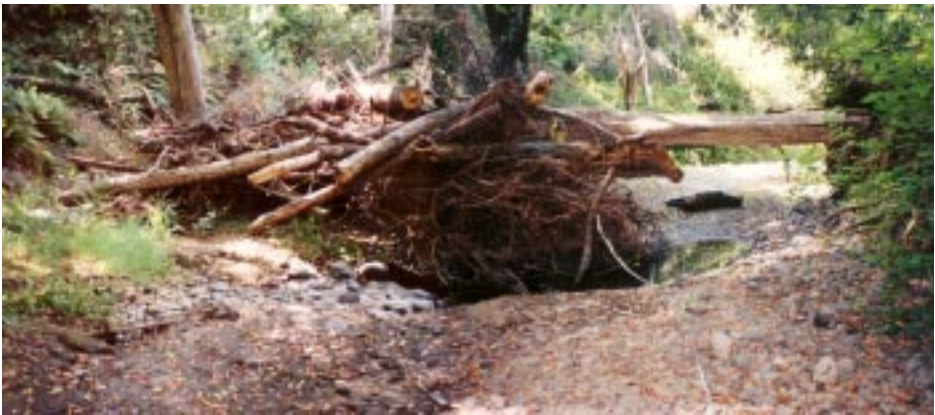
(Photo 49) A pool is formed by scour over a debris jam.

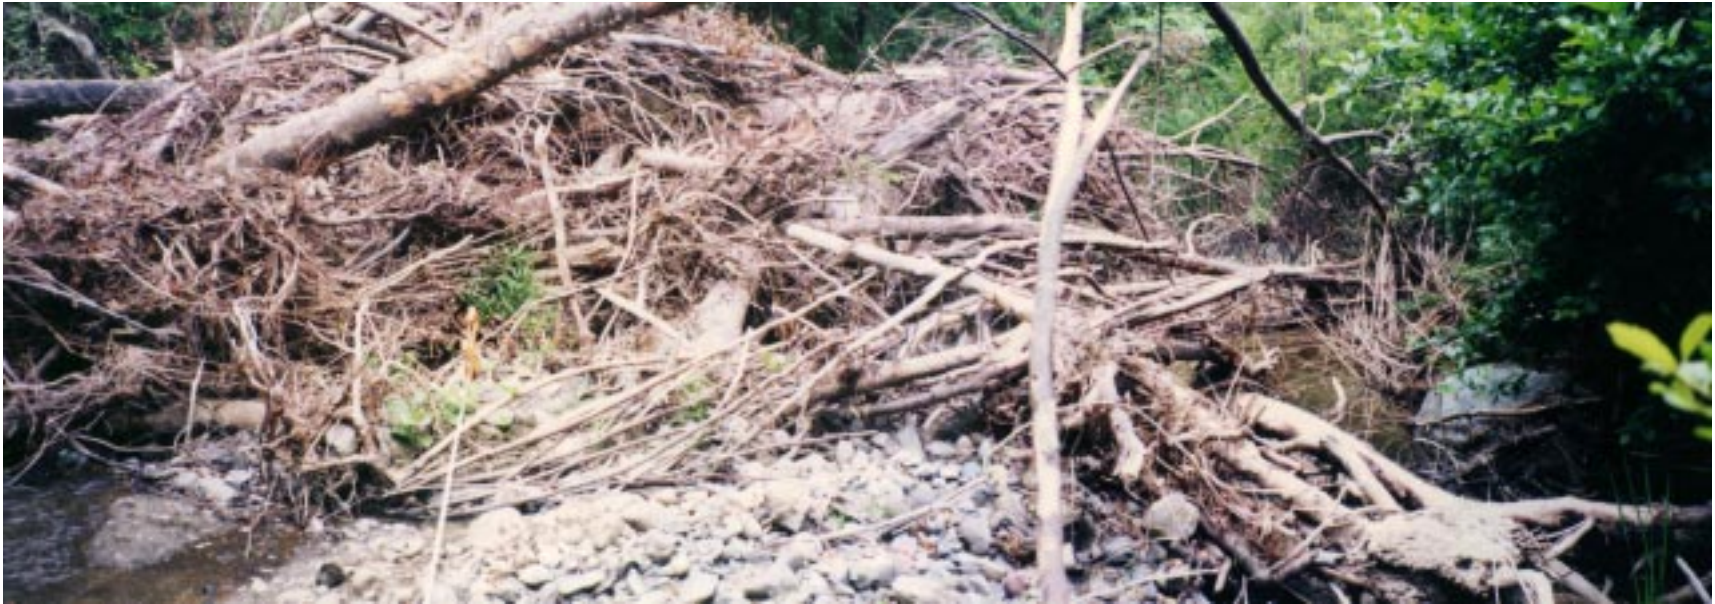
(Photo 50) An accumulation of different types of woody debris stores upstream sediment.

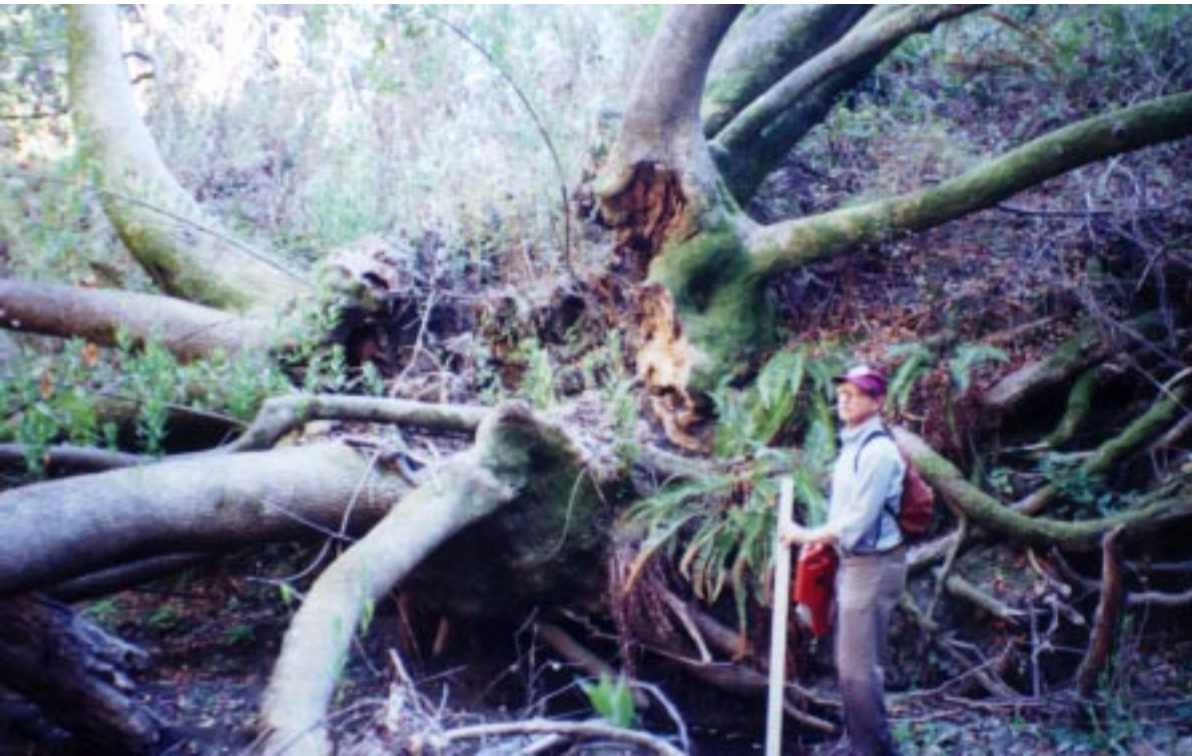
(Photo 51) A bay tree splits apart in 1996 summer after suffering severe rot from a fungal disease that attacked many trees. This was an important mechanism of woody debris recruitment of this species.

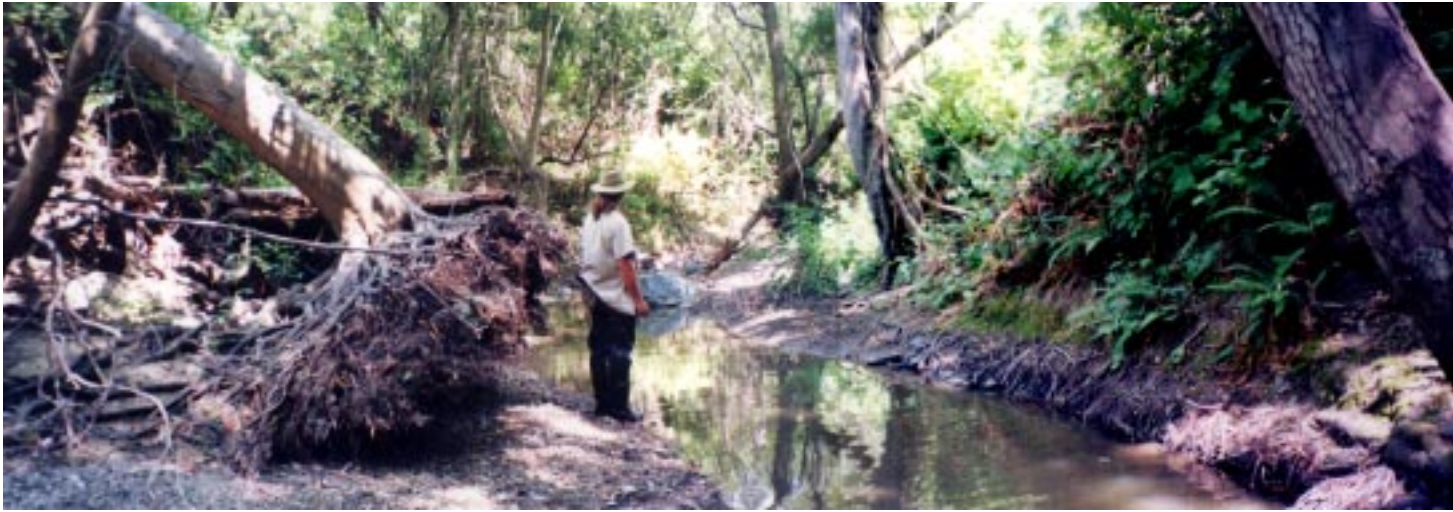
(Photo 52) Some alders are literally ripped from their beds when large floating debris rams into them during floods, May 1997.

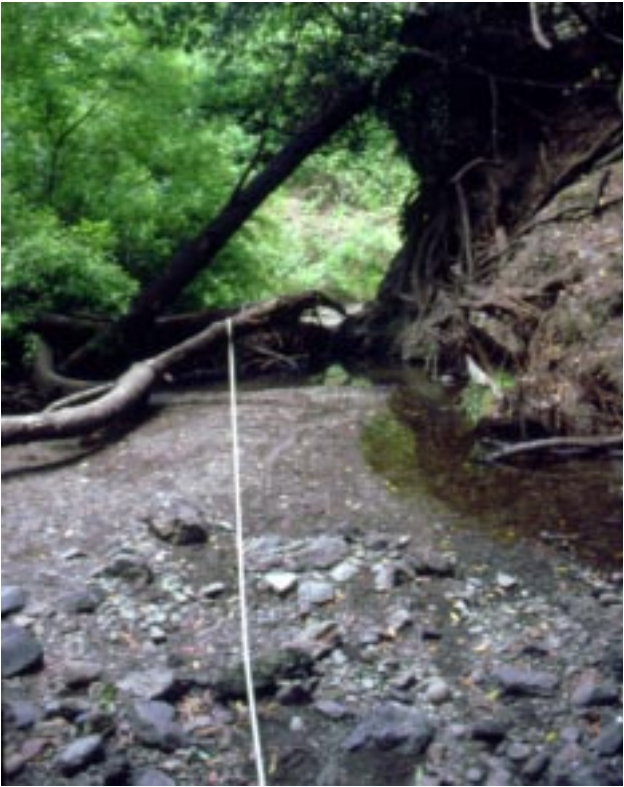
(Photo 53) Large woody debris is recruited to the channel by fluvial erosion of the banks.

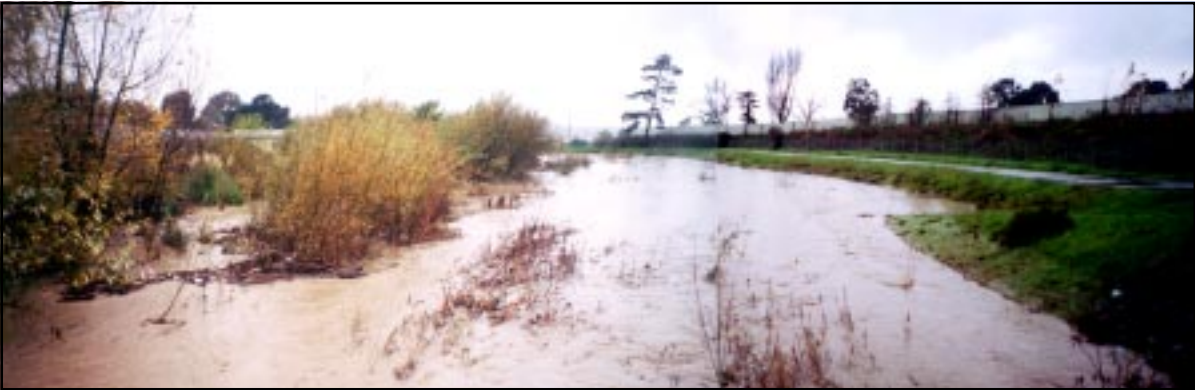
(Photo 54) The waning flood of January 1997 in the trapezoidal flood control channel divides between the constructed bankfull channel on the left and the constructed flood plain on the right. Debris has collected at the entrance of the low flow channel.

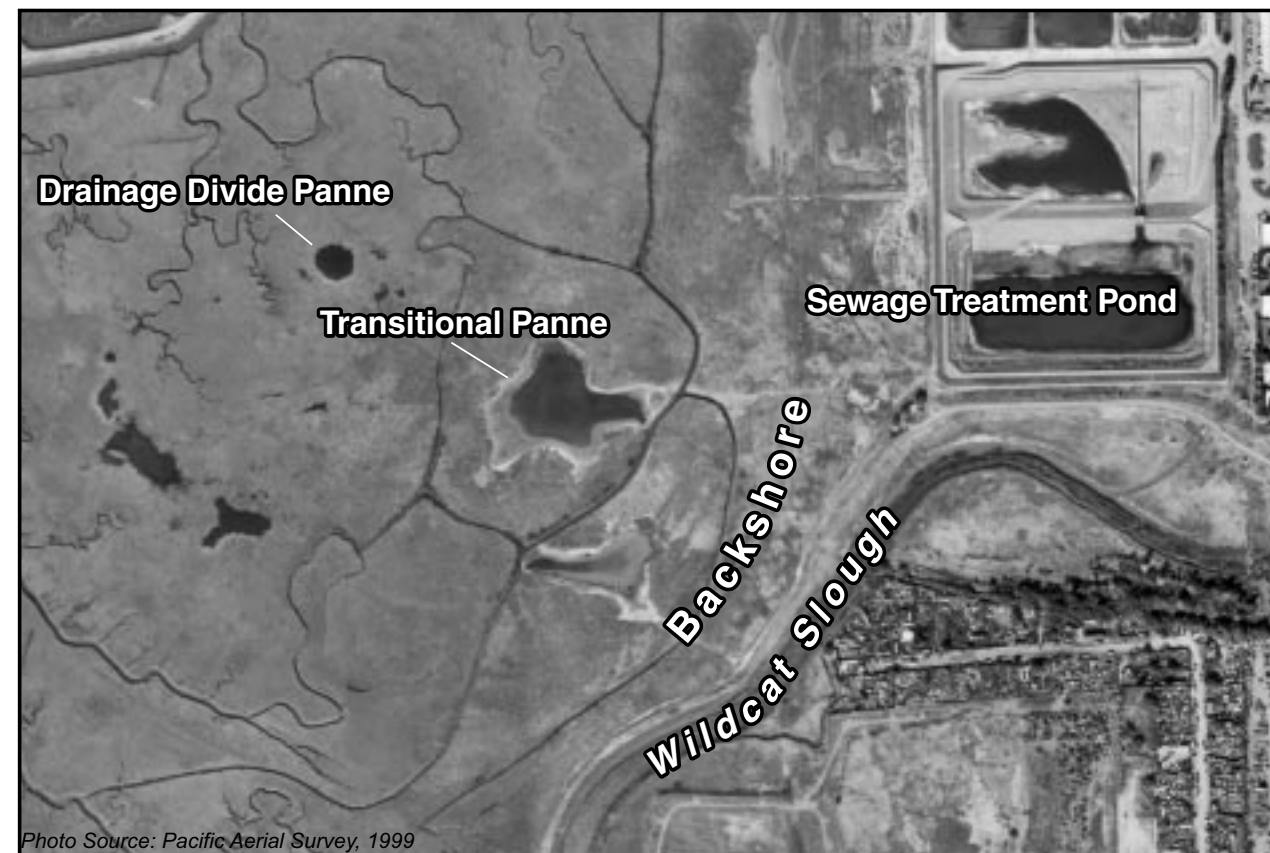
**Figure 82. A Detail of Wilcat Marsh**

Photo Source: Pacific Aerial Survey, 1999

The baylands consist of mudflats, tidal sloughs, natural levees along the largest channels, the foreshore of the tidal marsh, the marsh plain, tidal marsh pannes, and the backshore of the marsh (Figure 82) (Goals Project, 1999). The mudflats gradually slope upwards from about mean lower low water to the vegetated foreshore. The elevation of the foreshore varies with plant species and wave height, but it generally approximates mean tide level at Wildcat Marsh. The mudflat innervates the marsh through the network of tidal channels. The largest channels have low levees. The elevation of the marsh plain varies slightly around mean high water. The plain slopes upwards at the backshore, where the marsh plain transitions into upland.

A concrete-capped sewer line crosses Wildcat Creek downstream of the Richmond Parkway. It artificially raises the creek bed above the tides, restricting their upstream extent. The Creek has incised about 2 ft downstream of the sewer line since 1996. The concrete cap is preventing natural adjustment of the upstream gradient.

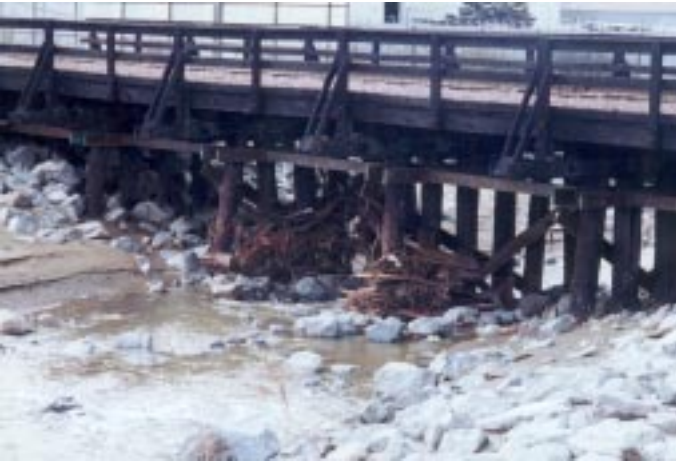
(Photo 55) Floating woody debris collects on the railroad trestle piers. The beams and the trestle impede the passage of flood flows and contribute to the formation of backwater floods. Flows have exceeded the top of the tracks.

effects of the trestle (see Photo 55, page 69). Floods have overtopped the trestle on several occasions.

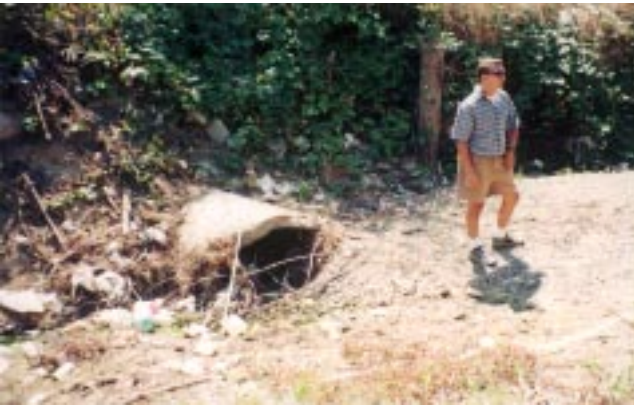
(Photo 56) A buried reinforced concrete pipe gives evidence of an aggraded bed. It is located near station 6200 on Figure A above.

Channel aggradation is still occurring in the area of the historical backshore of the tidal marsh, although tidal influence has been stopped thousands of feet downstream. There are four obvious reasons for this aggradation. First, the flood control basin is much less steep than the local historical gradient of Wildcat Creek, so it lacks the power to convey as much sediment. Second, the basin of the Flood Control Project was designed

to trap sediment at its upstream end, at about station 5000 ft. Third, the Rumrill Reach is trapping bedload because of a grouted riprap structure that has artificially elevated the creek bed. Fourth, there is occasional aggradation in this reach from debris jams and flood flows that transport of water and sediment impeded by the railroad trestle.

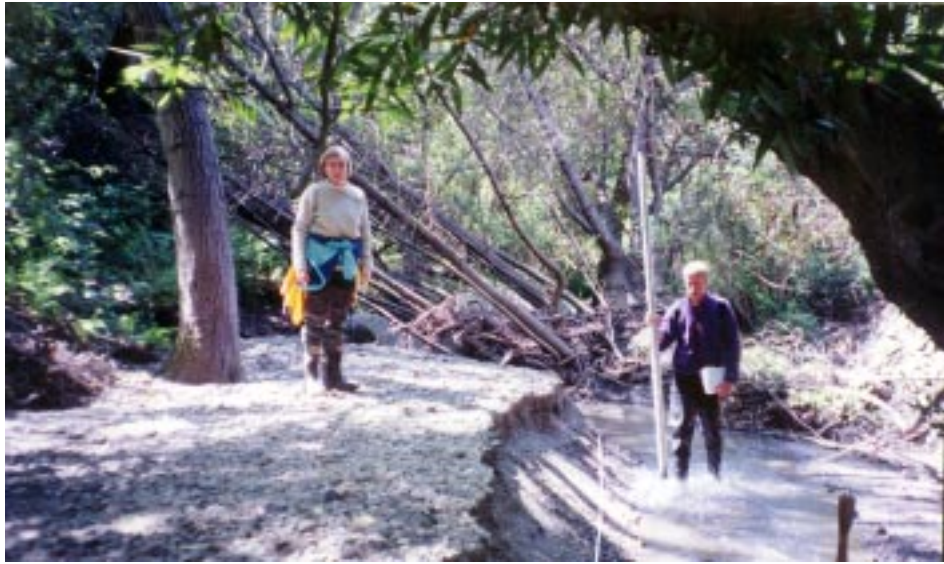
(Photo 57) Deposition of at least 3.5 ft has occurred behind a bay tree that slid into the channel, May 1999.

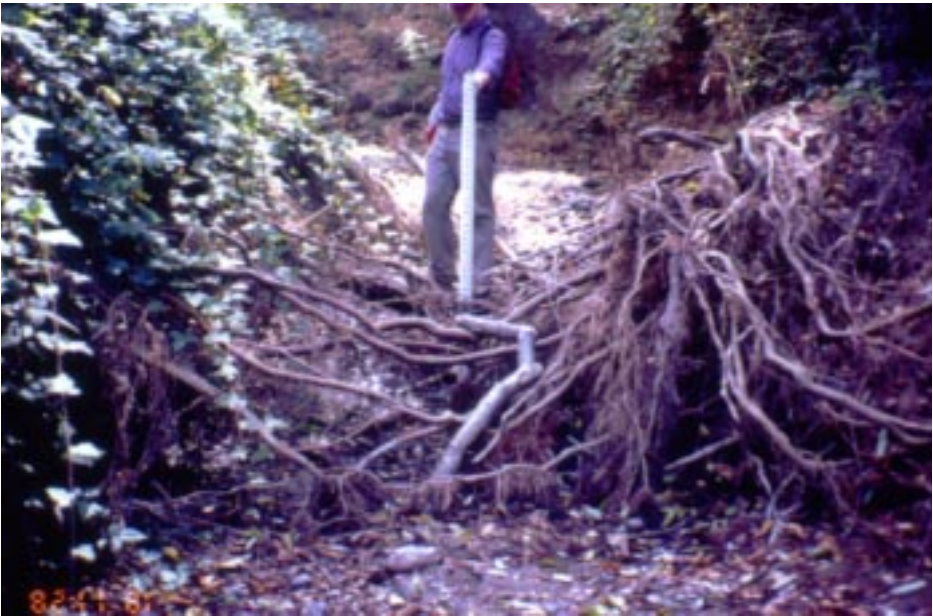
(Photo 58) Exposed roots in 1996 indicate the amount of bed incision that has occurred since 1987 when this reach was previously surveyed.

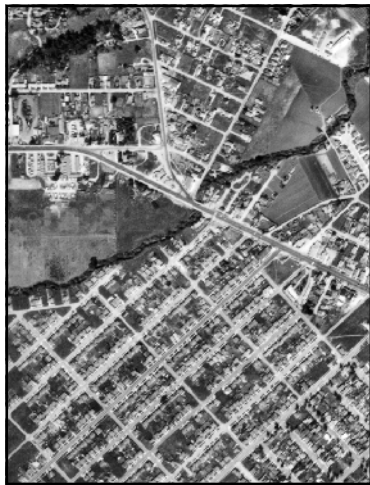
(Photo 63) 1947 Wildcat Creek and Upper Alluvial Plain. Source: Pacific Aerial Survey

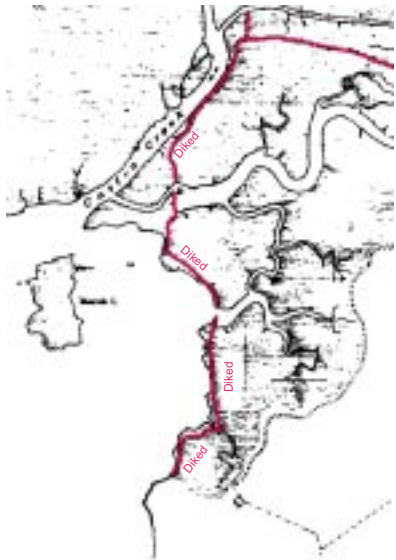
Figure 104  
Detail of Wildcat Marsh

Dikes in southern Wildcat Marsh circa 1860. Source: US Coast Survey T2445 1898.
