# McCosker Creek Restoration and Public Access Project:

## Alder Creek Daylighting Additional Monitoring Elements - Final Report

**San Francisco Estuary Institute**

December 2023

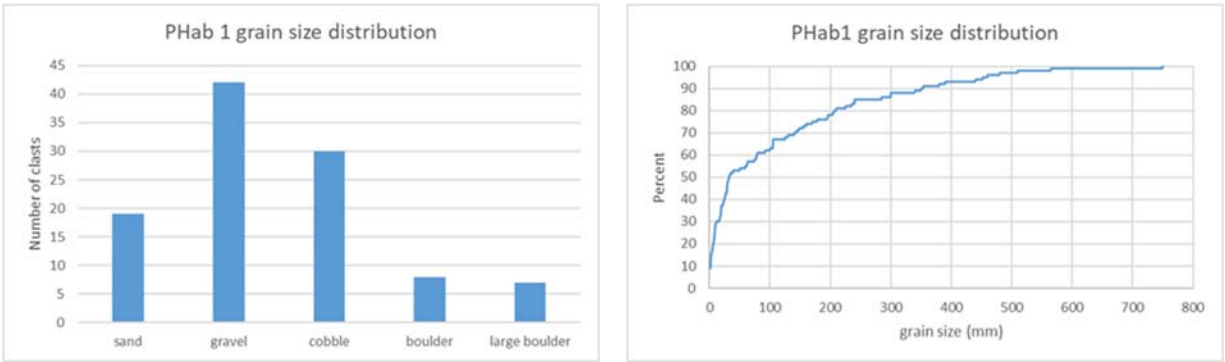
The grain size distribution was quantified by measuring the grain size of 100 individual clasts at each station. The median grain size (D50), and in a normal distribution one standard deviation from the median (D16 and D84) are reported for each station (Table 6). However, because the channel was constructed, and the design required a significant amount of large rock to be placed on the bed to maintain stability, the distribution is not normal (Figure 26). Instead it is skewed, with a long tail to the right, representing the largest boulder-sized rocks that were placed in the channel (Figure 27). While the largest clasts represented by the tail are not intended to be mobile (placed for channel stability), the majority of the measured grains (perhaps 70%), including smaller clasts used in construction, could be mobile in larger flood events. The skewed distribution is also evident by comparing the median (D50) and the mean for each station, and seeing the large difference between the two values.

**Figure 27.** Plots of the grain size distribution at PHab 1 to illustrate the skewed distribution of grain sizes.

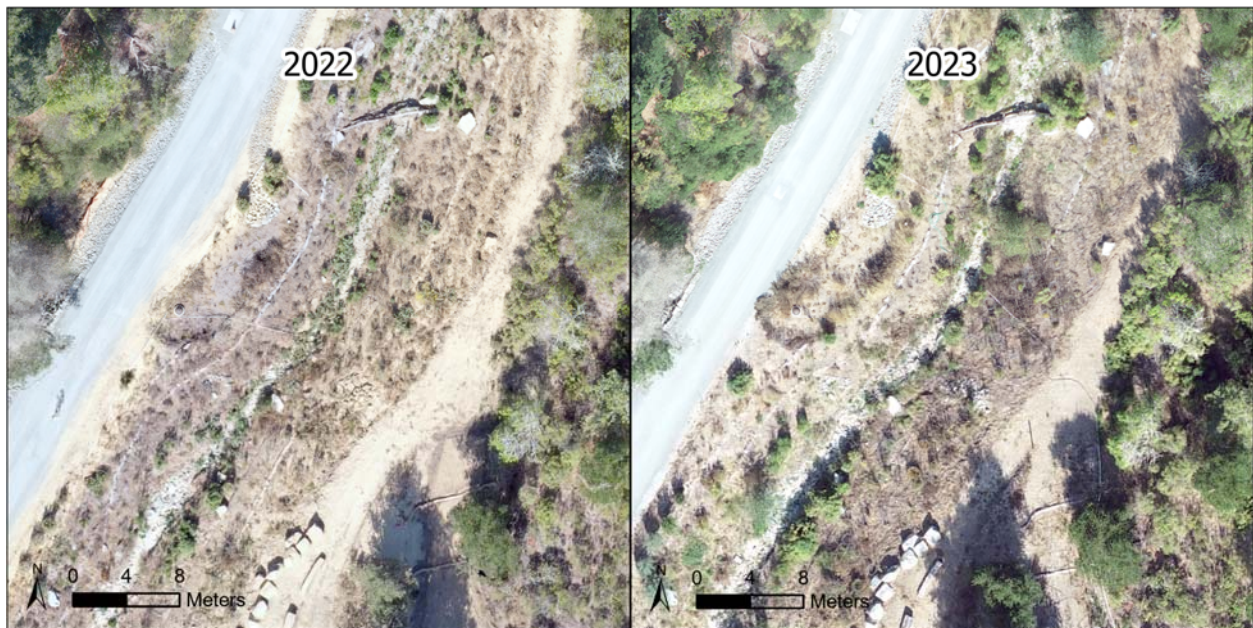
- Figure 30: Vegetation growth that has occurred between 2022 and 2023 within the planted vegetation, such as alders, willows, coyote brush, and other herbs and shrubs. This location, near the middle of the project, highlights the increase in canopy size for individual plantings.

**Figure 30.** Comparison between 2022 and 2023 illustrating the increase in canopy size of individual plantings.

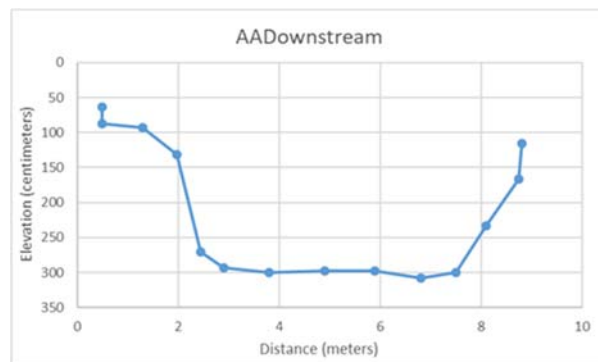
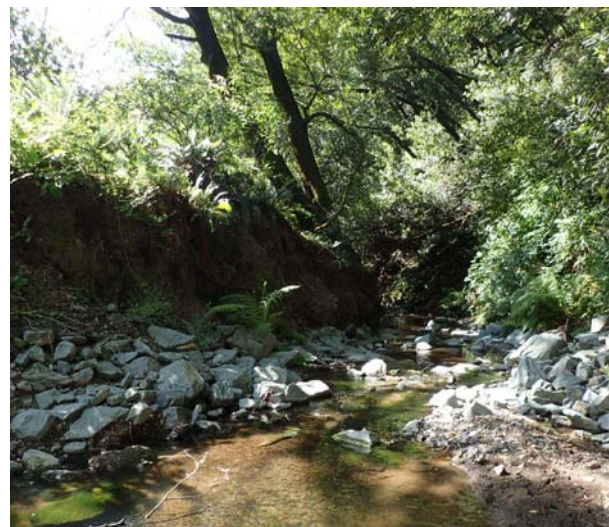
**Figure 37.** Left: Pre-construction channel cross section in the AA Downstream reach (Upper San Leandro Creek). Right: Photo looking downstream at the surveyed cross section location.

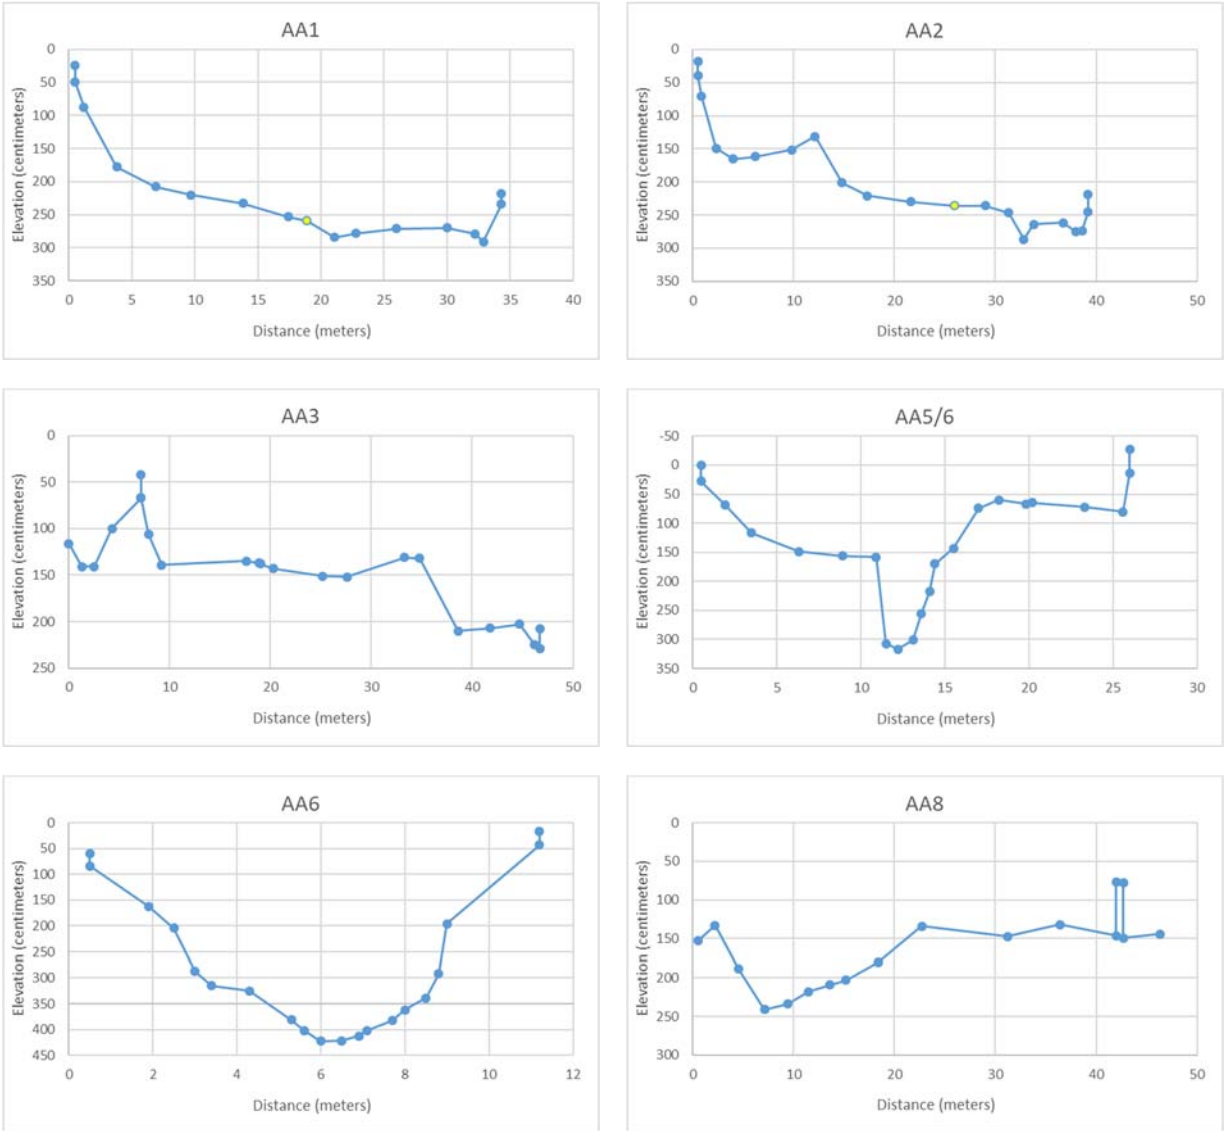
Simple plots of the seven channel/valley cross-sections (Figure 37 and 38) and the channel longitudinal profile (Figure 39) illustrate the pre-construction topography of the property. Notably, cross-sections AA1 and AA2 illustrate the flat valley floor, with the stream existing in the underground culvert. However, cross-section AA5/6 illustrates a reach where the culvert had failed, and the severely altered channel and culvert debris were exposed. And finally, the channel longitudinal profile illustrates the reaches where Alder Creek was exposed, reaches where it was culverted, reaches where the culvert was failing, and spot locations where the field team could survey the elevation of the sinkholes as compared to the adjacent valley floor elevation. In addition, the significant knickpoint (4.95 m in height) in the channel just upstream of the on-property residence is visible, indicating the instability of the system (Figure 40).

**Figure 38.** Pre-construction channel cross sections in the project footprint. Top left: Valley cross section in AA1. Yellow data point indicates the valley surface elevation above the culvert centerline. Top right: Valley cross section in AA2. Yellow data point indicates the valley surface elevation above the culvert centerline. Middle left: Valley cross section in AA3. Middle right: Valley and channel cross section in AA5/6. This location corresponds to the 2019 CRAM AA5, and the 2022 and 2023 CRAM AA6. Lower left: Channel cross section in 2019 AA6. This location is upstream and outside of the 2022 and 2023 AA6. Lower right: Valley cross section in AA8. Note the variable scales between plots.

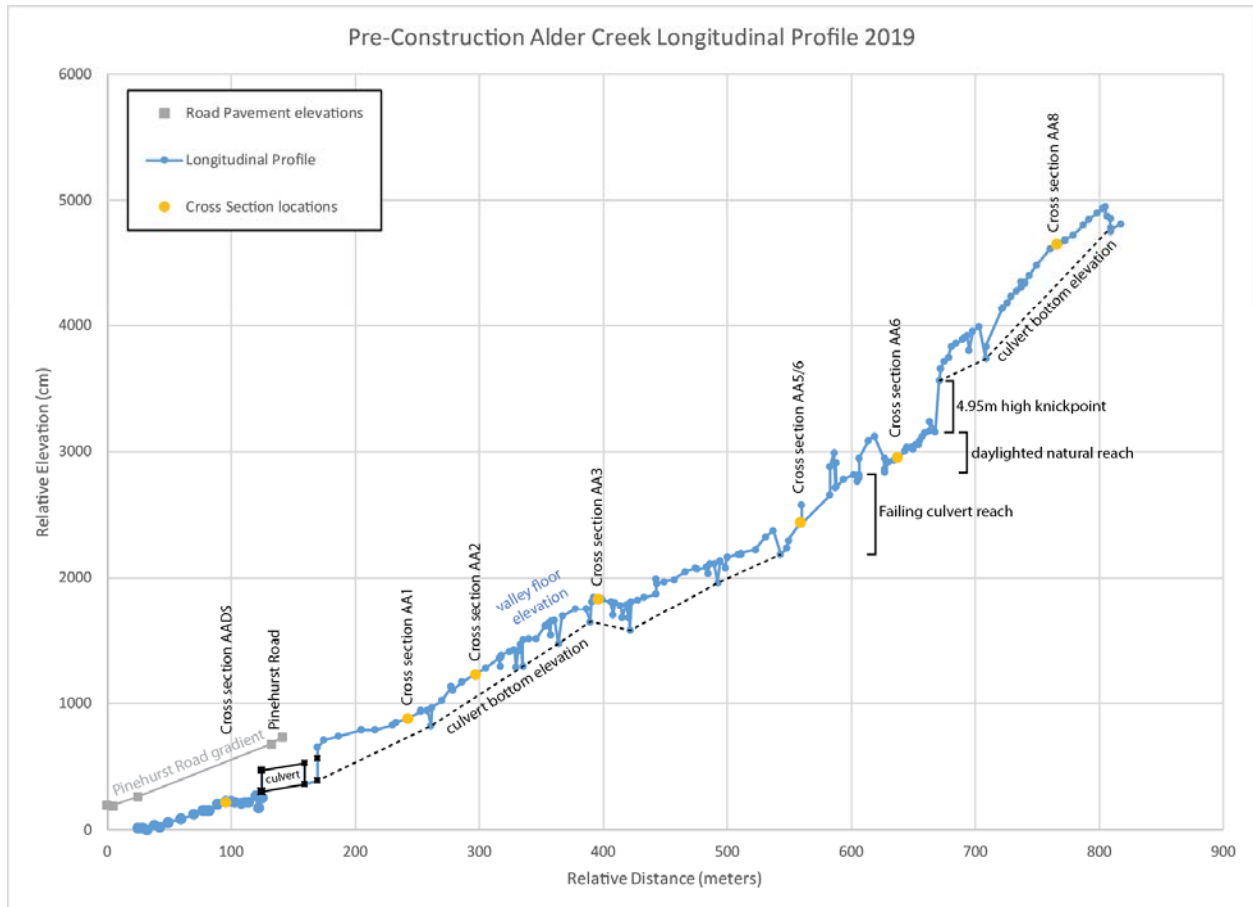
**Figure 39.** Pre-construction channel thalweg longitudinal profile. Profile extends from downstream in the AADS reach (Upper San Leandro Creek) upstream to the project boundary at the upstream end of the project.

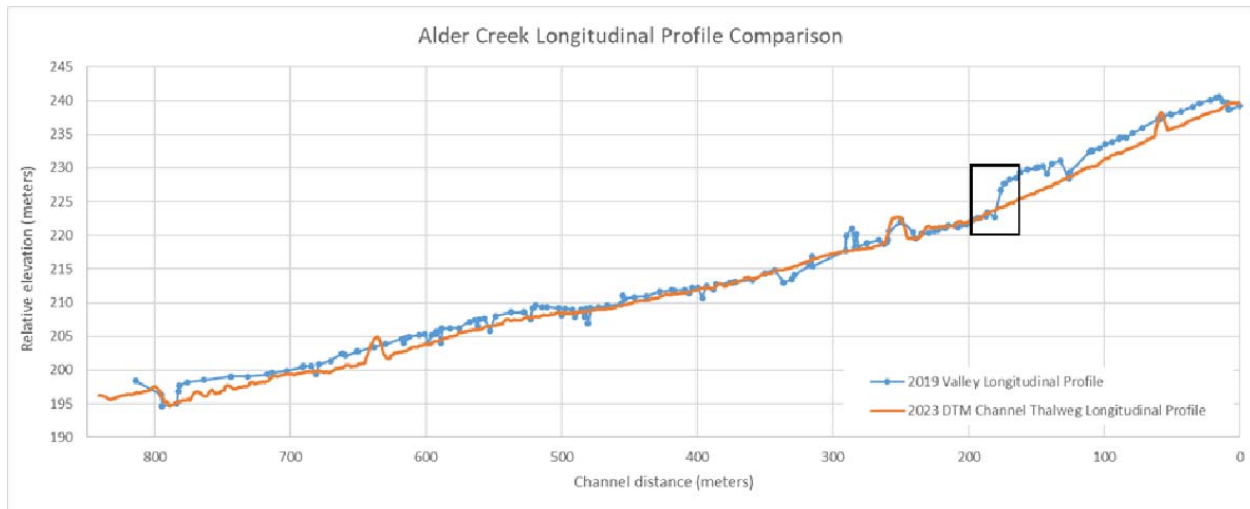
Although additional surveys were not completed after construction began, the pre-construction data can be combined with digital terrain model (DTM) data derived from the UAS surveys to illustrate the magnitude of change that has occurred. For example, Figure 41 shows the channel/valley cross section in CRAM AA1. In 2019, the valley floor was the dominant feature, without any hint of the channel, and only survey markers indicating the location of the underground culvert. However, the elevation data derived from the UAS survey at the same cross section location indicates the amount of change that has occurred through the construction of the new channel bed and banks. This same comparison can be completed for the cross section in CRAM AA8 (Figure 42), illustrating the extreme amount of excavation that was completed to create a stable channel bed. And finally, the comparison of the channel/valley longitudinal profile reveals the excavation that was required within the project to create a stable channel profile, given the steep valley slope (Figure 43).

**Figure 43.** Comparison of field-surveyed 2019 channel/valley longitudinal profile (orange) and 2023 Unoccupied Aerial Systems survey derived channel longitudinal profile (blue). Elevation is relative. Profile length and elevation were best fit to each other using a number of known locations between the two surveys. The three peaks in the 2023 surveys are capturing the three new constructed bridge elevations, while the downstream-most 50m of the 2023 survey captures Pinehurst road elevation rather than the thalweg elevation. The black inset box shows the location of Figure 44.
