STREAM INVENTORY REPORT for LA HONDA CREEK

Midpeninsula Regional Open Space District

**SAN FRANCISCO ESTUARY INSTITUTE
Watershed Program**

June 2007

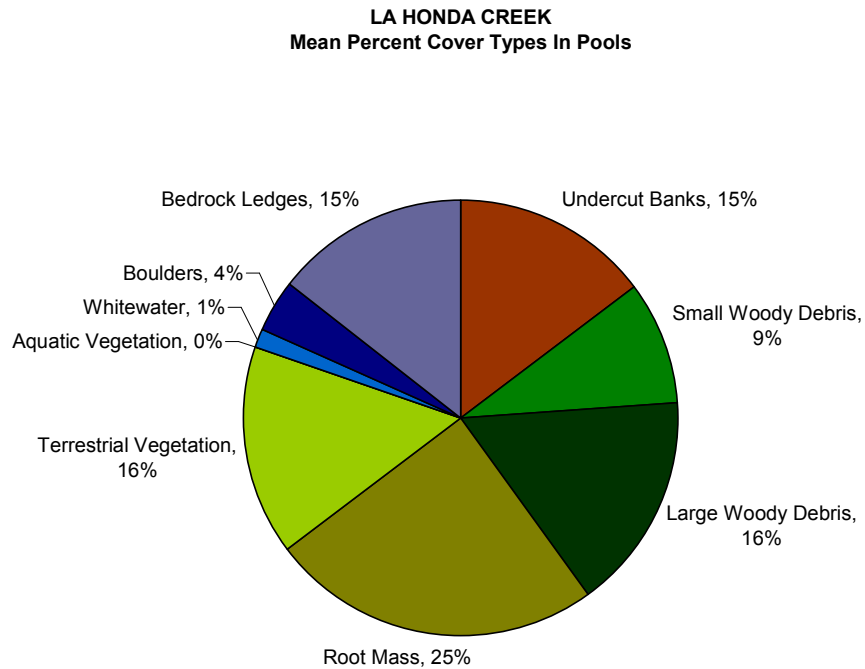
Shelter ratings (based on complexity and percent cover) were determined for each habitat unit, with the mean value for each habitat type reported. Based on a scale of 0-300 with 300 representing full instream cover and greatest complexity, the measured pools had a rating of 66, followed by flatwater at 34, and riffles at 25 (Table 5). Of the pool types, the dammed pool (DPL) and lateral scour boulder-formed (LSBo) pools had shelter ratings greater than 100. The mean rating of all scour pools was 86, followed by backwater pools (77) and main channel pools (20) (Table 7). The mean percent cover by habitat type is summarized in Table 9. Root masses are the dominant cover type in all habitat units in La Honda Creek (23%). Root masses also are the dominant cover types in pools specifically, followed by large woody debris, bedrock ledges, and undercut banks (Figure 12).

Figure 12. La Honda Creek mean percent cover types in pools.

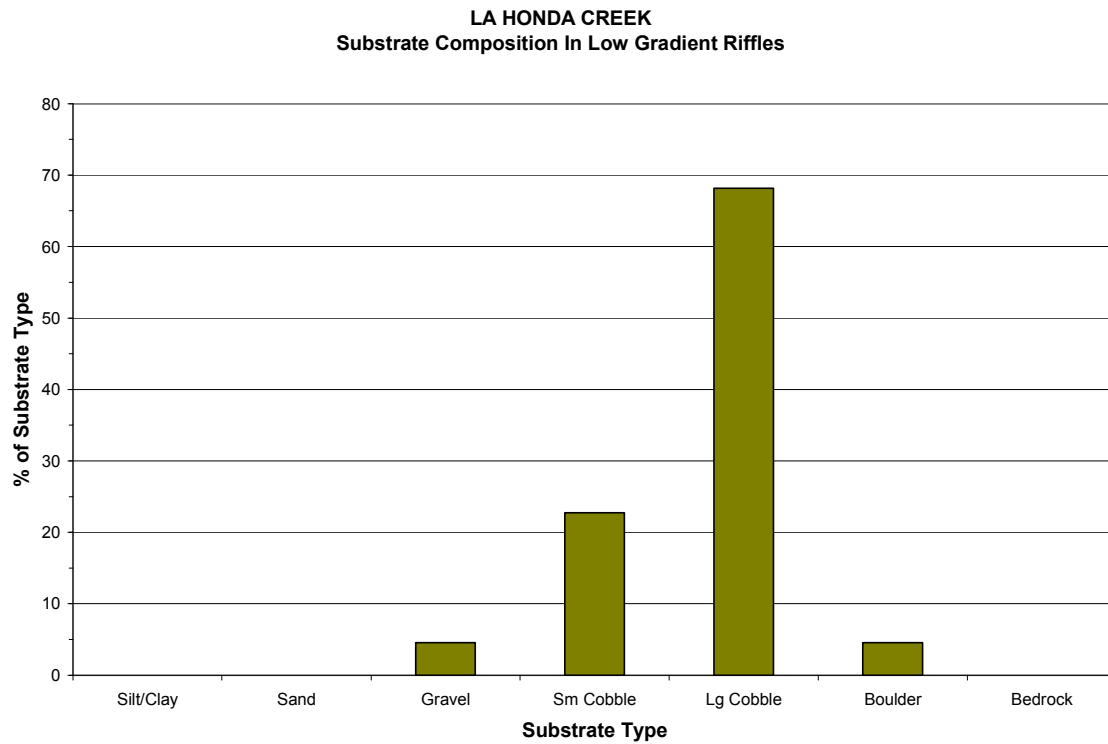
The March 2007 qualitative visual estimates of dominant and subdominant substrate composition by habitat type are summarized in Table 10. In all habitat units, large cobble has the greatest occurrence as the dominant substrate, found in 31% of the units. Sand closely follows as the dominant substrate in 27% of the units. Low-gradient riffles are consistently dominated by cobble, with 70% dominated by large cobble and 20% by small cobble (Figure 13). Gravel and boulders dominate the remaining low-gradient riffle units measured.

Figure 13. La Honda Creek substrate composition in low gradient riffles.

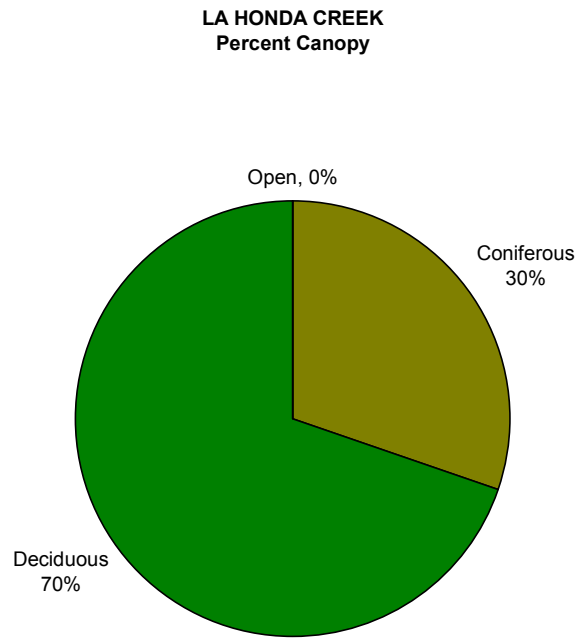
The percentage of canopy cover was estimated in all 70 units in March 2007. The mean percentage of canopy cover throughout all 70 units is 53% (Table 11). Approximately 70% of that canopy cover is from deciduous species, while the remaining 30% is due to coniferous species (Figure 15). These observations are similar to those made in the previous Brady et al. (2004) study, in which they found that the majority of the La Honda Creek corridor contains a continuous riparian canopy. Bank and riparian vegetation is generally similar throughout most of the study reach. Typically, at least 50% of the channel is shaded from the mid-day sun by the riparian canopy. Locations having less than 50% shading were usually caused by landslides that removed the canopy vegetation from the banks and adjacent slopes, bringing it into the channel along with the slide debris.

Figure 15. La Honda Creek percent canopy.

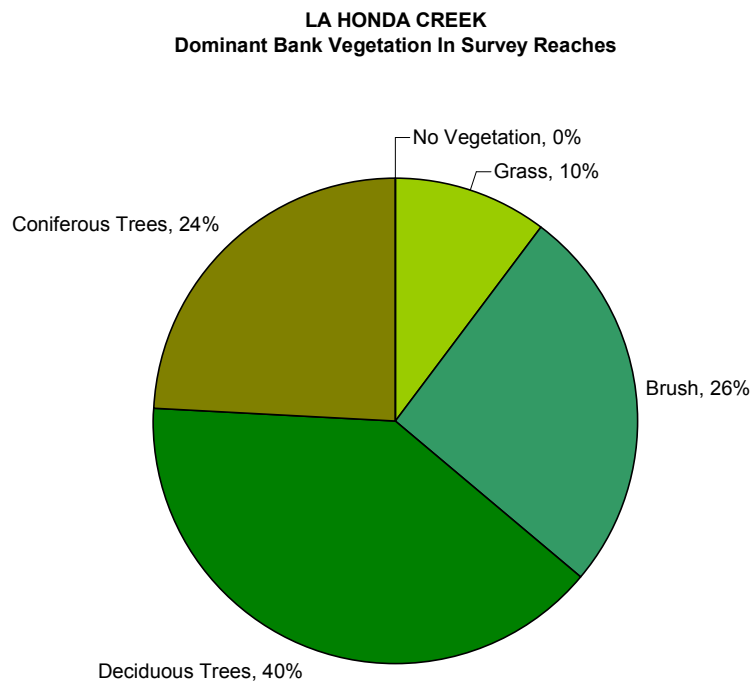
The March 2007 vegetation data broadly groups bank vegetation into a few categories following the CDFG Level IV methodology. We found that deciduous trees represent 40% of the bank vegetation and coniferous trees and brush each compose about one-fourth of the bank vegetation (Figure 18). The left bank on average had 59% vegetative cover and the right bank averaged 62% cover. These percentages are slightly lower than

Figure 18. La Honda Creek dominant bank vegetation in survey reaches as measured in 2002/2003.

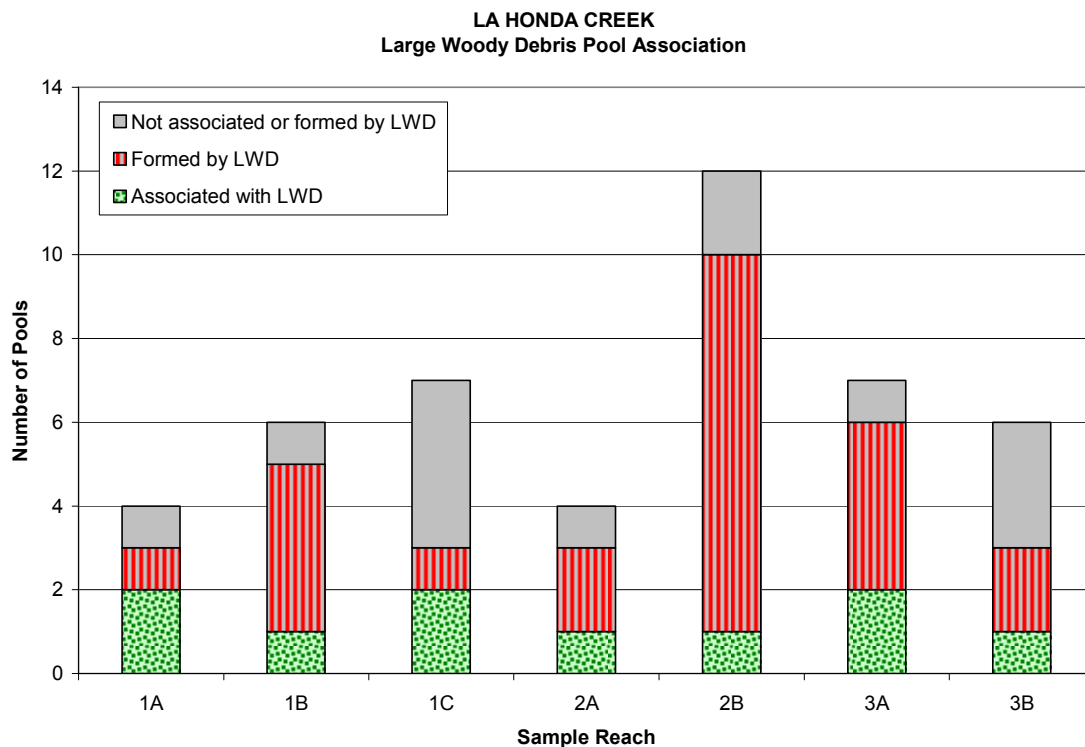
Large woody debris (LWD) including logs and rootwads is common in La Honda Creek because nearly continuous riparian corridor exists, the valley width is not much wider than the channel width in many reaches, and large landslides that convey wood into the channel are common in the watershed. The pieces are typically very large in comparison to channel dimensions, forming stable scour-causing elements. For this reason, nearly three-quarters of all pools measured in La Honda Creek are formed by, or contain significant LWD. LWD in pools is important to salmonids because each piece can shade, cover, or add complexity, increasing the habitat quality. Analysis of 2002/2003 data shows that in all sample reaches combined, 50% of pools measured are directly formed by LWD, and 22% contain LWD (Figure 22).

Figure 22. La Honda Creek number of pools associated with large woody debris in each survey reach as measured in 2002/2003.

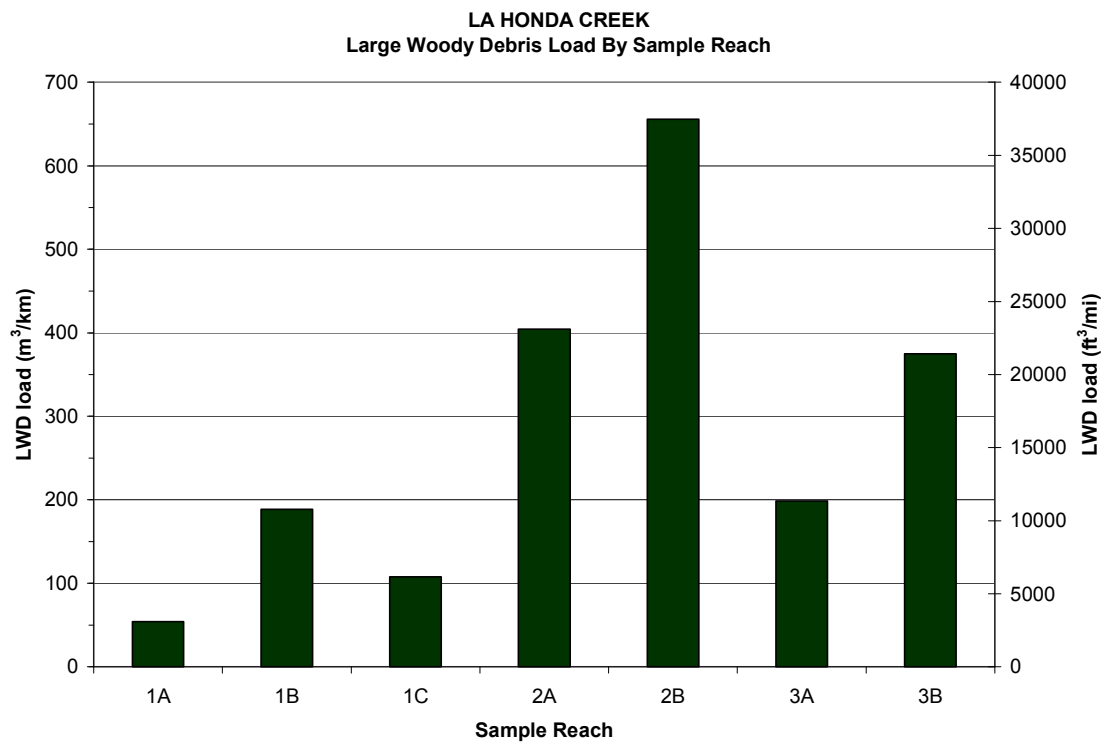
The number of pieces of LWD in each reach is fairly consistent, typically between 10 and 30, reflecting the nearly continuous riparian vegetation corridor. LWD loads range from 54 m³/km (114 yd³/mi) in reach 1A to 655 m³/km (1379 yd³/mi) in reach 2B (Figure 23). Reach 2B has the largest number of LWD pieces (99). This reach contains an unusually large LWD jam at the base of a shallow landslide. Many different species of LWD and live, upright trees were identified along La Honda Creek (Figure 24). Redwood and conifer trees are abundant in-channel LWD species because they are large, plentiful, and decay slowly. Other reaches contain large numbers of live, upright alders and other hardwoods whose roots extend into the bankfull channel, adding to the channel's roughness. Most hardwood logs in the channel have decayed beyond positive identification.

Figure 23. La Honda Creek large woody debris load by sample reach as measured in 2002/2003.

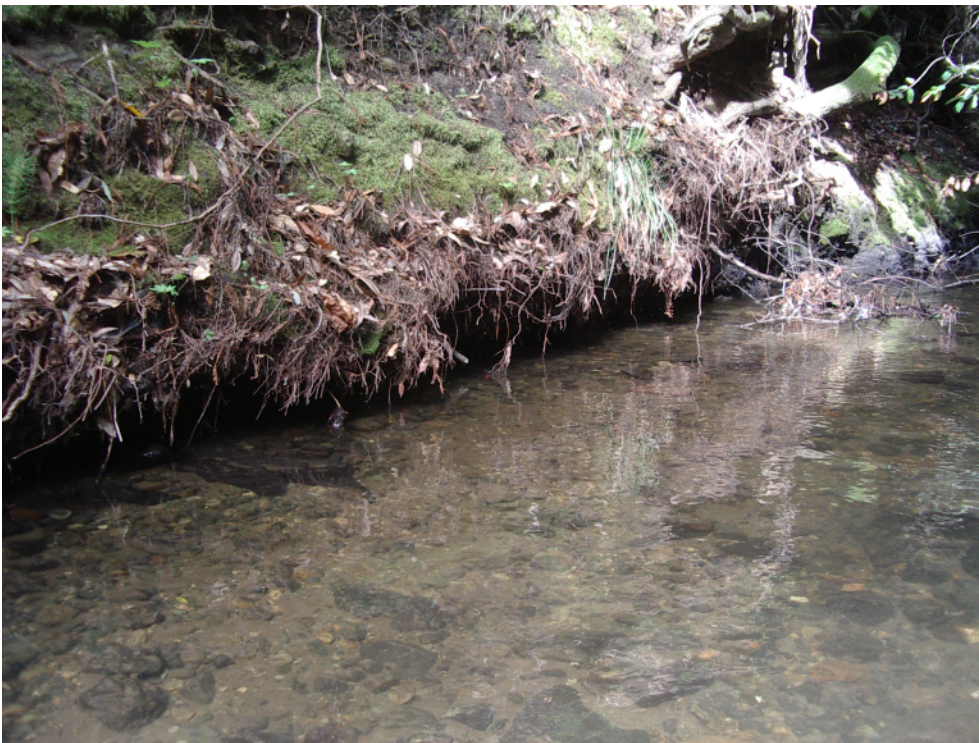
Figure 33. An example of an undercut bank in reach 2A (S. Pearce, 2007).

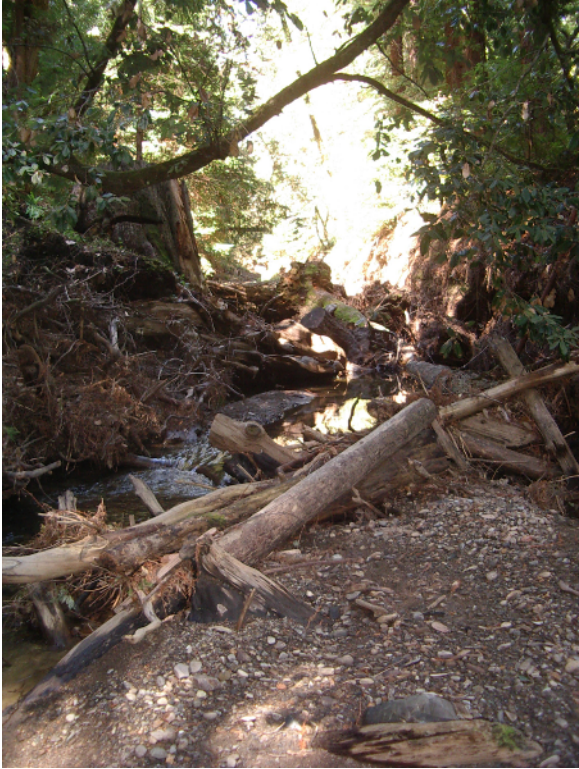
Figure 36. An example of a LWD jam in reach 3A (S. Pearce, 2007).

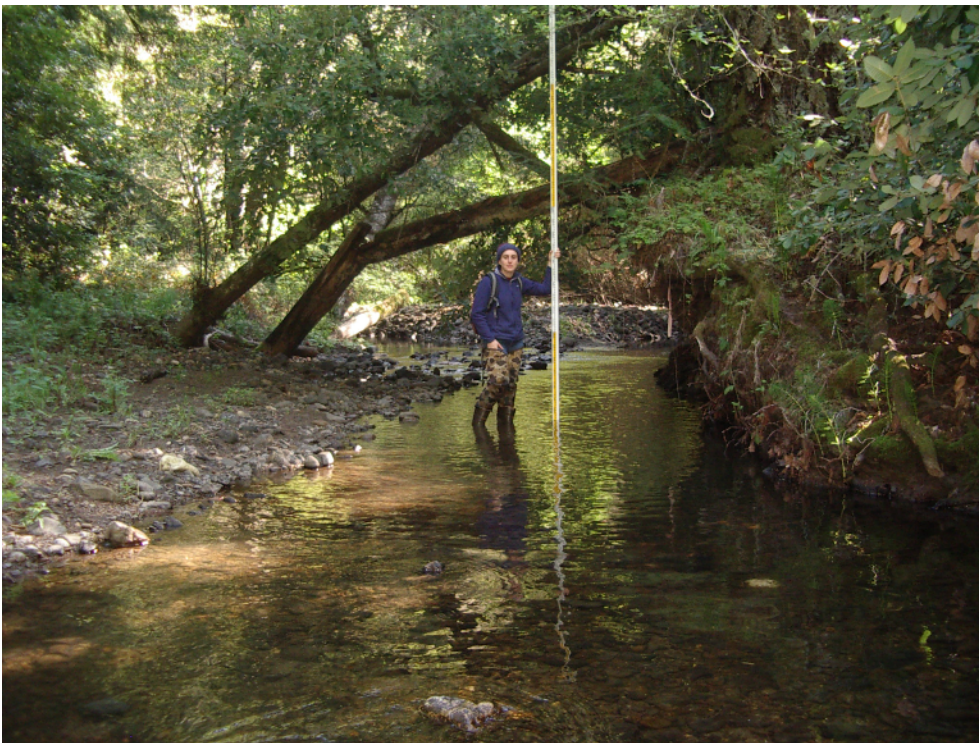
Figure 39. Example of an undercut bank providing cover in reach 2B (S. Pearce, 2007).

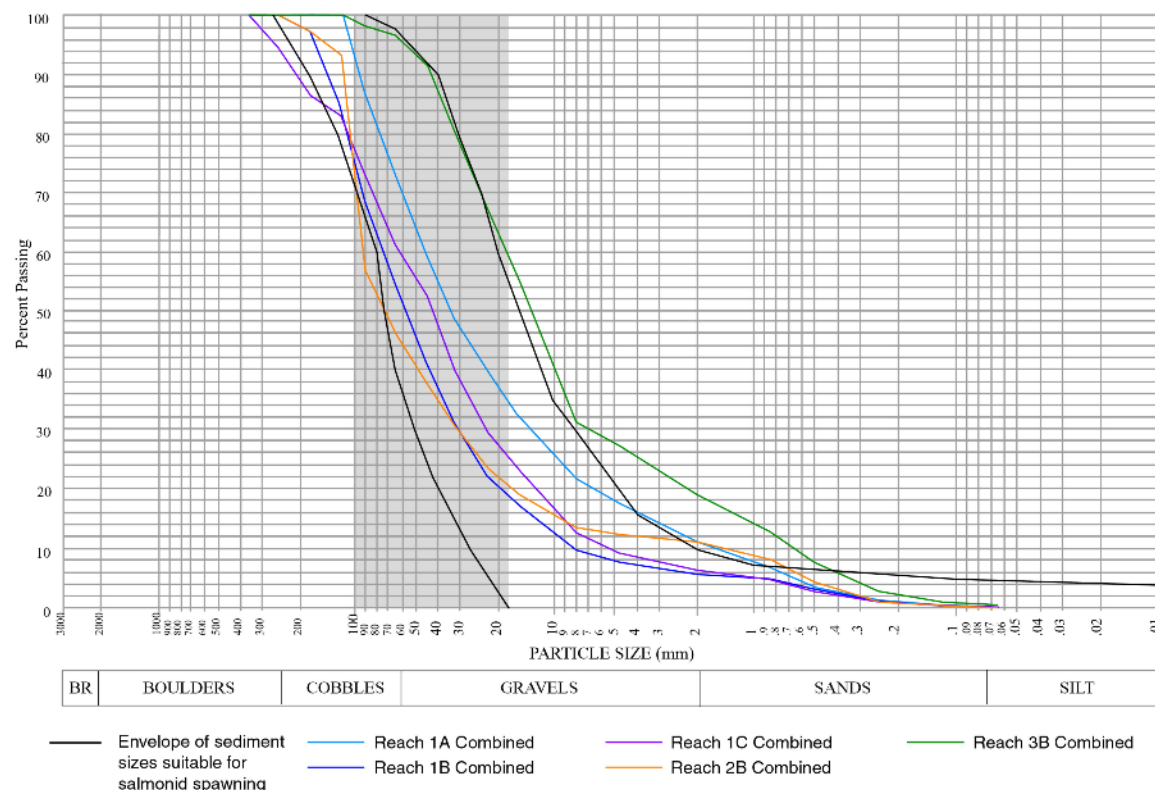
In 2002/2003, five bulk samples were collected, weighed and measured. The median grain size (D_{50}) ranged from a low of 14 mm (0.55 in) in reach 3B to a maximum of 90 mm (3.5 in) in reach 2B.

Figure E-1. Particle size distribution curves of combined (surface and subsurface) bulk sediment samples in sample reaches in all three study segments. Shaded area highlights framework grain sizes utilized by steelhead for spawning (Kondolf and Wolman, 1993). Envelope of sediment sizes suitable for salmonid spawning is shown in black (Bjorn and Reiser, 1991; Kondolf 2000; Shirazi and Siem, 1979). BR = bedrock.

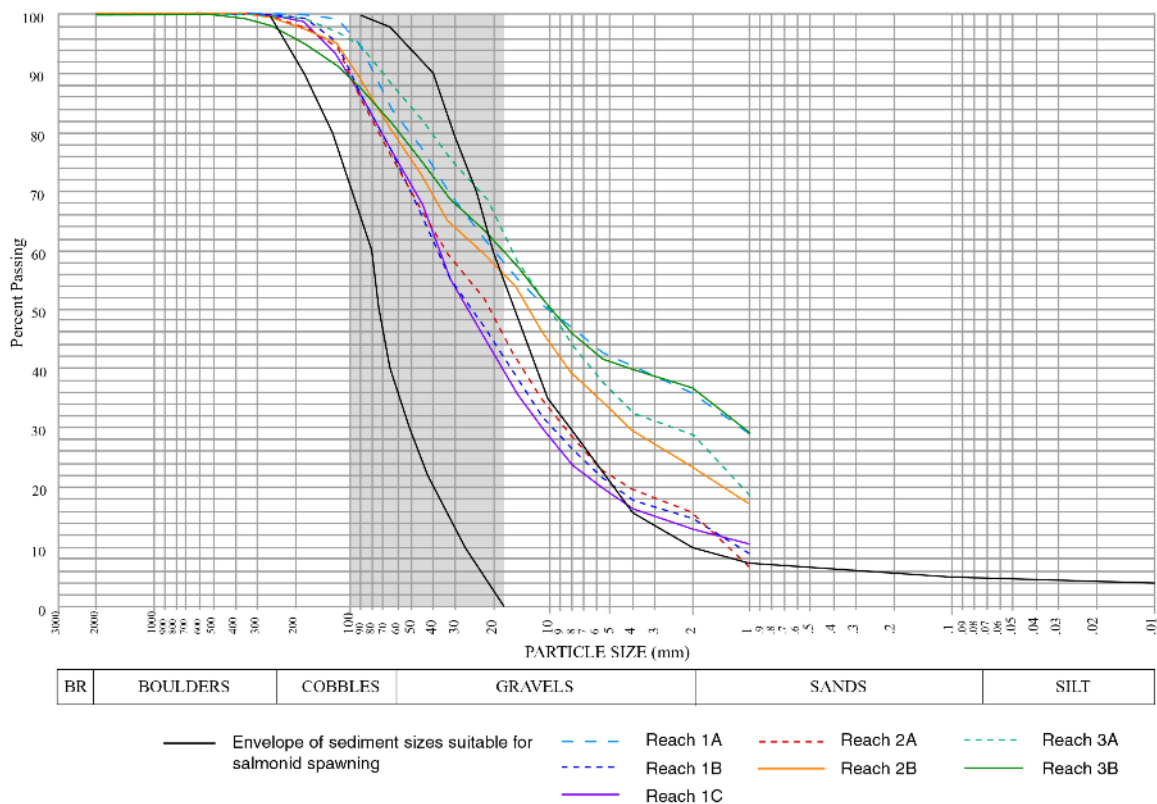
Figure F-1. Surface particle size distribution curves of samples in all three study segments. Shaded area highlights framework grain sizes utilized by steelhead for spawning (Kondolf and Wolman, 1993). Envelope of sediment sizes suitable for salmonid spawning is shown in black (Bjorn and Reiser, 1991; Kondolf 2000; Shirazi and Siem, 1979). BR = bedrock.
