APPENDIX
Dry Creek Reconnaissance Sediment Study
Technical Memo

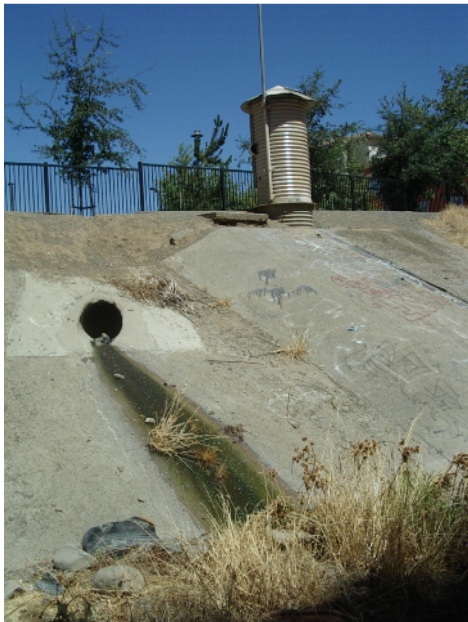
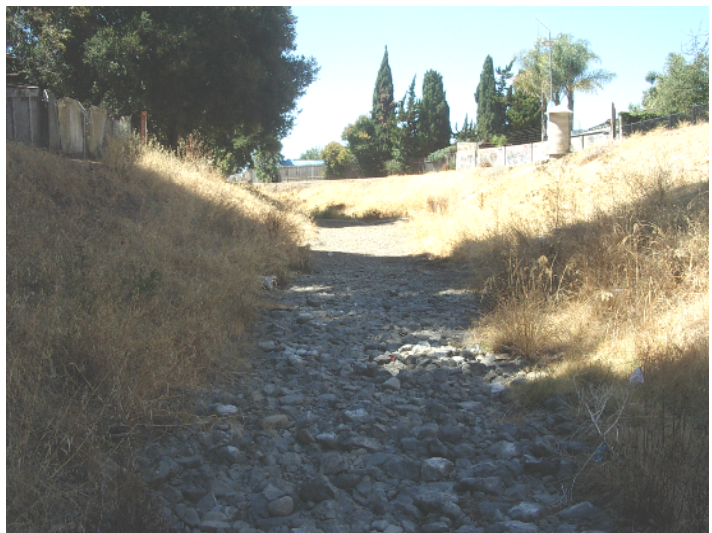
Appendix Figure 4. Photographs of the USGS gage station (11180500 Dry C at Union City CA) located downstream of Mission Boulevard. Left: looking at the right bank at the gage house. Right: looking downstream at the weir and gage house.

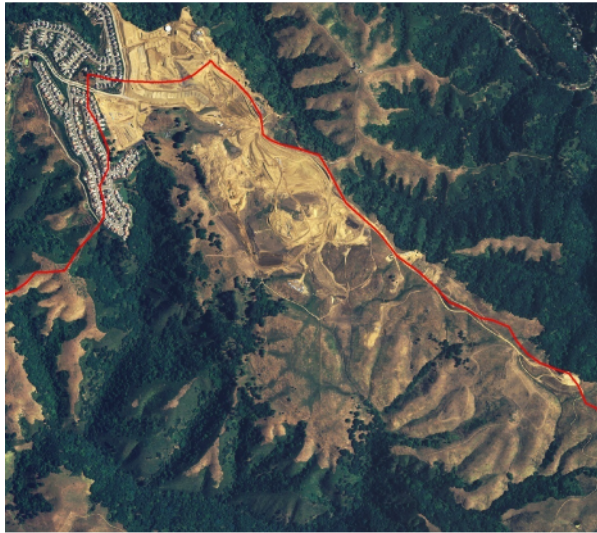
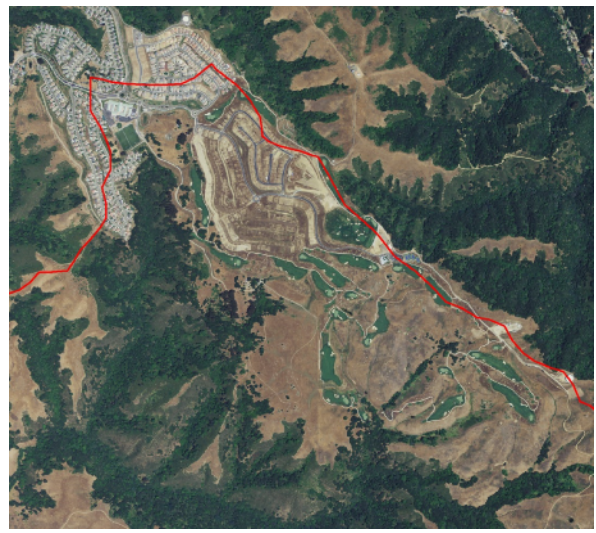
Appendix Figure 15. Left: Aerial photograph showing the 2005 construction of a residential area and golf course in the northern portion of the watershed. Right: The same area shown in 2009, note the extent of the golf course and the areas not yet built out.

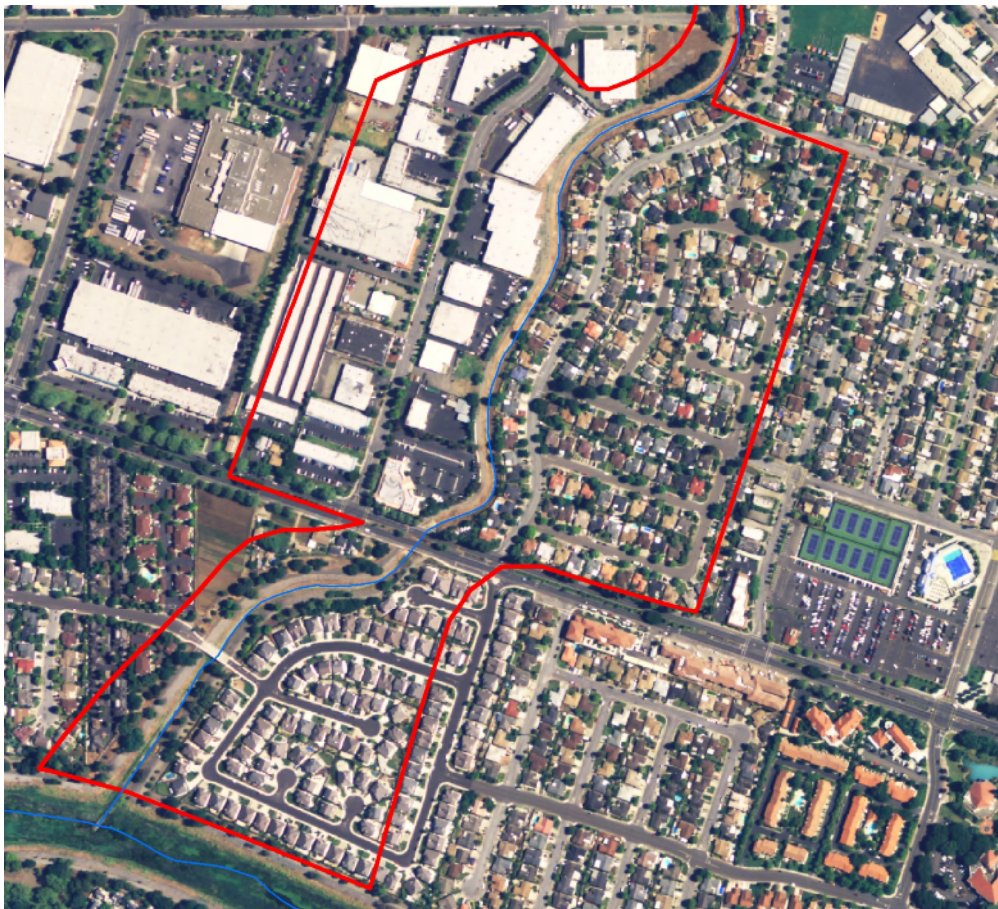
Appendix Figure 16. Aerial photograph showing a portion of the lower urbanized watershed.

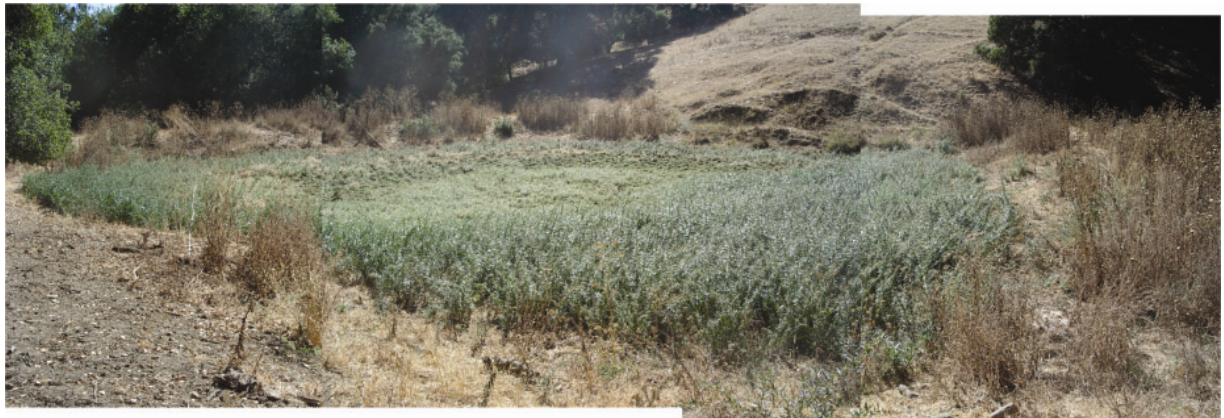
Appendix Figure 18. Example of a small stock pond (dry) observed in the watershed.

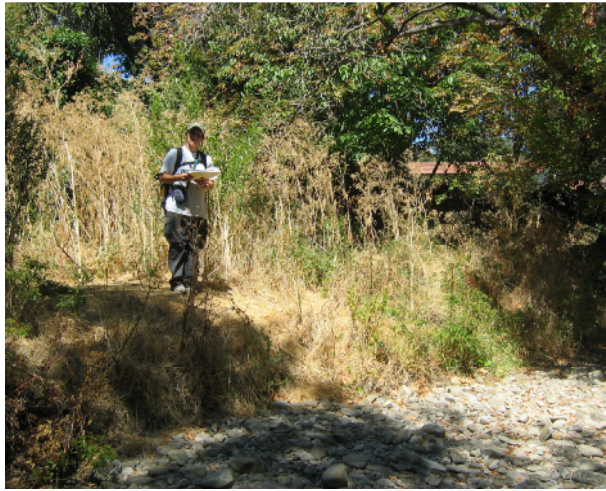
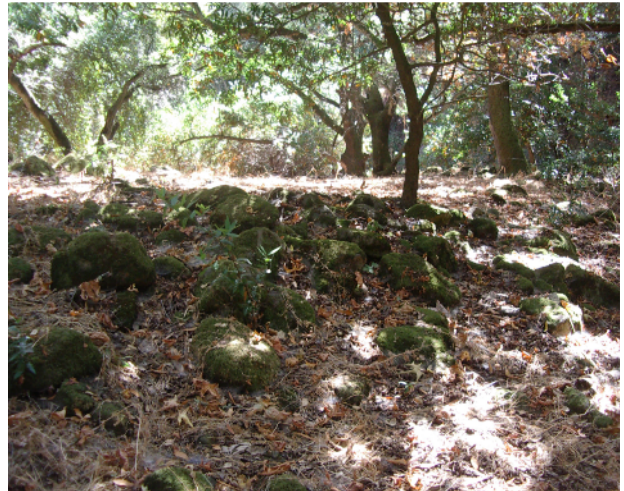
Appendix Figure 19. Left: Floodplain surface upstream of Mission Blvd. Right: coarse surface hypothesized to have been deposited during the 1950s events.

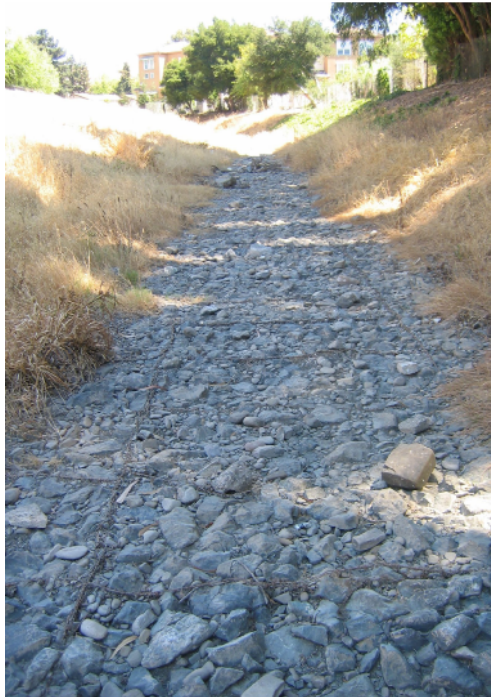
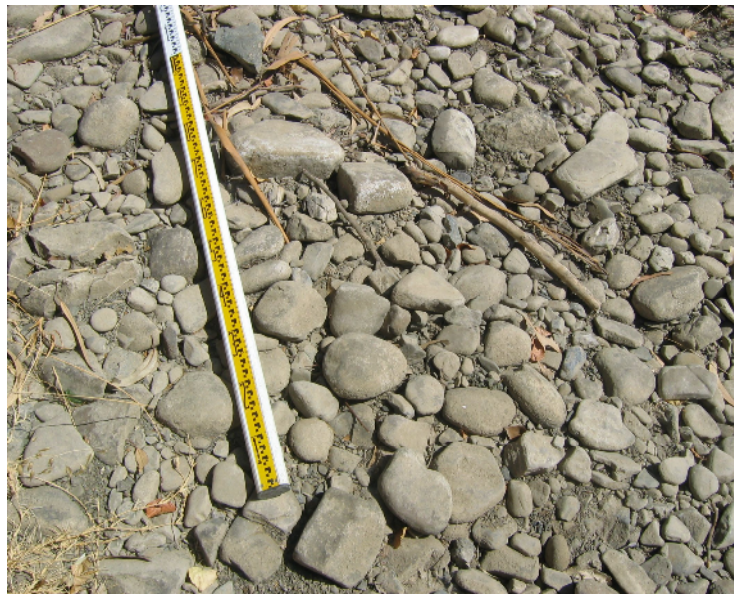
Appendix Figure 24. Left: Efficient channel reach downstream of Mission Blvd. Right: Typical bed grain size distribution.

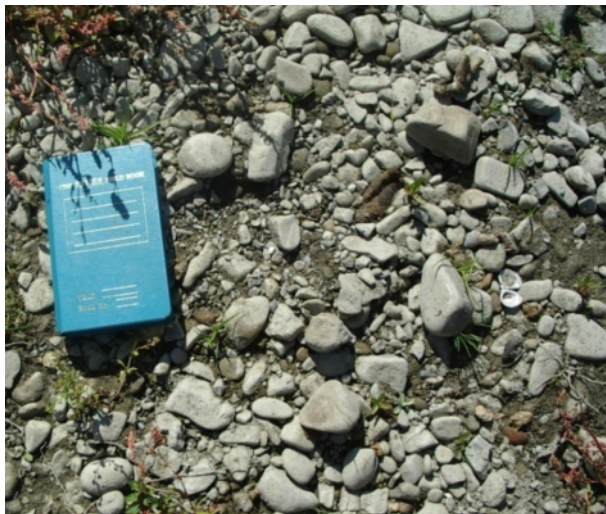
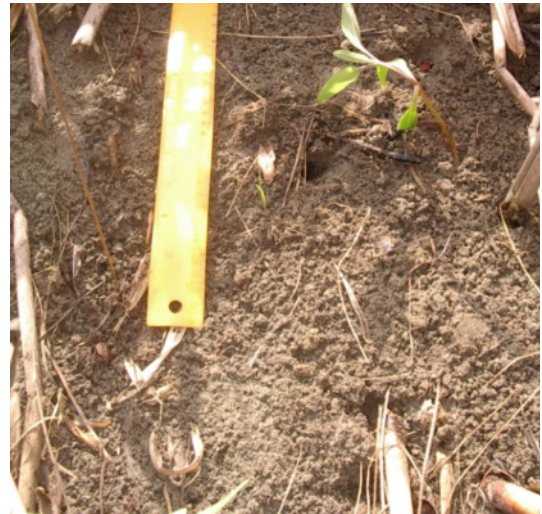
Appendix Figure 25. Left: example of the coarser grain sizes observed on the fan surface. Right: example of the finer grain sizes observed on the fan surface.

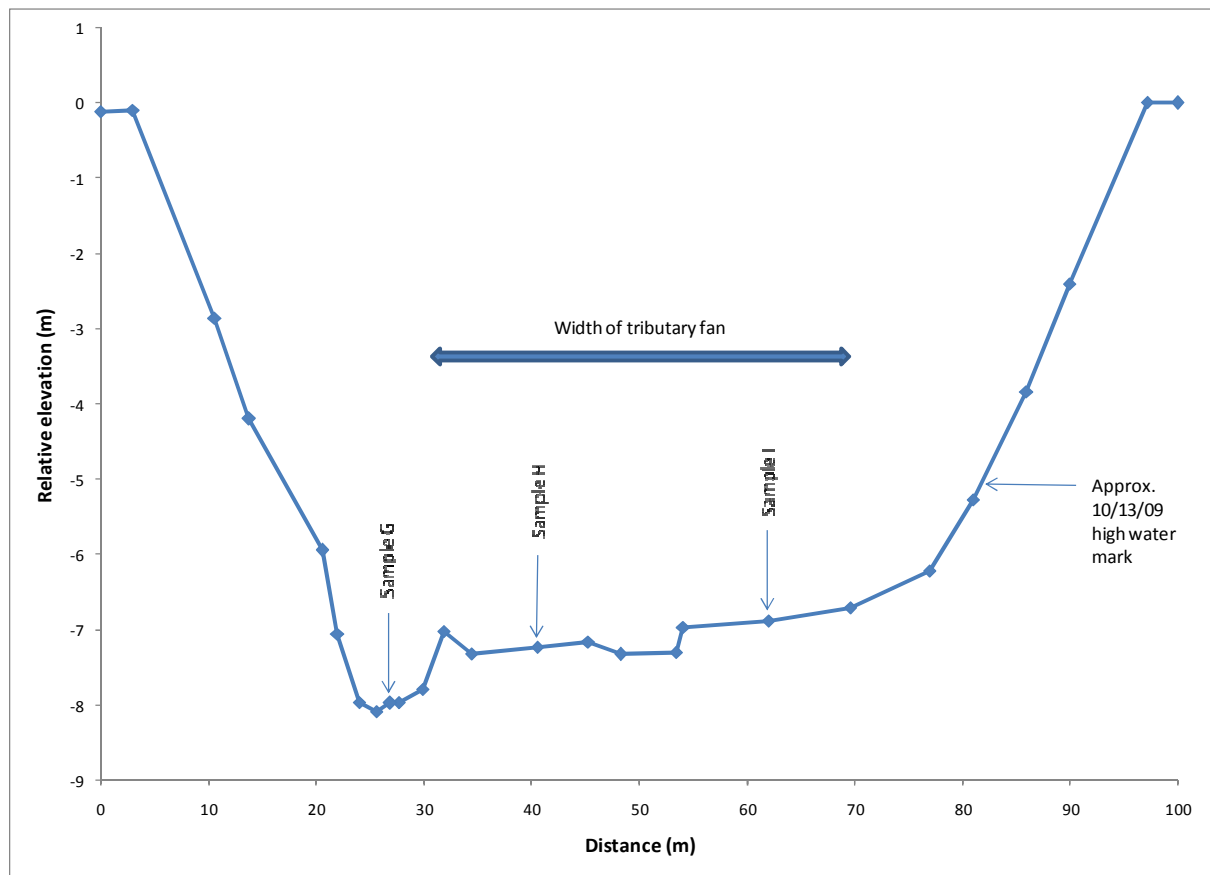
Appendix Figure 26. Cross section approximately in the middle of the fan, looking downstream. Locations of bulk sediment samples are noted.
