OBSERVATIONAL STUDY OF SYCAMORE REGENERATION

at two sites in Santa Clara County after the 2016-2017 Water Year

JUNE 2018

This memo serves as an update to the Sycamore Alluvial Woodland Habitat Mapping and Regeneration Study (Beagle et al. 2017), and describes changes seen at the two study sites, Upper Coyote Creek and Pacheco Creek, between fall 2015 and fall 2017. We were tasked with augmenting tree core data as reported in 2017 by adding additional trees to further investigate the relationship between sycamore establishment and geomorphic position, which partially serves as a proxy for the role flood processes play in improving the suitability of conditions for sycamore seedling establishment and growth. Coincidentally, major flooding during water year 2016-2017 provided us with an exciting opportunity to observe sycamore regeneration at these two study sites. This memo reports on tree coring results; documents and maps sycamore seedlings and other observed regeneration strategies of sycamores during 2018 related to geomorphic change at the two study sites; proposes natural and anthropogenic drivers of sycamore regeneration; and outlines next steps for further investigation.

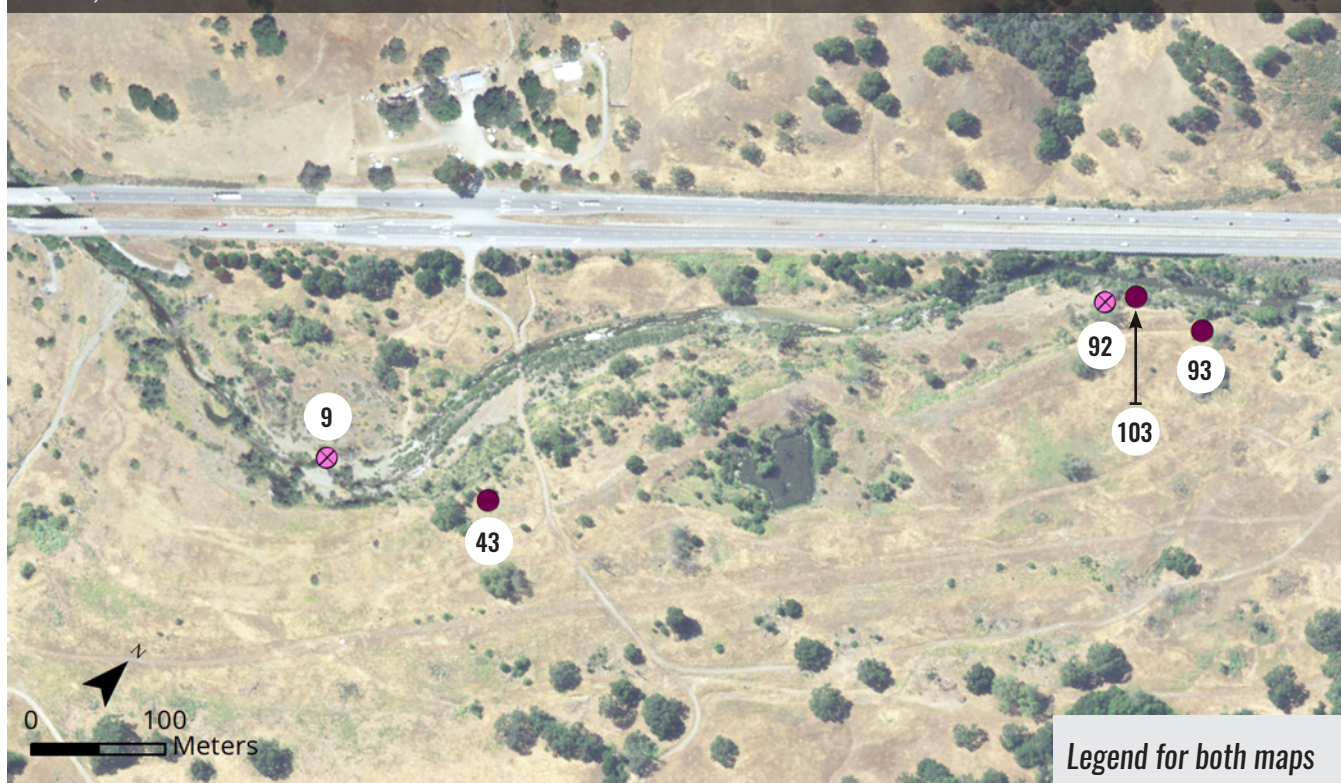
CORE SITES, PACHEGO CREEK

Figure 1. Site maps with location of tree cores on each creek. These maps show the location of 2016 cores (dark red) and 2017 cores (pink) on Pacheco and Upper Coyote creeks. The number next to the tree core symbol corresponds to the Tree ID (see Table 1).

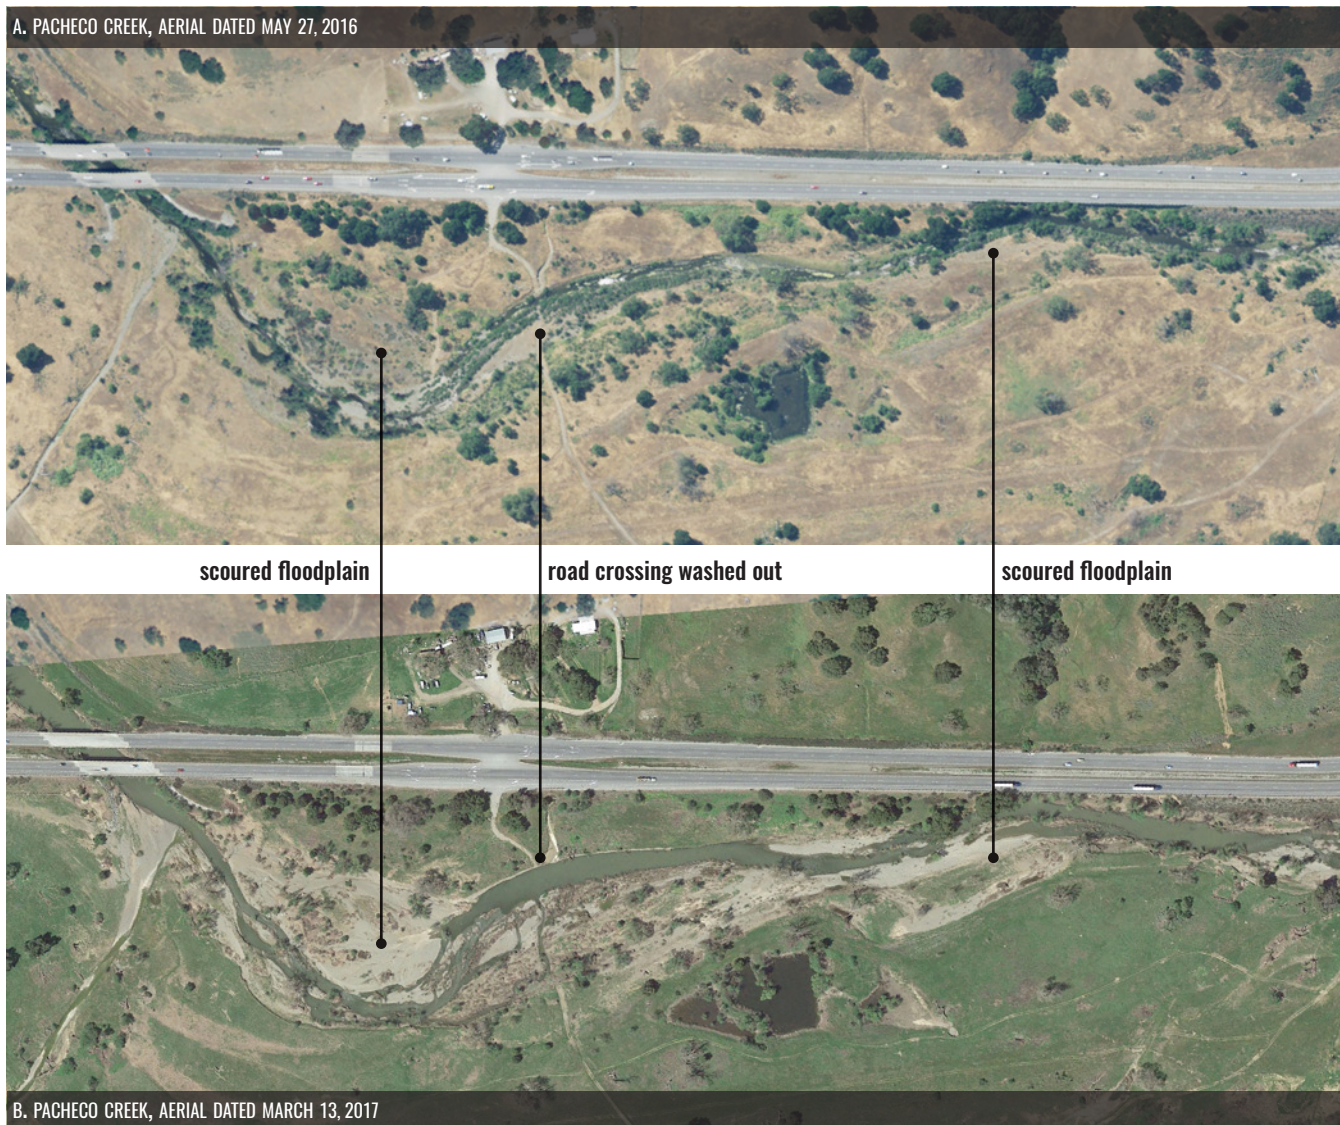
Figure 3. Geomorphic changes at Pacheco Creek. Pale areas indicate unvegetated cobbles and sediments. Note larger area of sediments reworked by flood flows during the 2016-2017 storms (B).

Pacheco Creek experienced its largest flood year on record since 1998, experiencing two >10 year events (Figure 2). As a result of the hydrologic activity, major geomorphic change was observed on site (Figure 3). These events scoured new floodplain areas, depositing coarse cobble and establishing what looked like an active channel in a previous grassy area. Similarly, side channels were activated or initiated, and new surfaces near and around the channel were scoured, forming new bars. The force of these events also damaged an in-channel road crossing and knocked down several trees.

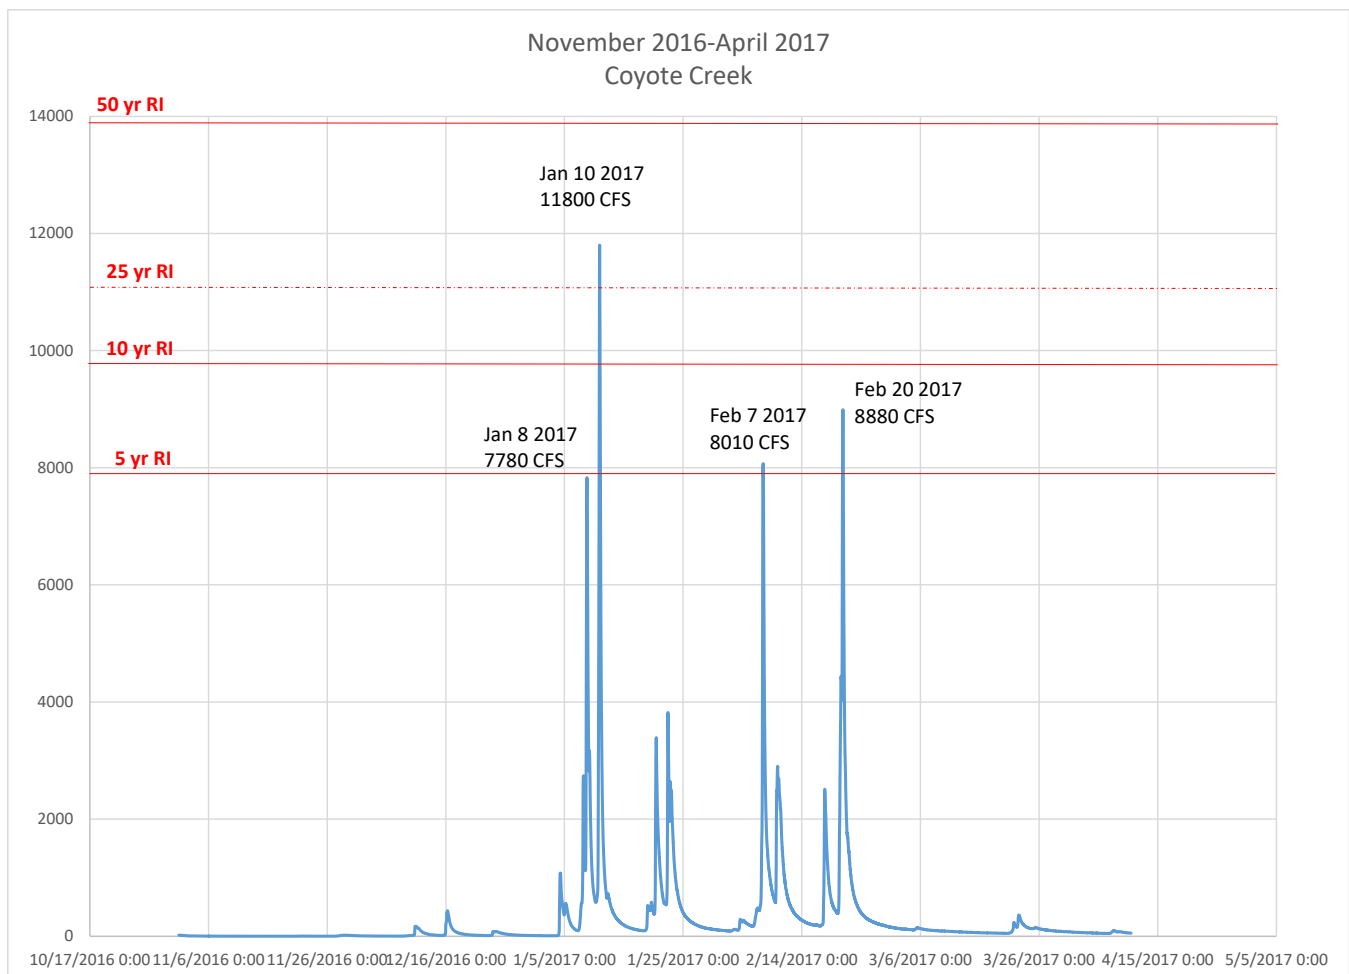
Figure 4. Hydrograph of flood events at Upper Coyote Creek from Water Year 2016-2017.

Upper Coyote Creek also experienced significant hydrologic events in the 2016-2017 water year, including an approximately 25-year event for this system and two >5-yr events (Beagle et al. 2017, Figure 4). These events lead to noticeable geomorphic changes: secondary channels were activated, depositing coarse sediment, and new medial bars were scoured (Figure 5). However, very few trees were downed, and a major historical side channel was not activated.

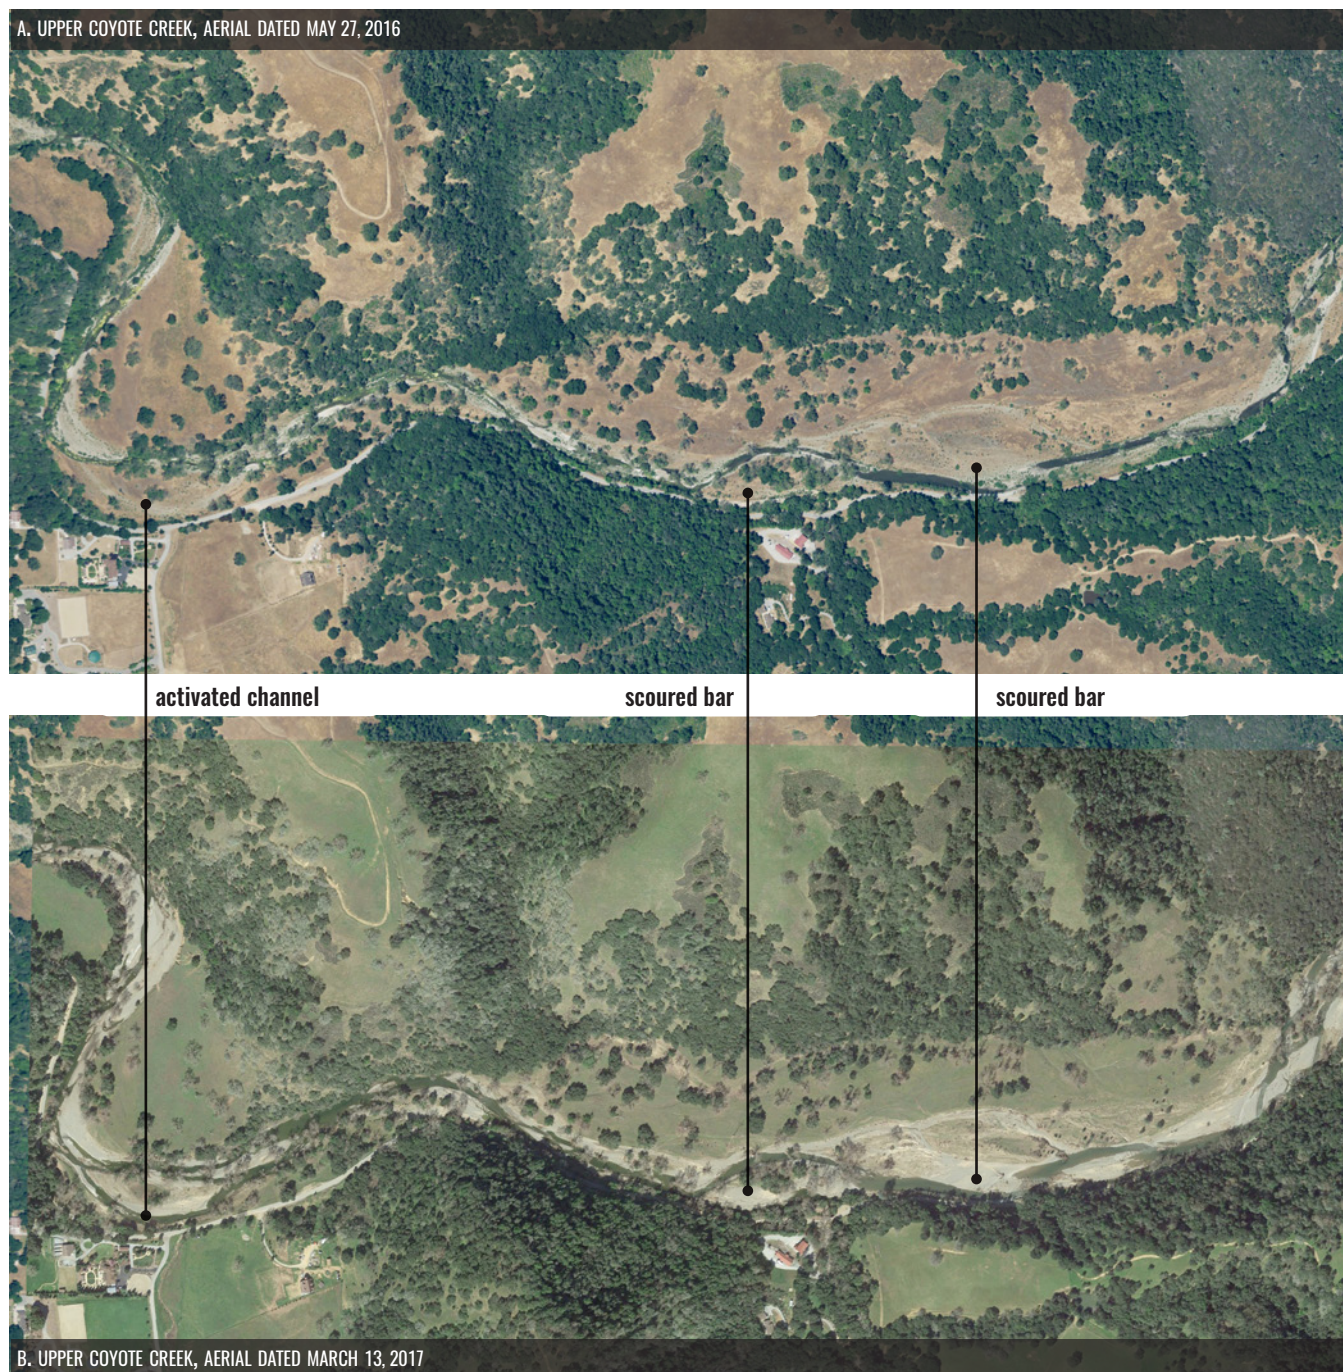
Figure 5. Geomorphic changes at Upper Coyote Creek. Pale areas indicate unvegetated cobbles and sediments. Note larger area of sediments reworked by flood flows during the 2016-2017 storms (B).

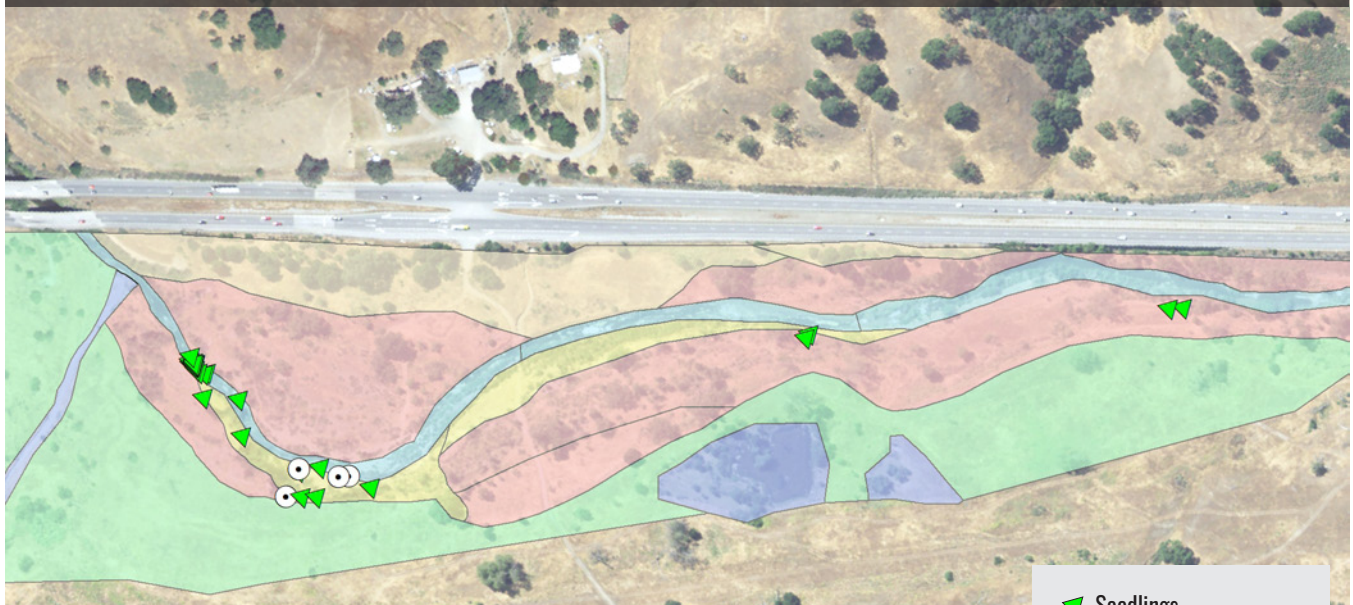
SEEDLINGS AND DOWNED, RE-SPROUTING TREES WITH GEOMORPHIC ZONES AT PACHECO CREEK

- ▼ Seedlings
- Downed re-sprouting trees
- Geomorphic Zones**
- Primary Channel
- Tributary Channel
- Inner Channel Corridor
- Inner Floodplain
- Outer Floodplain
- Pond
- Terrace

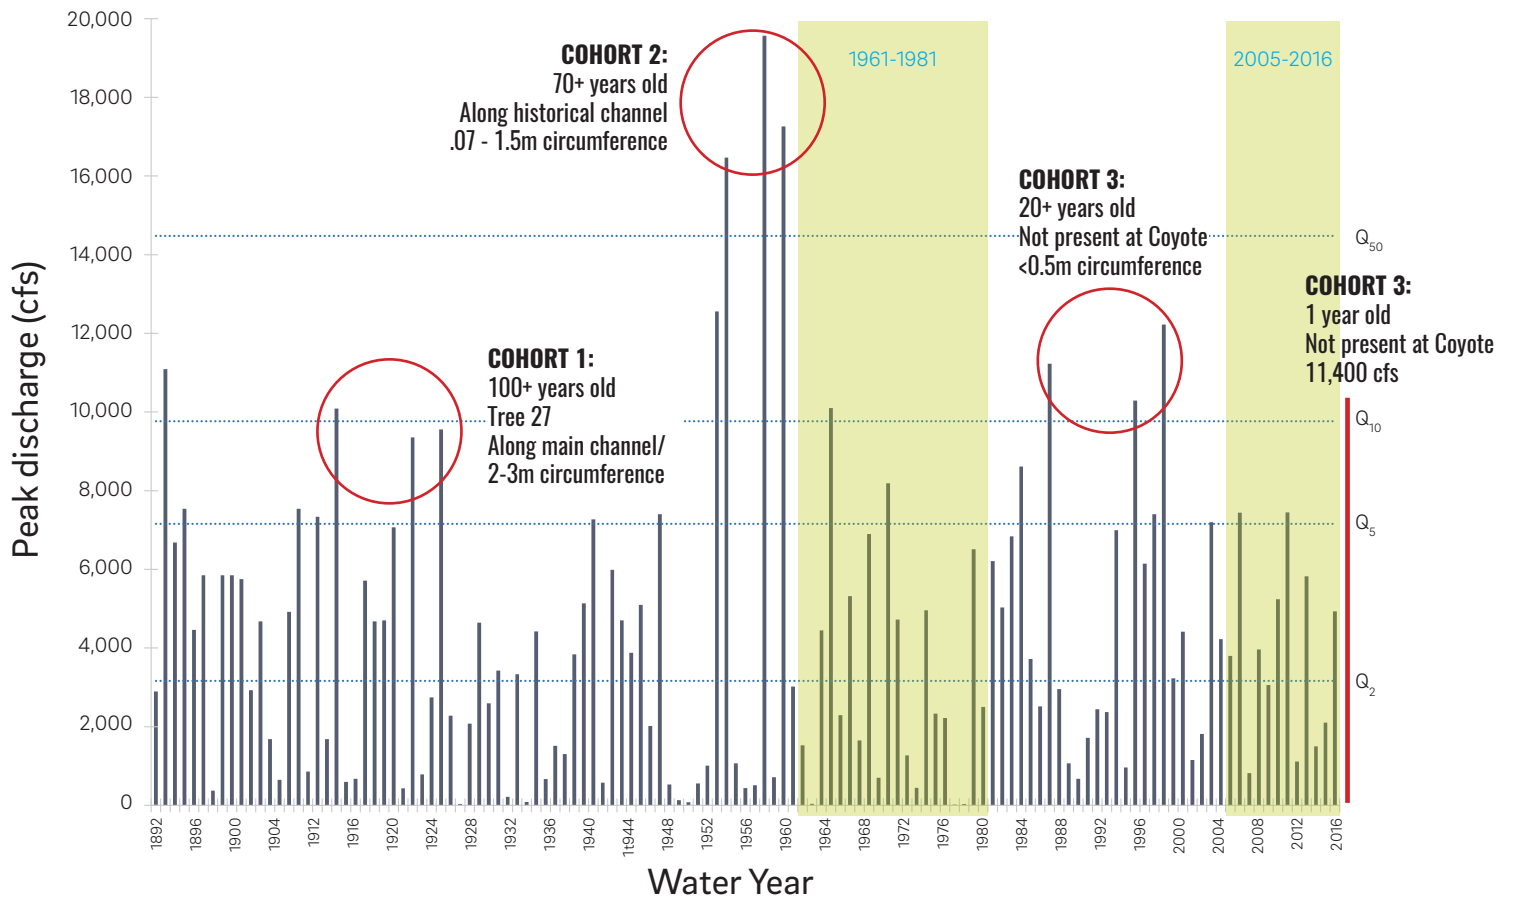
Figure 6 above shows the peak discharge from 1892-2017 from Coyote Creek at the Gilroy Gage, with missing data calculated from a regression from the Alameda Creek at Niles gage. Circles indicate major flood periods in the 1920s, 1950s, 1990s, and the 2017 event. Cohorts of sycamores observed at Coyote and Pacheco coincide with these flood events.

One potential pattern observed at both sites was groups of trees of the same size / age class within linear galleries. We speculate that these 'cohorts' of trees may have established during the same period under hydrologic conditions favorable to sycamore establishment and persistence. Correlating tree age with hydrological history could reveal patterns of regenerative flooding thresholds needed for sycamore establishment (Figure 6).

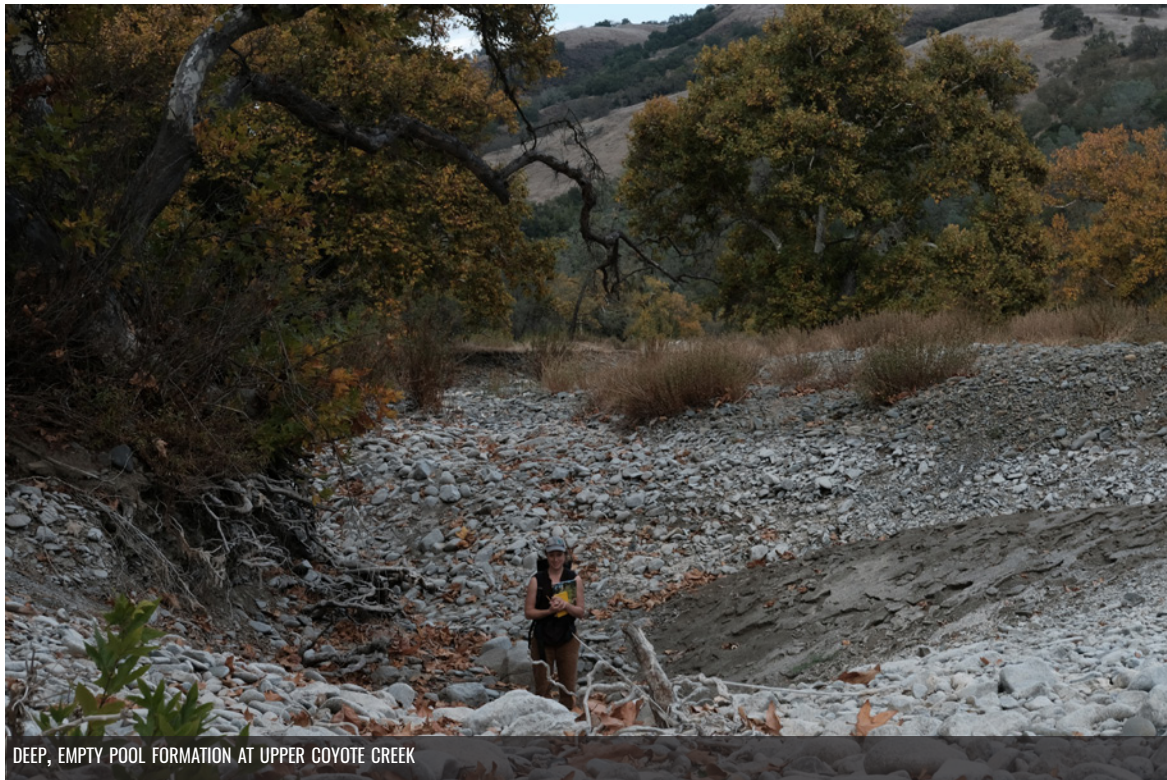
DEEP, EMPTY POOL FORMATION AT UPPER COYOTE CREEK

Many of the bars at Upper Coyote were steep sided, and the pool formations adjacent to them were deep (over 2 meters) and empty of water. It is possible that the gradient of the bars is too steep, or the difference in elevation between groundwater and the top of the bars is too great, to support healthy sycamore regeneration in these locations.

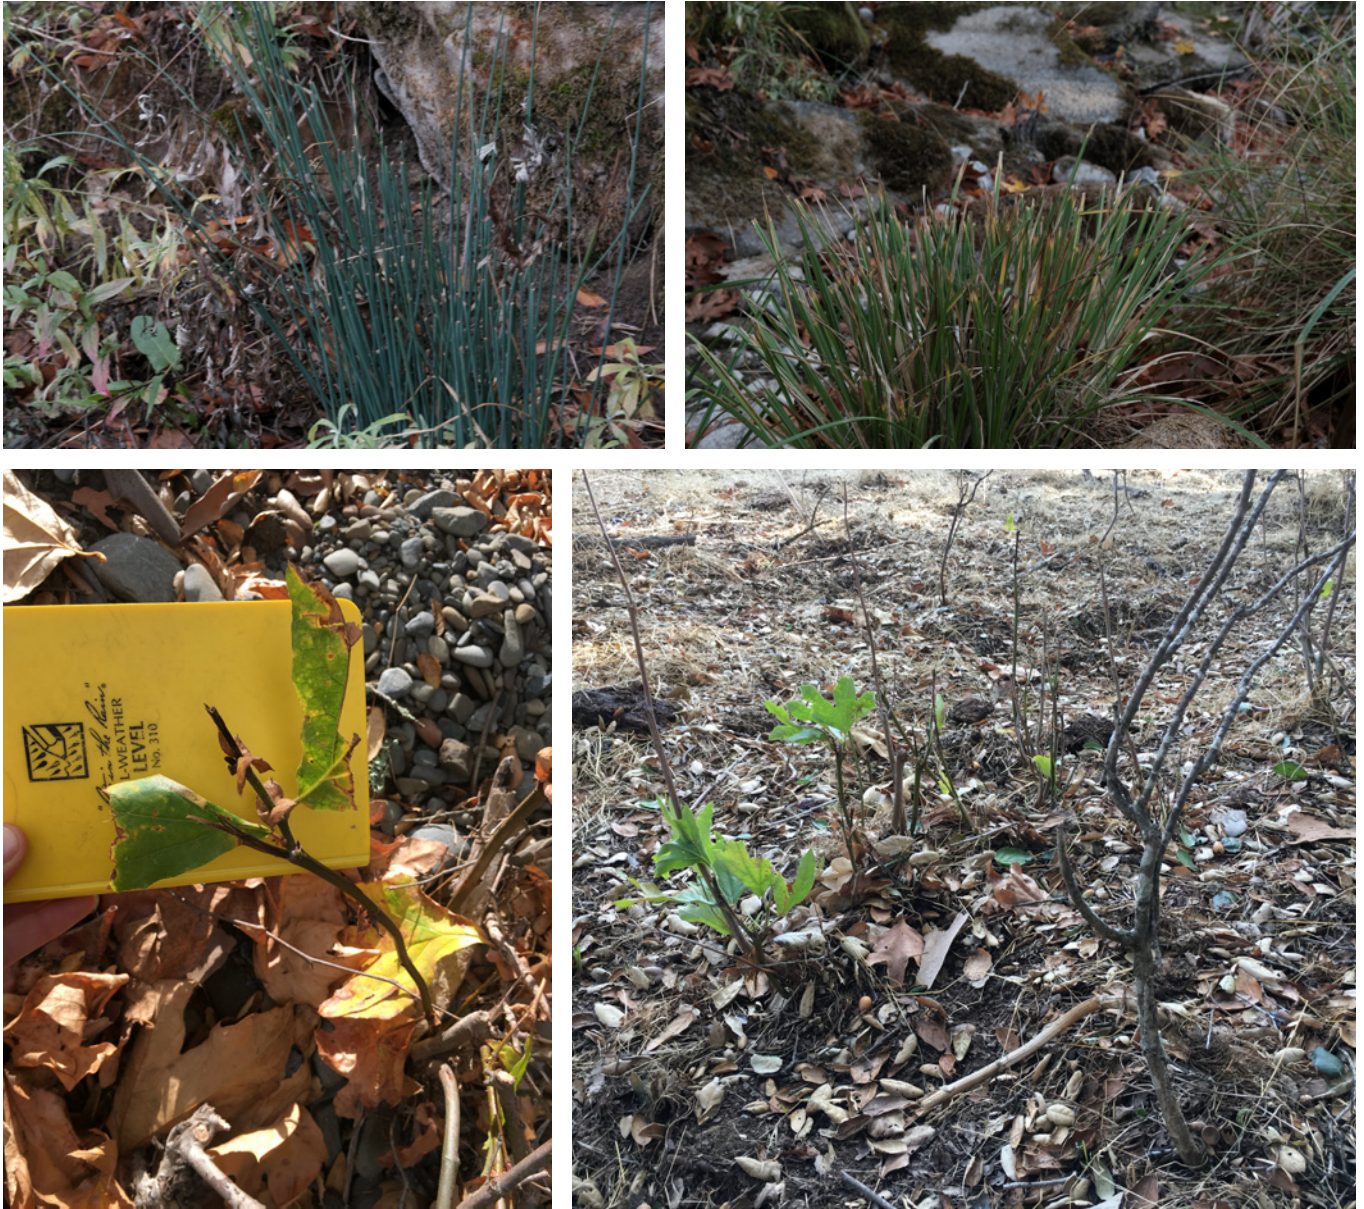
Figure 7. (above) Grazed *Carex* sp. at Upper Coyote Creek. (below) Browsed sycamore seedlings at Pacheco Creek. November 15, 2017.

Grazing and Browsing. More intensive grazing pressure might be limiting sycamore seedling survival at Coyote. Evidence of grazed vegetation was present throughout the site, including on mulefat, cottonwood, and young sycamore leaves (Figure 7). A browse line was observed at the more downstream end of the site. We also observed much deer scat and cow dung.
