Sonoma Creek

AN INTRODUCTION TO THE HISTORICAL ECOLOGY OF THE SONOMA CREEK WATERSHED

A tool for developing an action plan for the Critical Coastal Areas program

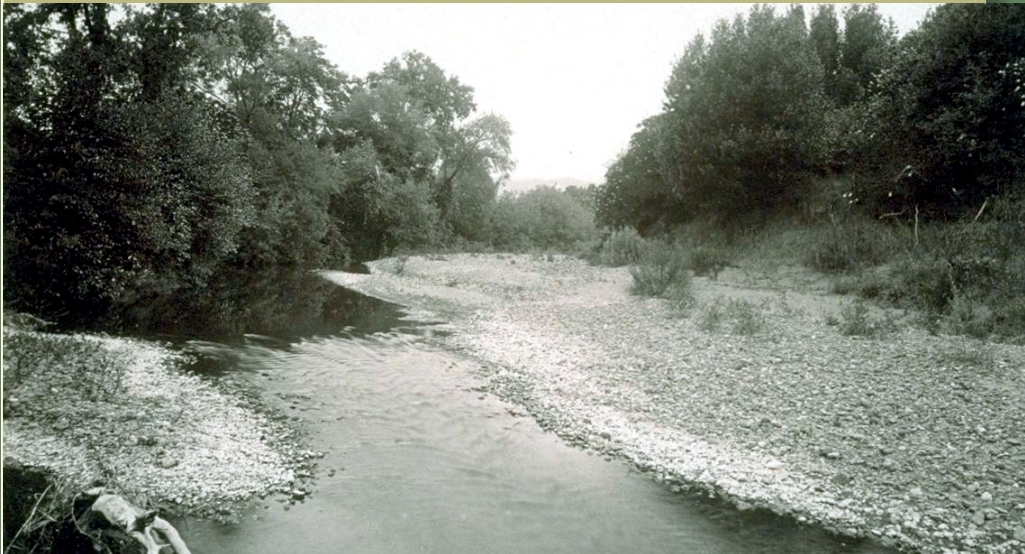
Discontinuous tributaries

Maps of Sonoma Valley made before 1875 consistently show tributary channels which seem to end on the valley floor (left) before reaching the mainstem of Sonoma Creek, especially in the El Verano area and above the Kenwood Marsh (O'Farrell 1848; Peabody 1851; Bowers 1867). Altimira describes a creek, which did "not flow beyond the base of the hills, but instead [ended] on the plain." He compares it to a nearby creek which "runs until it joins the Arroyo Sonoma." Similarly discontinuous tributaries may have included Rodgers, Carriger, Hanna, Winkle, Fisher, Champlin, Stuart, Nathanson, and Kunde creeks as well as numerous smaller ones. In the Kenwood area, Sonoma Creek itself was described as "spreading out and losing itself in the valley," "forming a kind of willow thicket and marsh or lagoon." (Boggs 1861). This evidence suggests that the mainstem Sonoma Creek may have lacked a direct channel between the outlet of the Kenwood Marsh complex and Adobe Canyon. One interpretation of this phenomenon is that these creeks descended from the hills and spread out into a system of distributaries, sinking under the surface as they crossed their alluvial fans. This historical pattern of isolated tributaries with channels ending on alluvial fans has been documented for other Bay Area watersheds including Napa River and Coyote Creek (Grossinger et al. 2006, 2007). Under winter conditions on saturated soils, sheet flows from these creeks probably spread out over much of the valley floor. Water from winter storms was slowly shunted down the valley, raising water levels of wetlands and lakes and replenishing groundwater as it moved toward the bay (Micheli 2003).

Sonoma Creek near El Verano. Watkins 1887.
Image courtesy The Bancroft Library, UC Berkeley

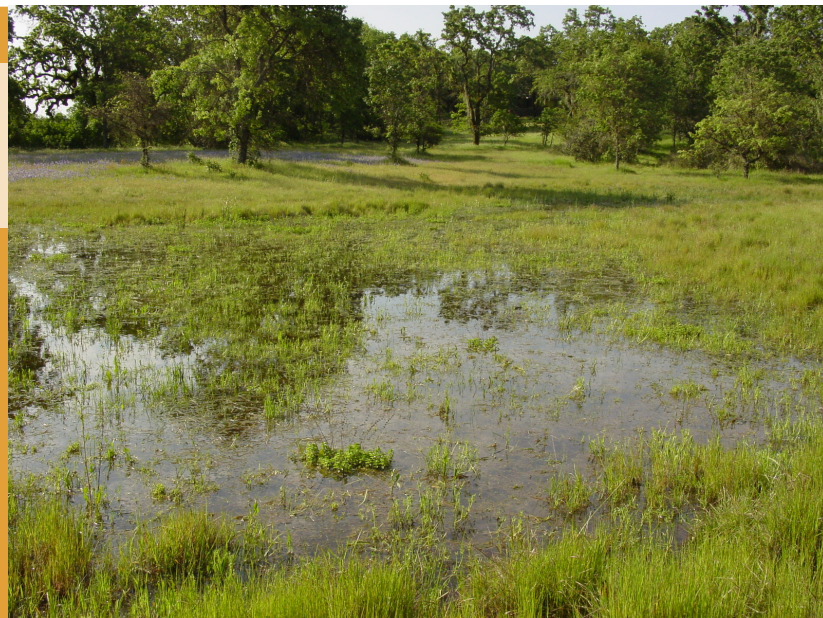
Perennial Wetlands

Early maps and accounts (Anonymous 1837; Peabody 1851, Boggs 1861) describe a large marsh complex near the upper end of the watershed covering about 400 acres. Known as the Kenwood Marsh (right A: 1851, B: 1942, C: 2005), these wetlands stretched five miles from the watershed boundary (Pythian Road), through present-day Kenwood, to near Dunbar School in Glen Ellen. In fact, this marsh was part of a larger wetland complex extending to present-day Santa Rosa. This suggests that a subsurface connection existed, and may still exist, between the Sonoma Creek and Santa Rosa Creek watersheds. Groundwater was exceptionally high throughout this part of Sonoma Valley. Parts of the Kenwood Marsh probably held surface water throughout the year. By catching runoff from winter storms and releasing it over many months, the Kenwood Marsh acted as a sponge, reducing downstream flooding and increasing the flow of Sonoma Creek during the summer dry season.
