APPENDIX

Appendix A- Series of air photographs

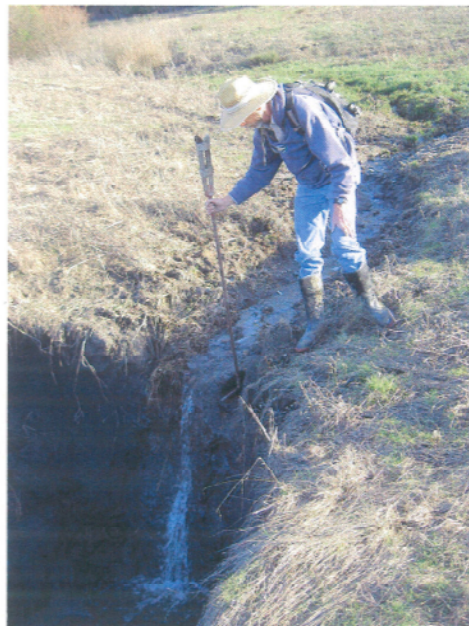
The soil immediately along the gully is loamy at the head-cut and at the “waterfall” half-way between Pinole Creek and the trees. However, the soil around it is clayey.

Head cut of section of Gully D showing erosive flows.

Suggested Remedies: Temporarily exclude grazing or delay grazing from all sites until soils are dry enough following the rainy season to prevent soil compaction. Natural shrinking and swelling of the soil, combined with continued vegetative cover, will reverse compaction after several years. Roughening the soil surface may also increase retention of storm-water and decrease runoff. Head-cuts may need to be laid back to 2:1 slopes (or more) and armored with rock and/or vegetation.

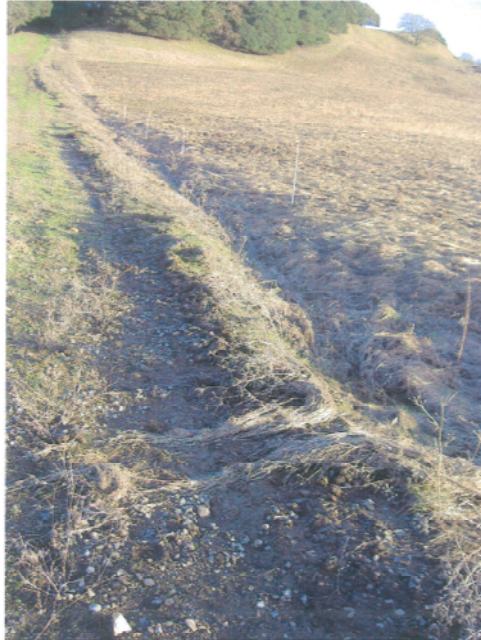
Surface runoff concentrating above access road, then flowing to eroded area below road. Gully D.

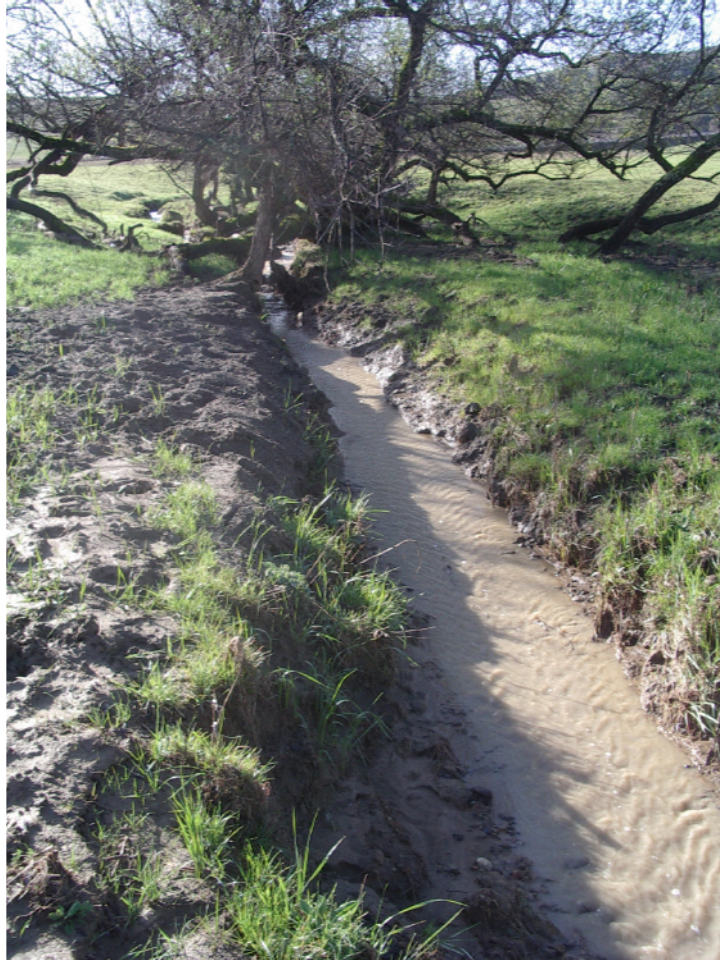
Figure A-40. Looking upstream along Gully A near AXS1, 3/2/2006.

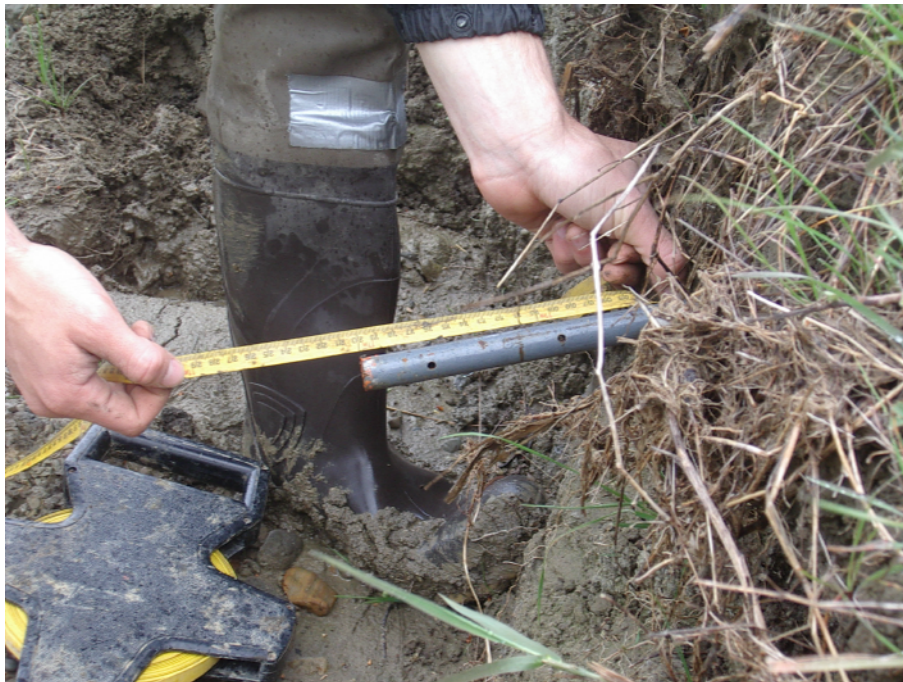
Figure A-42. Taking a measurement of an exposed bank pin at AXS1, 2/27/2006.

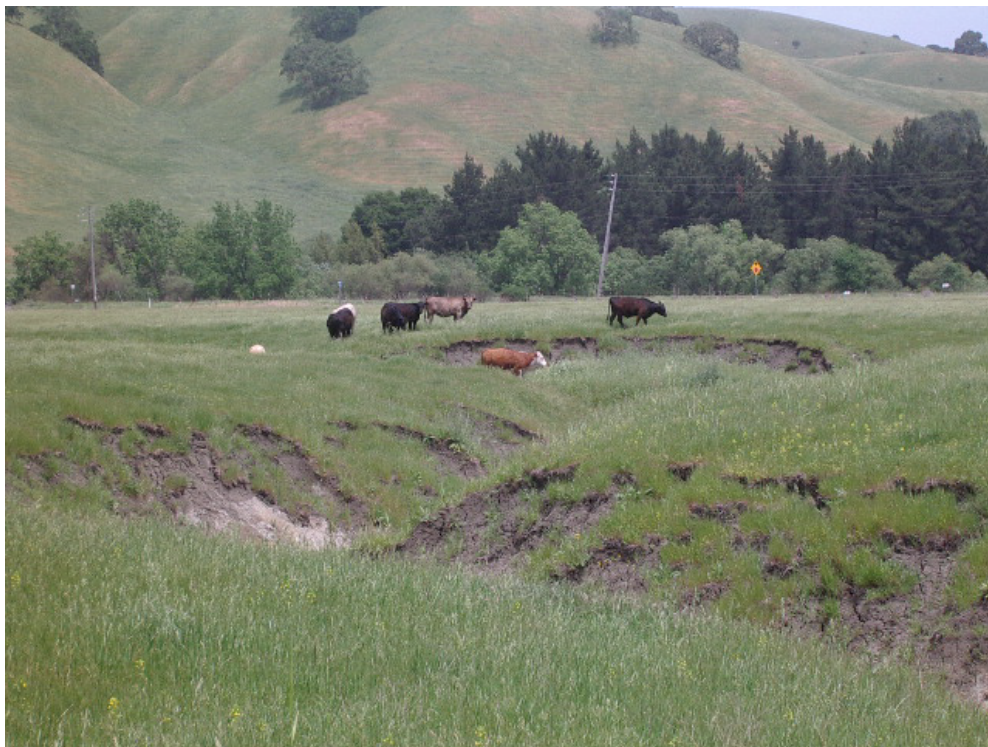
Figure A-46. Cattle in the Gully A channel, 5/12/2006.

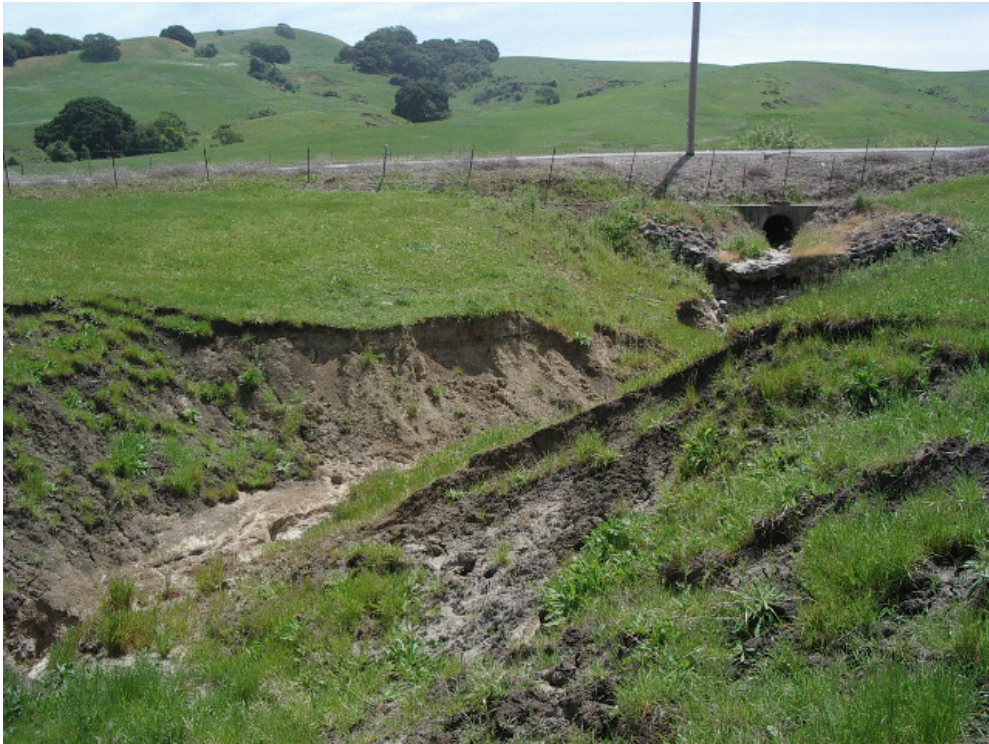
Figure A-47. Looking upstream at the culvert on Gully A at Castro Ranch Road.

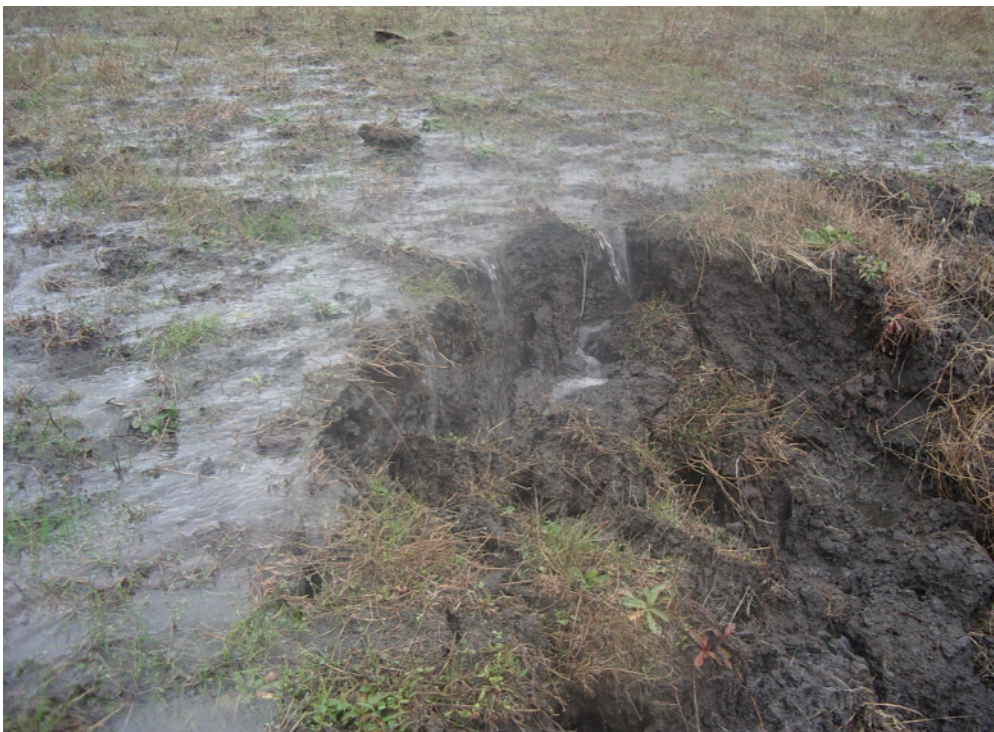
Figure A-51. Pasture surface runoff in Gully A near Castro Ranch Road, 12/18/2006.

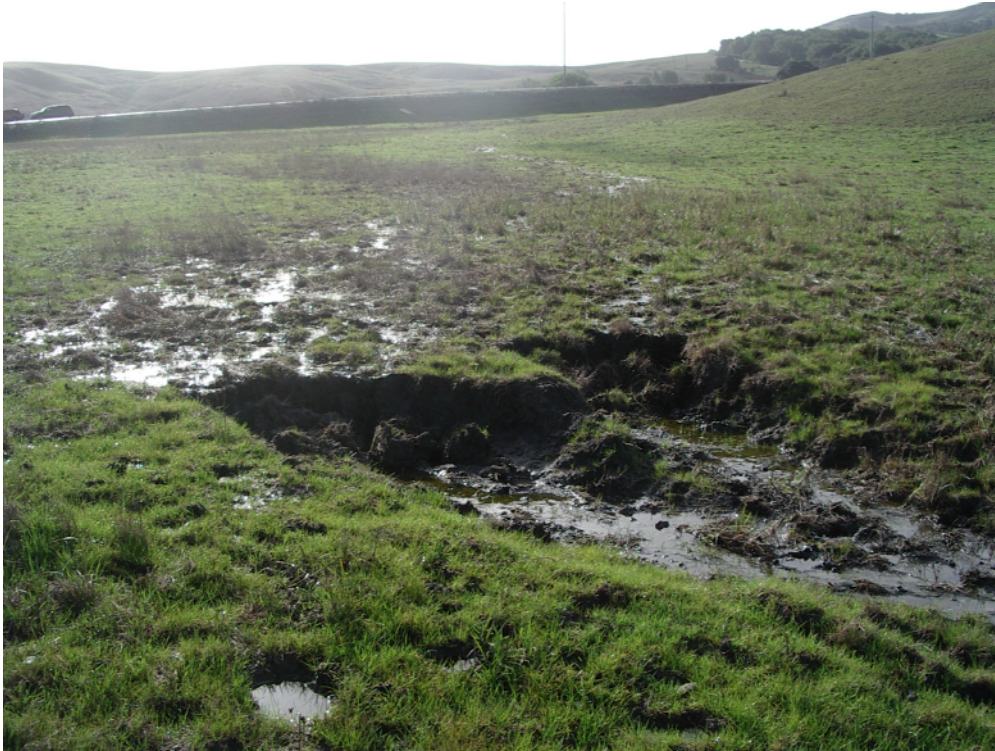
Figure A-52. The small headcut immediately upstream of AXS7.

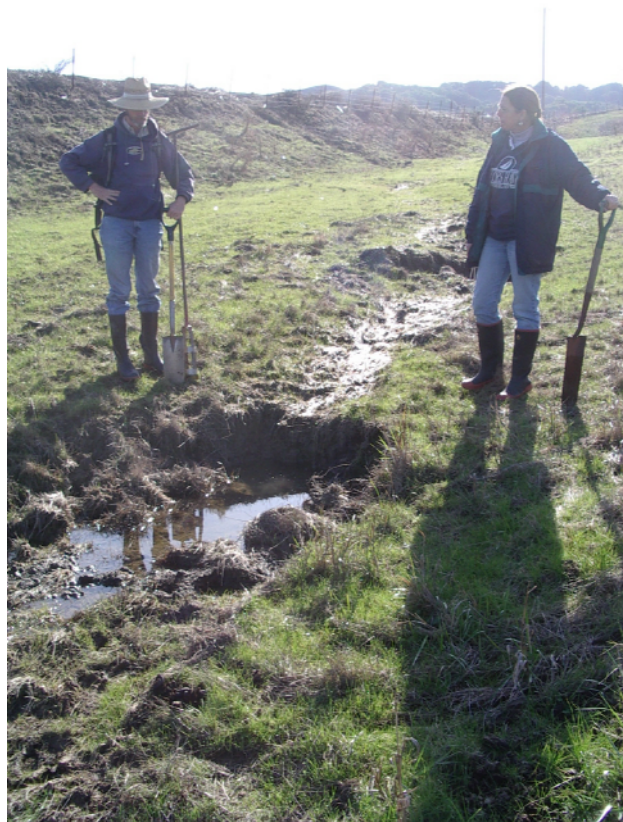
Figure A-53. One of the small headcuts in the pasture upstream of AXS7.

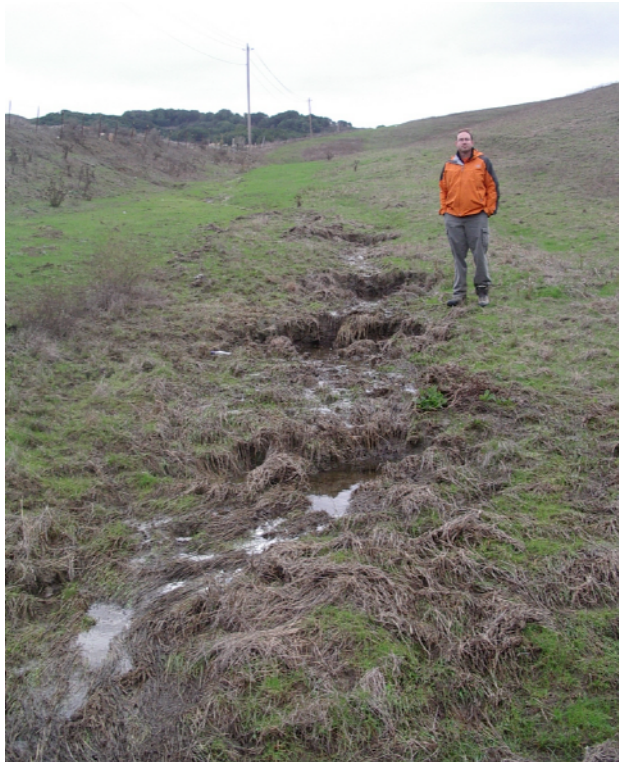
Figure A-54. The series of small headcuts upstream of AXS7, 1/1/2006.

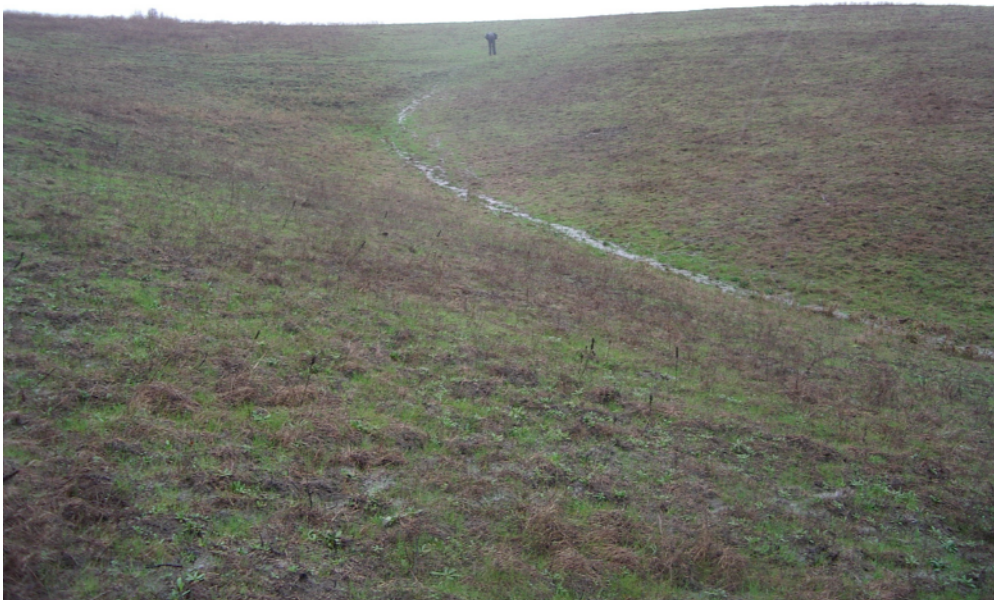
Figure A-55. Initiation of surface flow in a small Gully A tributary basin, 1/2/2006. Seth is standing at the point of initiation.

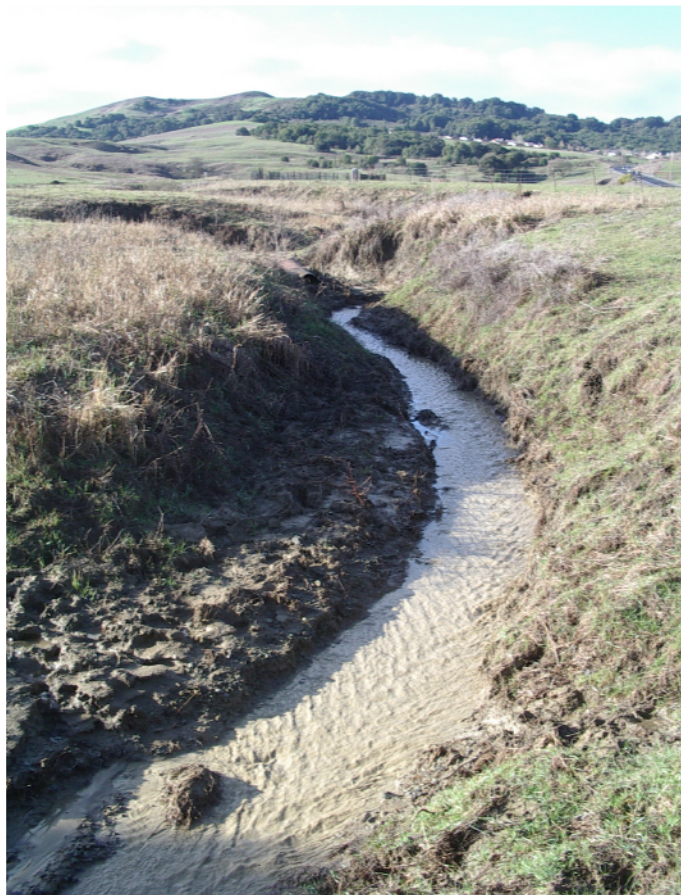
Figure A-59. Looking upstream along Gully B near the mouth, 3/6/2006.

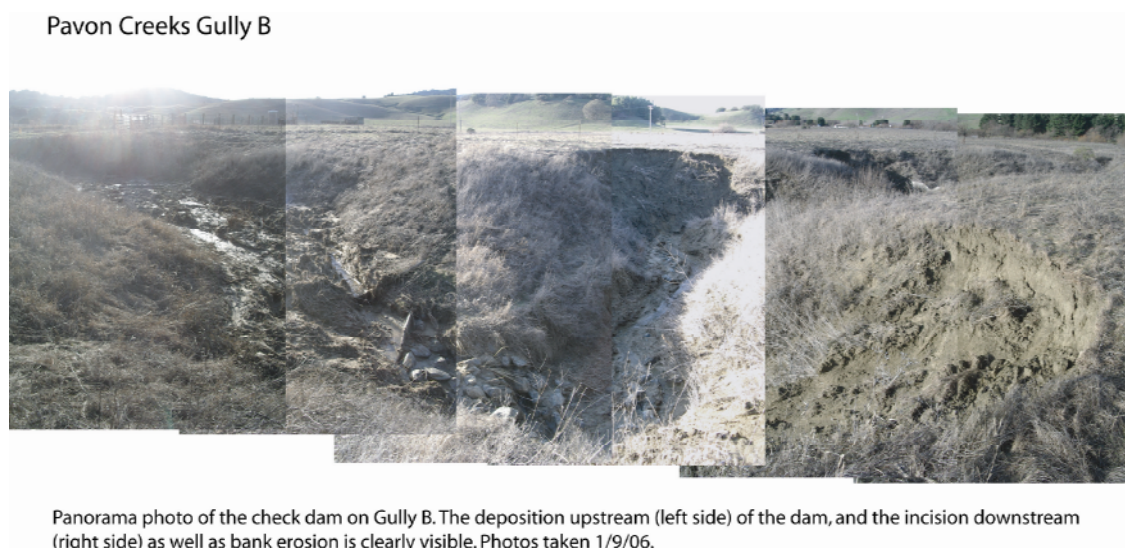
Figure A-61. Panoramic photograph of the check dam on Gully B.

- Stabilizing and maintaining the remaining grade control structure on Gully B downstream of the ranch road to prevent future failure (failure would release a large plug of sediment, and jeopardize the ranch road)

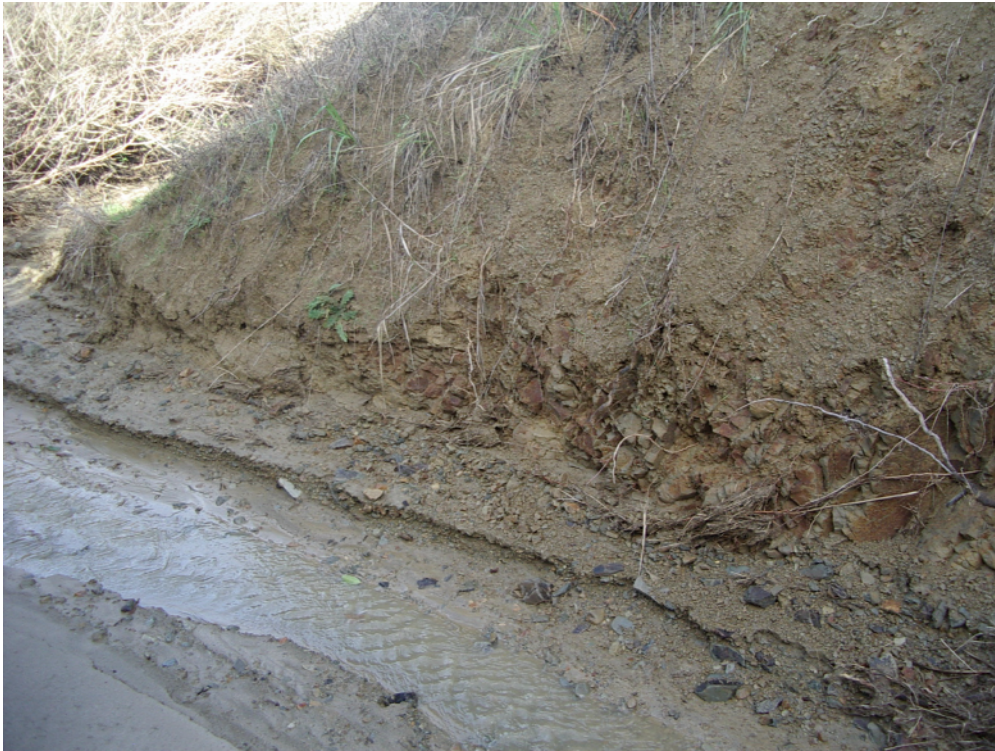
Figure A-62. Bedrock outcrop at the base of a bank in Gully B.

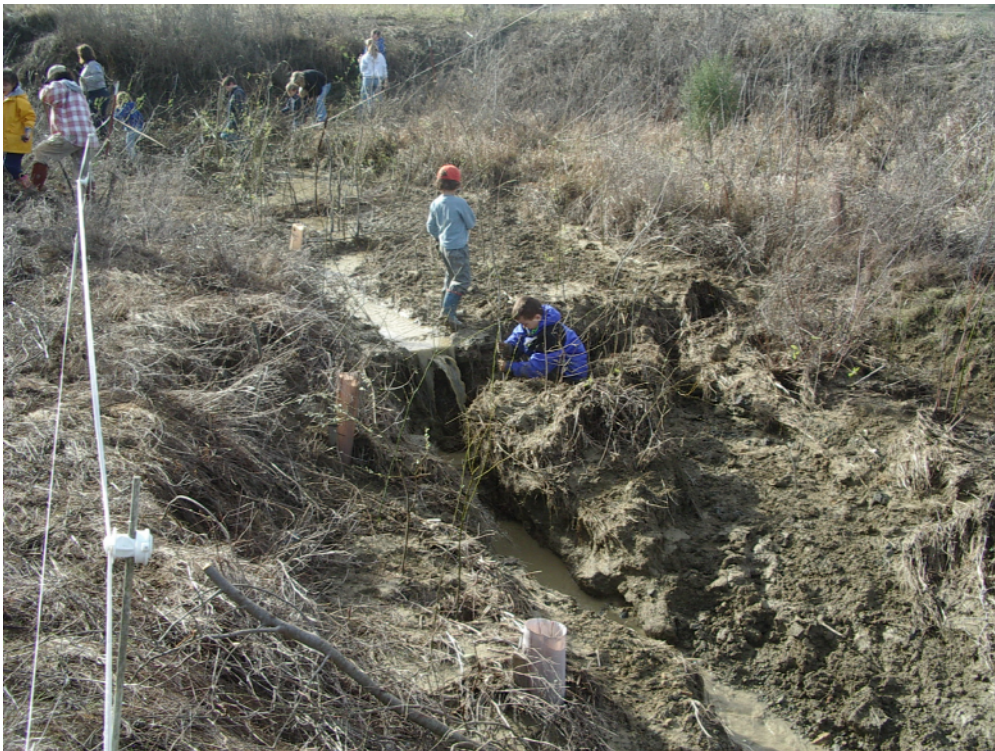
Figure A-63. A step in the profile of Gully B, upstream of the ranch road.

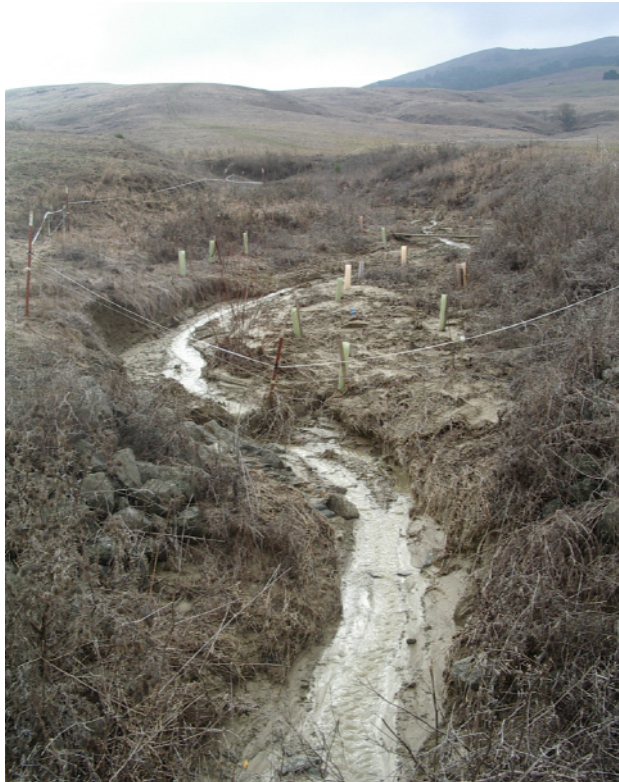
Figure A-64. Gully B aggradation upstream of the ranch road, 1/21/2006.

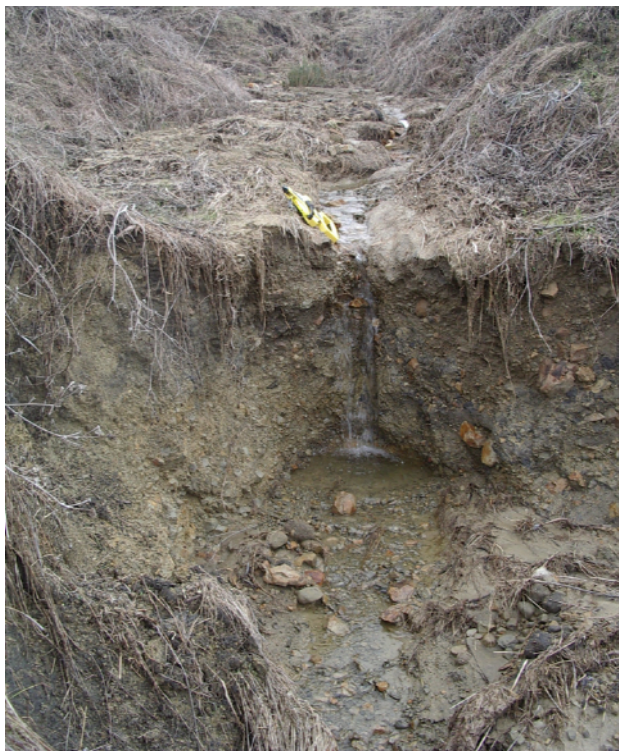
Figure A-65. One of many small knickpoints in the headwaters of Gully B. Note the previously deposited fluvial material in the gully bed.

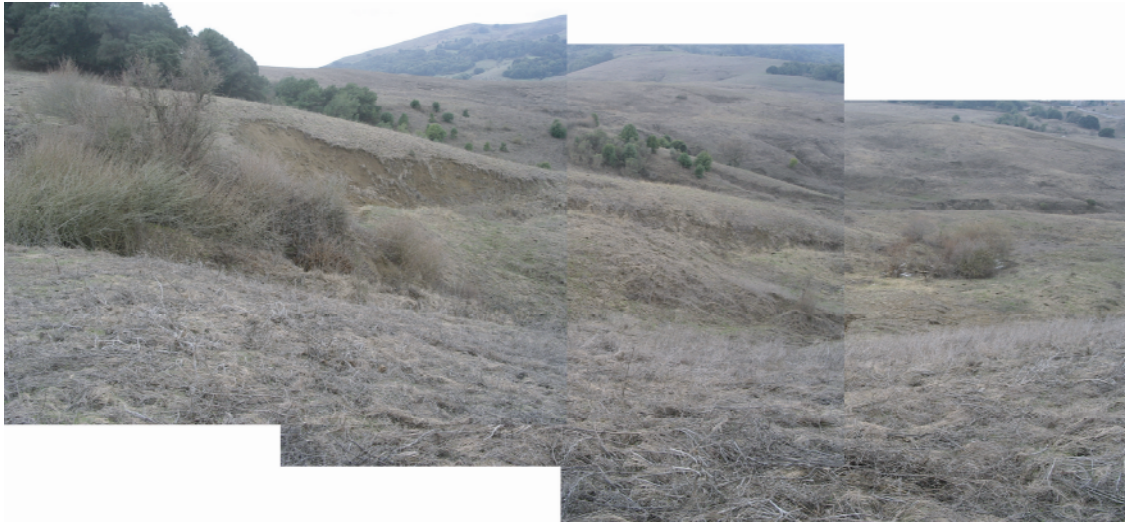
Figure A-66. One of the active landslides in the Gully B watershed.

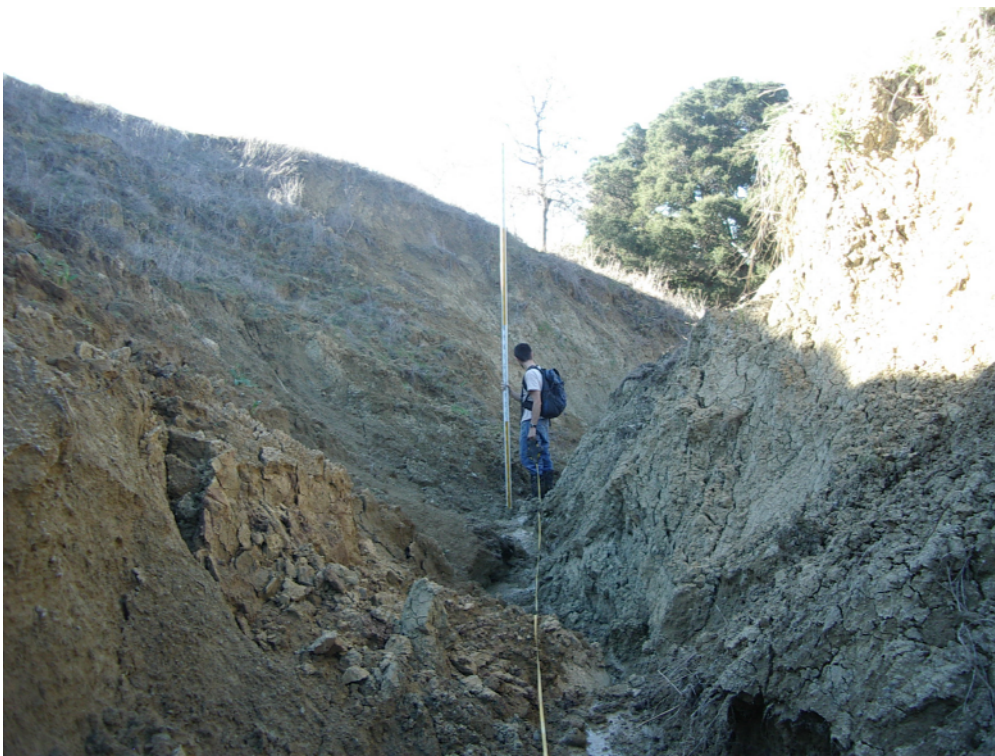
Figure A-67. Channel banks in the canyon reach of Gully B.

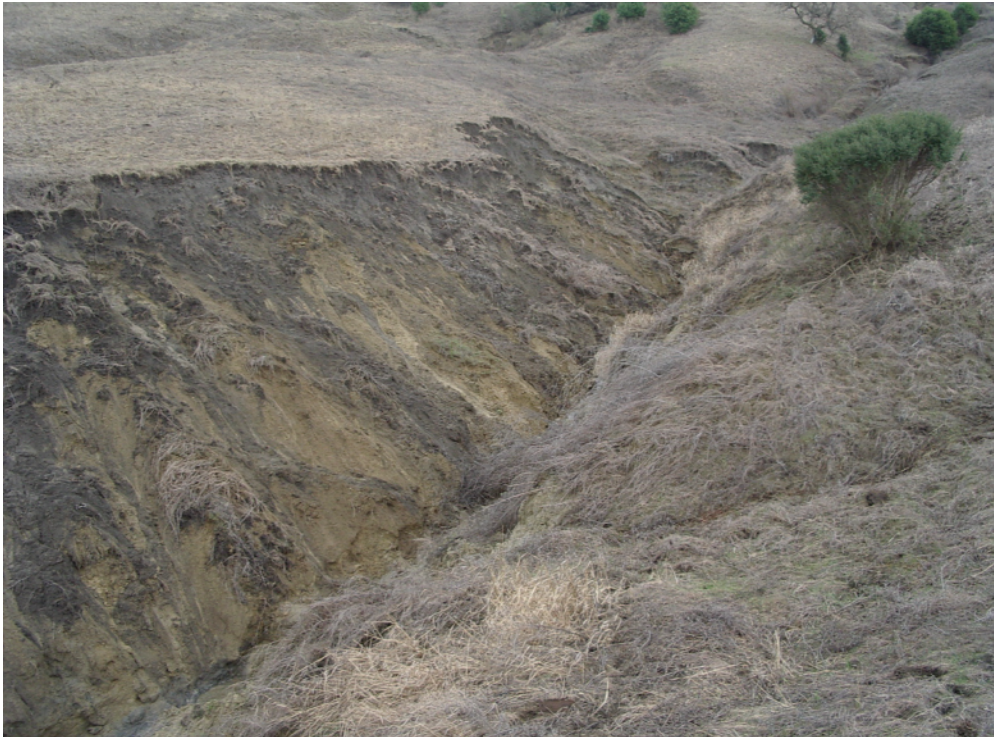
Figure A-68. Looking upstream in the canyon reach of Gully B, 1/1/2006.

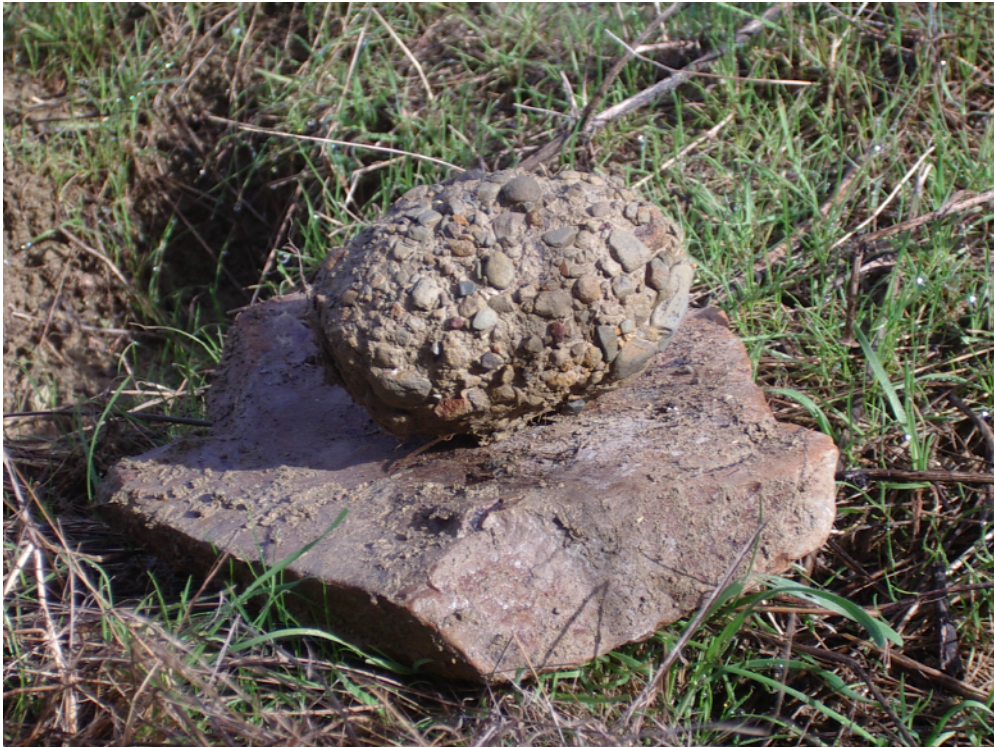
Figure A-69. Mudball from Gully B.

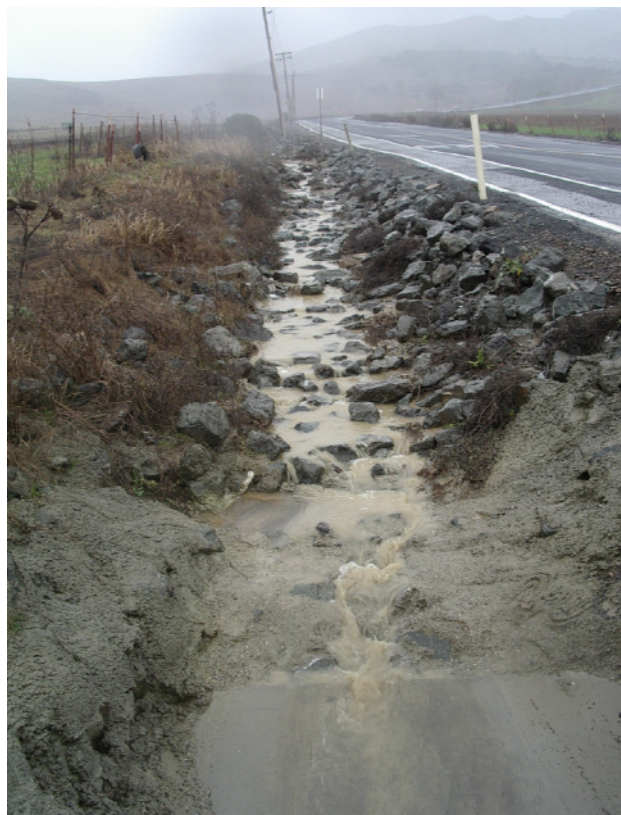
Figure A-71. Looking upstream at storm flow in Gully C, 12/30/2006.

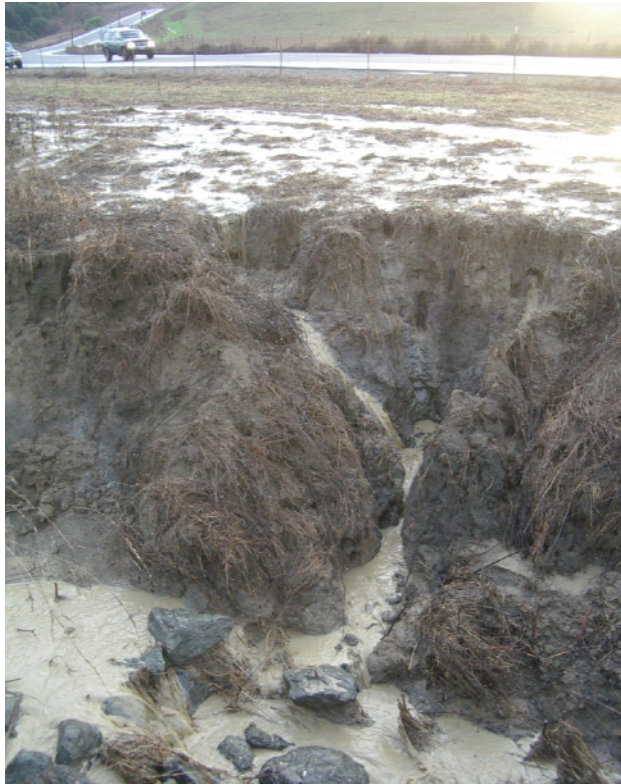
Figure A-72. Pasture surface flow returning into an incised reach of Gully C downstream of the ranch road, 1/2/2006.

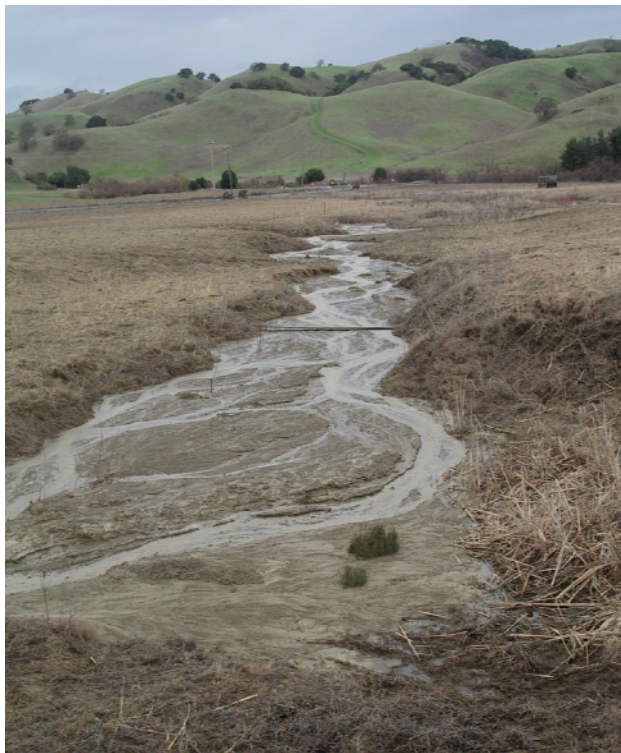
Figure A-73. Braided aggrading reach in Gully C, 1/1/2006.

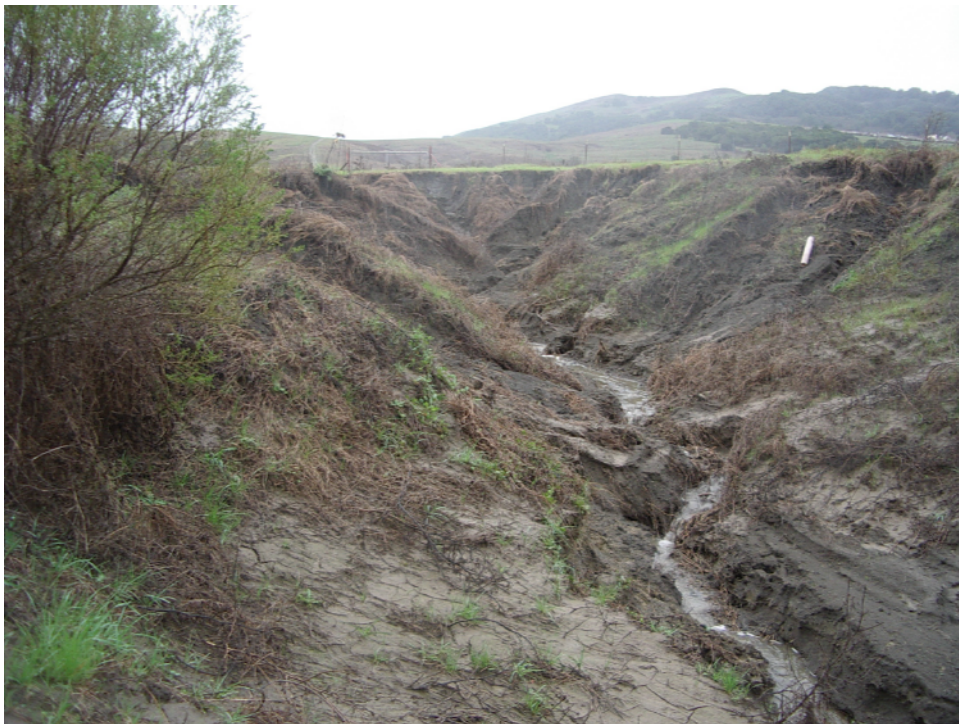
Figure A-75. Looking up the Gully BC headcut, 2/27/2006.

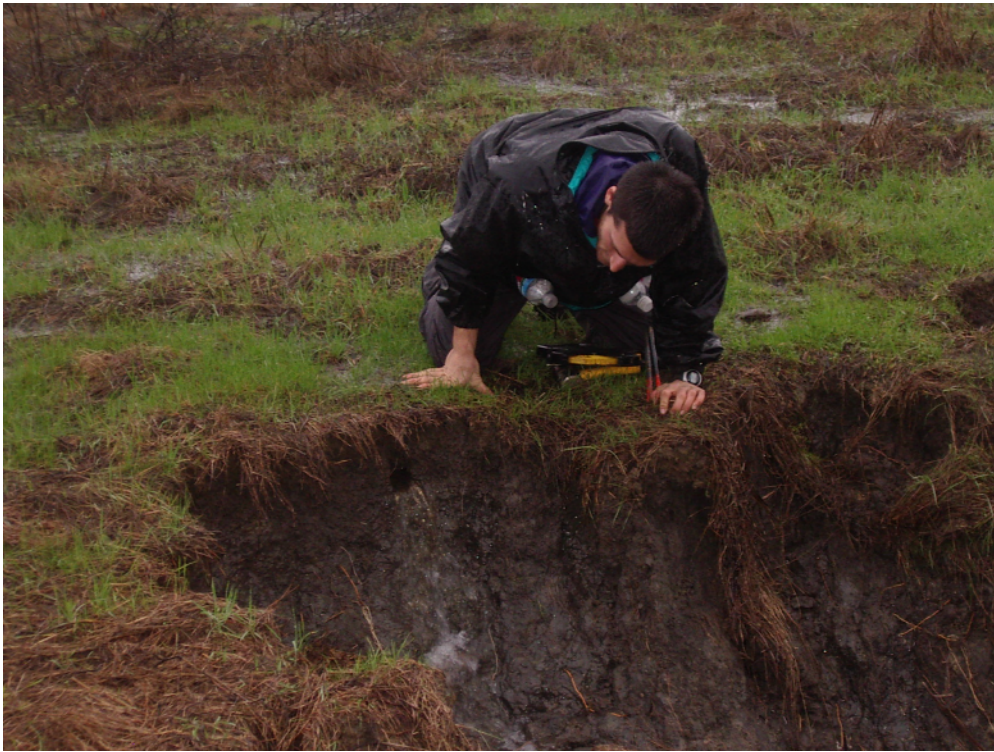
Figure A-76. Looking at a soil pipe at the BC headcut, 1/2/2006.

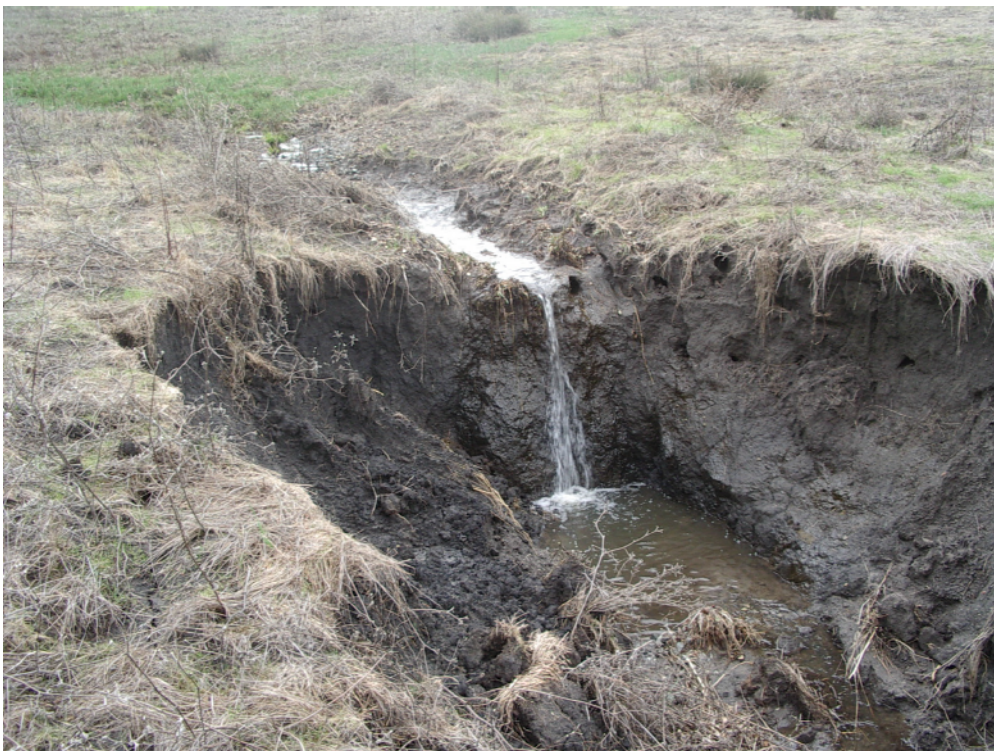
Figure A-77. The gully DXS2 headcut, 1/21/06.

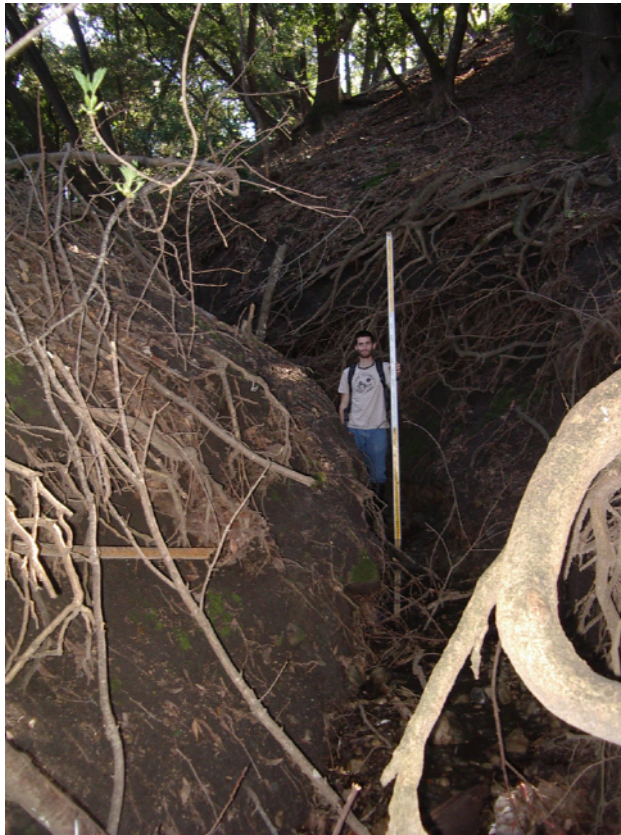
Figure A-78. Looking upstream in the canyon reach of Gully D.
